**Technical Report to the
U.S. Department of the Interior
Bureau of Land Management**

**Results of Environmental Monitoring
from 2004 to 2007 at the Belle Eldridge Site,
Lawrence County, South Dakota**

May 14, 2007

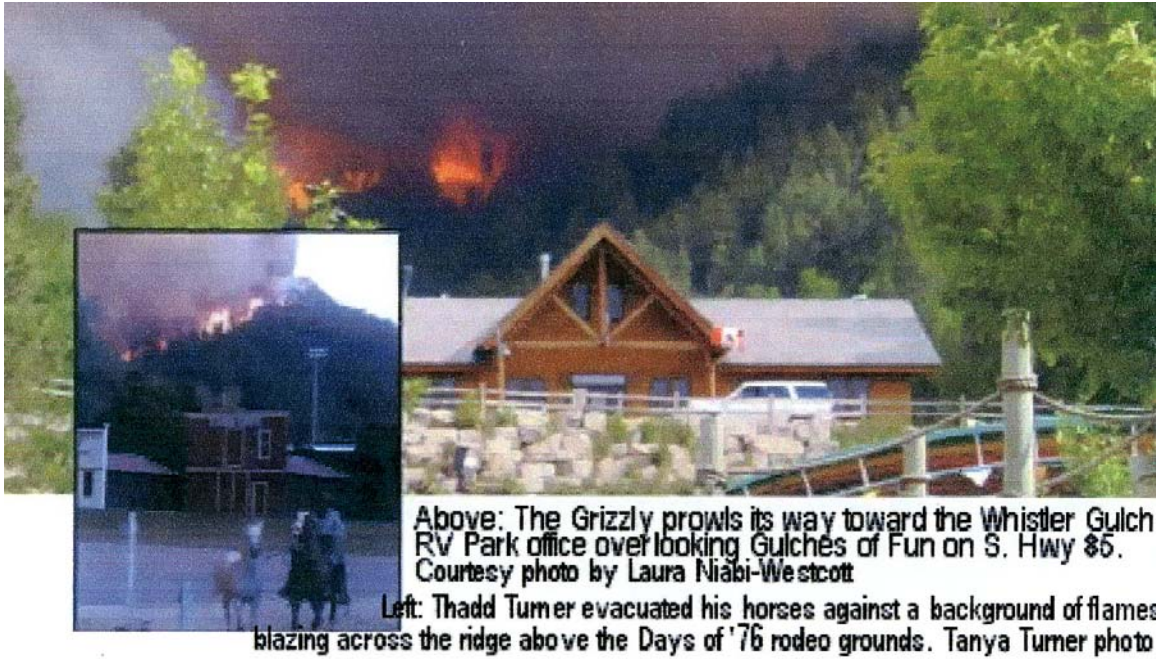
The Grizzly Gulch wildfire of July, 2002, consumed much of the Belle Eldridge site (Figure 3; Figure 4) and resulted in greater than normal erosion and sediment flushing during the months following the wildfire (Figure 5). Had the site not been remediated and the tailings emplaced within a capped repository, it is likely that off-site migration of heavy metals within sediments, and subsequent generation of acidity, would have been significant at downstream locations. During monitoring from 2004 to the first half of 2007, Spruce Gulch Creek appeared to have little turbidity or suspended sediments at the Belle Eldridge site, including the area of the former tailings dam. Thus, little suspended sediment was transported off-site to downstream areas. In addition, concentrations of dissolved metals in Spruce Gulch Creek generally were low.
