Fort Point National Historic Site
Golden Gate National Recreation Area

Abbreviated Fort Point Historic Structure Report

September 2006

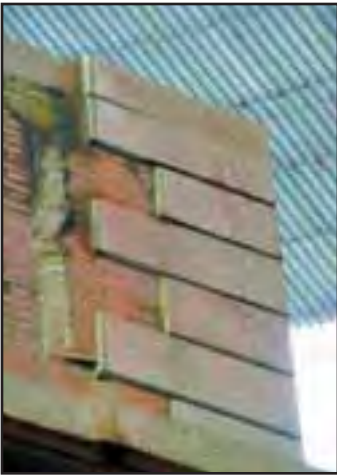
Lateral displacement is evident in the south flank parapet. (Jane Lehman, 2005)

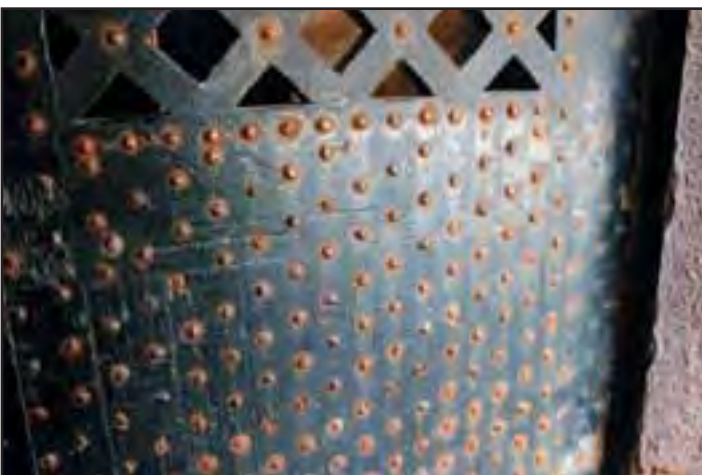
The rivets on the original wood doors rust quickly in the marine environment. (John Martini, 2005)

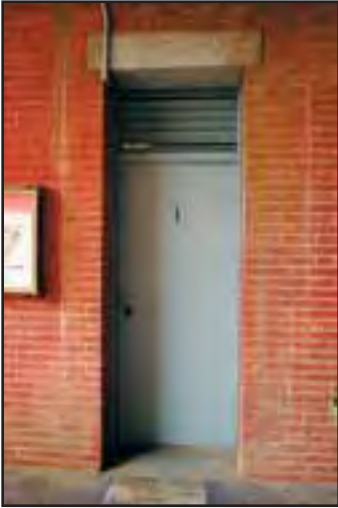
The transom windows above the 3rd tier gallery doors were replaced with wood louvers. These louvers need to be replaced because they are all installed backwards. (John Martini, 2005)

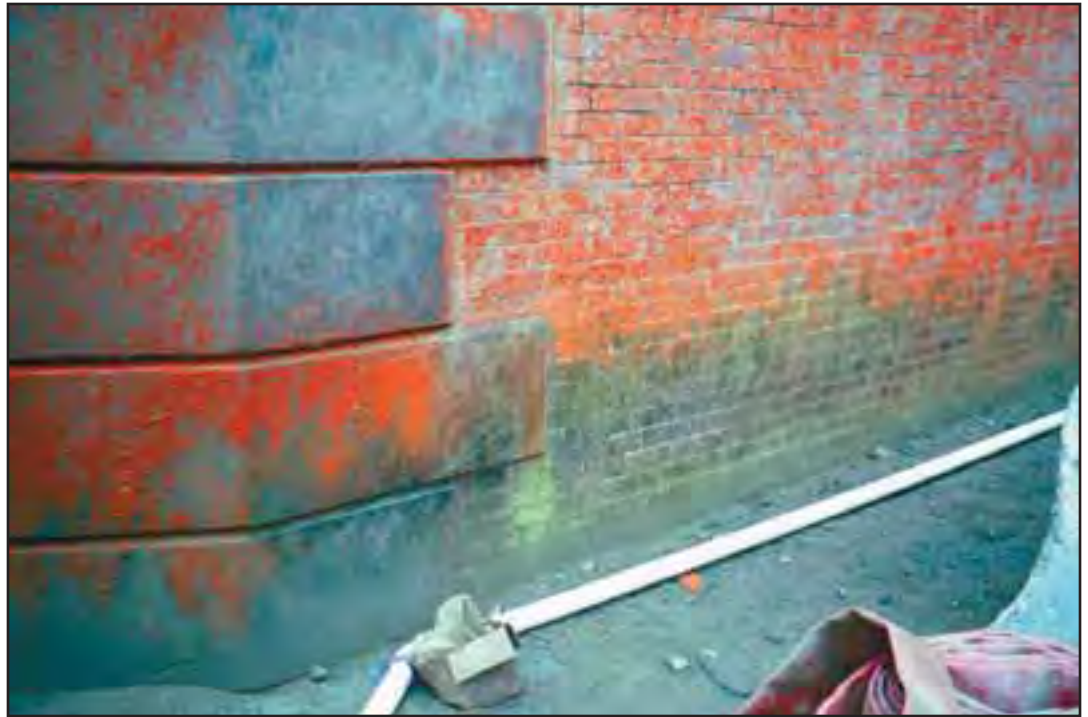
Condition Photo 2:
Intersecting Arch of Casements 98 and 99; Biological growth and efflorescence settle on masonry surfaces. (Courtesy of ARG, 2003)

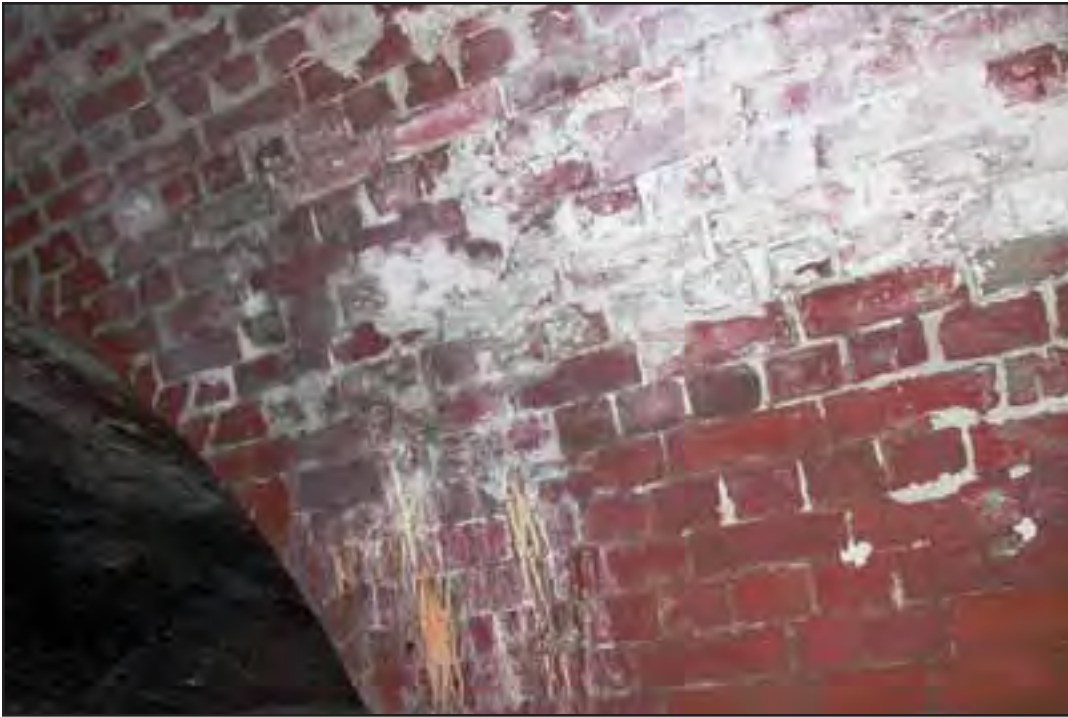
Condition Photo 3:
Casemate 101; Calcium deposits
are draining from open joints
and coating is no longer extant.
(Courtesy of ARG, 2003)

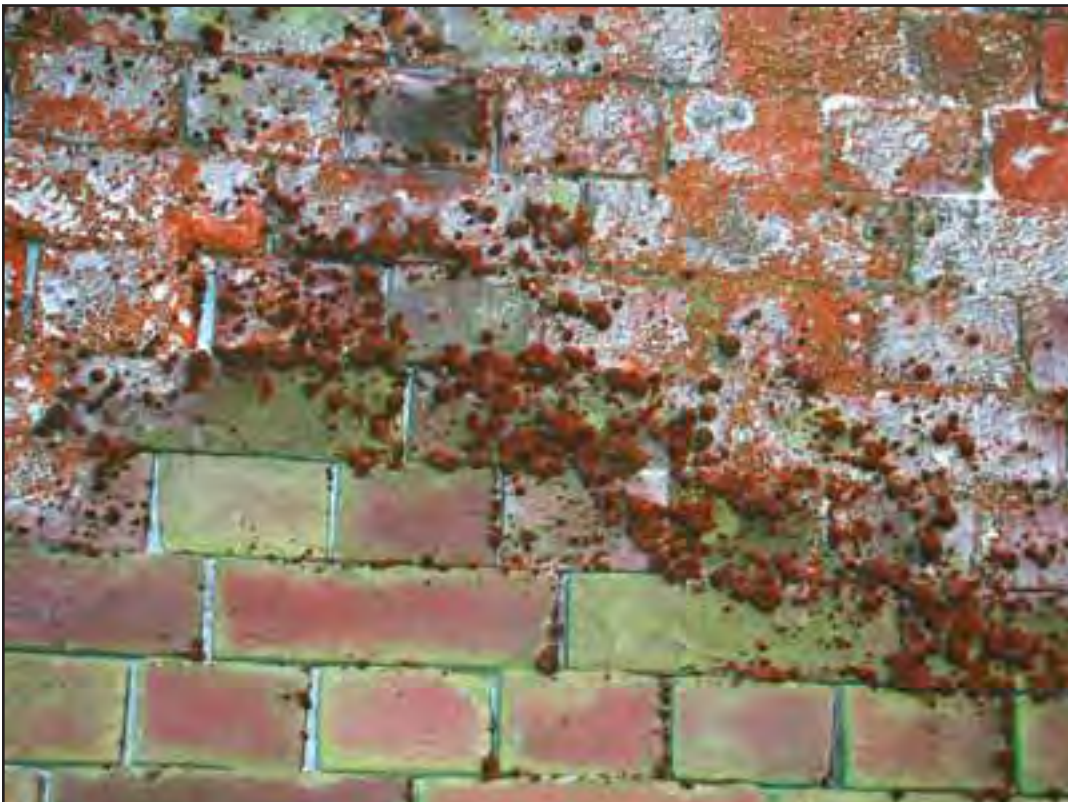
Condition Photo 4:
Casemate 100; Biological growth and
salts on masonry surface.
(Courtesy of ARG, 2003)

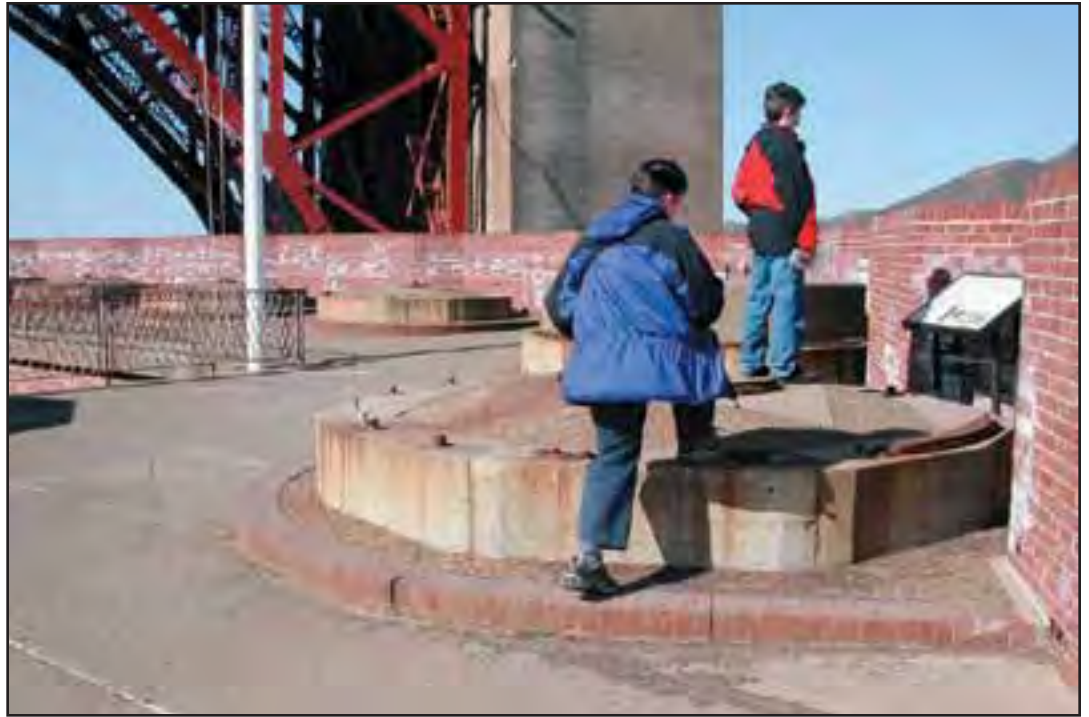
Condition Photo 6:
Top Landing at Barbette Tier; Crack
in granite. (Courtesy of ARG, 2003)

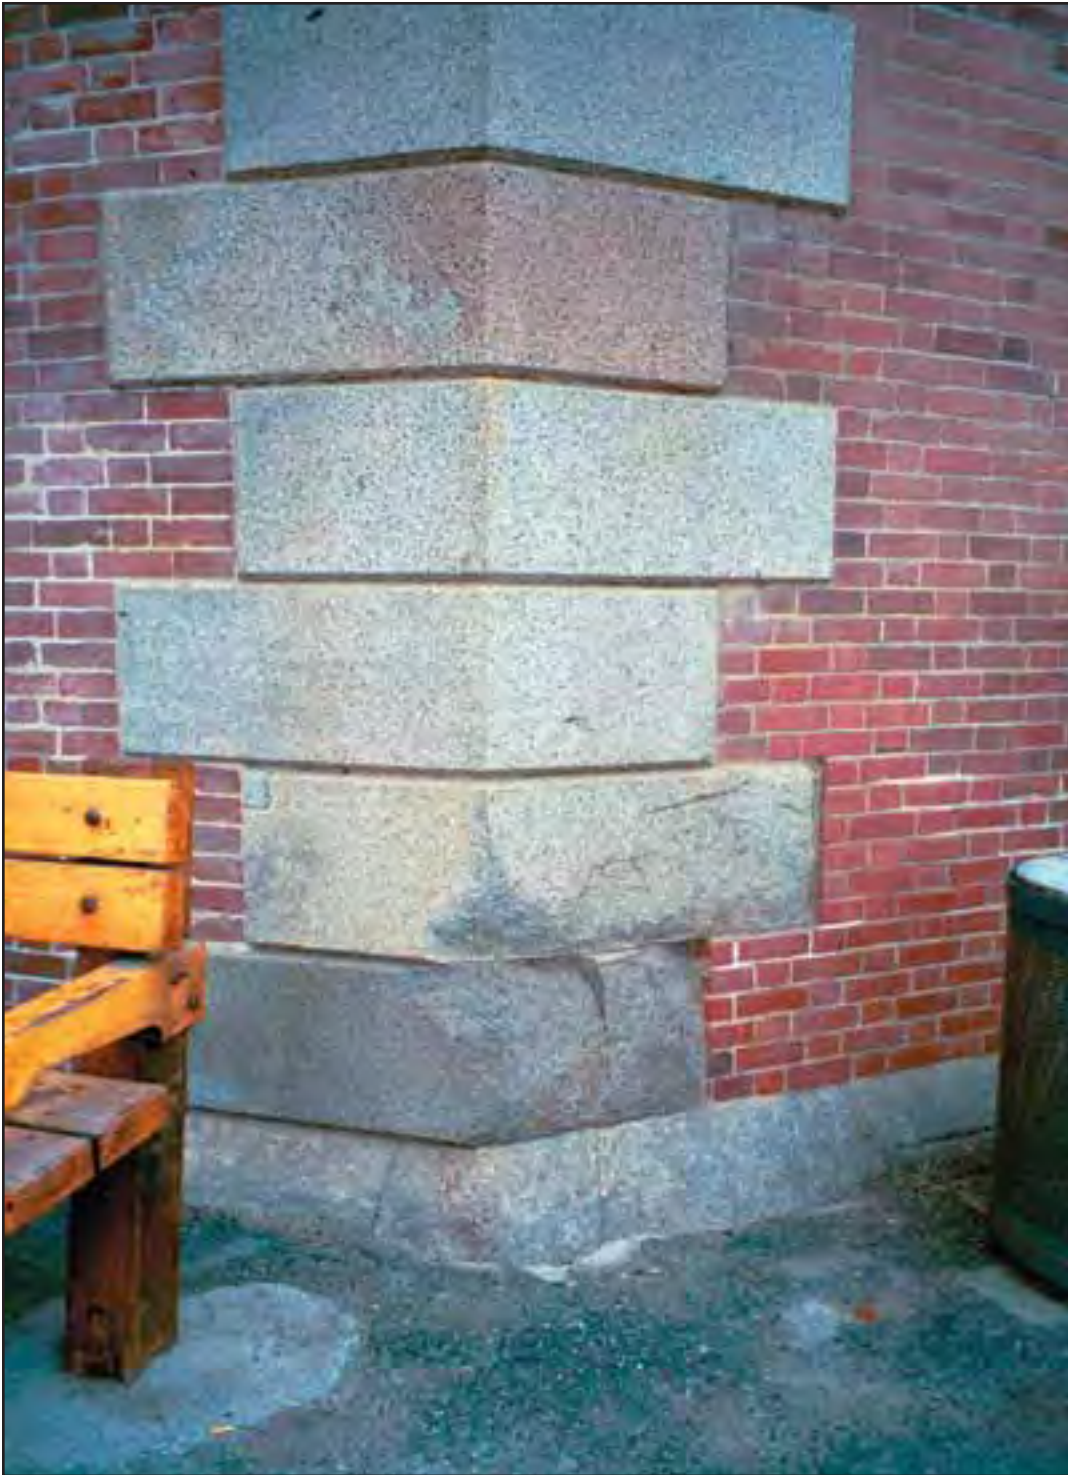
Condition Photo 7:
East Bastion—East Flank; Impact
damage at granite quoins and base.
(Courtesy of ARG, 2003)

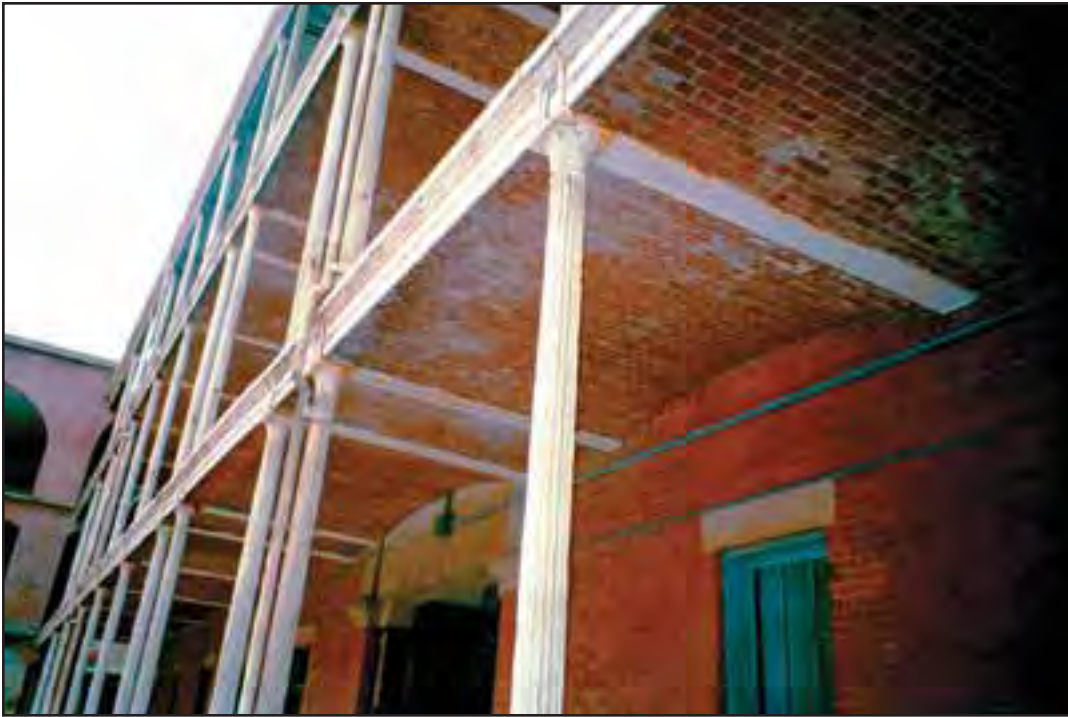
Condition Photo 10:
Southeast Face Courtyard; Corroding
metal columns and walkway
supports. Missing metal railings in
this photo have been reinstalled.
(Courtesy of ARG, 2003)

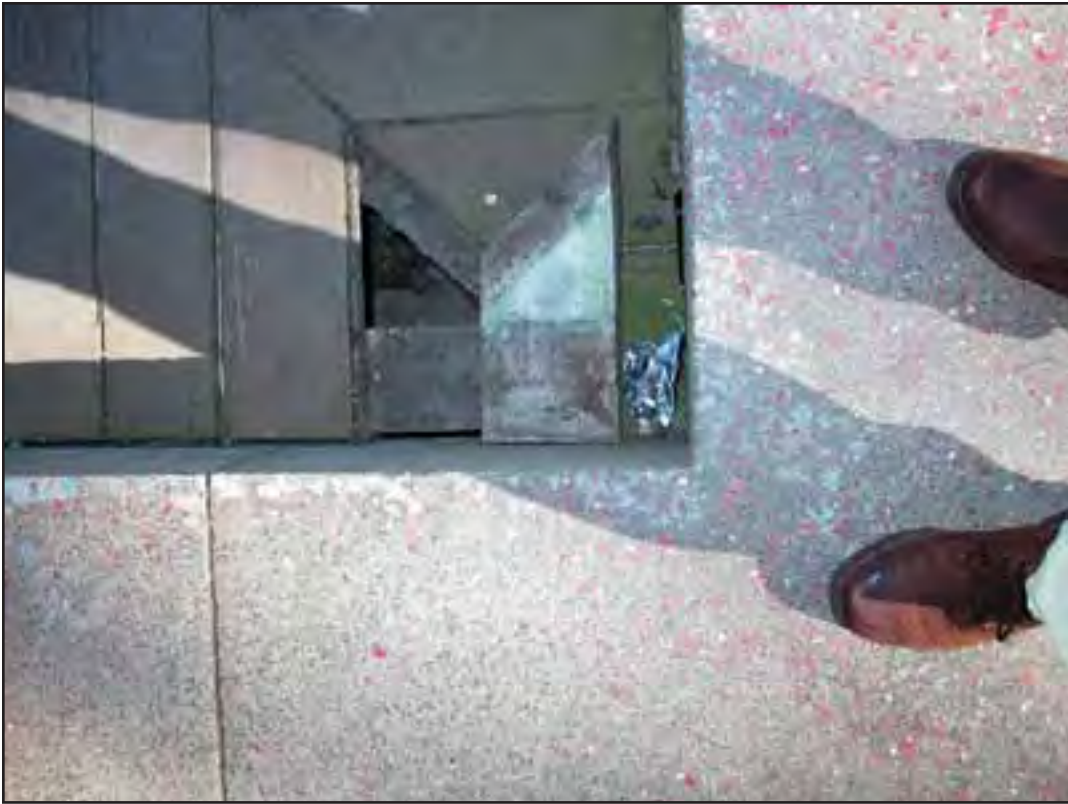
Condition Photo 14:
Wood Walkway – Barquette Tier
by Stair 1; Components are not
properly fastened at wood walkway.
(Courtesy of ARG, 2003)

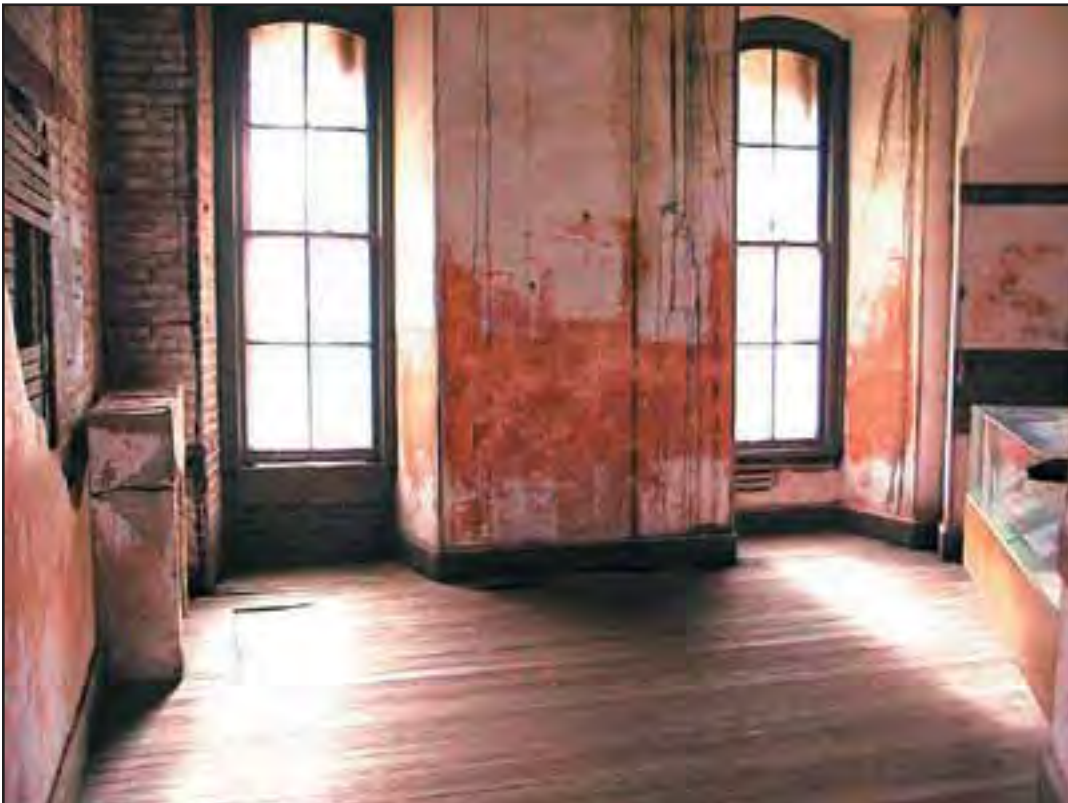
Condition Photo 23:
Stained plaster at Casemate 81.
(Courtesy of ARG, 2003)
