NIOSH HEALTH HAZARD EVALUATION REPORT

HETA #2005-0290-2992

**United States Environmental Protection Agency
Research Triangle Park
Durham, North Carolina**

March 2006

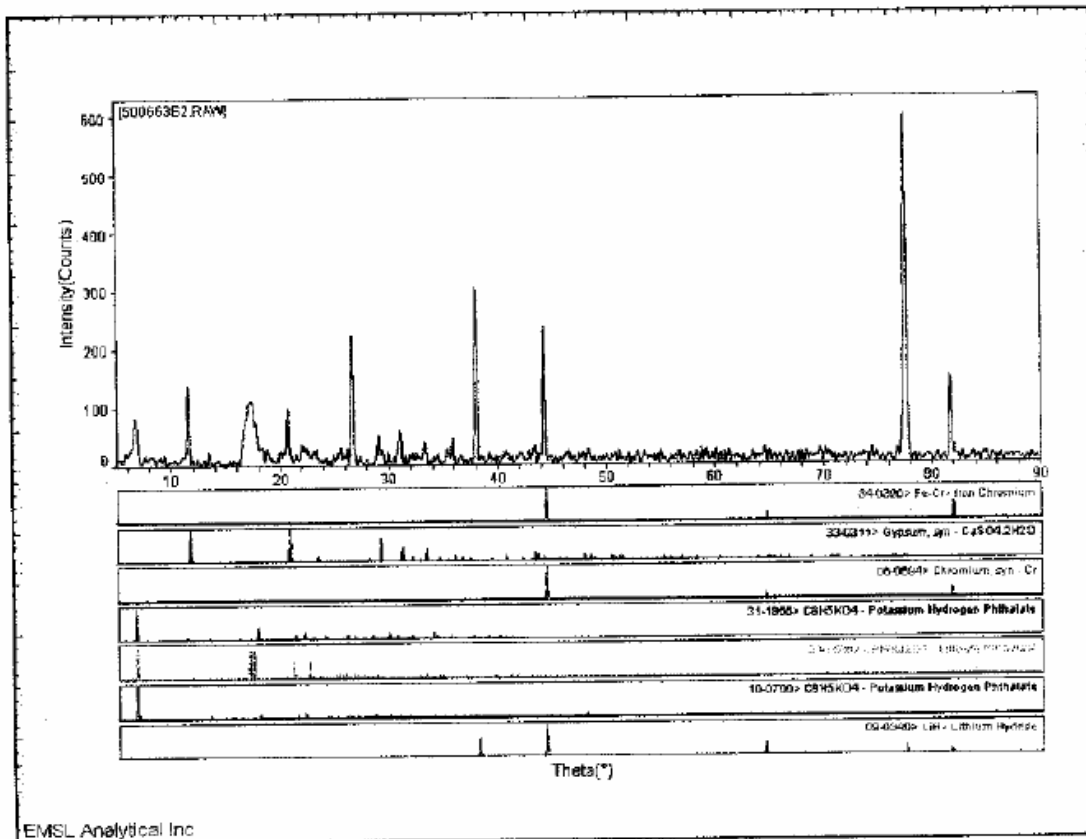
Figure 1: XRD Spectra showing the identification of several crystalline compounds noted in the sample # 0543.

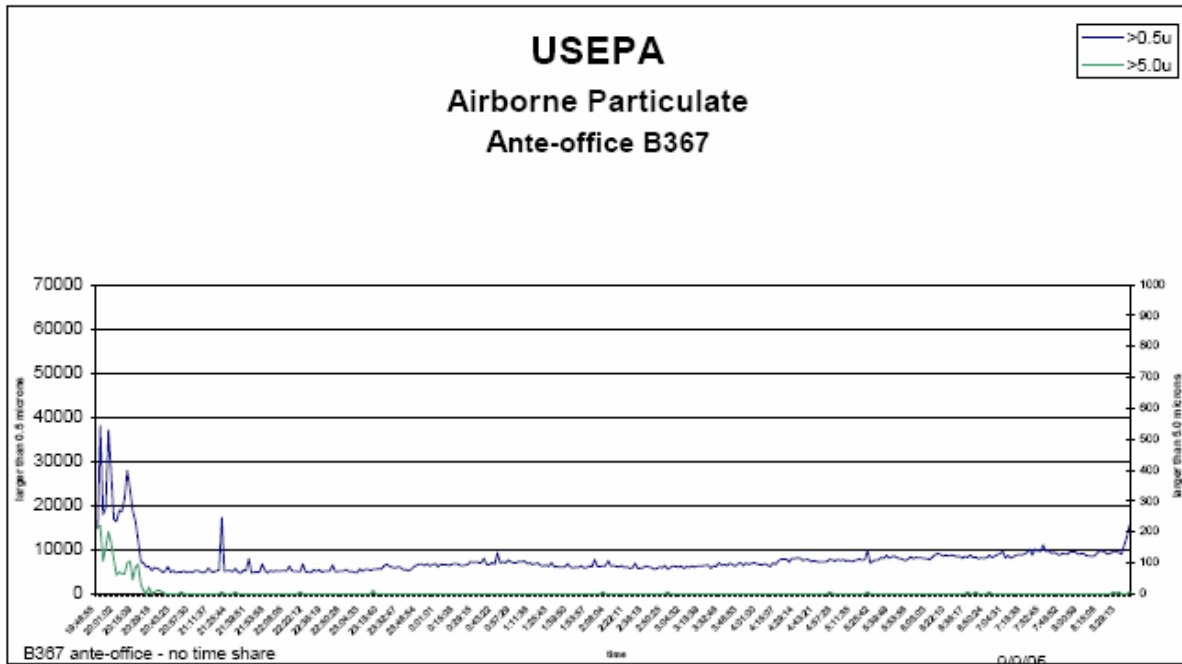
Peaks at left are from burnishing activities occurring in corridor.

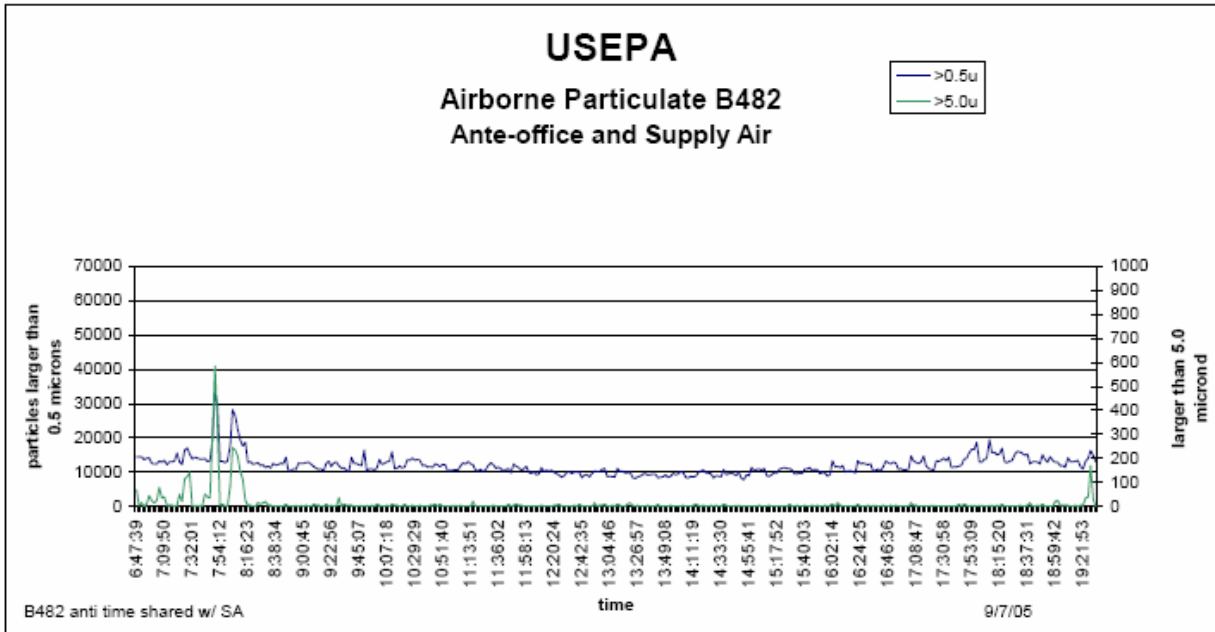
Peaks at left between approximately 7:13 and 8:20, were recorded during burnishing.
 Time-share was used for supply air (from supply duct) and office air.
 Valleys (between peaks) reflect sampling of supply air during burnishing event.

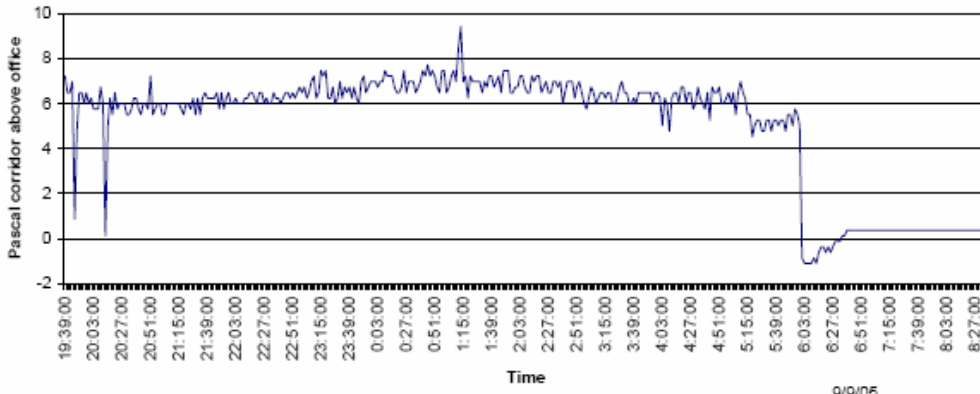
USEPA
Differential Pressure B376
Ante-office to corridor

Pressure drop at right and subsequent level pressure is unexplainable at this time.

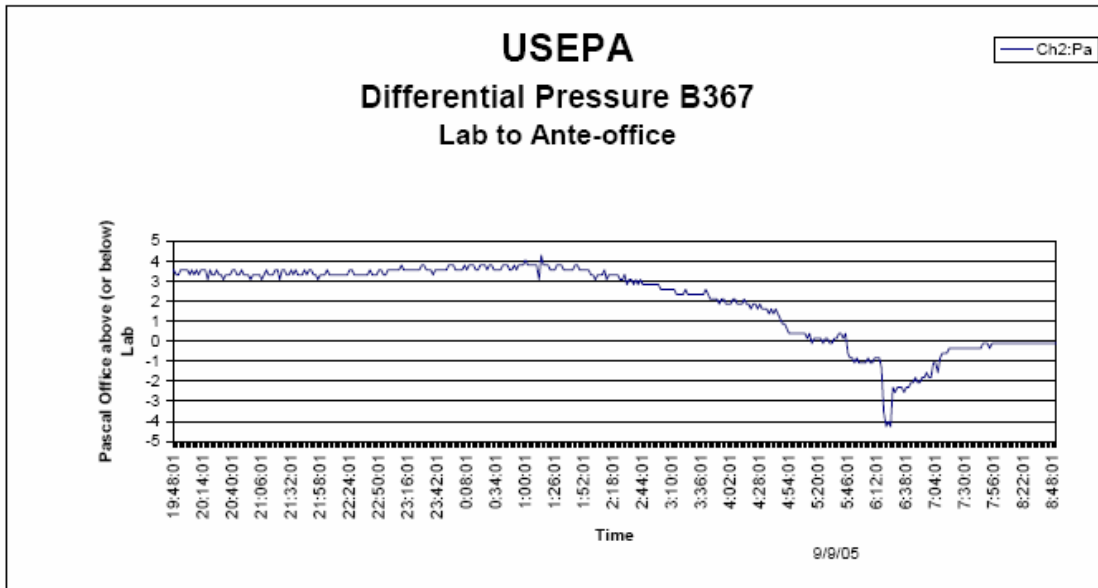
Drop in pressure difference between ante-office and laboratory is unexplained. Additional engineering study and ATC work is recommended.
