Assessing the Efficacy of the Coonamessett Farm (Cfarm) Turtle Excluder Sea Scallop Dredge in Reducing Injury to Loggerhead Sea Turtle Carcasses

**Ronald Smolowitz
Matt Weeks
Maryann Morin
Coonamessett Farm**

October, 2008

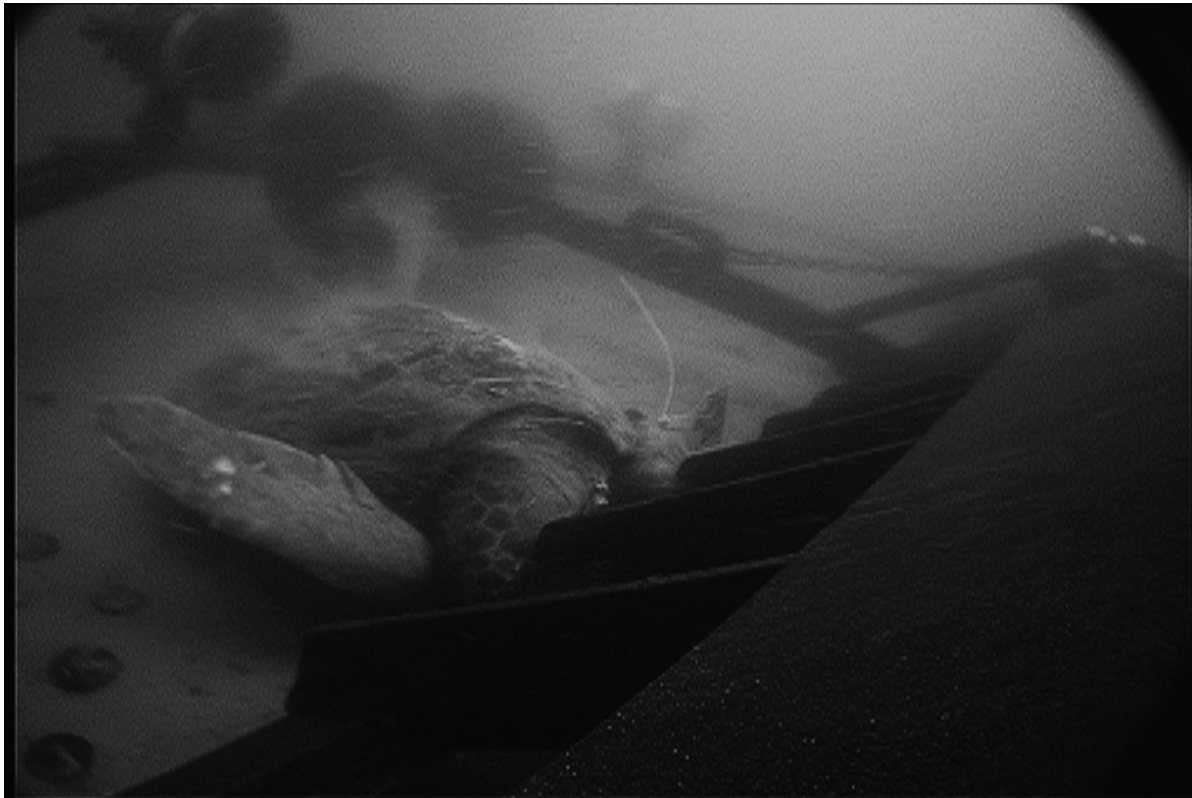
#3 17:17- Dredge on bottom; good view/visibility
20:06- Turtle (**Encounter 3**) goes under the port bale, hits the cutting bar, and flips right over the dredge frame. The encounter lasts less than 2 seconds.
21:06- A lobster goes under the bale and over cutting bar into the dredge frame.
28:04- Haulback 34:51- Dredge back on bottom
36:49- Turtle (**Encounter 4**) caught in front of port bale wheel. 36:51- Turtle free from bale wheel, passes over bale and over frame.
36:52- Turtle (**Encounter 5**) going over starboard bale, hits frame and goes right over dredge in less than 1 second.

Figure 2: Turtle carcass encountering cutting bar (Encounter #3).

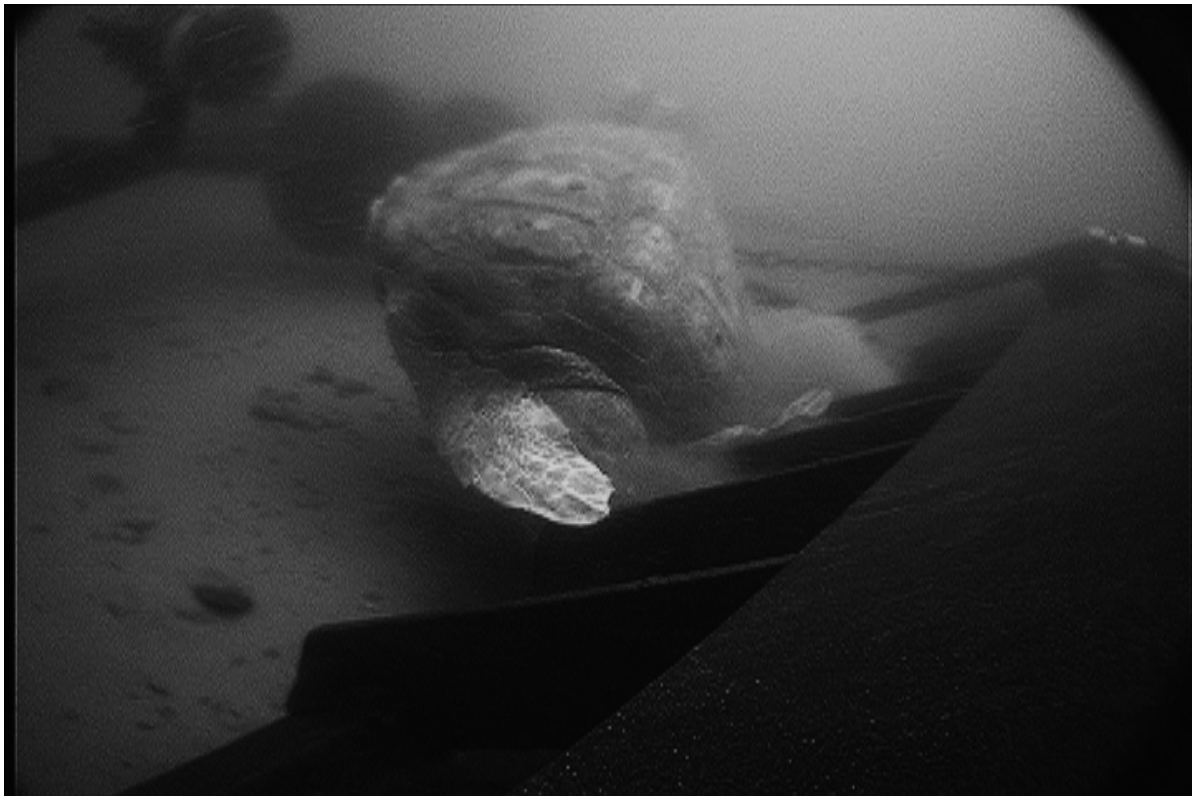
Figure 3: Same turtle carcass going up over dredge frame after cutting bar encounter.

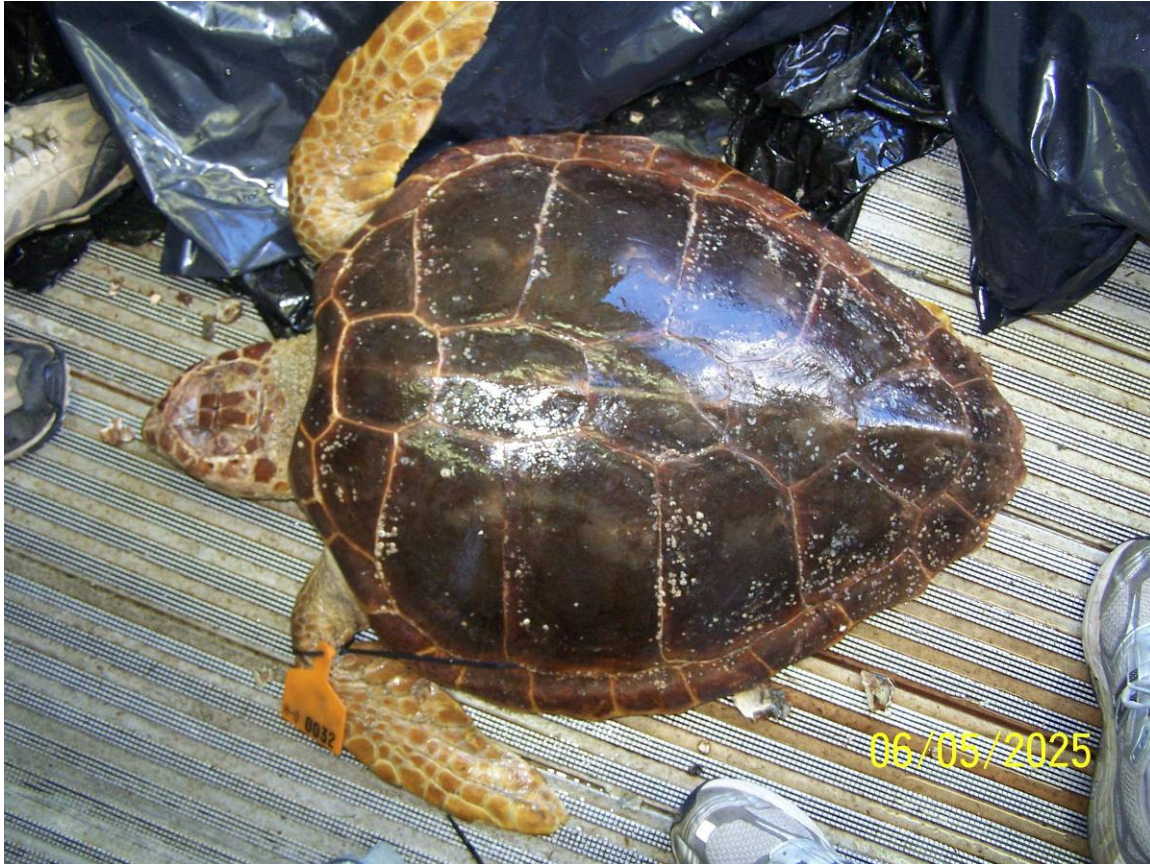
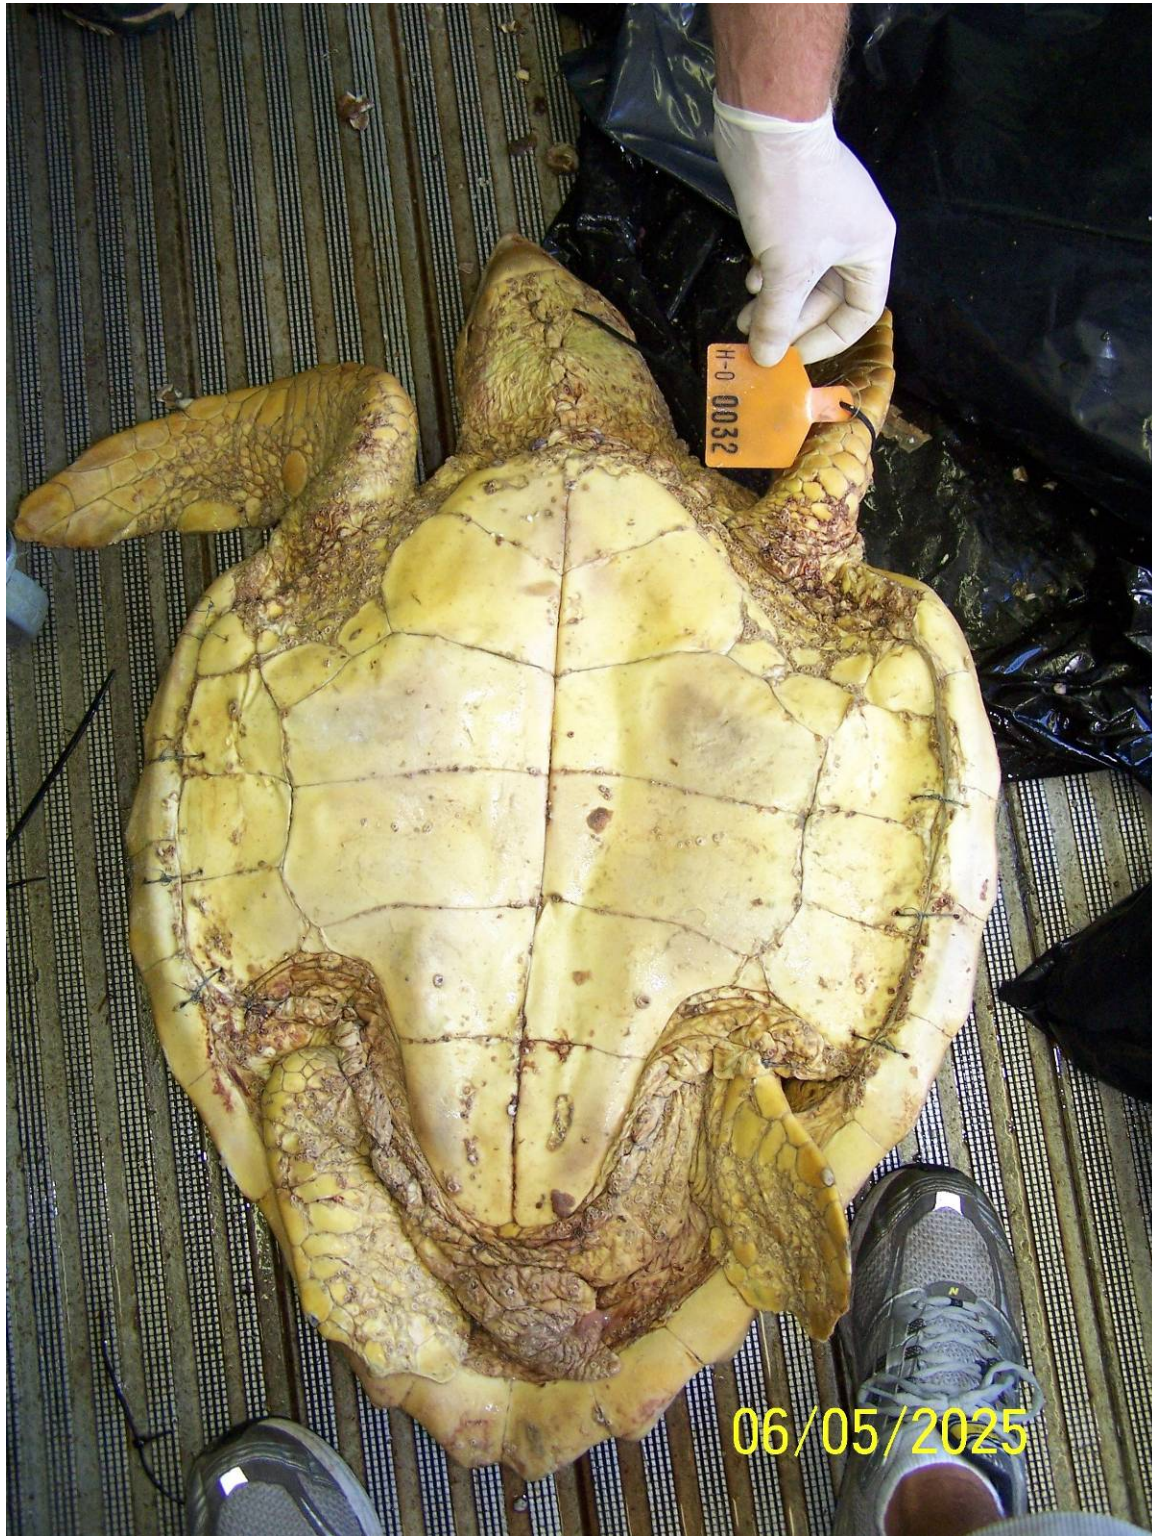
Tag ID # 0032

No apparent damage caused by dredge.
0032Pre

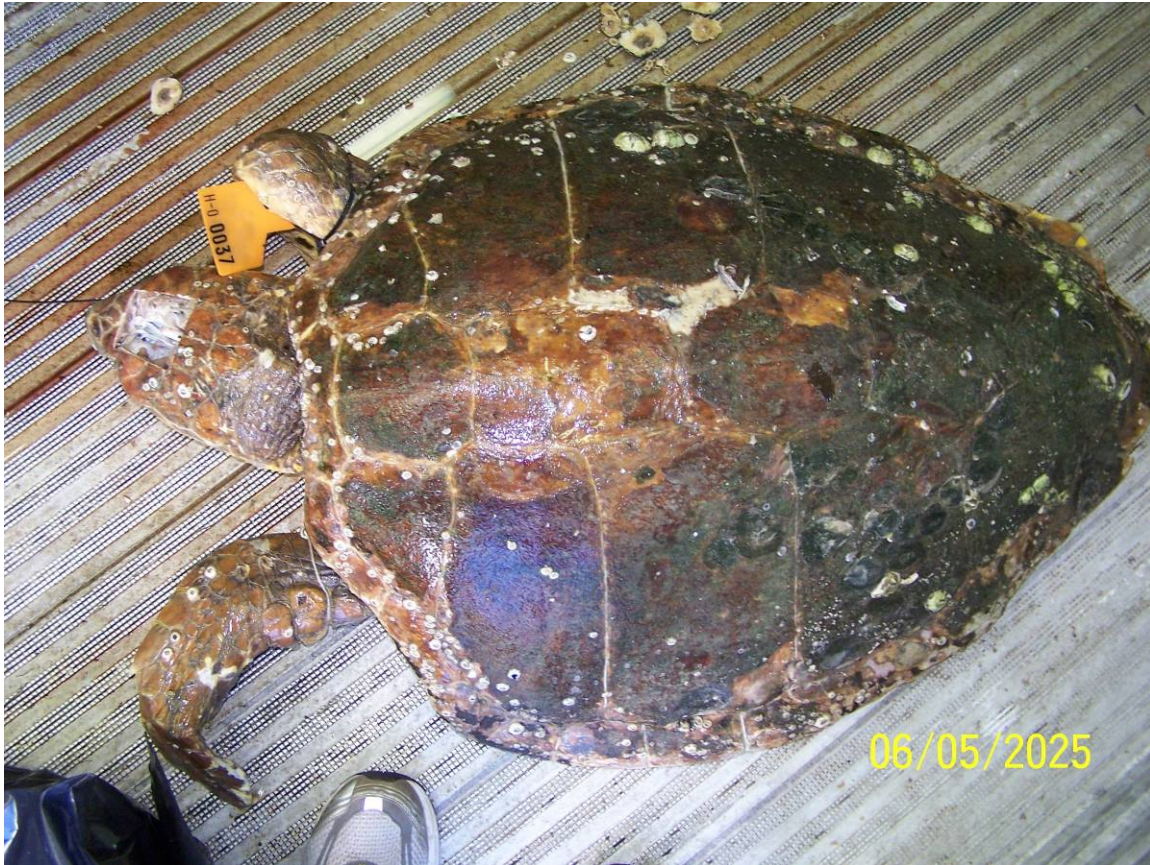
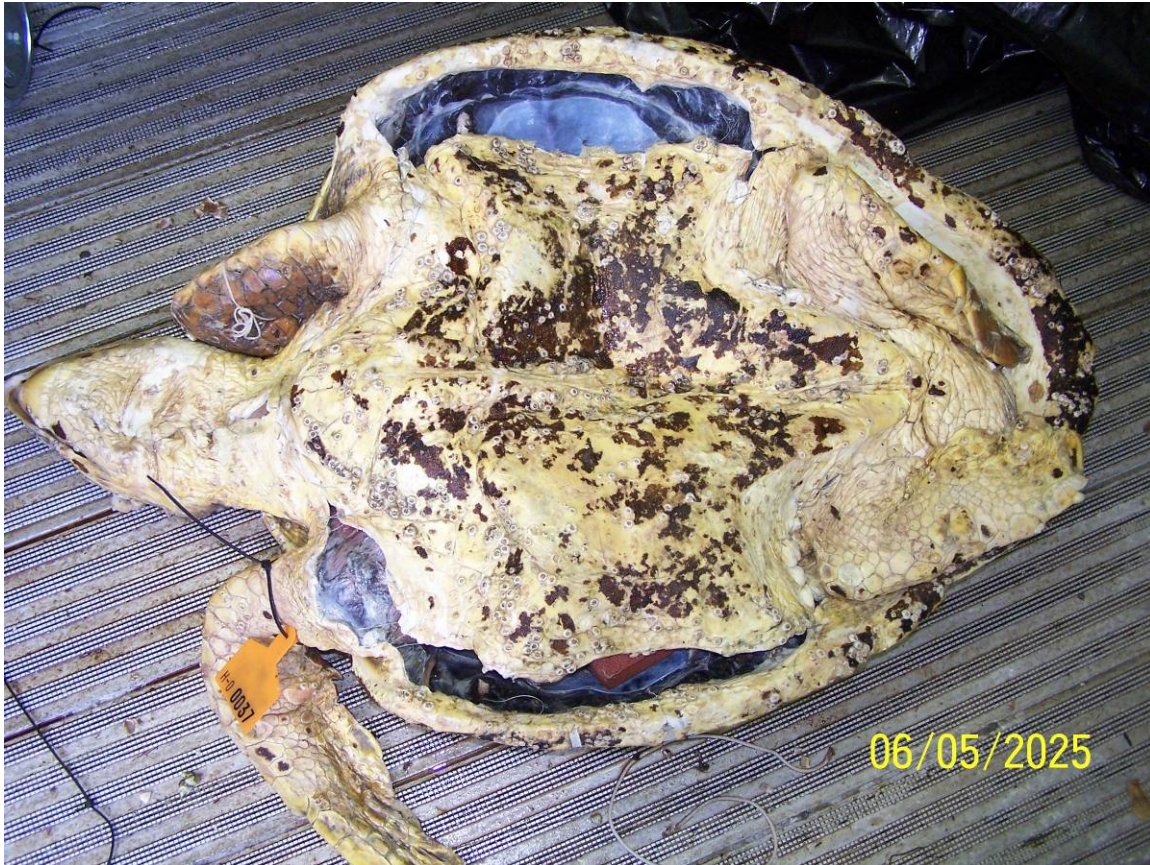
Tag ID # 0037

Posttest exam shows small chip in surface layer of carapace.

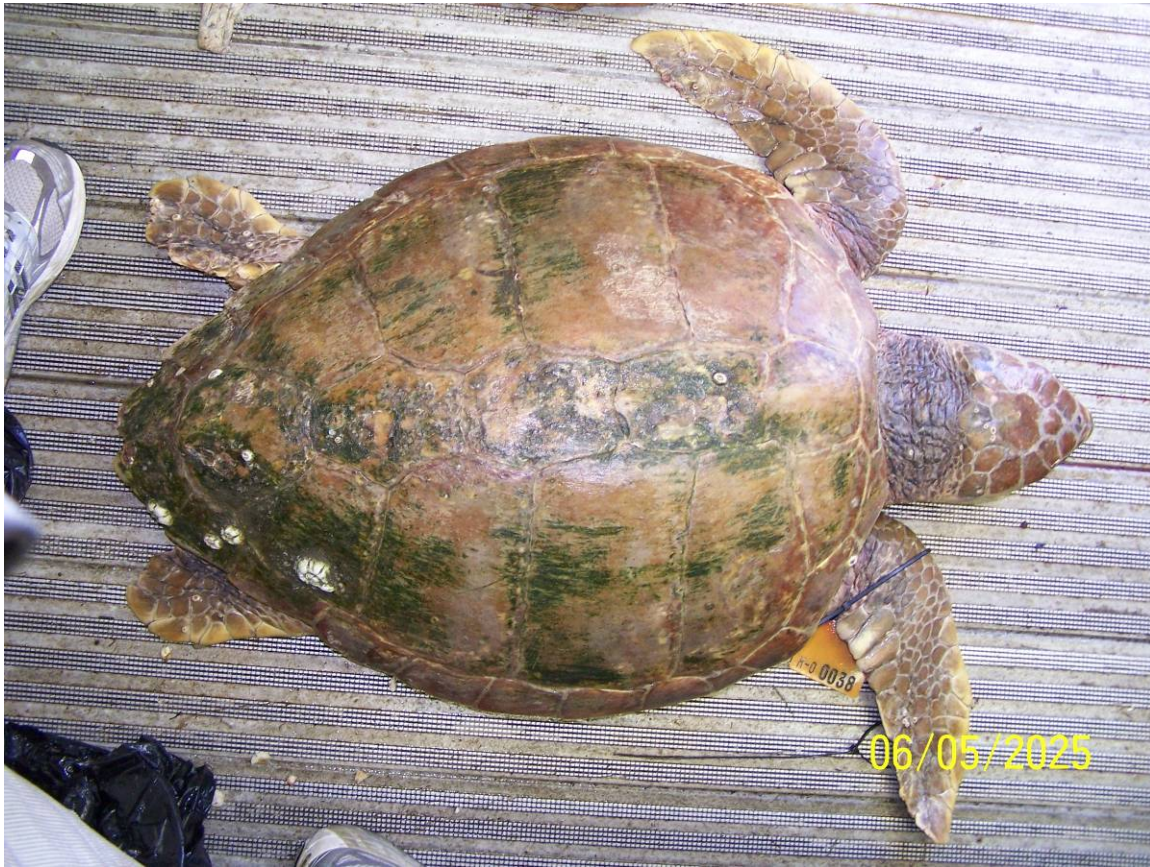
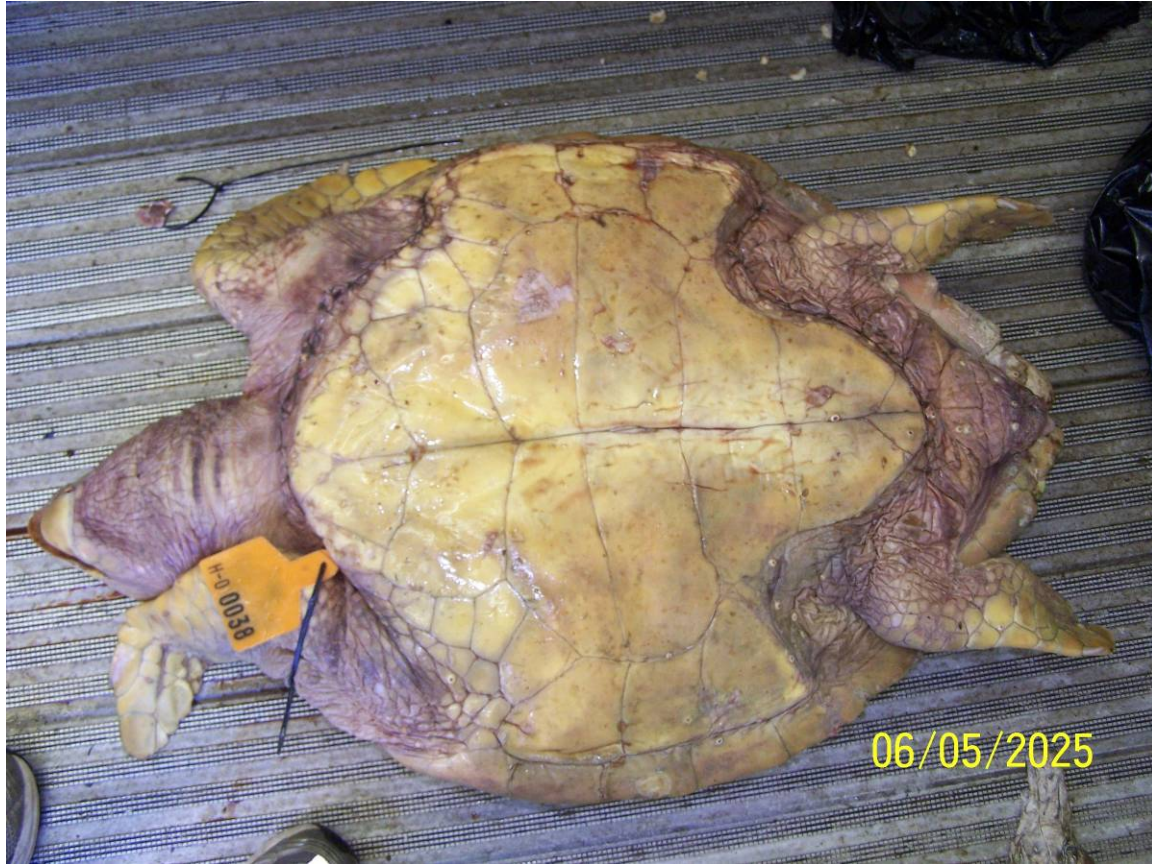
Tag ID # 0038

Wire sutures failed on left plastron

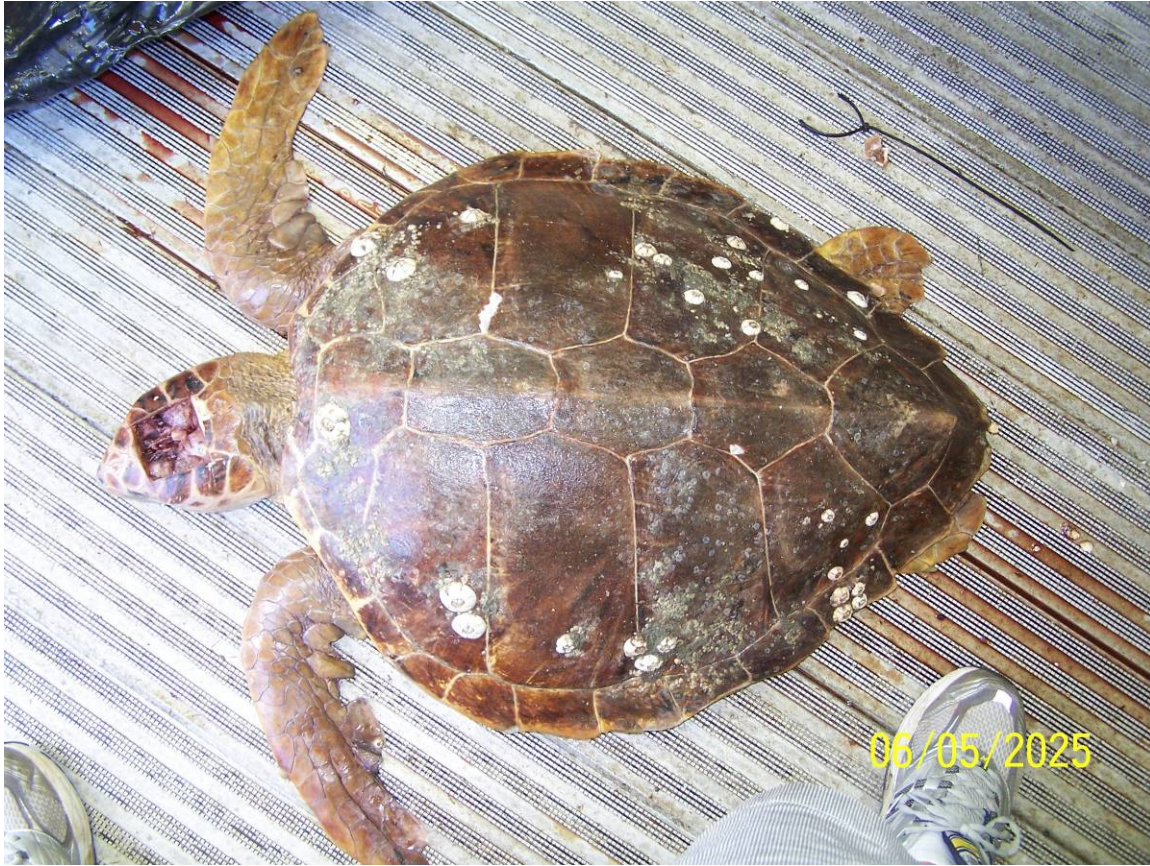
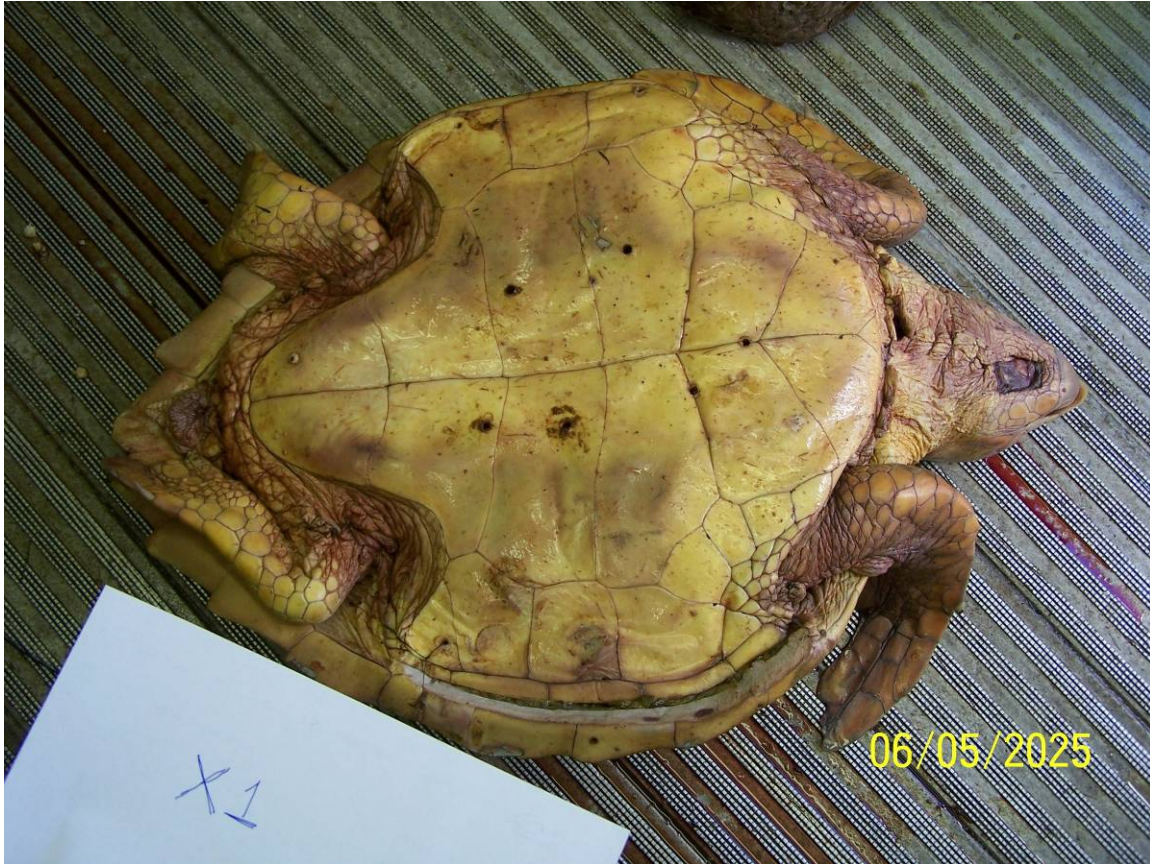
Tag ID # 0041

Wire sutures failed on left plastron. Tag was lost, but ID is clear from characteristics in the photos.

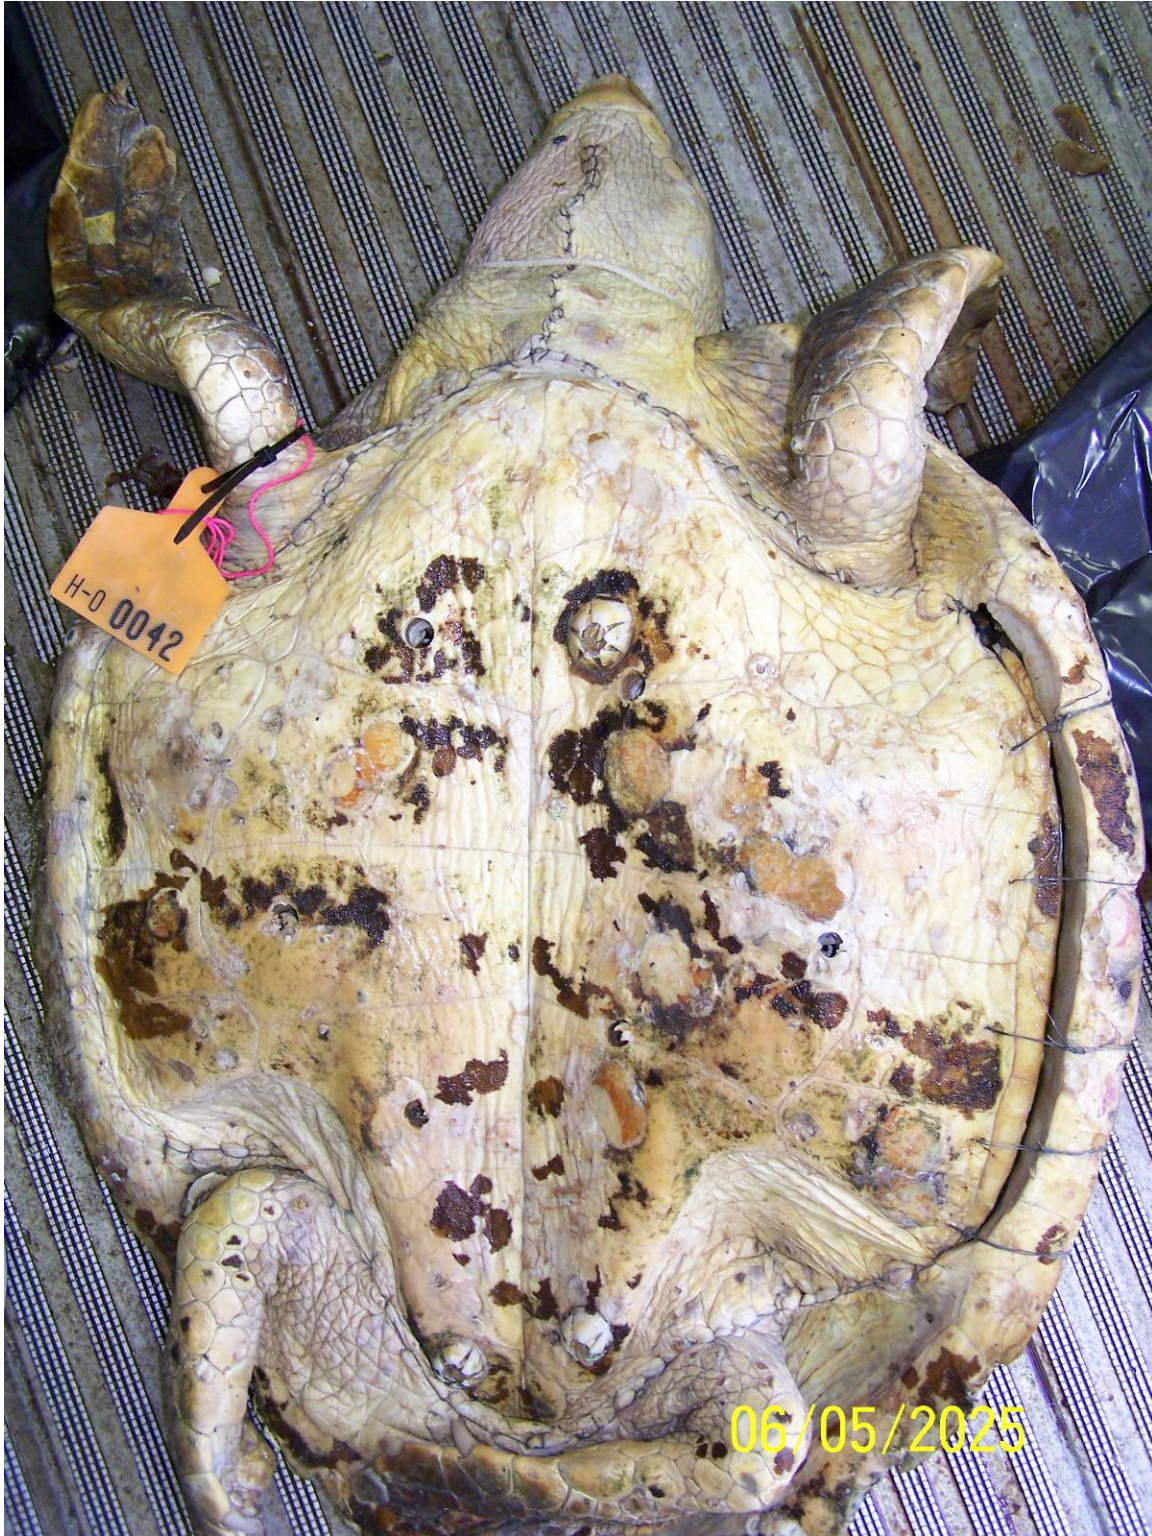
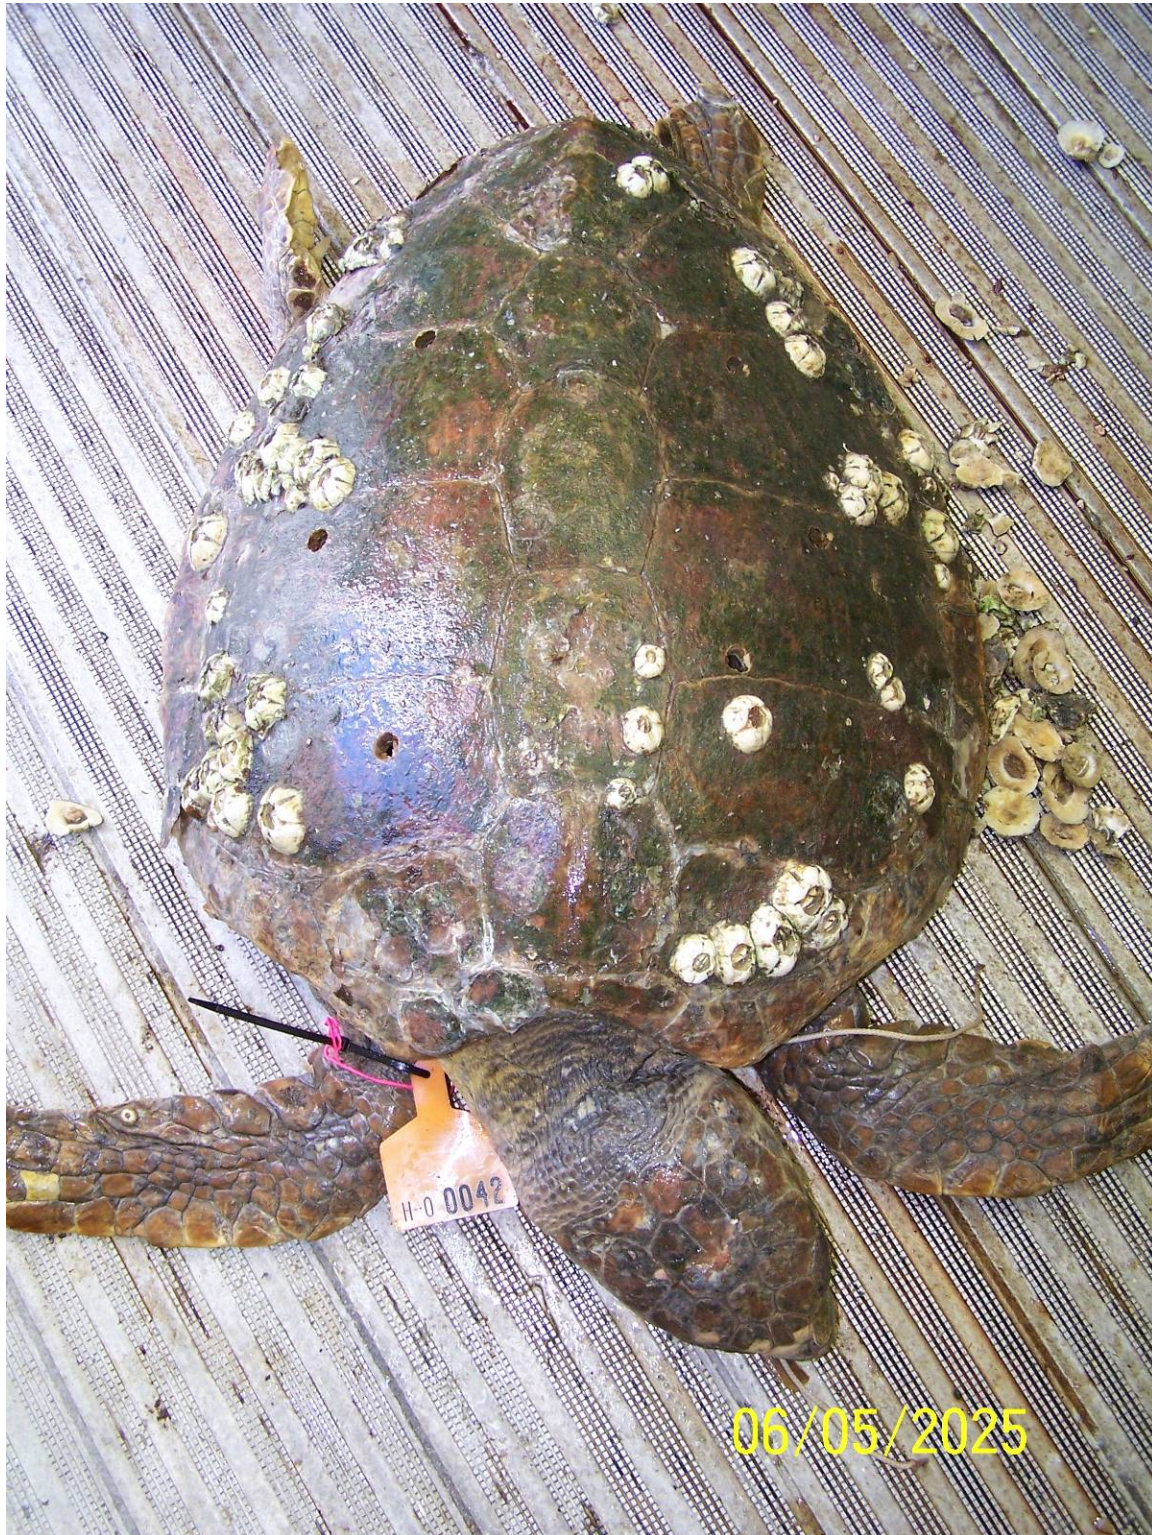
Tag ID # 0042

No apparent damage caused by the dredge. No Pre-test dorsal photos were taken.
0042Pre
