Second Five-Year Review Report

Tibbetts Road Superfund Site

Town of Barrington

August 2008

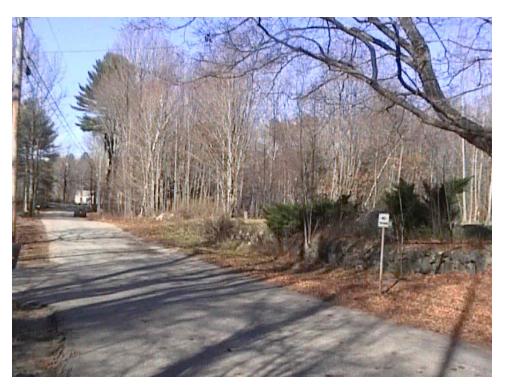
SCENE: Tibbetts Road facing west, the site is on the right hand side behind the stone wall.DATE/TIME: November 28, 2007PHOTOGRAPHY BY: D. Luce

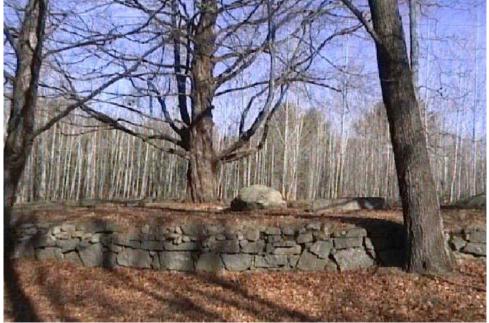
SCENE: Standing on Tibbetts Road looking northward into the site. The former Johnson residence stood behindthe Sugar Maple before it was removed in 1995.DATE/TIME: November 28,2007PHOTOGRAPHY BY: D. Luce

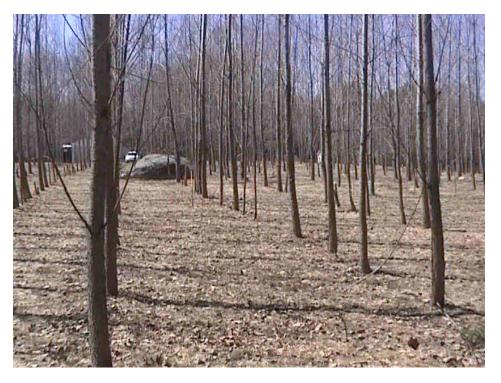
SCENE: Standing on the northern edge of the property line for the site and looking southward towards Tibbetts Road. The poplar trees were planted as part of the phytoremediation and are now 10 years old. DATE/TIME: April 15, 2008 PHOTOGRAPHY BY: D. Luce

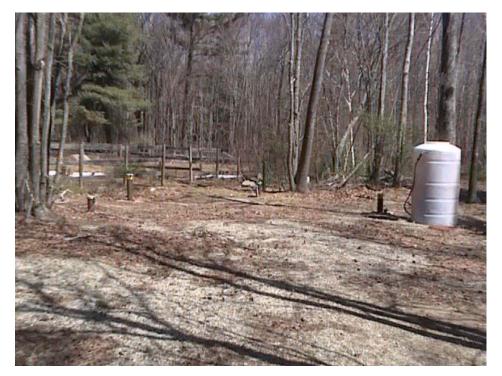
SCENE: Standing on the northern edge of the property line for the site and looking northward at wells 69R and169R.DATE/TIME: April 15, 2008PHOTOGRAPHY BY: D. Luce

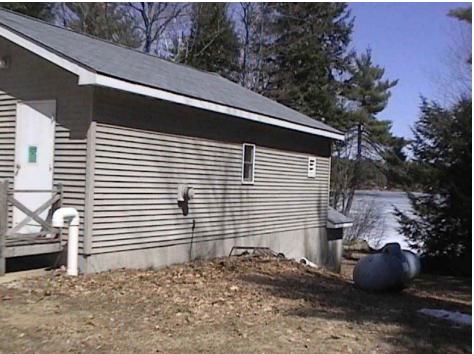
The Commissioners also pointed out that many of the components are worn. The drinking water treatment plant is now 20 years old. Back-up equipment has been installed to monitor and control the treatment system that is not the most compatible equipment or application. The Commissioners also made the point that they are the operators of the system and responsible for responding to emergencies, maintaining the aging equipment, and maintaining their training

SCENE: The Swains Lake Village Water District Treatment House Building looking northward towards Swains Lake (covered in ice). DATE/TIME: April 15, 2008 PHOTOGRAPHY BY: D. Luce APPENDIX D: TECHNICAL ASSESSMENT
