**Third
Five-Year Review Report**

**Syntex Facility Site
Verona
Lawrence County, Missouri**

September 2007

**Region 7
United States Environmental Protection Agency
Kansas City, Kansas**

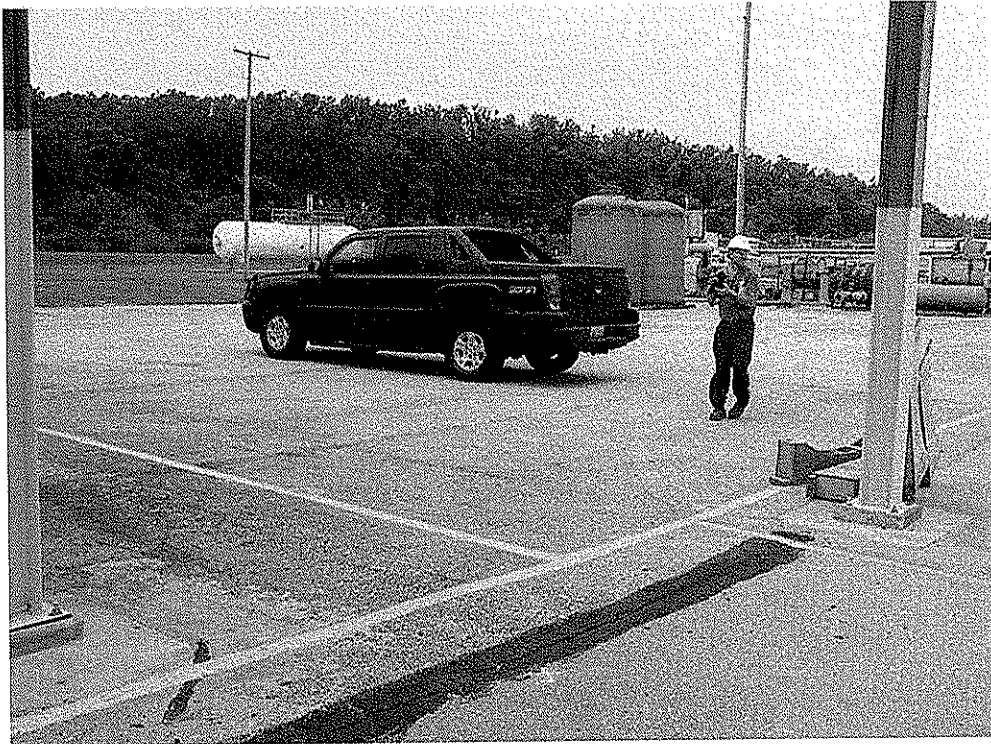
Spill Area Asphalt Cap – truck parked on cap – delineated by yellow lines

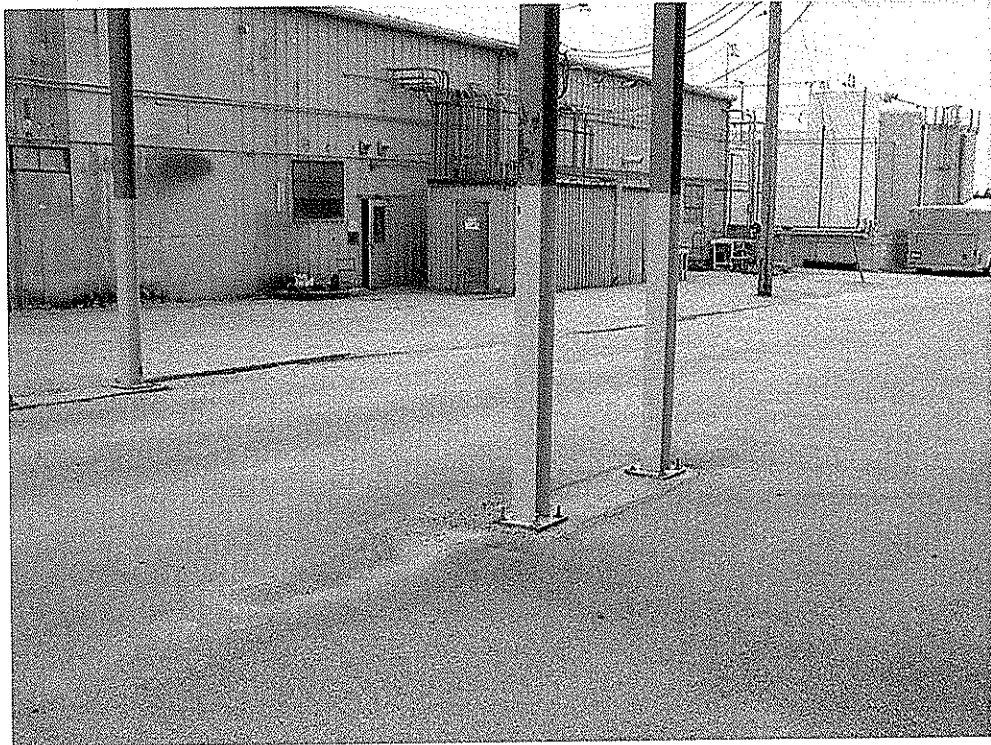
Areas inspected included the asphalt cover in the spill area and T-1 dike area. Painted yellow lines provided demarcation of each capped area. Overall the asphalt caps were in very good condition. There was one location in the T-1 dike area with some minor cracking along a previously sealed area. Since the objective of the cap is to prevent dermal contact and erosion of the underlying soil, this is not a significant issue. However, some additional asphalt sealant in this area would help prevent the progression of this crack.

T-1 Dike Area Asphalt Cap

6. Alternative Cover (armored rock, concrete, etc.)	<input type="checkbox"/> N/A
Remarks <u>Overall in very good condition. Minor crack sealing is recommended.</u>

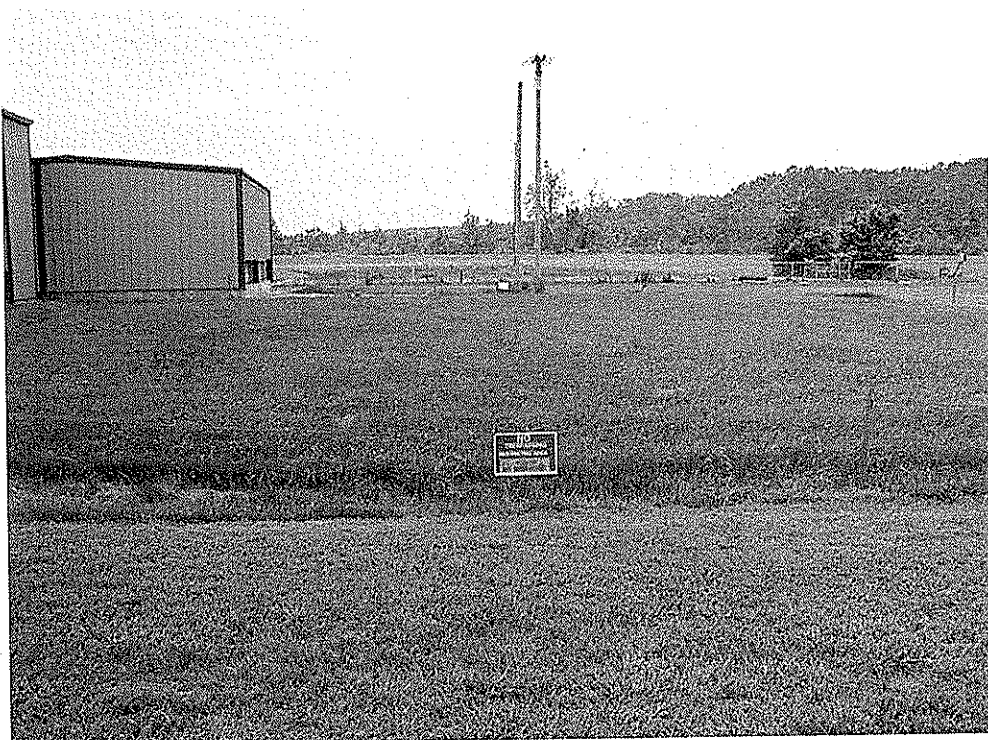
Irrigation Area Vegetative Cap – note warning sign
