Five-Year Review Report

Ace Services Site Colby, Thomas County, Kansas

September 2008

United States Environmental Protection Agency Region 7 Kansas City, Kansas

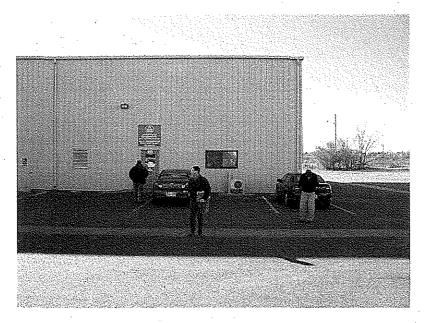
North Side of Treatment Building

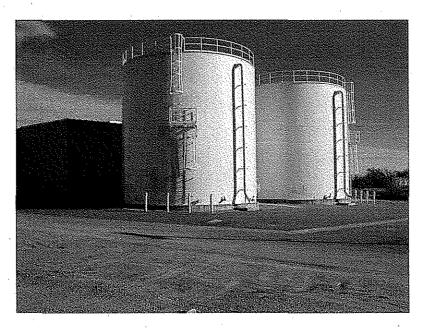
Influent and Effluent Tanks – South Side of Treatment Building

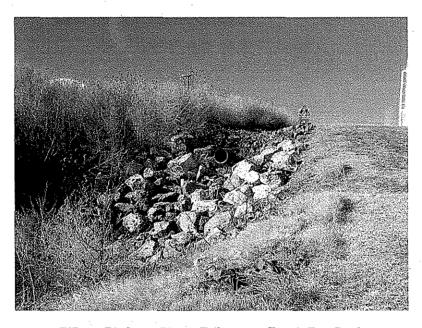
After reviewing discharge records it was found that the flow to the tributary is not continuous and discharge levels have all been below detectable levels with a detection limit below both the chronic and acute NAWQC standards for hexavalent chromium. Therefore, as currently operated, the remedy is ecologically protective.

Effluent Discharge Pipe to Tributary to Prairie Dog Creek

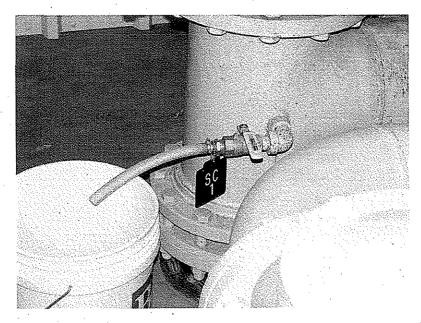
The plant, office, storage, and lab areas were clean and very well organized. Overall, the treatment plant was in very good condition, with no significant issues noted during the inspection. There was some minor rust on the treatment plant piping, apparently the result of persistent condensation during the hot summer months. This was identified in audit report No. 15 dated November 30, 2007, with a recommendation to prep and paint the piping during the winter when condensation was not an issue.

Influent Sample Port - Note Minor Rust on Piping

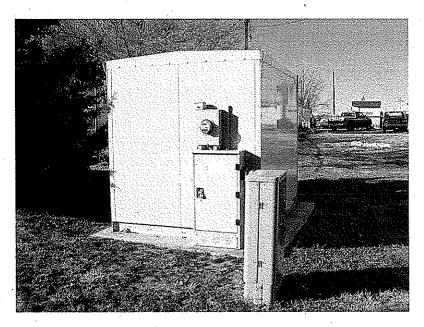
Protective Building - Former City Production Well PWS-8

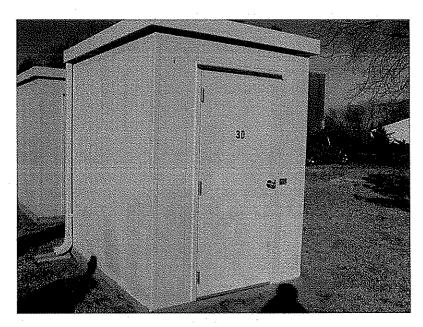
After the plant inspection, the team inspected each of the extraction well locations and nearby monitoring wells. Each extraction well, along with associated electrical components and valving, is housed within a locked shed. Each well and components was inspected and all appear to be in good condition. No signs of vandalism were apparent at any of the well locations. Access to extraction wells EX-3, EX-4, and EX-5 is via an unimproved road. There was significant rutting at a few locations along the road and it appeared it could become difficult to traverse during bad weather conditions. Project personnel indicated they had never experienced problems during their maintenance or monitoring activities. If conditions worsen, it may be necessary to fill the ruts with gravel or have a road grader even out the road.

EX-3D Protective Building – Typical for All Extraction Wells
