EPA/OSHA JOINT CHEMICAL ACCIDENT INVESTIGATION REPORT

Napp Technologies, Inc.
Lodi, New Jersey

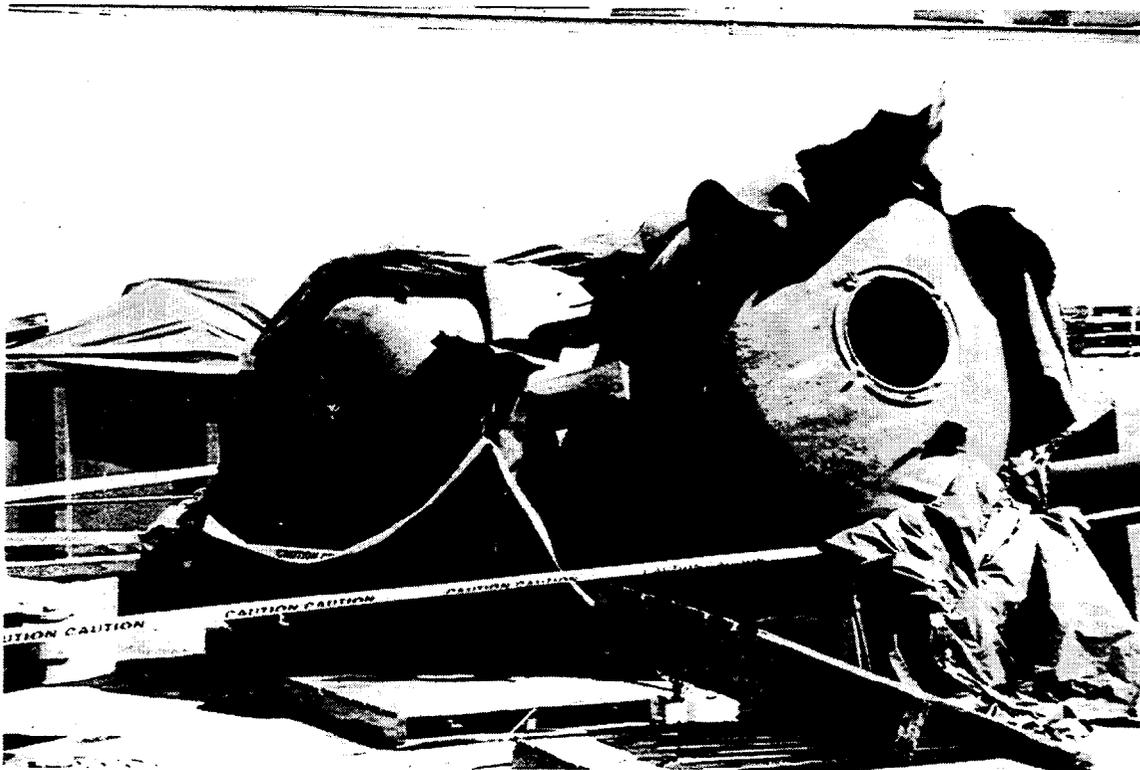
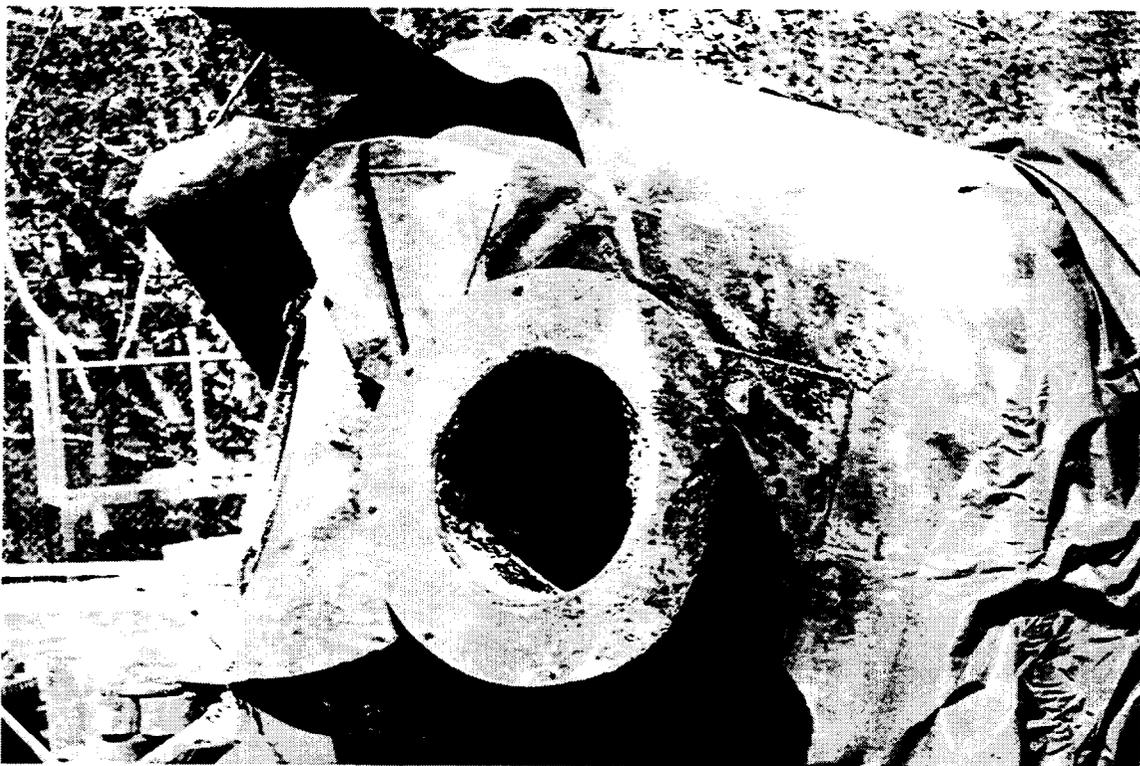
Figure 9: The general condition of the 125 cubic foot blender: a) the top access ports and damaged insulation jacket, and b) the flange to which the belt drive attaches.

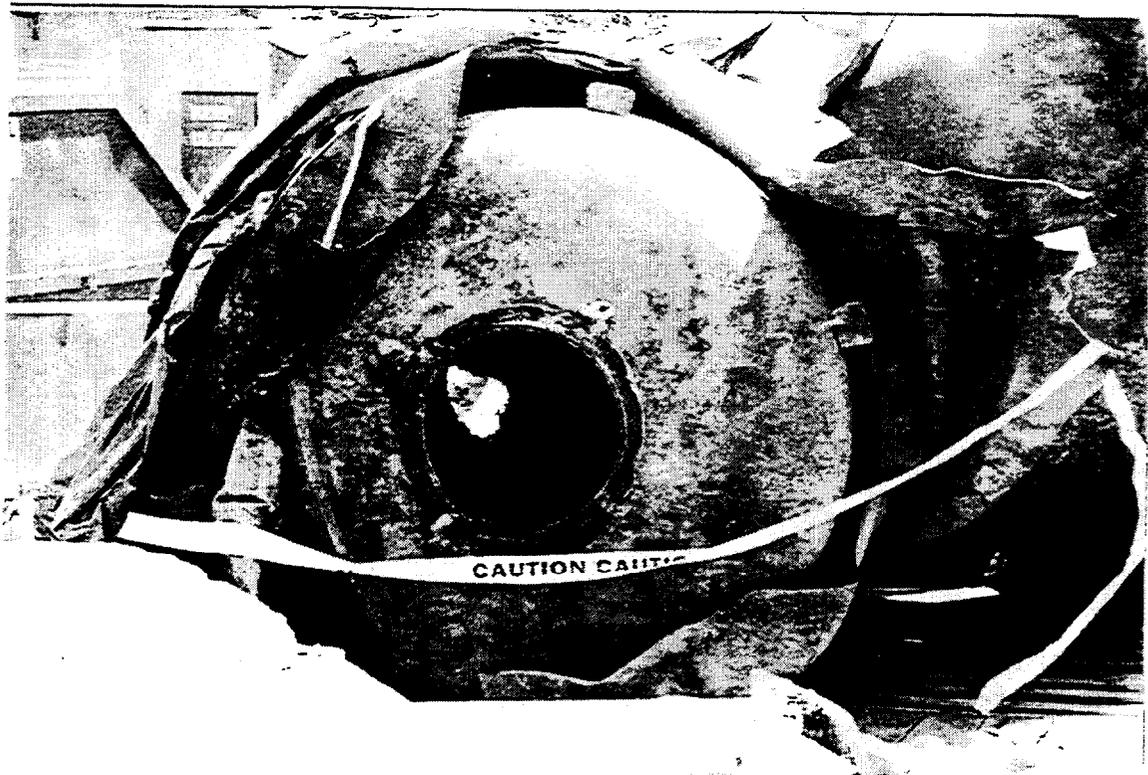
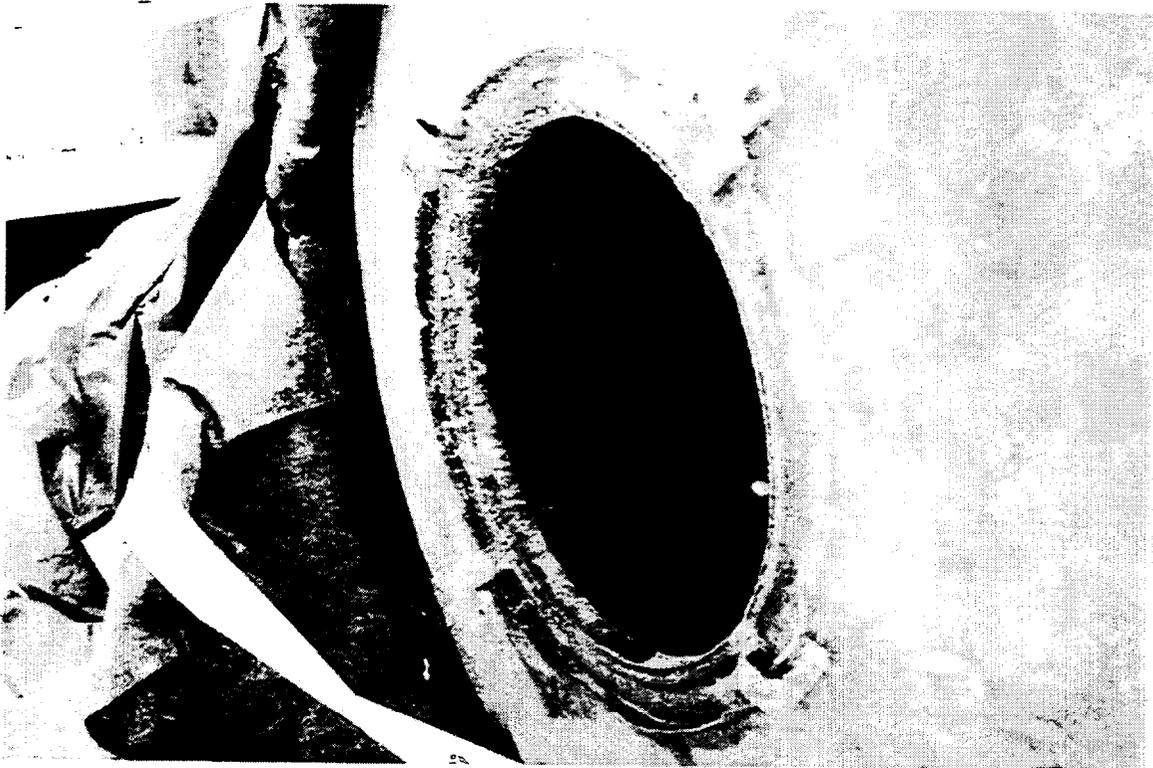
Figure 10: Top access port: a) looking through a top port and out the bottom off-load port, and b) close-up view of a top port.

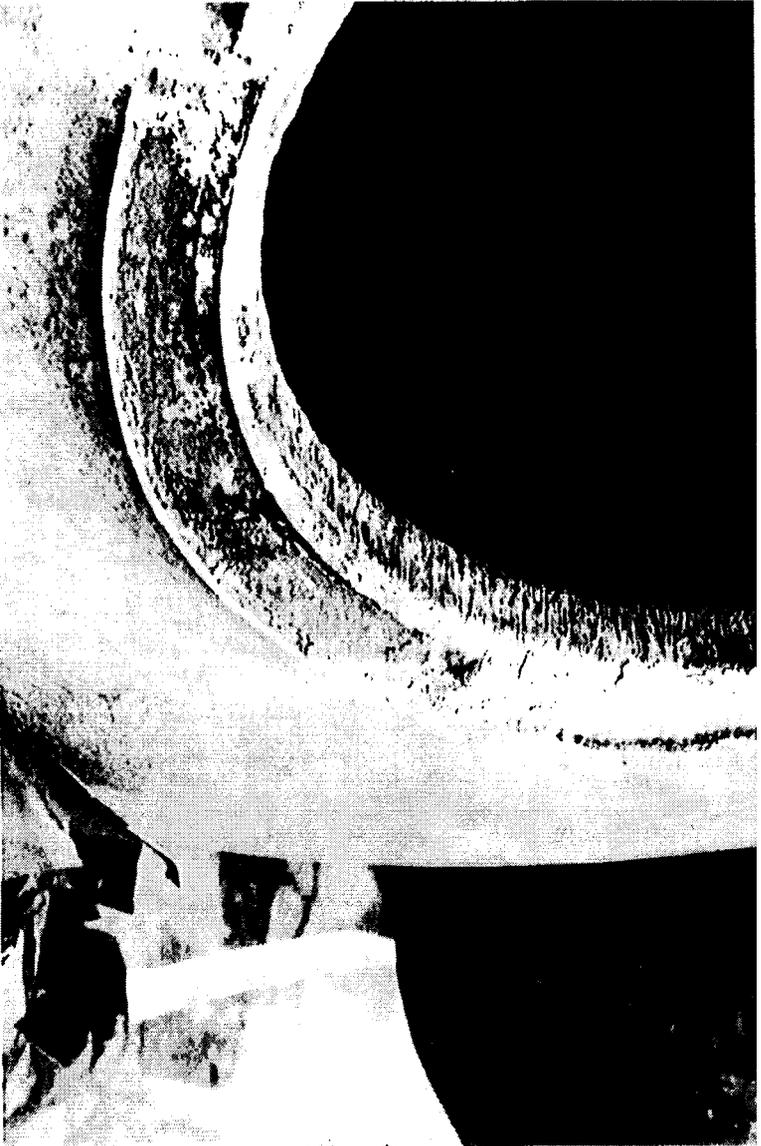
Figure 12: The striation markings on the top access ports.

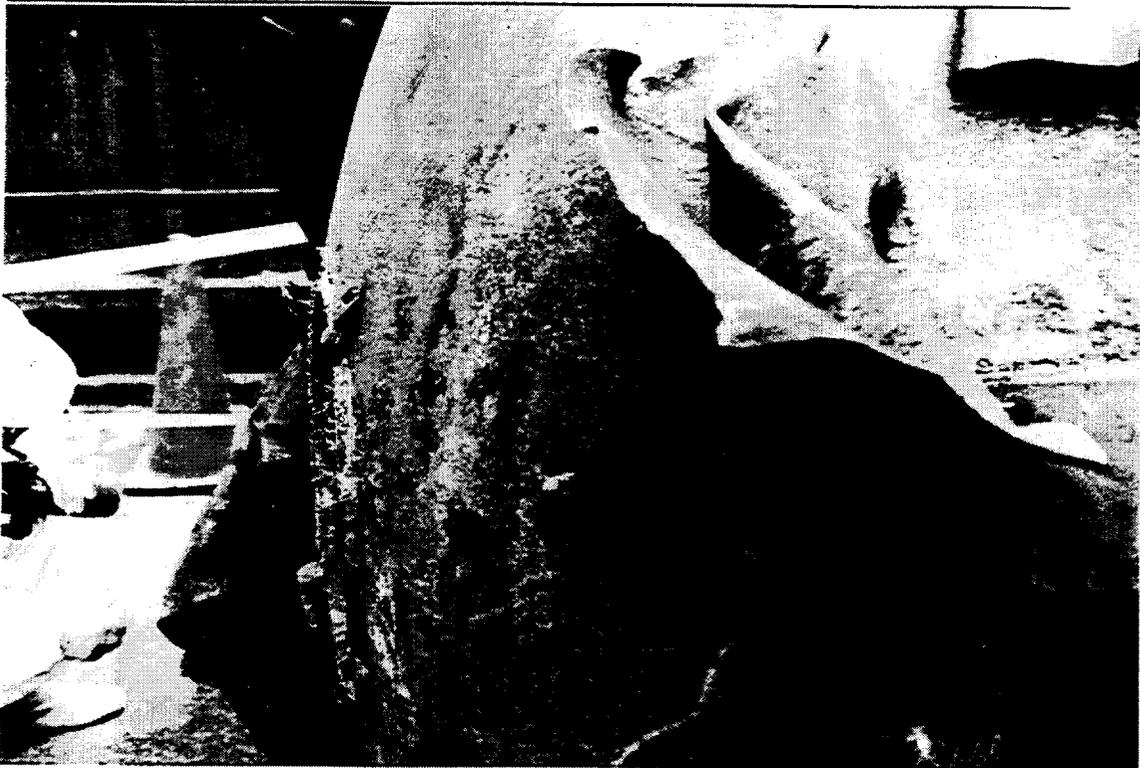
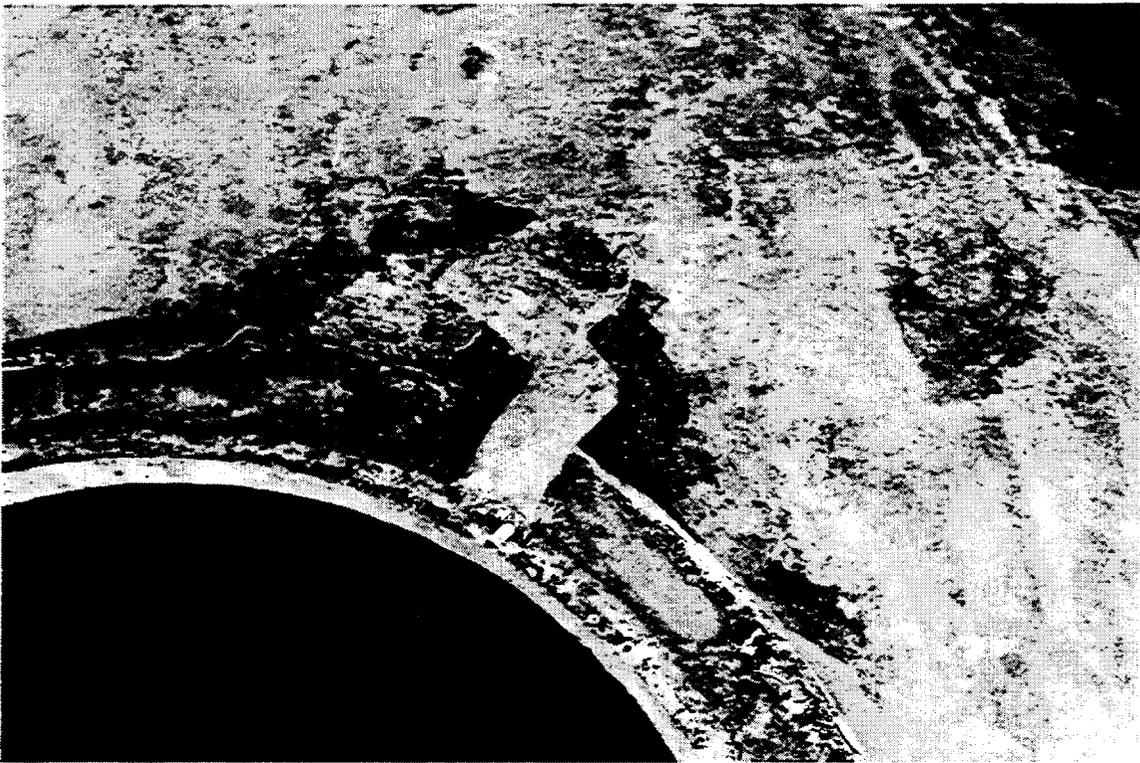
Figure 13: The tabs that held the to access port door are bent down against the stainless steel shell.

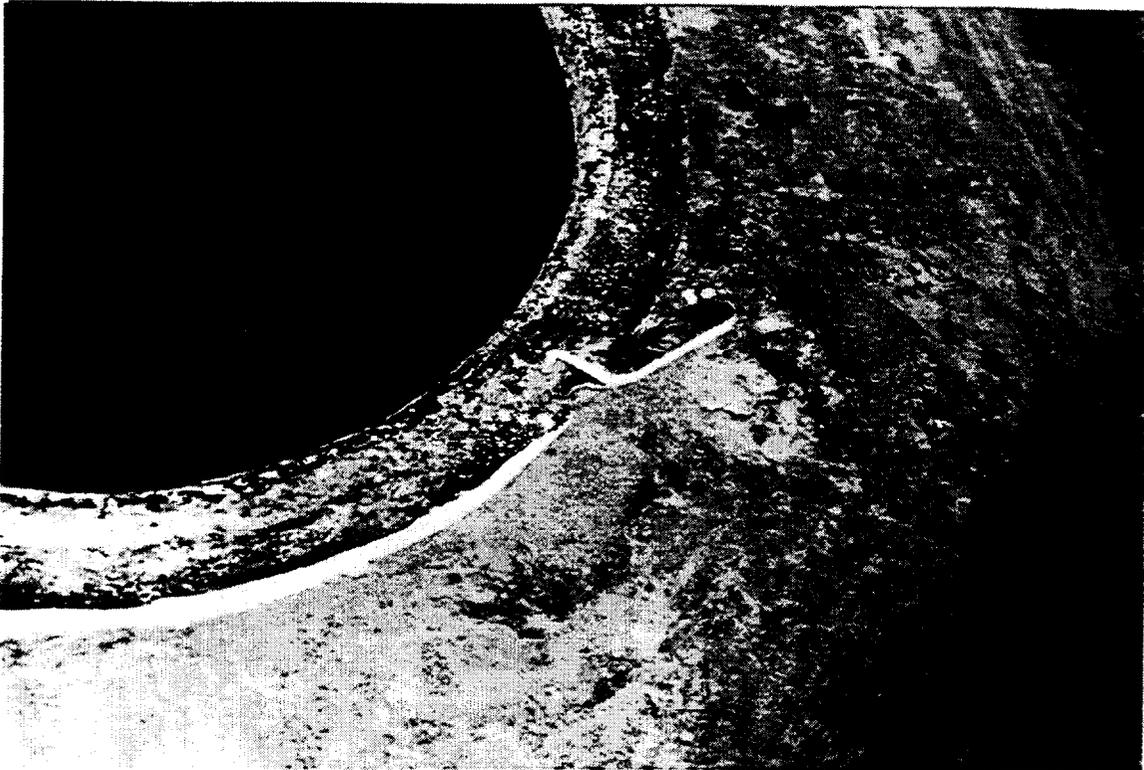
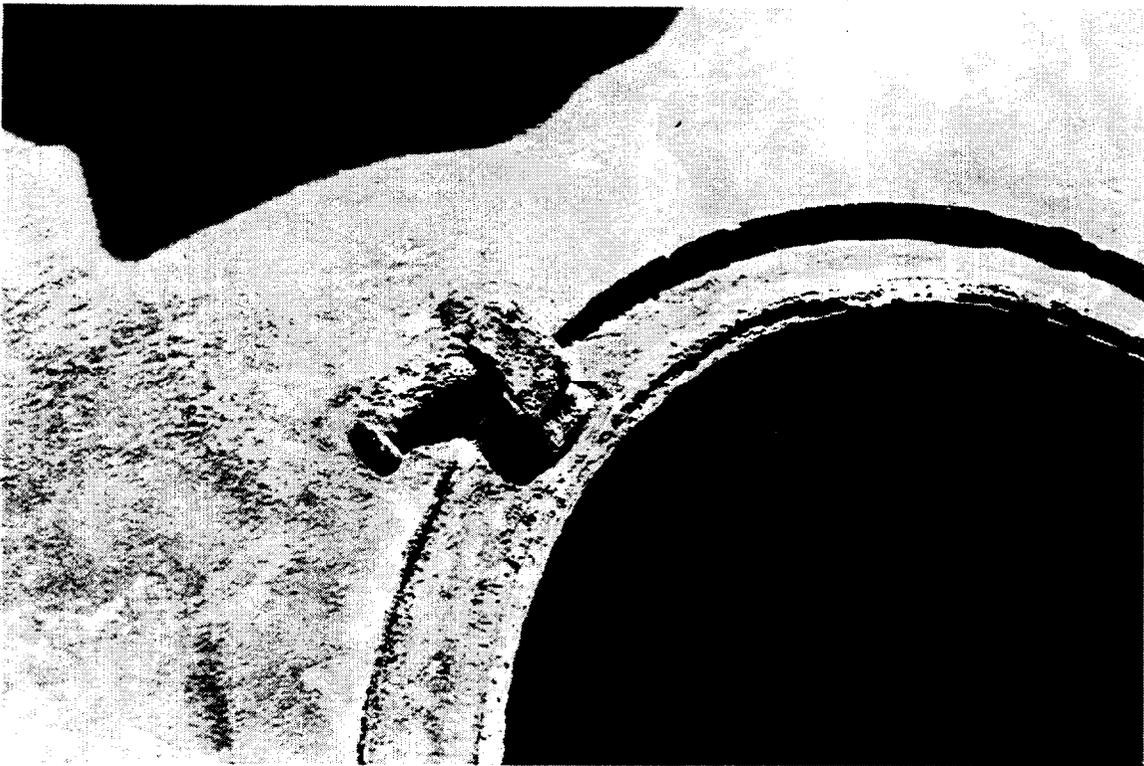
Figure 14: The insulation jacket has tom away from where it was attached to the stainless steel shell and the access door tabs are bent over against the shell.

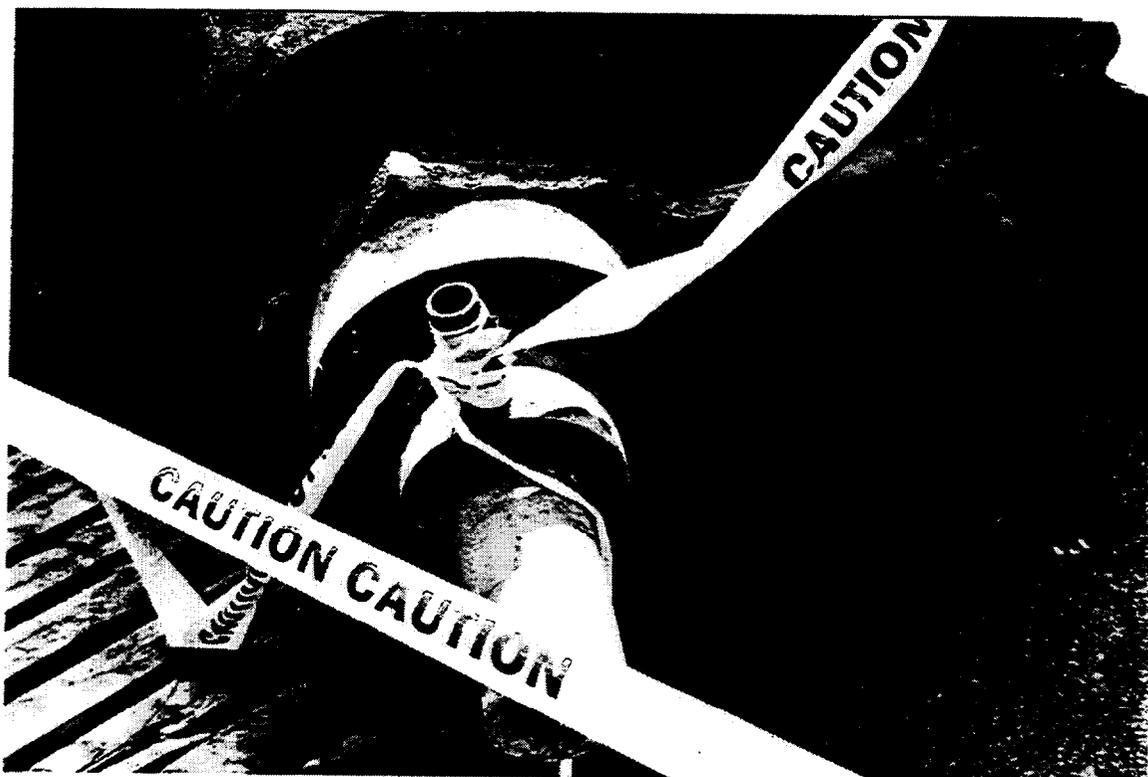
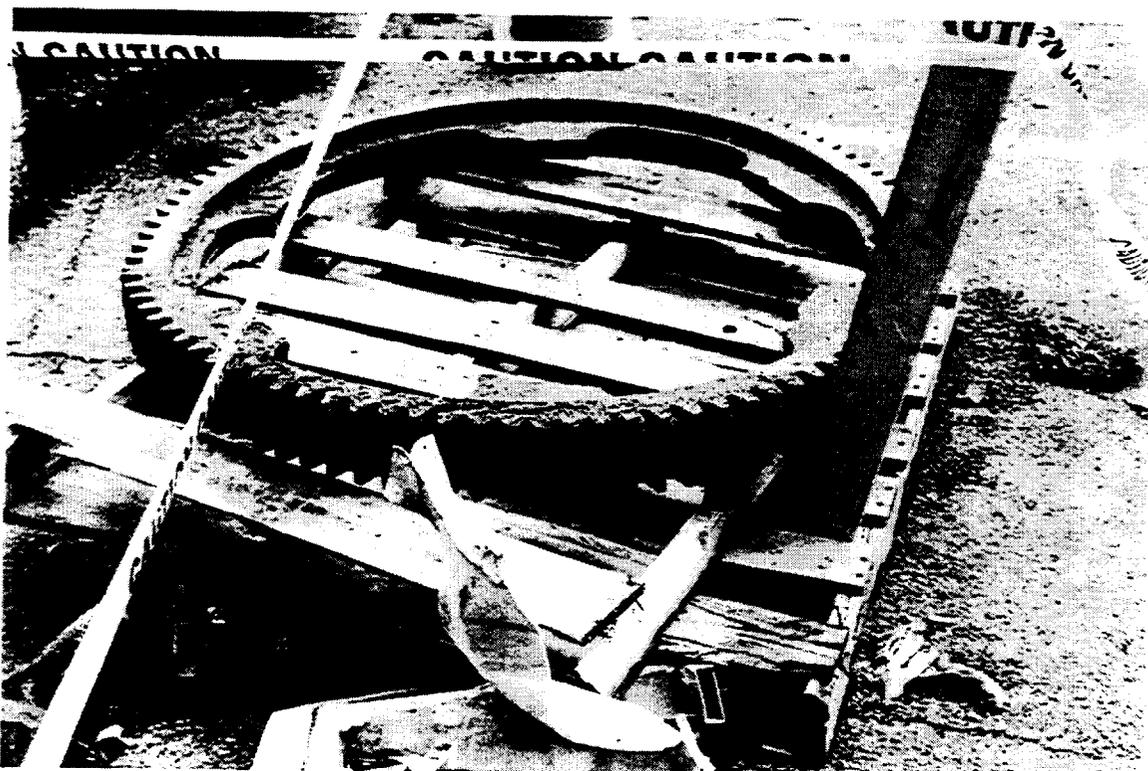
Figure 16: The gear drive side of the blender: a) the shaft (drive side) and b) the portion of the gear that fractured and separated from the blender in the accident.

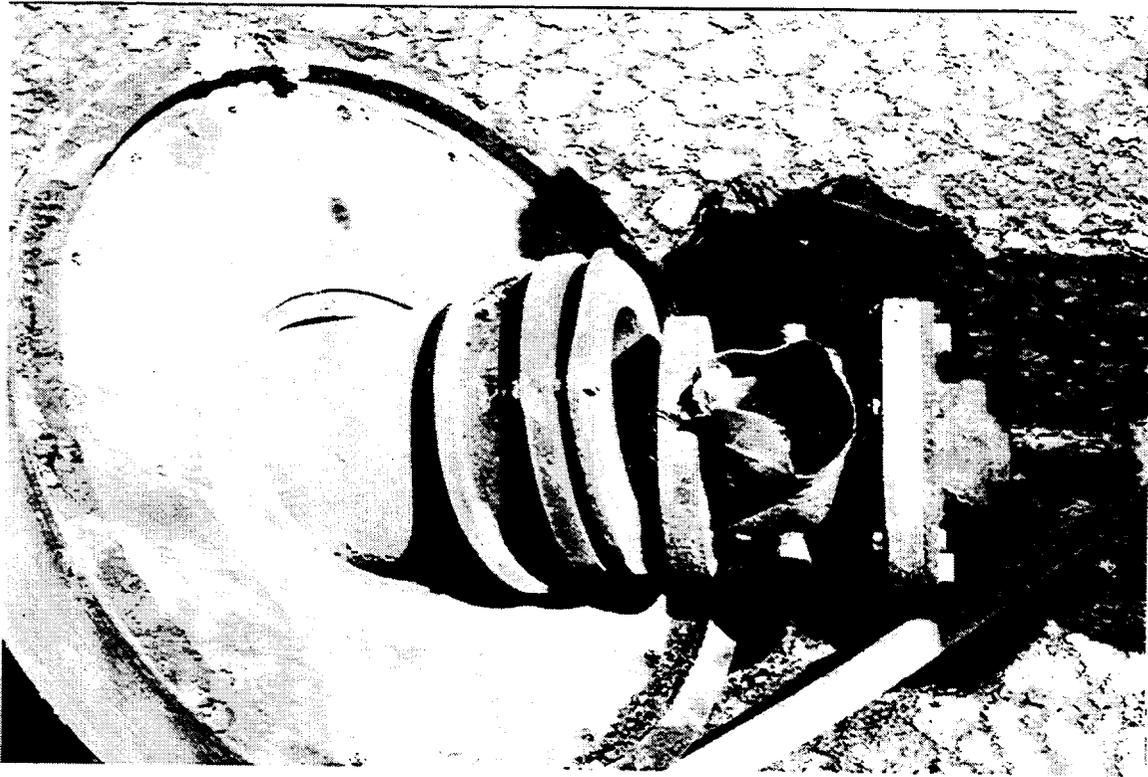
Figure 20: The wheel that supported the blender on the belt drive side and the shaft components: a) the wheel and shaft, b) the concentric shafts and tube that went into the interior of the blender.

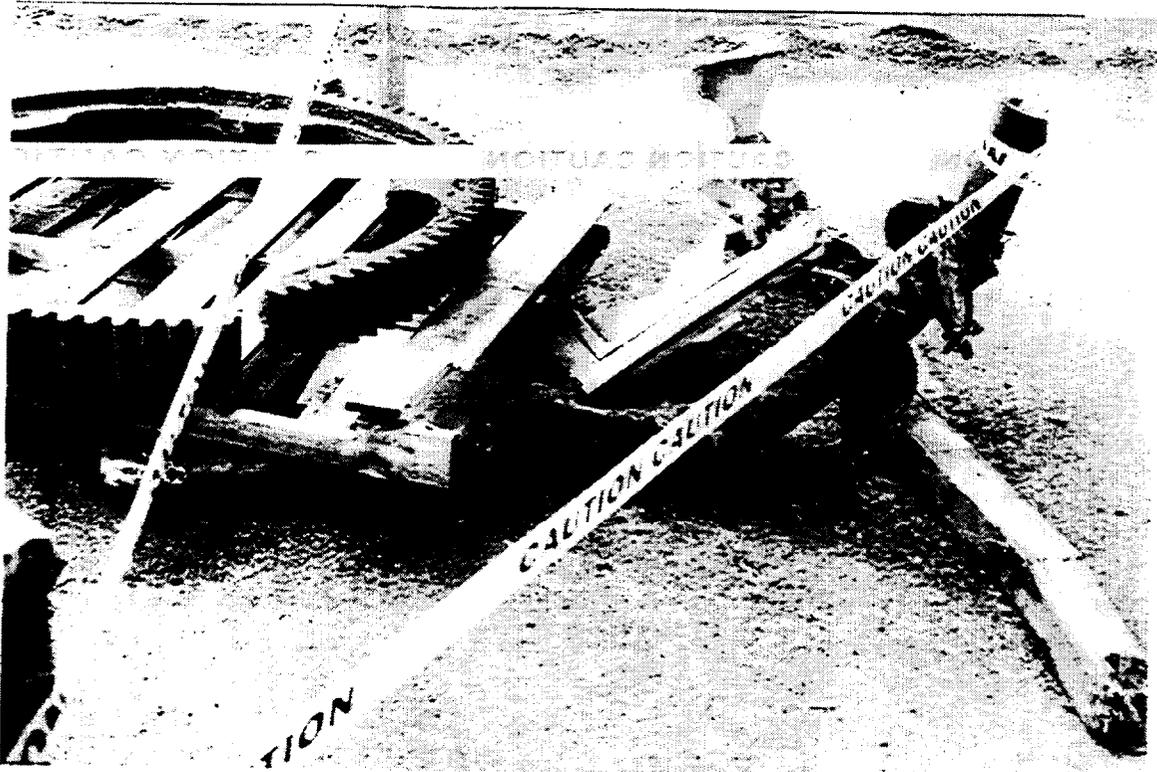
Figure 23: The intensifier bar: a) the shaft of the bar is severely deformed, b) two of the mixing plates are left, both are broken away from the shaft.

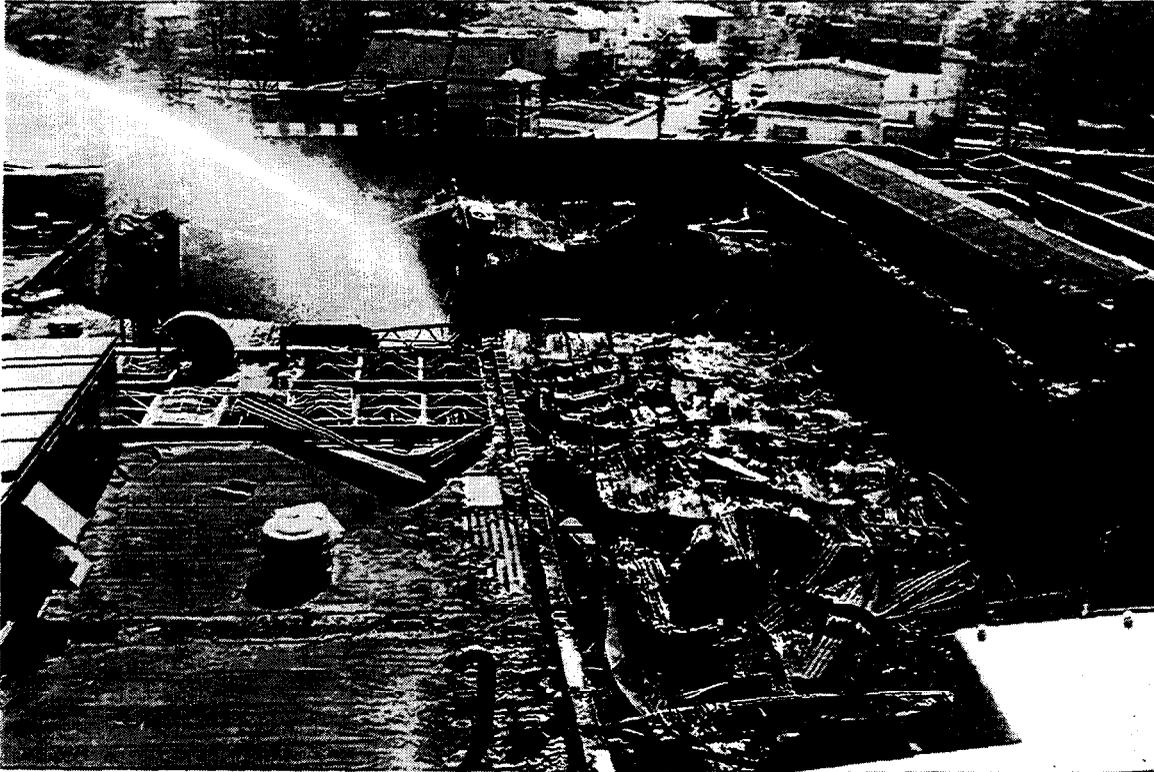
Figure 24: The Napp facility after the explosion and fire showing location in the plant where the processing took place and the location of the facility with respect to residential area in background.
