EPA/OSHA JOINT CHEMICAL ACCIDENT INVESTIGATION REPORT

**BPS, Inc.
West Helena, Arkansas**

Executive Summary

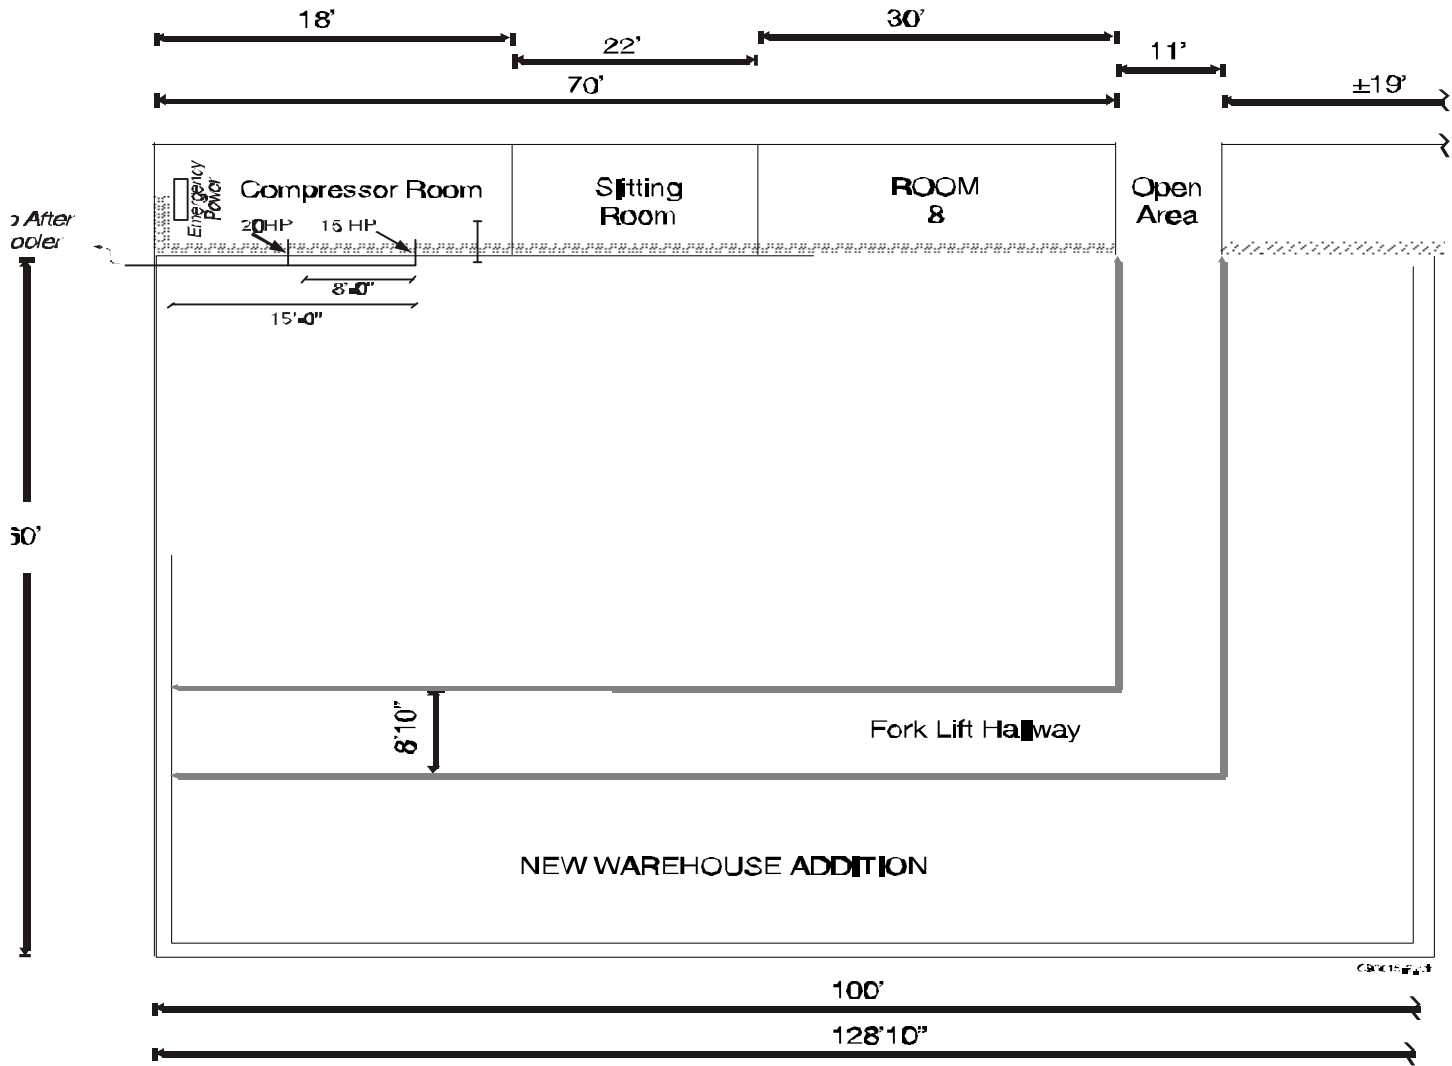
FIGURE 2: NEW WAREHOUSE ADDITION COMPRESSOR SYSTEM

Repackaging operations in the Unit Two building required the use of two reciprocating air compressors. The compressors were located in the southern portion of the original building. The compressors' discharge pipes went through the new warehouse addition's north wall into a common header pipe (Figure 2). This header pipe was fifteen feet long and 5'11" from the concrete pad floor. It ran parallel to the north wall to meet an after-cooler outside the new addition's west wall. The output from the after-cooler was piped back along the same wall 3'7" from the concrete floor carrying the cooled air back to the accumulator tanks under each compressor (Figures 3 and 4).

At the time of the incident, BPS personnel stated that the surface temperature in the pipe was approximately 145⁰ F (63⁰ C). In order to confirm this statement and determine the potential involvement of the compressor in the incident, the JCAIT conducted a series of activities. First, the team inspected and documented the compressor system conditions after the event. Observations from this inspection were supplemented with interviews with BPS employees and management and the compressor manufacturer.

- \$ Discussions held with the manufacturer of the two compressors used at BPS indicated that there are a number of factors which can affect the compressor discharge temperature such as ambient temperature and discharge pressure. However, under normal operating conditions the maximum discharge air temperature of the compressors at the cylinder head would be expected to be in the range of 300⁰ to 350⁰ F (149⁰ - 177⁰ C).

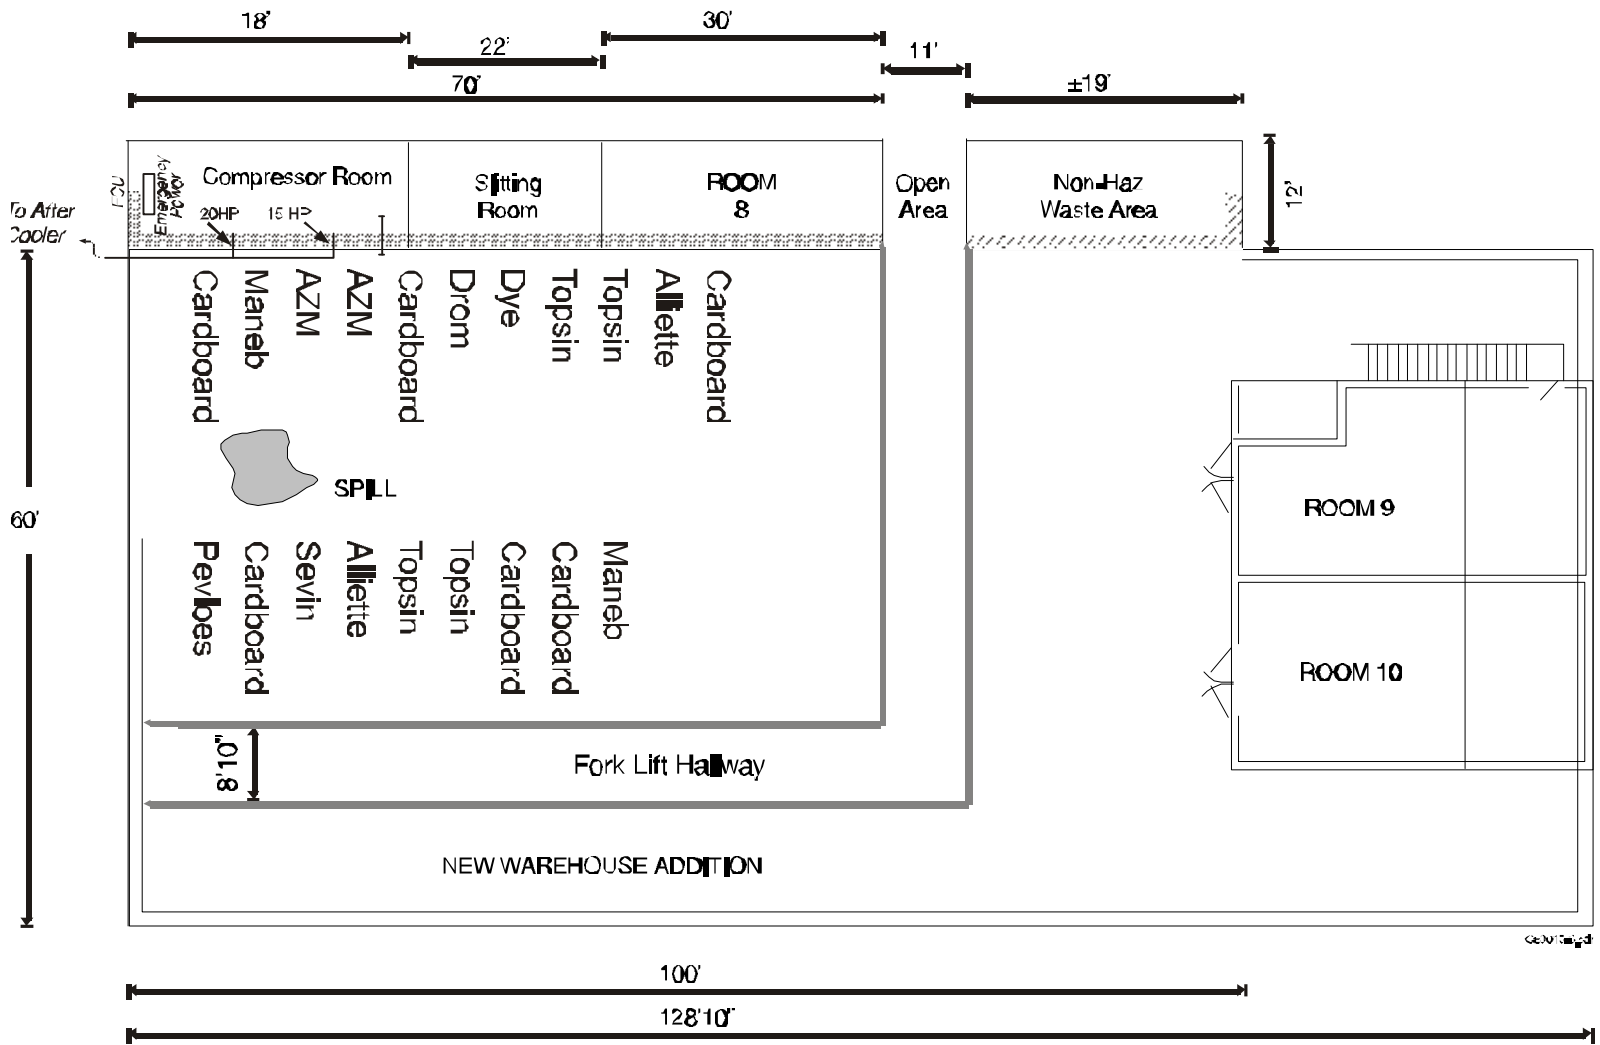
FIGURE 7: APPROXIMATE LOCATION OF CHEMICALS IN THE NEW WAREHOUSE ADDITION.

Based on witness interviews, the JCAIT identified the approximate location of the chemicals in the warehouse area (Figure 7). Even though witness accounts are somewhat conflicting regarding the quantity and approximate location of the stored chemicals, most statements agree that AZM supersacks had just been placed next to the compressor piping. Witnesses also agree that the yellow smoke or powder was coming from this location. Forklift operators recollect placing Maneb pallets by the compressor pipe in an attempt to make room for the incoming AZM. In addition to the witness statements the JCAIT:

- \$ Screened the bulk residue samples for various pesticides including AZM, Maneb, Topsin, and Sevin. Only semi-quantitative values of AZM and Maneb were reported.
- \$ Secured and analyzed the remains of the new warehouse addition ventilation fans which had visible yellow residue (Figure 8). AZM and its major decomposition products were confirmed.

The JCAIT concluded that it was highly probable that pallets of both AZM and Maneb were placed along the compressor pipe the day of the event.
