## IT HURTS TO BE IN THE “RED ZONE”

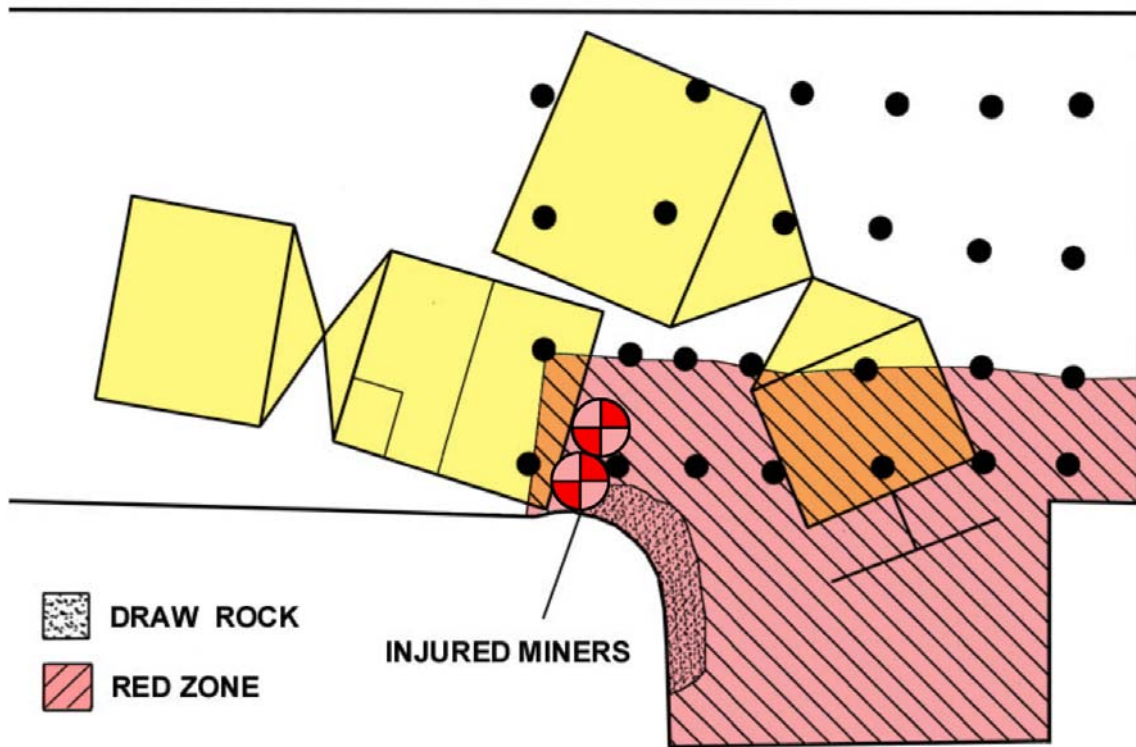
**Entering the “RED ZONE” continues to result in mine fatalities and injuries.** A recent non-fatal roof fall accident resulted in injuries to two miners who were working in the “RED ZONE”. The miners were loading supplies from a scoop onto a roof bolting machine that was positioned at the entrance to an unbolted crosscut. The scoop was positioned with its bucket extending into the “RED ZONE”, with the miners located in front of the bucket between the first and second row of roof bolts. As they moved the supplies, draw rock fell along the right rib, extending from the unsupported crosscut into the area where the men were working, striking and injuring both miners. Fortunately, the injuries were not life threatening.

Please take time to re-instruct all miners as to the location of the “RED ZONE” as shown in your mine’s approved roof control plan. *Working in the “RED ZONE” is not much different from working in an unsupported area. Roof material that begins to fall in the unbolted area doesn’t always stop at the first row of roof bolts. When that happens, it hurts to be in the “RED ZONE”.*

A best practice to prevent such an accident would be to move the equipment to a safe area outby the newly developed crosscut. This would prevent miners from being exposed to hazards associated with working within the “RED ZONE”.
