Fuel Economy and Quality
Vehicle Environmental Engineering
Tel (313) 594 3179
Fax (313) 390 0382

November 2, 1998

Subject Boston Police Ford Bronco Fuel Pump Failure

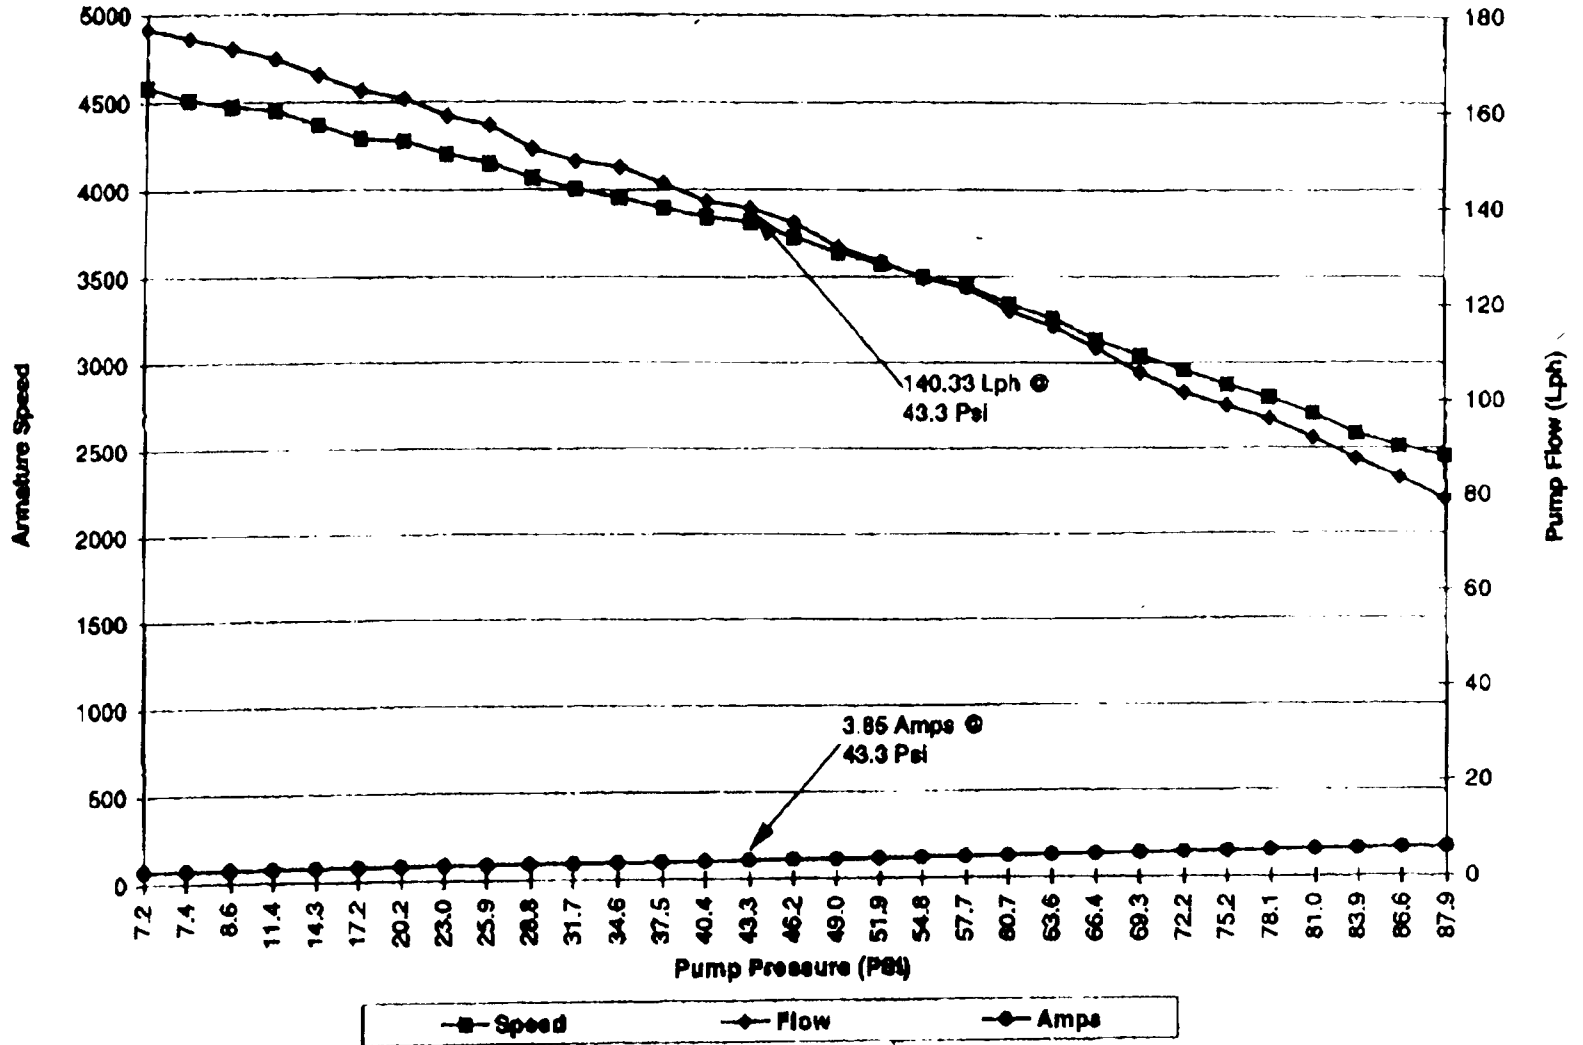
Fleet Return - 88MY Bronco/ Bosch Fuel pump
 Part# E7TF-9350-AA
 (12 Volt sweep)

Debbie, the Visteon fuel handling department which design and test fuel pumps for Ford have analyzed the returned pump which had operated on Federal Phase 2 gasoline. As the attached test sheet indicates the pump performance is still within our specification and suitable for use.
