Effectiveness of Road Restoration in Reducing Sediment Loads

Agreement No. FG7354IF

Final Report

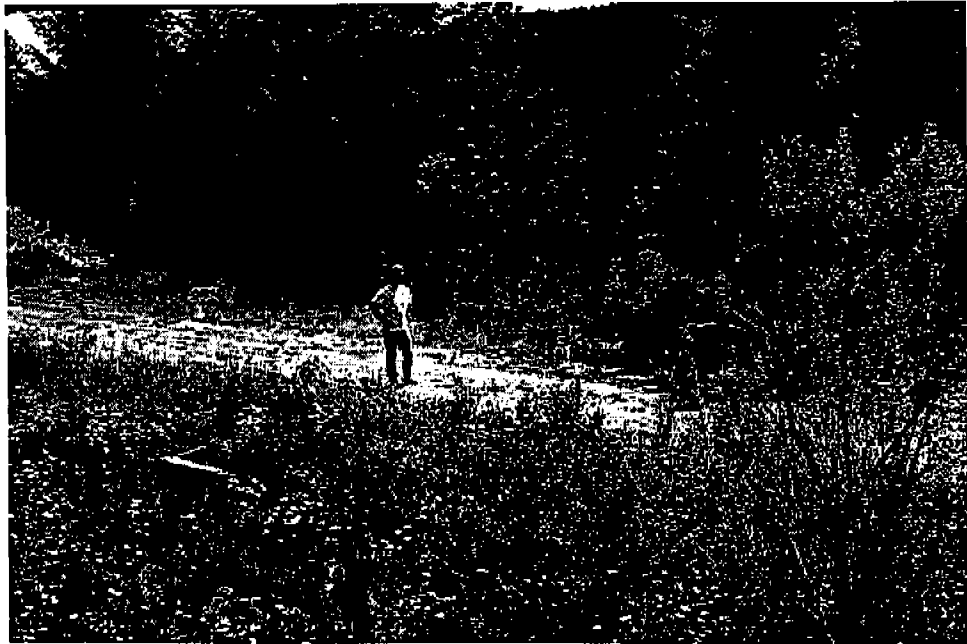
Figure 3: Another example of an excavated crossing. In this case, the stream channel is not as incised as the one in Figure 2, so the streambanks are not as steep or high.

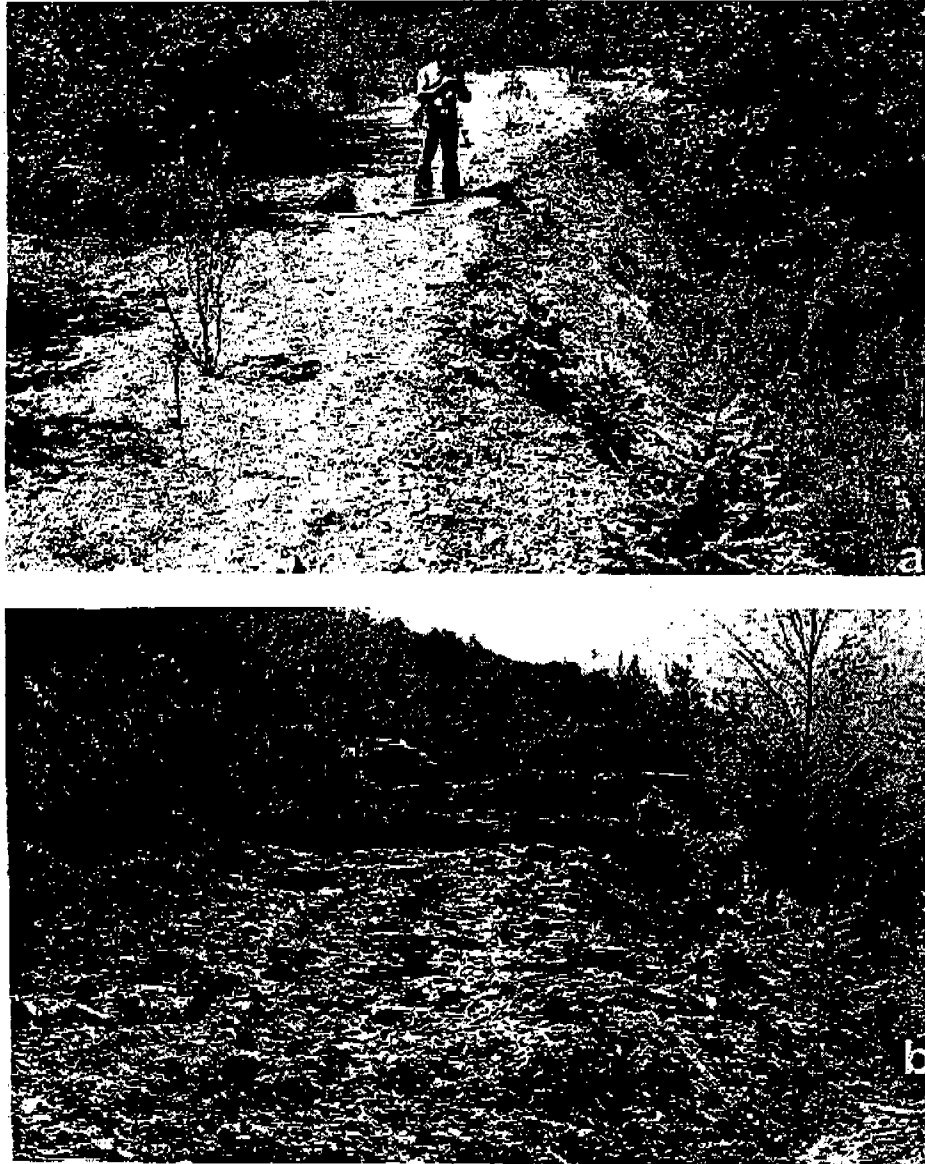
Figure 5. An example of the least intensive road rehabilitation technique. a) Abandoned logging road before treatment. b) The road surface is decompacted, and ditches are constructed perpendicular to the road alignment to drain the road. The road bench and road fill remain in place.

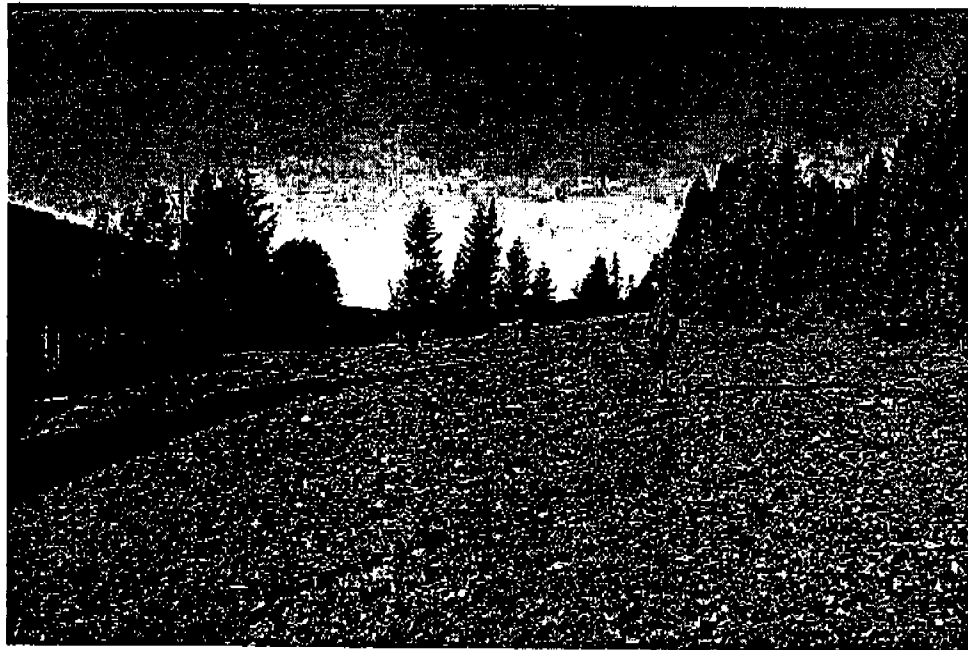
Figure 6. An example of partial outsloping a road bench.

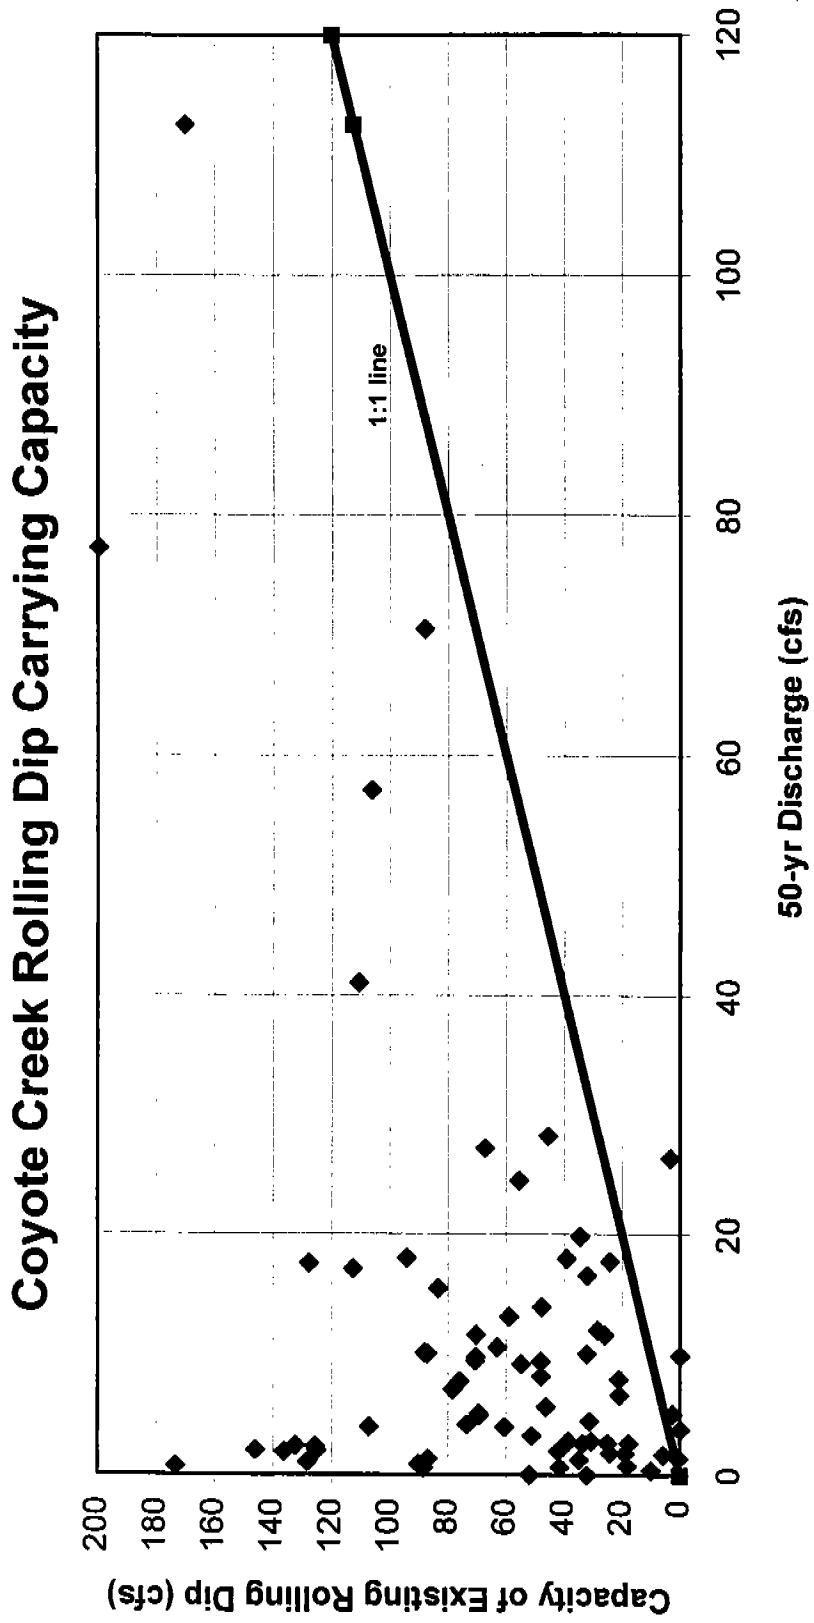
Figure 18 shows the results of this analysis. Dips plotting above the line have a capacity greater than the 50-year flow. Almost all rolling dips in this study had sufficient capacities to carry runoff from a large storm, if the culvert failed. Field constraints, such as shallow culverts or the presence of bedrock in the road bench, sometimes make it difficult to construct a rolling dip as large as the design. This inventory on Redwood National and State Parks lands suggests that most rolling dips should perform well in the next large storm, if culverts fail.

Figure 18: Comparison of the existing capacity of rolling dips to the estimated 50-year flood.
