TECHNICAL ASPECTS OF TECHNOLOGY TRANSFER DURING THE LORAL FAILURE INVESTIGATION

Background

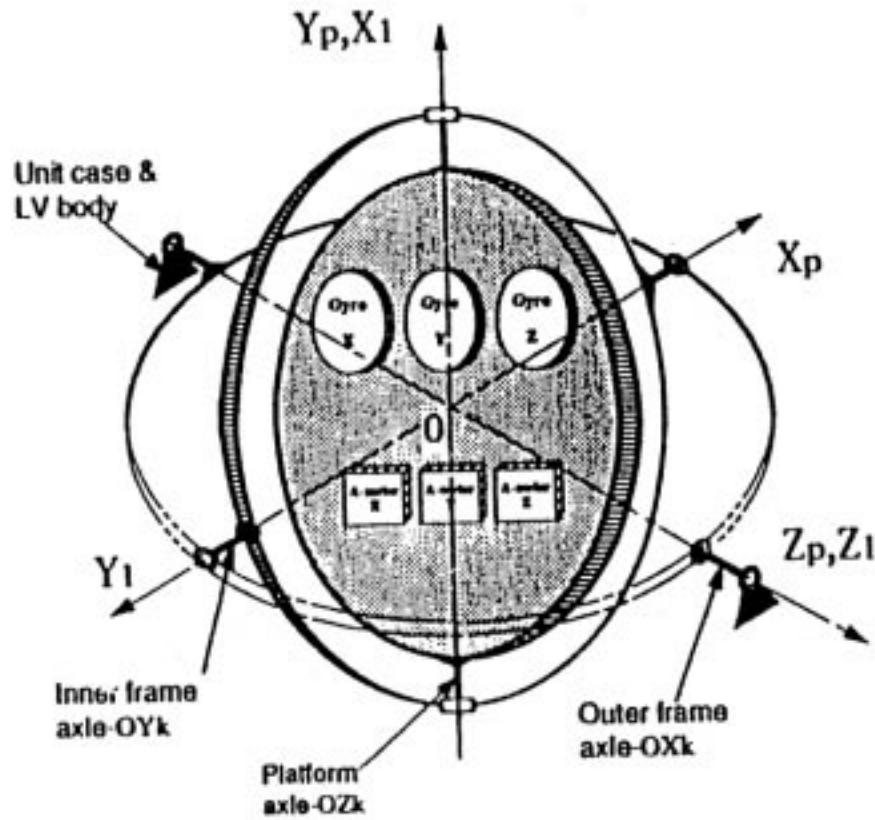
IMU of LM-3

As presented by the PRC participants, the older inertial measurement unit used in the Long March 3 weighed 140 kilograms, and measured 500 x 600 x 800 mm. It had three gimbal axes and three single-axis gyroscopes on its inertial platform. It was also said to have a high degree of redundancy to preclude single point failures. The newer Long March 3B inertial measurement unit was presented as having a weight of 48 kilograms, and dimensions of 300 x 300 x 400 mm. It had four gimbal axes with only two (two-axis) gyroscopes on its inertial platform.

An artist's rendition of the difference in design between the inertial measurement unit used on the Long March 3 as compared to that used on the Long March 3A, 3B, and 3C rockets. The two illustrations are not shown to the same scale; the Long March 3 inertial measurement unit is much larger, and weighs nearly three times more.

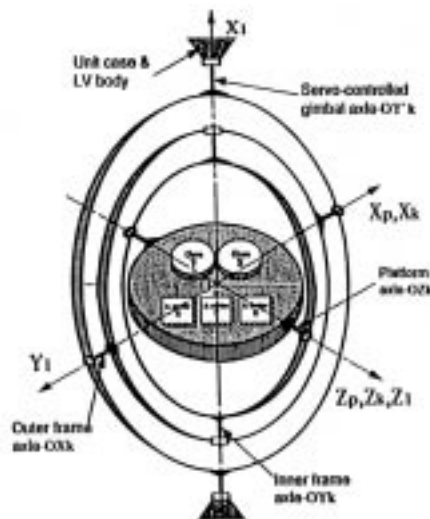
IMU of LM-3A/3B/3C

The fourth gimbal axis in the newer Long March 3B unit is associated with the addition of a follow-up frame to the platform mechanism. The follow-up frame precludes the occurrence of gimbal lock. This can take place in inertial platform assem-
