**EPA REGION 6 ANNOUNCES THE COMPLETION OF THE DRAFT FINAL
REMEDY SYSTEM EVALUATION (RSE) REPORT**

**HOMESTAKE MINING COMPANY SUPERFUND SITE
CIBOLA COUNTY, NEW MEXICO**

REMEDIATION SYSTEM EVALUATION (RSE)

**Homestake Superfund Site
Milan, New Mexico**

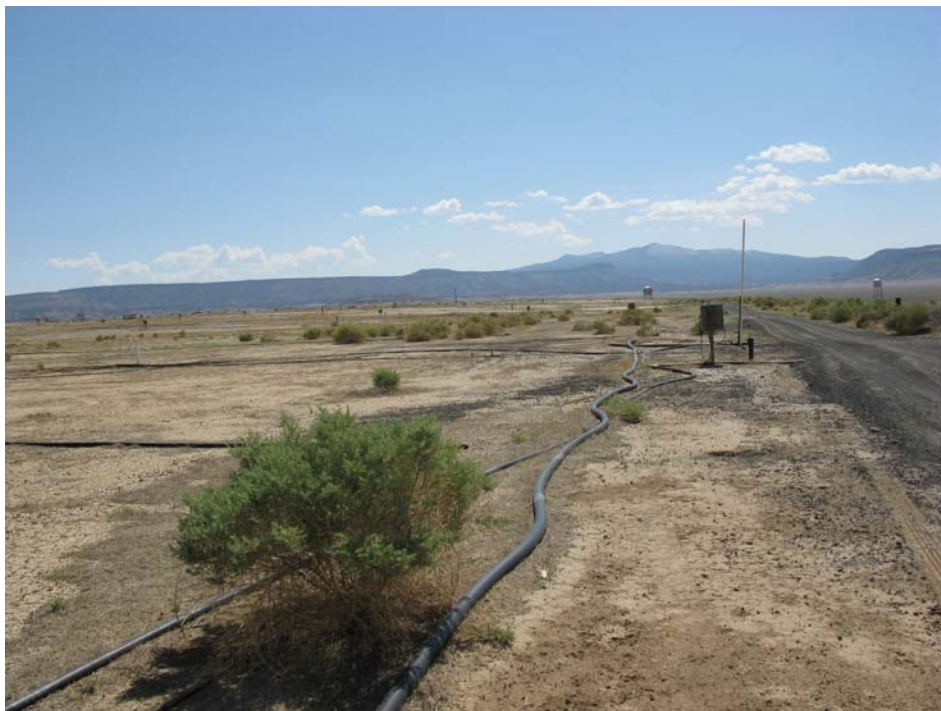
HMC utilizes miles of aboveground piping to move water around the Site. During the winter this piping may become frozen causing part of the groundwater remediation system to operate at less than optimal efficiency. Additionally, this pipe is subject to deterioration by the sun. However, even considering these problems, the RSE Team recognizes that the size of the remedial system and its intended flexibility, especially on the Large Tailings Pile, require that piping be left exposed to the elements and be easily moved. Placing piping on the surface also permits HMC to easily inspect the piping and to make any necessary repairs quickly.

Aboveground piping (looking east)

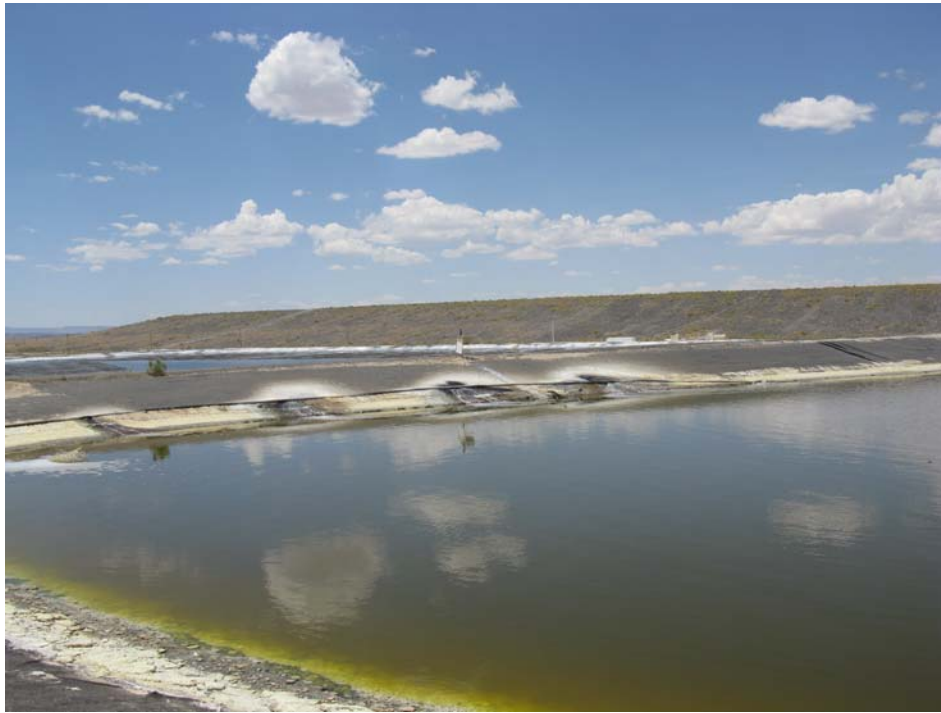
Evaporation Pond #1 showing pumping of water to cover liner with brine (yellow-white color)
(looking northwest)

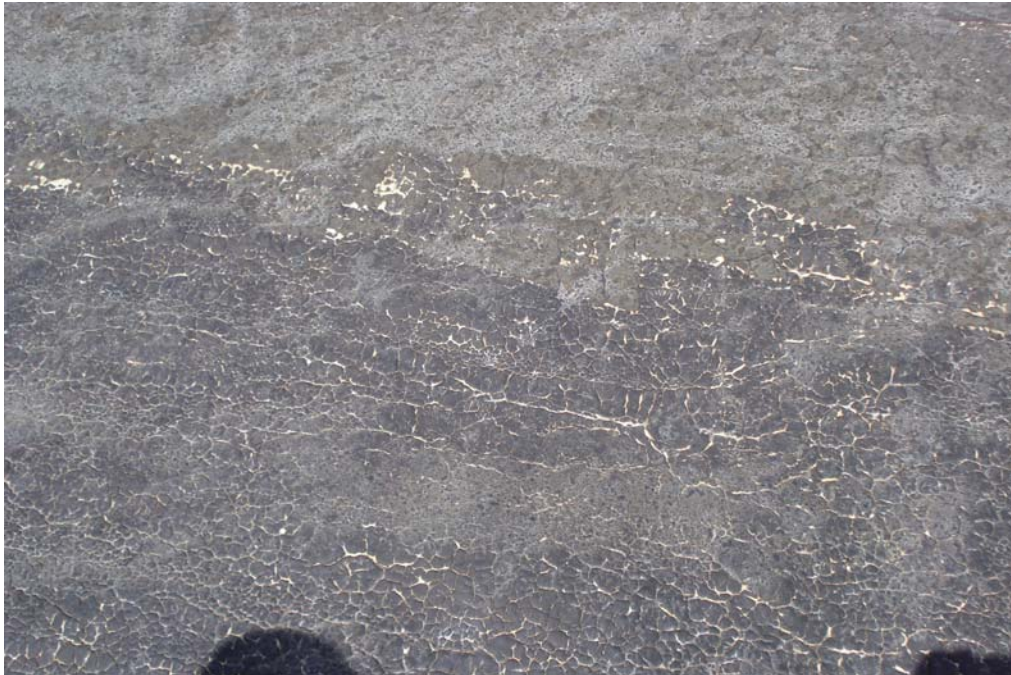
Evaporation Pond #2 liner showing effects of exposure to air and sun

7. To address deterioration of pond liners, HMC should evaluate methods to provide protection to the exposed liner to assure its integrity.
8. To assure environmental protection after remedial actions are complete, HMC should take such actions as are necessary to evaluate and demonstrate the effectiveness of entombment of all wastes in Evaporation Pond #1.

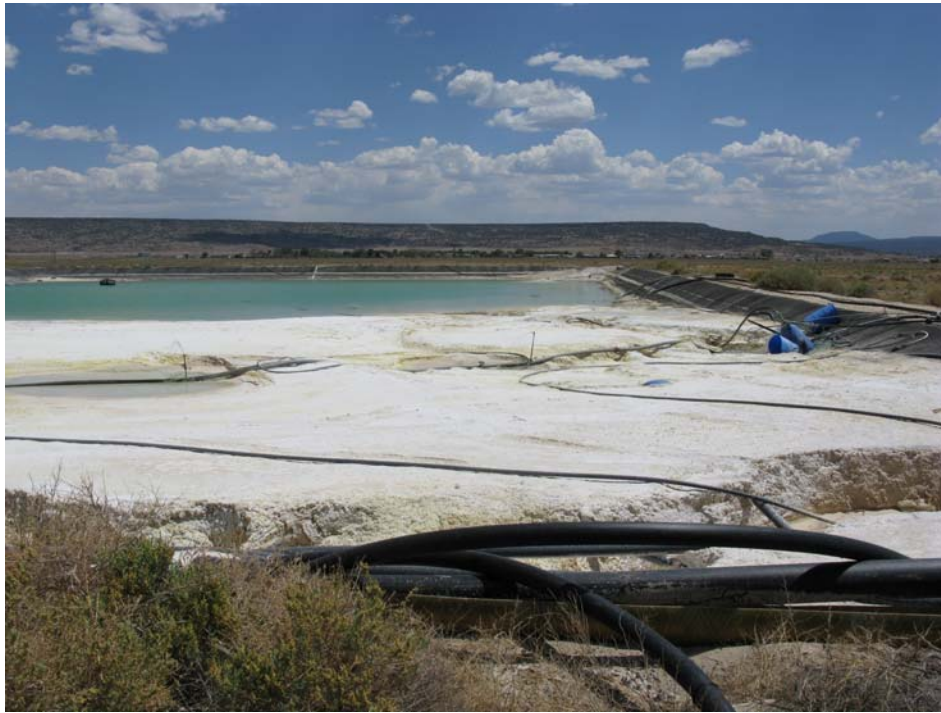
Collection Pond #1 showing sludge and various discharge lines (looking south)

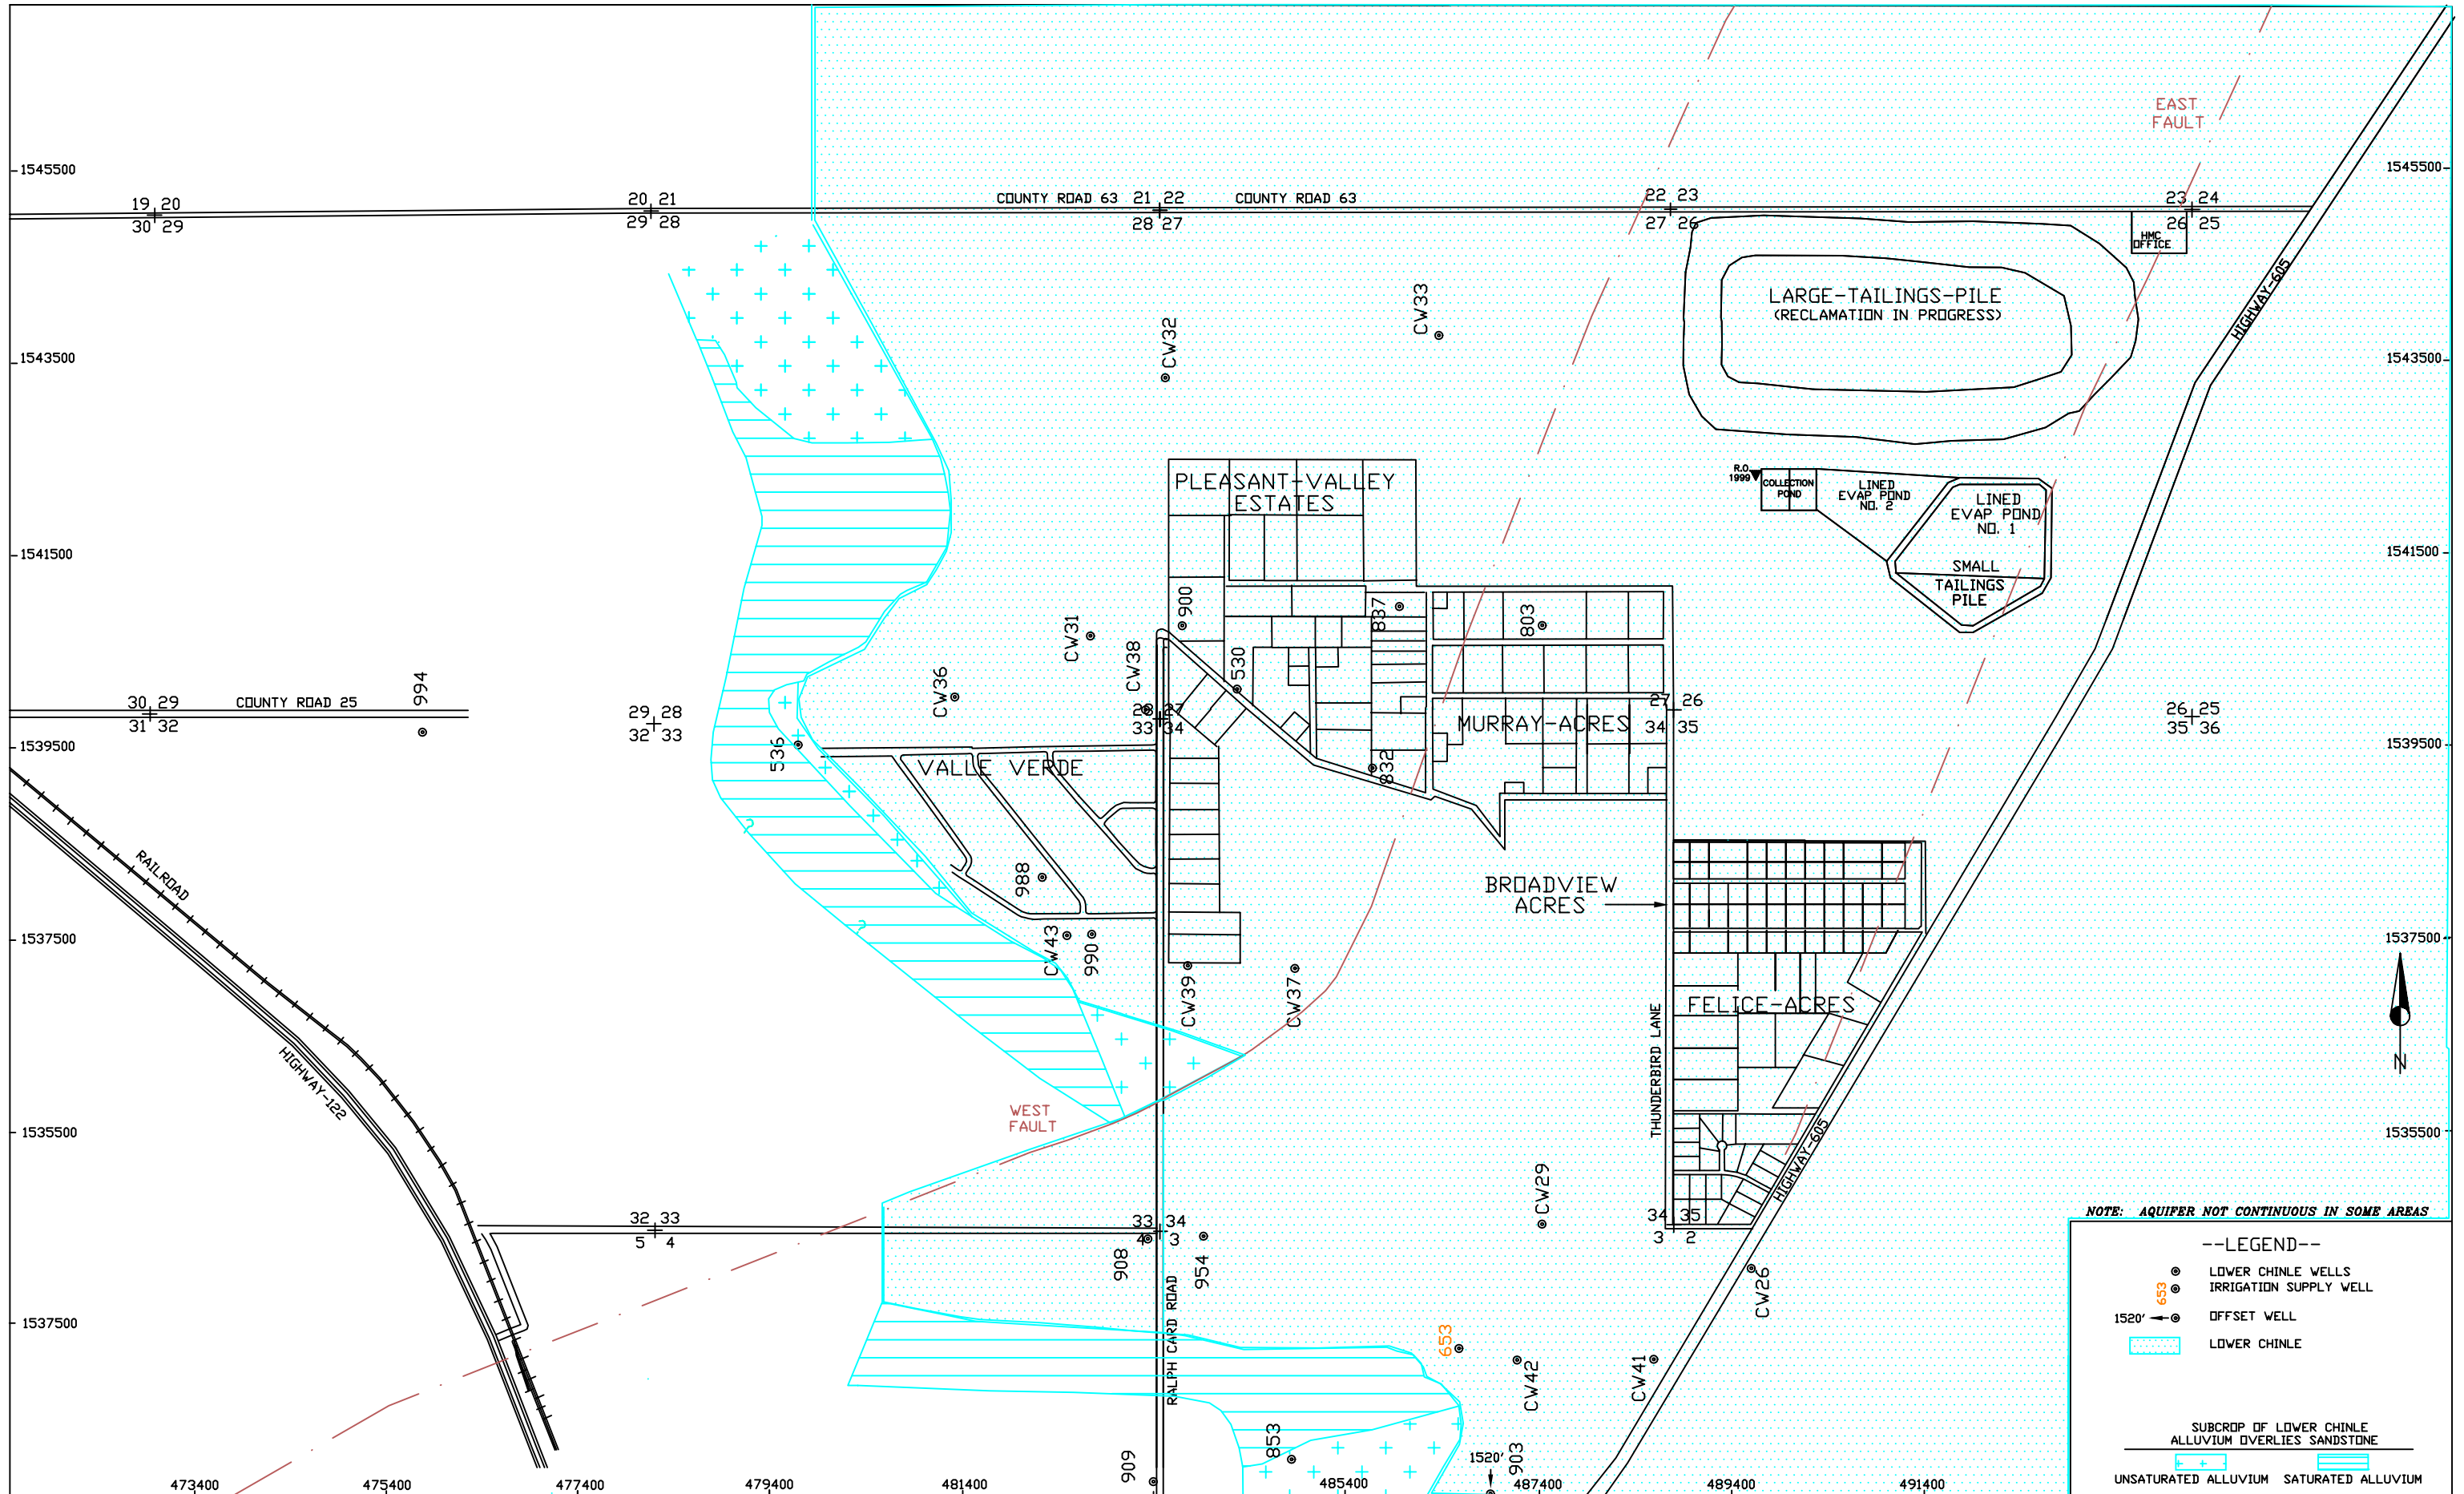
FIGURE 2-10. AREAL EXTENT OF THE
 LOWER CHINLE AQUIFER AND WELL LOCATIONS
 page 2-21

The Lower Chinle Aquifer is an up to 120-foot thick discontinuous zone of fractures within the Chinle Formation that provides secondary porosity sufficient to increase permeability. As depicted in Figure 2-10, the Lower Chinle Aquifer has an attitude consistent with the Middle Chinle Aquifer. The Aquifer subcrops with the Alluvial Aquifer west of Valle Verde and about a half mile south of Felice Acres. As depicted on Figure 7.2-1 the area of blue horizontal lines indicates where the Lower Chinle Aquifer is in direct contact and communication with the Alluvial Aquifer. Prior to and during groundwater remediation, the groundwater flow direction in the Lower Chinle Aquifer has remained northerly. The blue arrows show the direction a particle of water or entrained contaminant moves in the Lower Chinle Aquifer.

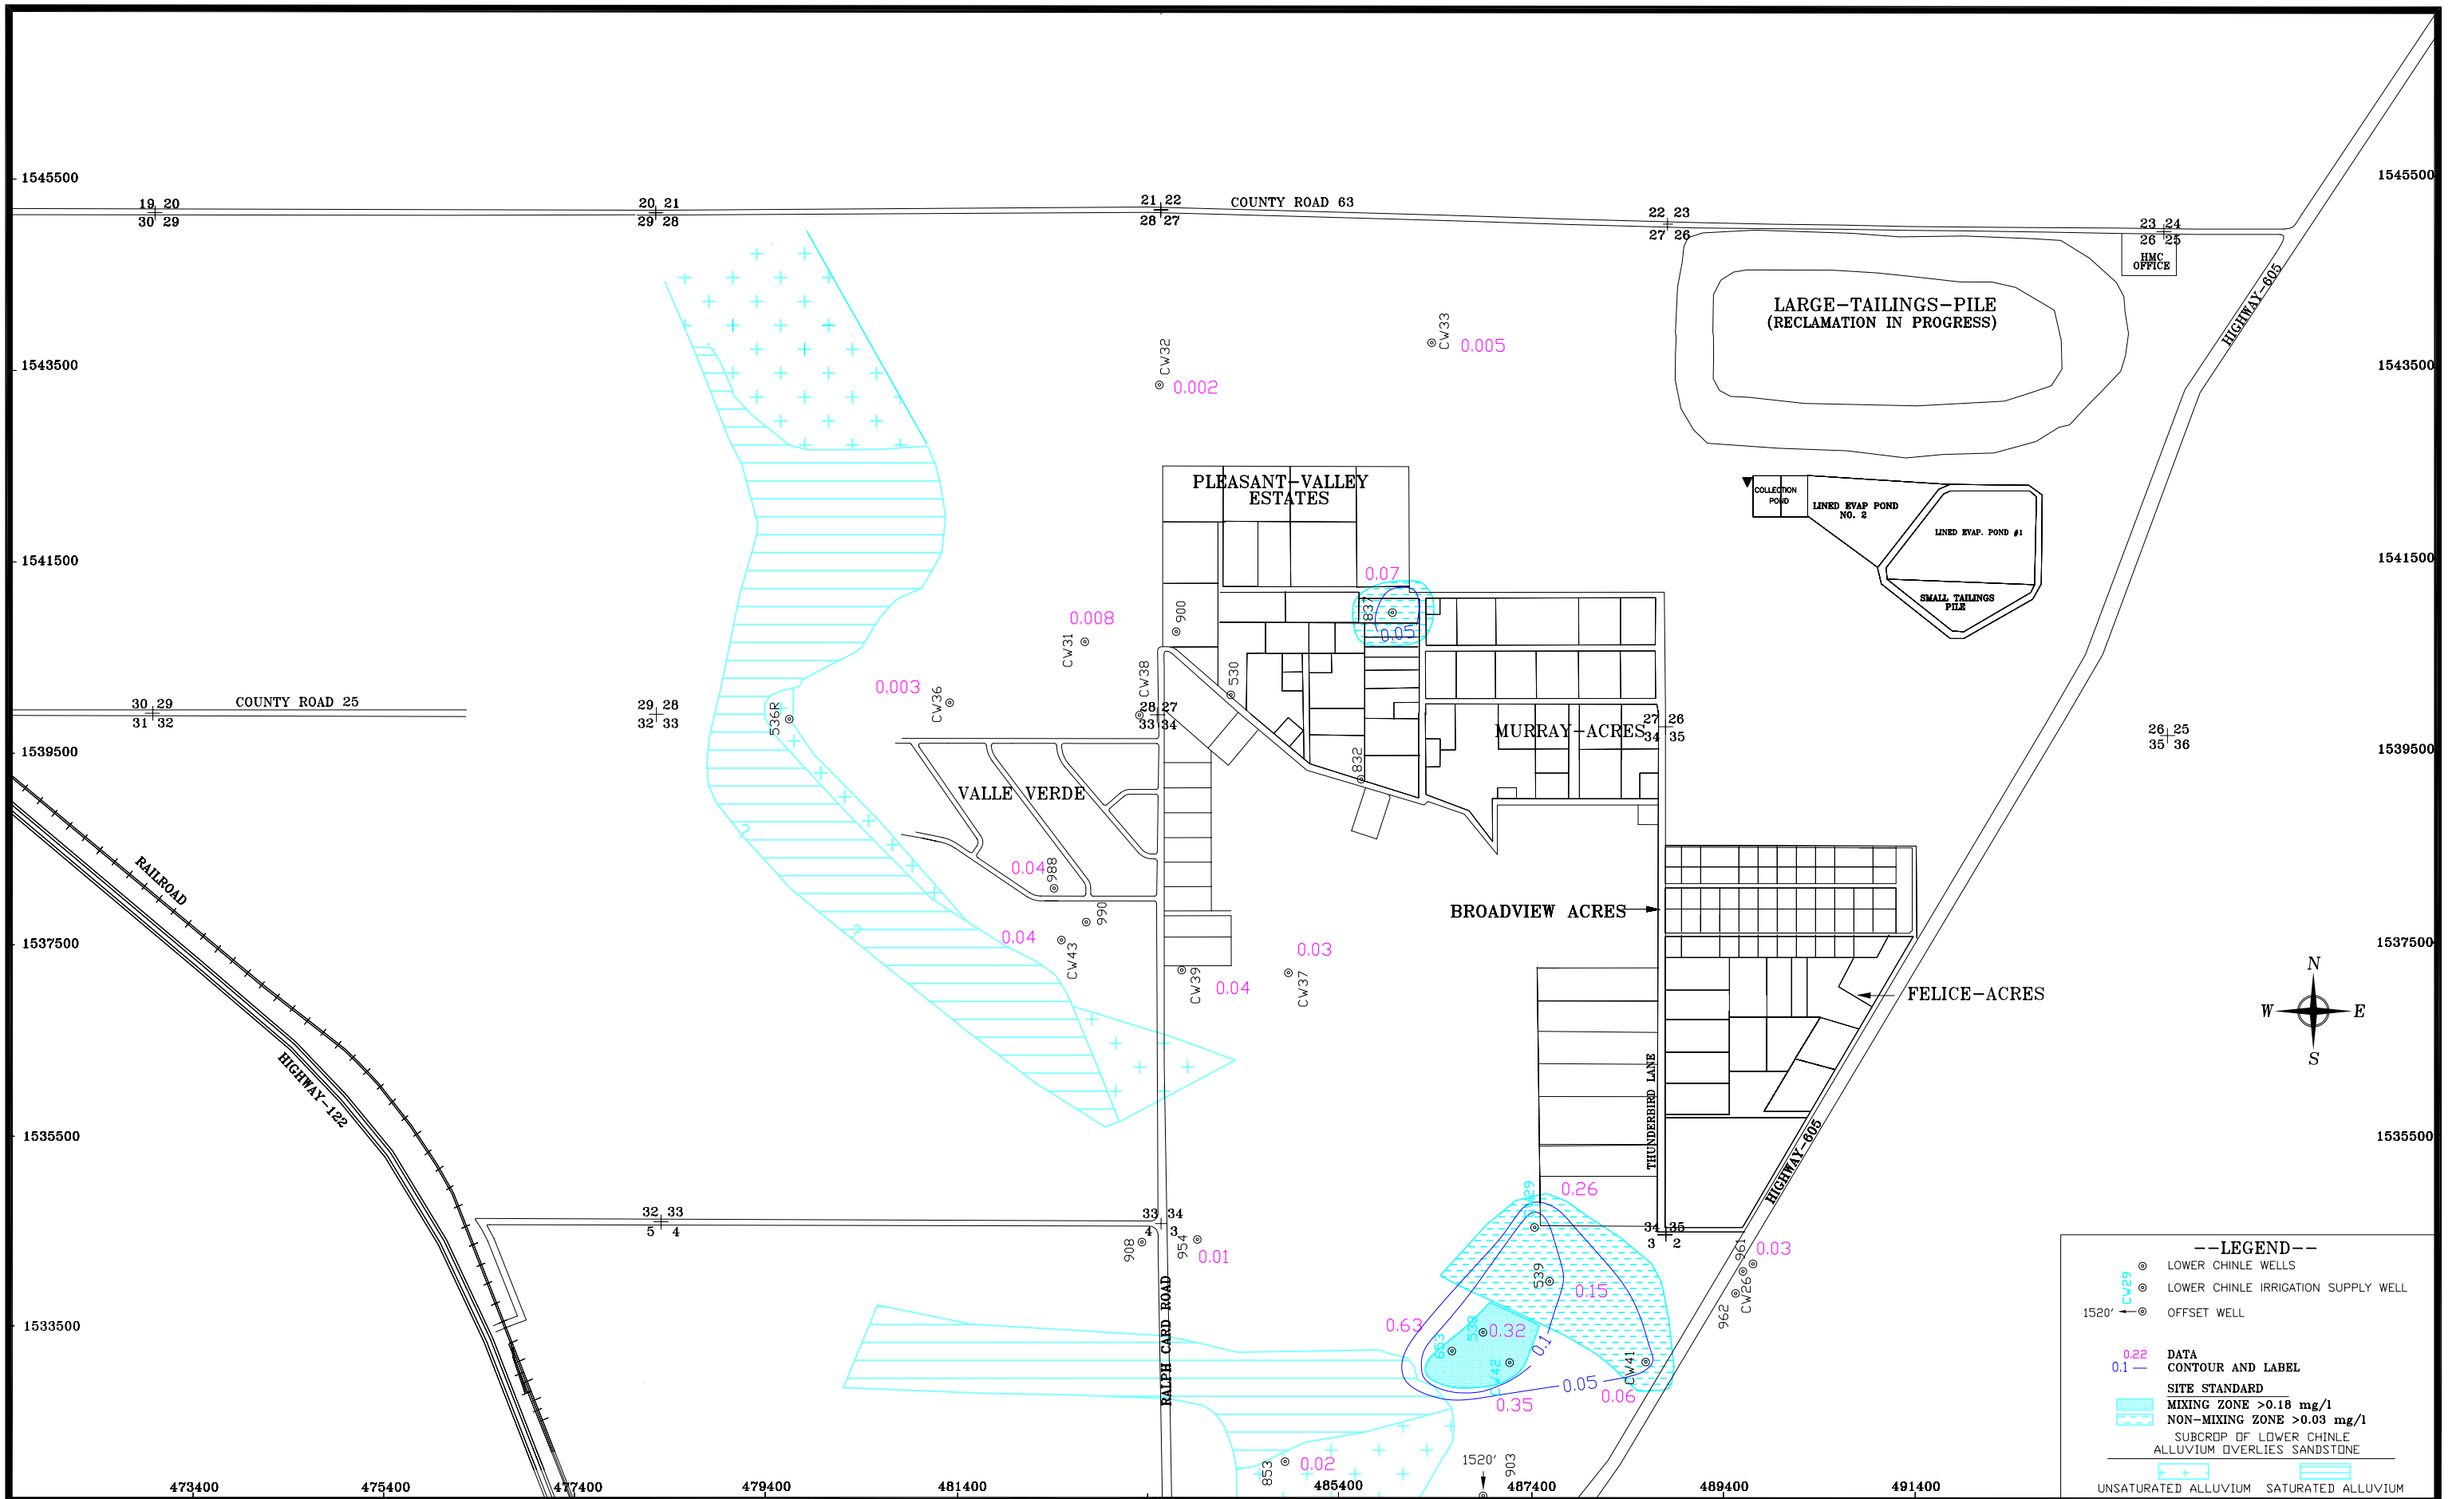
FIGURE 7.3-8. URANIUM CONCENTRATIONS OF THE LOWER CHINLE AQUIFER, 2007, mg/l

Uranium data and concentration contours for 2007 in the Lower Chinle Aquifer are presented on Figure 7.3-8. The blue shaded areas indicate where uranium concentrations are higher than the action level (i.e., 0.03 mg/l for the Aquifer and 0.18 mg/l for the mixing zone). Uranium concentrations are higher than the action level in the immediate proximity of well 837 in Felice Acres and south of Felice Acres near wells 653, 538, CW41 and CW42. The RSE Team suggests that the plume at well 837 is probably associated with an inadequately sealed well and the other plume may be associated with proximity to the subcrop or to inadequately sealed wells. From 1997 to 2007, the trend for uranium in both the mixing zone and Aquifer is decreasing concentrations as depicted in Figures 7.3-9 and Figure 7.3-10. In particular, wells 653 and CW37 indicate a decreasing trend while surrounding wells indicate that plume is not spreading but remaining stable in aerial size.

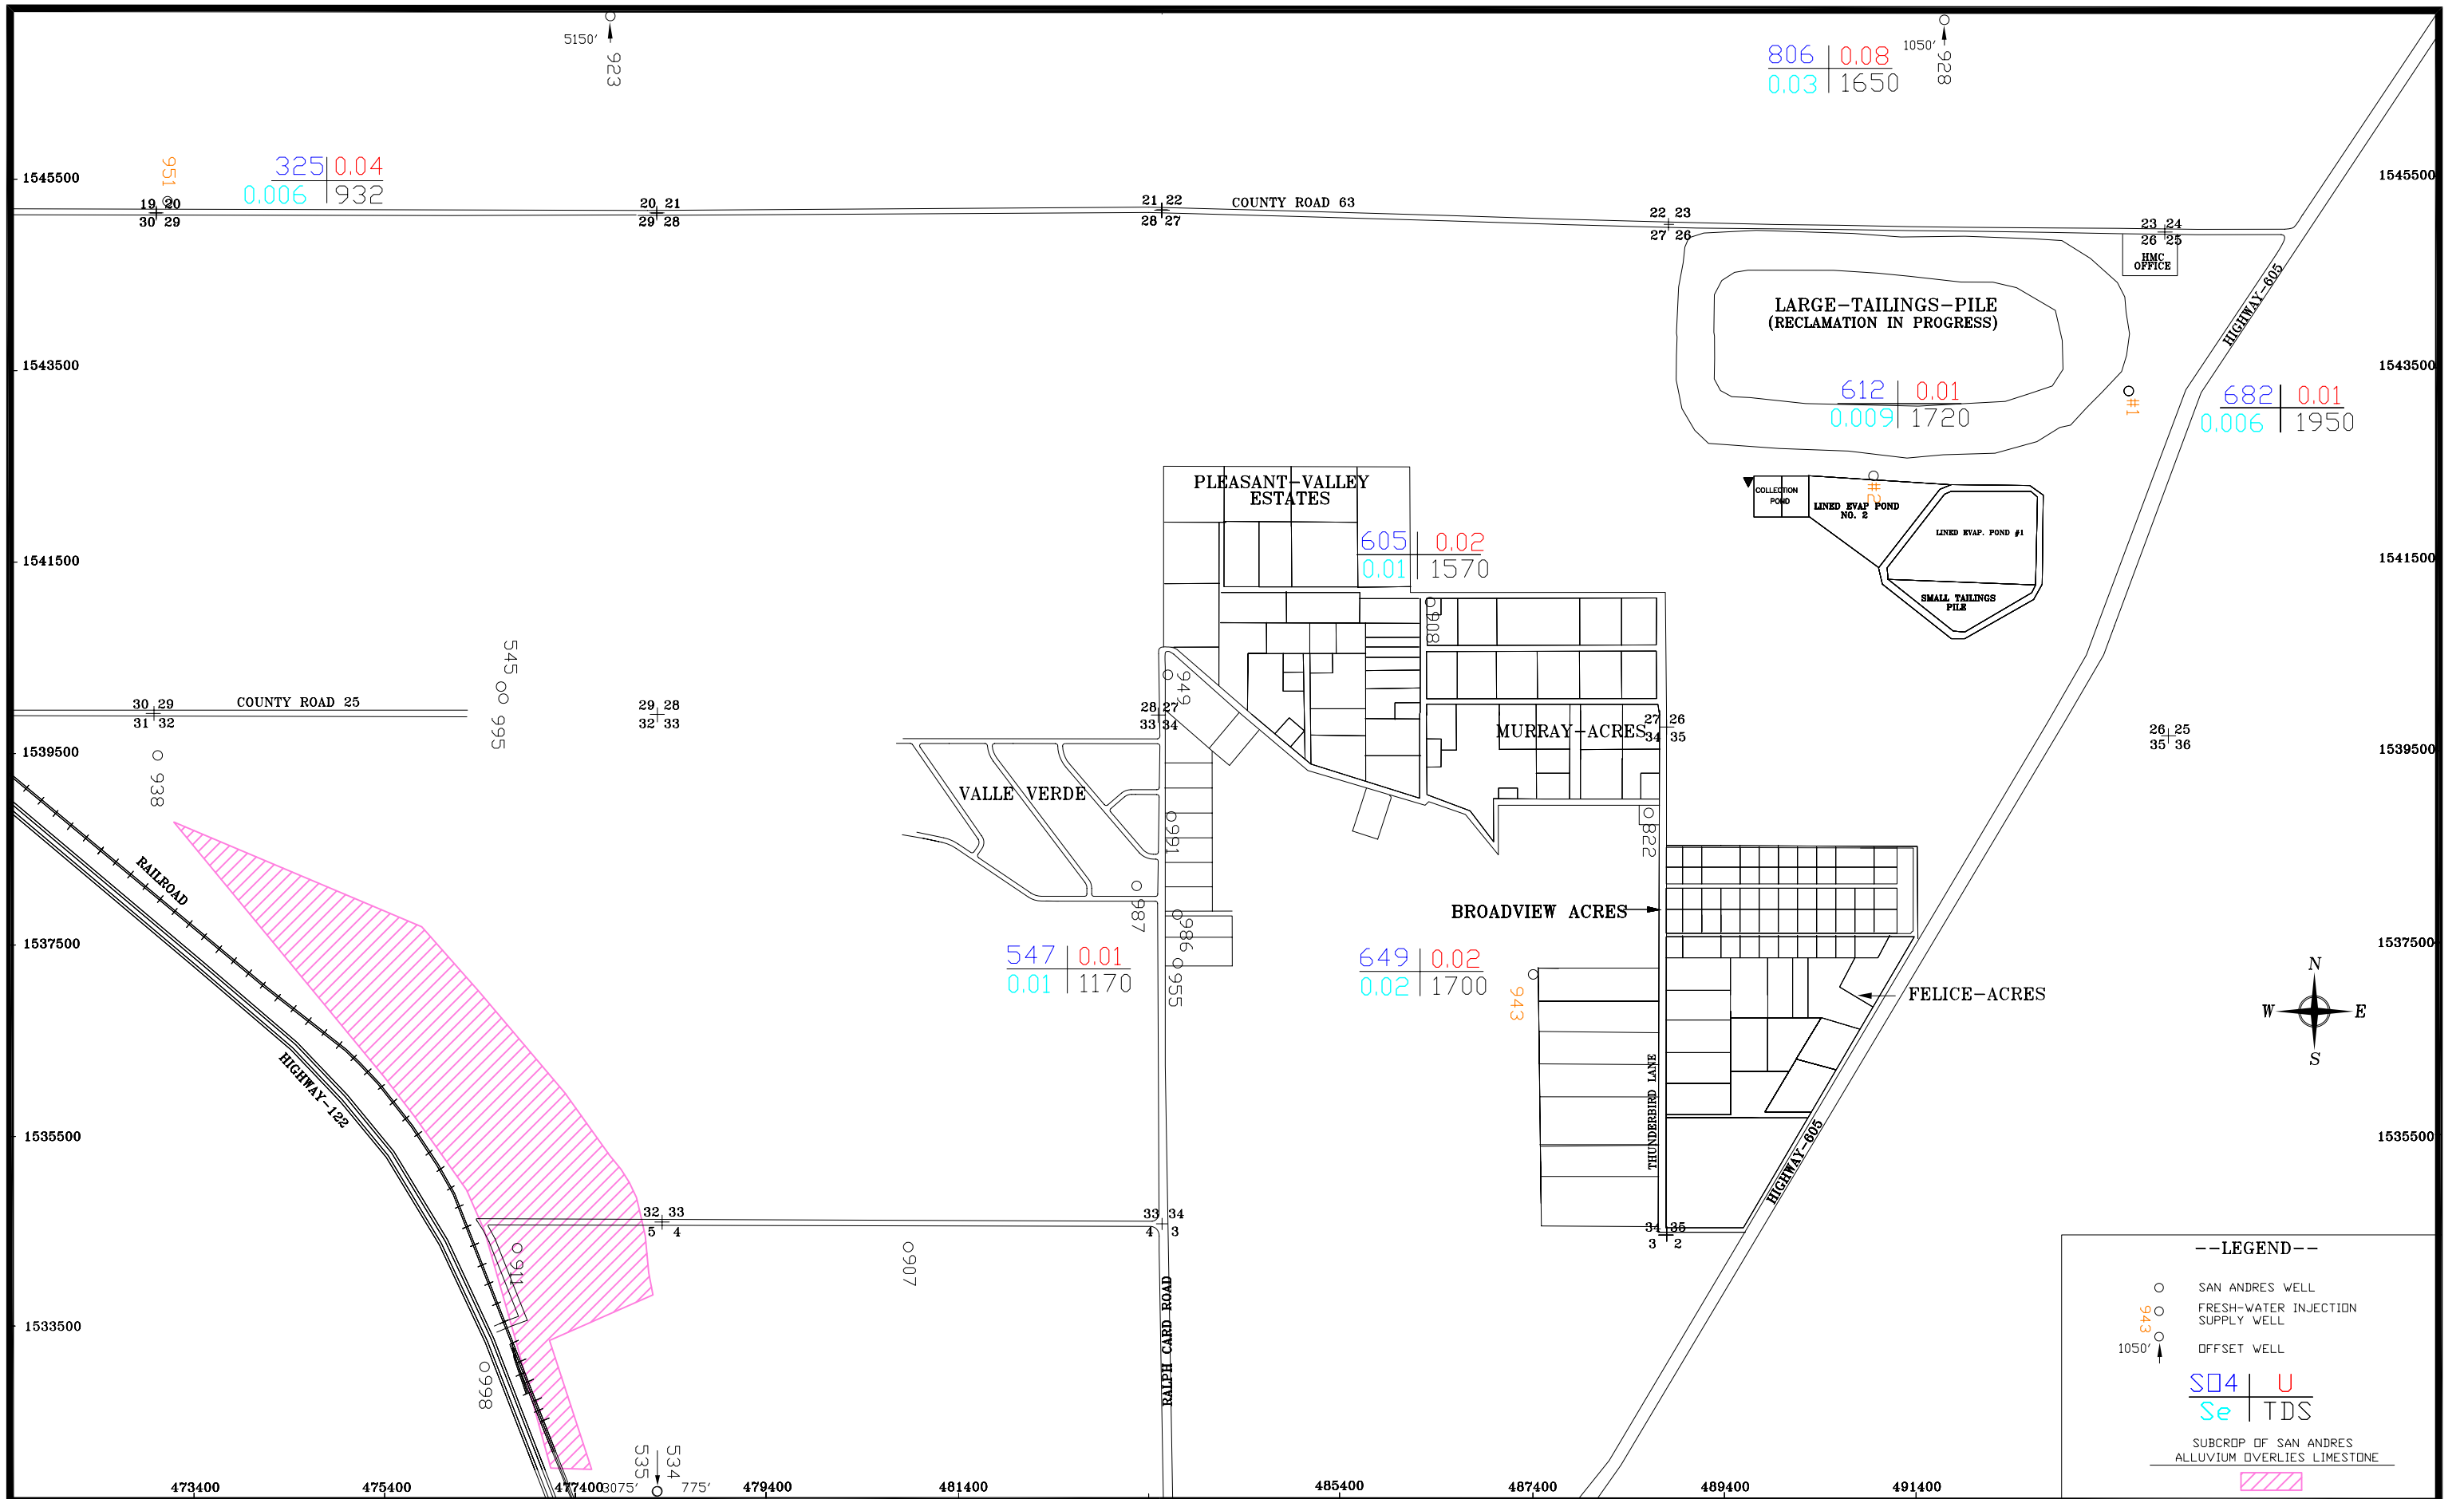
FIGURE 8.0-2. WATER QUALITY FOR THE SAN ANDRES AQUIFER, 2007, mg/l

Concentrations of uranium, selenium sulfate and TDS in the San Andres Aquifer are presented on Figure 8.0-2. No action levels have been established by NRC for the San Andres Aquifer to be used to establish plumes. There is no direct pathway of contaminant migration from the Alluvial Aquifer to the San Andres at the Site because the San Andres does not subcrop beneath the Alluvial Aquifer plume. Transfer from the Alluvial Aquifer to the San Andres is possible at inadequately sealed wells.

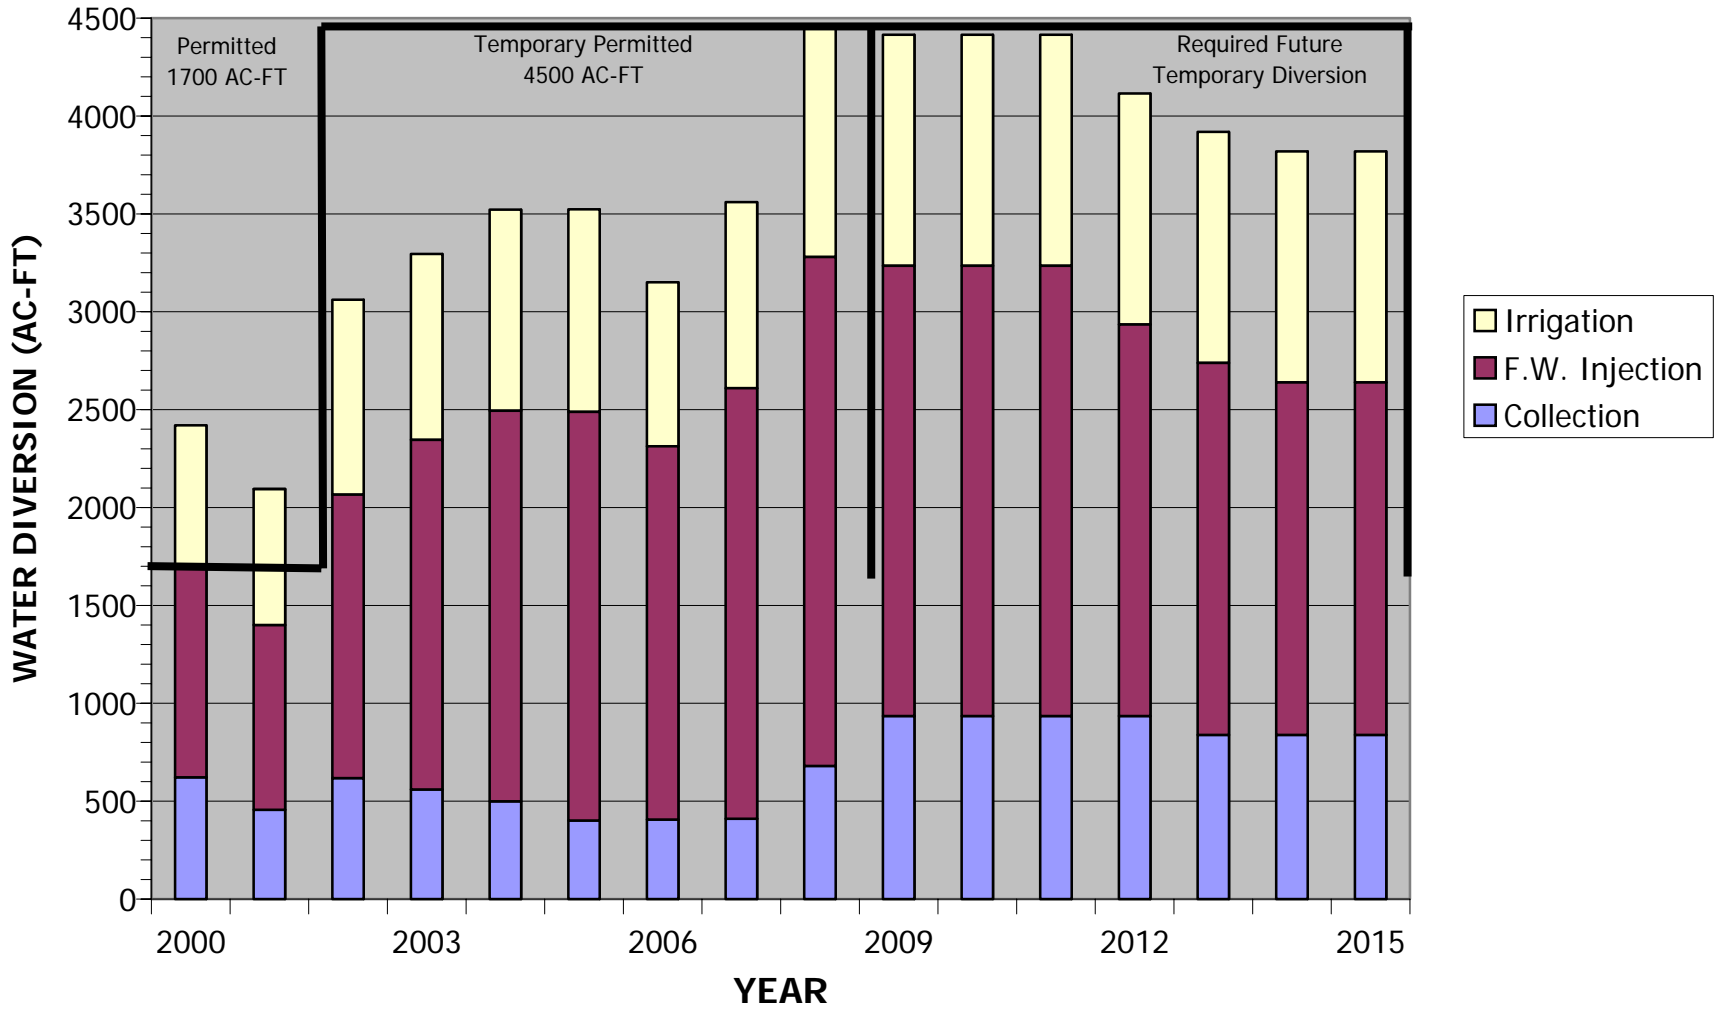
FIGURE 5-1. HISTORICAL AND PLANNED DIVERSION AT THE GRANTS SITE

Integral parts of the groundwater remediation system at HMC are State permits that control the diversion and use of groundwater. Figures 5-1 and 5-2 present historical and proposed future groundwater diversion and consumptive use of groundwater by HMC. Termination or significant reduction of either diversion or consumptive-use conditions would result in loss of the right to divert and use the groundwater with a subsequent proportional alteration of the active groundwater remediation system.
