FIVE-YEAR REVIEW REPORT

Cimarron Mining Corporation Superfund Site

Second Five-Year Review Report
For
Cimarron Mining Corporation Superfund Site
Operable Unit 1 and 2
Carrizozo, Lincoln County, New Mexico

June 2003

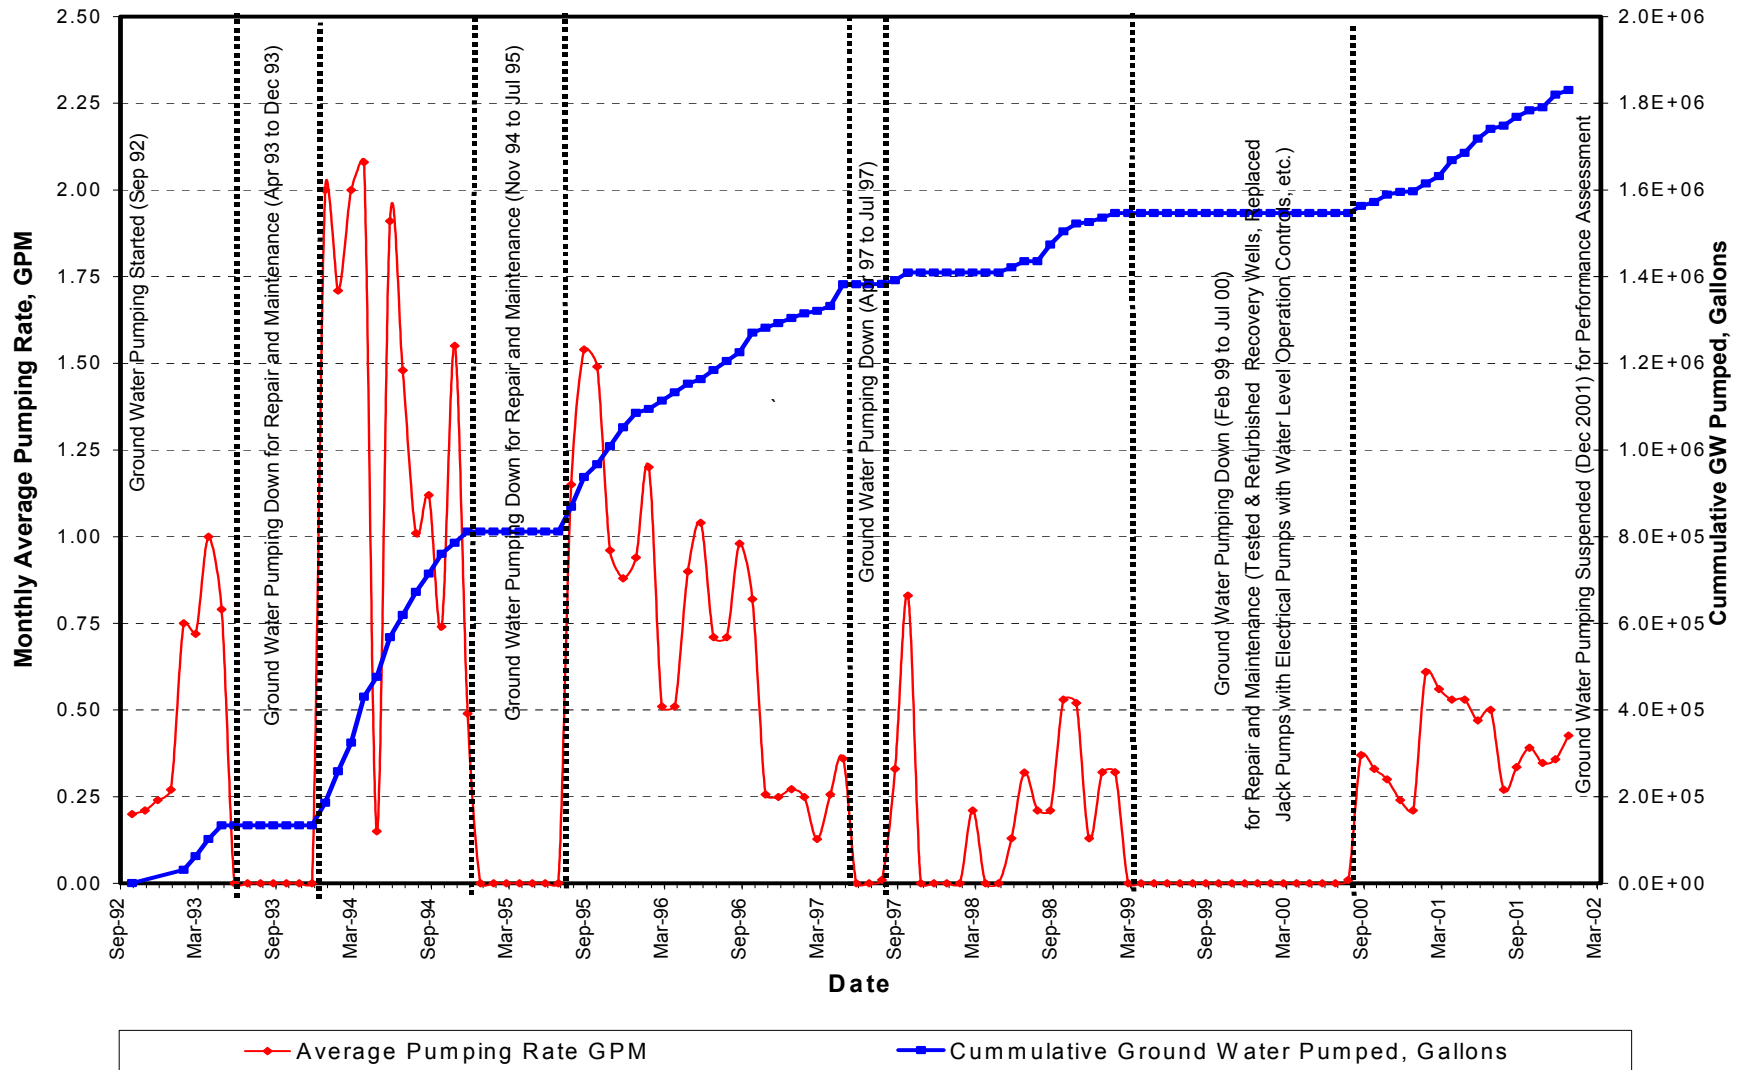
Figure 2
Ground Water Pumping Data @ OU-1

were installed in these three wells and pumping was restarted in June 2000. The pumps were set approximately five inches from the bottom of these wells. The submersible pump operation is controlled by water level probes integrated with pump operation control to prevent pump damage due to running in dry conditions. During the last six months prior to the suspension of the pumping for performance assessment, the monthly combined average ground water extraction rate from these wells has fluctuated between 0.2 to 0.5 gpm, as shown in Figure 2.

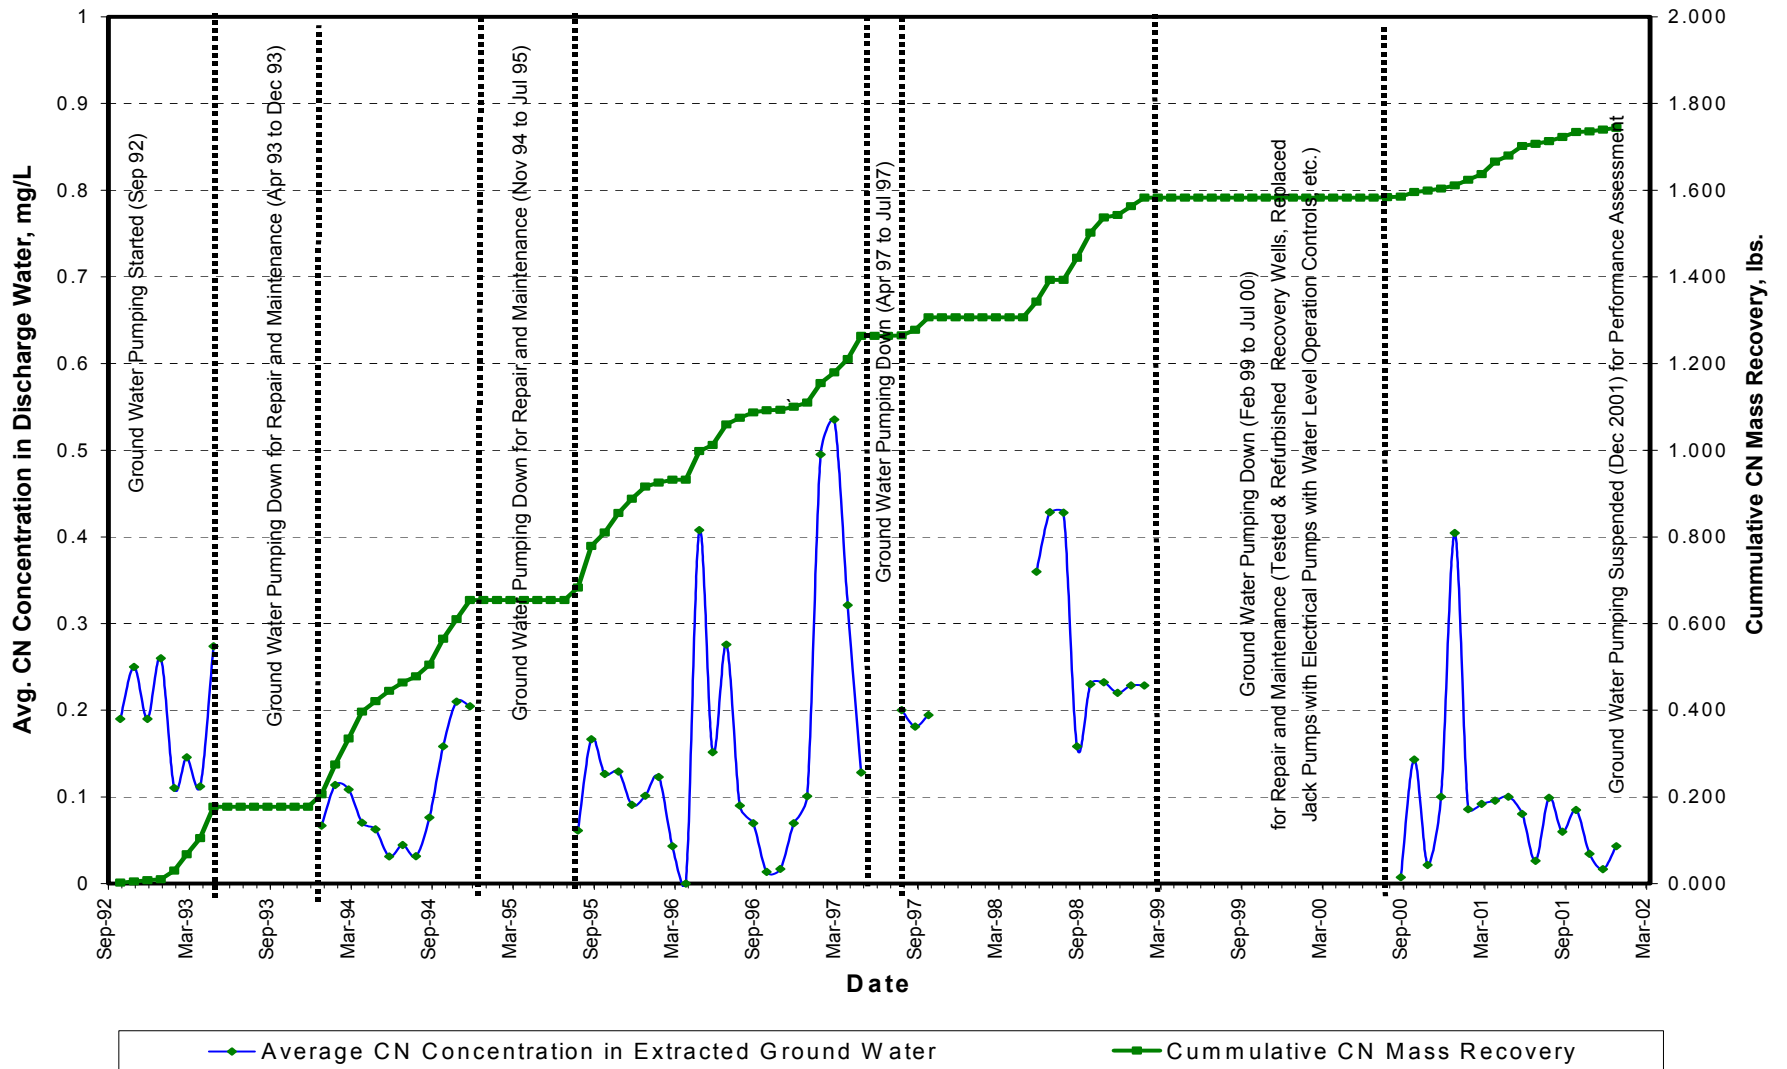
Figure 3
Total Cyanide Concentrations and Mass Recovery in Extracted Ground Water @ OU-1

A review of records and monitoring reports through March 2003, was performed for this data review. A summary of ground water pumping, discharge and contaminant mass recovery data is included in Attachment 3. The ground water pumping data are summarized in Figure 2. The data indicate that approximately 1,830,757 gallons of ground water was extracted and discharged to POTW during remedial action. The pumping data also show that the pumping rates decline over time. The initial decline in average pumping rates through January 1999, is thought to be the result of water level drawdown and reduced pumping efficiency due to wear and deterioration of the jack pumps. The results of the well refurbishment and testing indicated that the declines were not caused by well plugging. The overall low well yields and general decline through each pumping cycle are due in part, to the initial low saturated thickness that further decline with pumping. Average total cyanide concentration and mass recovery in extracted ground water is summarized in Figure 3. These results indicate an average total cyanide concentration of 0.11 mg/L in extracted and discharged water to POTW is far below the 5.0 mg/L pre-treatment discharge standard. A total of 1.74 lbs. of total cyanide mass was removed during the remedial action implementation.

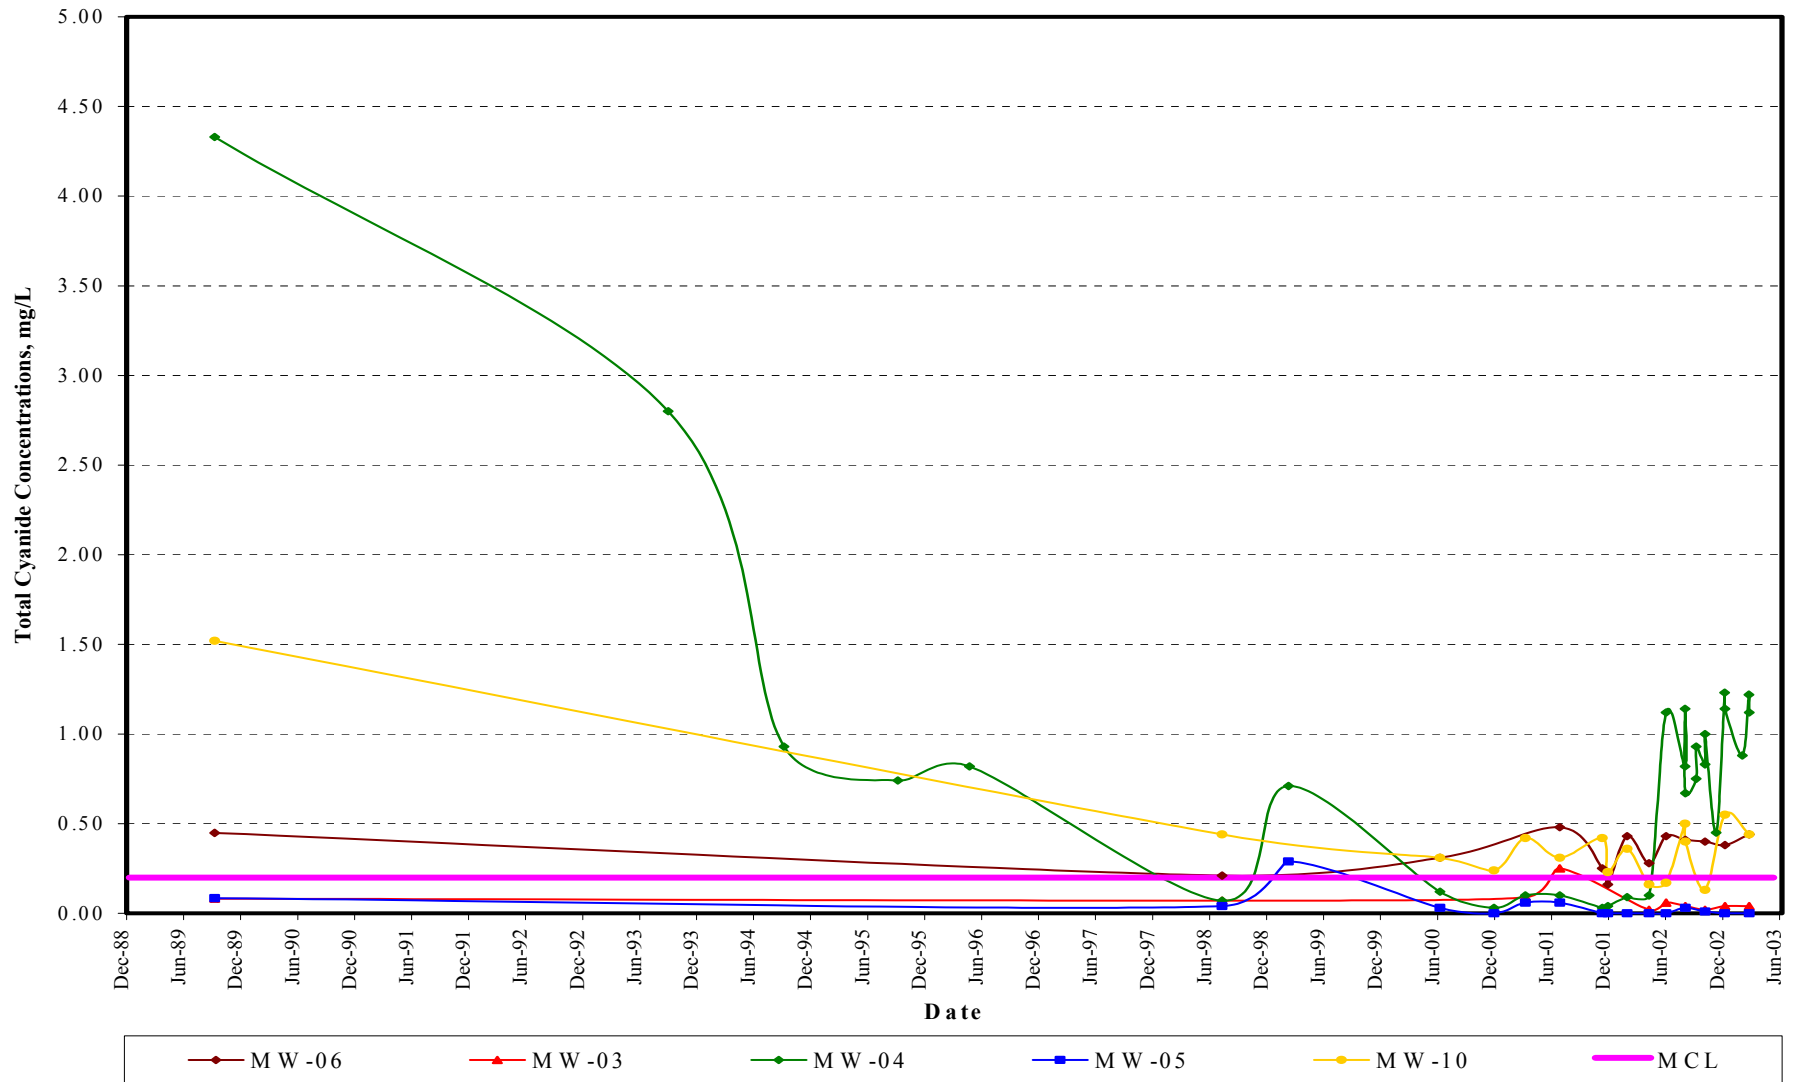
Figure 4
Total Cyanide Concentration Trend in Monitoring Wells @ OU-1

The monitoring results in Figures 4 and 5 show a rebound in total cyanide concentrations in monitoring well MW-04 and in three recovery wells following cessation of pumping. The rebound concentrations for total cyanide in wells MW-04, RW-2, RW-3, and RW-6 were in the range of 2 to 3 times the 0.2 mg/L remediation target. The water level measurements show that the increase in total cyanide concentrations corresponds with the rise in water elevations in each of these wells. Total cyanide concentrations observed since June 2000, in other Site wells appear to fluctuate with no apparent trends related to pumping or recovery following cessation of pumping. The total cyanide concentrations in most of these other wells remained below the 0.2 mg/L cleanup level for cyanide, although concentrations in wells MW-06 and MW-10 fluctuated between 0.15 and 0.5 mg/L.

The monitoring data included in Attachment 3, and Figure 4 of this report show a significant cyanide concentration rebound in monitoring well MW-04 following cessation of the pumping. While some of the rebound in cyanide concentrations may have been from the water table recovery due to cessation of pumping, part of the increase in cyanide concentrations observed at well MW-04 appears to be due to leaching of metal cyanide complexes by infiltration of the ponded water from the swamp cooler overflow at the nearby residential house-trailer. Thus, land use restrictions should be considered to prevent future leaching of iron cyanide complexes from the unsaturated zone by water infiltration from ponds, leaky pipes, leach fields or water discharges located in the former cyanide source areas. In addition, an institutional control or a measure for limiting completion of a well into the shallow ground water should be implemented to prevent potential exposure to contaminated ground water.

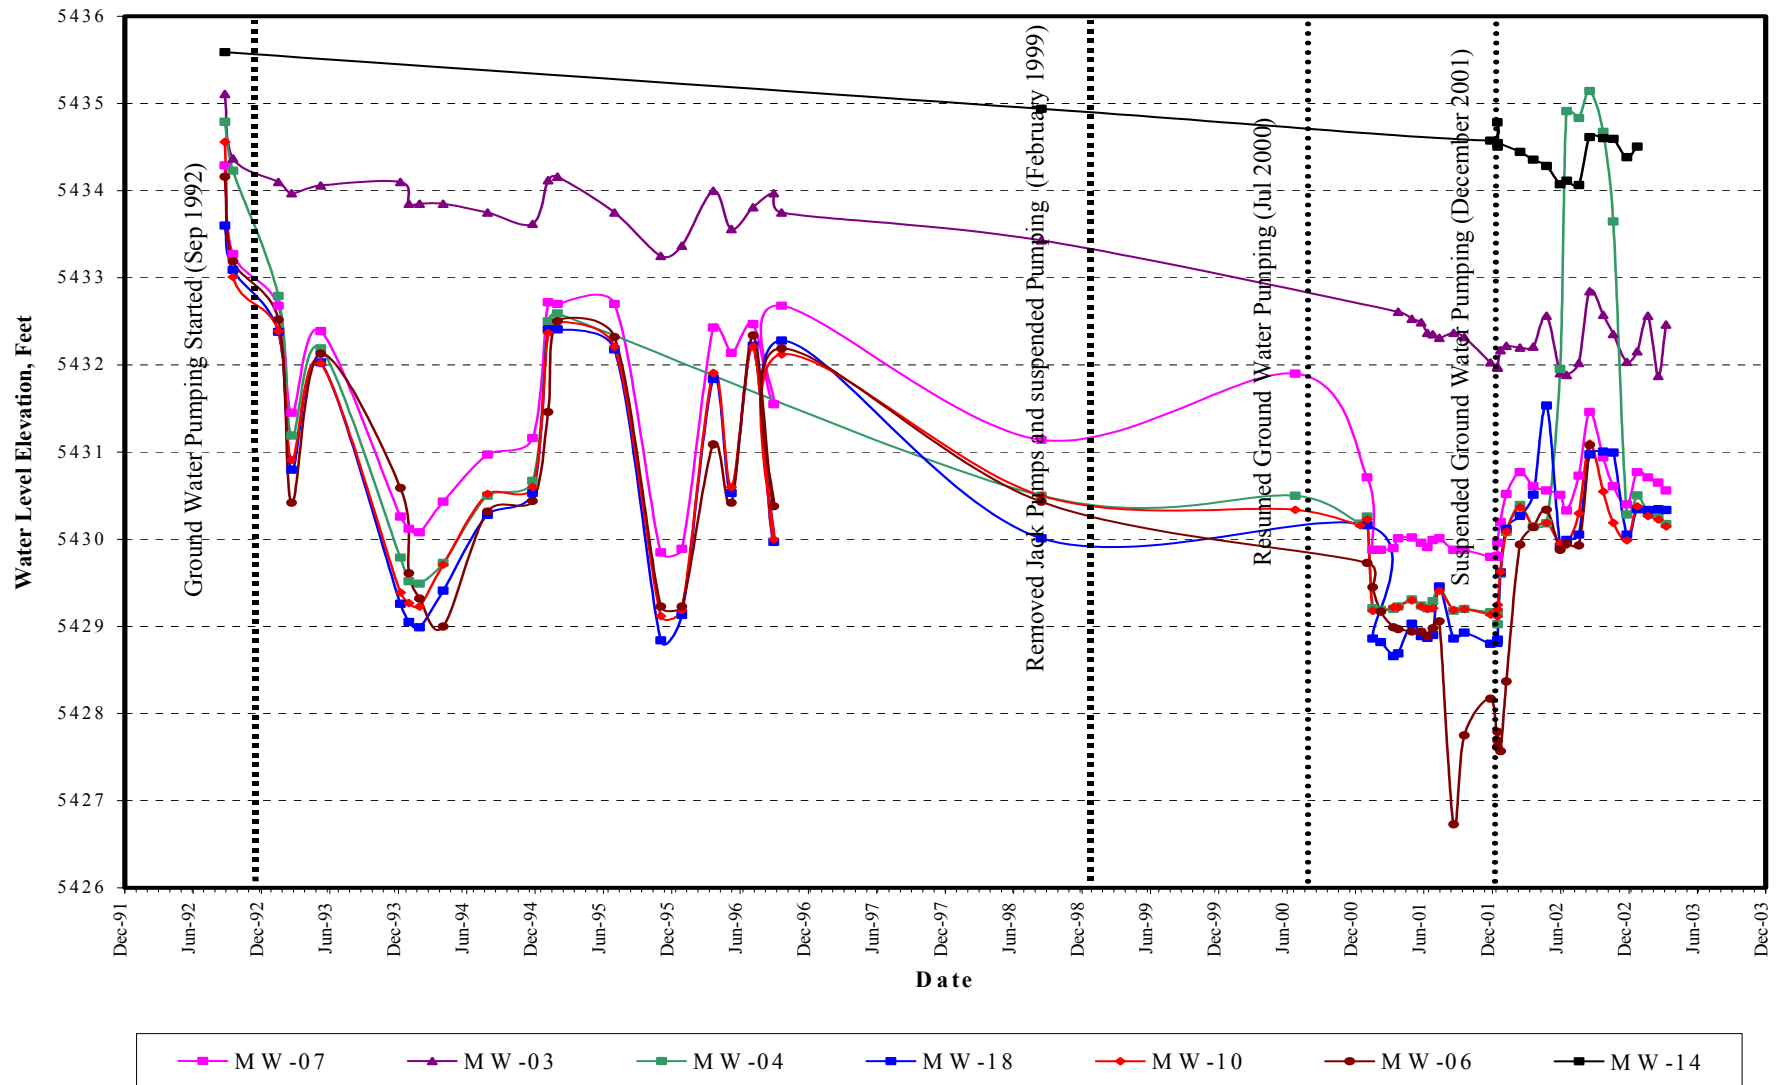
Figure 6
Water Level Elevation Trend in Monitoring Wells @ OU-1

Water level elevations for monitoring wells are plotted in Figure 6 and Figure 7. The water levels in monitoring wells located in the vicinity of the remediation wells show fluctuations that correspond closely with the temporary shut down periods and pumping rates shown in Figure 2. These wells also show a water level recovery of approximately a foot or more following suspension of pumping in December 2001. Water levels in wells MW-03 and MW-14 located upgradient of the remediation wells and in wells MW-15 and MW-16 located downgradient of the remediation wells show a slight decline during remedial action and little or no recovery following cessation of pumping. The water levels in the three recovery wells that were not pumped after January 1999, show drawdown and recovery patterns similar to the monitoring wells located in the vicinity of the remediation wells, as shown in Figure 8.

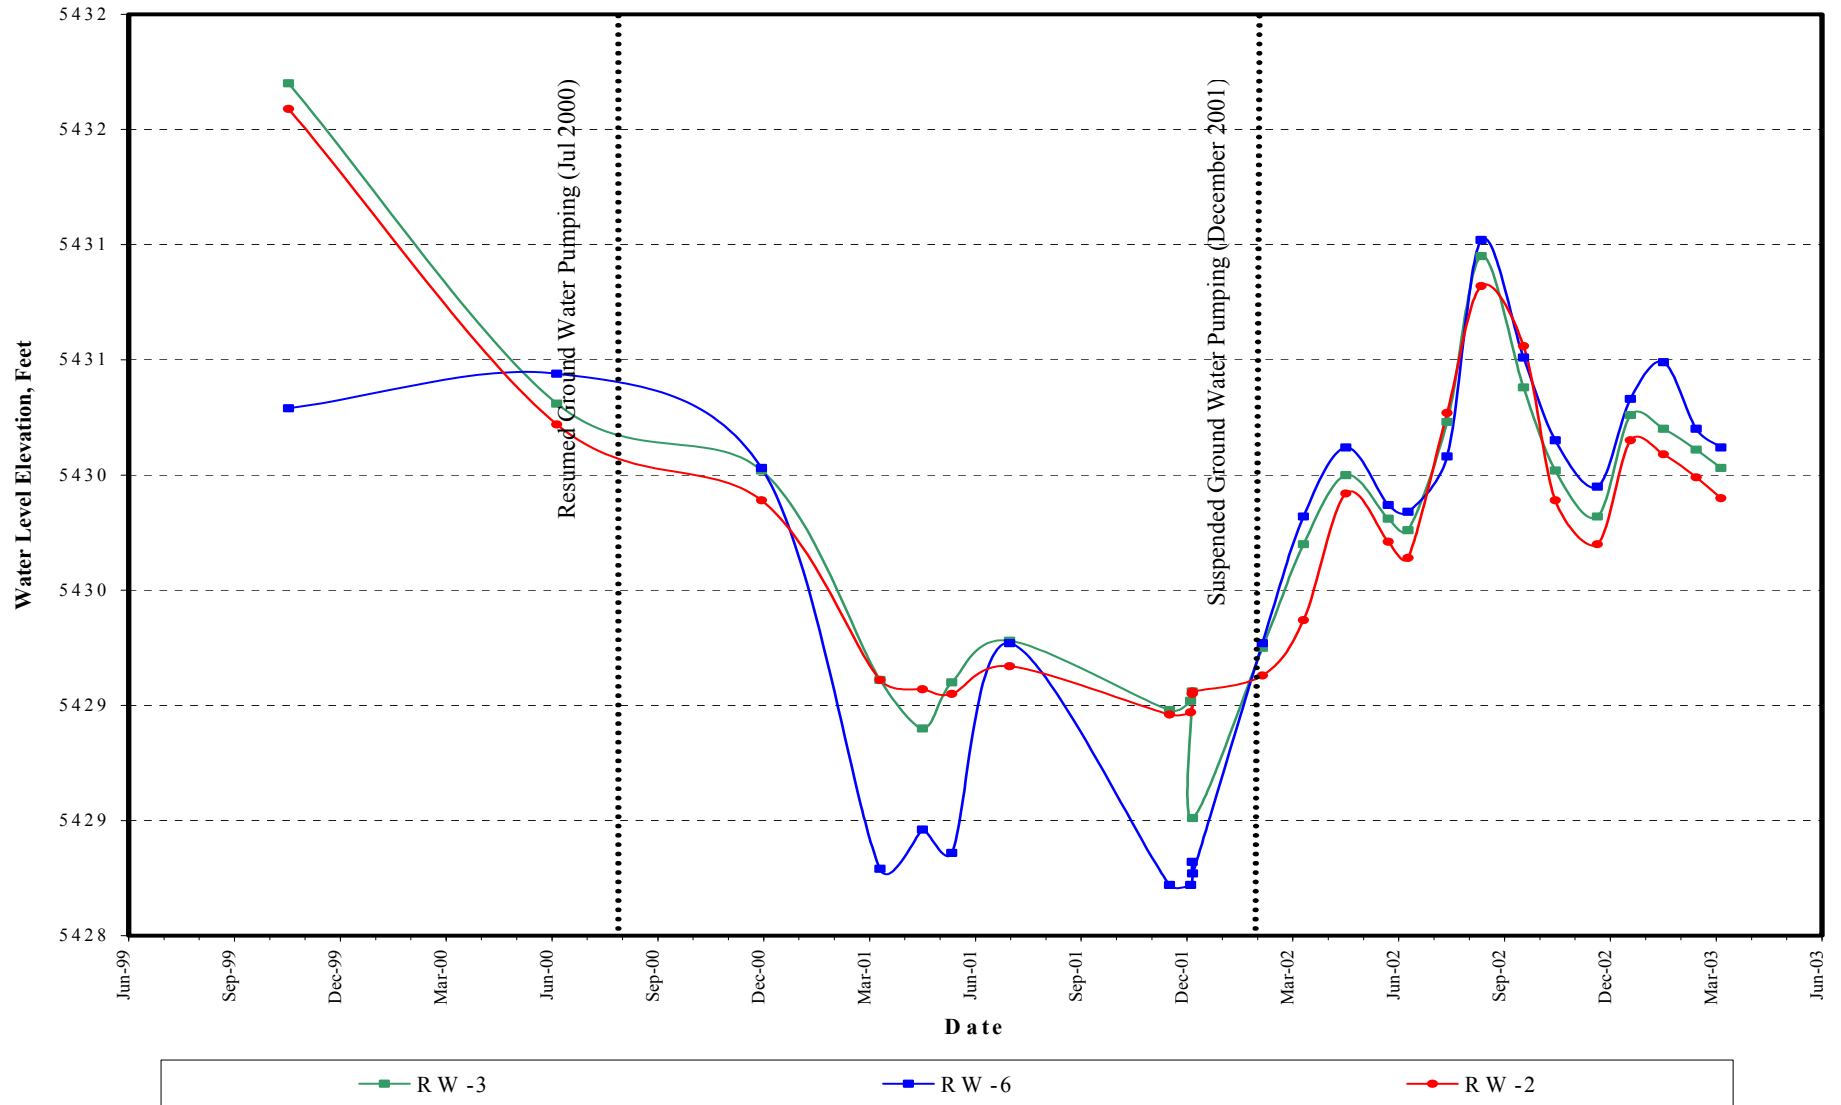
Figure 8
Water Level Elevation Trend in Recovery Wells @ OU-1

observed with the recovery or rise in water table elevations at wells MW-04, RW-1, RW-2 and RW-3 may be due to re-suspension of iron cyanide colloids and dissolution of metal cyanide complexes adsorbed on sediments near the original water table. The formation of metal cyanide complexes and adsorption by clay minerals and organic material in the sediment limits both the vertical and horizontal transport of cyanide in ground water. It also adversely affects the performance of ground water pumping for cyanide removal. As the water table is drawn down, ground water flushing becomes less efficient as ground water flow bypasses the location of highest concentrations near the water table. Pulse pumping was performed at the Site as indicated by Figures 6 through 8, and the cyanide removal may have been greater than that with continuous pumping, even though the total cyanide removed by pumping during the remedial action is relatively low. Thus, it appears that pulse pumping could provide a better mechanism for cyanide removal than continuous pumping.
