INDUSTRIAL WASTE CONTROL SUPERFUND SITE

SEBASTIAN COUNTY, ARKANSAS

SECOND FIVE-YEAR REVIEW FINAL REPORT

MAY 2002

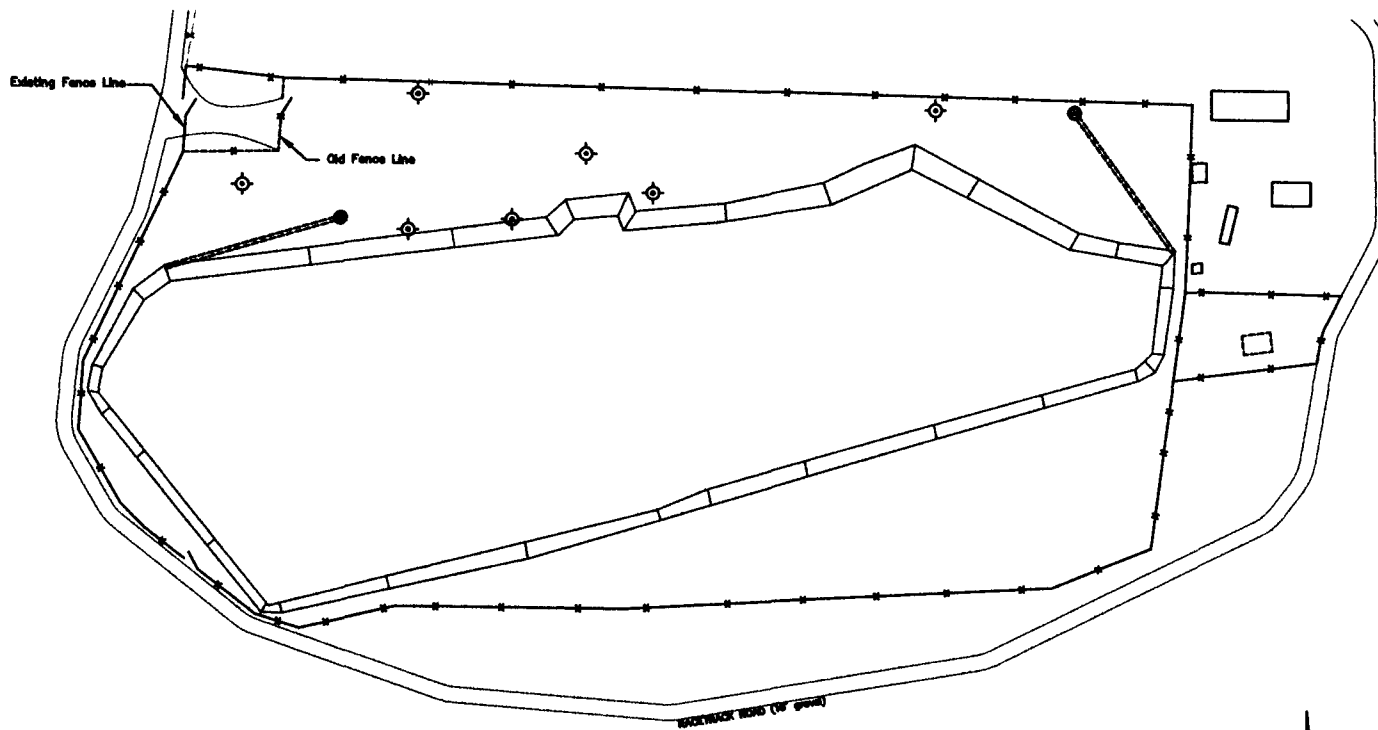
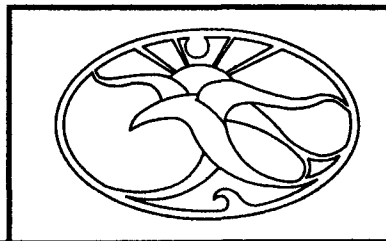
FIGURE 15.0

During the Event 31 Site inspection, there was no sign of disturbances at the Site and no evidence of forced entry or damage was discovered. During this event, the following Site improvements were made:

- The front entrance gate and fencing was moved forward toward Racetrack Road (see Figure 15.0).
- The animal burrows located around P-4, MW-3, MW-6, MW-7 and MW-8 were backfilled. The loose well pads caused by the burrowing were repaired.
- The deteriorating paint on the well covers was removed and the covers were repainted.
- The old locks and keys on all monitor wells, piezometers and recharge wells were replaced with new locks and keys.
- The Site was mowed and weeds were removed.
- New signs were mounted on the Site fence around the perimeter of the Site.
