Five-Year Review Report

Second Five-Year Review Report for the Vertac Incorporated Superfund Site Jacksonville, Pulaski County, Arkansas

November 2003

**CH2M HILL
Contract Number 68-W6-0036
Work Assignment Number 119-FRFE-0604**

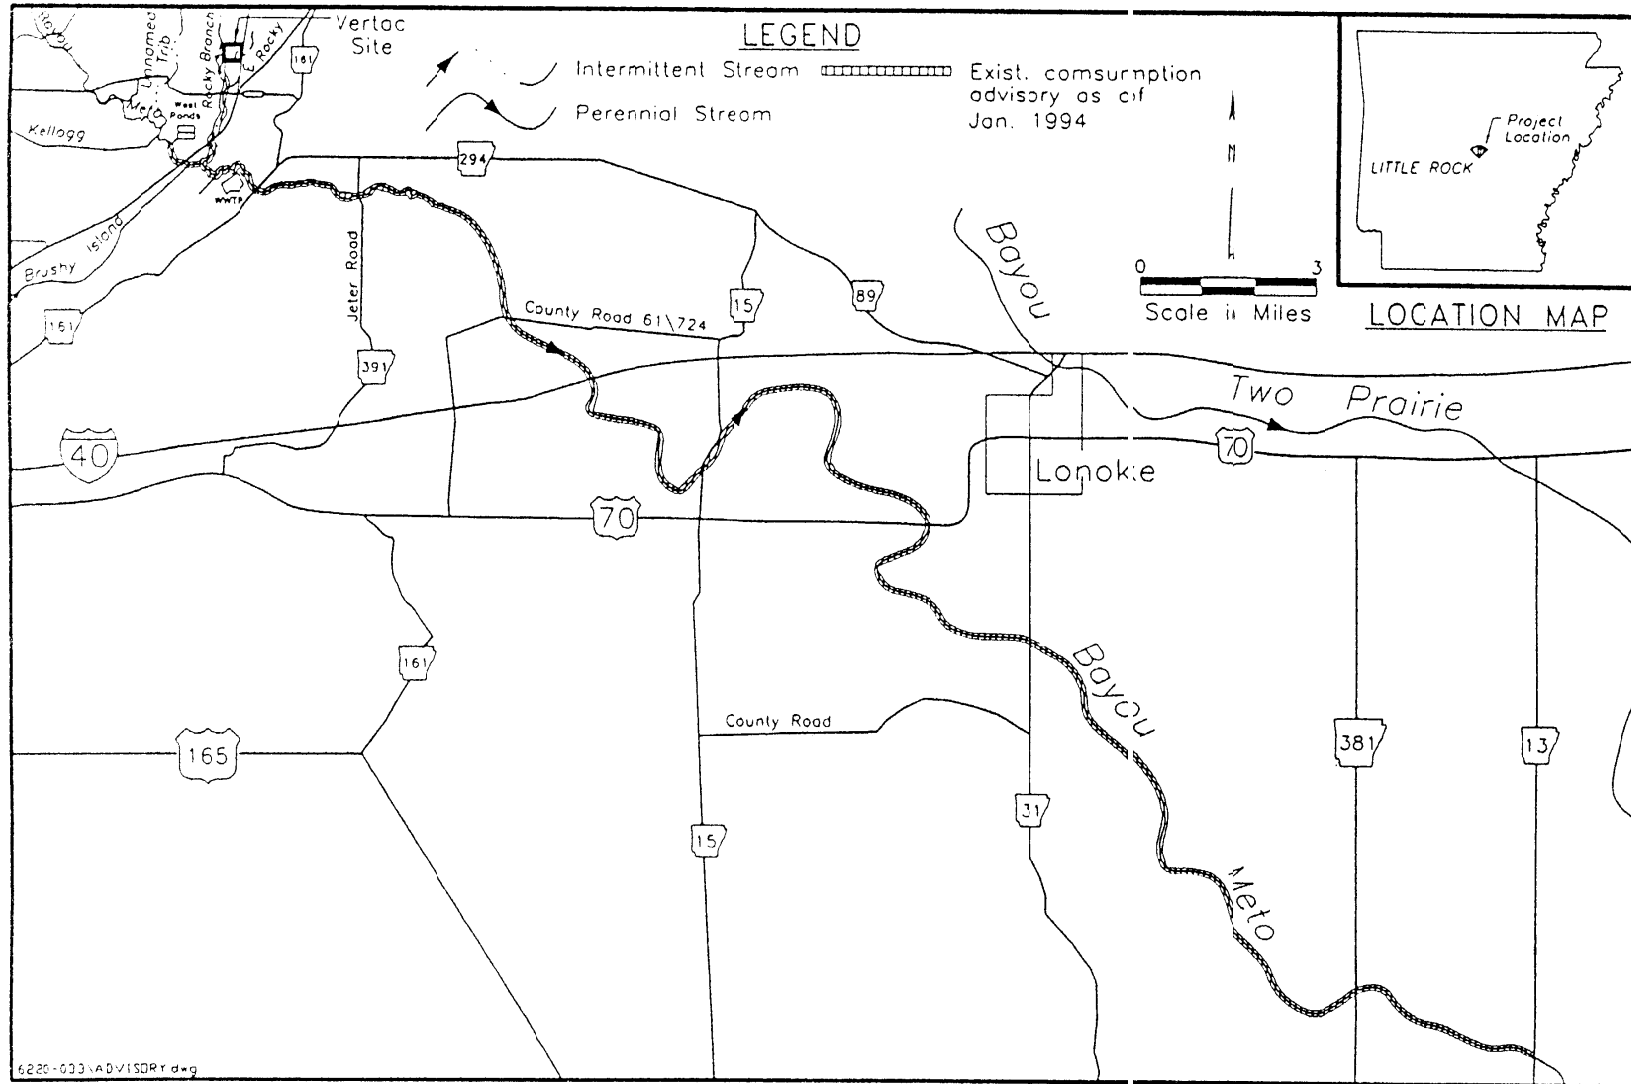
Figure 3, Bayou Meto Fish Consumption Advisory Area
Vertac Incorporated Superfund Site, Second Five-Year Review Report
[Figure reproduced from GMB & Associates, 1999]

1. Status of the Fish Consumption Advisory for Bayou Meto. The ADH has not completed the reevaluation of its fish consumption advisory for Rocky Branch Creek and Bayou Meto, including the 25 ppt TCDD action level for fish tissue and the geographic extent of the advisory, and it has not reinstated the full geographical extent of the fish consumption advisory as an interim matter. Both of these actions were recommended by the first five-year review in light of current EPA guidance on fish advisories.

Figure 1.1. Area of existing fish consumption advisory as delineated by the ADH (FTN, 1996).

- 1. Complete reevaluation of the fish consumption advisory for Bayou Meto.** ADH should complete the reevaluation of its fishing advisory for Rocky Branch Creek and Bayou Meto, including the 25 ppt TCDD fish tissue action level and the geographical extent of the advisory, and pending completion of its evaluation and determination of an updated action level, should reinstitute the geographical limits of the fish consumption advisory to the pre-existing boundary, as recommended by the first five-year review. This should be accomplished in light of that recommendation and current EPA guidance on fish advisories and the impacts of dioxin on such advisories. Hercules' recent recommendation on reducing the geographical extent of the current fish consumption advisory and dropping a sampling location is unacceptable and will not be adopted.

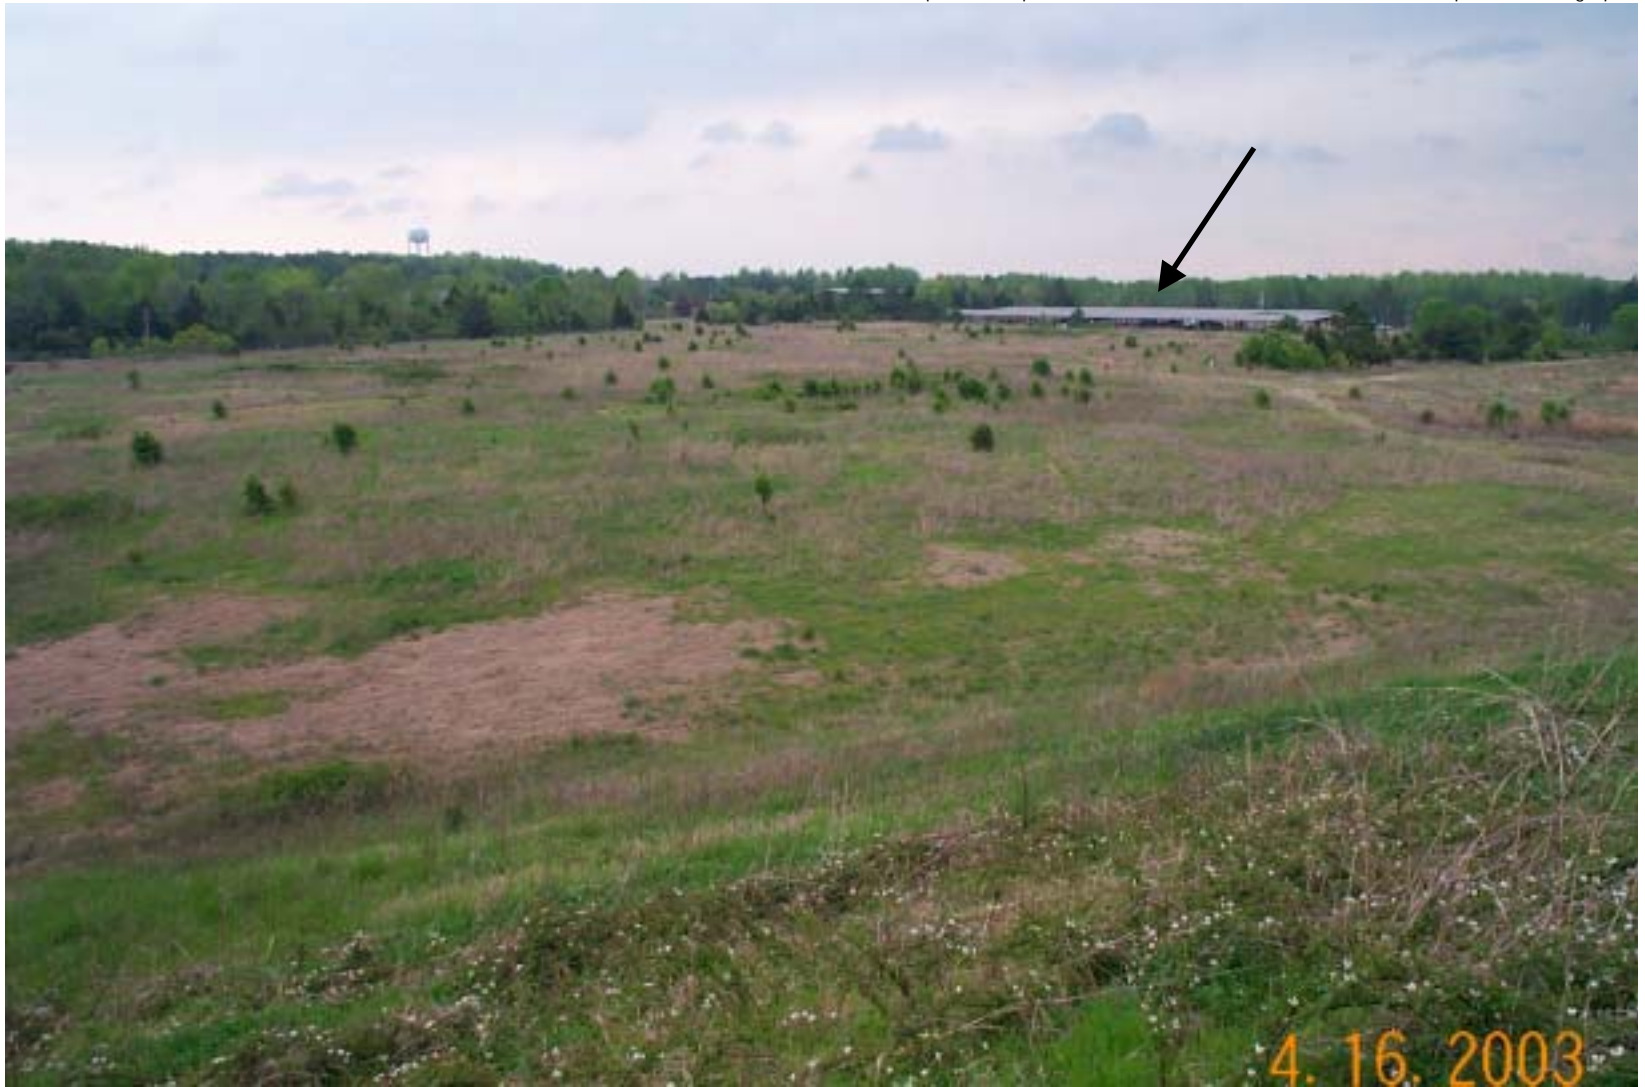
Photo 6: View across the North Burial Area from Sedimentation Vault (Mt. Vertac), facing north. Note trees growing on top of cap. Shed in background (at arrow) is a former storage shed used to store drums as part of the incineration (now used by City as part of recycling center).

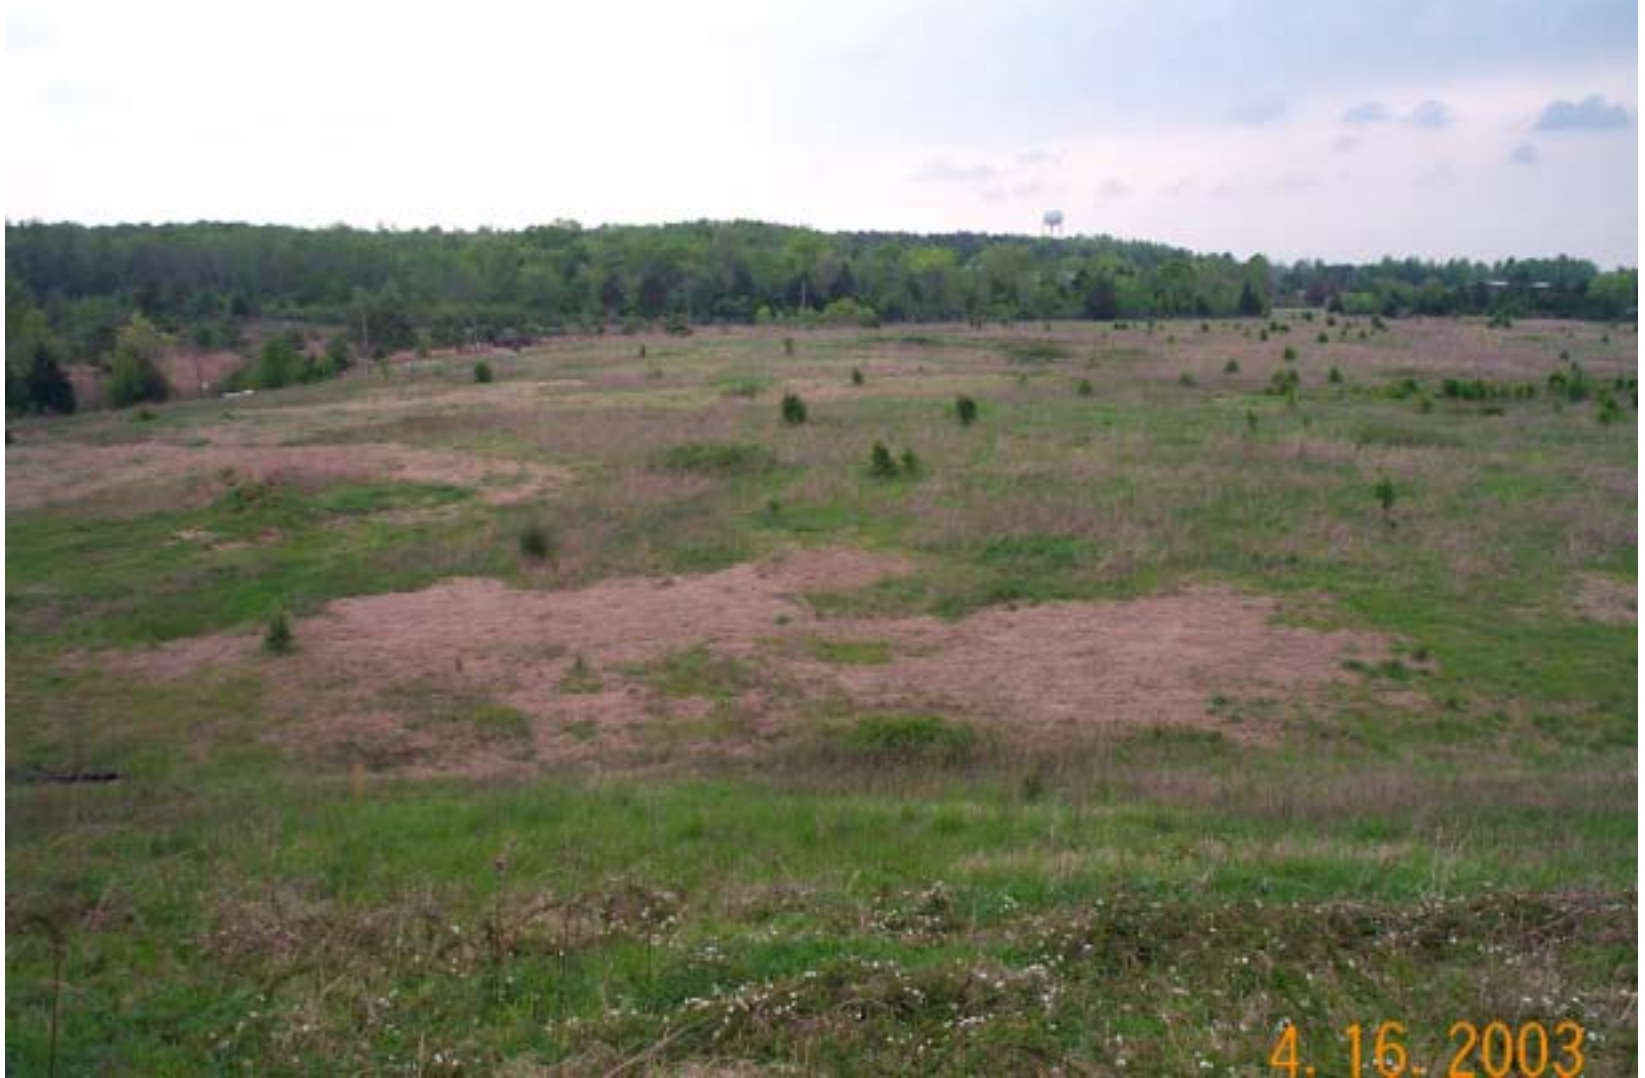
Photo 7: View across the North Burial Area from Sedimentation Vault (Mt. Vertac), facing north. Note trees growing on top of cap.

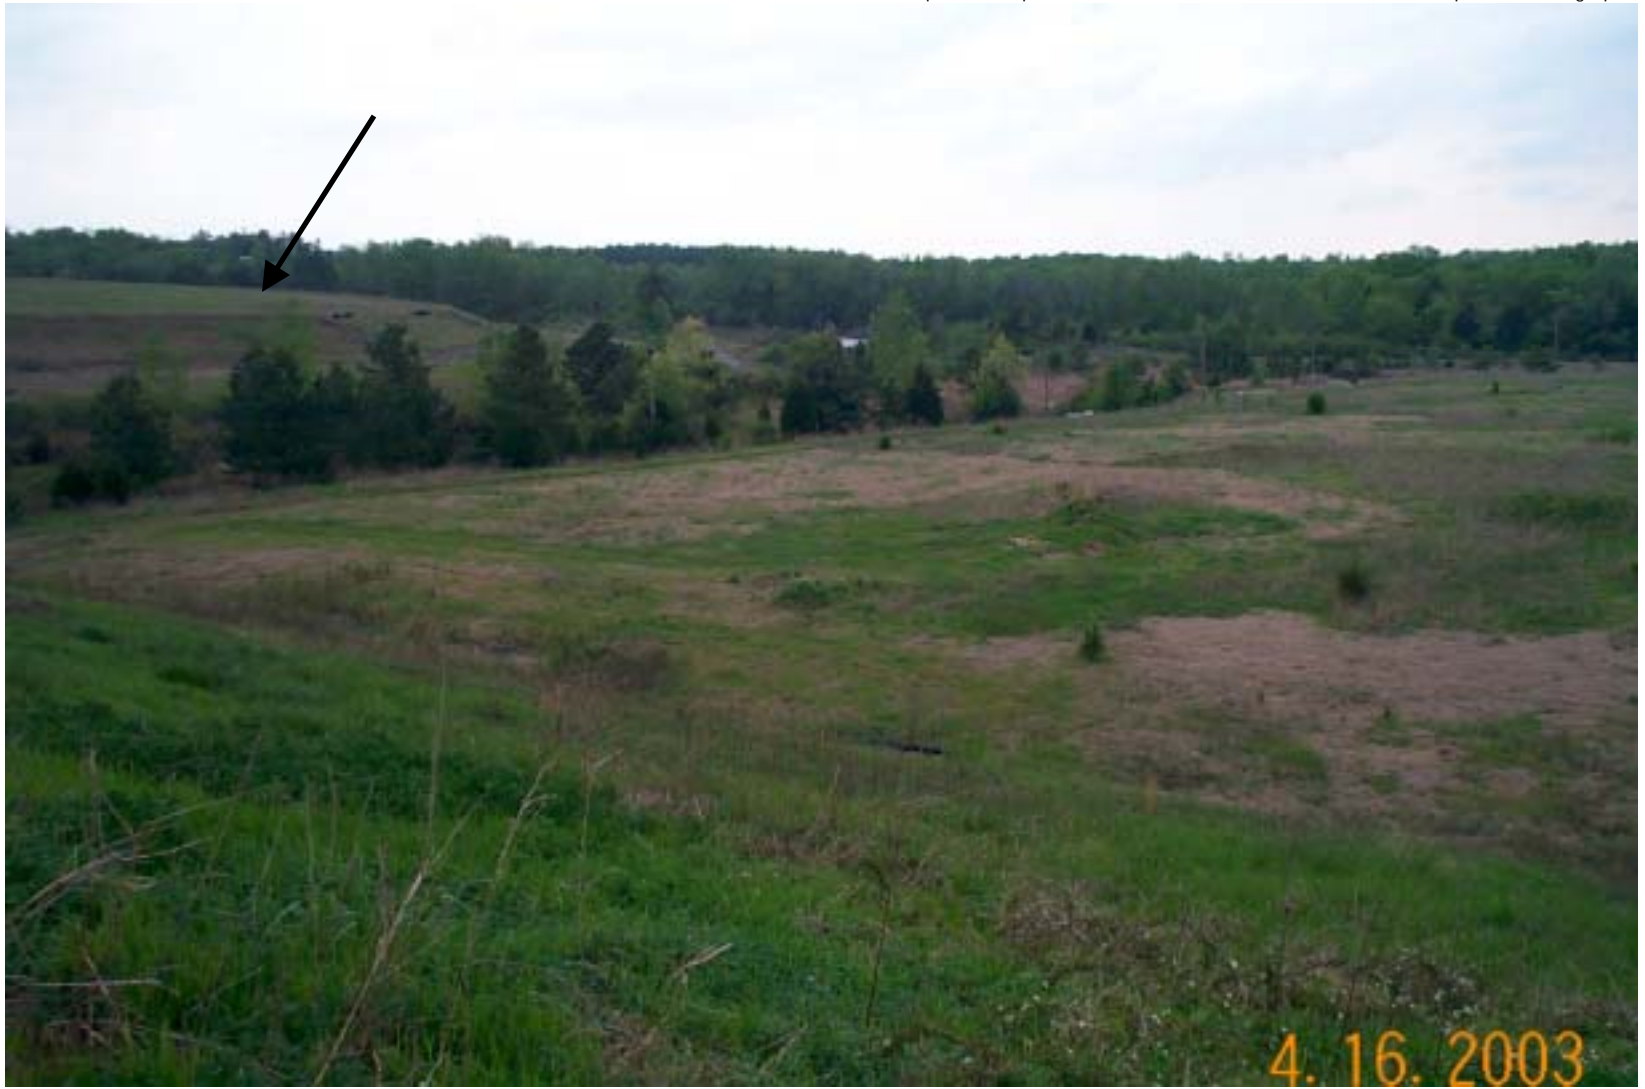
Photo 8: View across the North Burial Area from Sedimentation Vault (Mt. Vertac), facing northwest. Note trees growing on top of cap. The OU1 landfill is visible in the background at left (arrow).

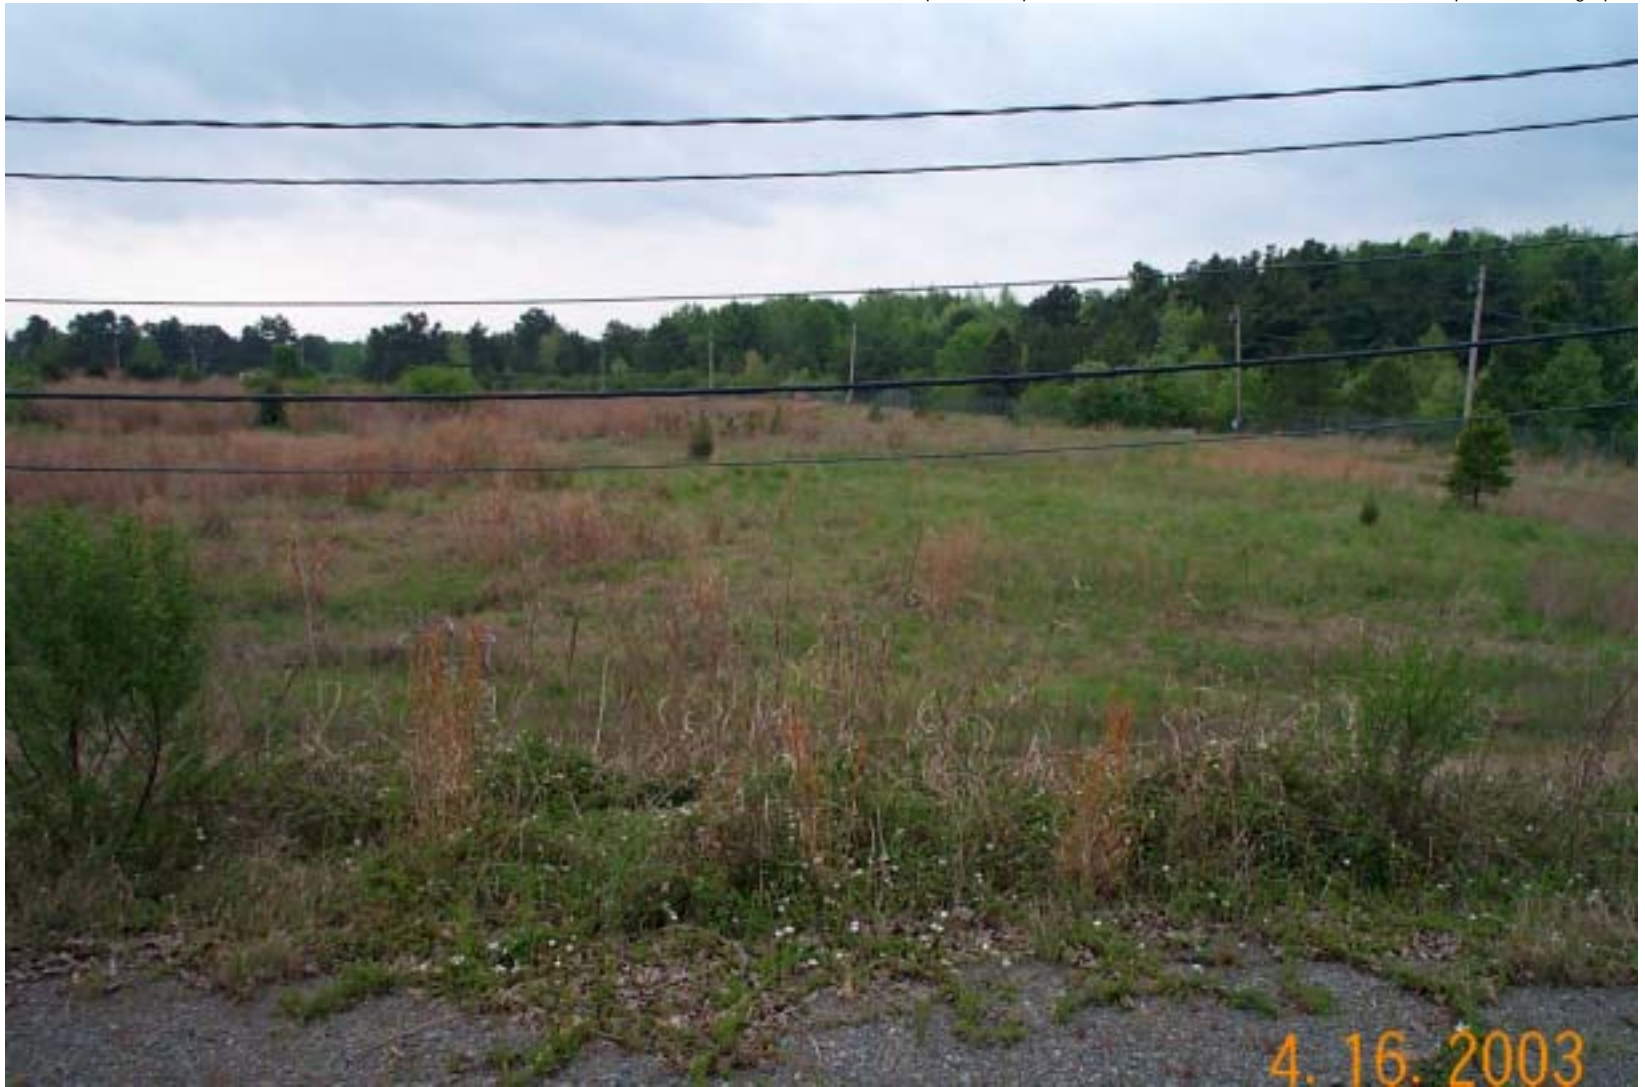
Photo 17: View of the Reasor Hill Burial Area. View is facing south. Note trees growing on the capped area.

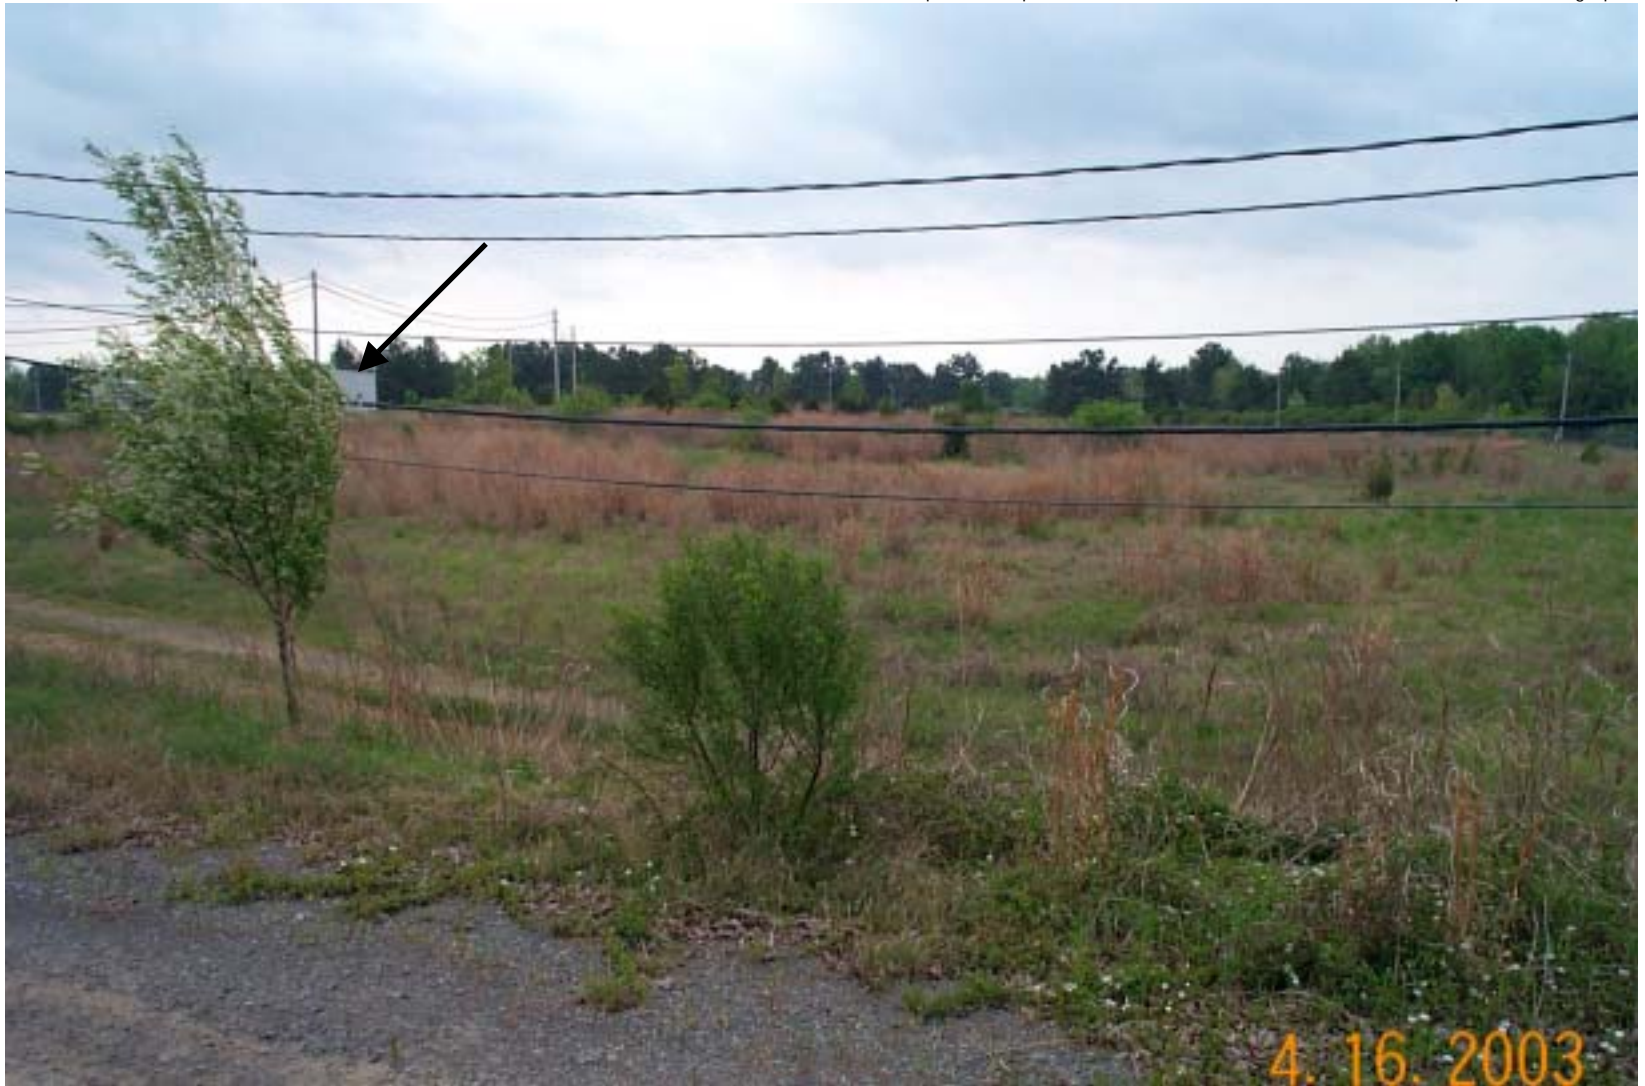
Photo 18: View of the Reasor Hill Burial Area. View is facing south. Note trees growing on the capped area. Building in background at left is the Wastewater Treatment Plant (at arrow).

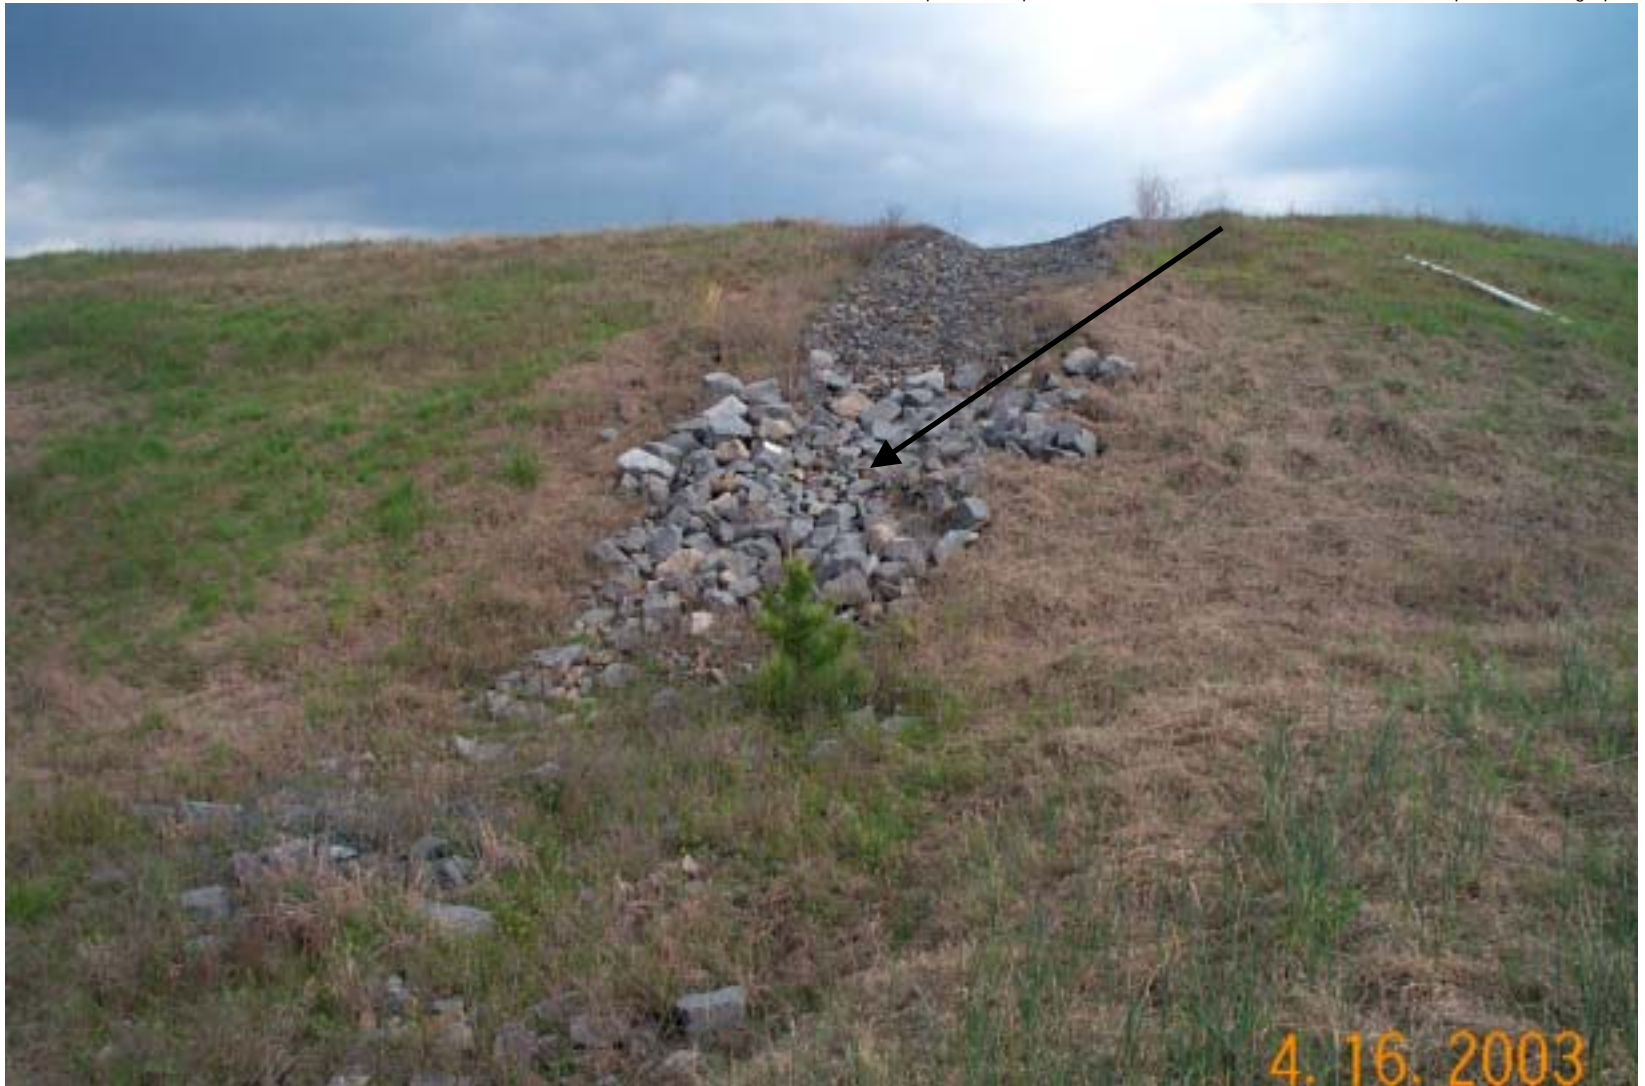
Photo 21: View of rock lined letdown channel (at arrow) at the OU1 landfill. These channels drain water from the top of the landfill cap. Note small tree growing along letdown channel in the center foreground.

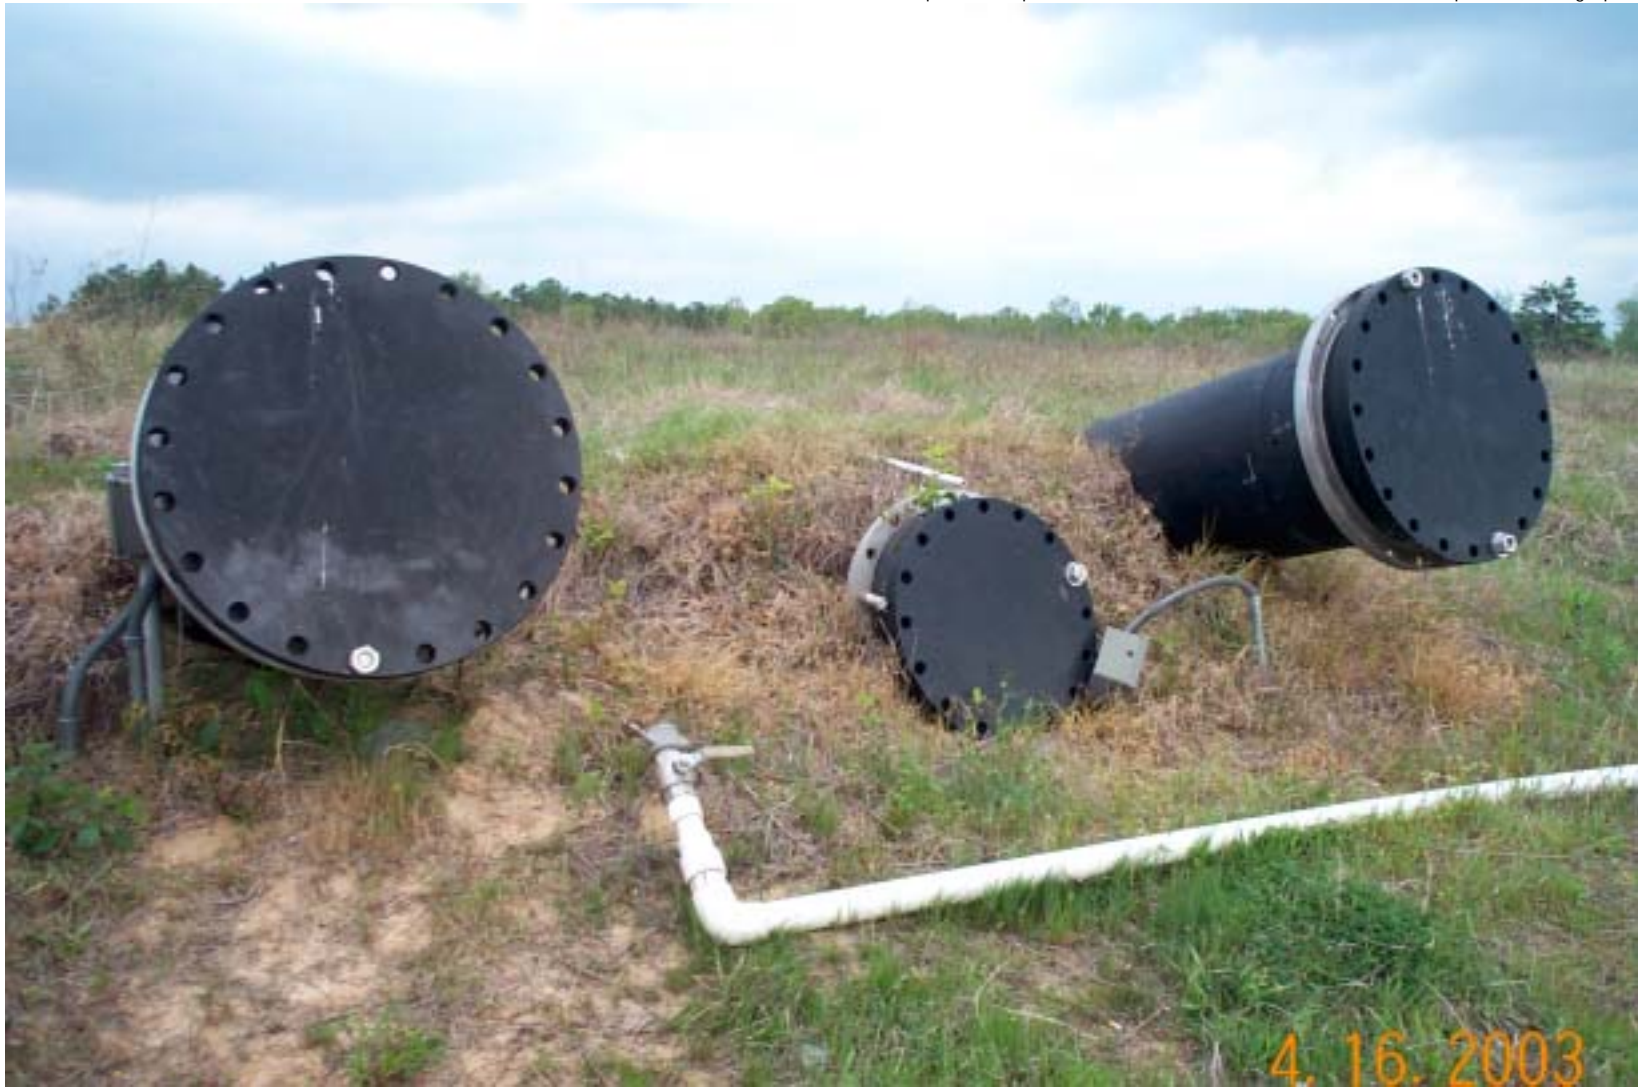
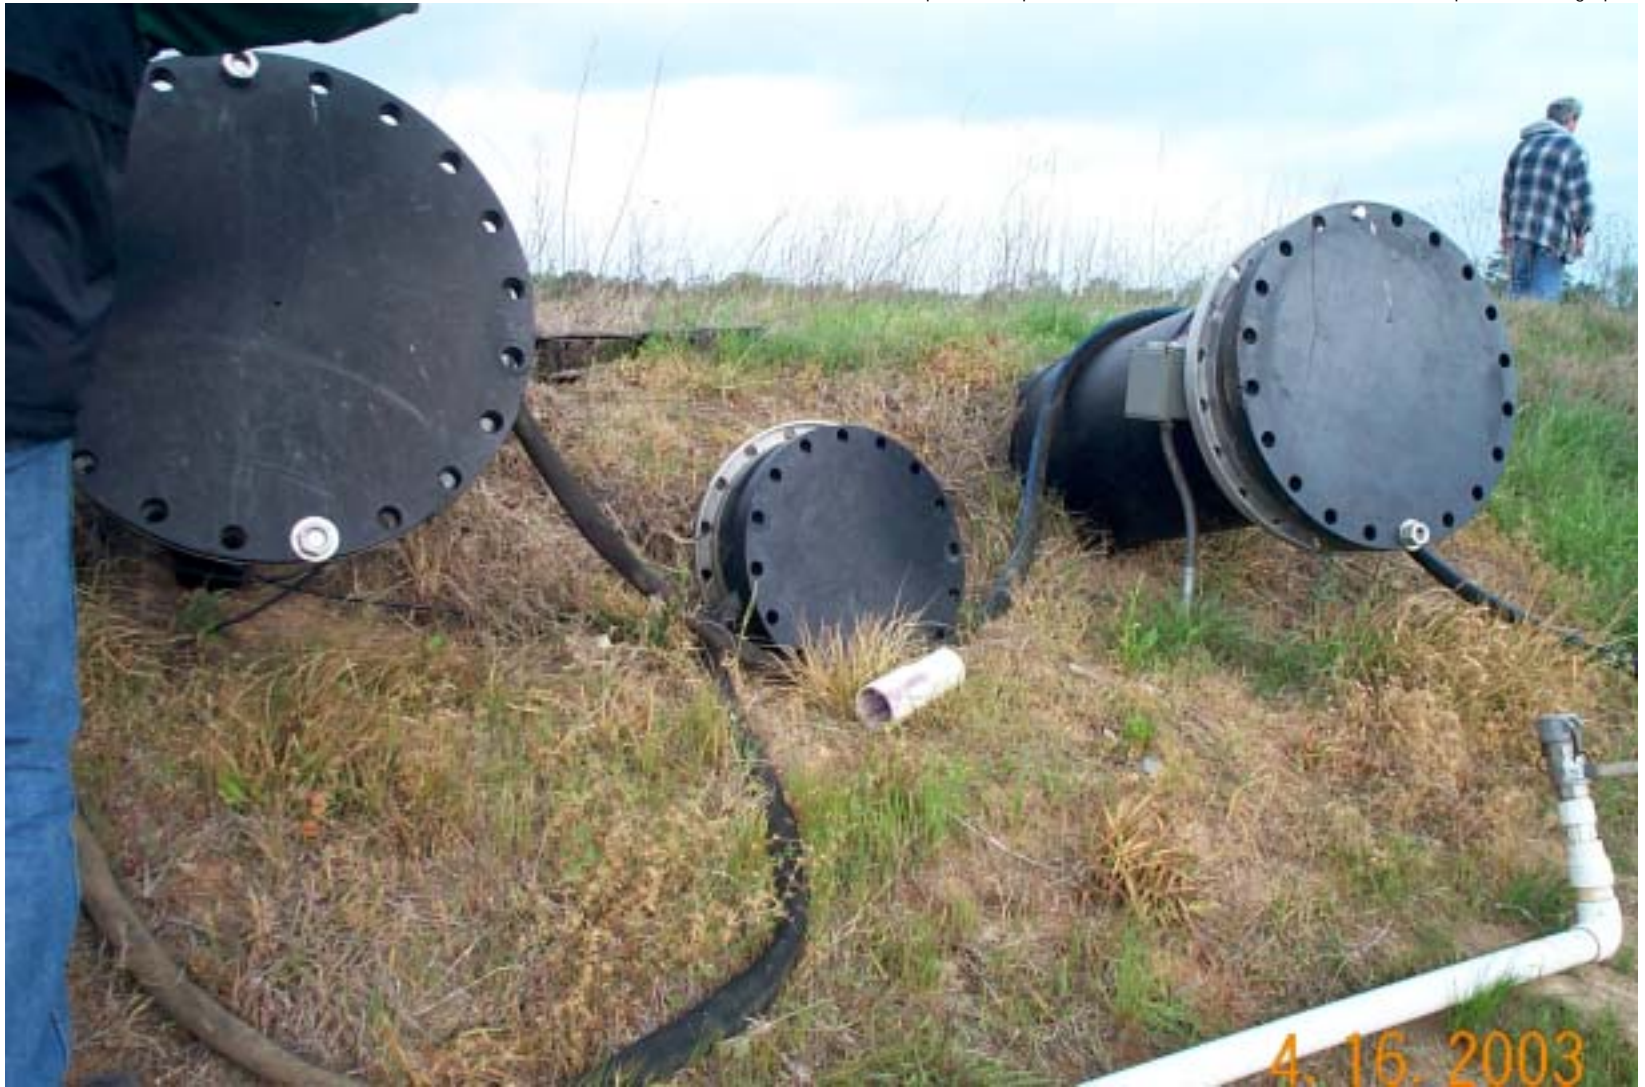
3. Disparity in leachate volume between the north and south cells of the OU1 landfill. At the time of the five-year review site inspection, the GEC operators indicated that a disparity in the volume of leachate was being observed between the north cell and the south cell of the OU1 landfill (with the north cell generating about 300 gallons a month, depending on rainfall amounts, which is significantly more leachate than is generated in the south cell). This caused the operators to suspect a leak in the top liner, although the landfill leachate collection system was able to adequately handle the increased volume.

Photo 23: Access outlets for leachate collection and leachate detection sumps at the OU1 landfill.

Photo 24: Access outlets for leachate collection and leachate detection sumps at the OU1 landfill.

- 3. Document status of disparity in leachate volume between the north and south cells of the OU1 landfill.** Actions taken and recommendations for responding to the disparity in leachate volume between the north and south cells of the OU1 landfill should be documented in the next annual progress report for the site and reviewed by EPA and ADEQ.

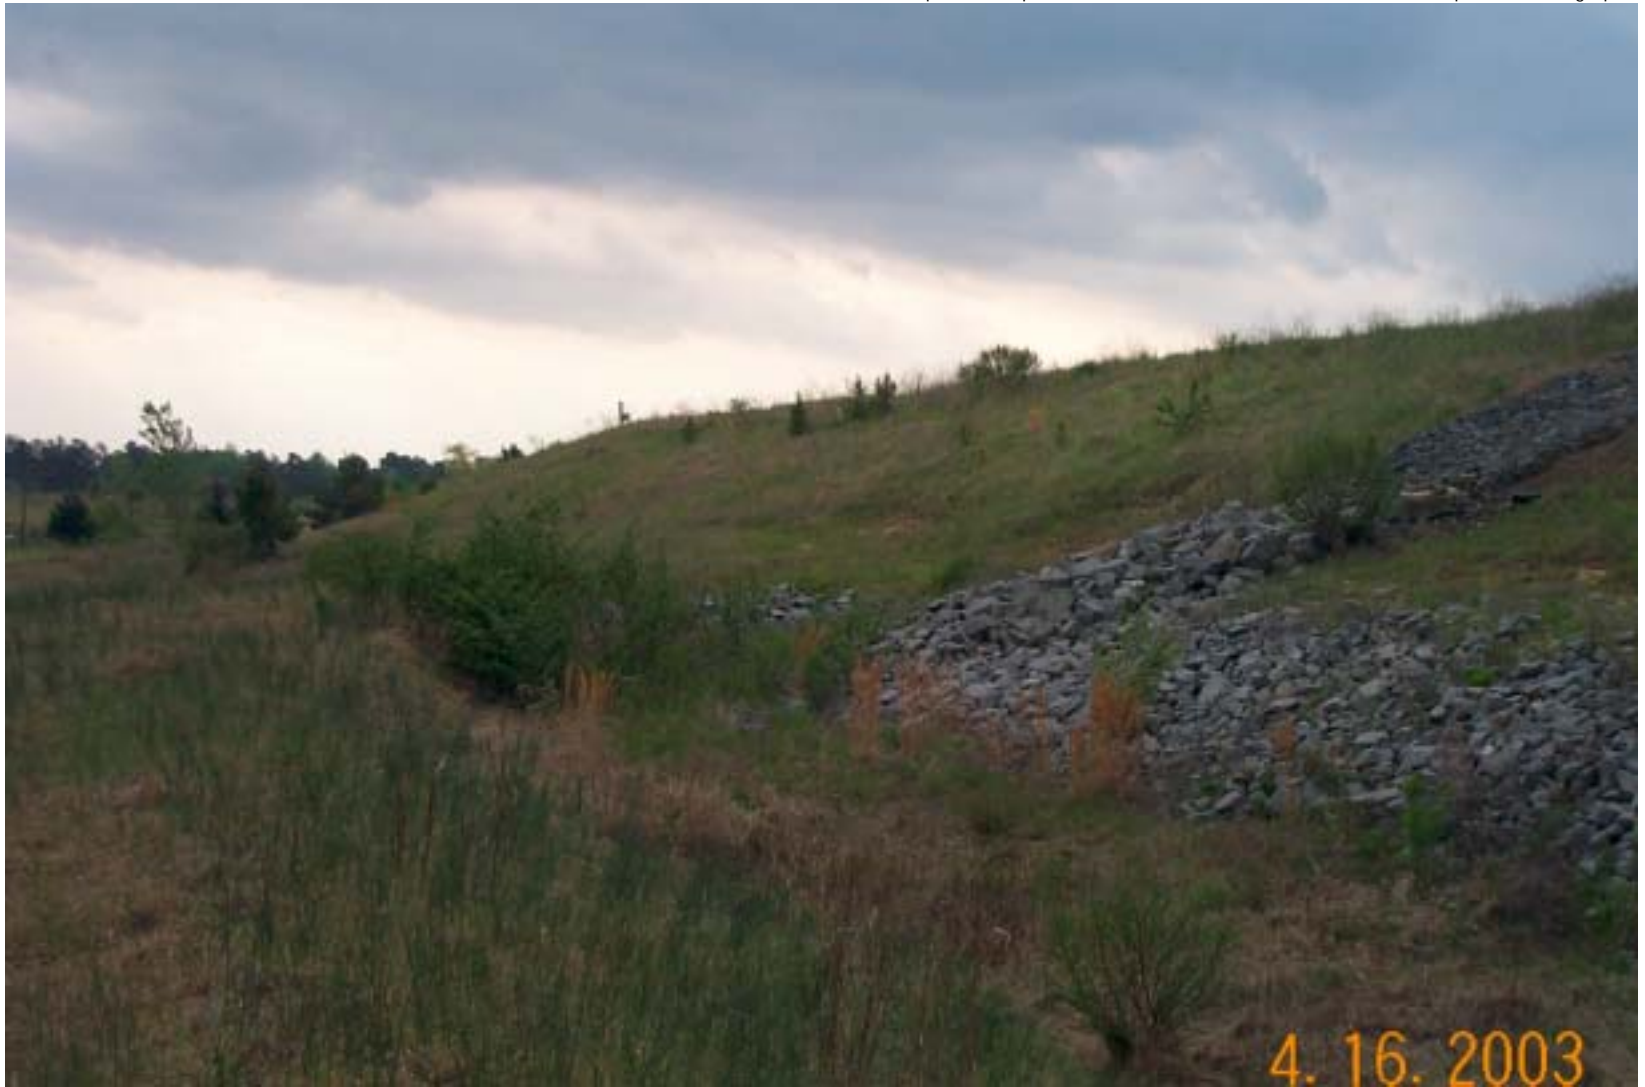
Photo 25: View of the east side of the OU1 landfill. View is facing south. Note small trees growing on the cap.

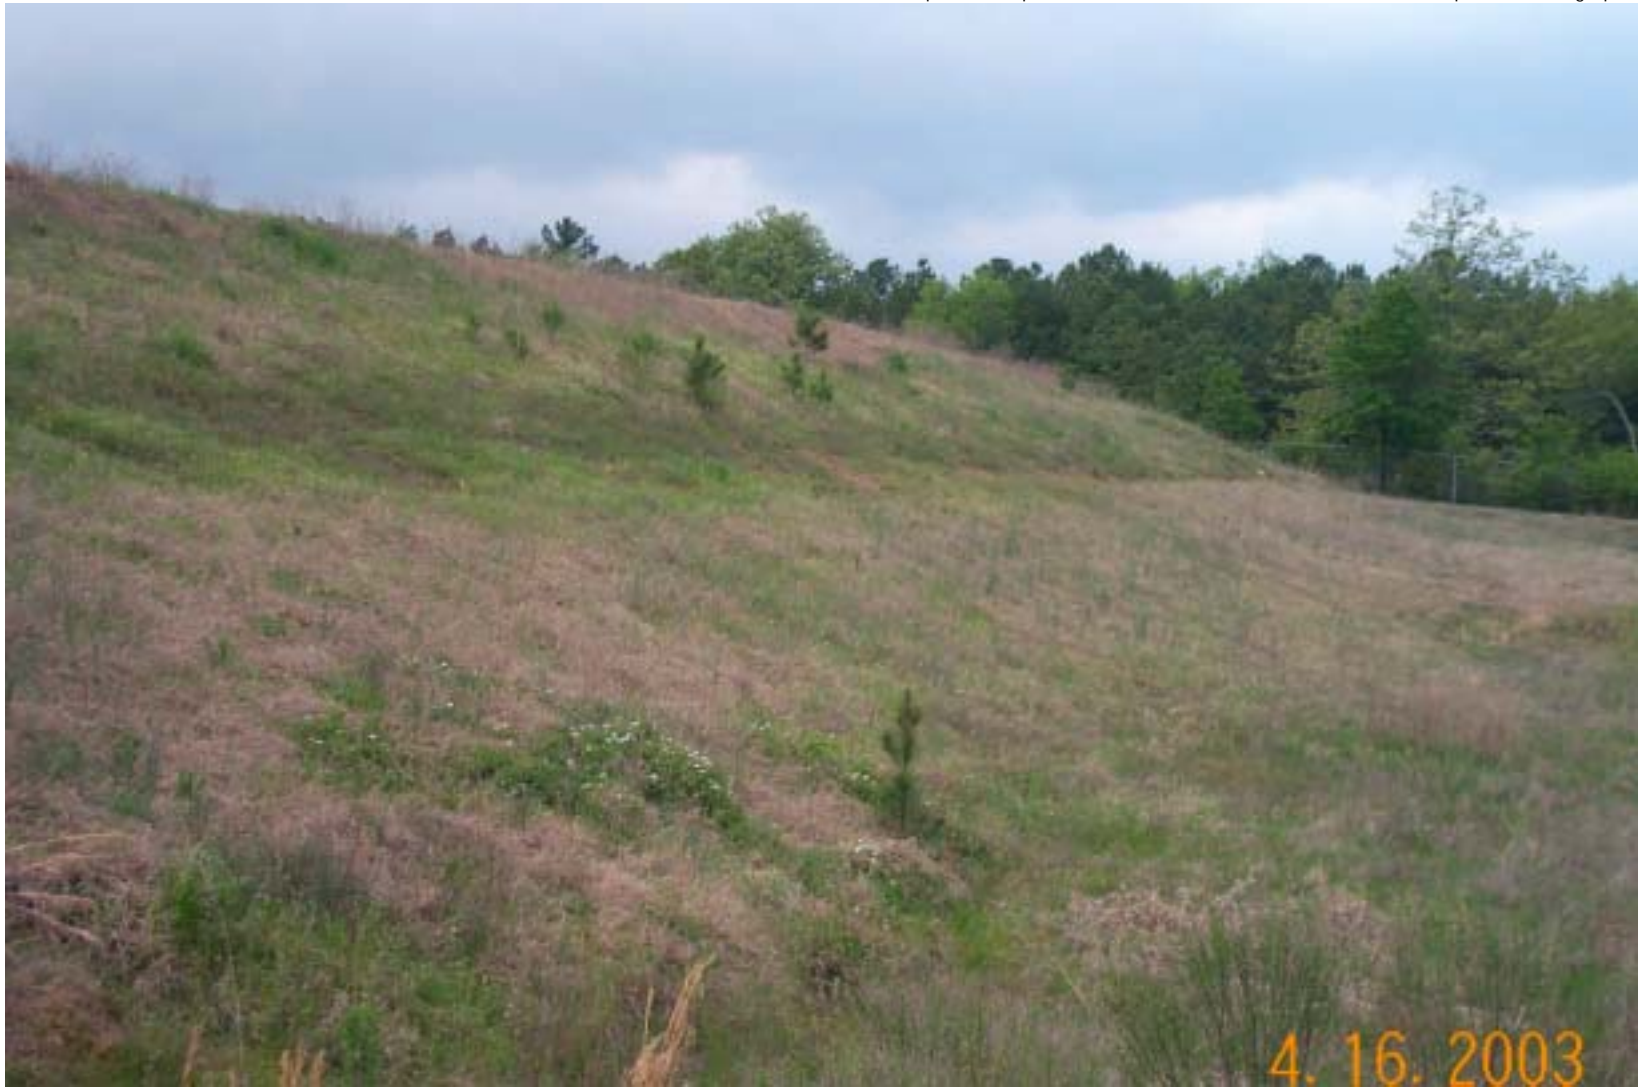
Photo 26: View of the north side of the OU1 landfill. View is facing west. Note small trees growing on the cap.

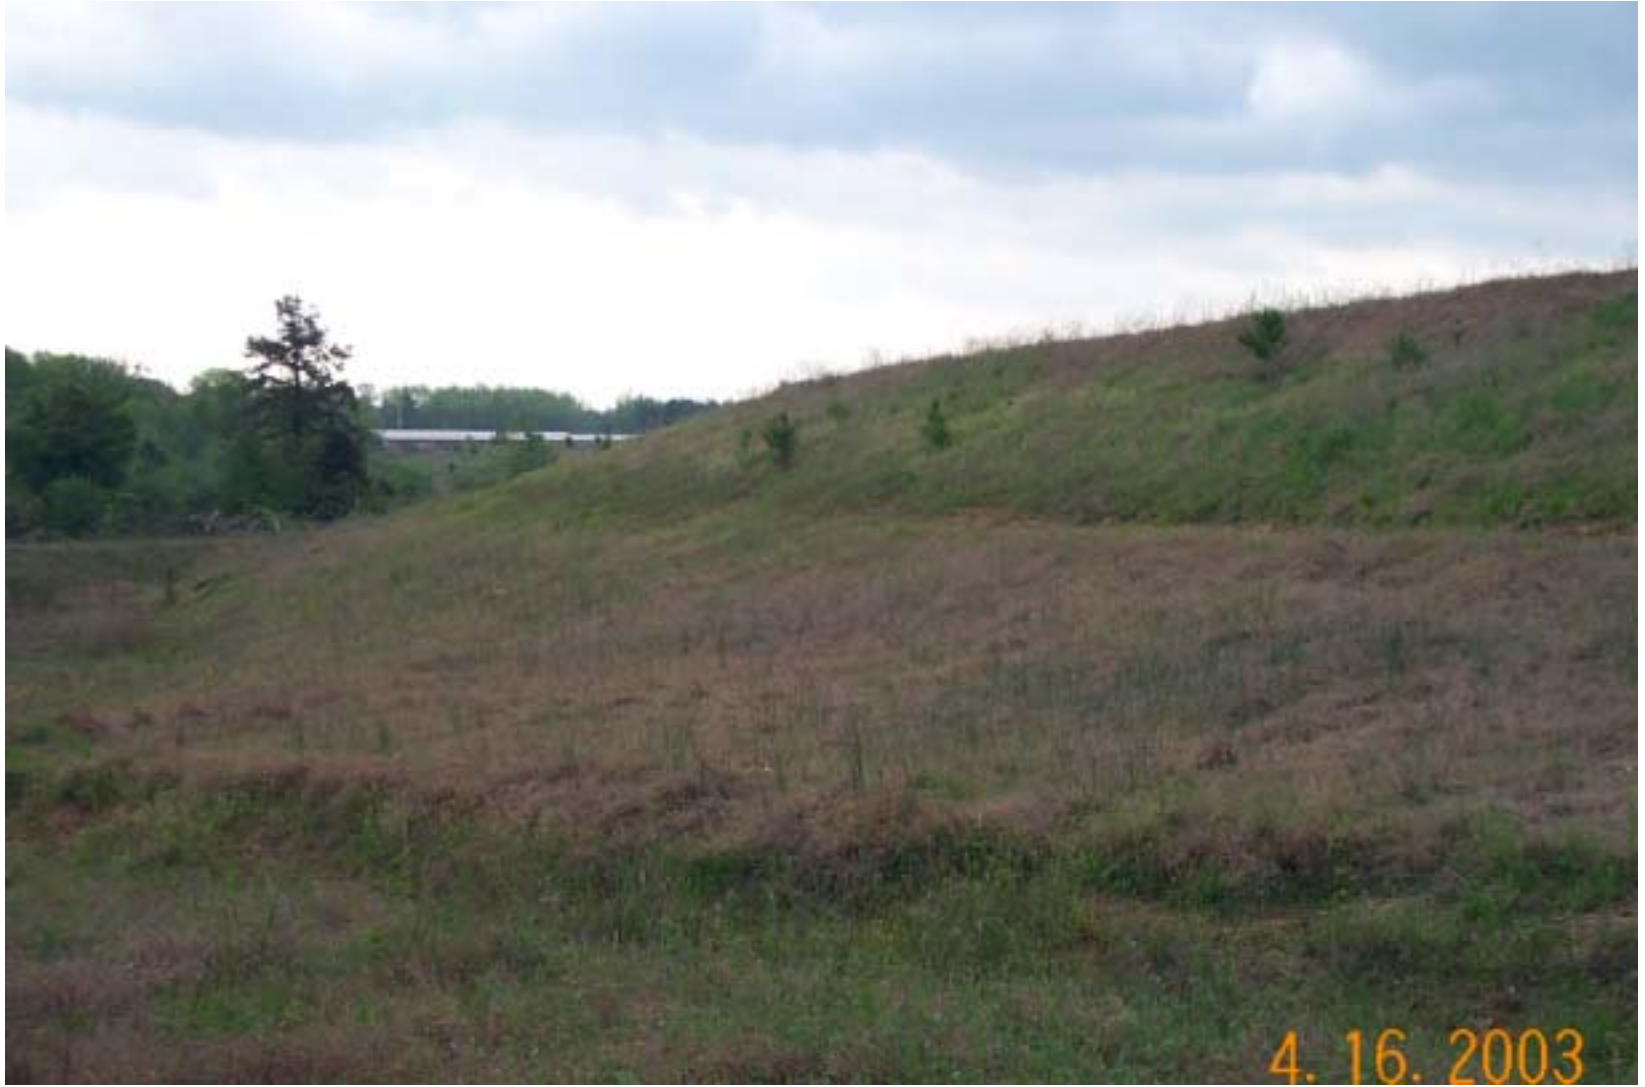
Photo 27: View of the north side of the OU1 landfill. View is facing east. Note small trees growing on the cap.
