Five-Year Review Report

Second Five-Year Review Report for the Vertac Incorporated Superfund Site Jacksonville, Pulaski County, Arkansas

November 2003

**CH2M HILL
Contract Number 68-W6-0036
Work Assignment Number 119-FRFE-0604**

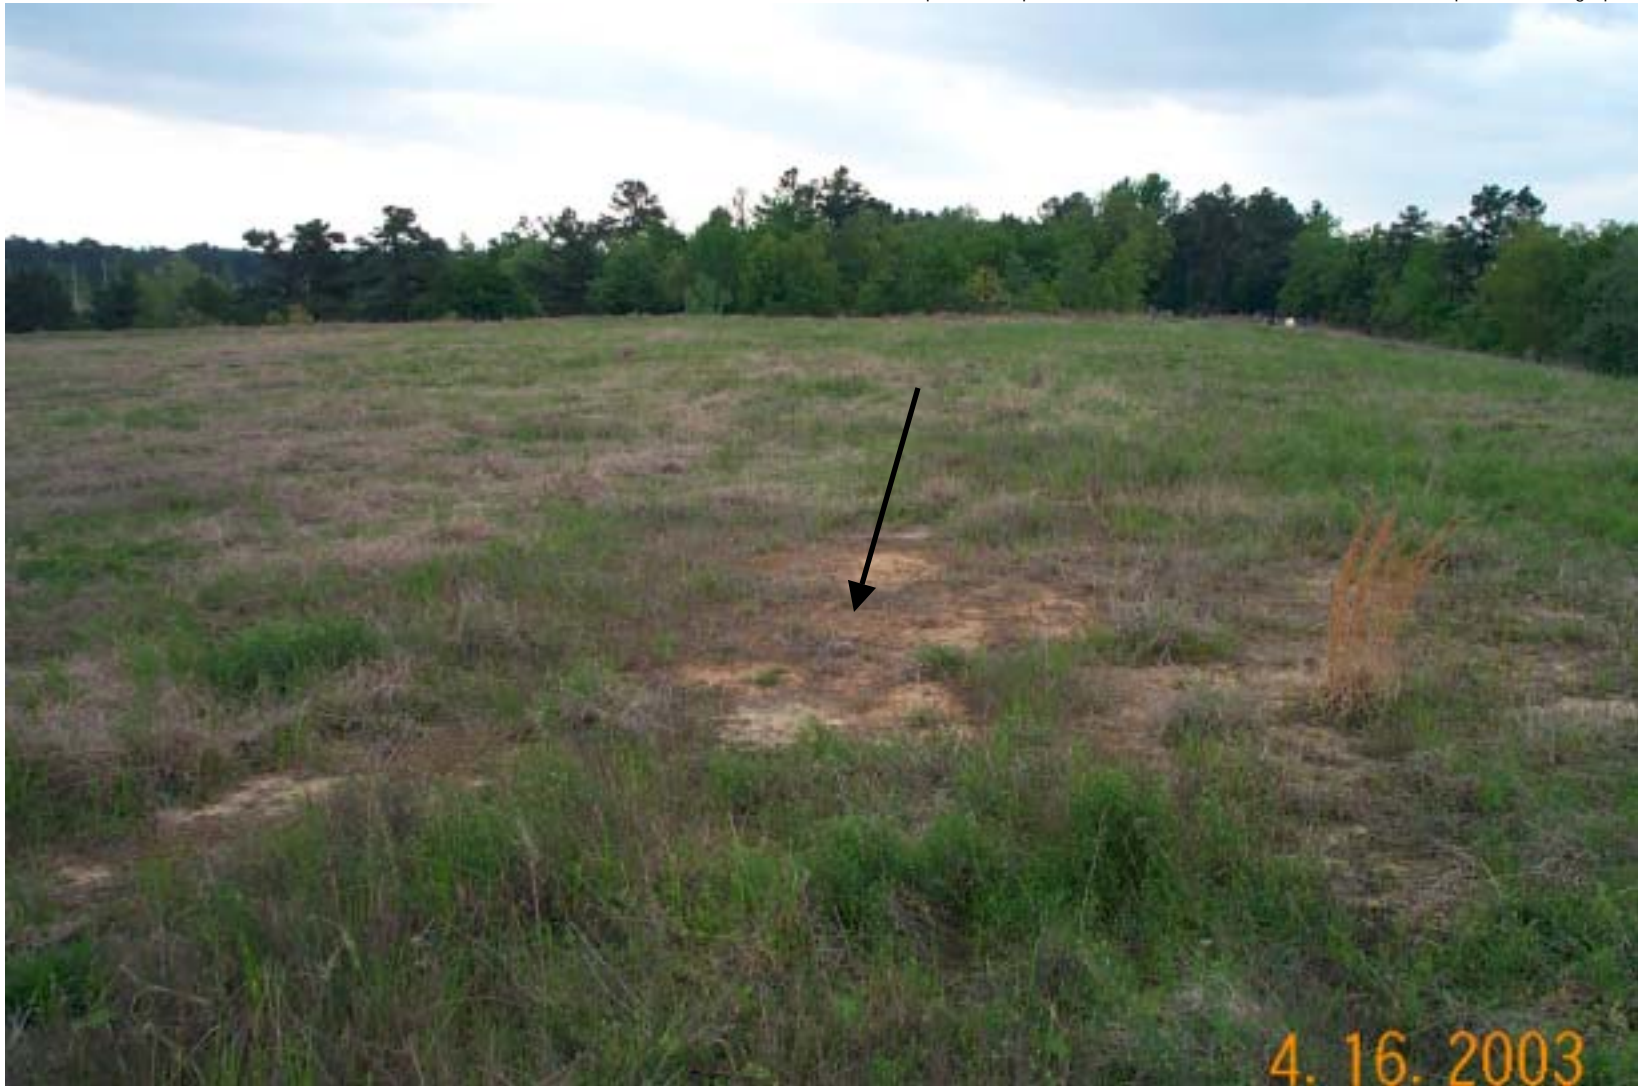
Photo 28: View of the top of the cap at the OU1 landfill. Note area of sparse vegetation (black arrow).

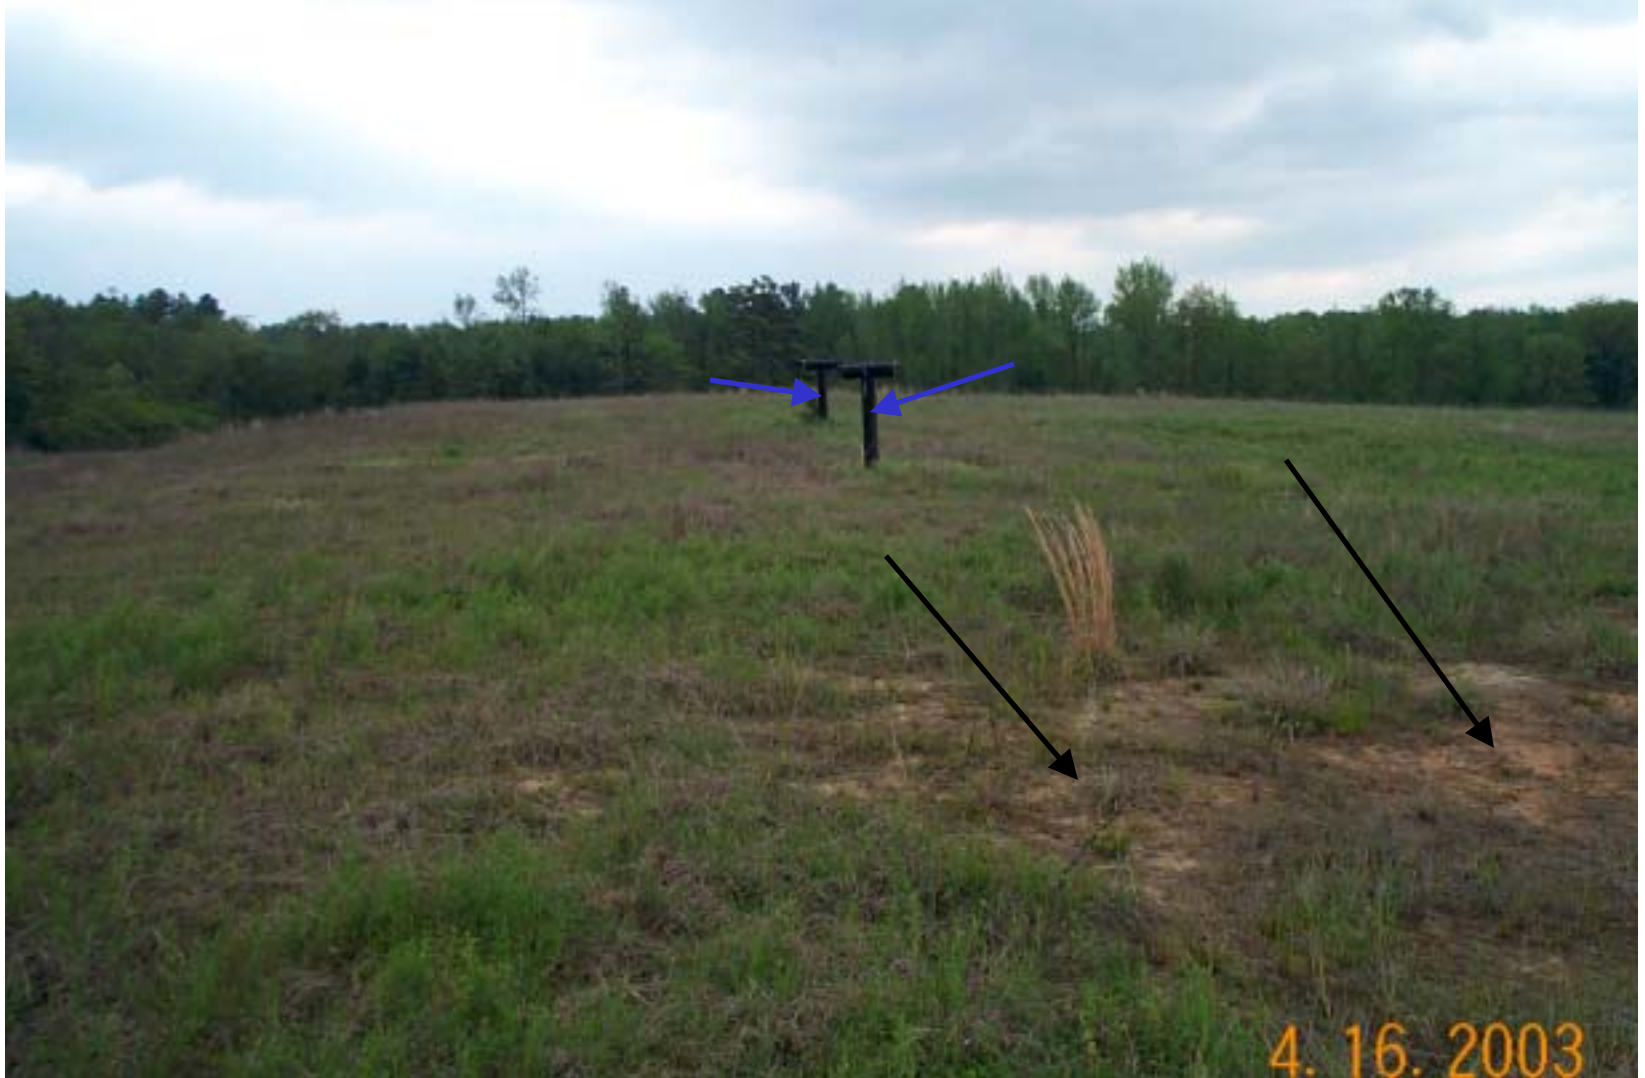
Photo 29: View of the top of the cap at the OU1 landfill. Note area of sparse vegetation (black arrow). Blue arrows are pointing to passive gas vents.

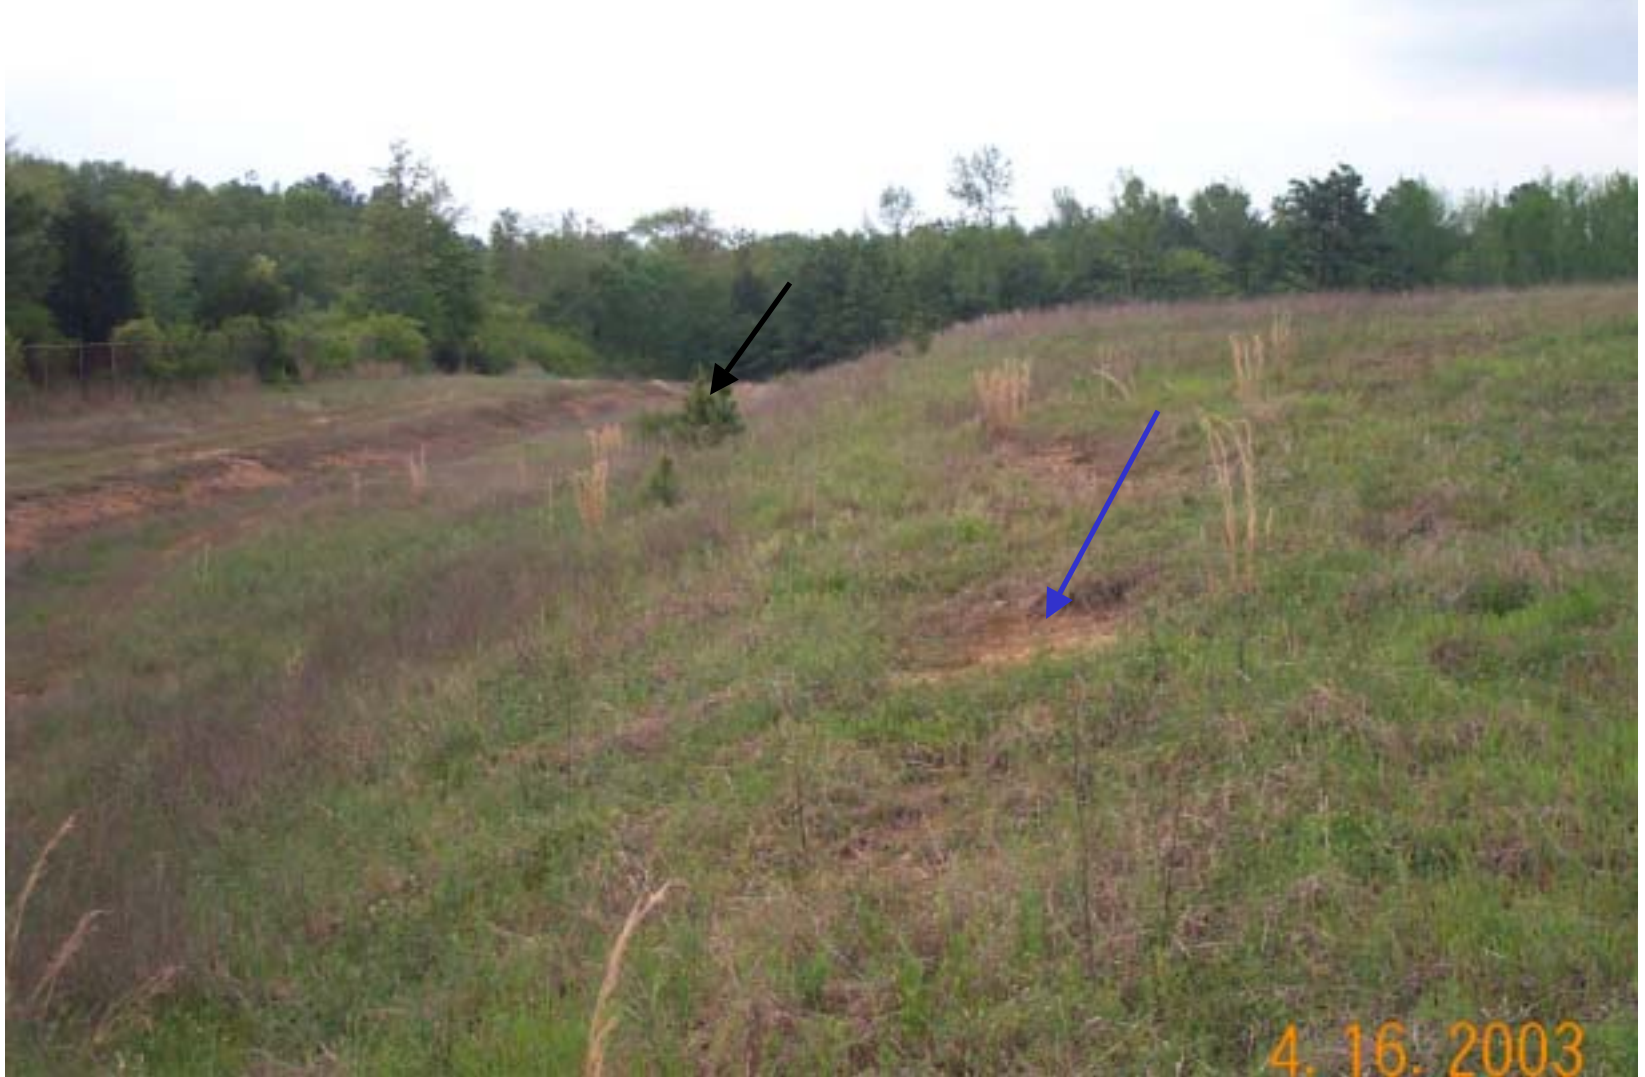
Photo 30: View of the west side of the OU1 landfill. View is facing north. Note small trees growing on the cap (black arrow) and area of sparse vegetation (blue arrow).

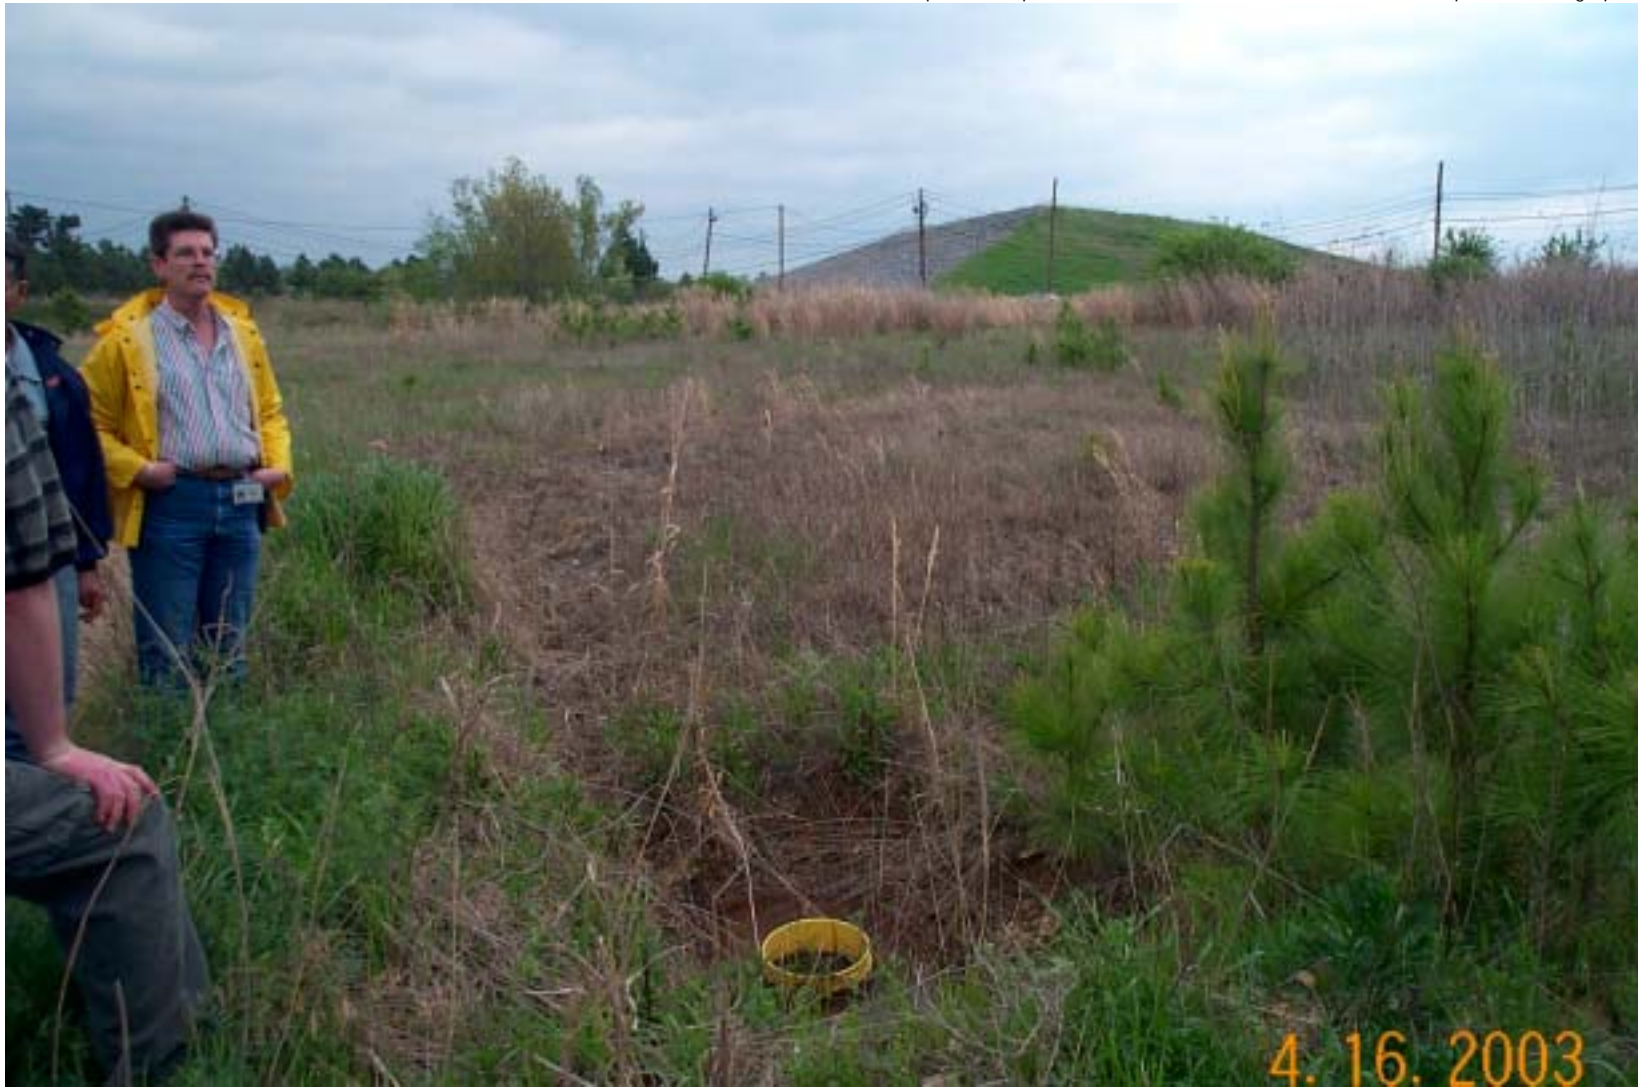
Photo 31: View facing north toward Mt. Vertac, across Reasor Hill Burial Area in center of photo. Yellow bucket is sump installed to collected observed surface seep.

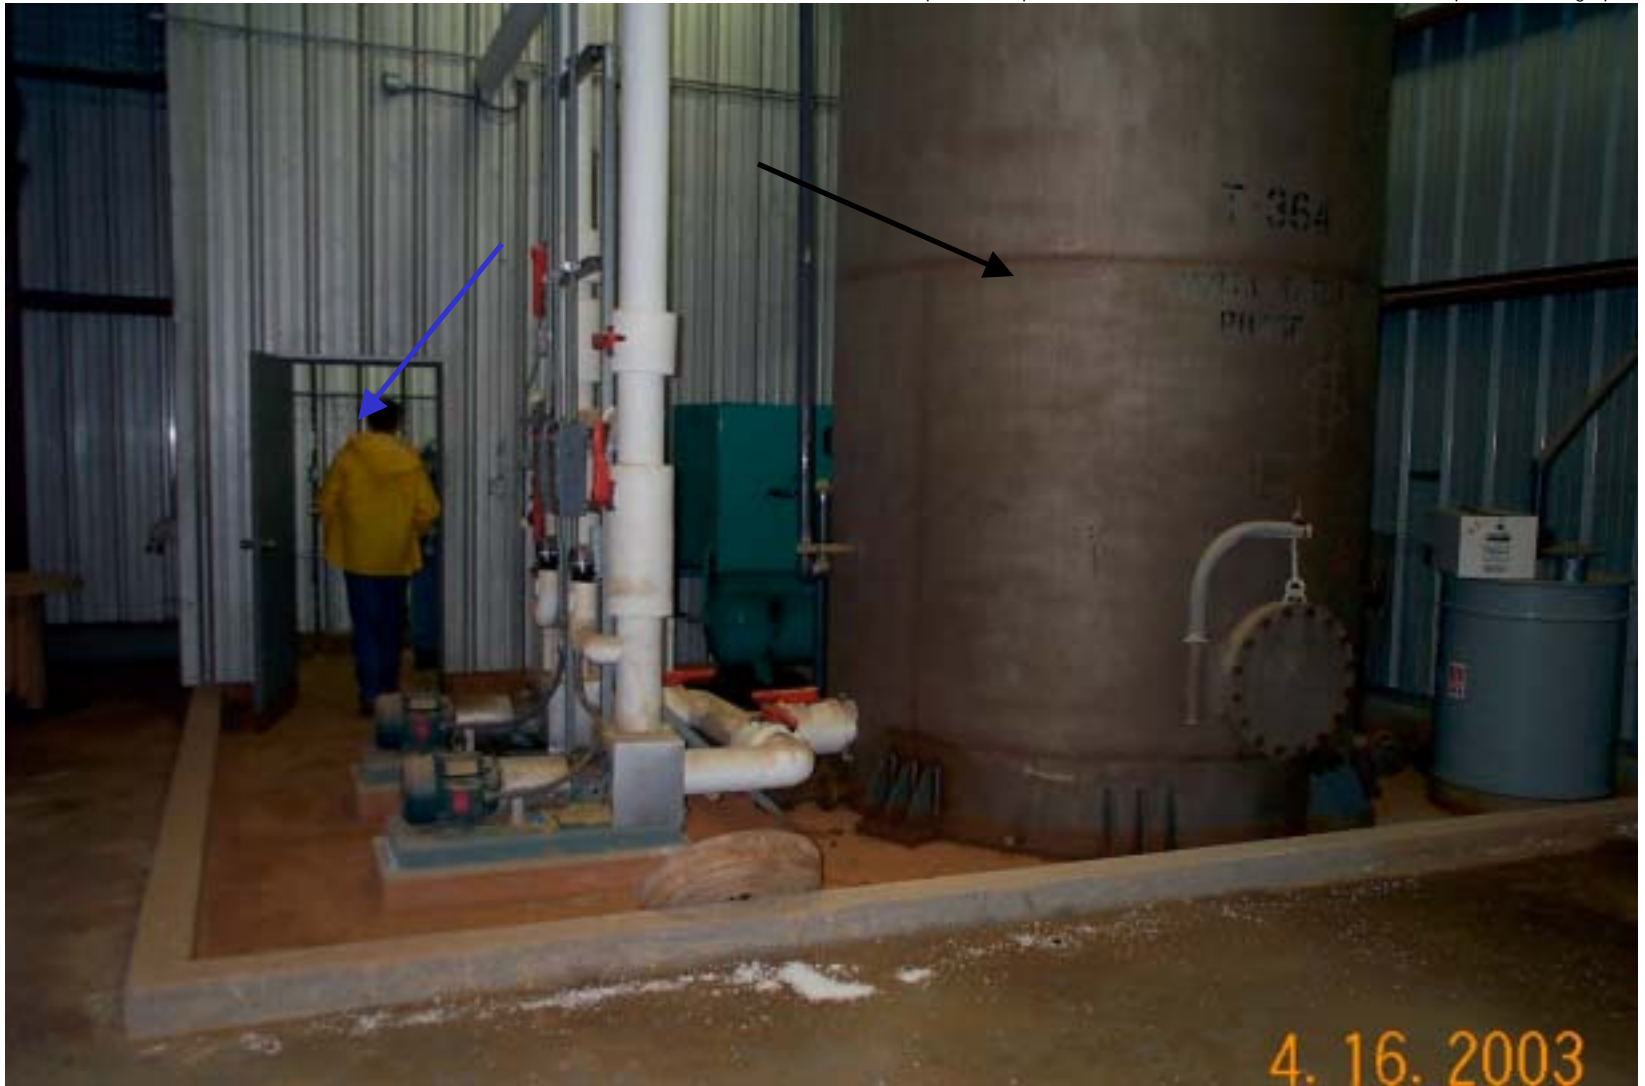
Photo 43: View inside the Groundwater Recovery Building. Tank to the right (black arrow) is used to store extracted ground water prior to transfer to the Wastewater Treatment Plant. The room at the back (blue arrow) contains valves for sampling monitor wells and extraction wells. Note dirt on the floor from leaking wall.

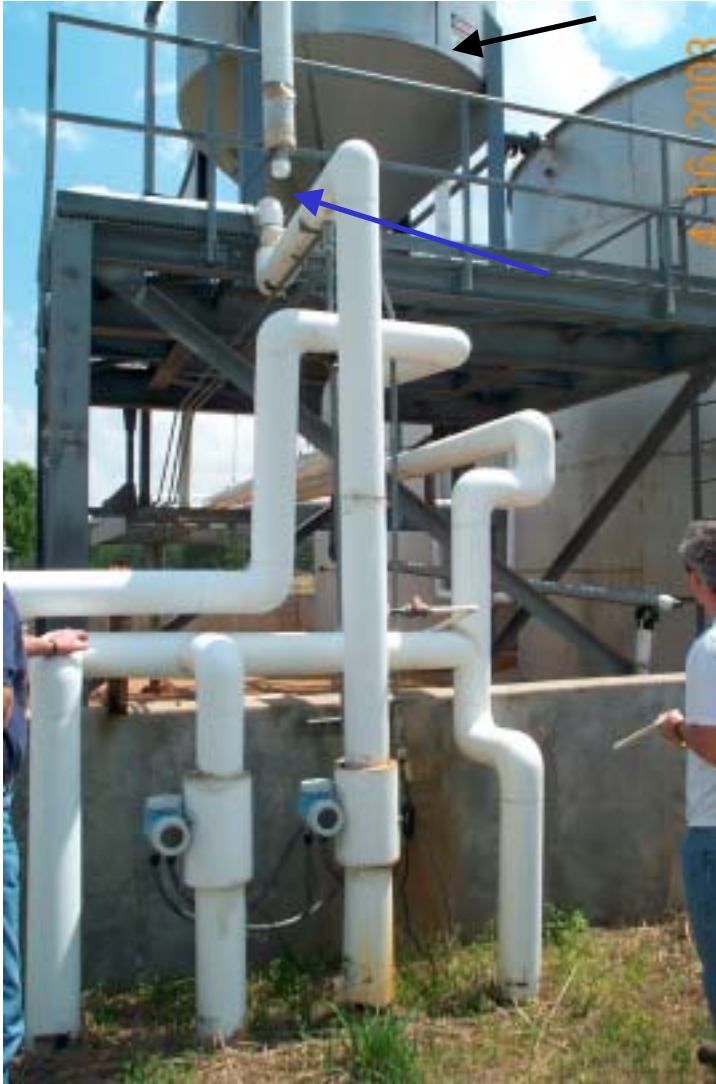
Photo 45: View of inlet pipes from french drain and ground water extraction systems at the waste Wastewater Treatment Plant. Tank at top of photo is the oil/water separator (black arrows). Note that the inlet pipes are no longer connected to the oil/water separator (blue arrow).
