Rail Passenger Equipment Accidents and the Evaluation of Crashworthiness Strategies

David C. Tyrell
Volpe National Transportation Systems Center
U.S. Department of Transportation

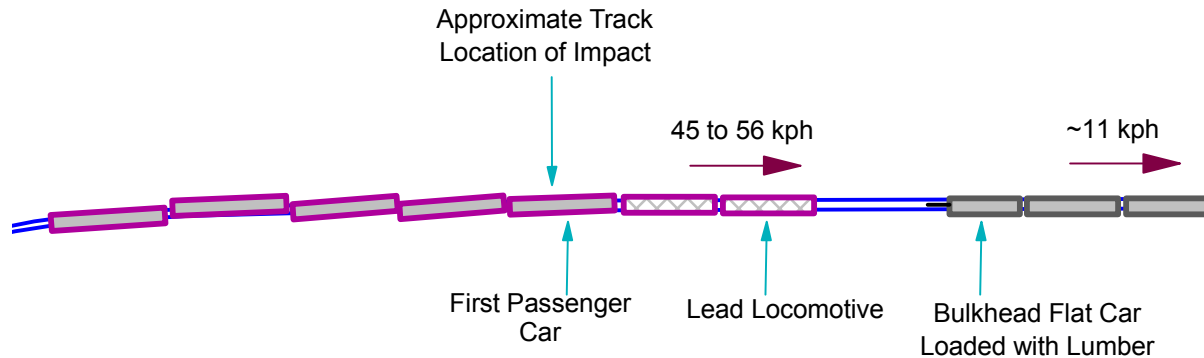
Figure 5 shows a post-accident schematic. The passenger train was made up of two General Motors/Electro-Motive Division F-40ph locomotives, a coach/dinette car, and four coach cars. Both locomotives were equipped with transit-style ribs on the anti-climber on the short-hood end. The freight train was made up of 88 loaded cars, four empty cars, and two locomotives. The trailing cars of the freight train were bulkhead flatcars carrying lumber. The last car of the freight train – the impacted car – was carrying a full load of framing lumber. This car was equipped with a hydraulic draft-cushioning device. At least two more cars of this type and load were ahead of the last car.

There was very little structural damage to the passenger cars. There was some damage to the flexible bellows between the cars closer to the lead end of the train, associated with the sawtooth lateral buckling of the first four passenger cars. There was also some scarring of the sides of the couplers and their lateral bump stops, also associated with the sawtooth buckling

of the cars. The freight cars remained in-line, and the track under them did not buckle. The hydraulic cushioning devices may have helped to prevent the cars from laterally buckling, as well as the longer shanks of the freight couplers (compared with passenger couplers) and the greater weight of the freight cars.

Figure 5. Post-collision schematic drawing, rear-end collision of a freight train by an inter-city passenger train, Syracuse, New York.

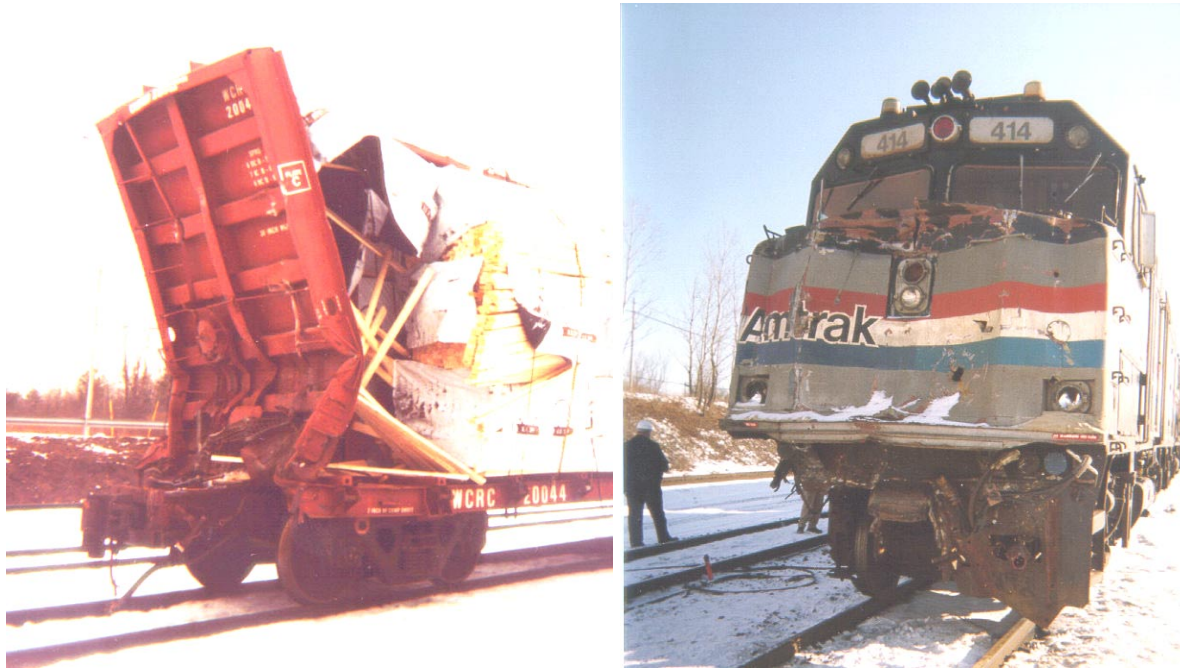
Figure 6 shows post-accident photographs of the inter-city passenger train's lead locomotive and the freight train's trailing bulkhead flatcar. It appears that crushing and displacing of the lumber on the loaded bulkhead flatcar absorbed most of the collision energy. The hydraulic cushioning devices on the trailing cars of the freight train also probably helped to dissipate some of the collision energy. (In effect, it appears that the hydraulic cushioning device and the lumber acted as a crash energy management system.) The body and lading of the bulkhead flatcar was crushed approximately 1.8 m (6 feet), from the trailing end of the carbody up to the trailing axle of the trailing truck. The draft sill and coupler of the bulkhead flatcar remained essentially intact, with the body and lading stripped off. The draft sill and coupler of the bulkhead flatcar acted as a battering ram which tore through the coupler and draft-gear box of the locomotive, which hang beneath the main sill structure of the locomotive. The coupler and the end of the draft sill of the flatcar impacted the front and top of the lead traction motor and front of the body bolster, helping to pry the truck from the locomotive and to push the truck back into the fuel tank. A lug on the lead truck punctured the fuel tank, causing a hole about the size of a baseball. The body of the locomotive began to climb the bulkhead flatcar, as the flatcar was crushing. Grooves from the ribs on the anti-climber can be seen on the bulkhead of the flatcar, 9 to 10 feet from top of rail. (The locomotive anti-climber normally sits approximately 5 feet above top of rail, at the end of the locomotive above the coupler.) The anti-climber engaged a transverse framing member of the bulkhead, which may have helped to stop the locomotive from climbing the bulkhead flatcar any further.

Figure 6. Post-accident photographs, passenger train lead locomotive and freight train trailing loaded bulkhead flatcar, Syracuse, New York collision.

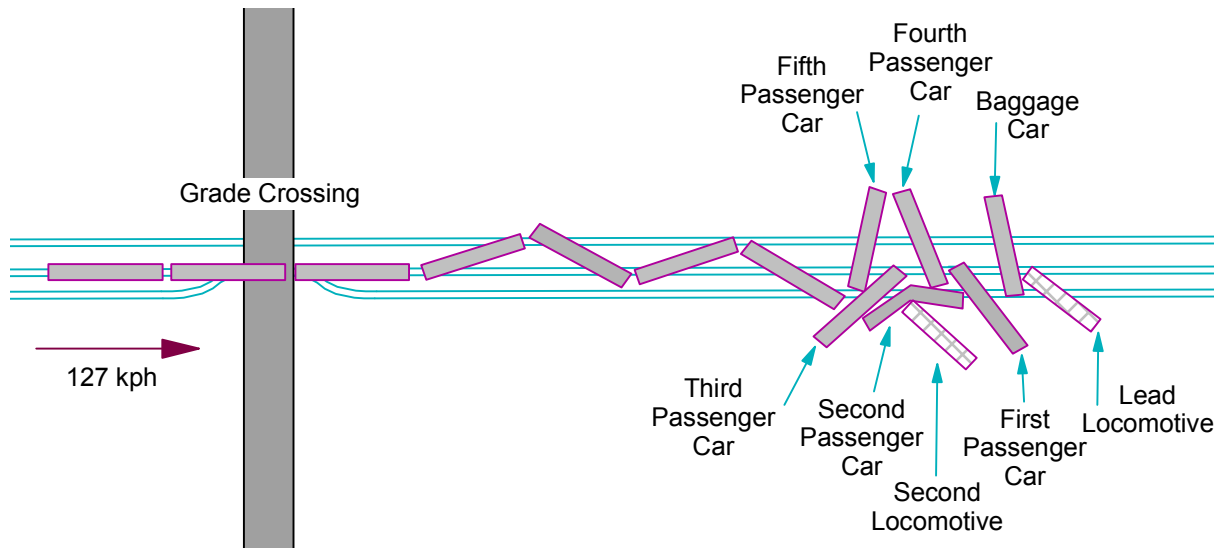
Figure 7 shows a post-collision schematic of the train. Because of the severity of the collision, it is very difficult to infer a likely sequence of events. The collision with the highway tractor-trailer likely resulted in little structural damage to the locomotive. The lead locomotive impacted the rear wheel of the trailer. The trailer was loaded with approximately 178 kN (40 kips) of steel rebar, a relatively light load. The principal impact was probably with the loaded freight cars.

Figure 7. Post-Collision schematic, passenger train collision with highway truck and subsequent collision with standing freight cars, Bourbonnais, Illinois.

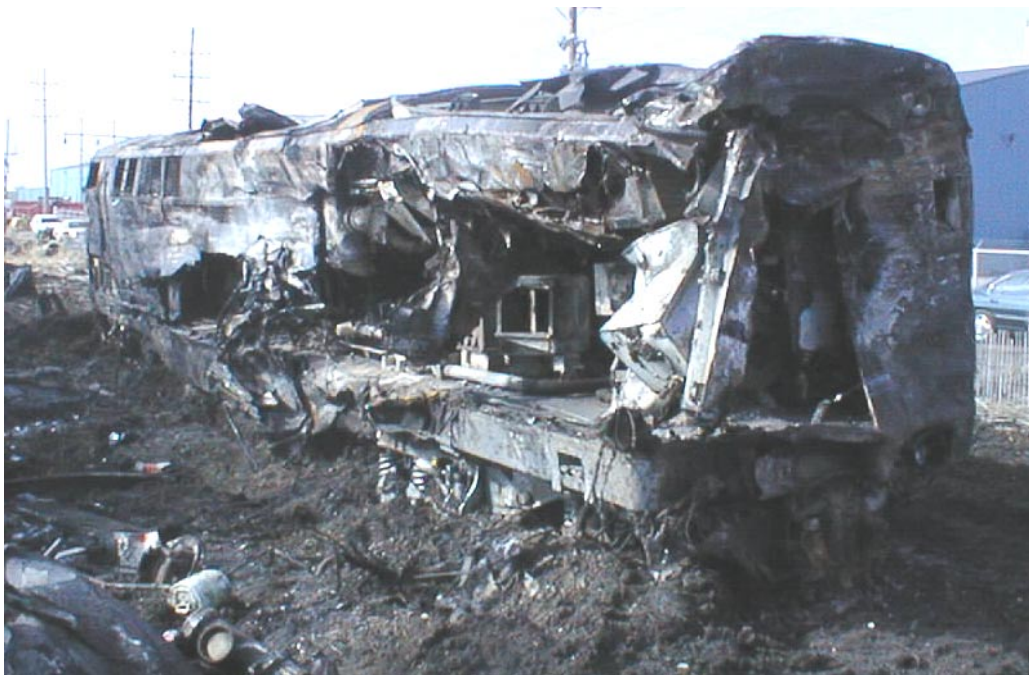
Significant structural damage occurred to the first and second locomotives, which are shown in Figures 8 and 9 respectively. The lead locomotive had significant damage on the left side, particularly near the rear. The fuel tank in this locomotive is integral with the center portion of the frame, i.e., the side sills between the trucks make up most of the fuel tank. There were several punctures and gashes in the fuel tank. The trailing locomotive was extensively damaged. The equipment in the rear third of the locomotive was stripped off, and the trailing third of the locomotive frame was bent into the shape of a ‘W.’

Figure 8. Post-Accident Photograph, Lead Locomotive, Bourbonnais, Illinois Collision.

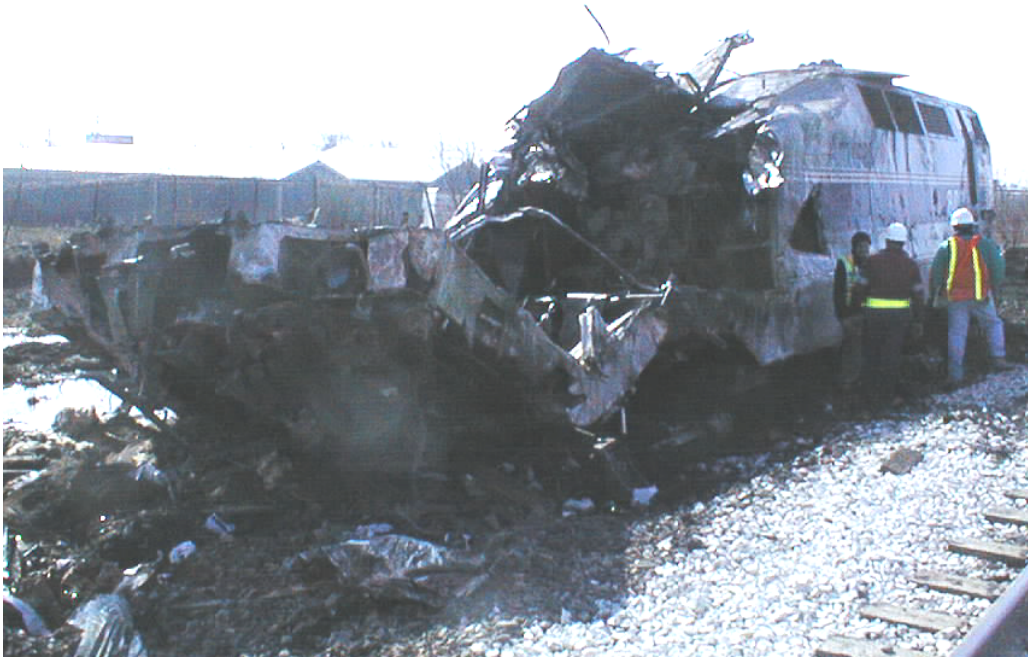
Figure 9. Post-accident photograph, second locomotive, Bourbonnais, Illinois collision.

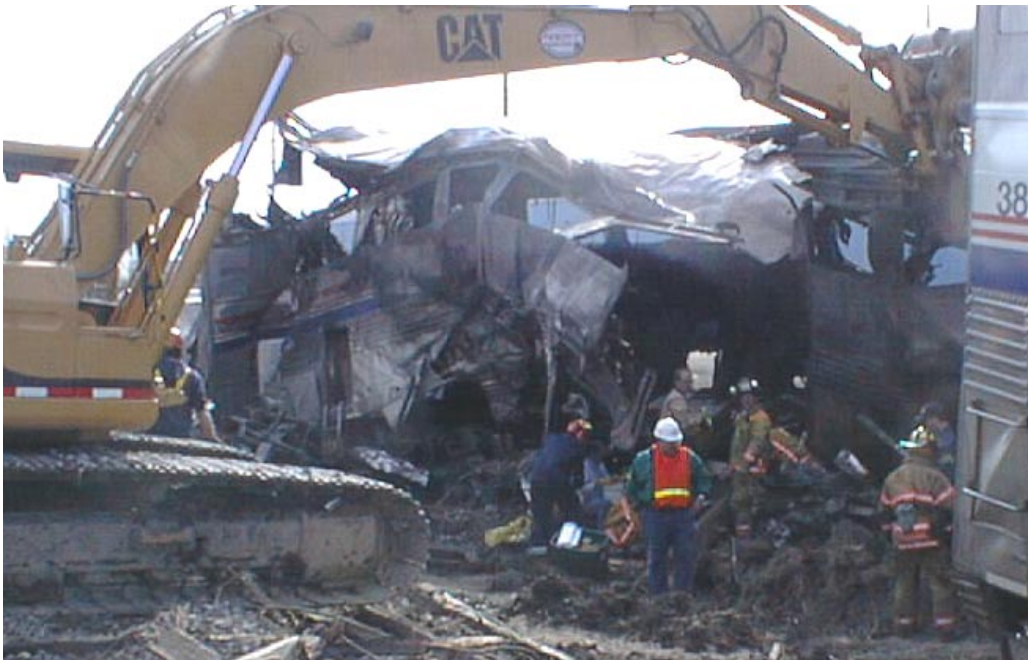
The most severely damaged passenger car was the second bi-level car, shown in Figure 10. In the pile-up, this car received lateral impacts from several other cars and the second locomotive. The rear of the second locomotive impacted it near the center of what is believed to have been the right side. There was a side-to-side impact with another bi-level car opposite the impact with the locomotive. The front of another bi-level car impacted it on the side near the lead truck.

Figure 10. Post-accident photograph, second bi-level passenger car, Bourbonnais, Illinois collision.

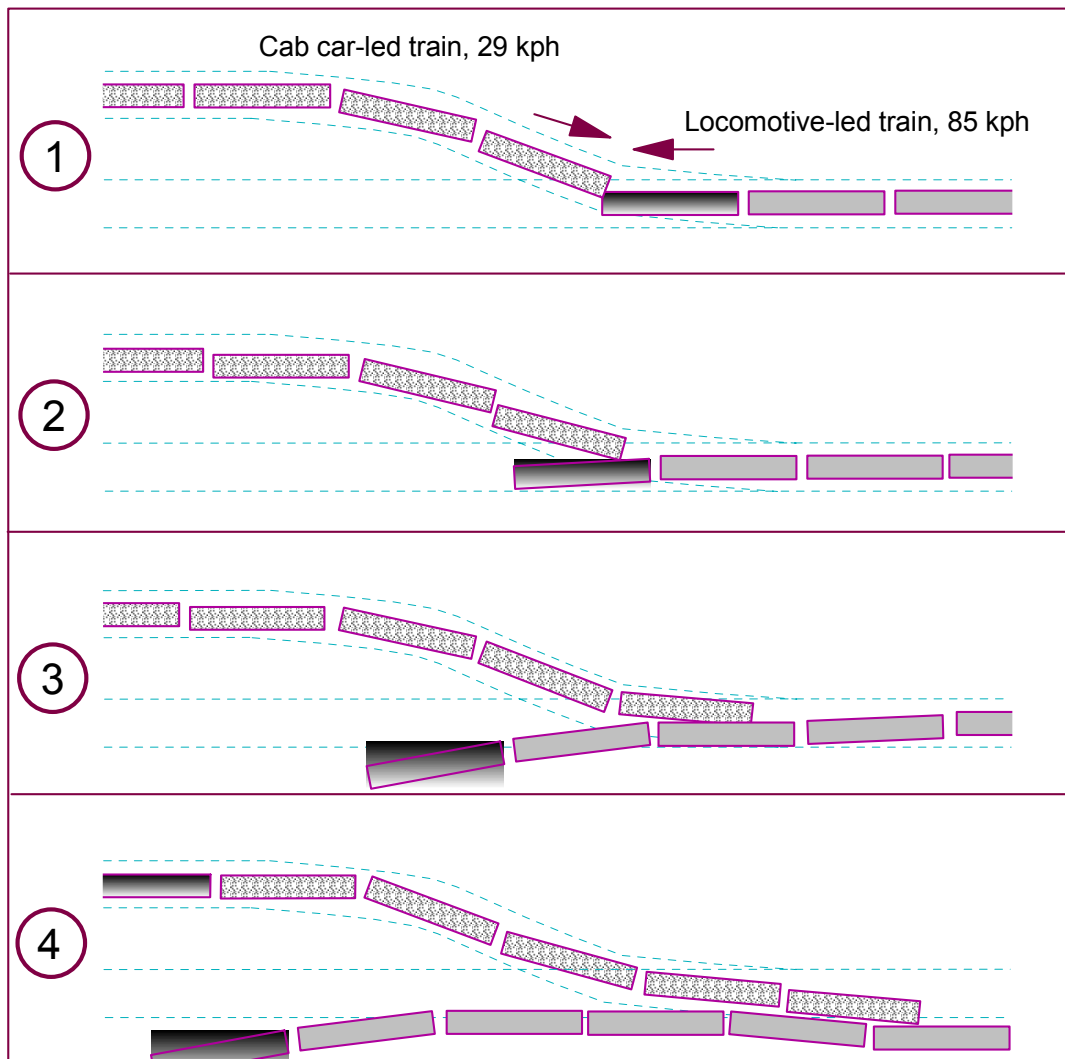
Figure 11 illustrates a potential sequence of events during the collision, based on conversations with FRA and NTSB officials. It appears that the collision progressed as follows:

1. The cab car was traveling at approximately 29 kph (18 mph) when it struck the front, right corner of the locomotive, which was traveling at approximately 85 kph (53 mph) in the opposite direction. Based on the track geometry, the angle between the two vehicles at the instant of impact was approximately 7°. The corner post on the right side of the cab car struck the right side of the locomotive. Both collision posts on the cab car remained in place, though the right post incurred some structural damage. The right corner post was torn away from the cab car. The roof plate from the right side of the cab car broke away and penetrated the window of the locomotive.

2. The cab car raked down the side of the locomotive. The left rail (field side) under the locomotive rolled over and the locomotive derailed.
3. The derailed locomotive pulled the trailing cars off the track. The cab car continued to rake the cars trailing the locomotive, damaging stairwells as it went.

4. Most cars in the locomotive-led consist derailed (the last car may have stayed on the track). Only the cab car derailed in the cab car-led consist. The cab car-led consist was stopped by the collision at the switch. The locomotive-led consist slid to a stop on the ties and ballast.

Figure 11. Schematic of Secaucus, New Jersey, cab car/locomotive collision (hypothetical).

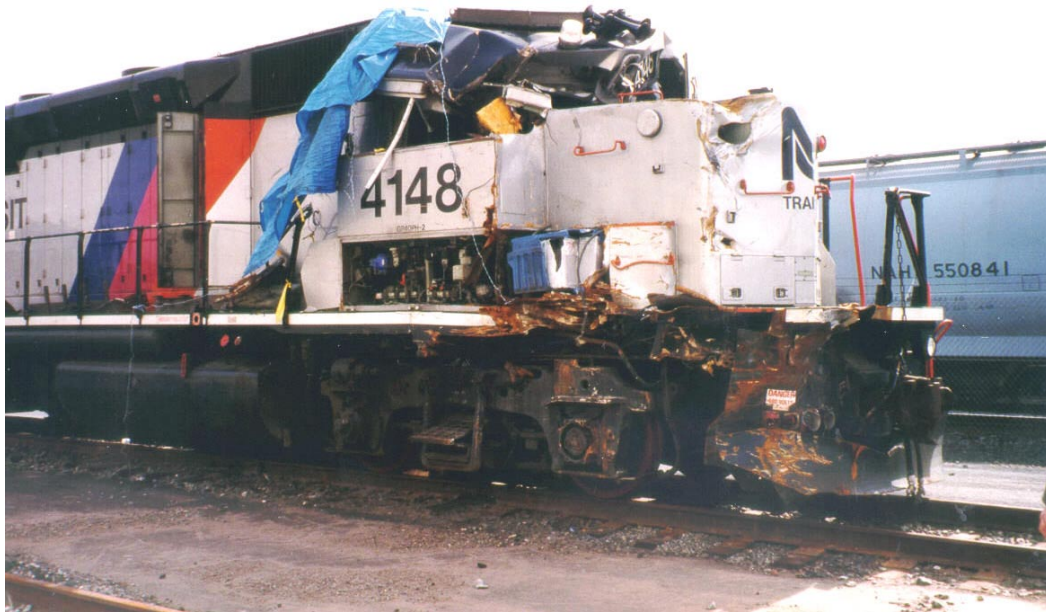
The roof plate of the cab car penetrated the operator's window of the locomotive. Damage to the hood of the locomotive appeared to be due to the roof plate riding up on the hood and through the window. Some superstructure damage to the front of the locomotive, approximately halfway between the coupler and the side of the locomotive, appeared to have been caused by the front of the cab car. The center sill and main structure of the locomotive remained essentially intact. A post-collision photograph of the locomotive is shown in Figure 12.

Figure 12. Post-accident photograph, impacted locomotive, Secaucus, New Jersey collision.

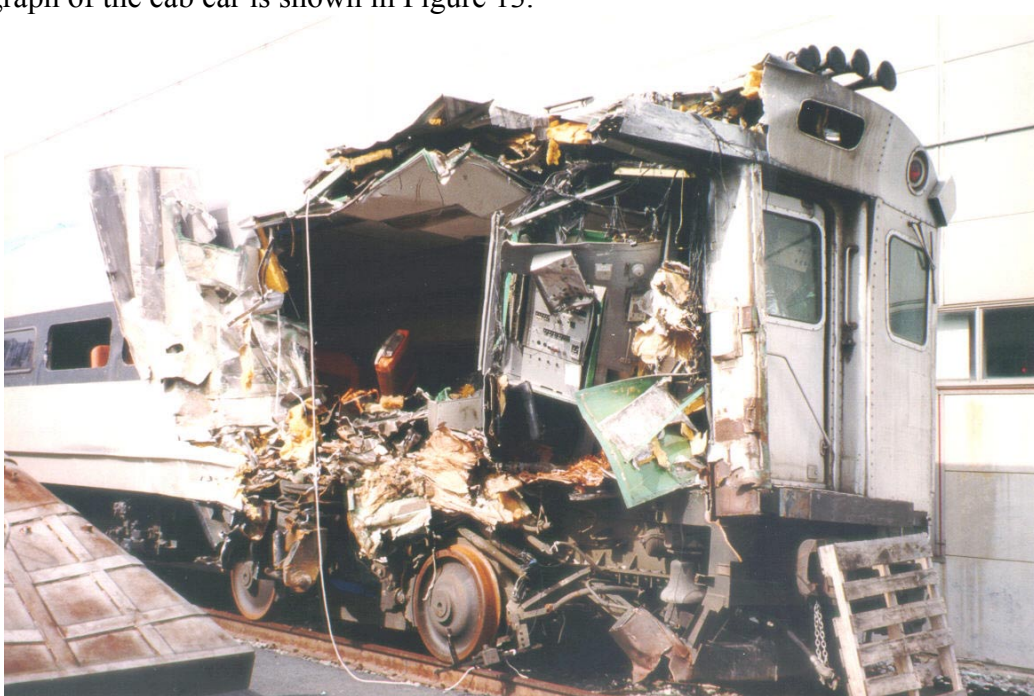
Damage to the lead cab car includes crushing of the right, front corner of the car from the end of the car to the body bolster. This area includes the operator's compartment and approximately five rows of seats. The right (track-side) collision post incurred substantial damage: there are several large cracks in and around the attachment point. This damage may have occurred when the end of the transverse floor member was torn off in the initial collision with the locomotive. The collision post itself may not have been loaded directly. The corner post and a portion of the roof plate were separated from the cab car. A post-collision photograph of the cab car is shown in Figure 13.

Figure 13. Post-accident photograph, lead cab car, Secaucus, New Jersey collision.

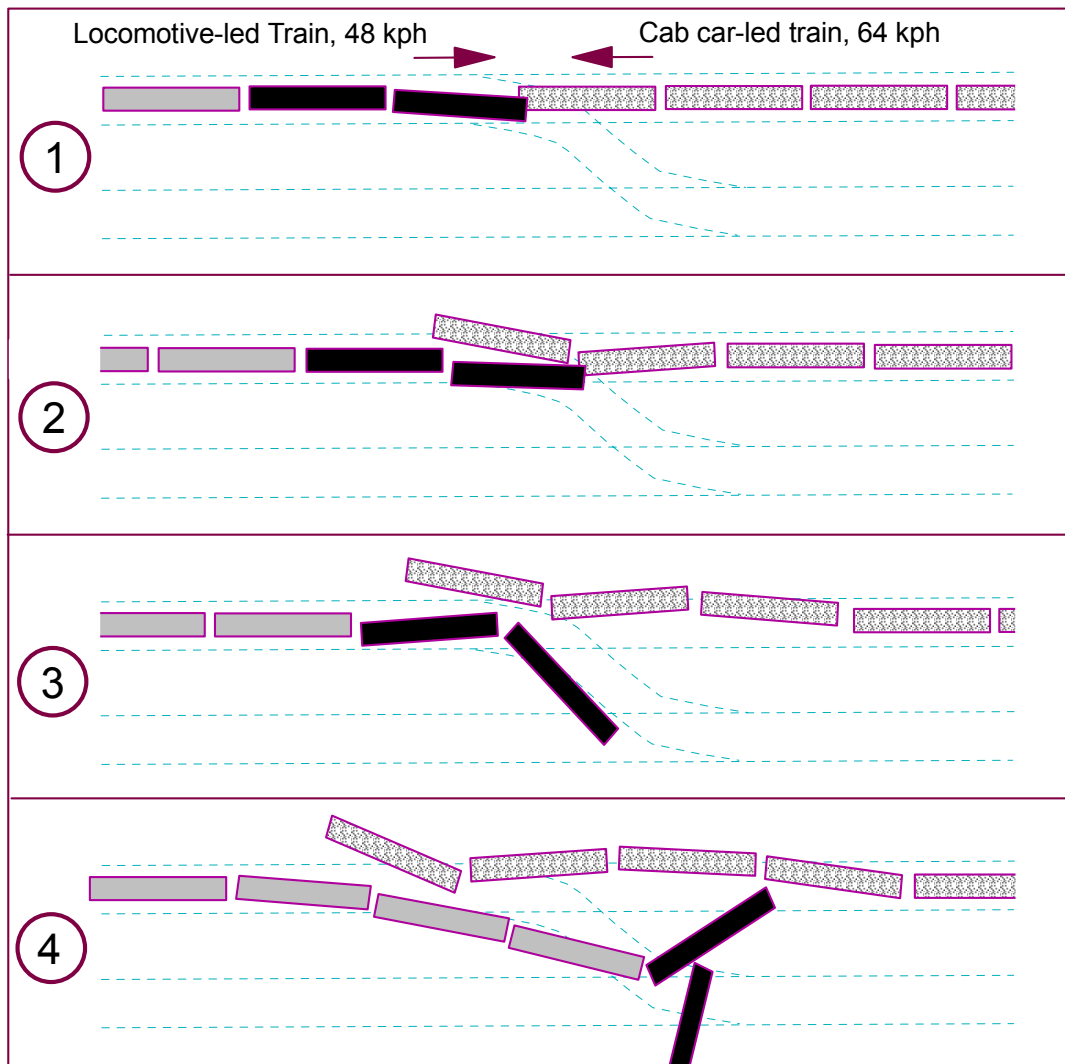
It appears that the collision progressed in several steps, which are illustrated Figure 16:

1. The lead cab car of the commuter train struck the front of the lead locomotive of the inter-city train. The locomotive of the inter-city train had just started to traverse a switch, and consequently the cab car and locomotive were misaligned when the collision started. The coupler of the cab car was approximately aligned with the side of the locomotive. The cab car subsequently raked along side of the locomotive, tearing off and rupturing the locomotive fuel tank. The difference in main structure heights between the locomotive and the cab car allowed the cab car underframe to shear off the equipment hung beneath the underframe of the locomotive and the locomotive underframe to tear the carbody skin above the side sill from the cab car.

2. The impact with the cab car nearly aligned the lead locomotive of the inter-city train with the direction of the track, but displaced the cab car laterally (to the right in the figure). The front of the lead locomotive of the inter-city train struck the front of the second car in the commuter train. This interaction started the front of the lead locomotive of the inter-city train moving to the side (toward the left in the figure)

3. The lead locomotive of the inter-city train separated from its lead truck and began to plow the earth while the second locomotive continues to push. The second locomotive of the inter-city train, in combination with the (small) lateral displacement due to the interaction with the second car of the commuter train, acted to turn the lead locomotive of the inter-city train clockwise. The impact between the lead locomotive of the inter-city train and the second car of the commuter train, in combination with the commuter train being pushed by its locomotive, resulted in the third car of the commuter train derailling (to the right in the figure).

4. The front of the lead locomotive of the inter-city train continued to plow; the couplers between the lead and second locomotives broke. The lead locomotive eventually turned clockwise approximately 270°. The remaining equipment slid to a stop.

Figure 16. Schematic of Silver Spring, Maryland, cab car/locomotive collision (hypothetical).

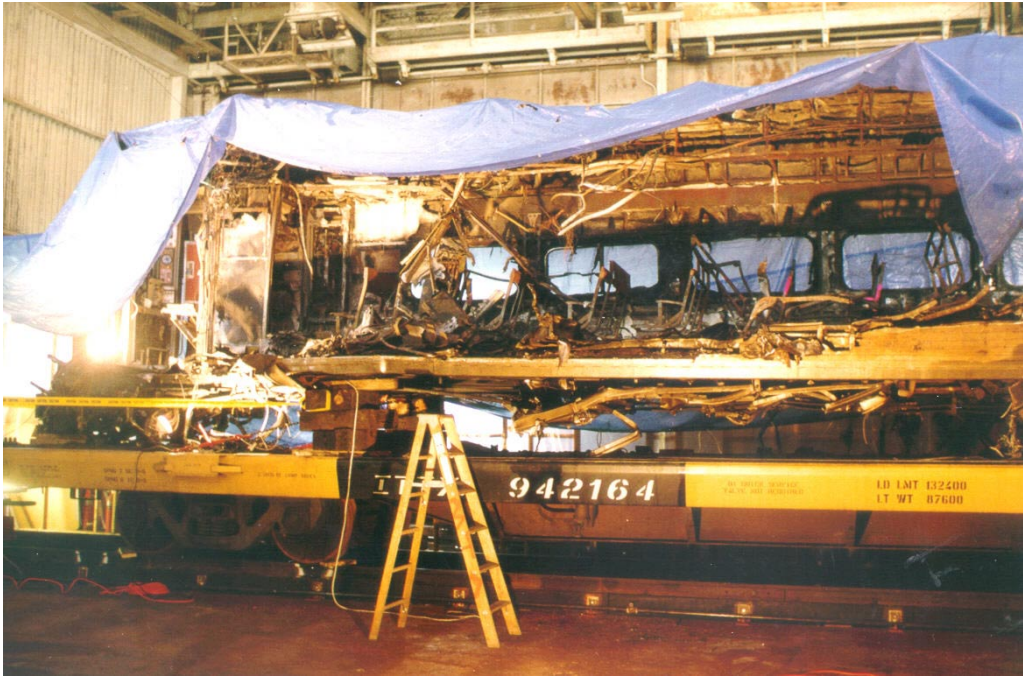
A post-collision photograph of the cab car is shown in Figure 17. In the photo, the cab car is sitting on a flatcar and the windows visible in the photo are on the far-side of the cab car. The wire frames in the photo are the metal remains of the seat frames and other interior fixtures; essentially all non-metal interior components were destroyed in the fire. There is extensive fire damage to the car, in addition to the collision damage. The structural damage to the second commuter car is similar to the damage done to the cab car, although there is little fire damage to the second car. The left side of the second car is crushed from the end of the car to the body bolster, although both collision posts are intact.

Figure 17. Post-accident photograph, lead cab car, commuter train, Silver Spring, Maryland collision.

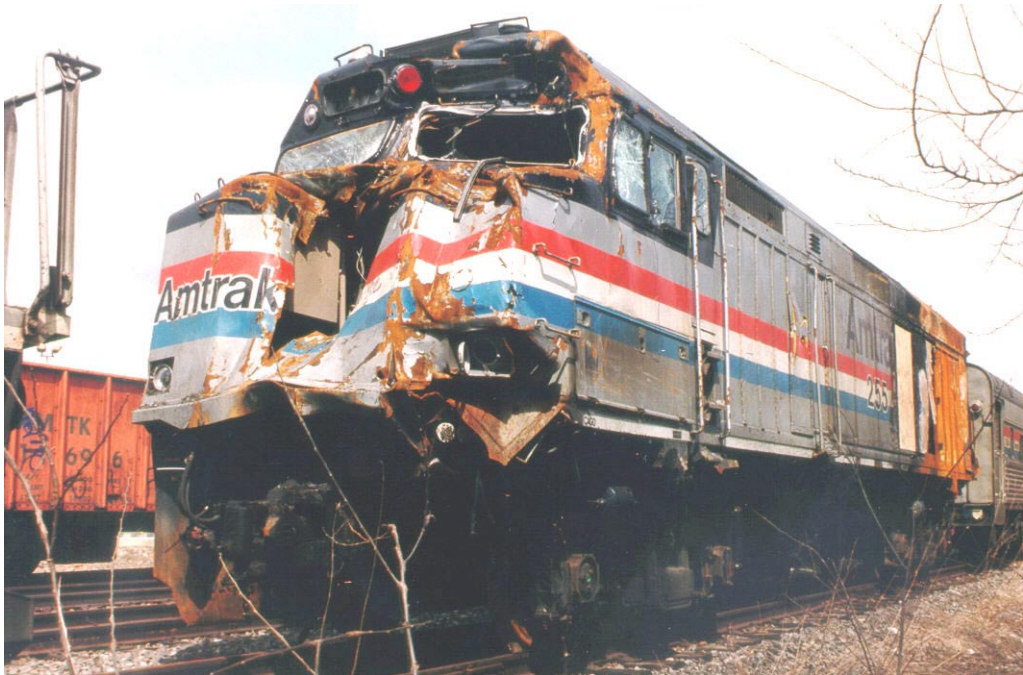
The damage done to the lead locomotive of the inter-city train includes puncture of the hood and removal of the equipment hung under the left (track) side of the locomotive, including the fuel tank. There is little damage to any of the main structural components of the locomotive. It is likely that the hood of the locomotive was punctured by the roof plate and corner post of the cab car. The operator's cab remained essentially intact, although both windshields were broken. A post-collision photograph of the lead locomotive is shown in Figure 18.

Figure 18. Post-accident photograph, lead locomotive, inter-city train, Silver Spring, Maryland collision.

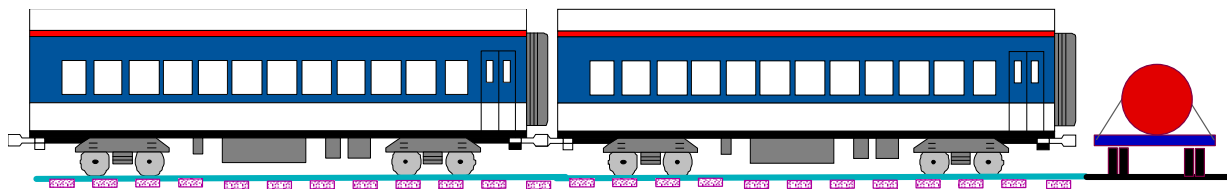
On June 18, 1998, a cab car led, two-car multiple-unit commuter train collided with a highway truck trapped at a grade crossing. The highway truck consisted of a tractor with two trailers. The trailers were loaded with coils of sheet steel. The second trailer, the one furthest from the tractor, was stopped on the tracks. The train collided with the second trailer, and during the impact a coil of steel broke free and punctured the end of the car. The train was traveling at a speed between 69 and 109 kph (43 and 68 mph) when it hit the highway truck. As a result of the collision, three people were killed: a deadheading railroad employee and two passengers. The initial conditions of the accident are shown schematically in Figure 19.

Figure 19. Schematic drawing of Portage, Indiana grade crossing collision.

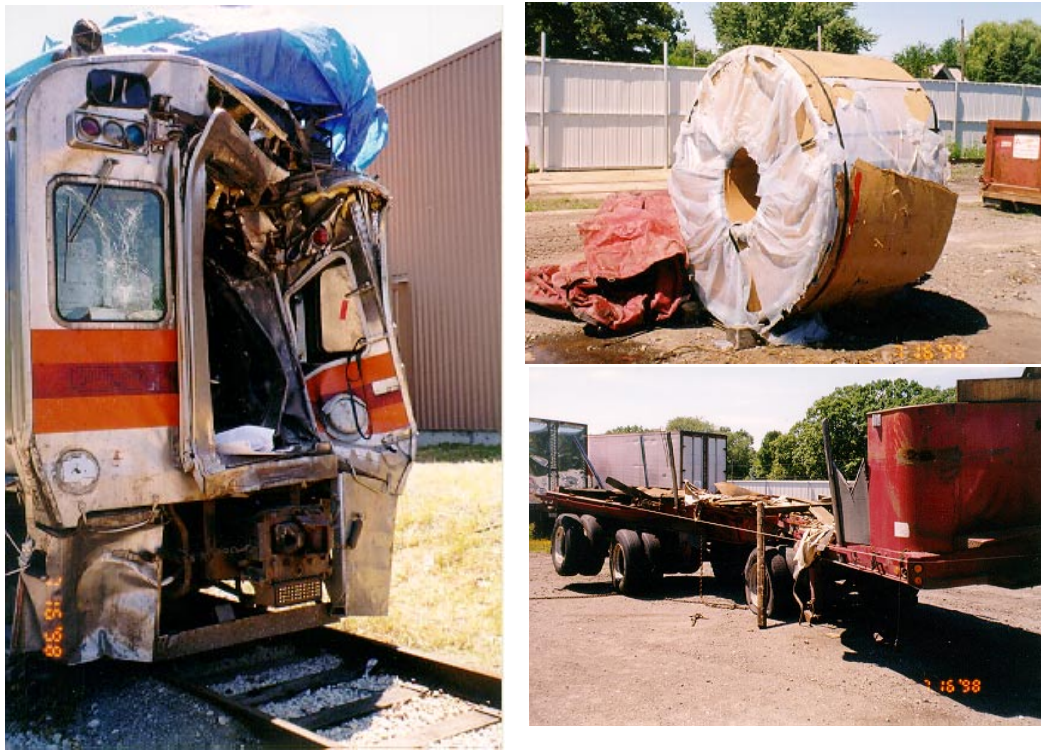
Figure 20 shows post-accident photographs of the cab car, the highway truck trailer, and the coil of steel. The coil of steel weighed approximately 178 kN (40 kips), and was about 1.8 m (6 feet) in diameter. It received little damage during the collision. Height of the floor of the trailer was several inches below the height of the floor of the cab car. Owing to the shape of the coil, it moved upward when it hit the end of the cab car. As shown in the photograph, the

coil of steel punctured the end of the cab car. The coil stopped inside the cab car after traveling about half its length, destroying about one-quarter of the passenger seats in the car.

Figure 20. Post-collision photographs, cab car, truck trailer, and steel coil involved in Portage, Indiana grade crossing collision.

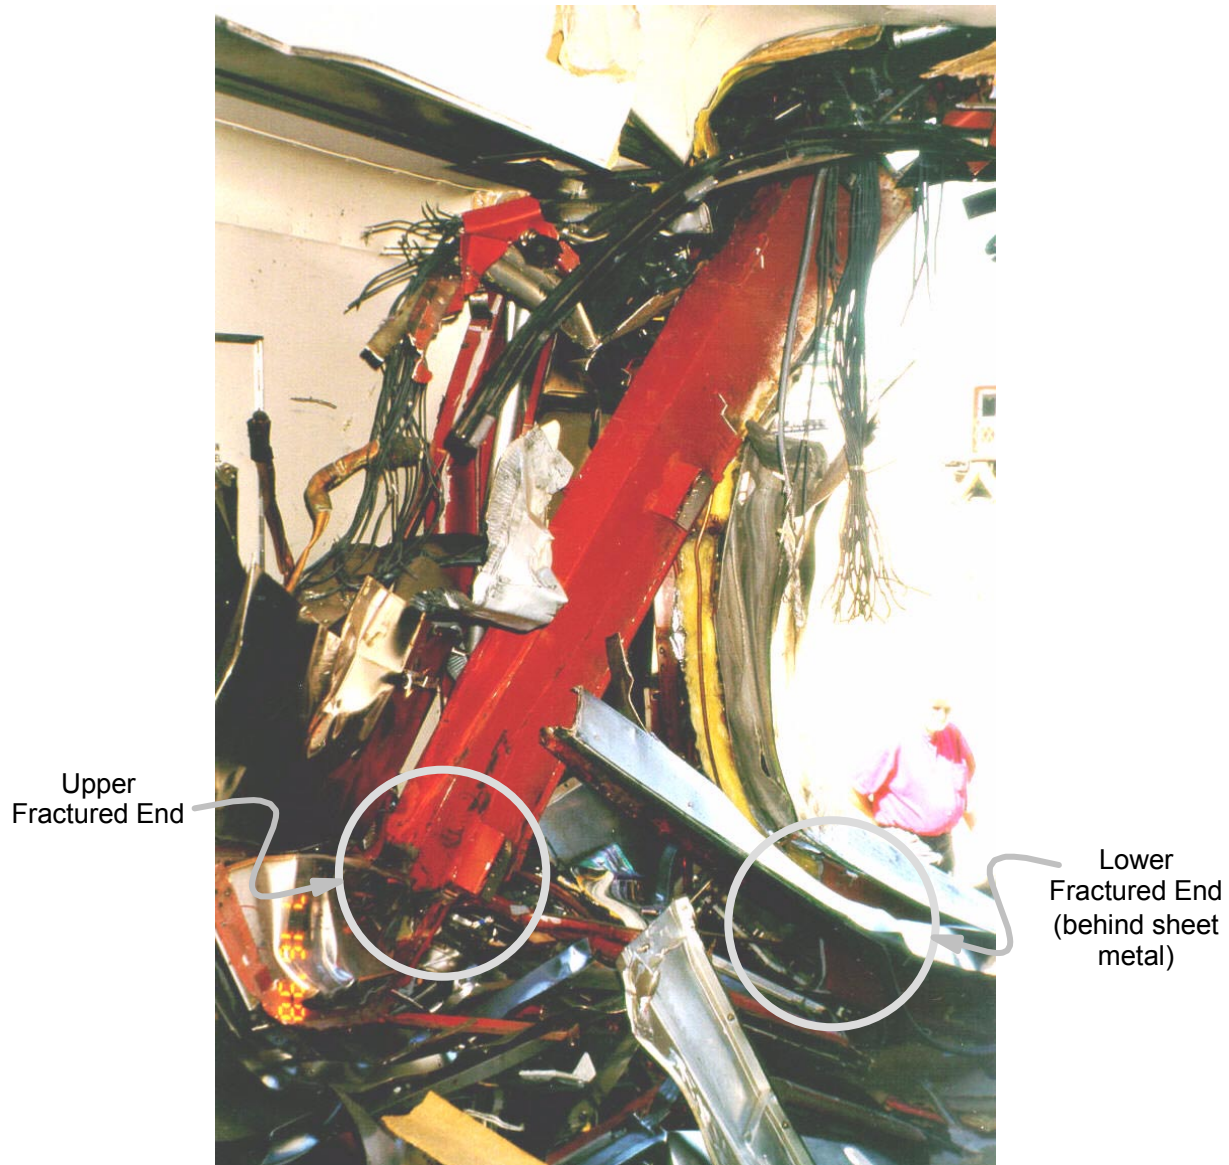
The coil struck one of the cab cars collision posts and it fractured. The fracture occurred near the impact point, which corresponds to the location where the doublers on the flanges ended. The fracture of the collision post is shown in Figure 22.

Figure 22. Post-collision photograph, cab car collision post fracture, Portage, Indiana grade crossing collision.

A simulation model has been developed based on this accident, to evaluate the influence of structural modifications on the consequences of the accident, and to evaluate the potential consequences of a similar accident where the coil strikes the corner post rather than the collision post (8). The results of analyses conducted with this model indicate that using the lateral end frame members to support the collision posts and corner post can significantly increase the crashworthiness of the cab car. Increased strength of the cross rail allows more effective distribution of the load and the crush among both collision posts and corner posts when one post is loaded. By integrating the end structure and by increasing the strength of the collision post by 25%, the maximum safe collision speed for the operator can be increased from 19 to 31 kph (12 to 19 mph) in a collision similar to the Portage, Indiana grade crossing

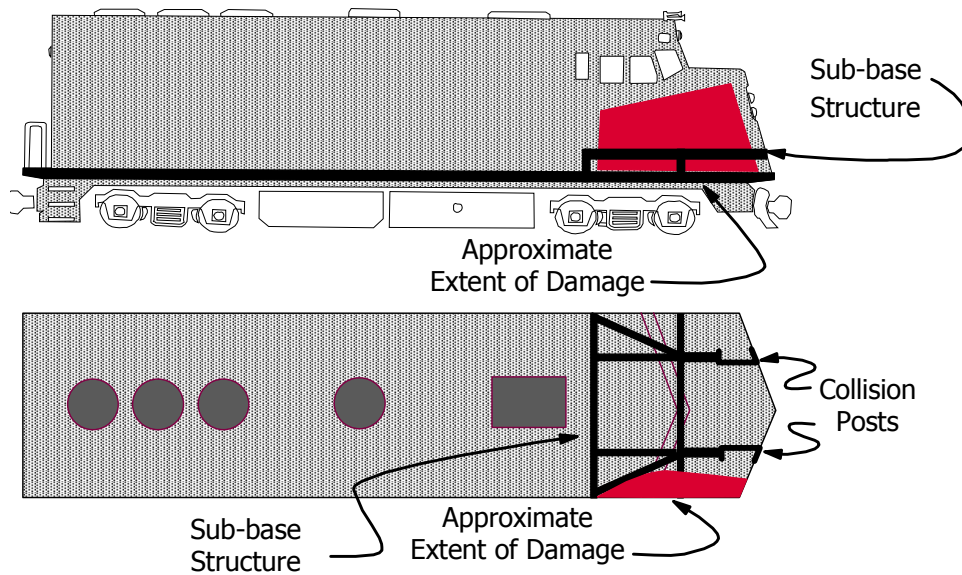
Figure 25 illustrates the damage to the locomotive from the impact with the container. The container initially impacted the sheet metal of the short hood approximately 229 mm (9 in) from the side of the locomotive. The damage extended back approximately 2.3 m (7.5 ft). For approximately the first 1.5 m (5 ft), the principal damage was to the short hood. For the remaining 0.8 m (2.5 ft) the principal damage included deformation of the sub-base and the sheet metal on the side of the operator's cab. The sub-base was the structure that provides the floor for the operator's cab and, beneath the floor, space for batteries and other ancillary

Figure 25. Schematic drawing, locomotive damage from impact with intermodal trailer, Selma, North Carolina oblique collision.

Potential modifications to improve the crashworthiness of locomotive designs have been evaluated with locomotive crush and train collision dynamics models, which simulate this oblique collision (26, 34, 35). The maximum safe closing speed for the locomotive operator can be increased from 56 to 153 kph (35 to 95 mph) by increasing the maximum strength crush strength of the short hood when it is loaded on the outboard corner from 445 to 1779 kN (100 to 400 kips).
