Rail passenger equipment accidents and the evaluation of crashworthiness strategies

D C Tyrell

Volpe National Transportation Systems Center, U.S. Department of Transportation, Cambridge, Massachusetts, USA

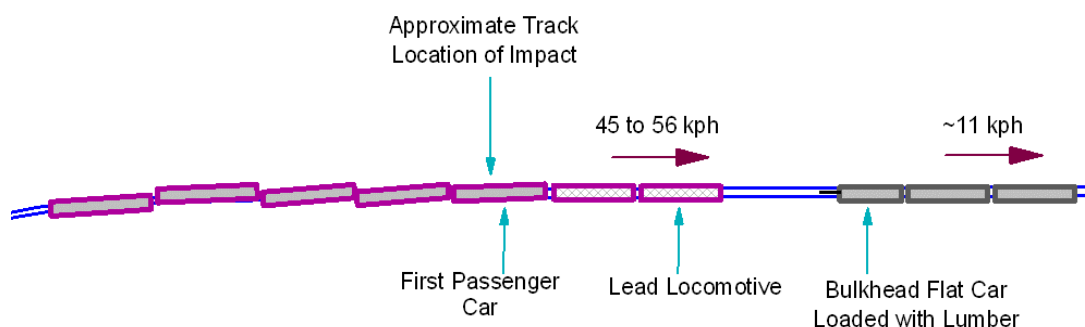
Fig. 2 Post-collision schematic drawing, rear-end collision of a freight train by an inter-city passenger train, Syracuse, New York

Figure 2 shows a post-accident schematic. The passenger train was made up of two locomotives, a coach/dinette car, and four coach cars, and had a total weight of approximately 4.8 MN (1,100 kips). The freight train was made up of 88 loaded cars, four empty cars, and two locomotives, and had a total weight of approximately 106 MN (24,000 kips). The trailing cars of the freight train were bulkhead flatcars carrying lumber. The last car of the freight train – the impacted car – was carrying a full load of framing lumber. This car was equipped with a hydraulic draft-cushioning device. At least two more cars of this type and load were ahead of the last car.

There was very little structural damage to the passenger cars. There was some damage to the flexible bellows between the cars closer to the lead end of the train, associated with the sawtooth lateral buckling of the first four passenger cars. There was also some scarring of the sides of the couplers and their lateral bump stops, also associated with the sawtooth buckling of the cars. The freight cars remained in-line, and the track under them did not buckle. The hydraulic cushioning devices may have helped to prevent the cars from laterally buckling, as well as the longer shanks of the freight couplers (compared with passenger couplers) and the greater weight of the freight cars.

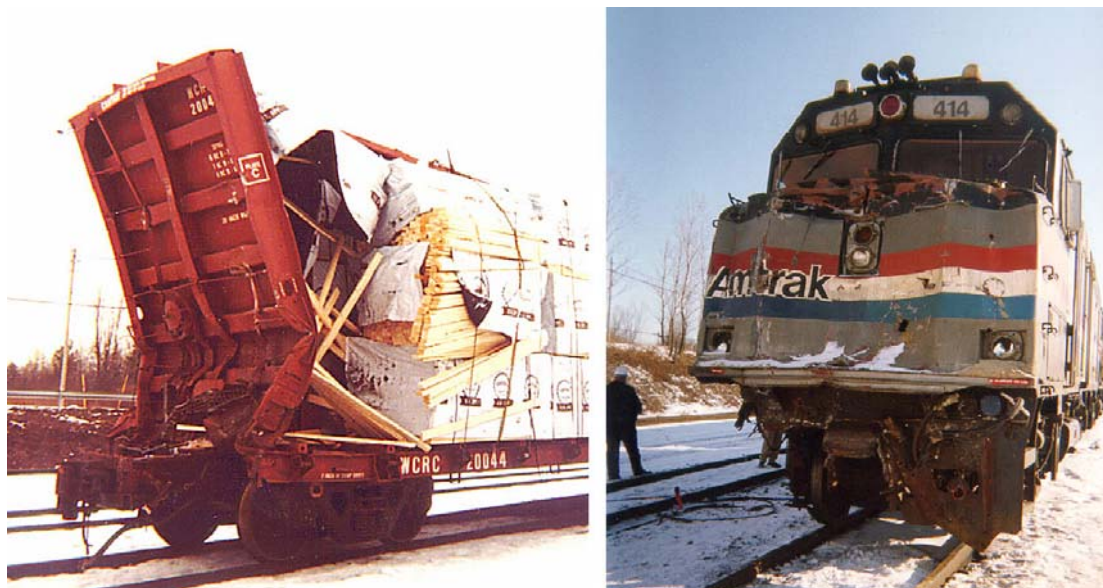
Fig. 3 Post-accident photographs, passenger train lead locomotive and freight train trailing loaded bulkhead flatcar, Syracuse, New York collision

Figure 3 shows post-accident photographs of the intercity passenger train's lead locomotive and the freight train's trailing bulkhead flatcar. It appears that crushing and displacing of the lumber on the loaded bulkhead flatcar absorbed most of the collision energy. The hydraulic cushioning devices on the trailing cars of the freight train also probably helped to dissipate some of the collision energy. (In effect, it appears that the

hydraulic cushioning device and the lumber acted as a crash energy management system.) The body and lading of the bulkhead flatcar was crushed approximately 1.8 m (6 feet), from the trailing end of the carbody up to the trailing axle of the trailing truck. The draft sill and coupler of the bulkhead flatcar remained essentially intact, with the body and lading stripped off. The draft sill and coupler of the bulkhead flatcar acted as a battering ram which tore through the coupler and draft-gear box of the locomotive, which hang beneath the main sill structure of the locomotive. The coupler and the end of the draft sill of the flatcar impacted the front and top of the lead traction motor and front of the body bolster, helping to pry the truck from the locomotive and to push the truck back into the fuel tank. A lug on the lead truck punctured the fuel tank, causing a hole about the size of a baseball. The body of the locomotive began to climb the bulkhead flatcar, as the flatcar was crushing.

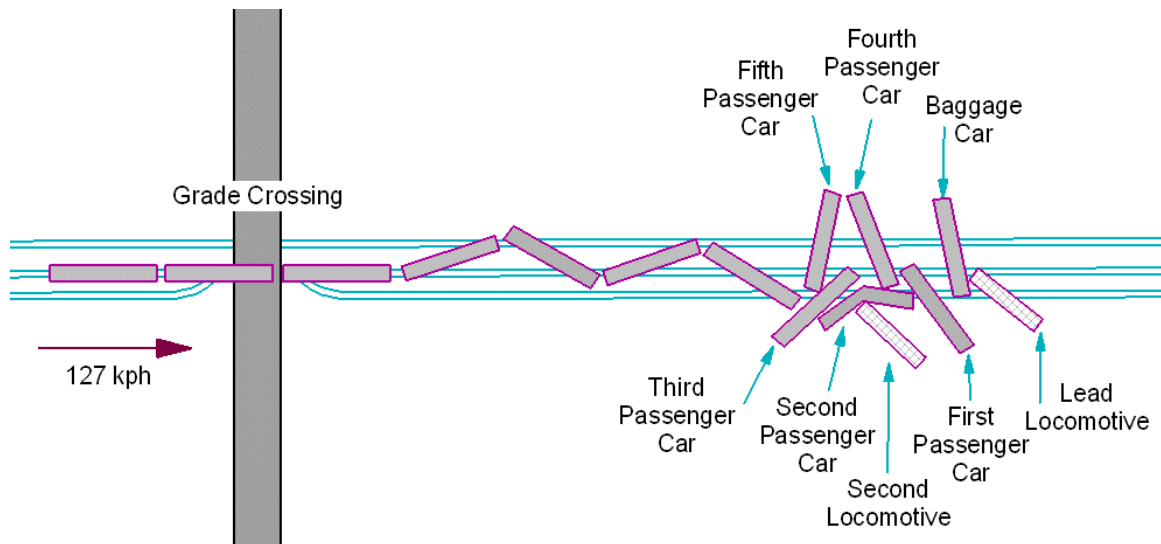
Fig. 4 Post-Collision schematic, passenger train collision with highway truck and subsequent collision with standing freight cars, Bourbonnais, Illinois

Figure 4 shows a post-collision schematic of the passenger train. Because of the severity of the collision, it is very difficult to infer a likely sequence of events. The collision with the highway tractor-trailer likely resulted in little structural damage to the locomotive. The lead locomotive impacted the rear wheel of the trailer. The trailer was loaded with approximately 178 kN (40 kips) of steel rebar, a relatively light load. The principal impact was probably with the loaded freight cars; the accident also appeared to have included one or more impacts with the berm on one side of the right of way.

Significant structural damage occurred to the first and second locomotives. The lead locomotive had

significant damage on the left side, particularly near the rear. The fuel tank in this locomotive is integral with the center portion of the frame, i.e., the side sills between the trucks make up most of the fuel tank. There were several punctures and gashes in the fuel tank. The trailing locomotive was extensively damaged. The equipment in the rear third of the locomotive was stripped off, and the trailing third of the locomotive frame was bent into the shape of a 'W.' A post-accident photograph of the second locomotive is shown in Figure 5.

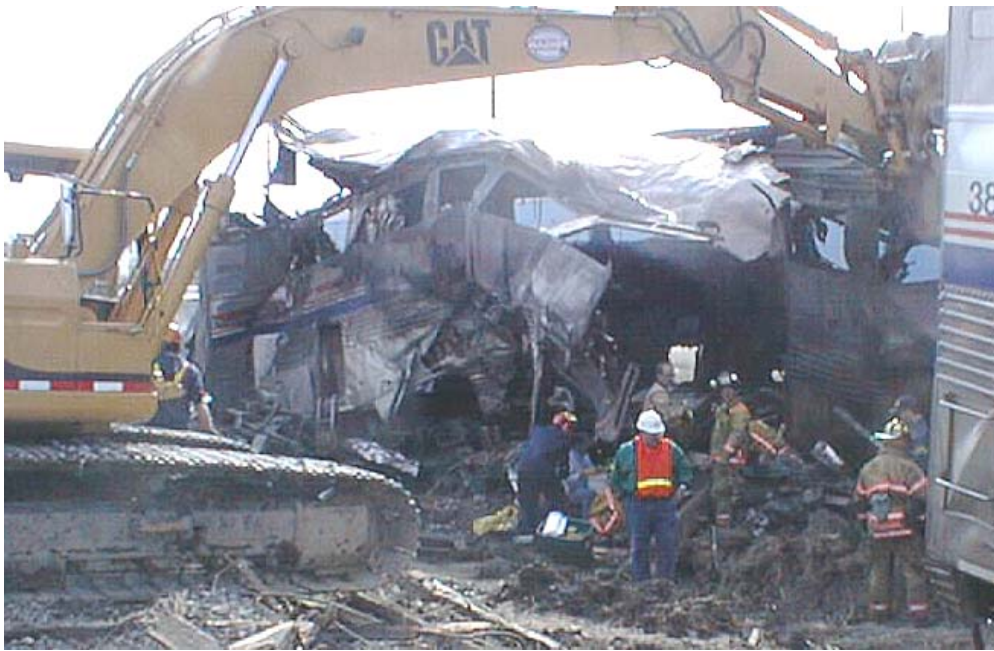
Fig. 6 Post-accident photograph, second bi-level passenger car, Bourbonnais, Illinois collision

The most severely damaged passenger car was the second bi-level car, shown in Figure 6. In the pile-up, this car received lateral impacts from several other cars and the second locomotive. The rear of the second

locomotive impacted it near the center of what is believed to have been the right side. There was a side-to-side impact with another bi-level car opposite the impact with the locomotive. The front of the other bi-level car impacted it on the side near the lead truck.

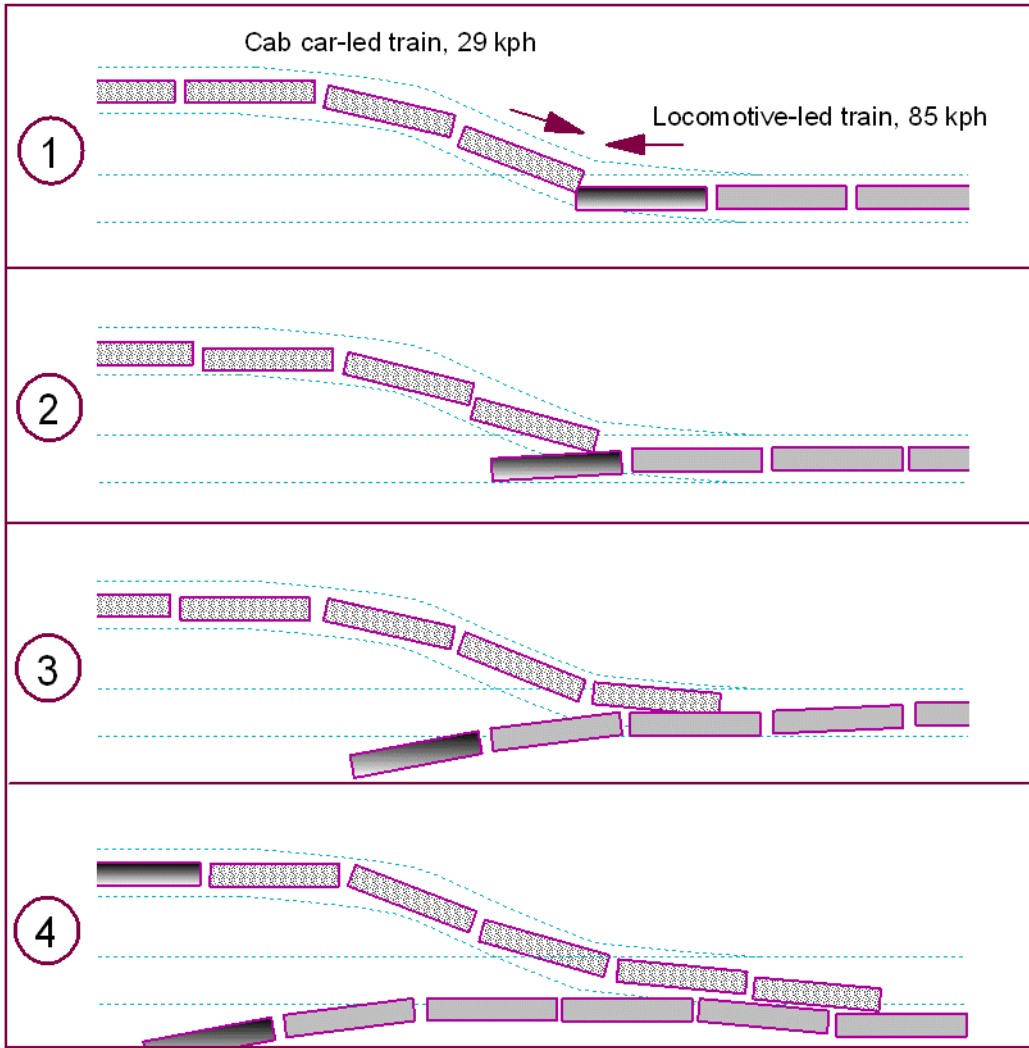
Fig. 7 Schematic of Secaucus, New Jersey, cab car/locomotive collision (hypothetical)

Figure 7 illustrates a potential sequence of events during the collision, based on conversations with FRA and NTSB officials. It appears that the collision progressed as follows:

1. The cab car was traveling at approximately 29 kph (18 mph) when it struck the front, right corner of the locomotive, which was traveling at approximately 85 kph (53 mph) in the opposite direction. Based on the track geometry, the angle between the two vehicles at the instant of impact was approximately 7°. The corner post on the right side of the cab car struck the right side of the locomotive. Both collision posts on the cab car remained in place, though the right post incurred some structural damage. The right corner post was torn away from the cab car. The roof plate from the right side of the cab car broke away and penetrated the window of the locomotive.

2. The cab car raked down the side of the locomotive. The left rail (field side) under the locomotive rolled over and the locomotive derailed.
3. The derailed locomotive pulled the trailing cars off the track. The cab car continued to rake the cars

trailing the locomotive, damaging stairwells as it went.

4. Most cars in the locomotive-led consist derailed (the last car may have stayed on the track). Only the cab car derailed in the cab car-led consist. The cab car-led consist was stopped by the collision at the switch. The locomotive-led consist slid to a stop on the ties and ballast.

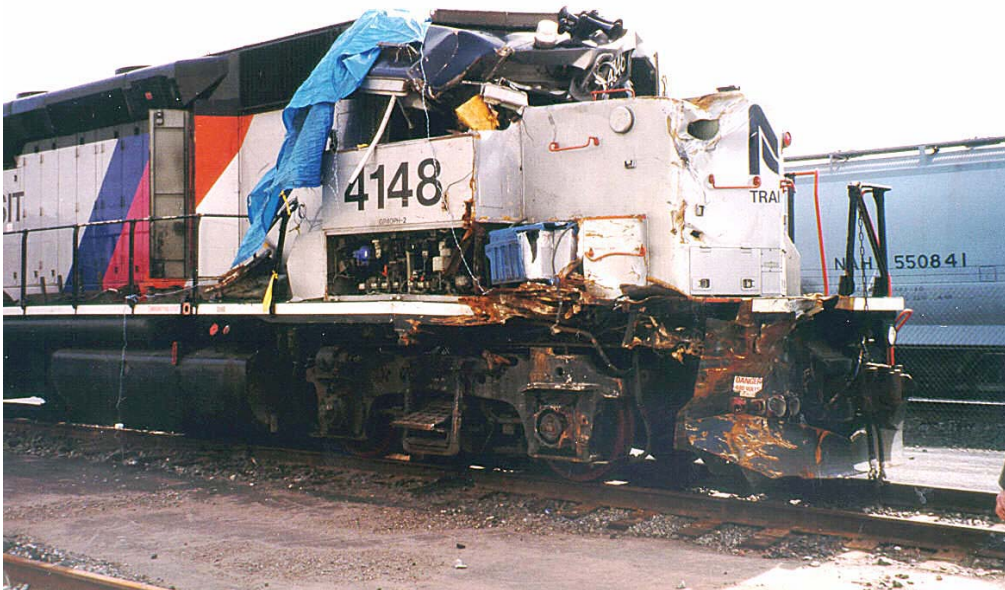
Fig. 8 Post-accident photograph, impacted locomotive, Secaucus, New Jersey collision

Damage occurred principally to the lead vehicles of each of the trains. A portion of the roof of the cab car penetrated the operator's window of the locomotive. Damage to the hood of the locomotive appeared to be due to the portion of the roof riding up on the hood and through the window. Some superstructure damage to the front of the locomotive, approximately halfway between the coupler and the side of the locomotive, appeared to have been caused by the front of the cab car. The main structure of the locomotive remained essentially intact. A post-collision photograph of the locomotive is shown in Figure 8.

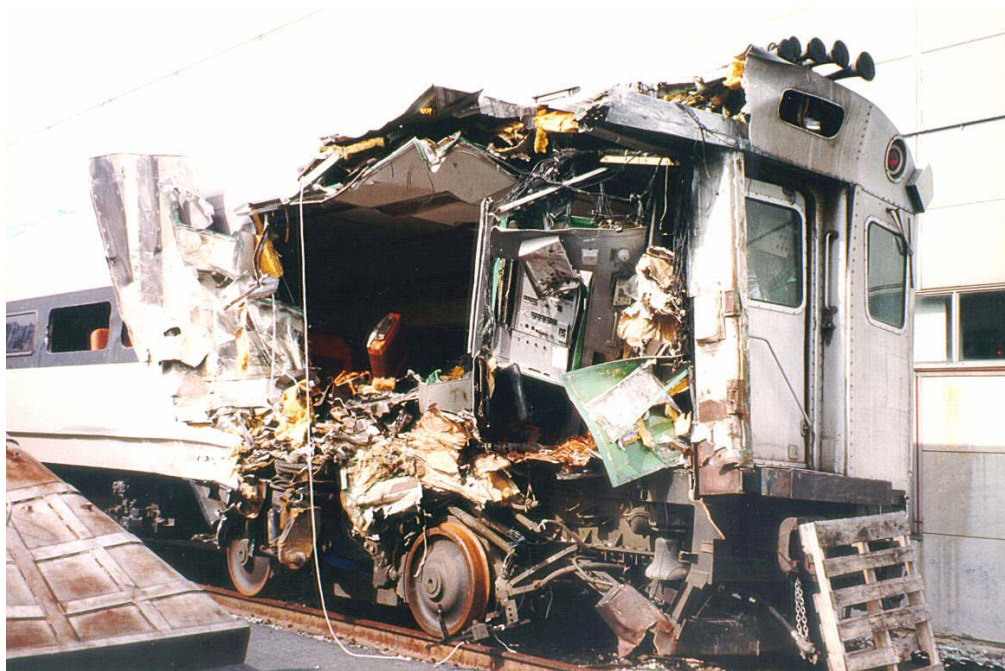
Fig. 9 Post-accident photograph, lead cab car, Secaucus, New Jersey collision

Damage to the lead cab car includes crushing of the right, front corner of the car from the end of the car to the body bolster. This area includes the operator's compartment and approximately five rows of seats. The right (track-side) end door vertical framing member (collision post) incurred substantial damage: there are several large cracks in and around the attachment point. This damage may have occurred when the end of the transverse floor member was torn off in the initial collision with the locomotive. The collision post itself may not have been loaded directly. A post-collision photograph of the cab car is shown in Figure 9.

Seat frames in the cab car were crushed or missing from the body bolster forward on the side of impact. The seats across the aisle from the crushed seats also

incurred substantial damage, due to debris from the collision and damage to the floor. In all, approximately 25 seat positions were destroyed during the collision. In areas away from the structurally damaged sections, the seat frames and luggage racks generally remained intact.

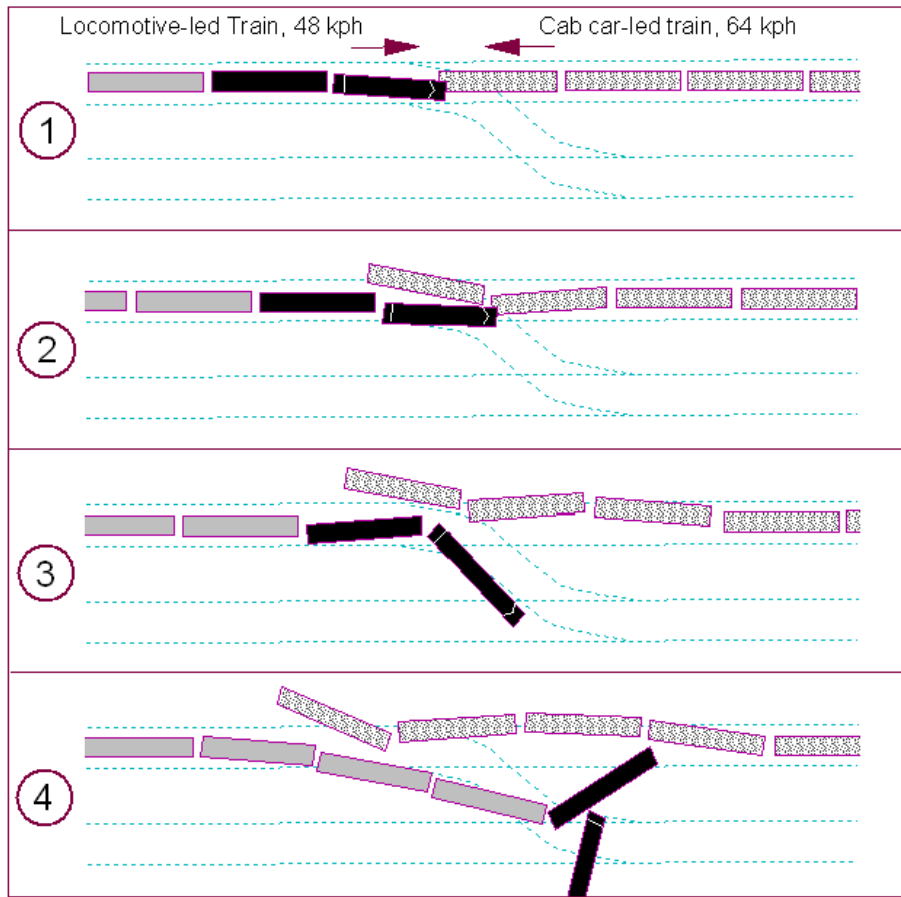
Fig. 10 Schematic of Silver Spring, Maryland, cab car/locomotive collision (hypothetical)

It appears that the collision progressed in several steps, which are illustrated Figure 10:

1. The lead cab car of the commuter train struck the front of the lead locomotive of the inter-city train. The locomotive of the inter-city train had just started to traverse a switch, and consequently the cab car and locomotive were misaligned when the collision started. The coupler of the cab car was approximately aligned with the side of the locomotive. The cab car subsequently raked along side of the locomotive, tearing off and rupturing the locomotive fuel tank. The difference in main structure heights between the locomotive and the cab car allowed the cab car underframe to shear off the equipment hung beneath the underframe of the locomotive and the locomotive underframe to tear the carbody skin above the side sill from the cab car.

2. The impact with the cab car nearly aligned the lead locomotive of the inter-city train with the direction of the track, but displaced the cab car laterally (to the right in the figure). The front of the lead

locomotive of the inter-city train struck the front of the second car in the commuter train. This interaction started the front of the lead locomotive of the inter-city train moving to the side (toward the left in the figure)

3. The lead locomotive of the inter-city train separated from its lead truck and began to plow the earth while the second locomotive continues to push. The second locomotive of the inter-city train, in combination with the (small) lateral displacement due to the interaction with the second car of the commuter train, acted to turn the lead locomotive of the inter-city train clockwise. The impact between the lead locomotive of the inter-city train and the second car of the commuter train, in combination with the commuter train being pushed by its locomotive, resulted in the third car of the commuter train derailed (to the right in the figure).
4. The front of the lead locomotive of the inter-city train continued to plow; the couplers between the lead and second locomotives broke. The lead locomotive eventually turned clockwise approximately 270°. The remaining equipment slid to a stop.

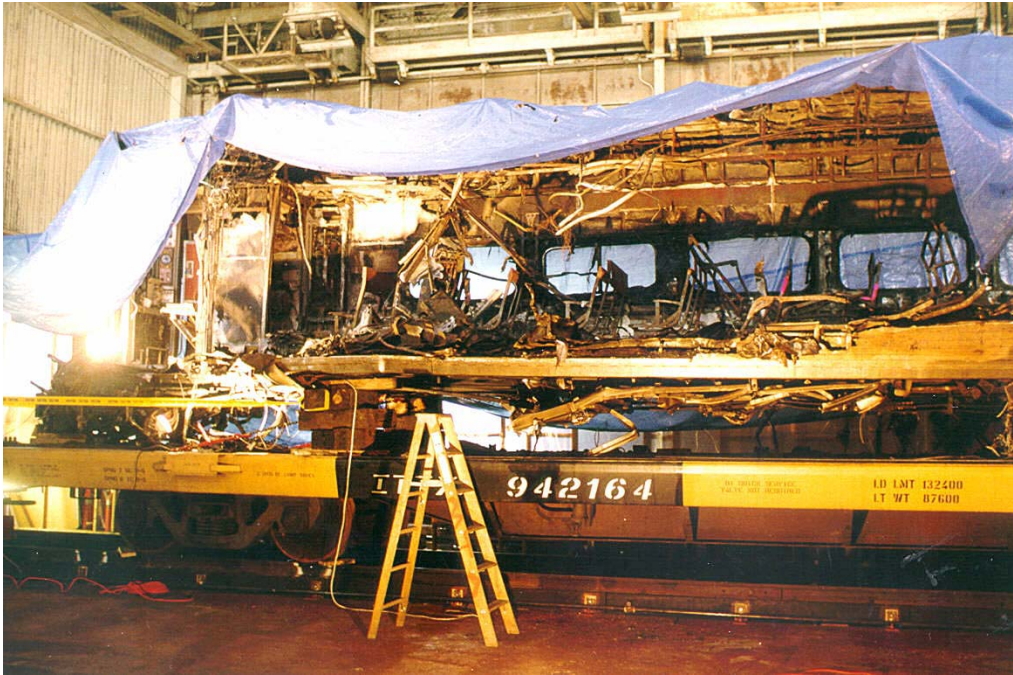
Fig. 11 Post-accident photograph, lead cab car, commuter train, Silver Spring, Maryland collision

A post-collision photograph of the cab car is shown in Figure 11. In the photograph, the cab car is sitting on a flatcar and the windows visible in the photograph are on the far-side of the cab car. The wire frames in the photograph are the metal remains of the seat frames and other interior fixtures; essentially all non-metal interior components were destroyed in the fire. There is extensive fire damage to the car, in addition to the collision damage. The structural damage to the second commuter car is similar to the damage done to the cab car, although there is little fire damage to the second car. The left side of the second car is crushed from the end of the car to the body bolster, although both collision posts are intact.

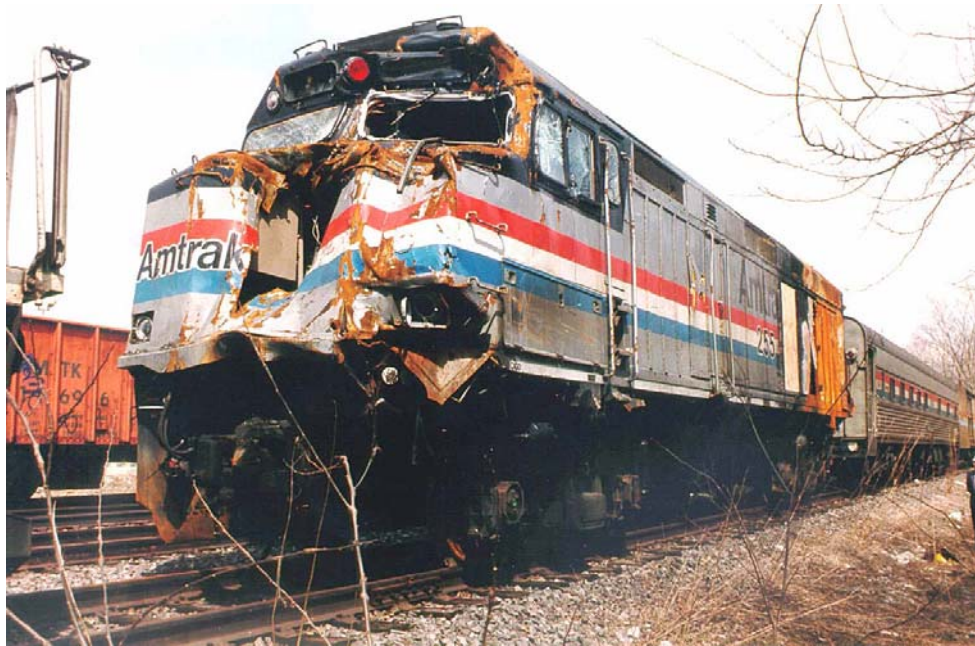
Fig. 12 Post-accident photograph, lead locomotive, inter-city train, Silver Spring, Maryland collision

The damage done to the lead locomotive of the intercity train includes puncture of the hood and removal of the equipment hung under the left (track) side of the locomotive, including the fuel tank. There is little damage to any of the main structural components of the locomotive. The operator's cab remained essentially intact, although both windshields were broken. A post-collision photograph of the lead locomotive is shown in Figure 12.

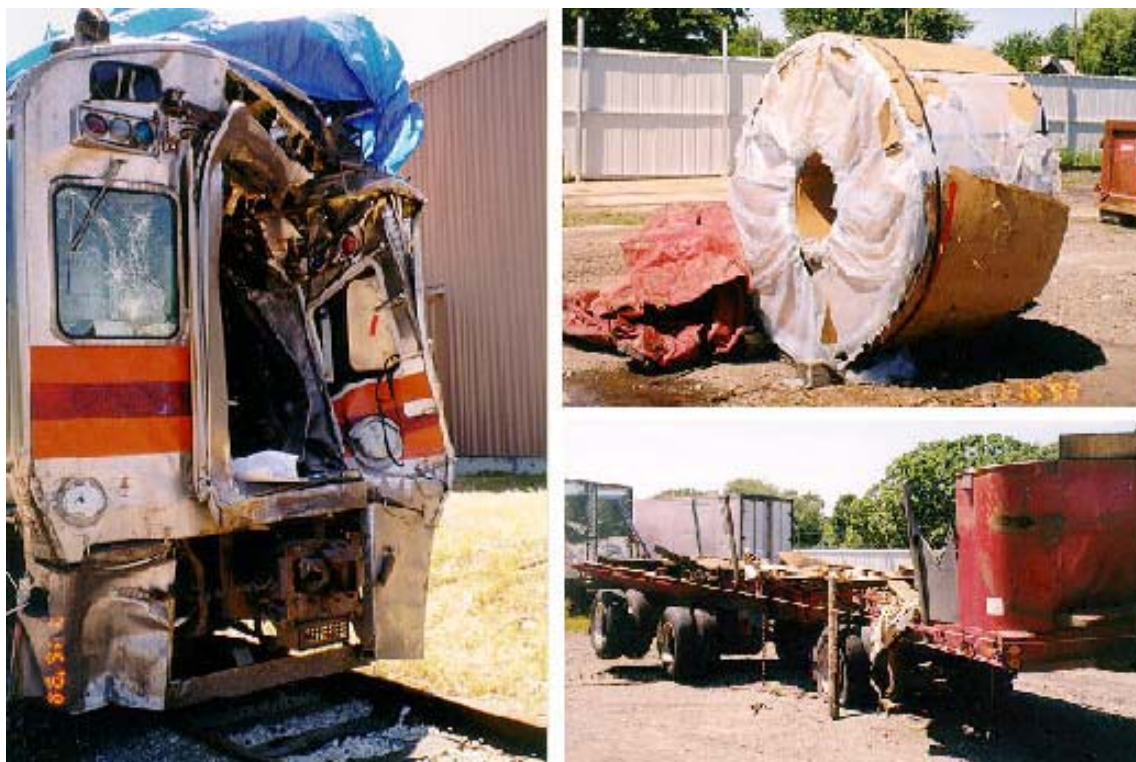
Fig. 14 Post-collision photographs, cab car, truck trailer, and steel coil involved in Portage, Indiana grade crossing collision

Figure 14 shows post-accident photographs of the cab car, the highway truck trailer, and the coil of steel. The coil of steel weighed approximately 178 kN (40 kips), and was about 1.8 m (6 feet) in diameter. It received little damage during the collision. The height of the floor of the trailer was several inches below the height of the floor of the cab car. Owing to the shape of the coil, it moved upward when it hit the end of the cab car. As shown in the photograph, the coil of steel punctured

the end of the cab car. The coil stopped inside the cab car after traveling about half its length, destroying about one-quarter of the passenger seats in the car.

A simulation model has been developed based on this accident, to evaluate the influence of structural modifications on the consequences of the accident [8]. The results of analyses conducted with this model indicate that using the lateral end frame members to support the vertical end frame members can significantly increase the crashworthiness of the cab car. Increased strength of the end structure lateral member near roof level (the anti-telescoping plate) allows more effective distribution of the load and the crush among the end structure vertical members when one vertical member is loaded. By integrating the end structure and by increasing the strength of the end door vertical framing members (collision posts) by 25%, the maximum safe collision speed for the operator can be increased from 19 to 31 kph (12 to 19 mph) in a collision similar to the Portage, Indiana grade crossing collision. With the same modifications, the maximum safe speed for the passengers can be increased from 32 to 48 kph (20 to 30 mph).

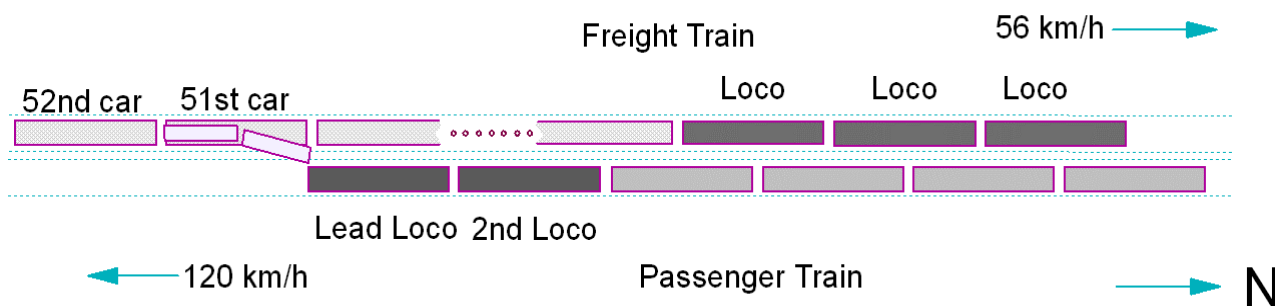
Fig. 15 Schematic drawing, initial conditions of Selma, North Carolina oblique collision.

weighing approximately 270 kN (60 kips), on the 51st car was overhanging the southbound track and engaged the lead locomotive of the passenger train. At the onset of contact, the trailer was above the deck and offset outside of the collision posts of the passenger train lead locomotive. The assistant engineer was killed during the accident and the engineer was severely injured. Figure 15 schematically depicts the conditions that initiated the oblique impact.

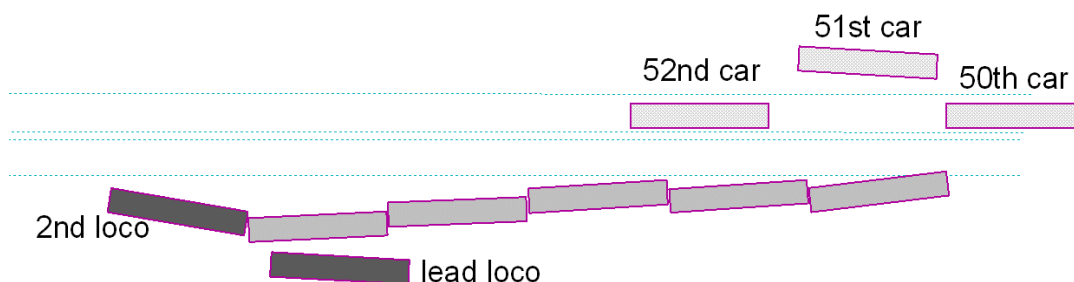
Fig. 16 Schematic drawing, final conditions of Selma North Carolina oblique collision.

Damage to the short hood began at the right front corner and extended along the right side to the control compartment. The lead locomotive in the passenger train derailed and rolled over, coming to rest on its left side. All but one of the trailing cars, as well as the second locomotive, left the track, but remained upright. Only the last two cars in the freight train derailed and were damaged. The trailer, which was full of cat litter, burst open, spilling its contents along the track. The flatcar carrying the intruding trailer came to rest about 12 m (40 ft) off the track in an upright position with the deck and end bent. Figure 16 schematically depicts the conditions immediately after the accident.

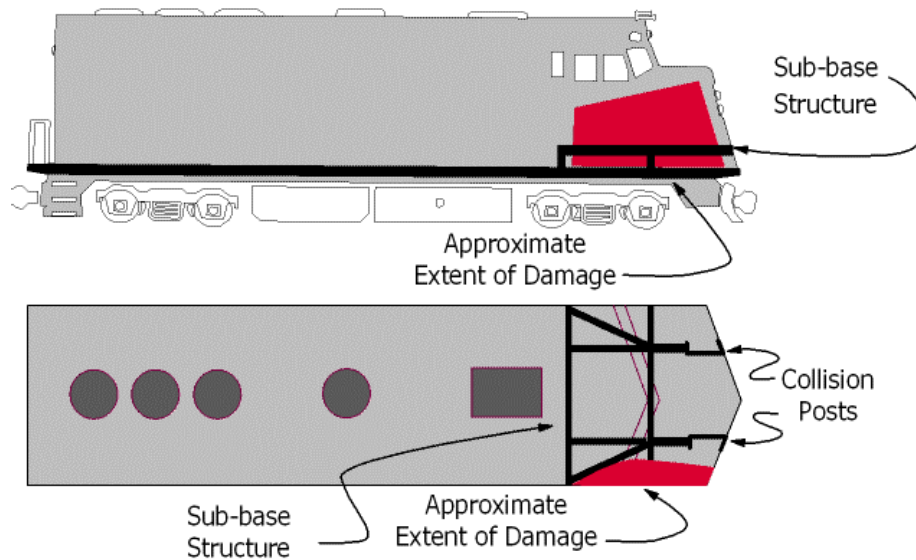
Fig. 17 Schematic drawing, locomotive damage from impact with intermodal trailer, Selma, North Carolina oblique collision.

Figure 17 illustrates the damage to the locomotive from the impact with the container. The container initially impacted the sheet metal of the short hood approximately 229 mm (9 in) from the side of the locomotive. The damage extended back approximately 2.3 m (7.5 ft). For approximately the first 1.5 m (5 ft), the principal damage was to the short hood. For the remaining 0.8 m (2.5 ft) the principal damage included deformation of the sub-base and the sheet metal on the

side of the operator's cab. The sub-base was the structure that provides the floor for the operator's cab and, beneath the floor, space for batteries and other ancillary equipment.

Potential modifications to improve the crashworthiness of locomotive designs have been evaluated with locomotive crush and train collision dynamics models, which simulate this oblique collision [31, 32]. These modifications consist principally of changes in the short hood material properties and thickness. The maximum safe closing speed for the locomotive operator can be increased from 56 to 153 kph (35 to 95 mph) by increasing the maximum strength crush strength of the short hood when it is loaded on the outboard corner from 445 to 1779 kN (100 to 400 kips).
