**RAIL-CAR IMPACT TESTS WITH STEEL COIL:  
CAR CRUSH**

**Eloy Martinez  
David Tyrell  
John Zolock**

Volpe National Transportation Systems Center  
US Department of Transportation  
Cambridge, MA 02142 USA

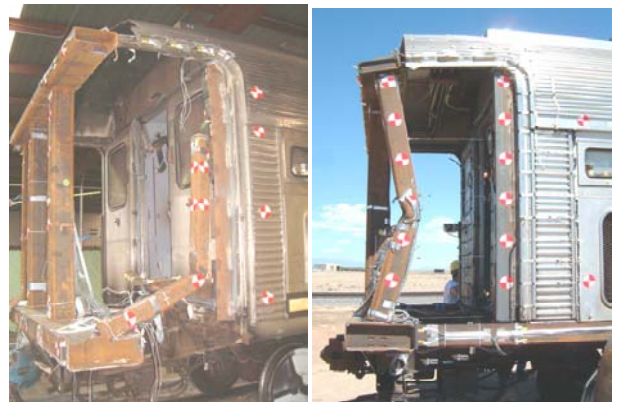
Figure 3. Post-Test Photographs of 1990's and SOA Design Cab Cars

Figure 3 shows the final deformed shapes taken from the tests of the 1990's design and the SOA design. During the test of the 1990's design, the corner post pulled out of its attachment at the top. The results of the test show that this corner post design is not sufficient to preserve the operator's volume in such an impact. During the SOA design test, the corner post remained attached. The maximum rearward deformation measured was approximately 8 1/2 inches. The results of this test show that the SOA design is sufficient to prevent the operator from being crushed in such an impact.

load from the coil and the tension load due to the bending of the beam. The end beam did not visibly plastically deform, and so the floor attachment acted as a fixed connection. The anti-telescoping plate and the cant rail did deform downward, and consequently the roof connection of the corner post acted as a pinned connection. A post-test photograph of the deformed shape of the corner post is shown in Figure 3.

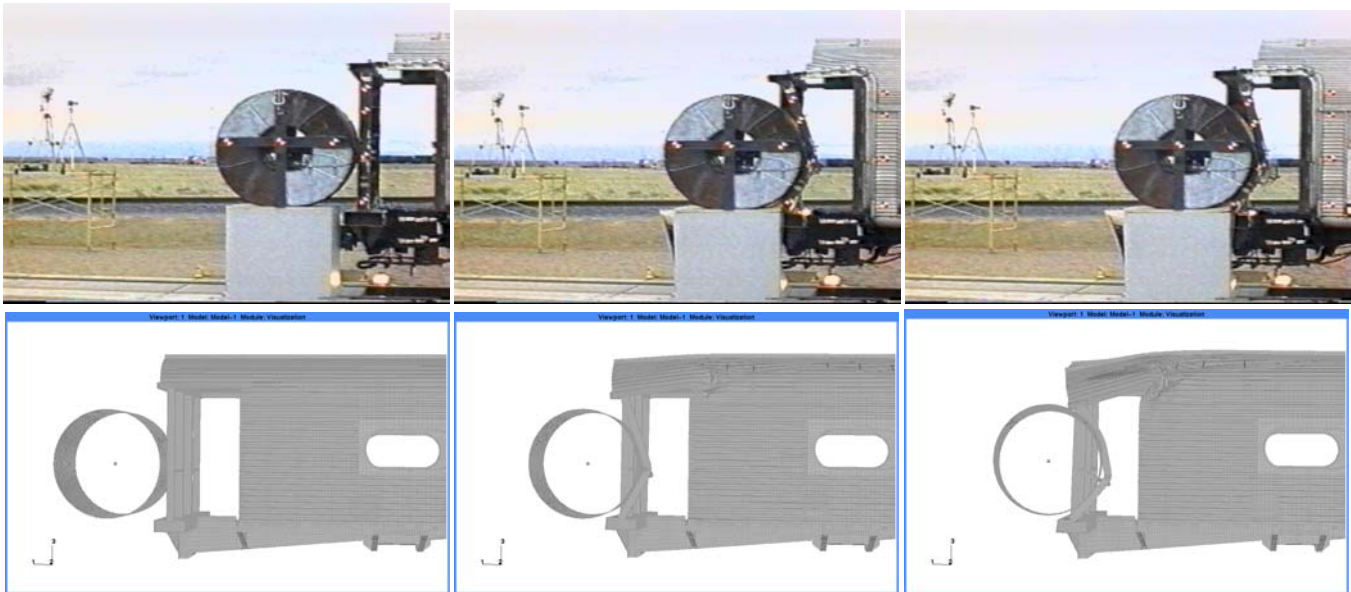
Figure 10. Measured and Pre-Test Predicted Mode of Deformation, 1990's Design, Up to Corner Post Upper Attachment Failure

Figure 10 shows three still photographs taken from a high-speed movie film of the 1990's design grade-crossing test. The first frame shows the coil and corner post at the instant of impact. The second frame shows the coil and cab car just prior to complete failure by pull-out of the corner post from the anti-telescoping plate at ~0.08 seconds. At this time the post has displaced inwards 18 inches. The third frame shows the coil and cab car after 0.09 seconds and 19 inches of displacement of the corner post. Just below those three frames are results from the pre-test analysis with material failure for the mode shape of the cab car end structure at the same times and nearly the same displacements.

The predicted mode shape matches the mode shape observed in the test but for one detail: in the third frame, the frame from the test shows only a small amount of vertical distortion of the roof above the upper rear corner of the near-side doorway, while the frame from the model predictions shows more distortion of the top of this doorframe. This difference in mode may be due to the changes in the attachment of the end frame to the original car structure as well as the strain-to-failure criterion used. In addition, note the difference in length of roof material not present on the test vehicle. The original model integrally attached roof sheeting to the anti-telescoping plate, which experiences a counter-clockwise torque as the anti-telescoping plate is pulled downwards. To maintain compatible deformations this load is reacted above the doorframe where a plastic hinge is formed in the cant rail, the roof sheeting, and the hat sections on top of the roof.

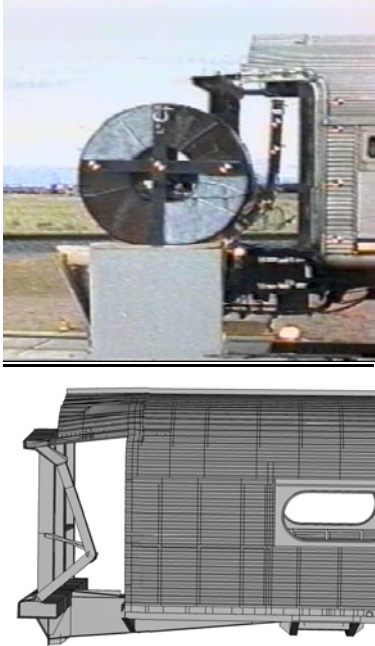
Figure 11. Measured and Post-Test Predicted Mode of Deformation, 1990's Design, Corner Post Upper Attachment Failure

Figure 11 shows a still photograph taken from the high-speed film. This frame shows the failed upper attachment of the corner post. Just below the photograph is a plot of the deformed mesh from the revised finite-element analysis. The coil has been removed for clarity. The results of the revised analysis are in close agreement with the test observations. The pull-out mode of failure has been captured using the model with a refined mesh and a lower strain-to-failure criterion in the anti-telescoping plate's material. There is a shift in the time it takes for the pull-out failure to occur as noted in the string potentiometer discussion.

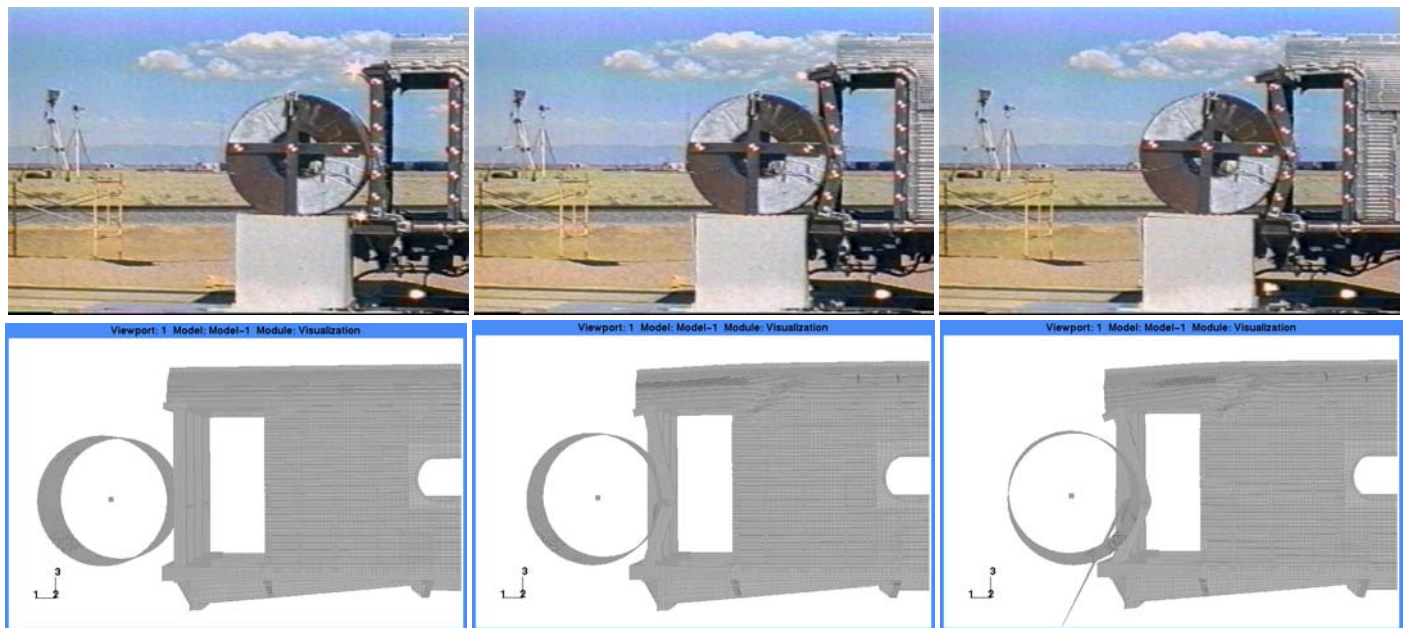
Figure 15. Measured and Pre-Test Predicted Mode of Deformation, SOA Design

Figure 15 shows three still photographs taken from a high-speed movie film of the test of the SOA design. The first frame shows the coil and corner post at the instant of impact, the second frame shows the coil and the cab car after approximately 0.03 seconds and 5.25 inches rearward displacement of the corner post. The third frame shows the coil and the cab car after approximately 0.08 seconds and 9 inches of displacement of the corner post. Just below those three frames are results from the pre-test analysis with material failure for

the mode shape of the cab car end structure at the same times and nearly the same displacements. The predicted mode shape closely matches the mode shape observed in the test. There is slightly more vertical distortion of the roof above the upper trailing corner near-side doorway predicted by the model than seen in the test result. Similar late changes in the attachment of the end frame to the original car structure were made in the SOA design as in the 1990's design, however, the SOA design is not as sensitive to these changes, since the corner post was attached to both the top and bottom plates of the anti-telescoping plate. The additional strength of the attachment in the SOA design forced the anti-telescoping plate to deform downward, rather than allowing the attachment to fail, as it did in the 1990's design.

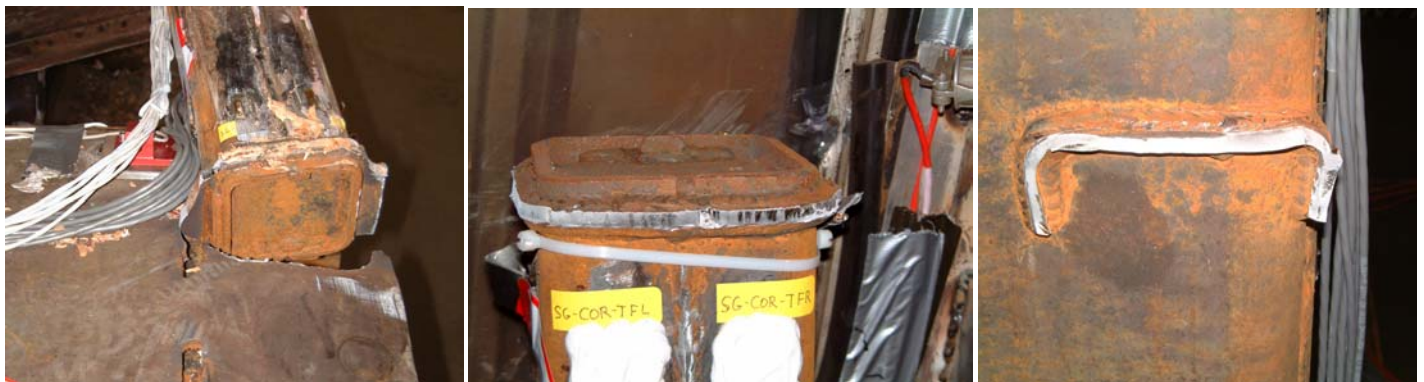
Material failure occurred in the 1990's end frame design test at the attachment of the corner post to the end beam, at the attachment of the corner post to the anti-telescoping plate, and at the attachment of the lateral member/shelf to the corner post. Close-ups of the material failures at these locations are shown in Figure 16. The left hand photograph shows the failure that occurred at the base of the corner post/end beam connection. As the central hinge in the corner post rotated and pushed inwards large bending and tensile stresses developed on the top plate of the end beam on the impact side, while large bending and compressive stresses devolved on the aft side of the connection. The failure of the top plate is in the parent material of the sheet just outside the weld, effectively in the heat-affected zone. The photograph on the center shows the top of the corner post, which pulled out of the anti-telescoping-plate during the collision. The stress state to cause this failure mode was almost a pure state of shear. The right side photograph shows the attachment of the lateral member/shelf to the collision post. This connection failed due to the combination of bending and shear.

Figure 16. Post-Test Photographs of Material Failure in 1990's Design, Corner Post Connection to End Beam, Failed Connection at Top of Corner Post, and Failed Connection to Shelf on Collision Post

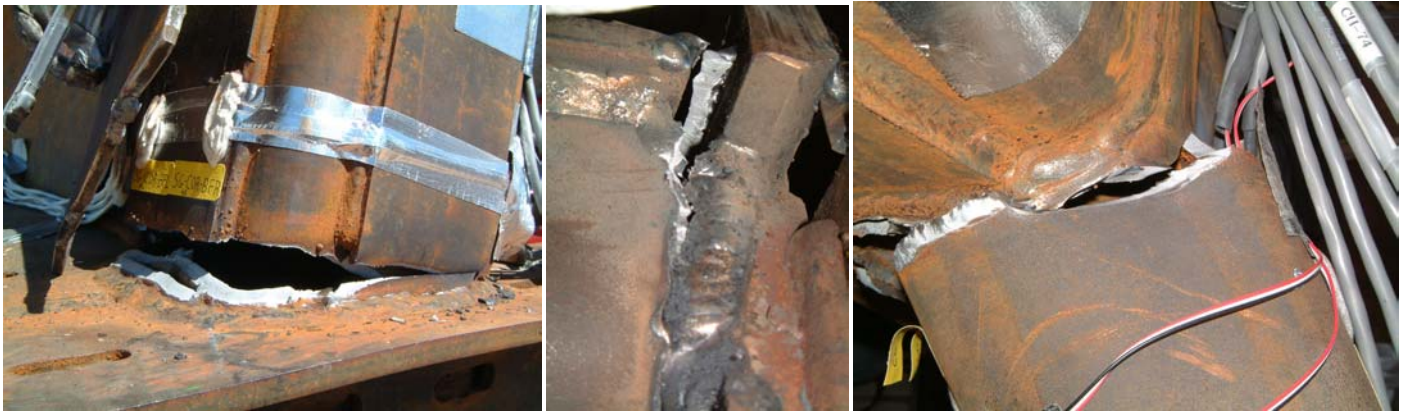
Material failure occurred in the SOA end frame design test at the connection of the corner post to the end beam, at the attachment of the anti-telescoping plate to the cant rail, and at the attachment of the lateral member/shelf to the corner post. Figure 17 shows photographs of the material failure at these locations. Again as the central plastic hinge rotated and displaced inwards large tensile and bending stresses developed on the impacting side of the corner post at its connection with the end beam, while large bending and compressive stresses developed on the aft side of the corner post. Unlike the failure mode experienced by the 1990's end frame design, this time the parent material in the corner post rather than the end beam failed. The failure progressed nearly the full depth of the post. There is no upward bending in the end beam upper flange because this design had the corner post penetrating through both the upper and lower flanges of the end beam, and the end beam was reinforced by the closed side sill

that extended all the way forward from the aft operators compartment wall. The necking/cup-cone deformations present on both the pulled-out post and the in-situ post are indicative of a tensile failure that then proceeded to further open due to the combined tension and bending. The material failure that occurred at the anti-telescoping connection with the cant rail was in the region of a weld. This failure mode was caused by the rotation of the anti-telescoping plate as the central hinge displaced inwards and a prying load ensued between the anti-telescoping pad connection point and the cant rail. Finally, the last area with material failure is at the connection point of the bulkhead sheet with the lateral member/shelf and the collision post. As the coil penetrated inwards during the collision, both the bulkhead sheet and the lateral member/shelf transmitted load to the collision post. Large tensile and shear stresses developed at this connection point. The failure proceeded from the outside inwards and downwards between the collision post and bulkhead sheet weld.

Figure 17. Post-Test Photographs of Material Failure in SOA Design, Corner Post Connection to End Beam, Anti-Telescoping Plate Connection to Roof Plate, and Shelf Connection to Collision Post
