## JRCICE2007-40051

### CRASH ENERGY MANAGEMENT CRUSH ZONE DESIGNS: FEATURES, FUNCTIONS, AND FORMS

#### ABSTRACT

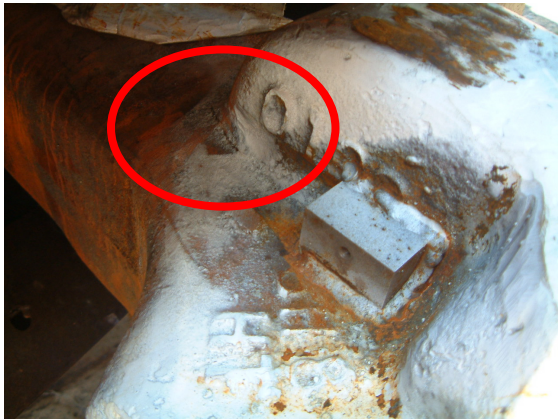
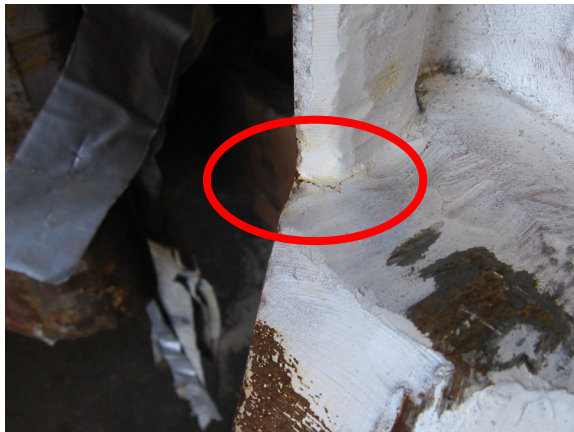
**Coupler** Two cracks were observed in the coupler of the leading cab car. Both were observed on the coupler's top side. In Figure 2, the top picture shows a crack located on the left side (as you are looking from the front of the car end) between the coupler head and shaft. The crack in the bottom picture is on the right side of the coupler head.

Figure 2. Cracks in the Coupler Head

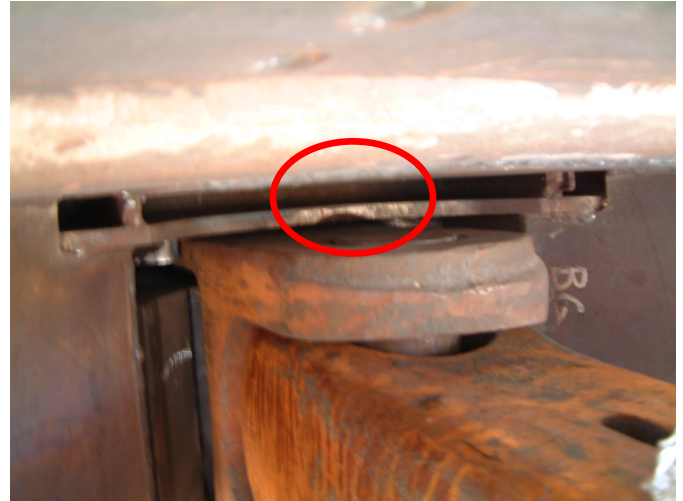
The coupler pin, which connects the coupler yoke to the draft gear and allows the coupler to yaw, interfered and indented the plate above it. Figure 3 shows the indentation in the plate made by the coupler pin. Figure 4 shows the indentation on the coupler pin. Had the pin interfered sufficiently, such that it stuck on this plate, the coupler would not have pushed back as planned. This event could have resulted in lateral buckling at the colliding interface and the end frame may not have engaged directly with the front of the impacting locomotive.

Figure 3. Plate Indented by the Coupler Pin

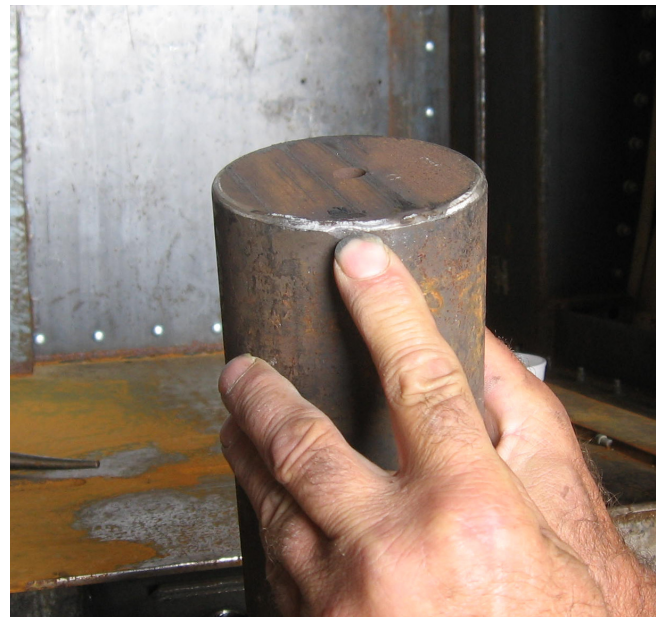
Figure 4. Indentation on Coupler Pin

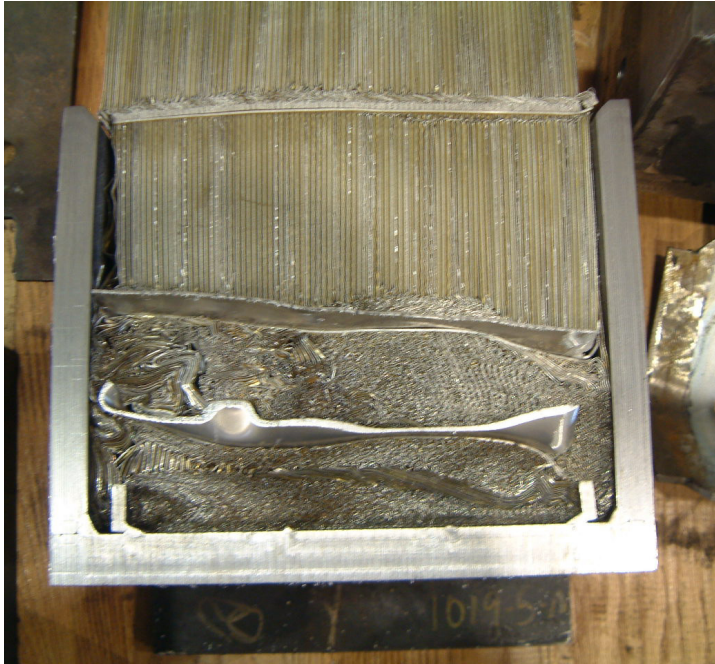
lug has been cut to reveal the manner in which the honeycomb crushed. Even though the honeycomb in the pushback coupler crushed unevenly, the top of the honeycomb is level. While the honeycomb stayed in line and absorbed energy, the uneven crushing may lead to less coupler stroke or energy absorption at a higher load level than anticipated.

**Figure 5. Honeycomb in the Buff Lug for the Pushback Coupler**

The pushback coupler design worked adequately. As shown in the post-test autopsy, the honeycomb does not crush evenly. This may affect the energy absorption capabilities for collisions with more energy. A redesign of the lifting link at the rear of the coupler head should be done for this type of pushback coupler.

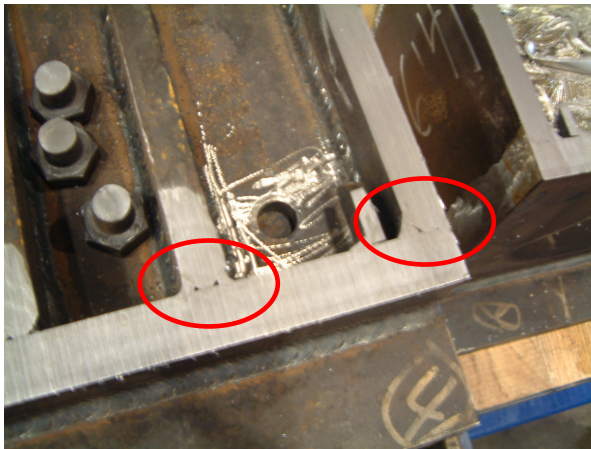
When the buff lug was cut open during the post-test autopsy, evidence of poor welding was found. Figure 6 shows the poor welds. Oversight should be used in manufacturing these components.

**Figure 6. Evidence of Poor Welding Practices Found in the Buff Lug Welds**

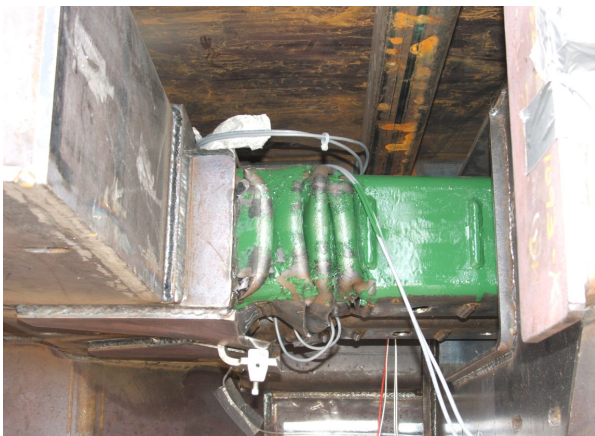
absorbers experienced material failure in the form of fracture. Figure 9 shows one set of primary energy absorbers after the train-to-train test. The primary energy absorbers in this picture crushed in a manner typical for all the primary energy absorbers. The bottom of the energy absorber has fractured. The primary energy absorbers must absorb energy in a controlled progressive manner. The amount of energy they absorb and the force level at which they absorb energy must enable the crush to be pushed back to subsequent interfaces. The energy absorbers are not required to take vertical or lateral loads, this is required through the fixed and sliding sills. Fracture is allowed in the energy absorbers, as long as the deformation mode is repeatable and the appropriate amount of energy is absorbed consistently. Due to the large amount of fracture seen in these components, future designs should minimize the potential for material failure.

**Figure 9. Primary Energy Absorbers, Post-Test**

The primary energy absorber design could be improved. Other methods for energy absorption should be explored. In general, material failure, although permitted in certain circumstances, should be avoided if possible. This may be accomplished by one or more of the following options: use thinner sections, use a ductile material, anneal if necessary, increase the number of energy absorbers, and redesign the placement of the energy absorbers.

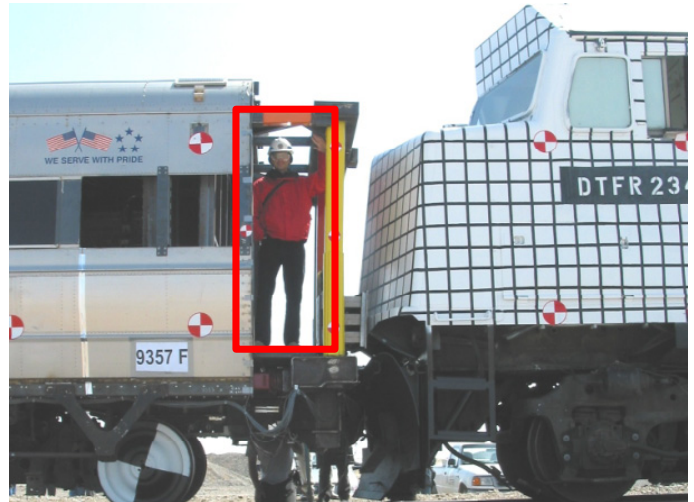
Figure 11 shows the engineer's compartment at the colliding interface after the test was performed. The system was not exhausted in the test, and all the space for the engineer was preserved. This design met the test requirements. Alternative designs are possible, including a nose on the front end and placing the engineer's compartment behind the crush elements.

**Figure 11. Engineer's Compartment, Post-Test**

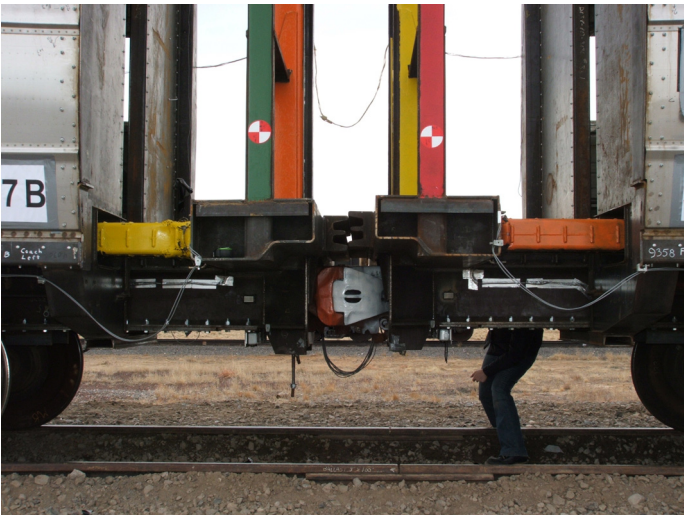
Figure 12 and Figure 13 show a typical coupled interface pre- and post-test. The post-test photo is a closeup view of the coupler, primary energy absorbers, and interlocking conventional anti-climbers. The crush zones remained inline laterally and vertically during the collision at all coupled interfaces.

**Figure 13. Coupled Interface Post-Test**

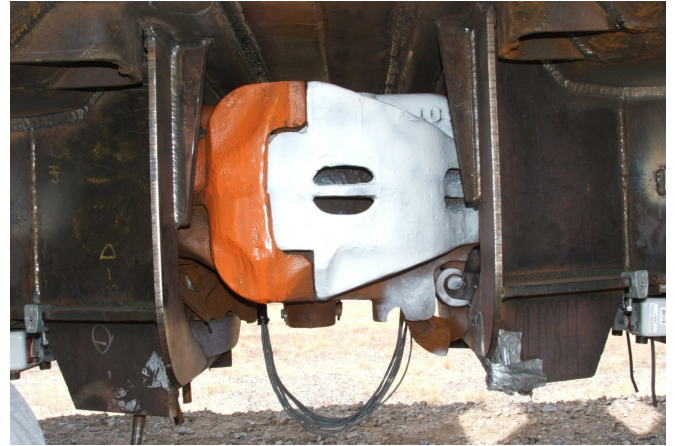
**Couplers** In the non-cab ends, the pushback couplers must absorb energy in a controlled progressive manner and prevent lateral buckling by allowing the ends of the cars to come together. By allowing the car ends to come together, the collision load is distributed over a large area. In the test, the couplers triggered appropriately, and the car ends engaged. Figure 14 shows the couplers at one of the interfaces, post-test. The couplers have pushed back into the coupler housing, and lateral buckling has been prevented.

**Figure 14. Couplers After They Have Pushed Back into the Coupler Housing**

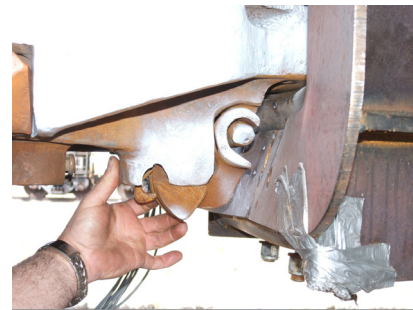
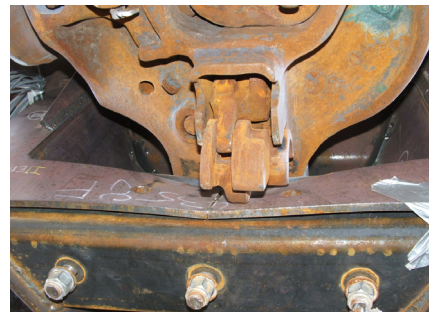
During the test, some of the couplers unexpectedly uncoupled after their initial impact. A coupler lifting link is on the underside of the coupler. When the pin is lifted, the cars can uncouple. Figure 15 shows the coupler lifting link. The top and middle pictures are side views of the coupler and the bellmouth. The middle picture shows a hand lifting the lifting link. During the test, the coupler carrier applied a force in approximately the same position. The bottom picture is a worm's eye view of the coupler and bellmouth. The uncoupling did not affect the crashworthiness of the train or the design requirements for the coupler. Addressing this detail, however, would easily prevent the uncoupling.

**Figure 15. Interaction of the Coupler Lifting Link with the Coupler Carrier**

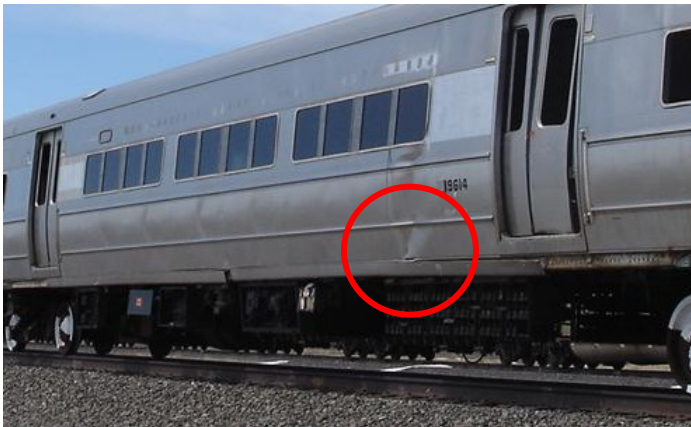
**Passenger Volume/Side Sills** During the test, the passenger volume was preserved. The Budd M1 carbody side sills buckled before the exhaustion of the crush zone energy absorbers. Figure 16 shows one of the side sill buckles. Figure 17 shows a closeup of the side sill buckle. The center sills were not damaged. The damage to the side sills occurred between the body bolsters. The cars were not modified between the body bolsters during the CEM retrofit. Outside of the body bolsters, near the crush zones, modifying the cross-section to be a closed section strengthened the side sills. It was also noted post-test that at the location of the buckle, a gap is in the welding.

**Figure 16. Side Sill Buckle in Budd M1 Car 9614**

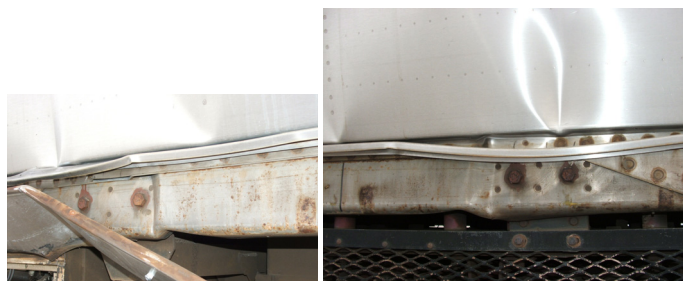
**Figure 17. Closeup View of Side Sill Buckle**

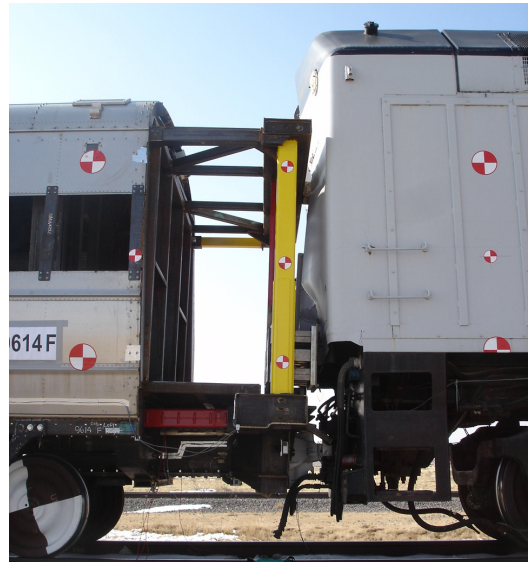
Figure 18 shows the trailing cab car and the trailing locomotive, post-test. In this picture, the deformable anti-climbers are in contact with the locomotive skirt. The locomotive skirt has deformed. The locomotive coupler is visible, but the cab car coupler has pushed back into the coupler housing and is not visible.

**Figure 18. Trailing Cab Car and Trailing Locomotive, Post-Test**

**Coupler** The cab car coupler did pushback all the way during the test, as Figure 18 shows. However, the trailing locomotive moved laterally, and the coupler did not remain in line. A modification would be to install a pushback coupler on the trailing locomotive.

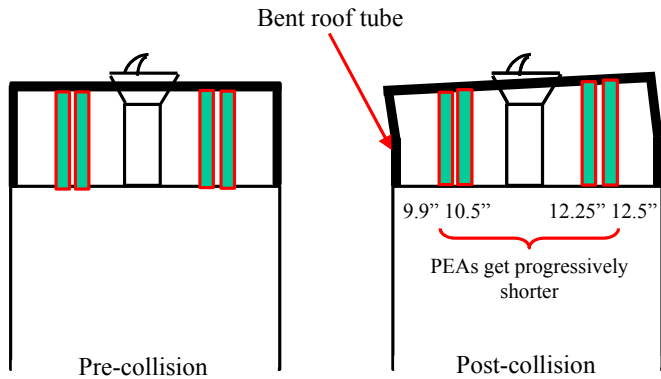
**Sliding Sill/End Frame Connection** Figure 19 is an overhead schematic of the trailing cab car, post-collision. Once the locomotive contacted the crush zone laterally off center, the roof tubes bent, and the end beam rotated. The roof tubes bent to the side during impact. The end beam bent at an angle to the car, deforming the connection between the fixed sill and the end beam. The primary energy absorbers crush different amounts, corresponding to the rotation in the end beam. The fixed sill stayed inline, relative to the car. The sliding sill made scraping marks on the inside of the fixed sill as it pushed back.

**Figure 19. Overhead Schematic of the Trailing Cab Car End Crush Zone, Pre- and Post-Test**

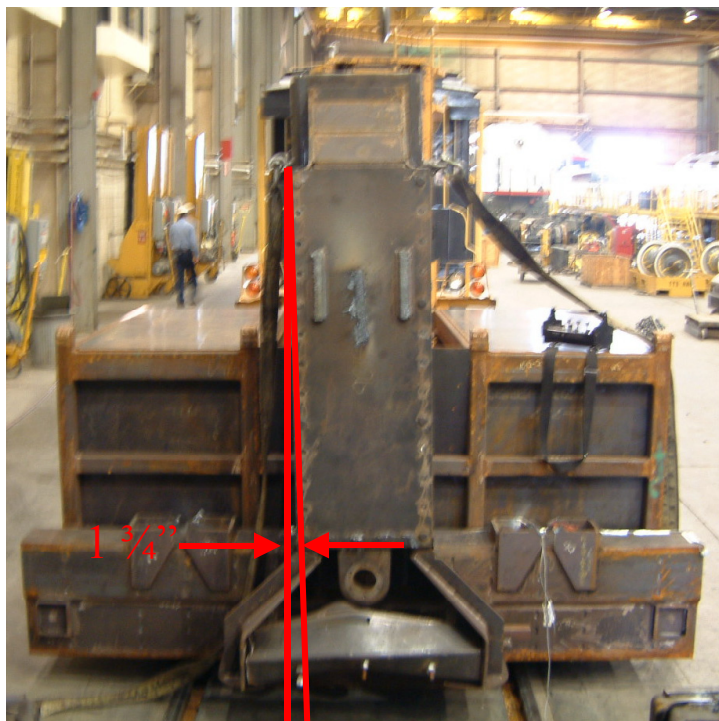
The entire sliding sill twisted at an angle, relative to the end frame. In Figure 20, the crush zone has been removed from the trailing cab car. The front of the crush zone is resting on level ground, on the anti-climber. In this bottom view, it is clear that the sliding sill is twisted relative to the end frame.

**Figure 20. Bottom View of the Sliding Sill**

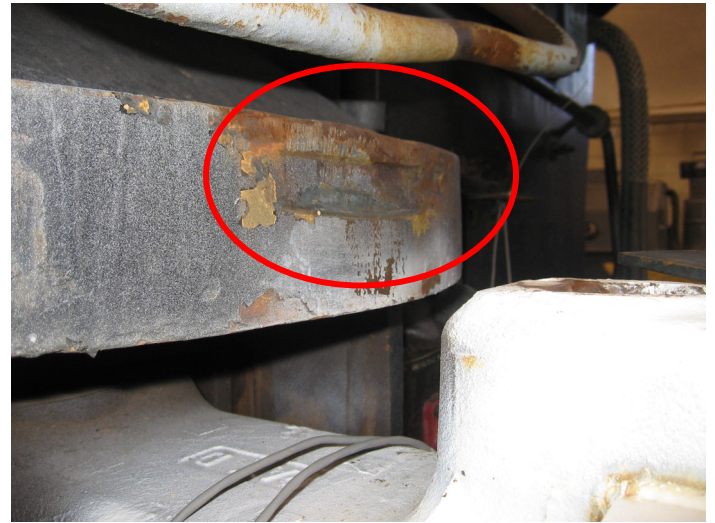
The end frame twisted at an angle during the collision. The trailing locomotive coupler was initially attached to the trailing cab car coupler. During the collision, when the force was transmitted from the cab car to the locomotive, the cab car coupler crushed inline, and the locomotive coupler began to buckle laterally. The skirt of the locomotive hit the anti-climber of the cab car off center. Figure 21 shows the contact

area between the locomotive and the anti-climber on the cab car.

**Figure 21. The Locomotive Edge Where It Hit the Anti-Climber**

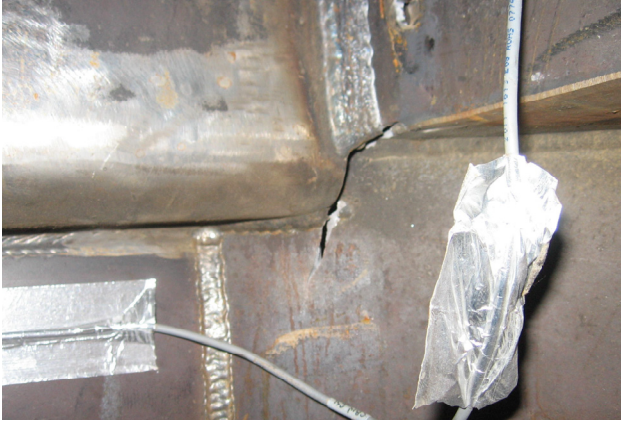
Some unexpected fracture occurred in the trailing end crush zone. A vertical movement in the locomotive put a downward force on the deformable anti-climber that caused unexpected fracture. The fracture occurred at a designed cutout in the connection between the sliding sill and the buffer beam. An opening is the connection between the cab car sliding sill and the buffer beam. This opening creates a stress concentration in an area that experiences high loads. In general, care should be taken to avoid stress concentrations in areas that experience high loads. Stress concentrations facilitate fracture. Figure 22 shows the connection.

**Figure 22. Crack on the Outside of the Bellmouth**

Figure 22 shows the bellmouth crack, taken from the outer side of the bellmouth. The weld at the top center of the picture is stretched but is still holding. To the right of the stretched weld is one of several failed slot welds.

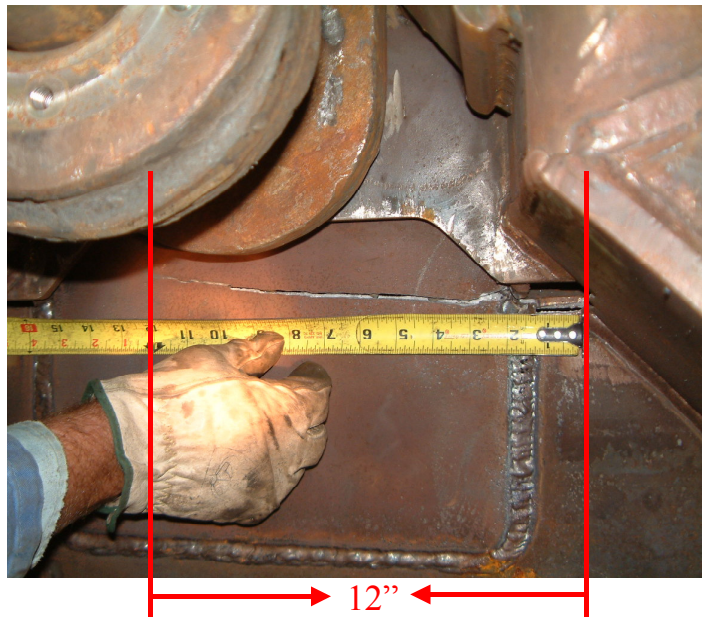
Under very high loads, a crack formed in the bellmouth, allowing the end frame and the sliding sill to twist at an angle, as shown in Figure 20. Figure 23 shows the crack in the coupler carrier. In the picture, the crush zone has been removed and is resting on the anti-climber on the front. The bellmouth is facing the ground. The bottom of the sliding sill has been removed, along with the draft gear, coupler, buff lugs, and honeycomb. The crack runs along the top of the bellmouth. The length of the crack is 1 foot, stretching from the connecting point of the top and side of the bellmouth across the top of the bellmouth.

**Figure 23. Crack on the Top of the Bellmouth**

**Coupler Carrier** Figure 23 shows the bottom side of the coupler carrier after the coupler, draft gear, and buff lug have been removed. The crack spans two pieces of metal in this photo. The total crack length on this side is 12 inches. Below is a closeup view of the crack. This picture also shows a clear view of the material gap in the connections between several plates, at the right side of the crack. The gap created a stress riser in the coupler carrier. This crack may have been avoided if the pieces were designed to connect without a gap.

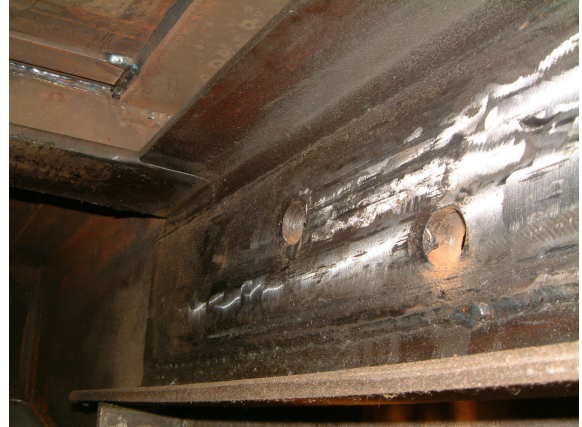
When the sliding sill slid into the fixed sill, the sides of the sills scraped against each other. Figure 24 shows the scraping along the inside of the fixed sill.

**Figure 24. Signs of Scraping on the Fixed Sill Where the Sliding Sill Contacted**

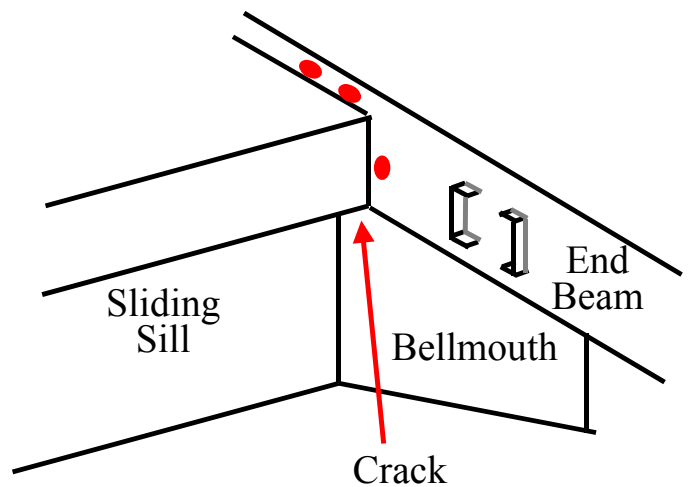
When the cracks in the bellmouth and coupler carrier formed, the slot welds near the crack failed. The slot welds connect the inner and outer plates of the end beam. The schematic in Figure 25 shows the locations of the failed slot welds. Figure 26 shows the failed slot welds. All welds should be properly made and inspected in order to prevent failure.

**Figure 25. Schematic Showing the Location of the Failed Slot Welds**

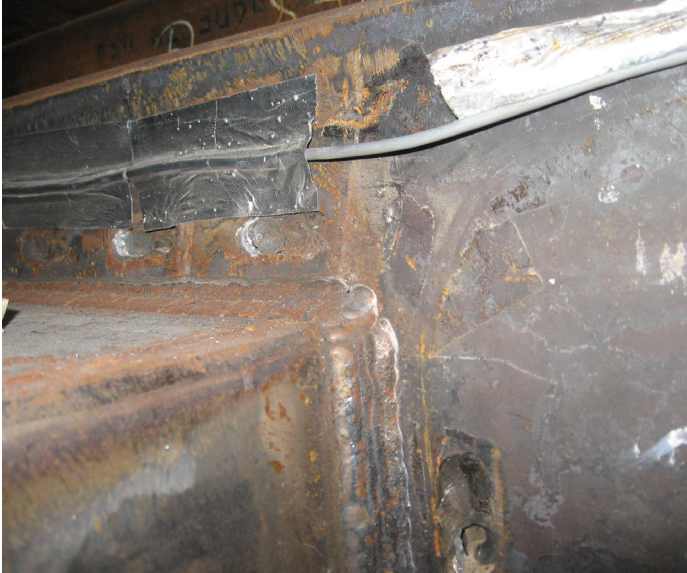
**Figure 26. Three Failed Slot Welds**

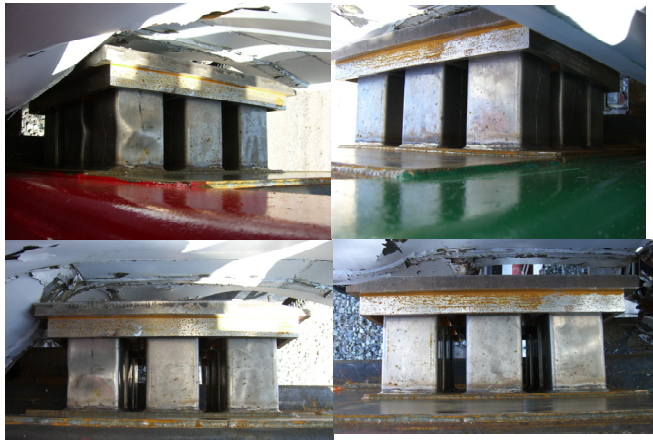
**Deformable Anti Climbers/Locomotive Skirt** The deformable anti-climbers in the trailing cab car crush zone behaved well with minimal crushing. Figure 27 shows pictures of the deformable tubes. The trailing locomotive was softer than the deformable anti-climbers. As shown in Figure 27, the deformable anti-climbers did not deform as much as the anti-climbers at the front end; instead the locomotive skirt crushed.

**Figure 27. Two Deformable Anti-Climbers from Various Angles**

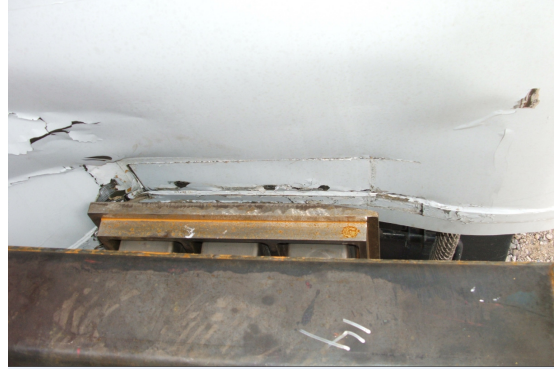
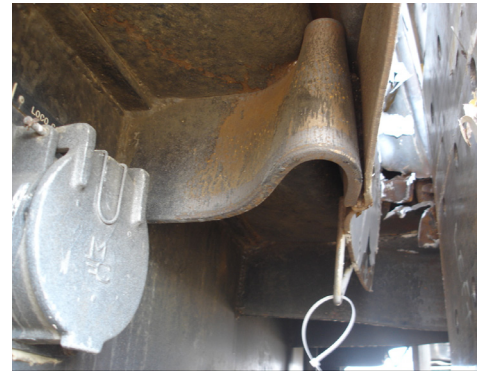
Figure 28 shows the deformation at the interface between the trailing cab car and the trailing locomotive. This deformation was uncontrolled due to the folding of the locomotive skirt. The locomotive was not modified for this test.

**Figure 28. Deformation in the Trailing Locomotive Skirt**

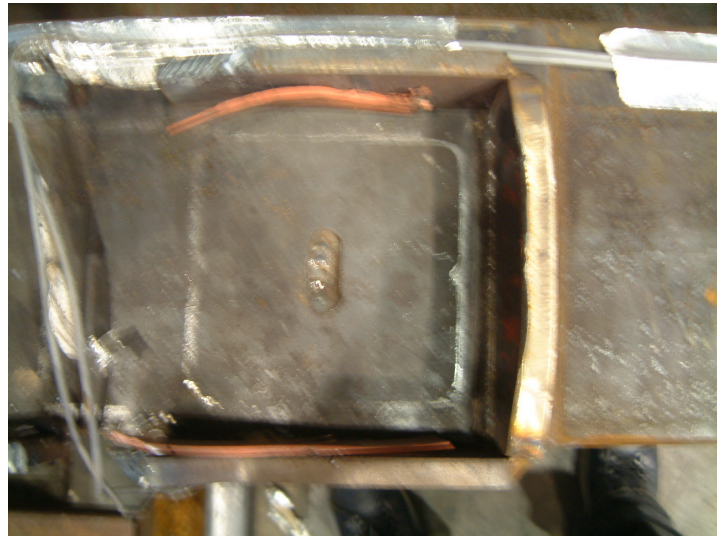
**Primary Energy Absorber Attachment** The primary energy absorbers were removed from the crush zone as part of the post-test autopsy. As shown in Figure 29, the splitting at the corners of the attachment interfered with the folding of the primary energy absorbers and contributed to the undesirable modes of deformation at the ends of the crush elements.

**Figure 29. Bulging in the Primary Energy Absorber Attachment Plates**
