# RTDF2008-74020

# A DYNAMIC TEST OF A COLLISION POST OF A STATE-OF-THE-ART END FRAME DESIGN

Michelle Priante Patricia Llana Karina Jacobsen David Tyrell Benjamin Perlman US Department of Transportation Volpe Center Cambridge, MA

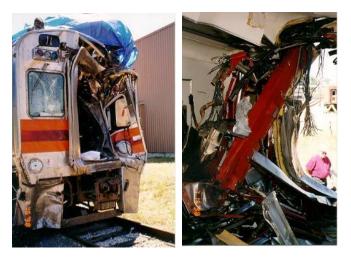
Figure 1. Cab car involved in the grade crossing collision in Portage, Indiana

Figure 1 shows the exterior and the interior of the cab car after the collision. The picture on the right shows the interior of the car. The collision post had been severed and pushed back into the car. Figure 2 shows the 6-foot diameter, 19-ton steel coil. This grade crossing collision is significant because the coil loaded the superstructure of the car, not the underframe.

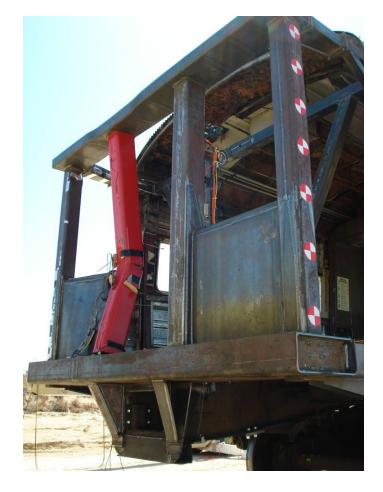
Figure 12. A photograph of the end frame after the test

**End Frame Performance** Figure 12 shows the end frame after the test. The impacting object pushed in the collision post, lateral shelf and bulkhead sheet. The collision post partly separated from the buffer beam, as did the bulkhead sheet. The shelf separated from the collision post and the corner post. The AT beam, which runs laterally at the top of the end frame, bent down at the connection to the collision post. The welds between the collision post and the AT beam did not crack or fail.

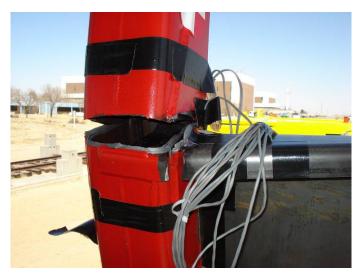
Figure 14. The back of the collision post, at the connection to the shelf, post-test (bottom)

Figure 14 shows the back of the collision post and the connection to the shaft, after the test. The post fractured along the backside and almost entirely along the sides of the post. The front of the post did not fracture. The shelf fractured at the location of the gap between the collision post and the shelf. There are external gusset plates along both the sides of the posts. The plates fractured also.

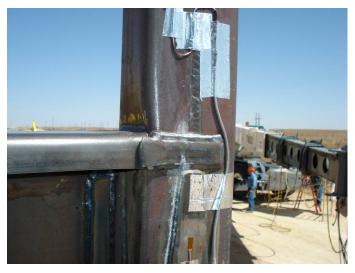
Figure 16. The connection of the shelf to the corner post, post-test

Figure 16 shows the connection between the corner post and the shelf, after the test. During the test, the shelf was pushed in longitudinally toward the center of the train and outward laterally toward the corner post. The corner post has been pushed in and deformed plastically at the shelf. Also, the tab of the shelf fractured off.

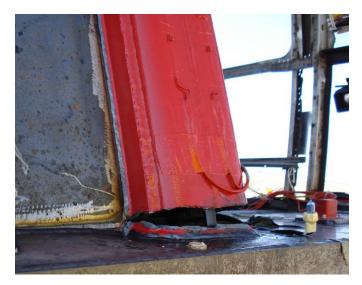
Figure 17. Fracture at the connection between the collision post and the buffer beam

The collision post fractured at the connection to the buffer beam. Figure 17 shows the fracture. The bulkhead sheet tore from the buffer beam at the corner. The crack on the left side of the post (as seen in the picture) extends behind the bulkhead sheet. On the right side of the post, the crack extends almost down the entire side. The buffer beam was distorted and the top plate of the buffer beam pushed down at the location of the collision post and the bulkhead sheet.

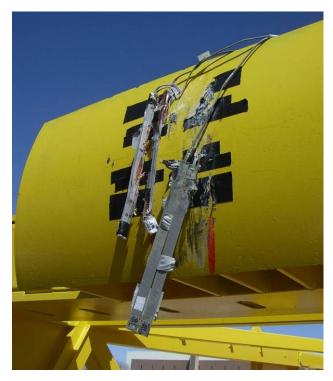
Figure 19. Cart impactor, post-test

**Cart Performance** The most important requirements for the cart were that it not deform or absorb any energy during the collision. A rigid cart ensured that the collision post and end frame would absorb the required collision energy. Figure 19 shows the impactor after the test. The cart performed as expected during the test and did not deform. After the test, the cart derailed as expected, due to the off-center load. The cart remained upright. The derailment did not damage the cart.
