**JRC2009-63035**

## **DYNAMIC AND QUASI-STATIC GRADE CROSSING COLLISION TESTS**

**Michelle Mühlanger  
Patricia Llana  
David Tyrell**

Volpe National Transportation Systems Center  
U.S. Department of Transportation  
Cambridge, Massachusetts, USA  
[www.volpe.dot.gov](http://www.volpe.dot.gov)

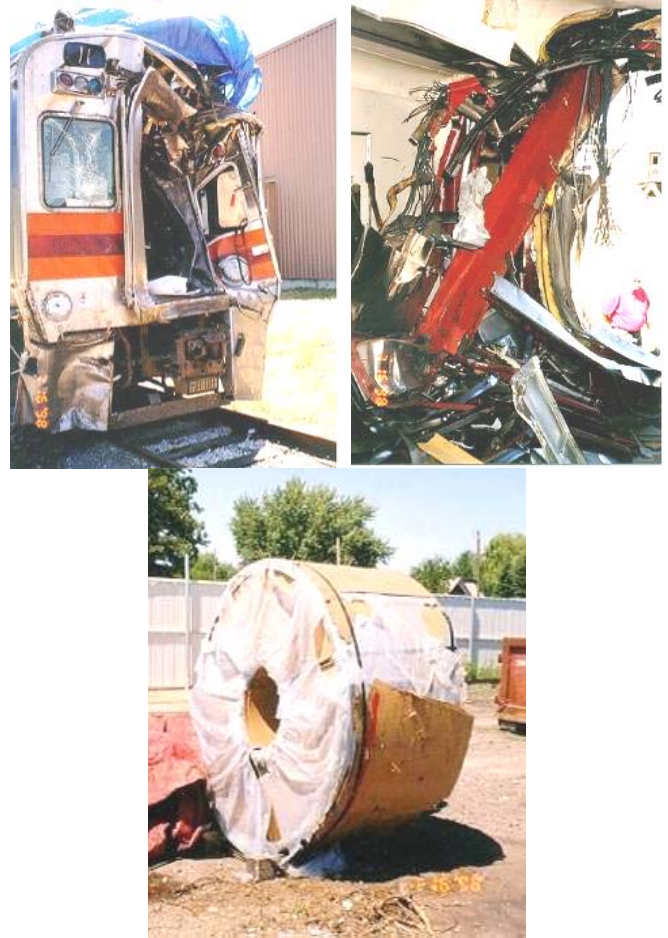
Figure 1 shows the exterior and the interior of the cab car after the collision. The picture in the top right shows the interior of the car. The collision post had been severed and pushed back into the car. Figure 1 also shows the 6-foot diameter, 19-ton steel coil. In this collision, the coil loaded the superstructure of the car, not the underframe.

**Figure 1. Cab car and steel coil involved in the grade crossing collision in Portage, Indiana.**

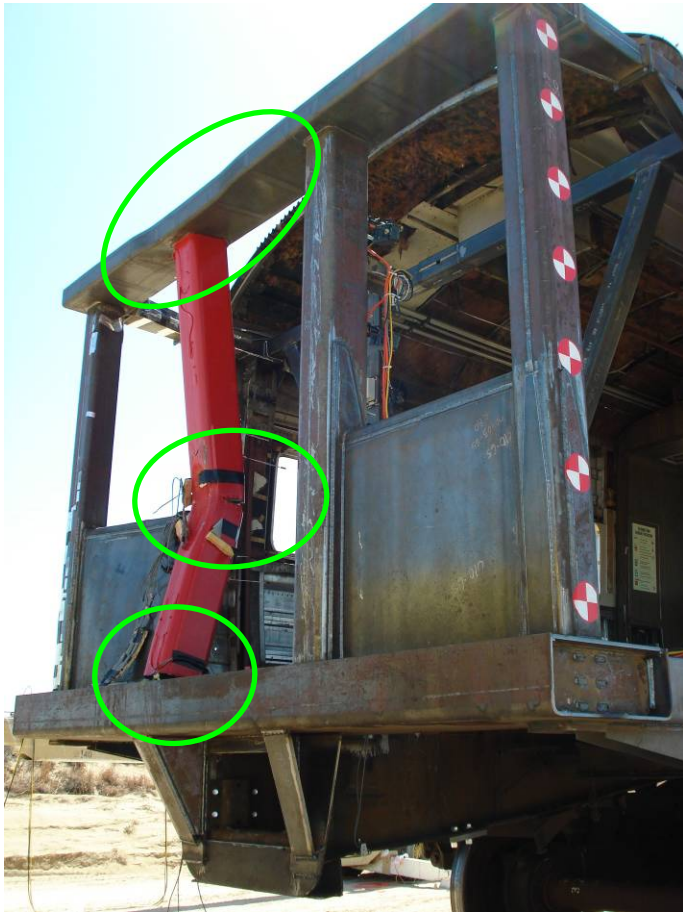
Figure 6 shows the end frame after the test. The impacting object pushed in the collision post, lateral shelf and bulkhead sheet. The bottom oval shows where the collision post and bulkhead sheet partly separated from the buffer beam. The shelf separated from the collision post and the corner post. The AT beam, which runs laterally at the top of the end frame, bent down at the connection to the collision post, as shown in

the top oval. The welds between the collision post and the AT beam did not crack or fail. The middle oval surrounds the impact area, and the crack in the collision post behind the impact location.

**Figure 6. A photograph of the end frame after the dynamic collision post test.**

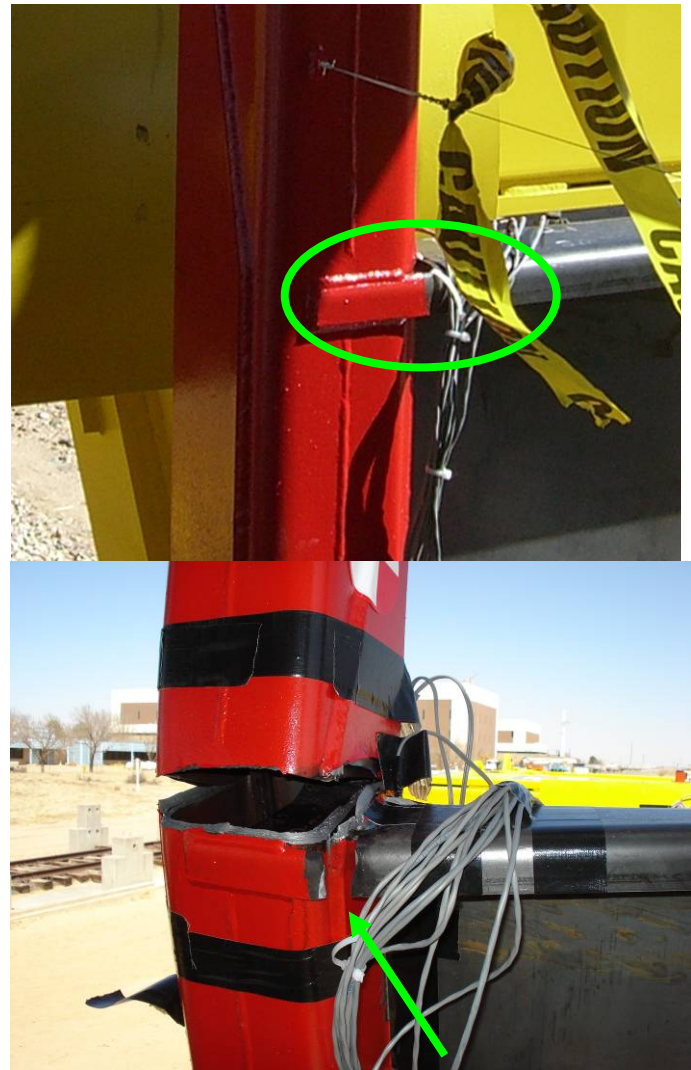
Figure 7 and Figure 8 show important details of the mode of deformation. The collision post fractured in two places during the test: at the back of the post at the impact point and at the connection to the buffer beam. The top photo in Figure 7 shows the back of the collision post and the connection to the shelf before the test. A shelf tab extends from the shelf and is welded to the back of the collision post. There is a gap between the side of the post and the shelf. The post is a box cross section formed by two U-sections welded together at the front and back of the post. There are several internal gussets in the horizontal plane. The back of the post fractured at this location during the test. The front of the post did not fracture. This fracture was not predicted in the pretest modeling, but the end frame was still able to meet the energy absorption requirements. The tab connecting the shelf failed as well.

**Figure 7. The back of the collision post, at the connection to the shelf, pre-test (left) and post-test (right).**

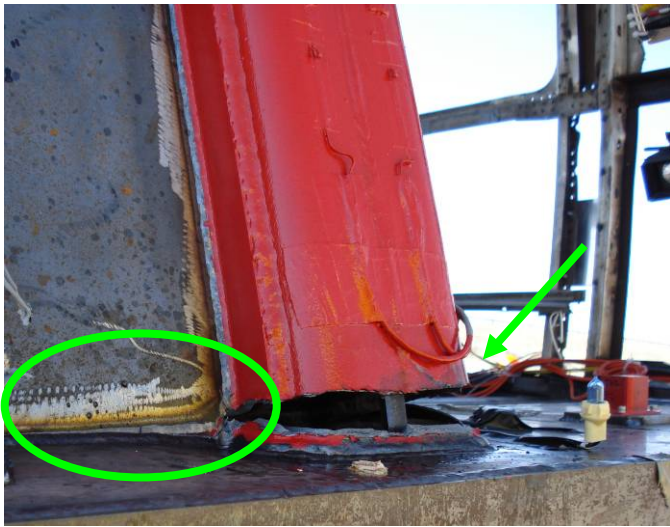
The collision post also fractured at the connection to the buffer beam. Figure 8 shows the fracture. The bulkhead sheet tore from the buffer beam at the corner. The crack on the left side of the post (as seen in the picture) extends behind the bulkhead sheet. The crack is circled in the figure. On the right side of the post, the crack extends almost down the entire side. The buffer beam was distorted and the top plate of the buffer beam pushed down at the location of the collision post and the bulkhead sheet. Despite fracture in this location, the post still met the test requirements.

**Figure 8. Fracture at the connection between the collision post and the buffer beam.**

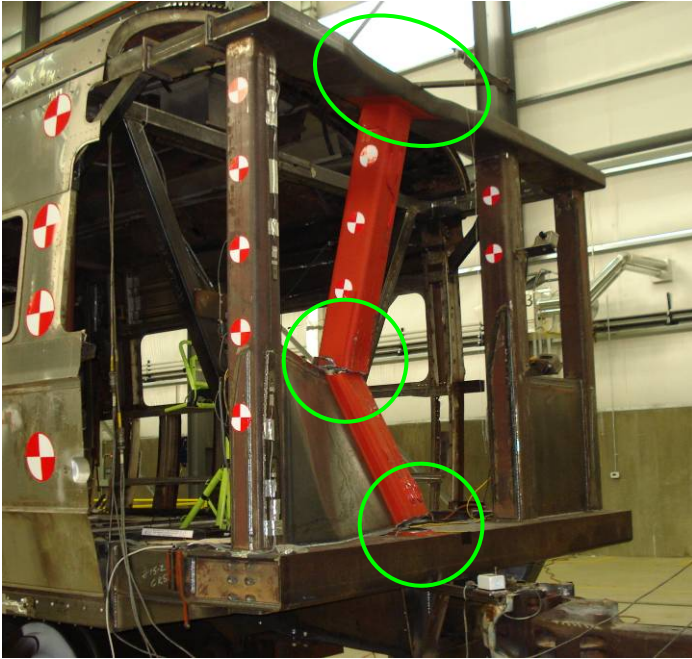
The mode of deformation in the quasi-static collision post test is very similar to the mode of deformation seen in the dynamic collision post test. The top circle in Figure 11 shows where the collision post pulled down on the AT beam. The middle circle shows the post deformation at the loading location. The post was loaded past 15 inches of deformation and did eventually fail completely in the middle. The bottom circle in the figure shows where the collision post fractured as it separated from the buffer beam.

**Figure 11. Post-test quasi-static collision post test.**

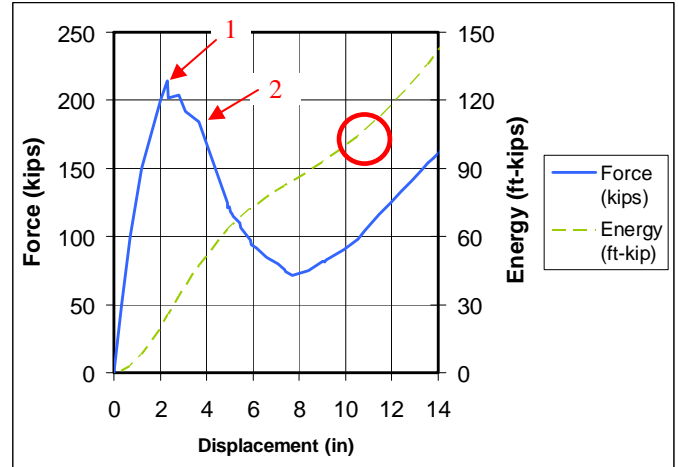
The force-displacement characteristic is required to assess the energy absorption of the collision post and end frame. This characteristic is shown in Figure 12. The force, shown as the solid blue line, increases until approximately 2.25 inches. When the post had deformed this far (location 1 on the graph), the back of the collision post fractured, resulting in a sharp decline in load. As the post continues to crush, the back of the post continues to fracture, resulting in a declining force. After approximately 3.5 inches, fracture occurred at the connection of the post to the buffer beam (location 2 on the graph). After this point, the load continues to decrease as the post crushes. When the crush of the post reaches 8 inches, the force begins to increase, due to tension in the post connection. After 11 inches of crush, the post has absorbed 110,000 ft-lb of energy, as circled on the dashed green line. Based on the unloading characteristic measured during the test, 11 inches of crush is approximately equal to 10 inches of permanent deformation.

Since the collision post and end frame were required to absorb 135,000 ft-lb of energy in 10 inches of permanent deformation, but only absorbed 110,000 ft-lb of energy, the test article did not pass the requirements. A closer look was given to the test set-up and the SOA end frame design and manufacturing.

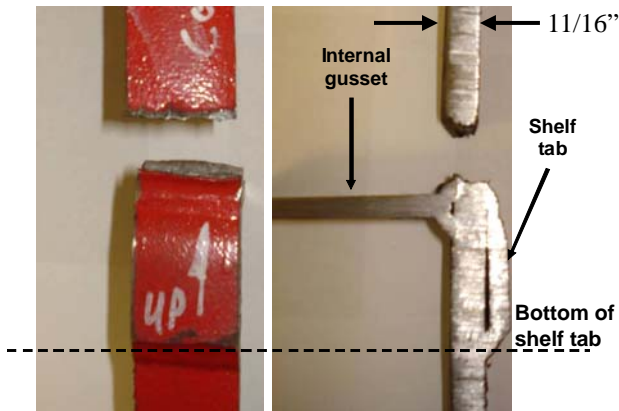
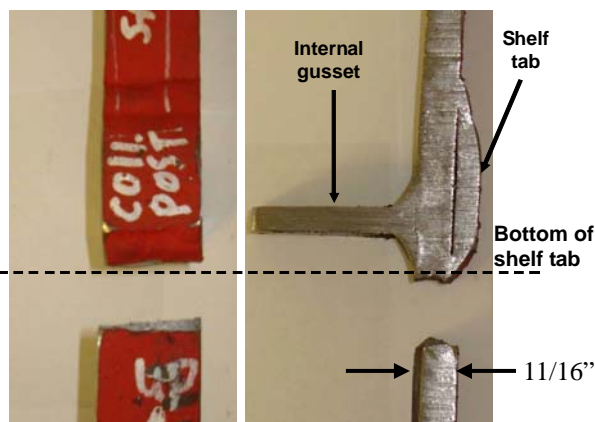
Figure 13. Gusset, shelf, and fracture locations on the collision post for the quasi-static and dynamic tests.

The premature fracture at the back of the collision post is of concern. The fracture kept the collision post from absorbing enough energy during the test. Three potential contributing factors were explored: material properties, fabrication quality, and design details. As part of the post-test autopsy, material samples were taken from various locations on the collision and corner posts from the dynamic and quasi-static test of a collision post. Three-point bending tests of the specimens demonstrated that the ductility of the material was within specification. Material properties were ruled out as a contributing factor to the fracture. A visual inspection of the specimens confirmed that the welds were within specification, so fabrication quality was also ruled out as a cause of fracture.

The design details warranted a closer look. The specimens taken at the location of the fracture revealed that an internal gusset on the post coincided with an exterior shelf tab. Figure 13 shows specimens taken from the collision posts in the dynamic and quasi-static tests. The gusset locations were within specification for these posts. However, there is some flexibility with the location of the gusset relative to the location to the shelf tab. In both the dynamic and quasi-static tests, the fracture occurred at the location of both the gusset and the shelf welds. The rigid gusset did not allow the post to oval as it deformed, causing the fracture at the back of the post.

In response to the results of the quasi-static test of the collision post, the shelf was redesigned so the tab was removed and the depth of the shelf was decreased. The circle in Figure 14 shows the tab before modification and the arrows show the decreased shelf size after modification. This reduced the amounts of welds at the corner and back of the post. The corner post was not designed with internal gussets, so the design detail did not need to be addressed.

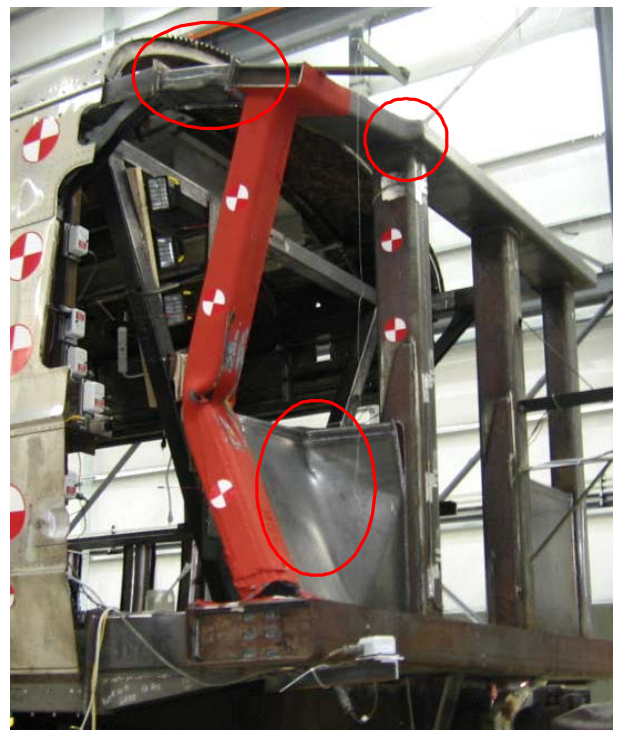
In the quasi-static corner post test, the end frame deformed as expected and absorbed energy while deforming. Figure 15 shows an overview of the deformation of the end frame at the end of the test. Circles show the areas where the AT plate has been pulled down significantly and where the shelf and bulkhead have deformed. Figure 16 shows the details of the fracture locations. The photo on the bottom shows a close up of the fracture at the bottom of the corner post. The photo on the top shows the connection of the shelf to the corner post. Although the connection between the shelf and the post has fractured, the post itself has not fractured.

Figure 15. Quasi-static corner post post-test overview photo.

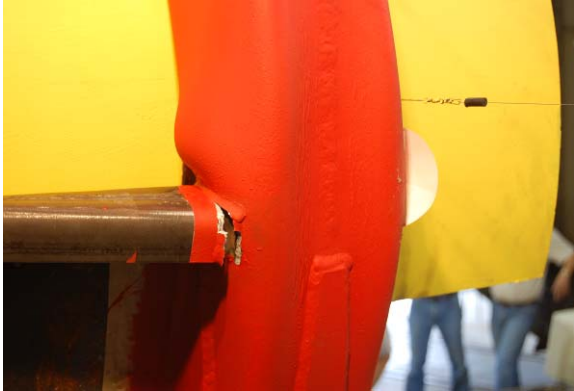
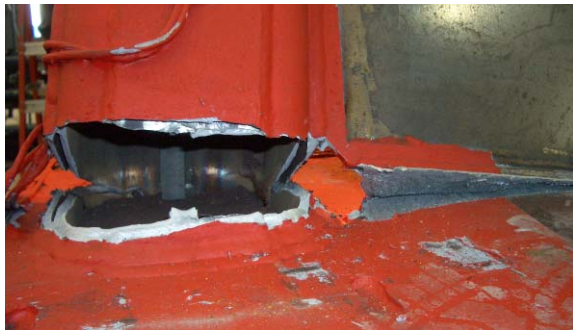
**Figure 16. Quasi-static corner post post-test detail photos.**

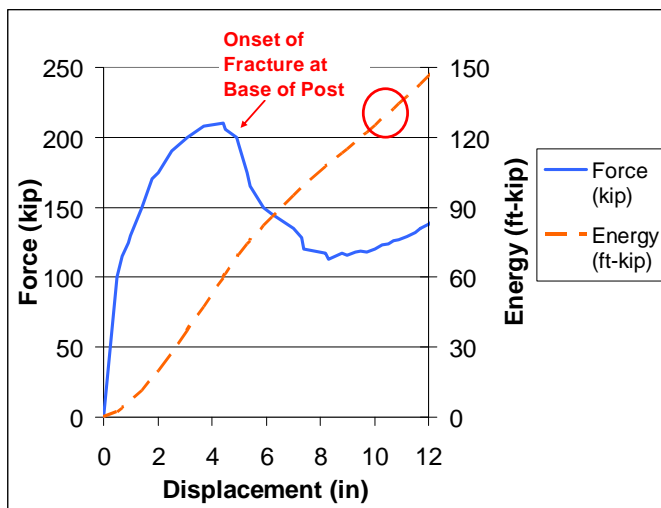
The force-displacement characteristic is shown in Figure 17. After about 4.5 inches of crush, as pointed out in Figure 17, failure initiated at the connection of the post to the buffer beam. The post and end frame absorbed 136,000 ft-lb of energy in 11 inches of crush. After elastic recoil, 11 inches of crush results in 10 inches of permanent deformation. The hydraulic ram loaded the corner post through 14 inches of deformation. The post would have continued to deform past 14 inches, but the hydraulic ram was out of stroke.
