**Second Five-Year Review Report
For**

**Arkwood, Inc. Site
Boone County
Omaha, Arkansas**

February 2006

**Prepared By
Region 6**

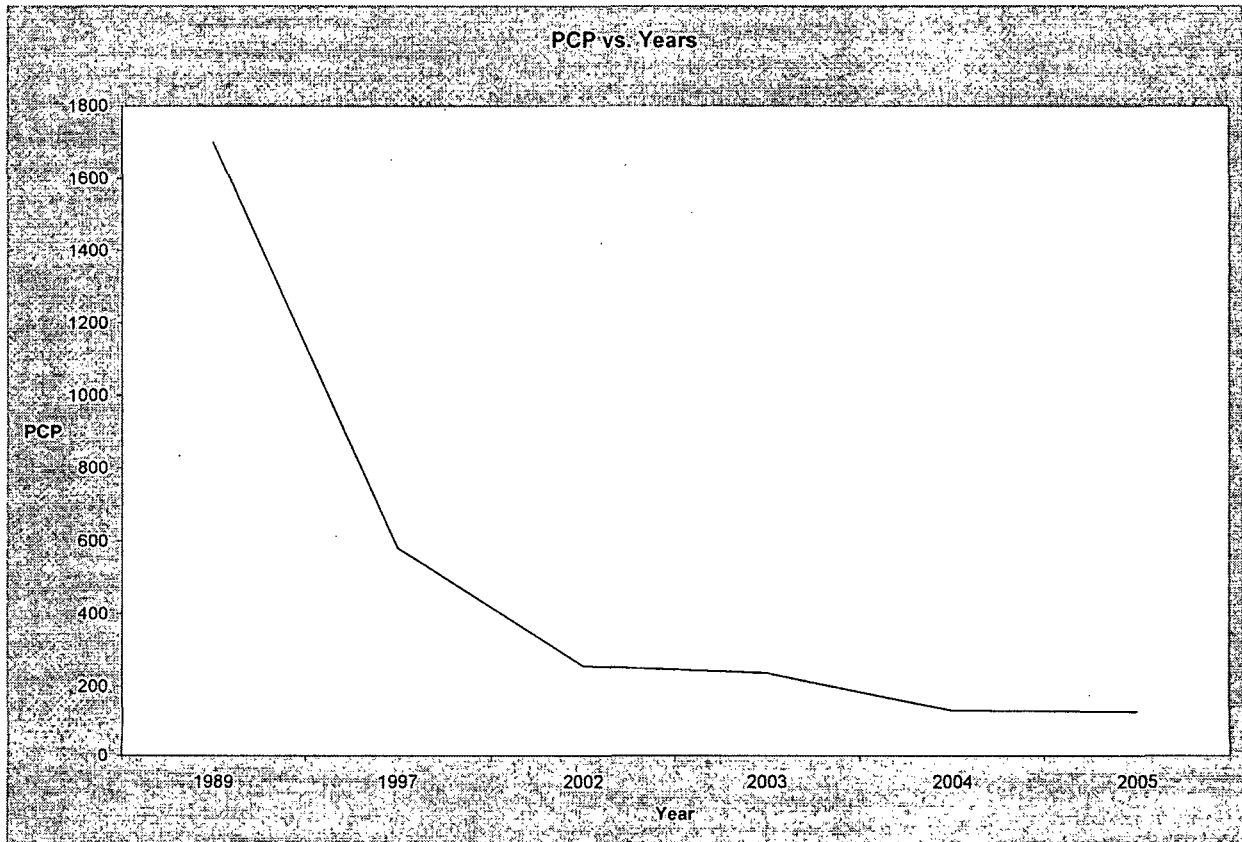
Figure 2
1989-2005

Based on the dye tracing studies, four springs were identified for monitoring: New Cricket Spring, Walnut Creek Spring, Cricket Creek Spring, and Railroad Tunnel Spring. As shown in Table 2 below, these springs were sampled quarterly from 1996 through 1999 except during periods of insufficient flow. In year 2000, spring sampling was reduced to only New Cricket Creek since this is the only spring that continues to be impacted with PCP. Monthly sampling was initiated May 15, 2000. Data from the sampling from 1996 to 2005 is shown in Table 2 and Figure 2.

PCP vs. Years
1989/1990 \approx 1700
1996/1998 \approx 581
2002 \approx 255
2003 \approx 237
2004 \approx 134
2005 \approx 132

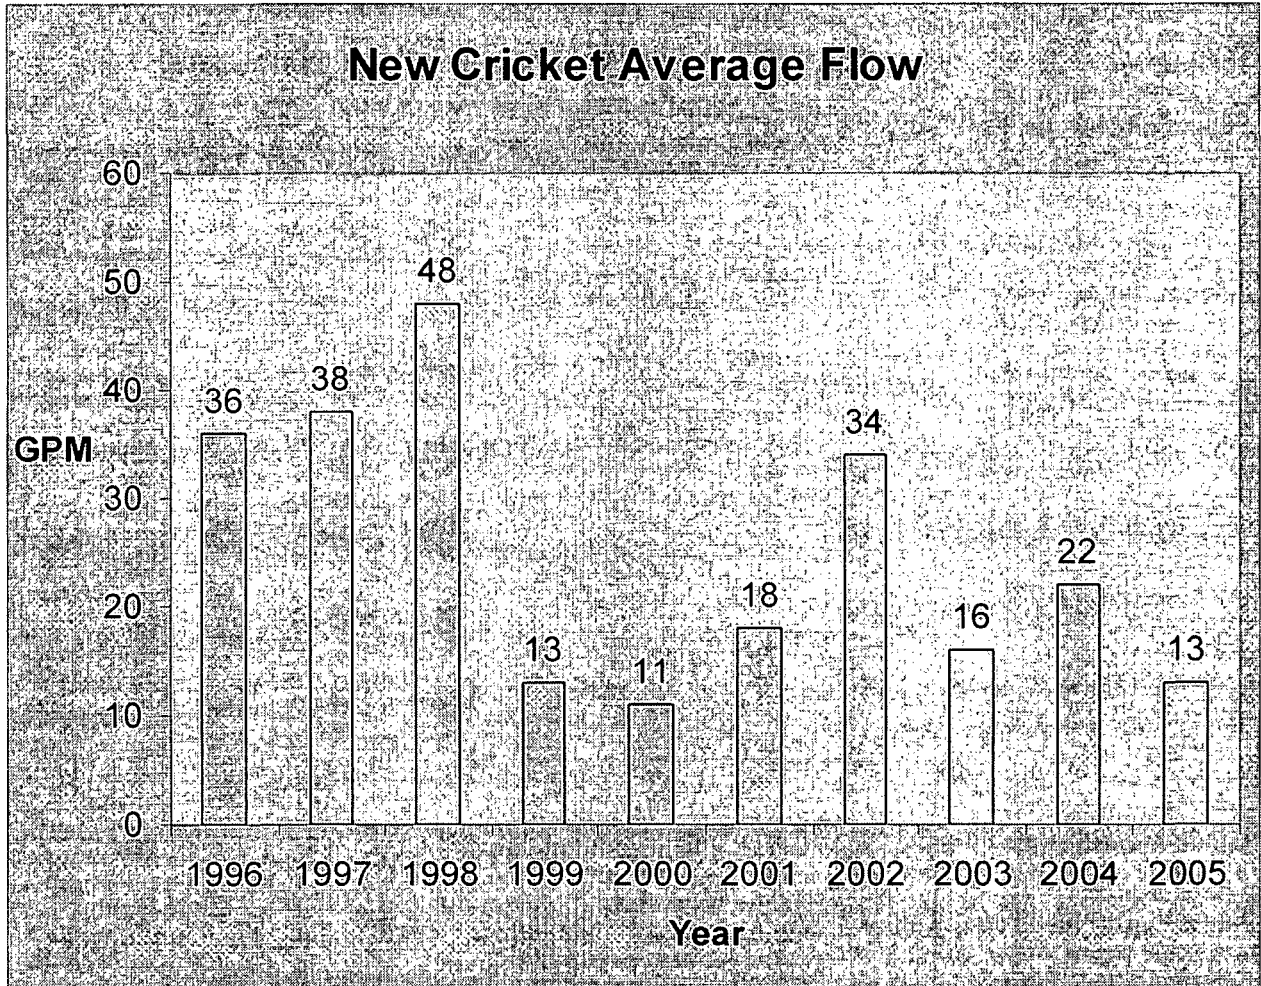
The volume of water flow at New Cricket Spring has been measured over the past ten years. Flows vary from less than 1/2 gallon per minute (gpm) to over 1,000 gpm. From the spring of 1999 through summer 2000, a drought affected the mid-west and south-eastern United States. Spring flows recovered briefly during 2002. However, it appears that the effect of drought years has returned as the flows for 2003 and 2004 are significantly lower than those recorded during 1996 through 1998. Table 3 and Figure 3 below present average monthly and yearly spring flows for the past ten years.
