Five-Year Review Report

Third Five-Year Review Report for the Bayou Bonfouca Superfund site Slidell, St. Tammany Parish, Louisiana

**Region 6
United States Environmental Protection Agency
Dallas, Texas**

May 2006

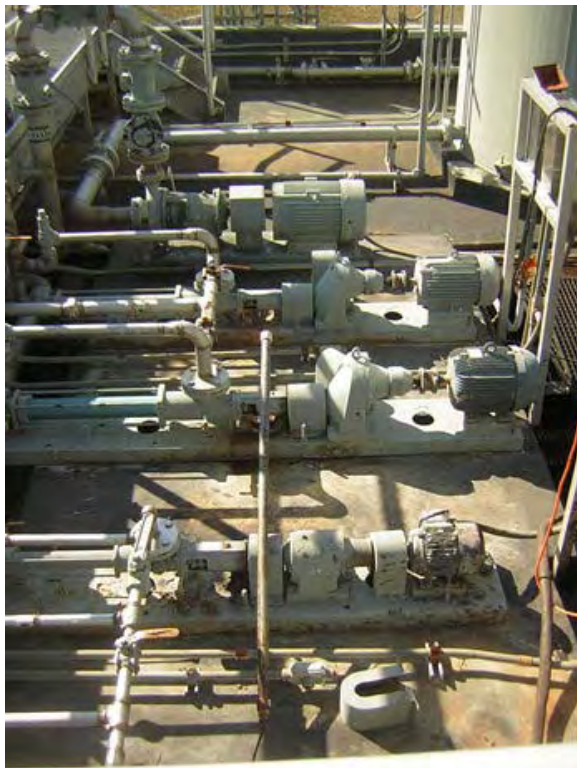
1. At the time of the site inspection the ground water treatment system was operating at a reduced ground water/NAPL recovery rate because of damage sustained to plant systems by Hurricane Katrina. Repairs to the treatment system and the plant requiring replacement parts are pending.

Photo 6: Pumps within ground water treatment system, submerged and damaged during Hurricane Katrina. Taken 2/16/2006.

1. Recommended repairs to system components damaged by Hurricane Katrina should be completed as soon as possible in order to restore the treatment system to its required level of operation. At the time of the site inspection, recovery system pumps were operational; however, repairs requiring replacement parts are pending. Some of the well vaults that were submerged appear to have increased rates of corrosion.

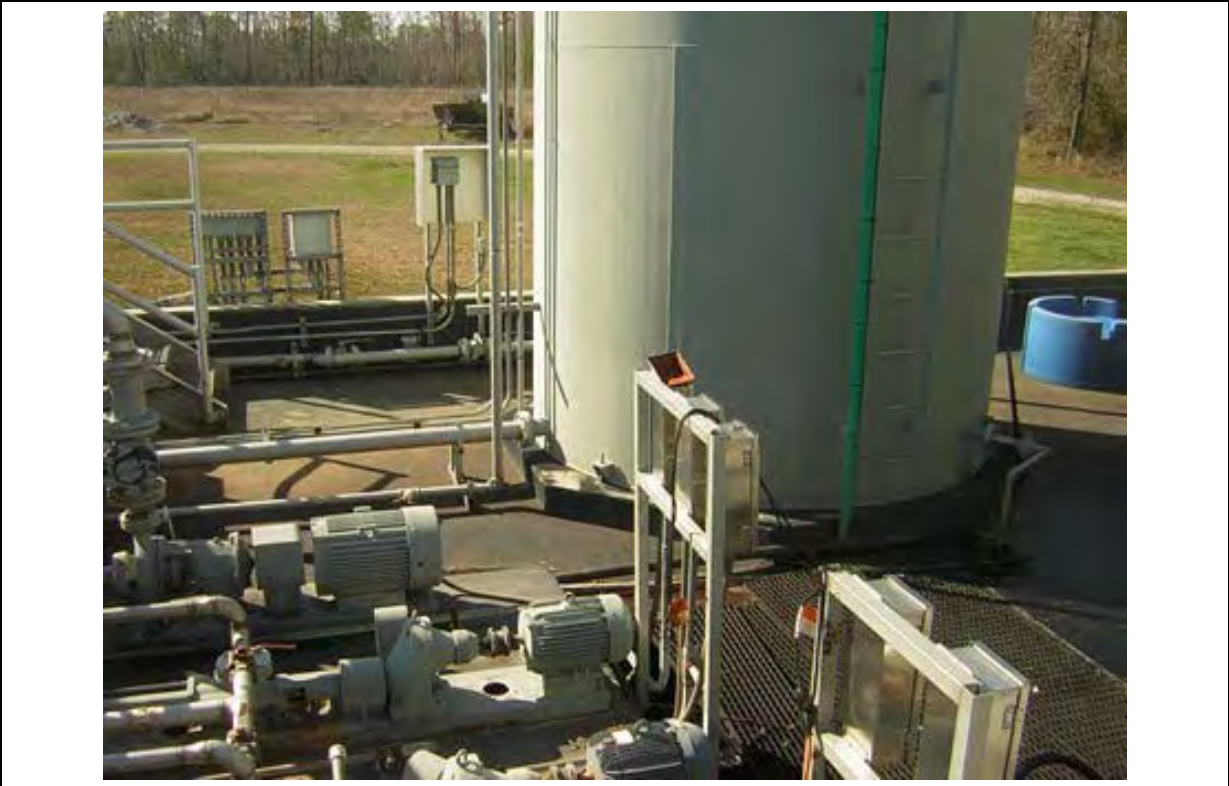
Photo 7: Bottom left, pumps within ground water treatment system, submerged and damaged during Hurricane Katrina. Taken 2/16/2006.

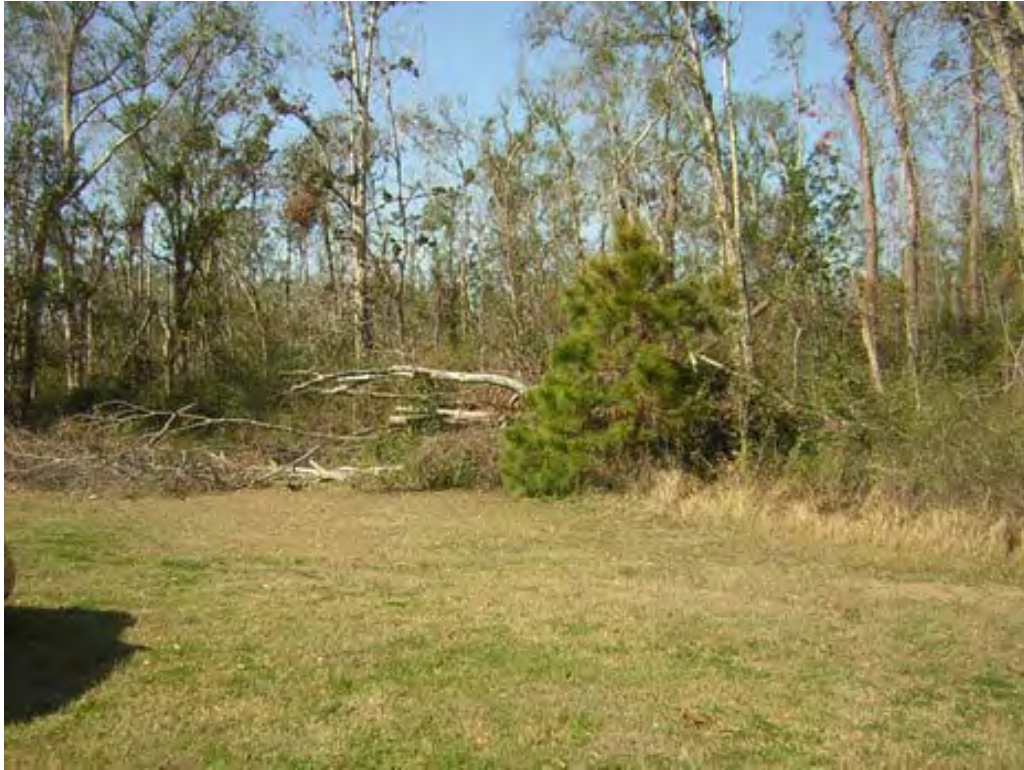
Photo 9: Downed trees from Hurricane Katrina west of the ground water treatment plant. Taken 2/16/2006

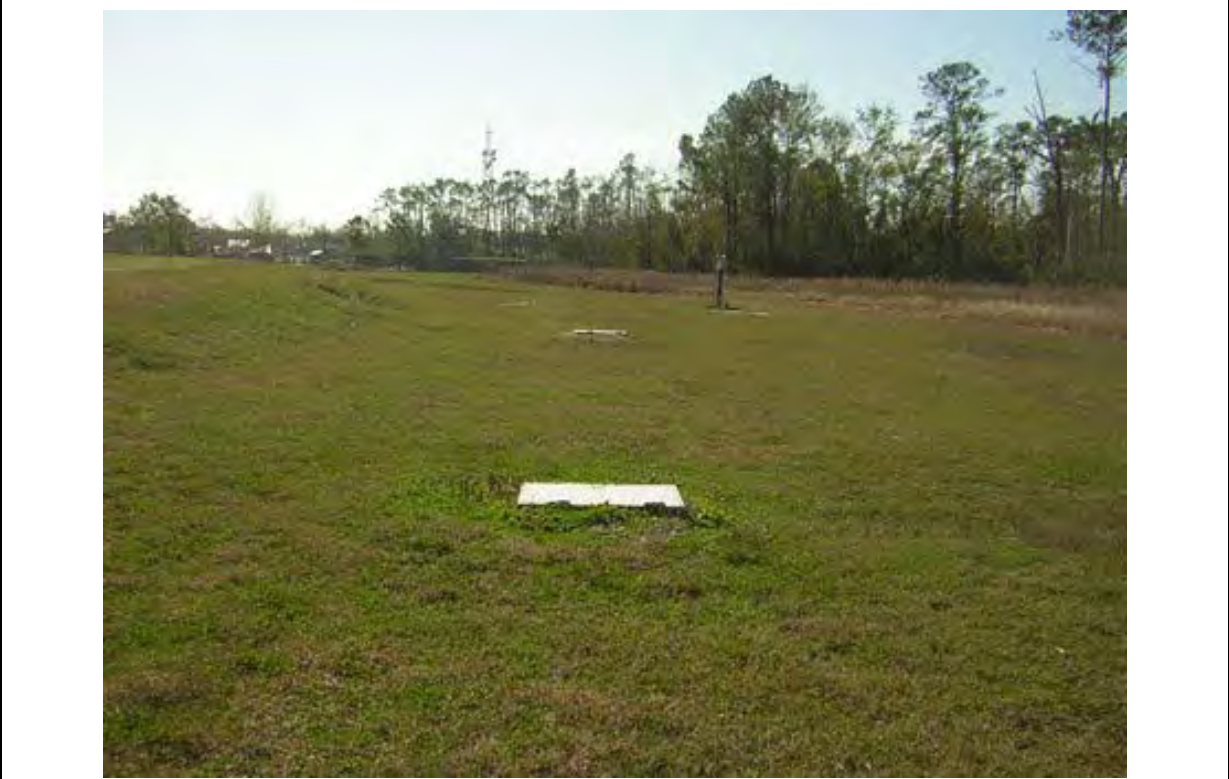
Photo 14: Looking south along recovery array 1A. Well vaults are flush-mount, and were inundated with water during Hurricane Katrina. Taken 2/16/2006

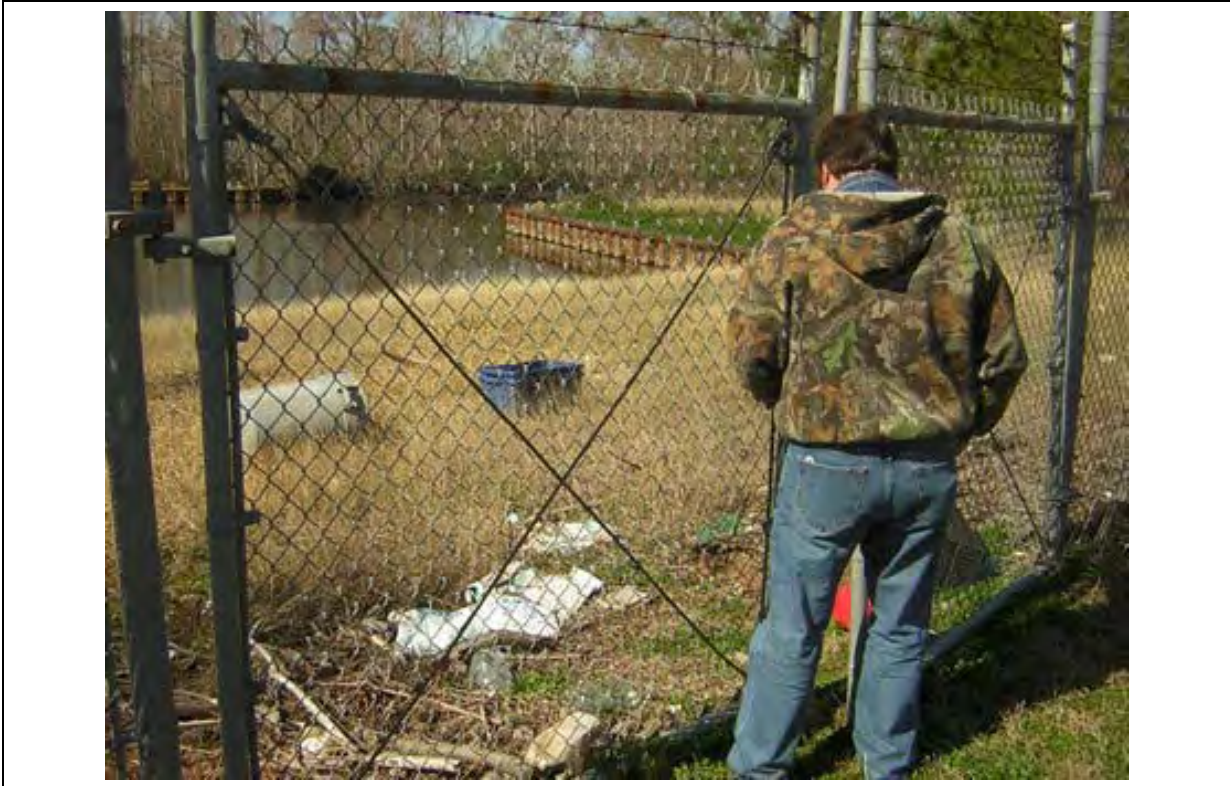
Photo 19: Looking west through fence at southwest edge of site along bayou. Debris deposited by floodwaters from Hurricanes Katrina/Rita. Taken 2/16/2006

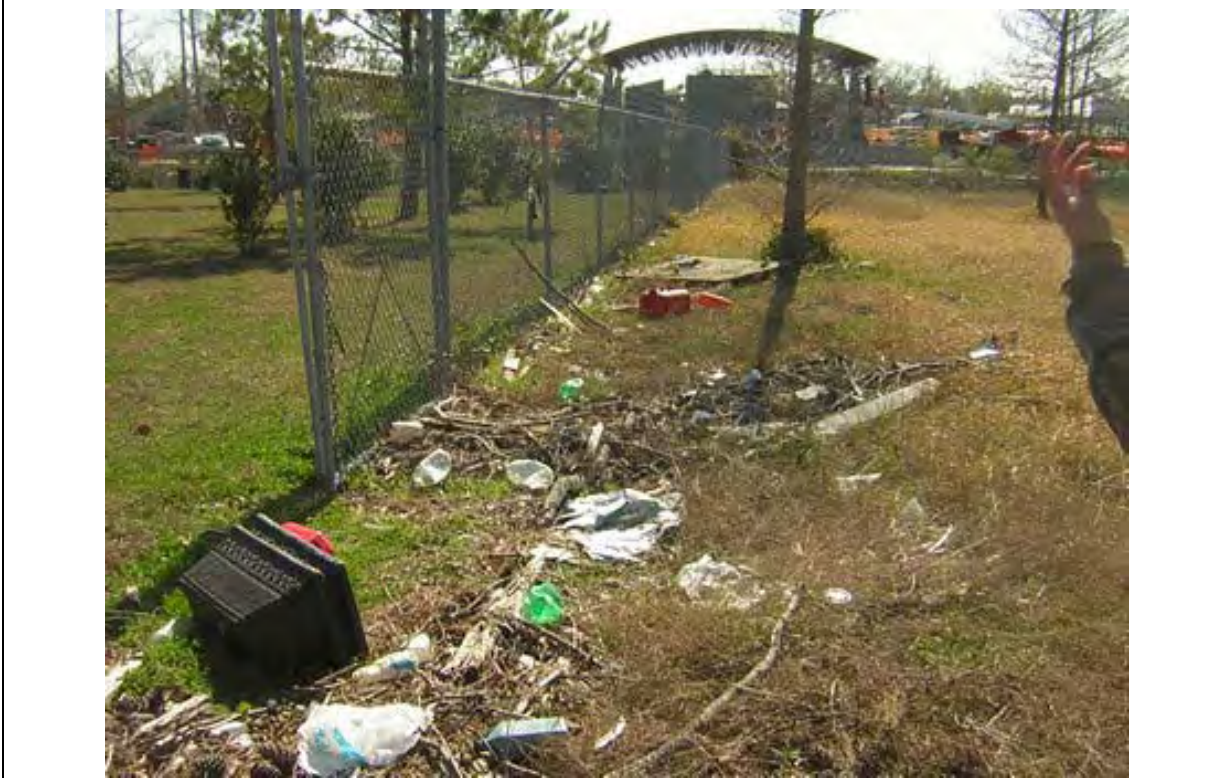
Photo 20: Looking south along fence at southwest edge of site along bayou. Debris deposited by floodwaters from Hurricanes Katrina/Rita. Taken 2/16/2006

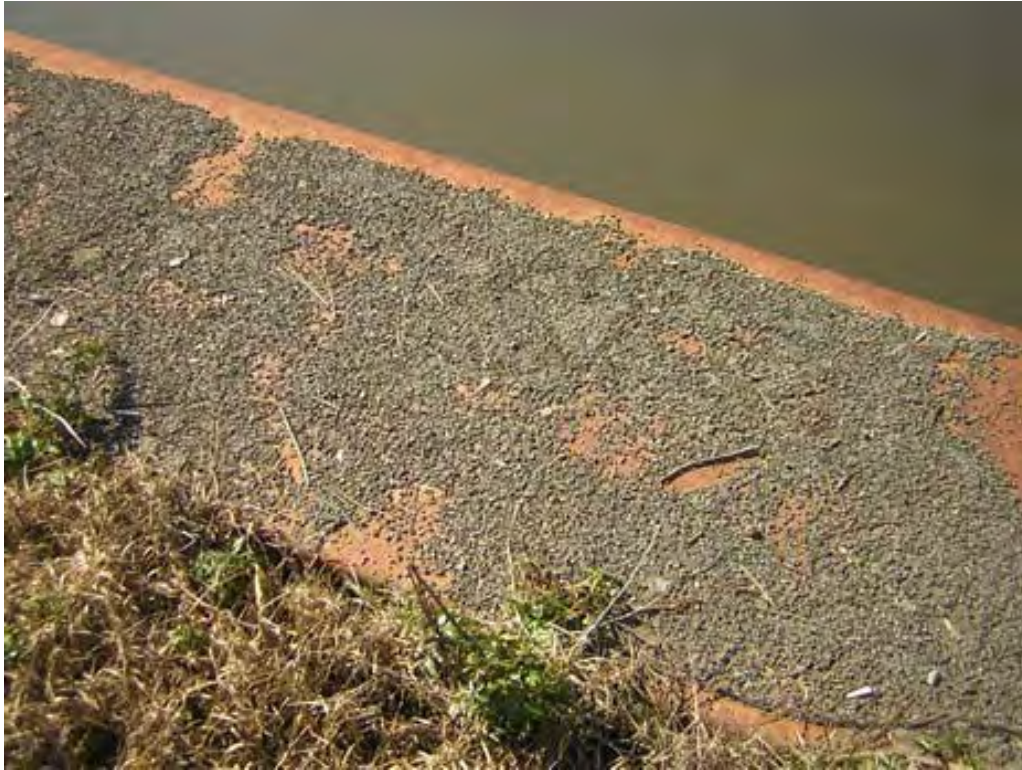
Photo 21: Dried sediment on top of sheet pile wall along bayou left behind by floodwaters associated with Hurricanes Katrina/Rita. Taken 2/16/2006

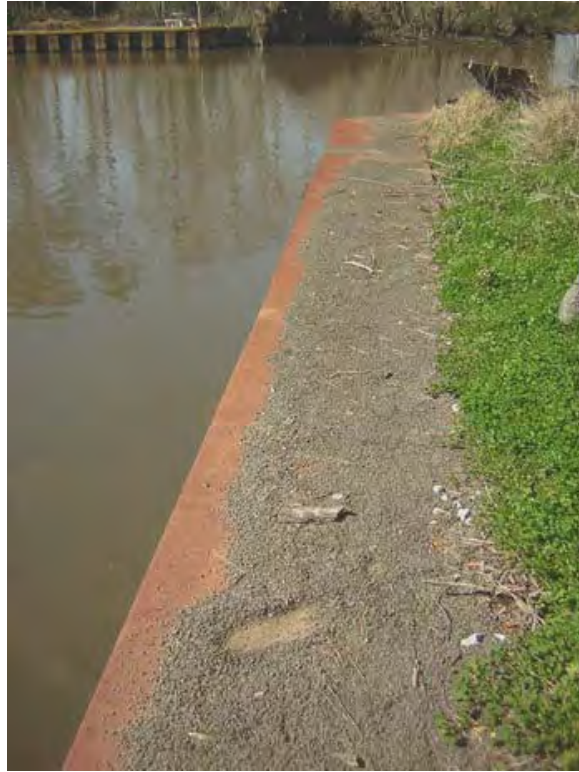
Photo 29: Dried sediment on top of sheet pile wall along bayou left behind by floodwaters associated with Hurricanes Katrina/Rita. Taken 2/16/2006

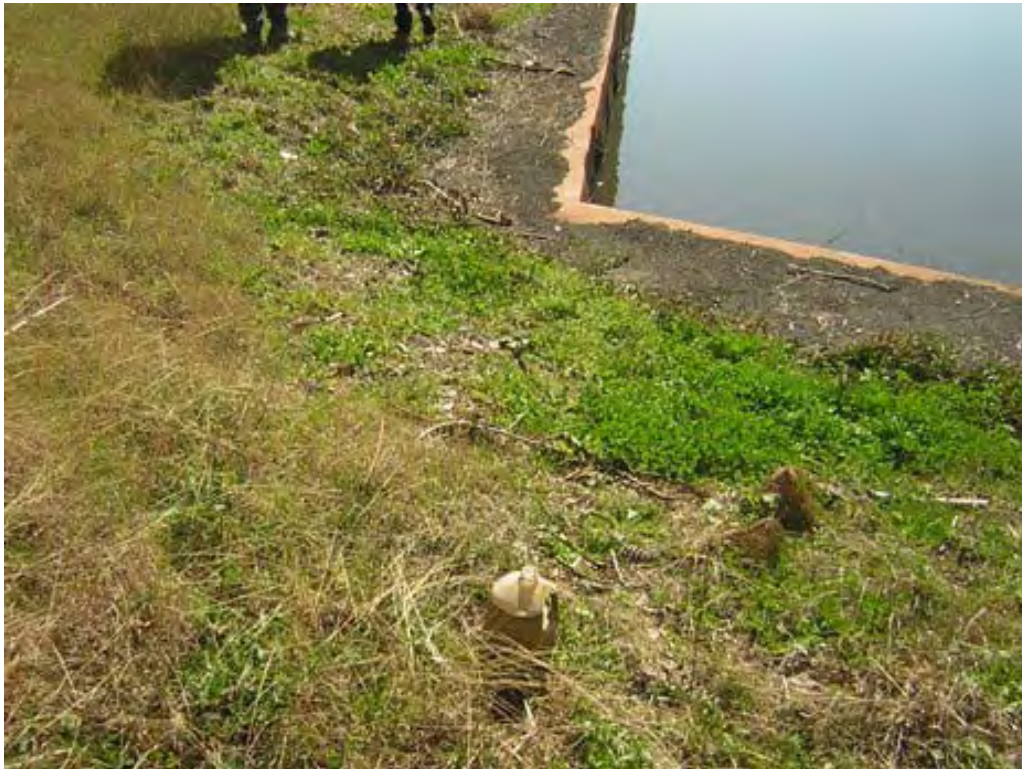
Photo 30: Dried sediment on top of sheet pile wall along bayou and debris left behind by floodwaters associated with Hurricanes Katrina/Rita. Taken 2/16/2006

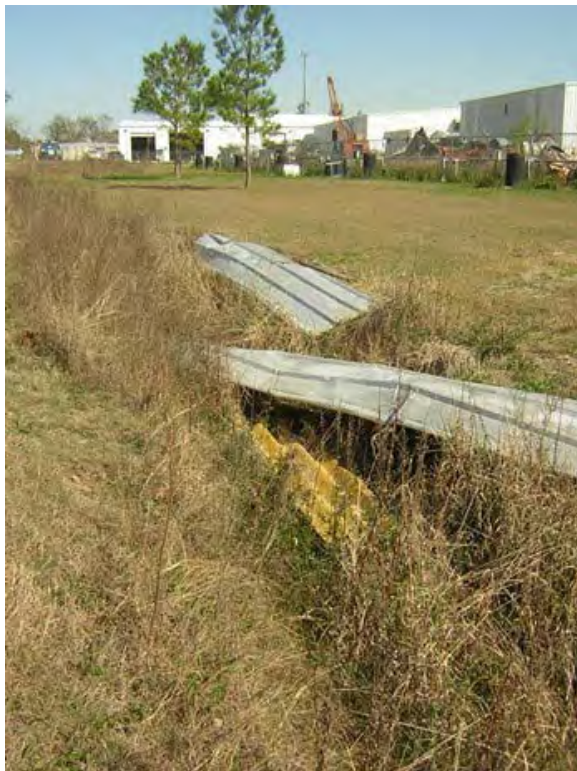
Photo 39: Looking north along surface drainage ditch. Debris from Hurricanes Katrina/Rita visible in ditch. Taken 2/16/2006

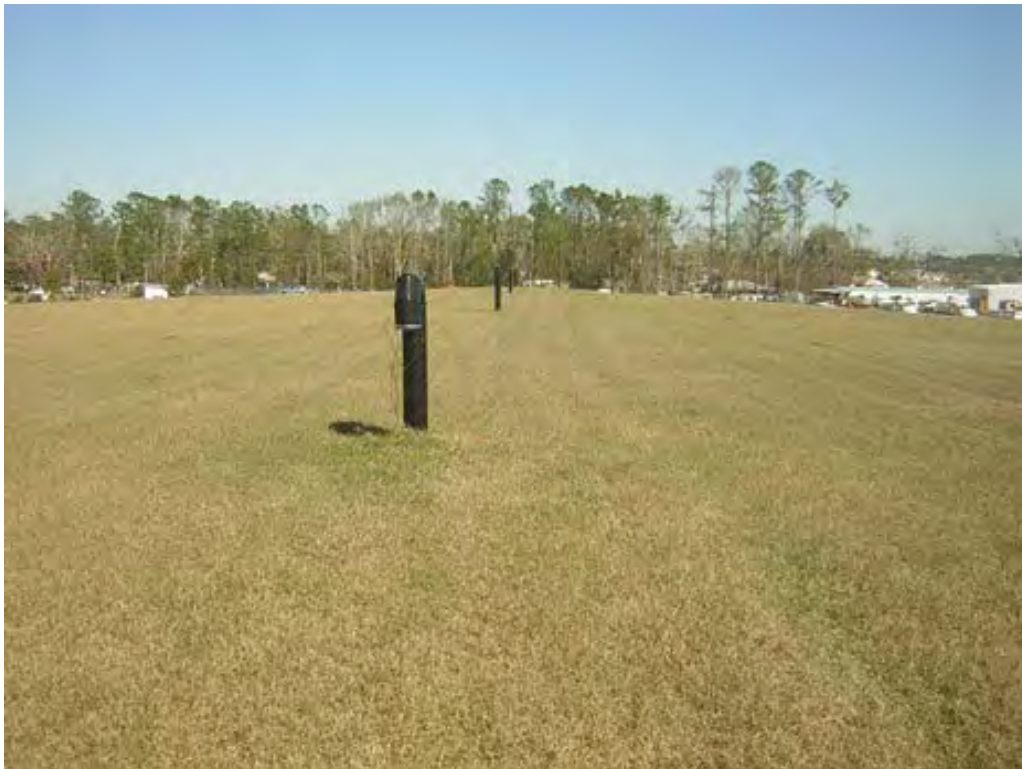
4. A small sapling, approximately three feet high, is growing near one of the landfill vents. If it is allowed to continue growing, its root system could damage the landfill capping system.

Photo 44: Looking north along line of vent pipes on top of landfill cover. Note small tree growing adjacent to vent pipe in foreground. Taken 2/16/2006

3. The hurricane damaged sections property line fence should be repaired to restrict unauthorized entry to the site.
4. A small tree (2-3 feet tall) was growing near a vent at the top of the landfill. If allowed to continue growing, the root system could damage the landfill cap. This tree should be removed before damage to the cap occurs.

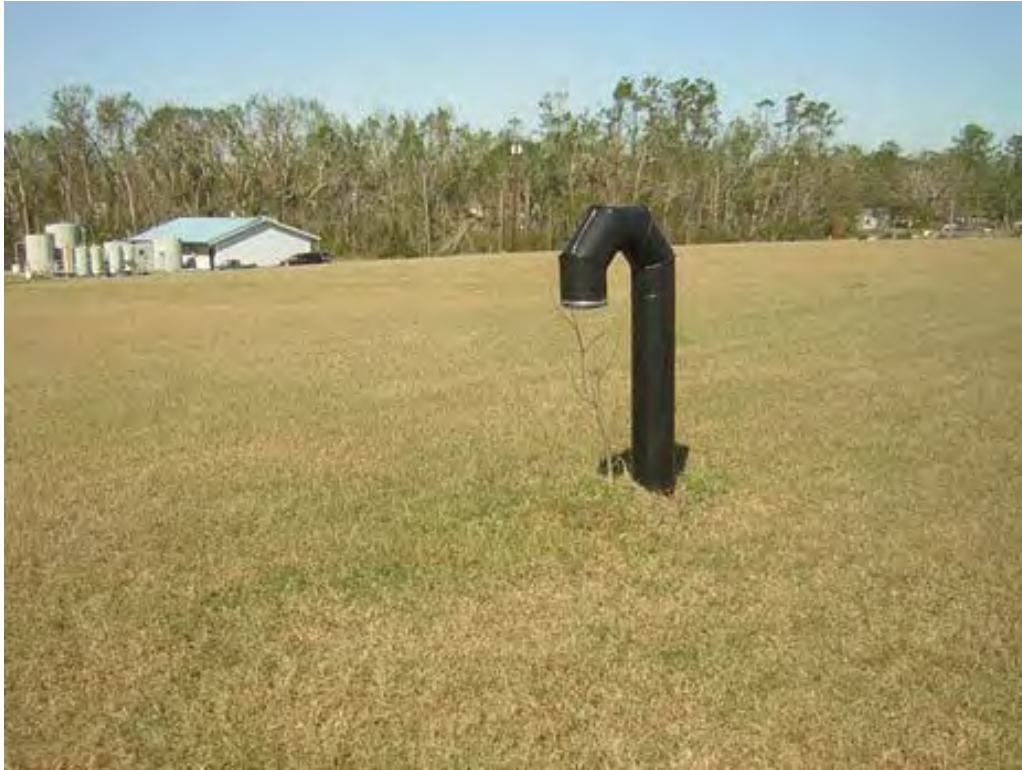
Photo 45: Vent pipe on top of landfill cover. Note small tree growing adjacent to vent pipe. Taken 2/16/2006

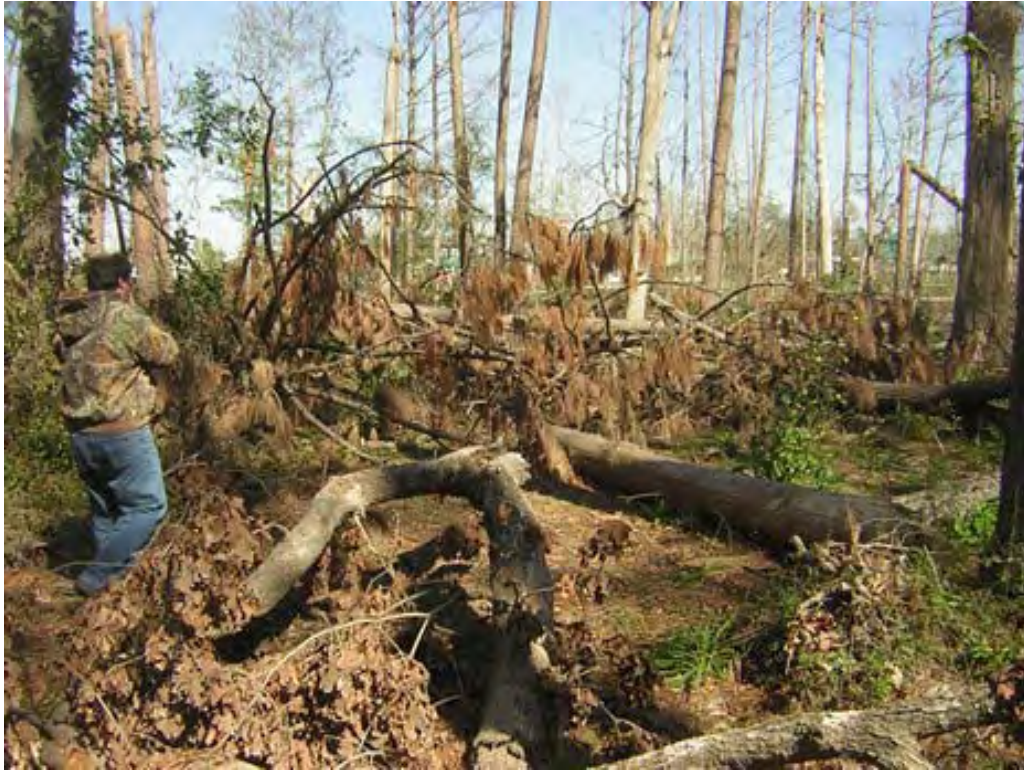
Photo 47: West side of Bayou Bonfouca at south end of recovery array 3. Downed trees associated with hurricane damage. Taken 2/16/2006

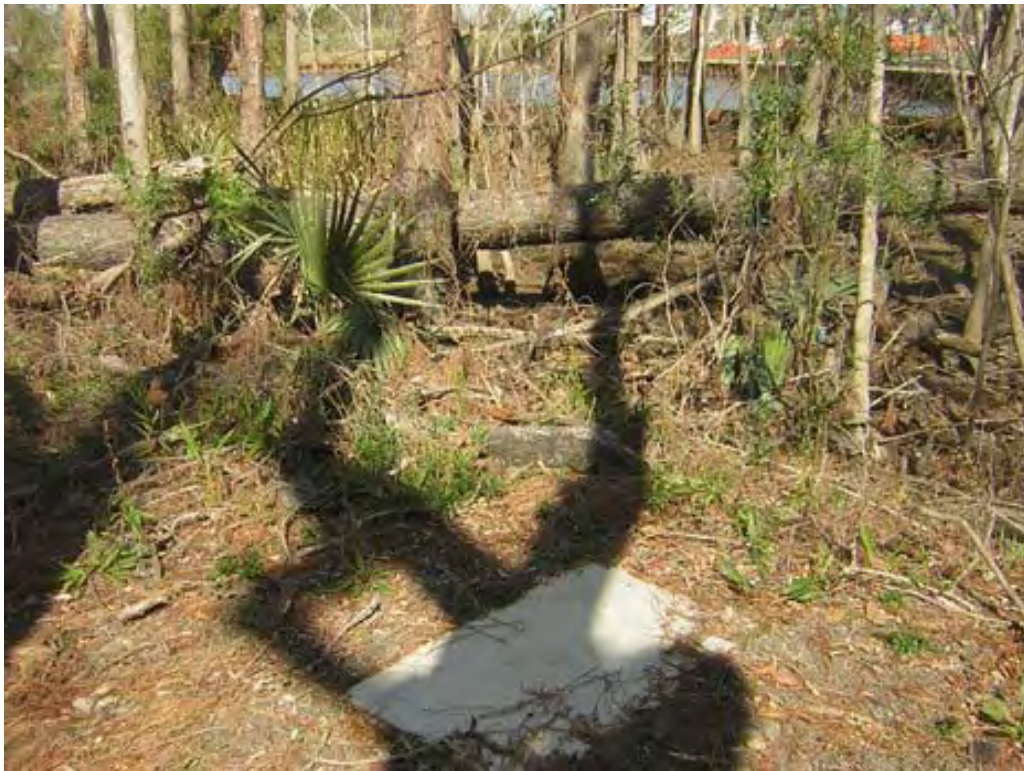
Photo 48: West side of bayou, south end of recovery array 3. Well vault cover visible in foreground. Downed trees associated with hurricane damage. Taken 2/16/2006.

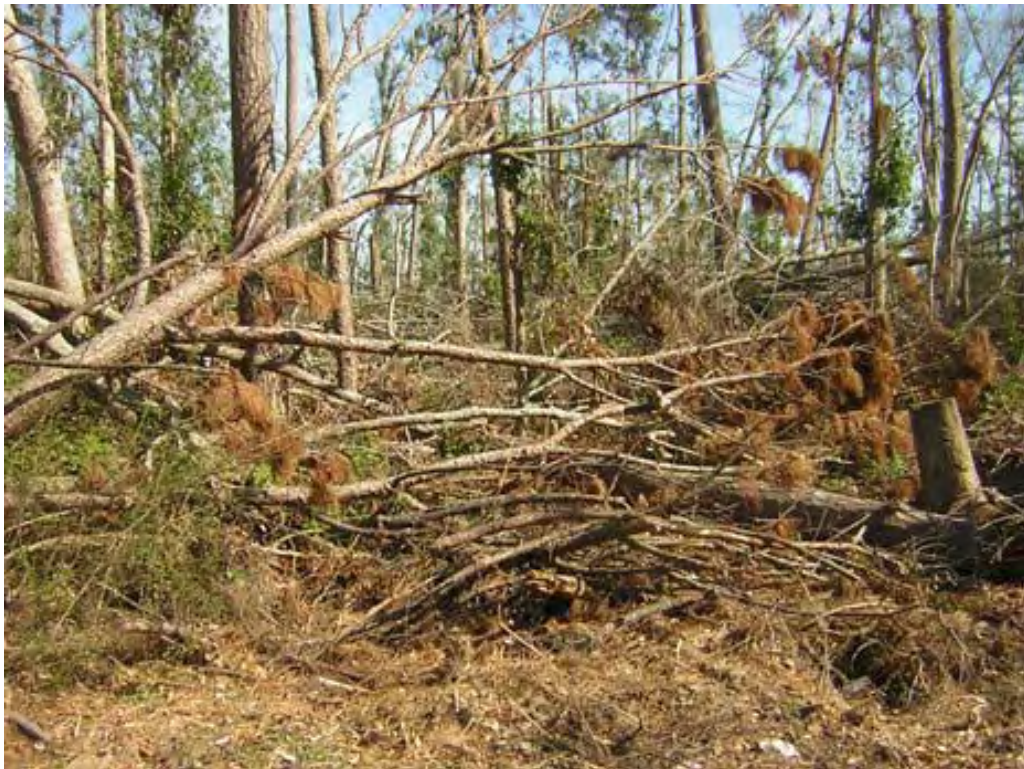
2. Labeling on some treatment system components has faded or is no longer legible.
3. The property line fence north and west of the site that runs through the wooded area sustained damage from downed trees from Hurricane Katrina. The damaged fence could allow unauthorized access to the site.

Photo 56: Downed trees along east side of St. Tammany Street. Top rail of perimeter site fence visible in background. Taken 2/16/2006

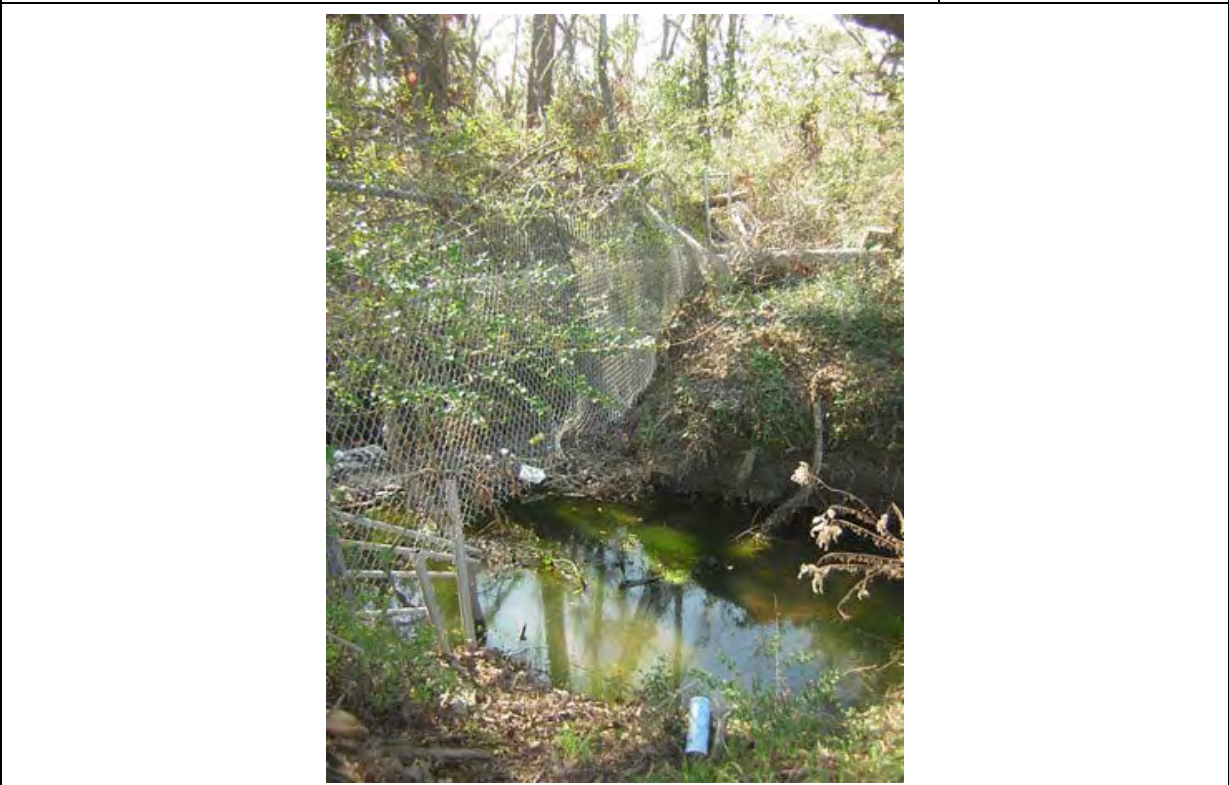
Photo 60: Damaged perimeter fence west of site entrance gate. Taken 2/16/2006
