**THIRD FIVE-YEAR REVIEW
FOR THE
MID-SOUTH WOOD PRODUCTS SUPERFUND SITE
MENA, ARKANSAS**

SEPTEMBER 2007

**UNITED STATES ENVIRONMENTAL PROTECTION AGENCY
REGION 6
DALLAS, TEXAS**

**THIRD FIVE-YEAR REVIEW FOR
MID-SOUTH WOOD PRODUCTS SUPERFUND SITE
MENA, ARKANSAS
EPA ID# ARD092916188**

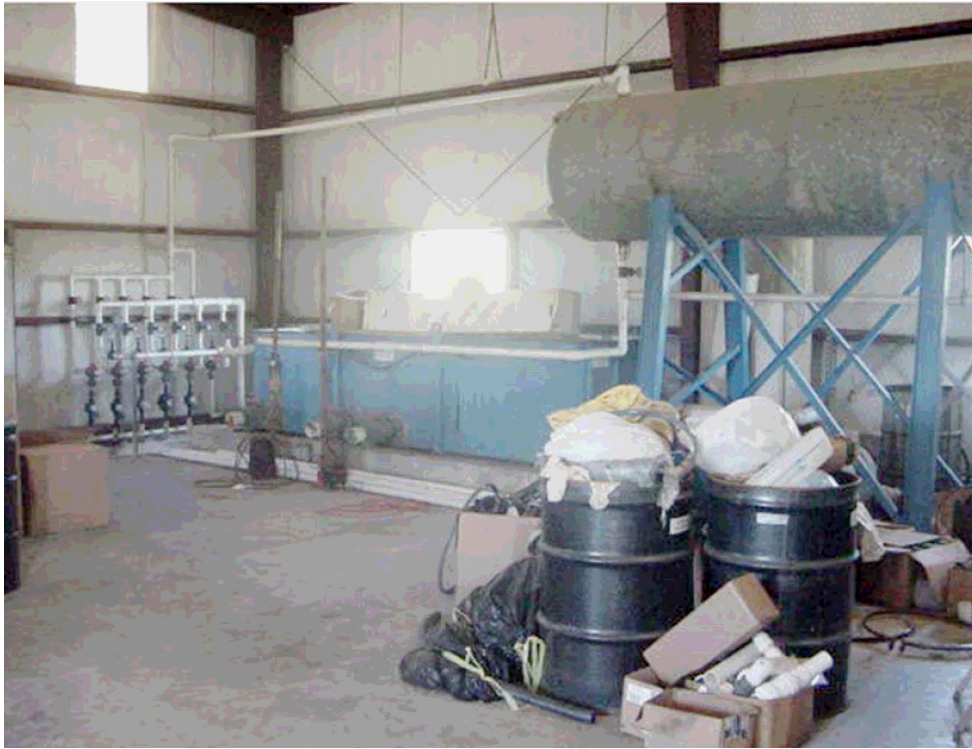
Photo 1: Oil-Water separator within wastewater treatment plant (WWTP)

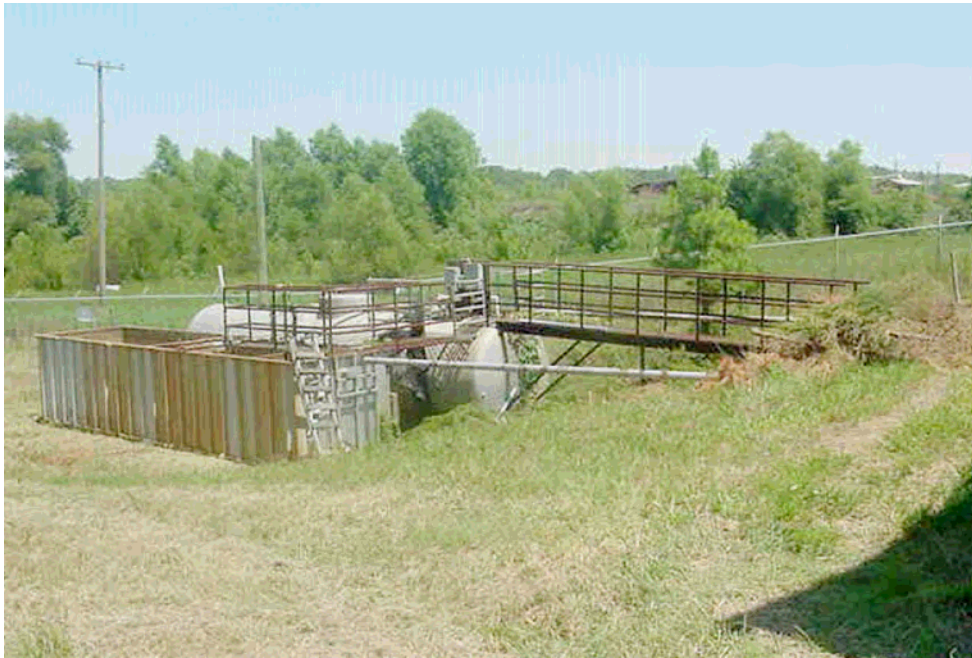
Photo 2: Storage and Overflow tanks north of (WWTP)

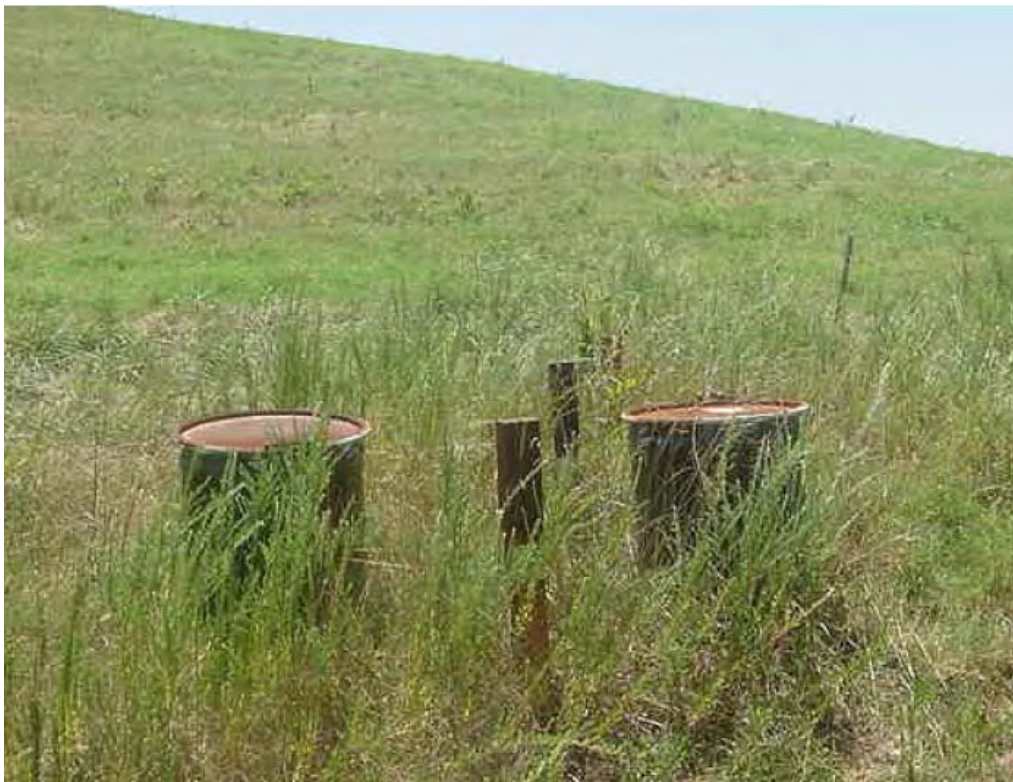
- Monitoring well -11 and observation wells M-4A and M-4B should be properly secured. The hinged protective casing for monitoring well MW-11 should be repaired.

Photo 4: MWs 4A & 4B; North Landfarm area in background

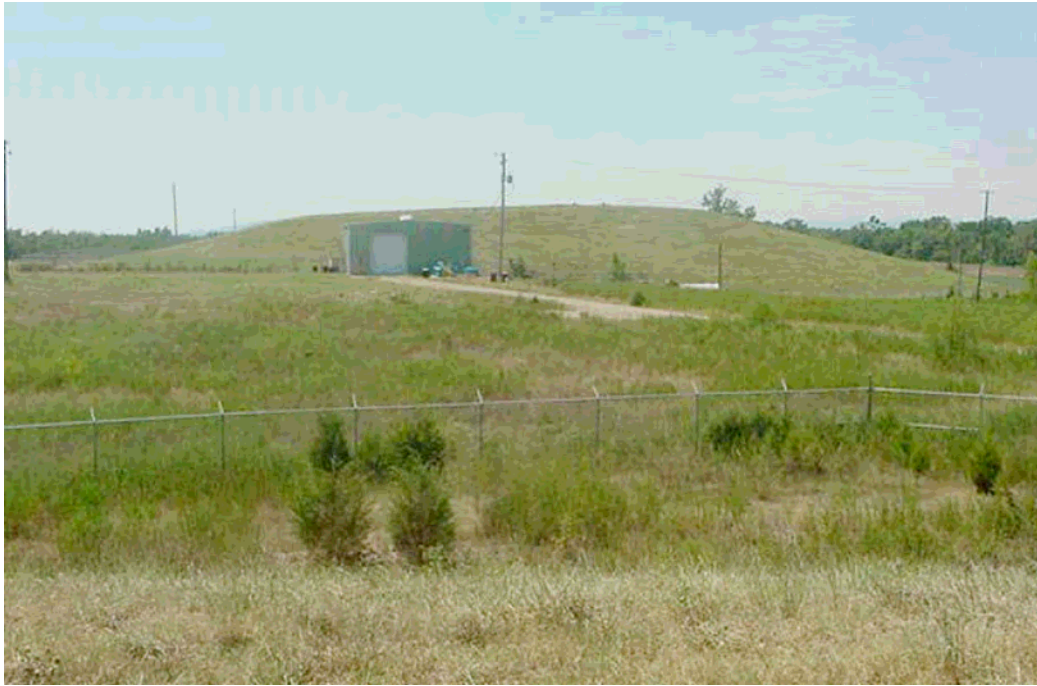
The RAO to protect human health and the environment by preventing direct contact, ingestion, and migration of the wood-treating wastes and associated soils continues to be met by the intact caps (North Land Farm and Old Pond Areas). The caps were noted to be in good condition. In addition, the fence, gates, locks, and signs are in place and verified sound.

Photo 5: Standing on Old Pond capped area; note WWTP in distance and landfarm capped area; note perimeter security fence, which encircles Old Pond; fence also encircles Landfarm capped area

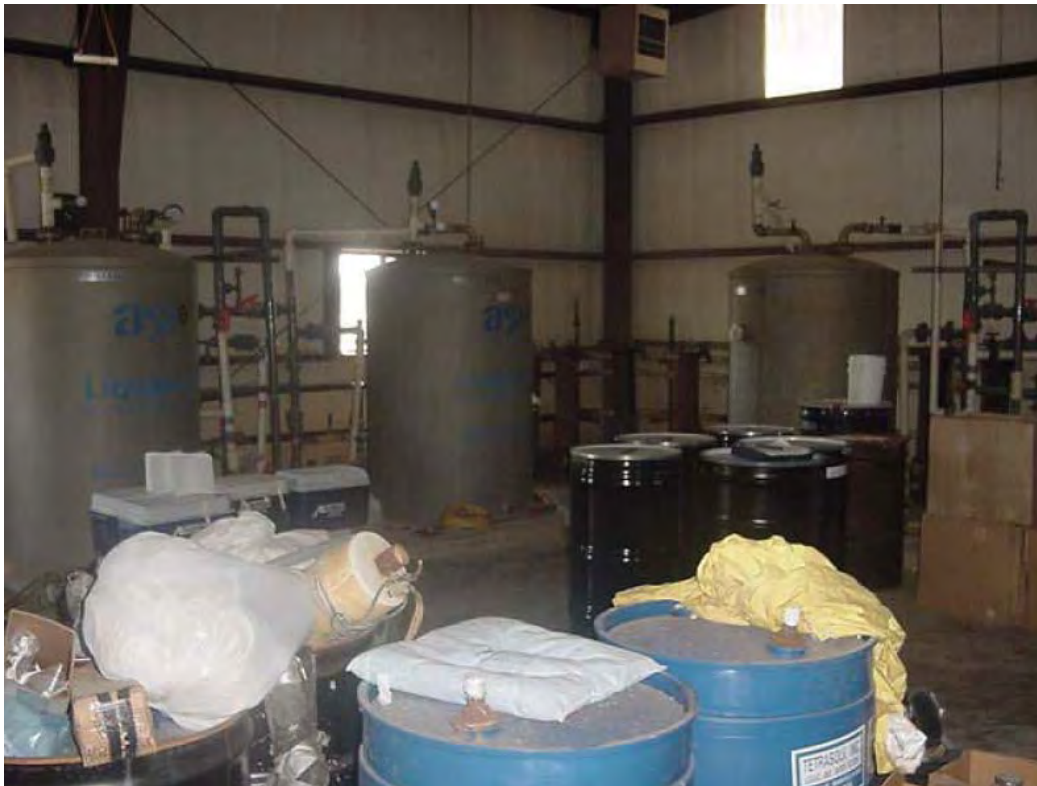
Inspections of the water-treatment facility resulted in both routine maintenance (such as cleaning and changing the filtration socks and backwashing the carbon canisters) and repairs (electrical and plumbing) while the plant was operational between 2000 and 2003.

Photo 6: Activated carbon canisters and fabric filters on south side of WWTP

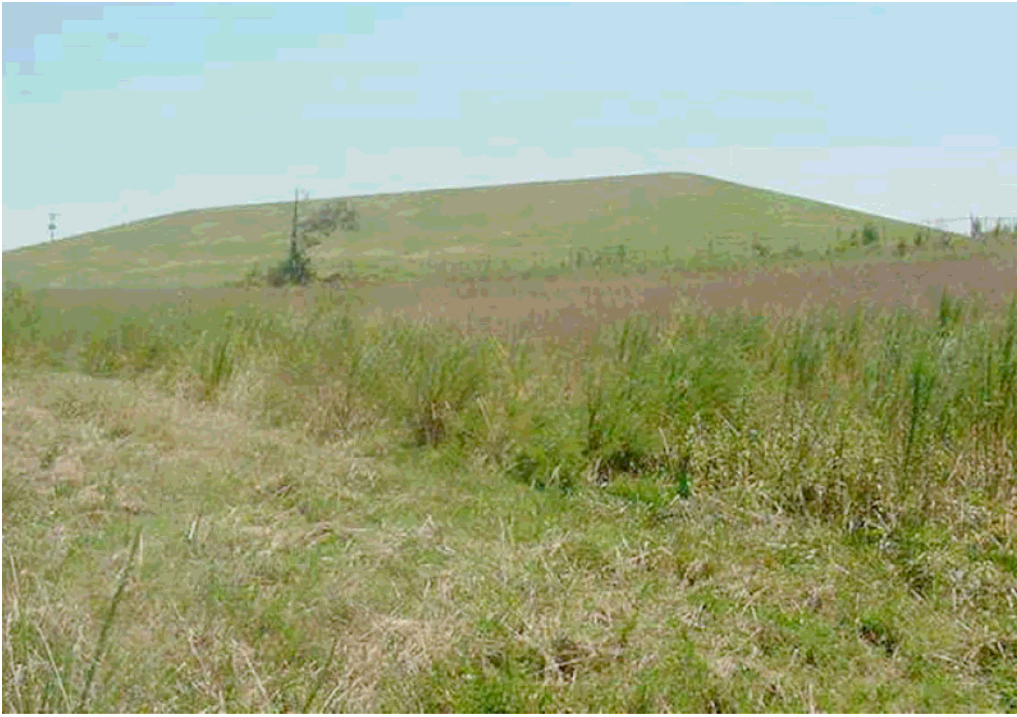
Photo 7: Landfill area

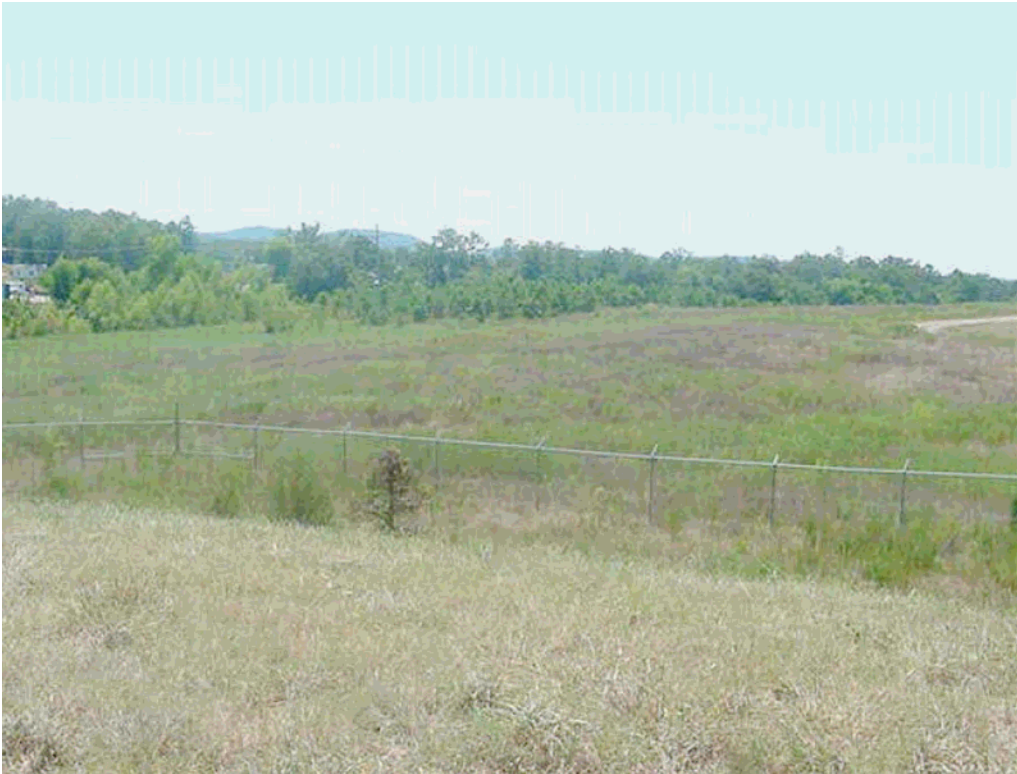
Photo 8: Former South Landfarm area
