Five-Year Review Report

Second Five-Year Review Report for North Cavalcade Street Houston, Harris County, Texas

September 2003

FIVE-YEAR REVIEW
North Cavalcade Street Superfund Site
EPA ID# TXD980873343
Houston, Harris County, Texas

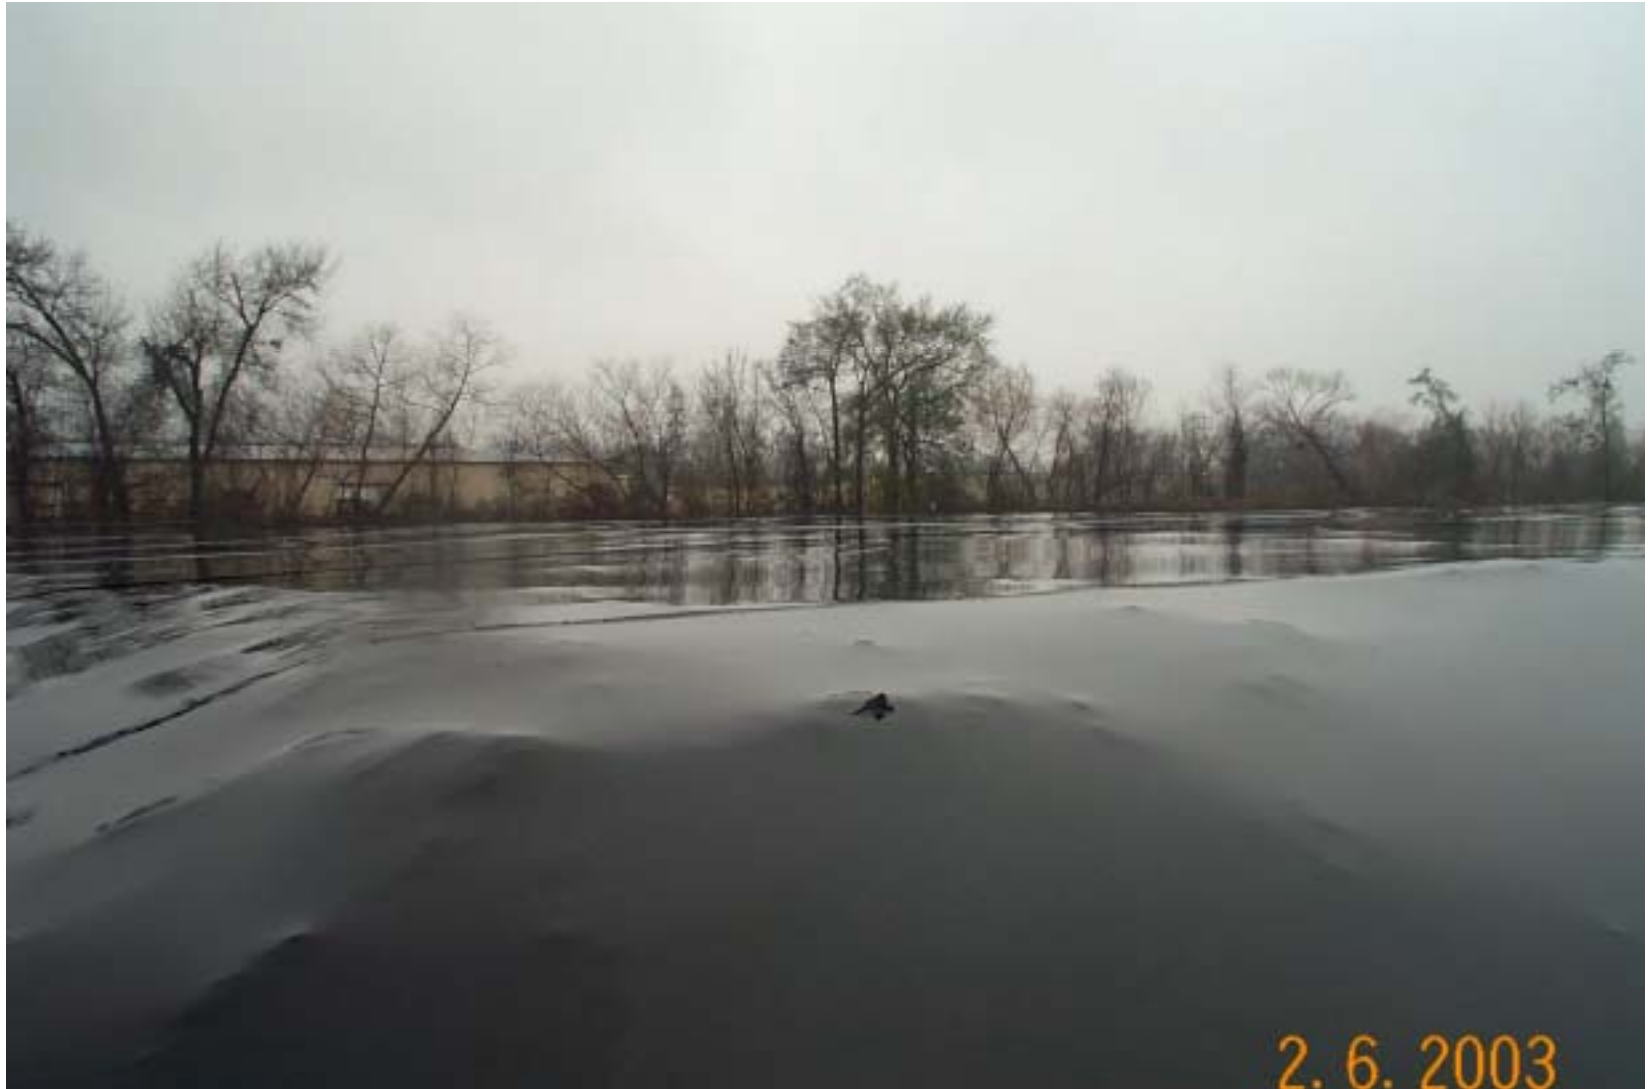
Photograph 3 of 53

The soil bio-pile is contained on the northern portion of the North Cavalcade Street site, and access is restricted appropriately by fencing on all four sides. During the second five-year review inspection, there were minor tears noted in the HPDE cover. TCEQ's contractor has since repaired the tears and now conducts monthly inspections of the cover and leachate collection system. Although the bio-pile is contained and contact with soils is further prevented with the cover, this is considered a temporary remedy. Other options will be re-evaluated after the ground water work has been completed.

Looking northwest from the southeast corner of the covered biopile. Note the apparent tear in the biopile cover.

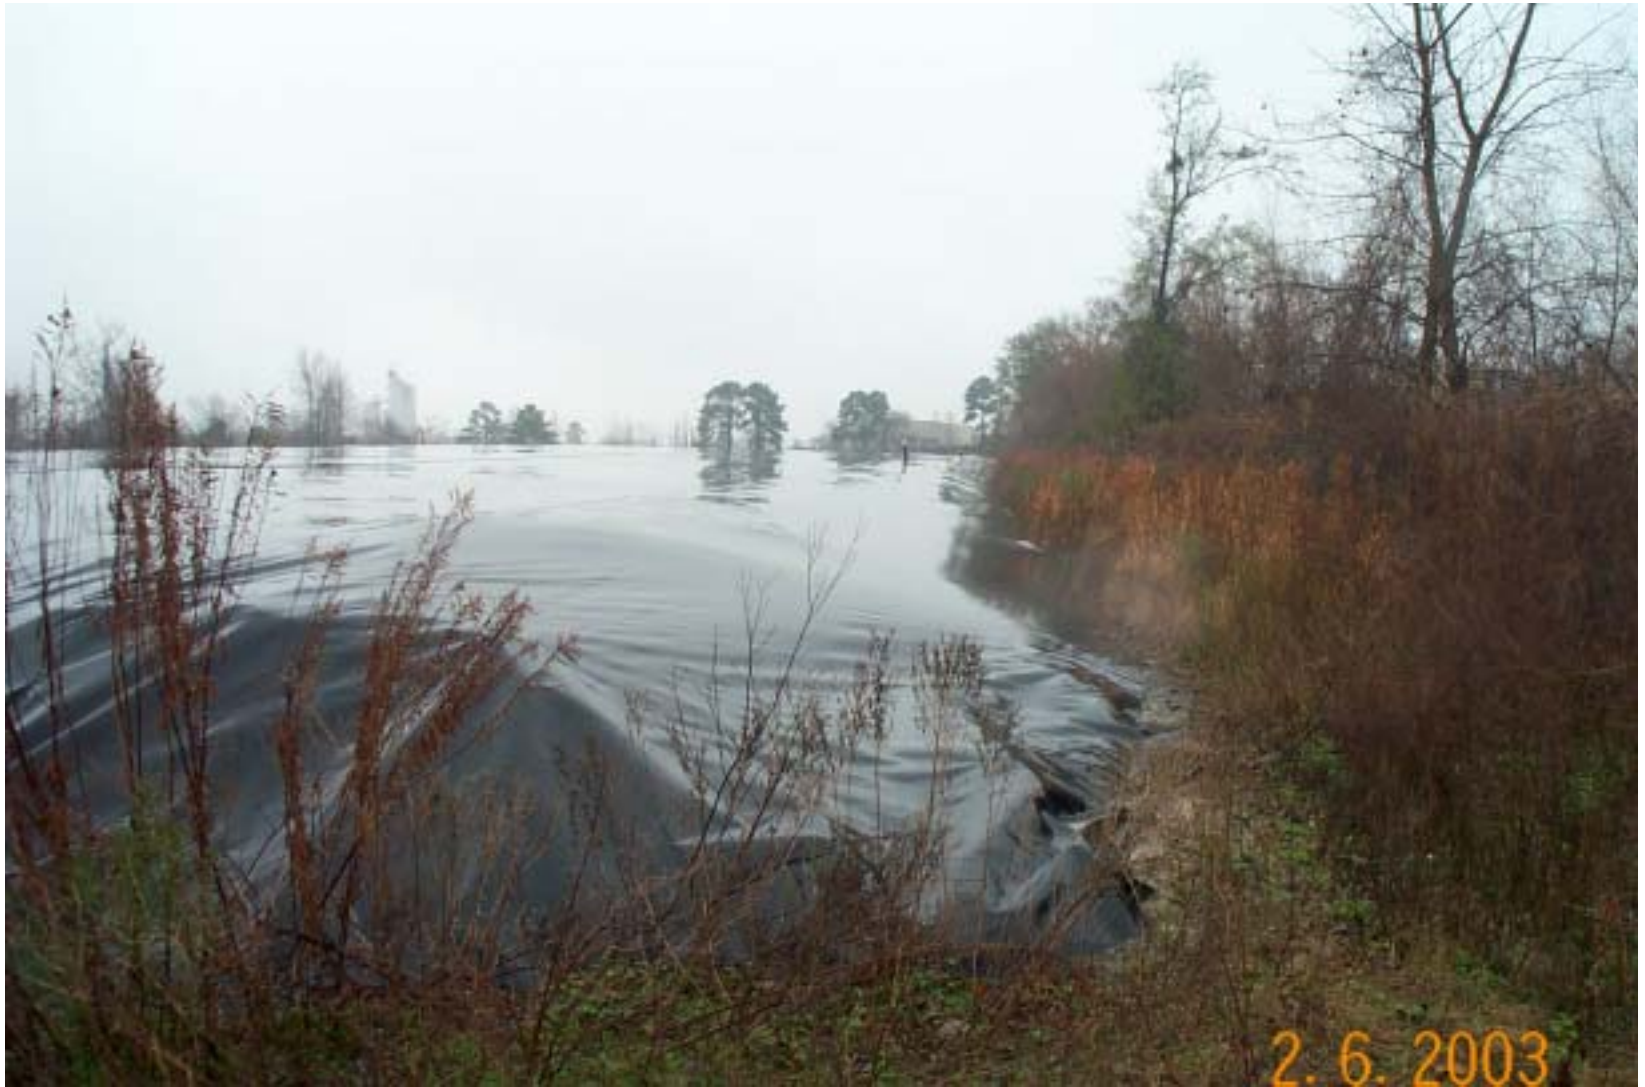
Photograph 13 of 53

Looking south from the north west corner of the covered biopile, along the west side of the covered biopile. The biopile cover appears to be loose and soil may have been released from the cell (either at the time of installation or since that time).

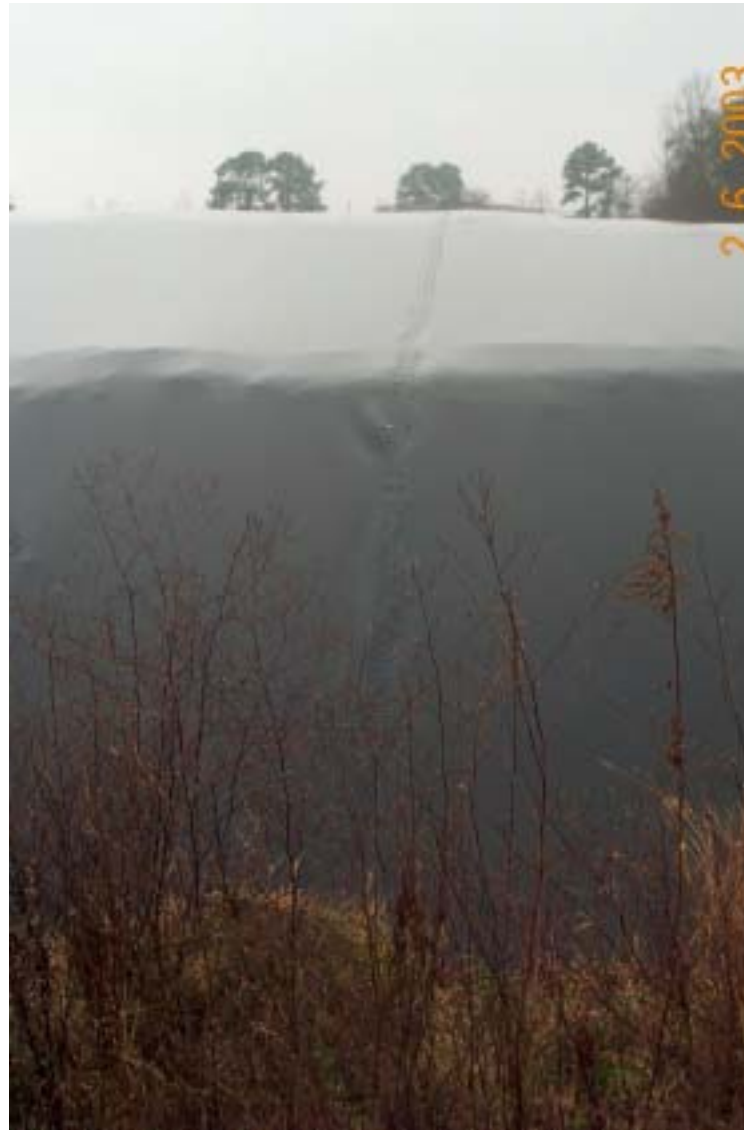
Looking west, across the biopile cover, at a seam in the cover.

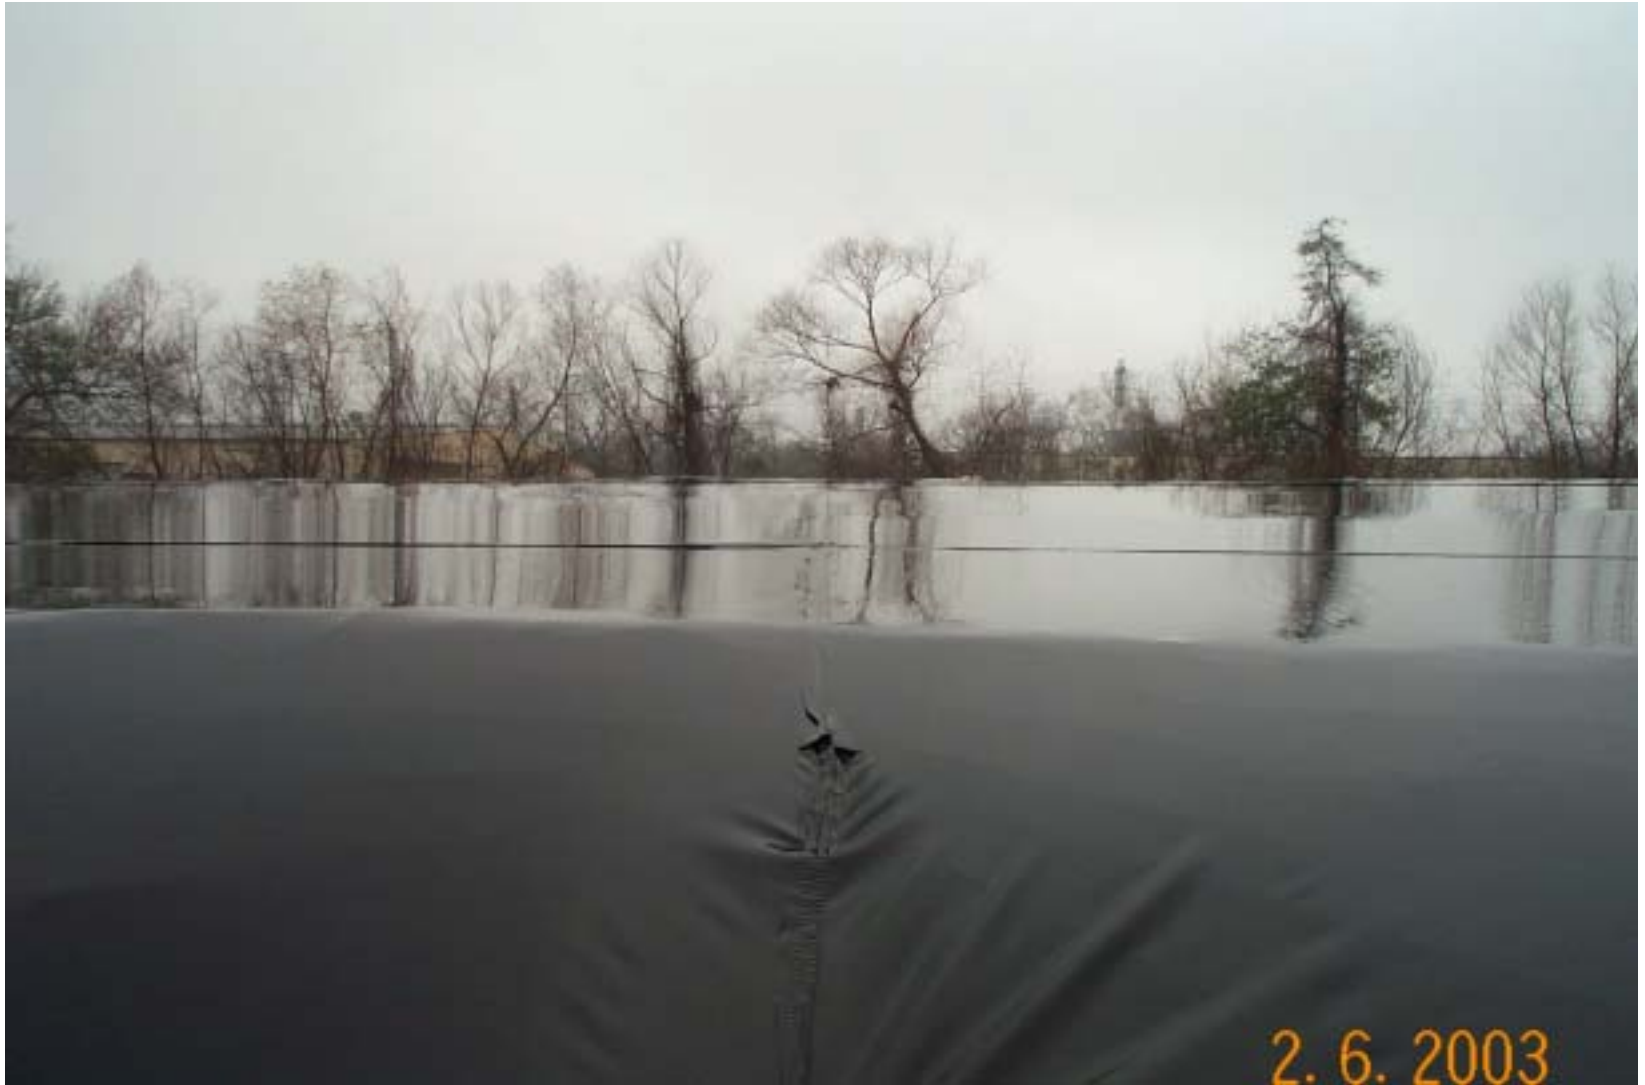
Photograph 16 of 53

Looking west, across the biopile cover. The seam in the center of the photograph appears to be torn.

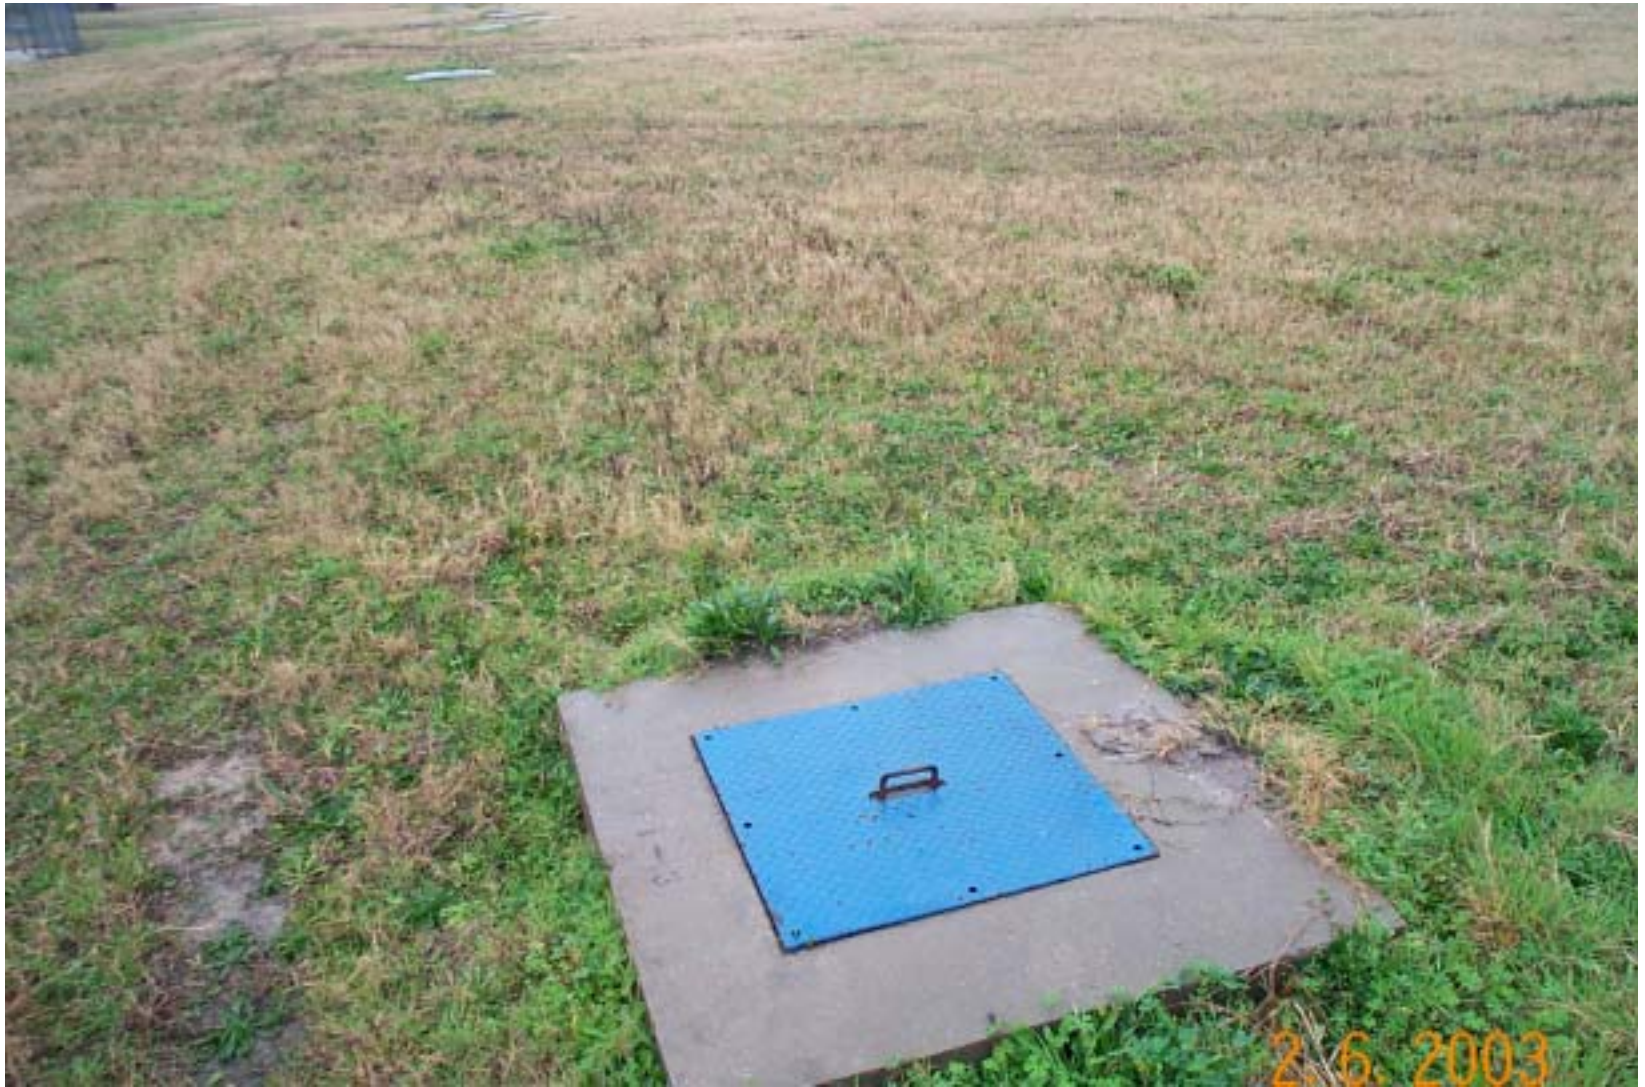
Photograph 26 of 53

- During the site inspection in February 2003, it was noted that the extraction wells and ground water monitoring wells could be accessed by walking around the gate and fence at Cavalcade Street or crossing the railroad tracks located on the east boundary of the site. The well covers were not locked.

Extraction well E1-3. The vault cover is not secured to the concrete pad.

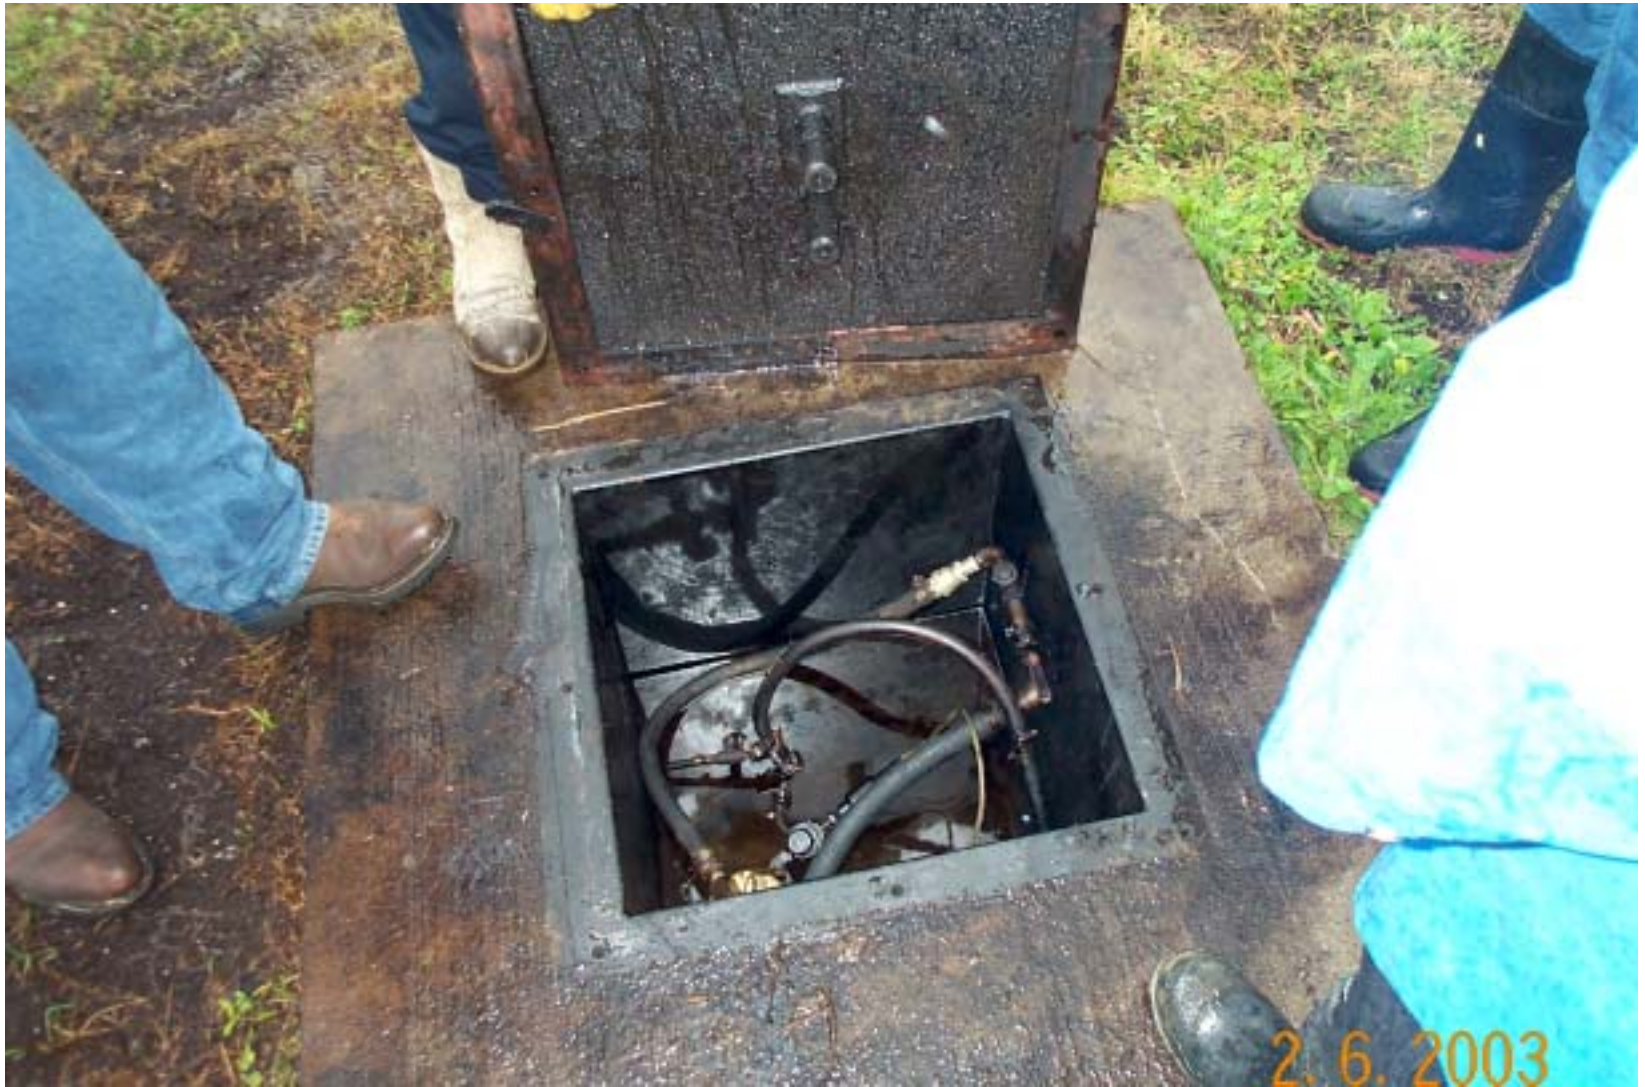
Photograph 30 of 53

An Extraction well. DNAPL in vault is from a recent leak. The leak has been repaired.

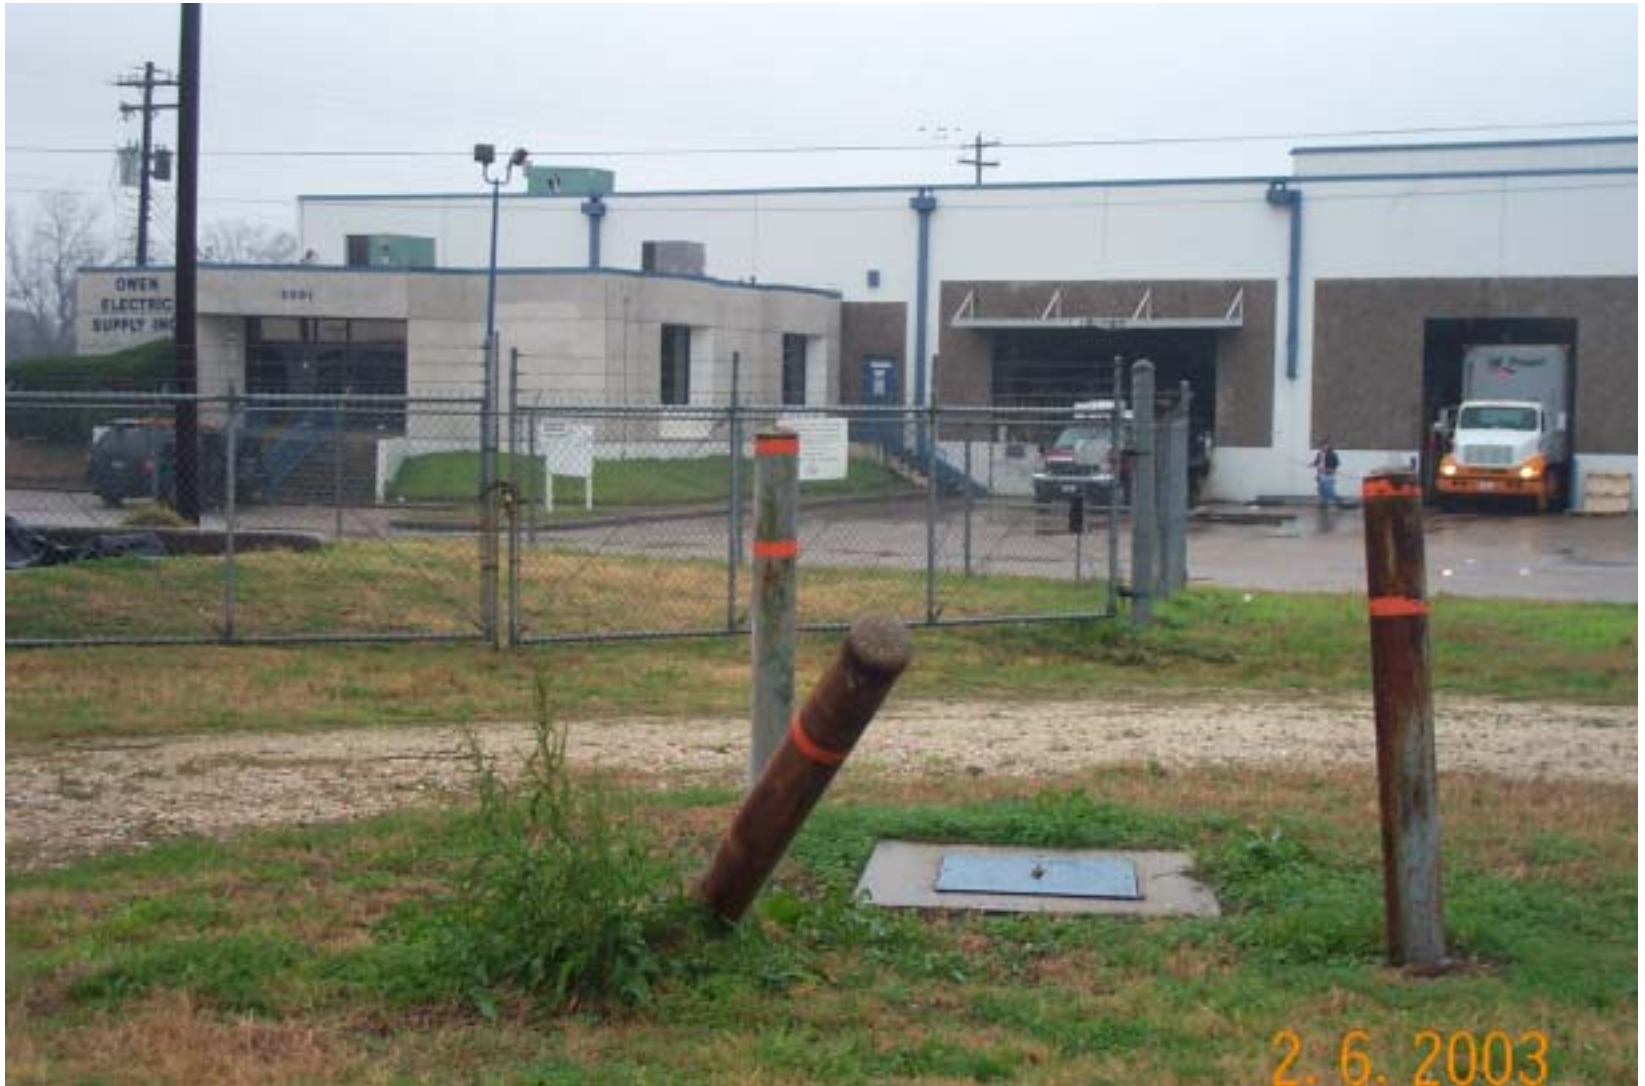
Looking west towards Owens Electrical Supply Inc. An extraction well is in the foreground/one of the protective posts is bent. The groundwater treatment system is to the left of the photograph inside the security fence.

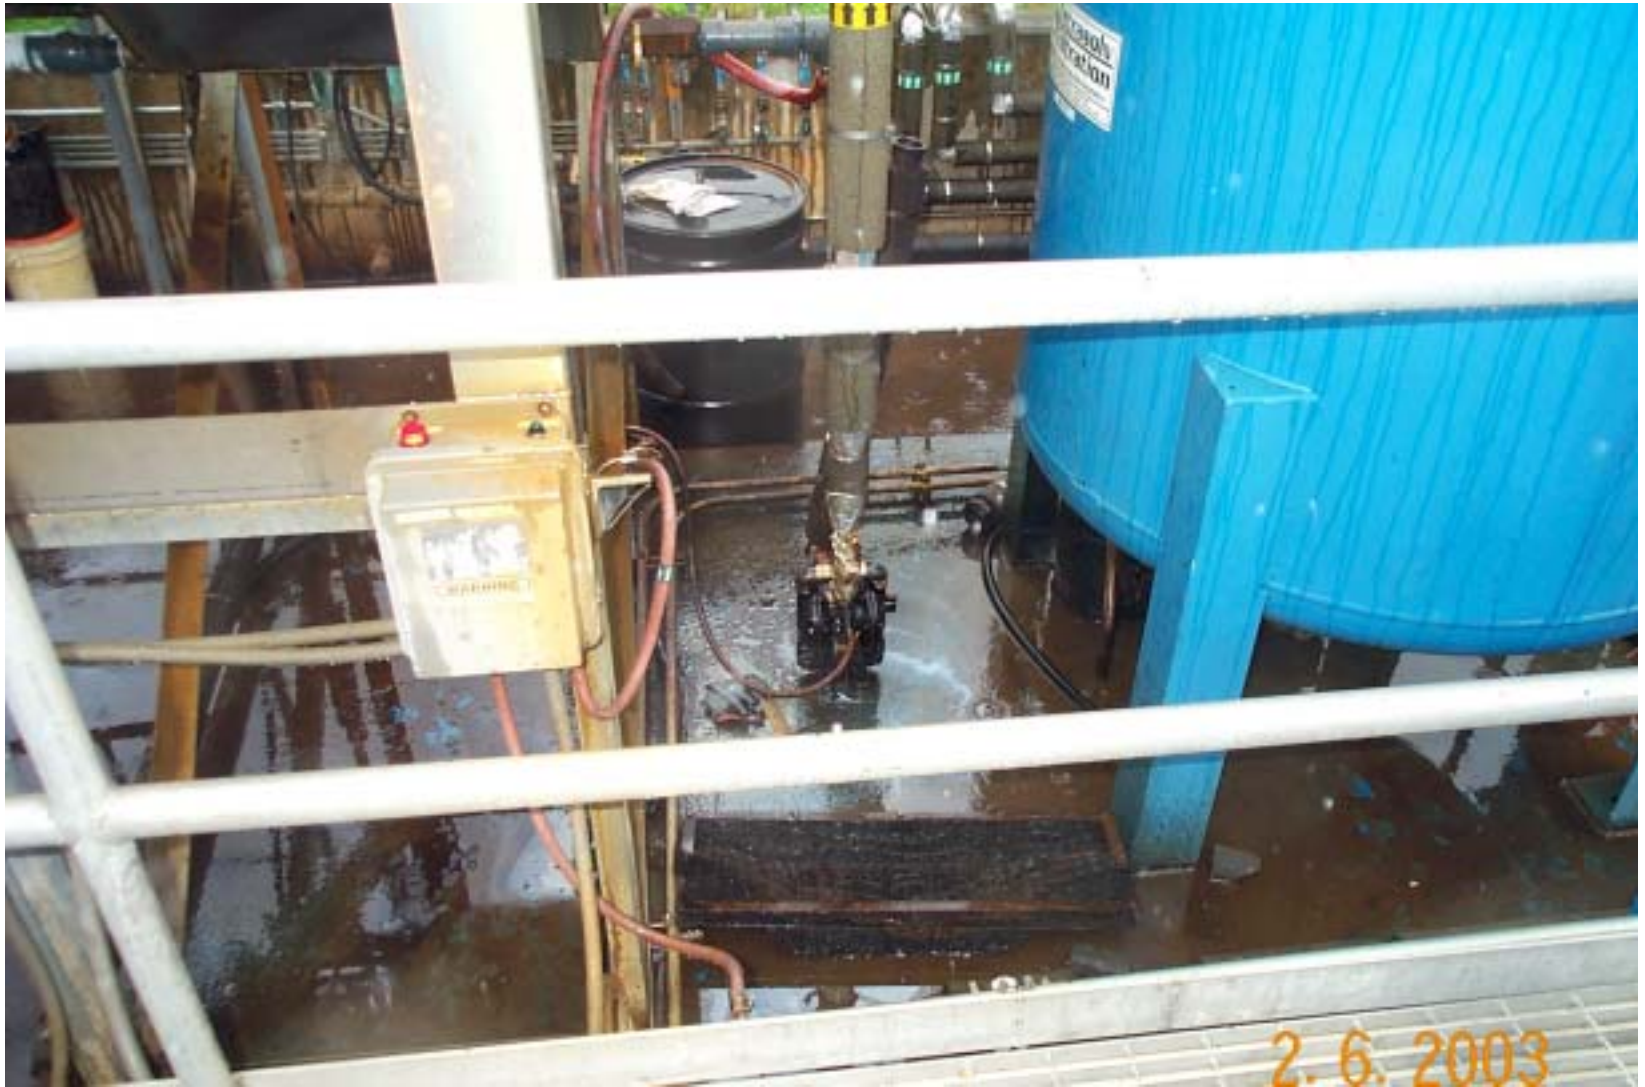
Photograph 41 of 53

Groundwater treatment system. The blue tank is for DNAPL storage (currently not used). Note the spent filter on the floor of the secondary containment structure in the center foreground.
