First Five-Year Review Report

Sprague Road Ground Water Plume Superfund Site Odessa, Ector County, Texas

September 2008

FIRST FIVE-YEAR REVIEW REPORT
Sprague Road Ground Water Plume Superfund Site
EPA ID No. TX0001407444
Ector County, Texas

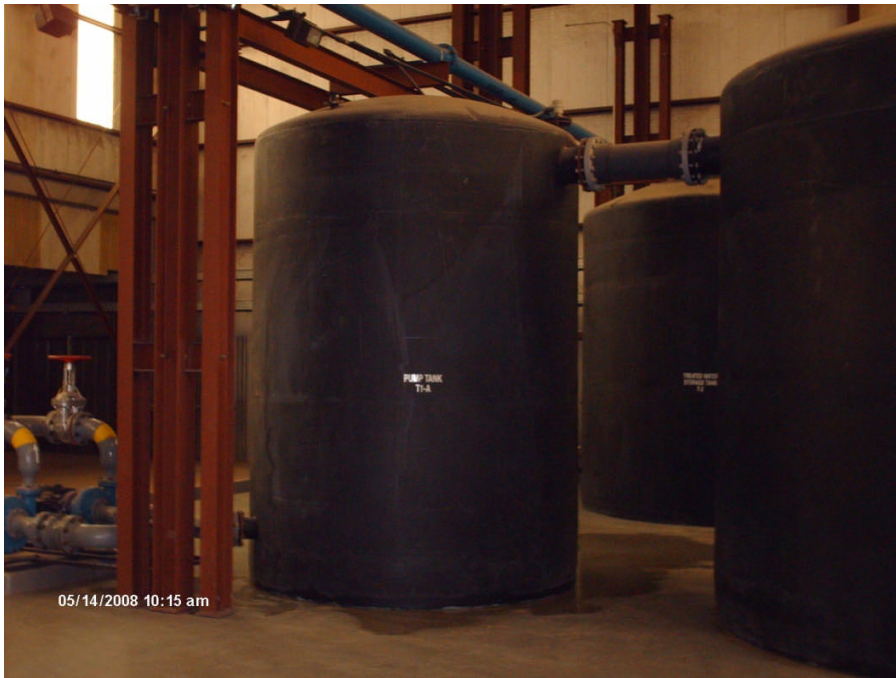
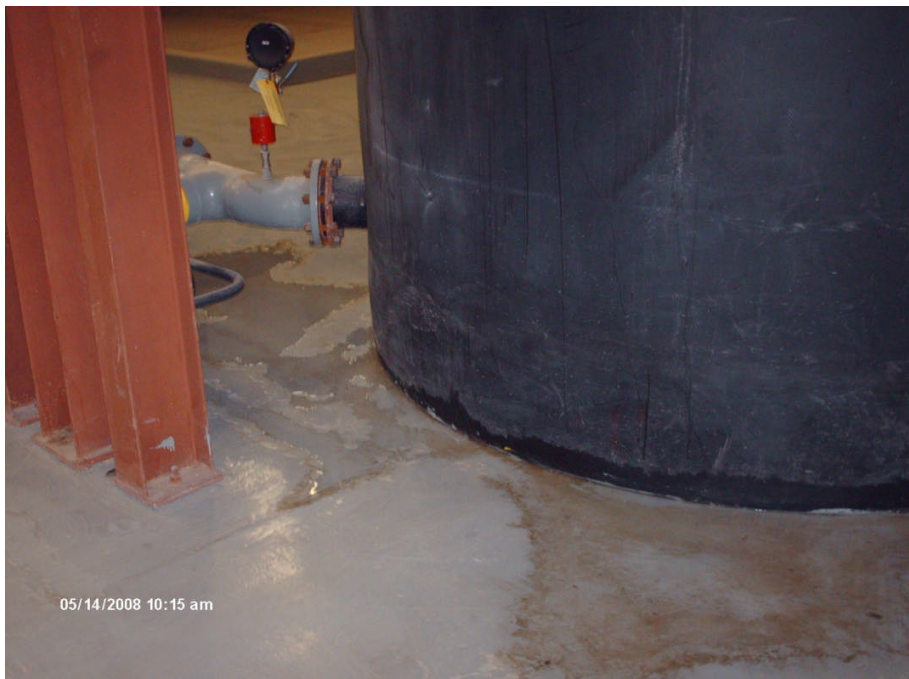
Photograph No. 1 Site: Sprague Road Ground Water Plume Superfund Site
Description: View of leaking Tank T-1A inside the LM treatment facility.
Date: 14 May 2008

Photograph No. 2 Site: Sprague Road Ground Water Plume Superfund Site
Description: Additional view of leaking Tank T-1A.
Date: 14 May 2008

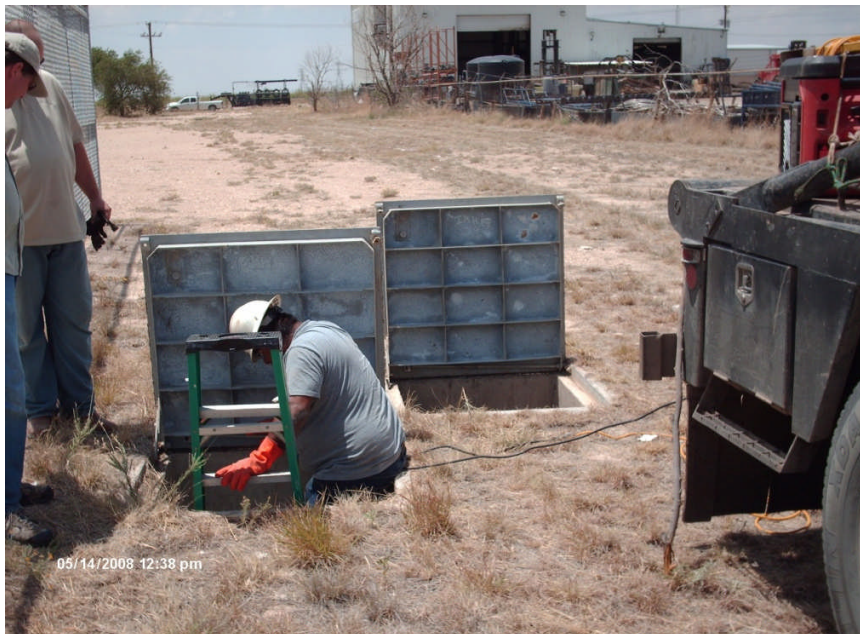
- **Corrosion of electrical components in the well vaults**—Electrical pull boxes at the Machine and Casting (M&C) facility were flooded at the time of Site inspection as a result of rainfall earlier in the week. The Site inspection team observed contractors drilling drainage holes in the electrical pull boxes in order to alleviate the problem and prevent water migrating along the conduit and flooding the well vaults. Corroded electrical components were replaced in numerous recovery and injection well vaults in 2007, and Coyote Pump Protectors were installed on select recovery wells in order to make the wells less vulnerable to flooding.

Photograph No. 3 Site: Sprague Road Ground Water Plume Superfund Site
Description: View of contractor drilling drainage holes in flooded electrical pull boxes at the M&C facility.
Date: 14 May 2008

- Complete maintenance and repair work on the electrical components for the ground water extraction and injection network. The installation of Coyote Pump Protectors, drainage holes in electrical pull boxes, and replacement of corroded electrical components should be completed as planned.

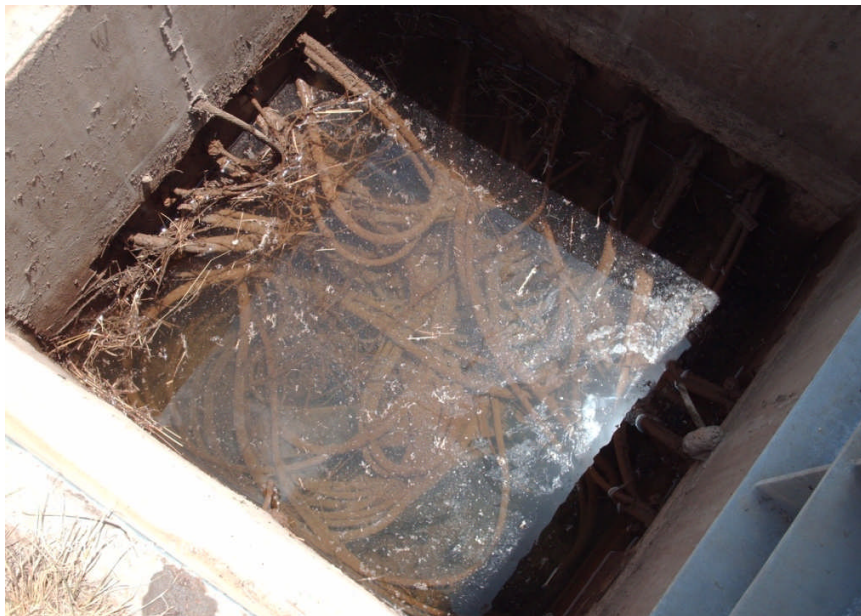
Photograph No. 4 Site: Sprague Road Ground Water Plume Superfund Site
Description: View of flooded electrical pull box at the M&C facility.
Date: 14 May 2008

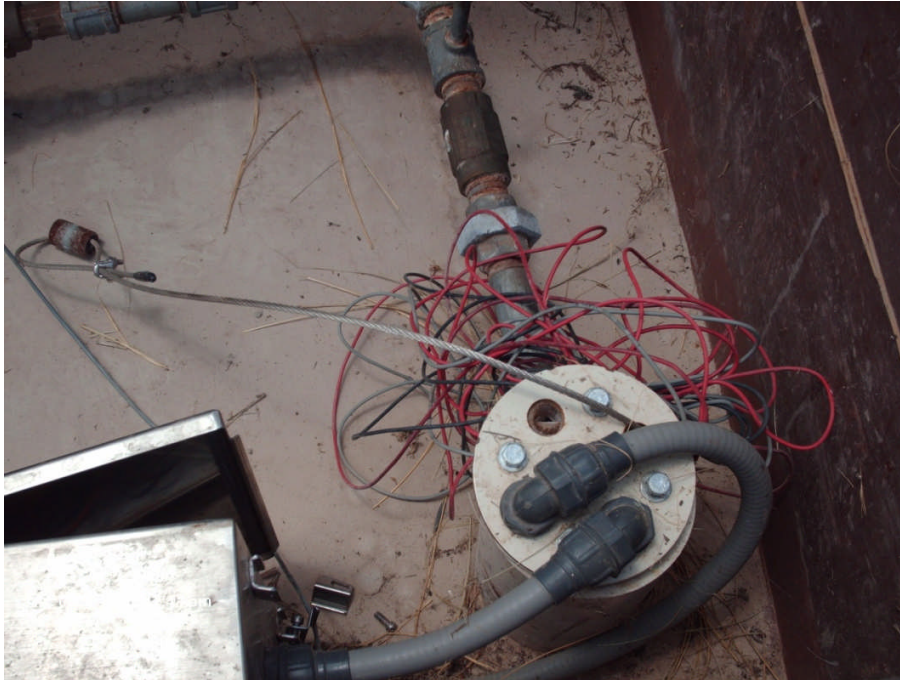
Photograph No. 5 Site: Sprague Road Ground Water Plume Superfund Site
Description: View of wiring in extraction well MRW-2.
Date: 14 May 2008

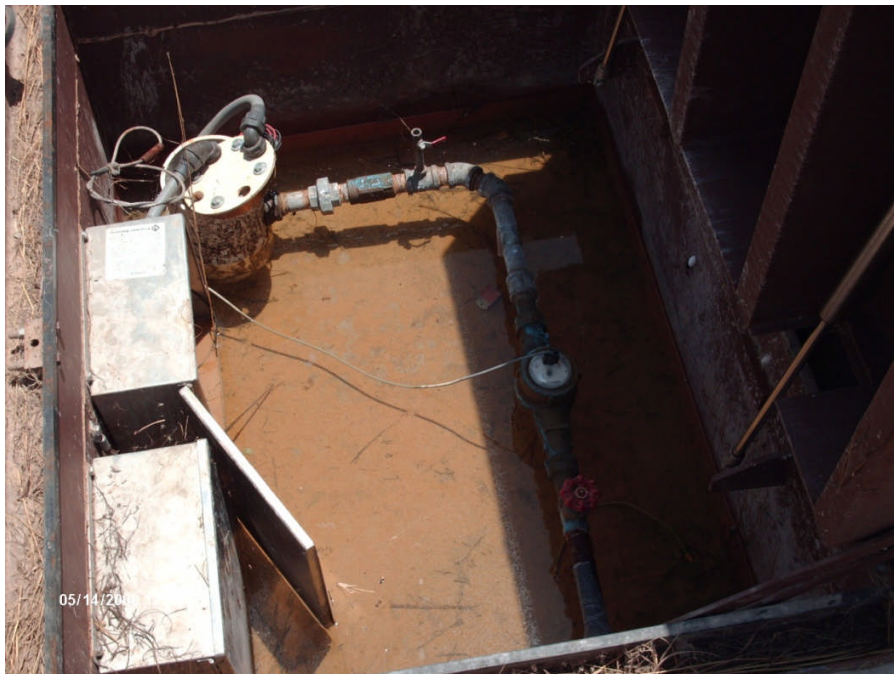
Photograph No. 6 Site: Sprague Road Ground Water Plume Superfund Site
Description: View of flooded well vault in extraction well MRW-1.
Date: 14 May 2008

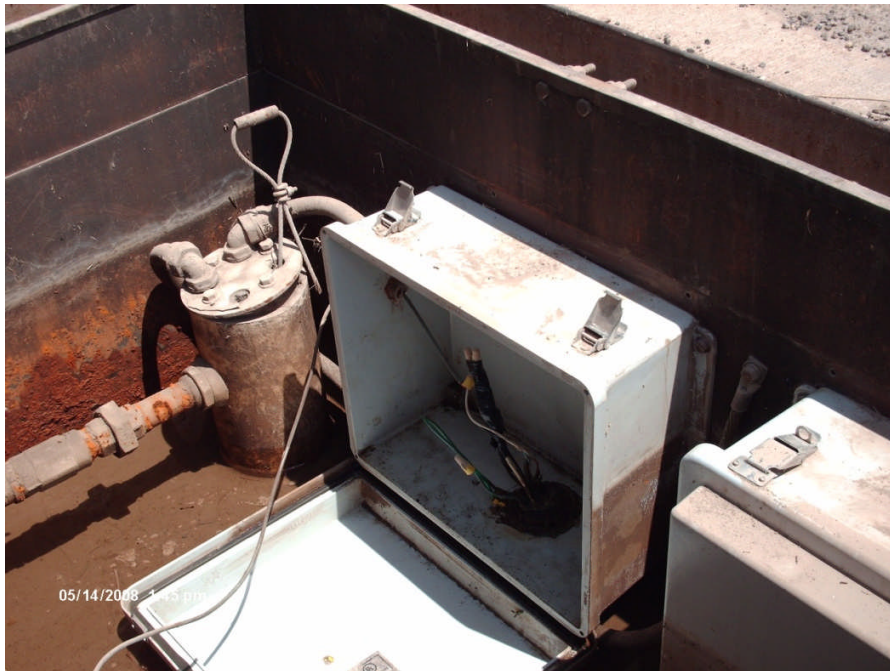
Photograph No. 7 Site: Sprague Road Ground Water Plume Superfund Site
Description: View of wiring in extraction well NRW-17. The Coyote controller eliminates the need for relays in the vaults.
Date: 14 May 2008

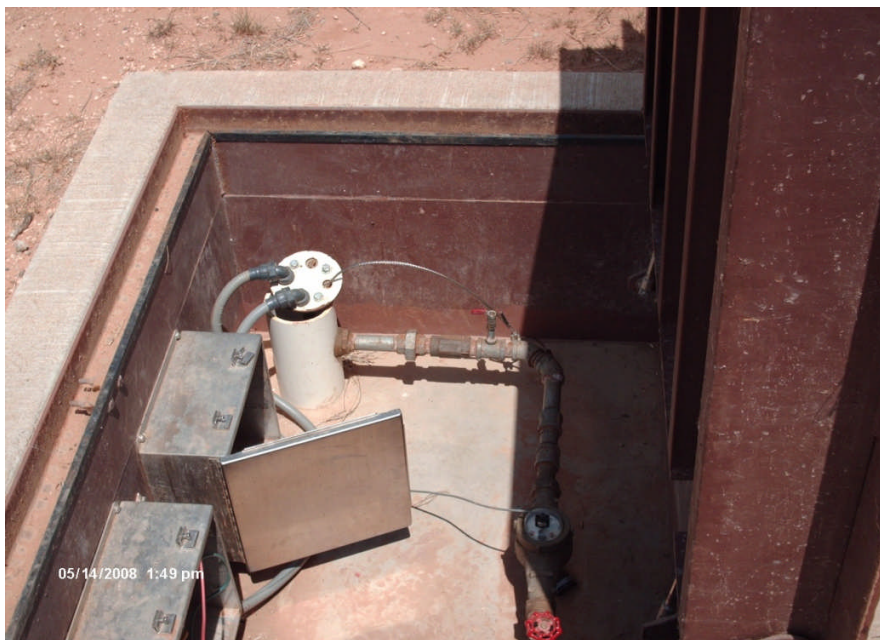
Photograph No. 8 Site: Sprague Road Ground Water Plume Superfund Site
Description: View of wiring in extraction well NRW-13. The Coyote controller eliminates the need for relays in the vaults.
Date: 14 May 2008

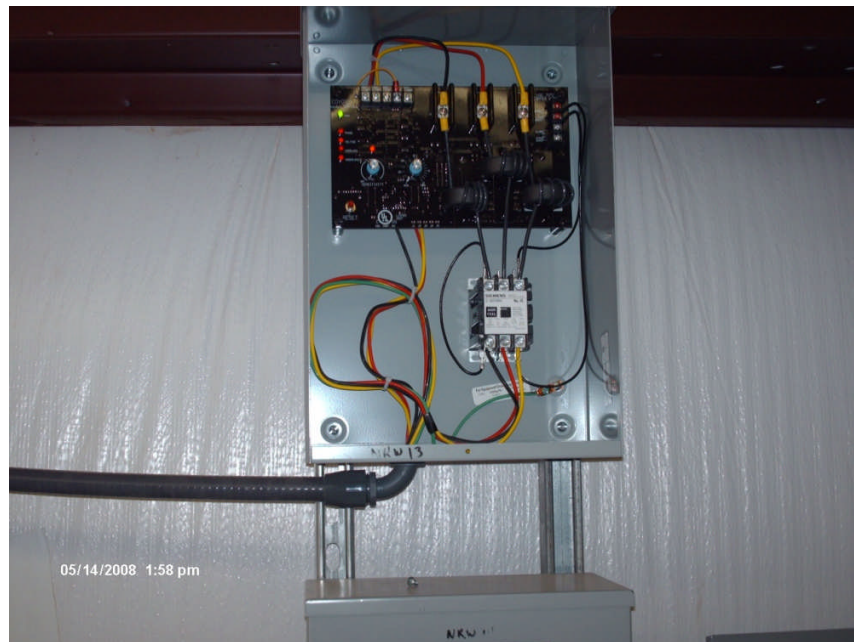
Photograph No. 9 Site: Sprague Road Ground Water Plume Superfund Site
Description: View of Coyote control box for NRW-13 inside the NCC control building.
Date: 14 May 2008

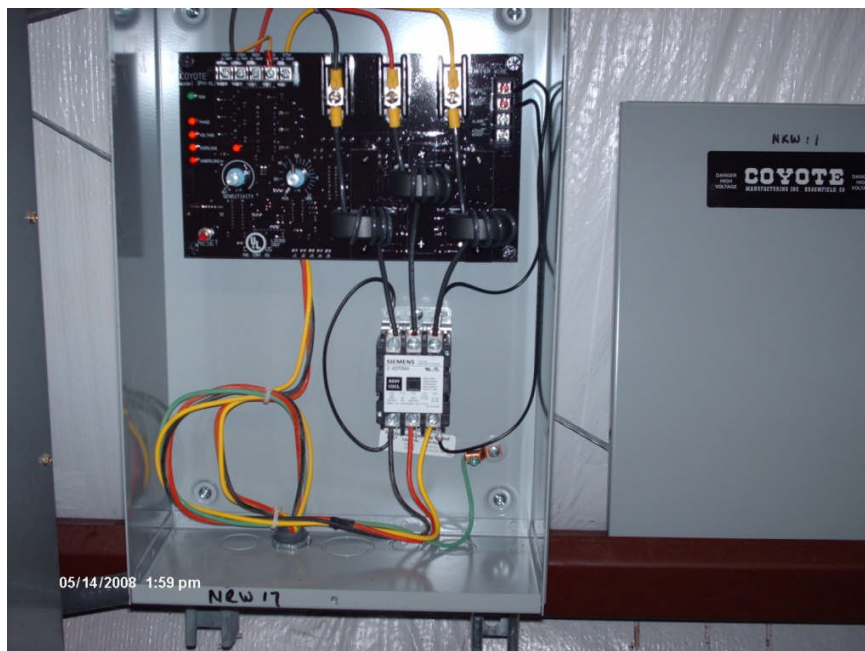
Photograph No. 10 Site: Sprague Road Ground Water Plume Superfund Site
Description: View of Coyote control box for NRW-17 inside the NCC control building.
Date: 14 May 2008
