FIVE YEAR REVIEW

**PESSES CHEMICAL COMPANY
SUPERFUND SITE**

FORT WORTH, TEXAS

JULY 2005

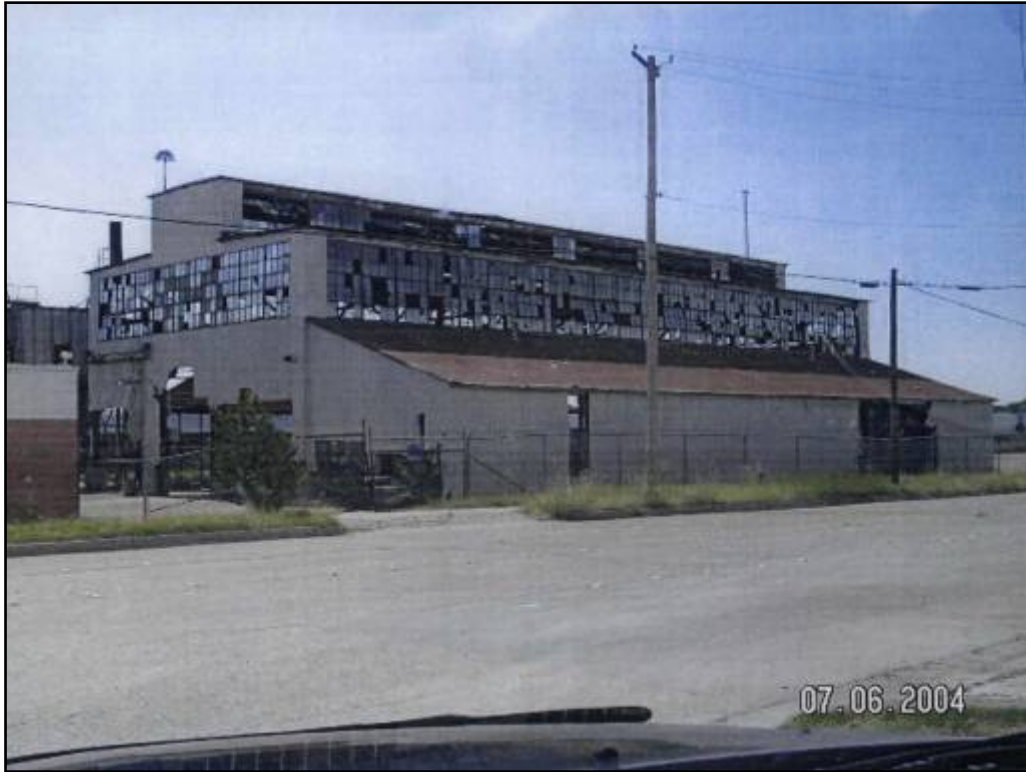
**Metal Warehouse
View to southwest across South Main Street**

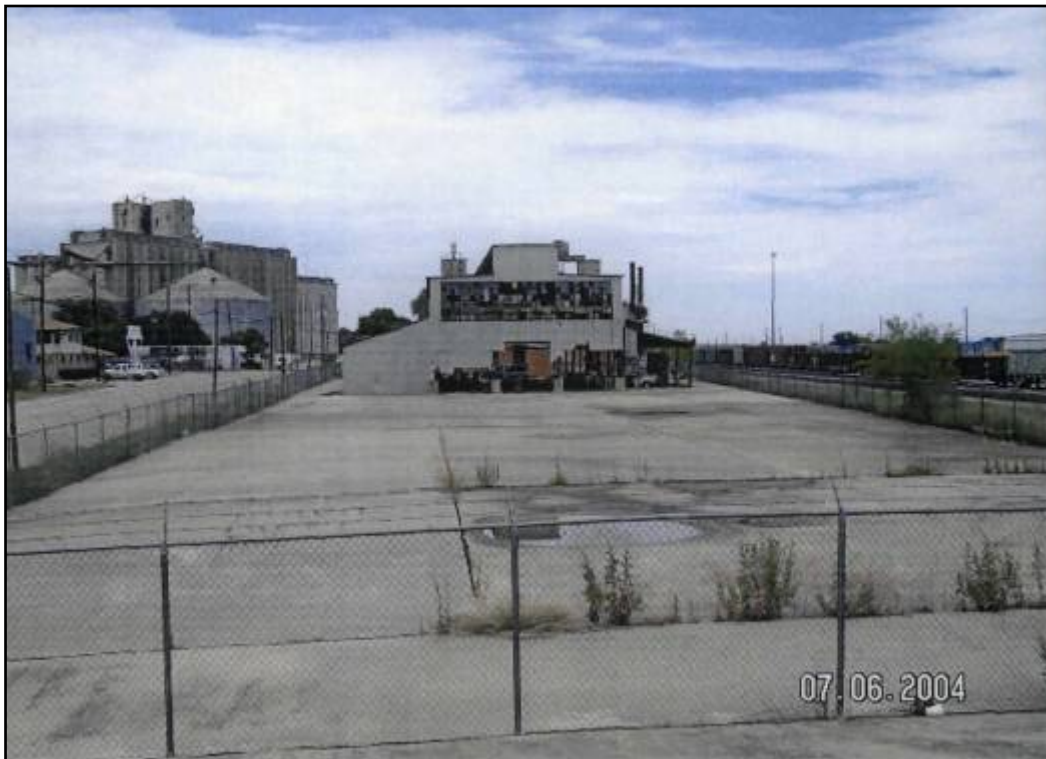
**View to the north across concrete paved South Storage Yard
From the Containment Cell Cap**

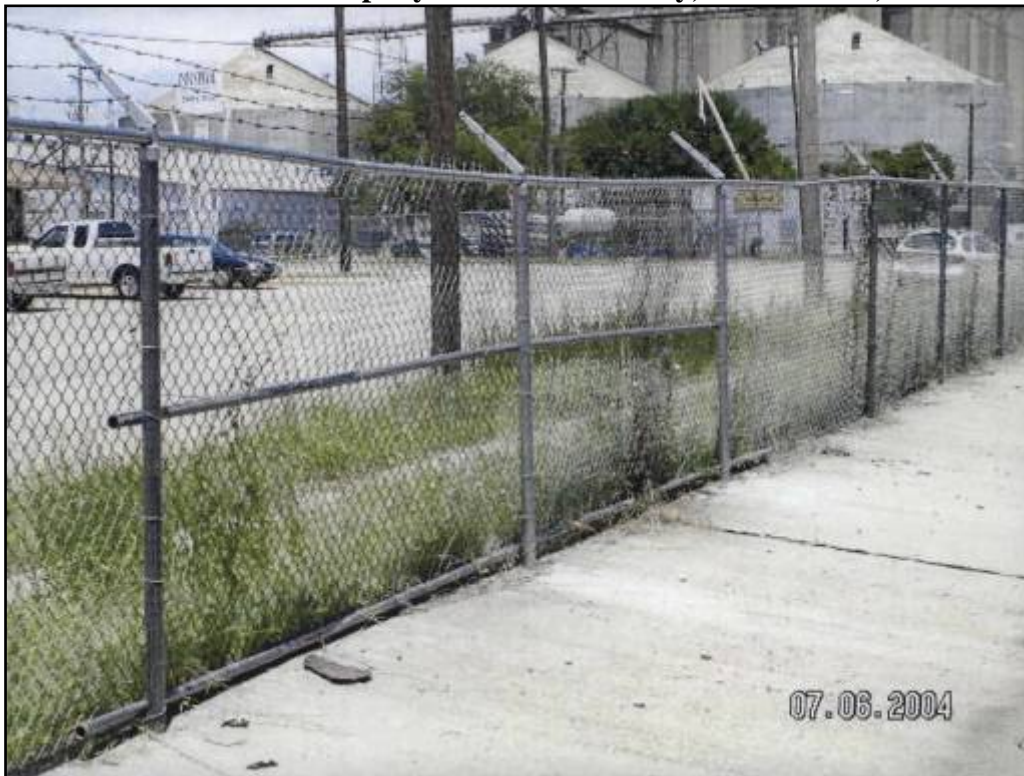
**View to Northwest from the Metal warehouse
Fence Repair Area**

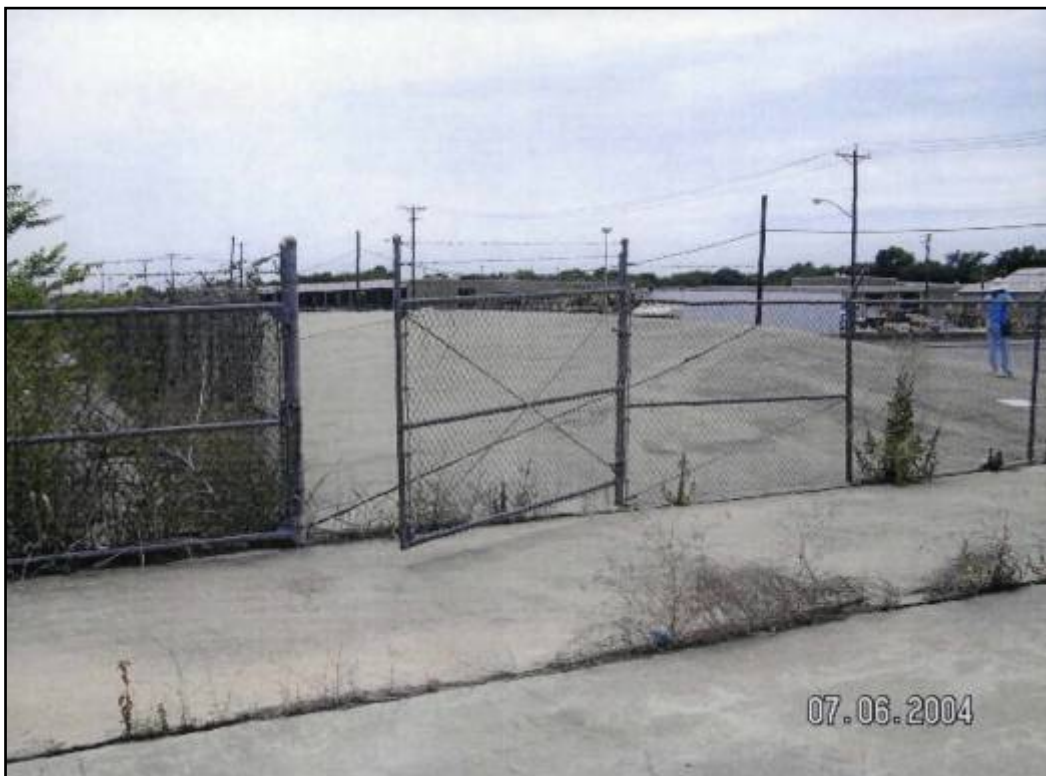
**Containment Cell
View to southwest from the concrete paved South Storage Yard**

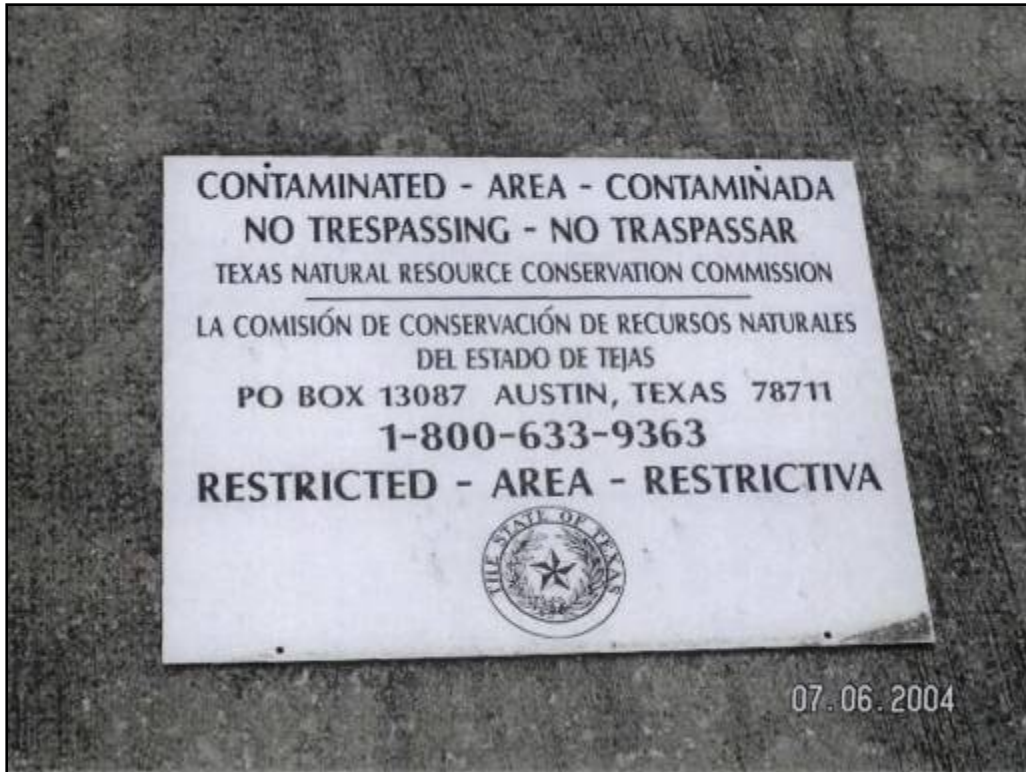
**Pesse site Sign
Placed on the Containment Cell Cap**

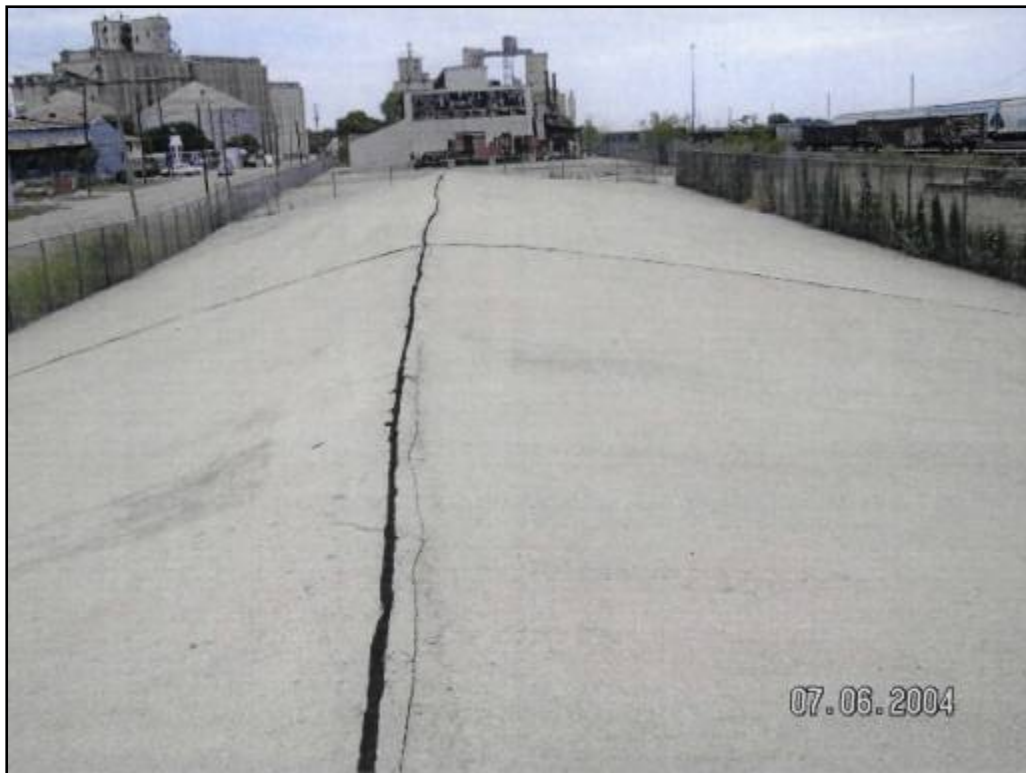
During the inspection the containment cell concrete cap and expansion joints were found to be in good condition. No separated cracks were detected in the cap. There were cracks in the concrete along the top centerline seam of the cell cap. The seam sealant requires replacement at various areas along the expansion joints. It was observed that previous concrete repairs had been made in other cap areas and along the expansion joints.

**Containment Cell Cap
Concrete Crack adjacent to Crest seam
View to the North**

All cap joints, drainage channel joints, the rust pop-off spot, and the separated concrete repair on the crest require resealing with asphaltic material.

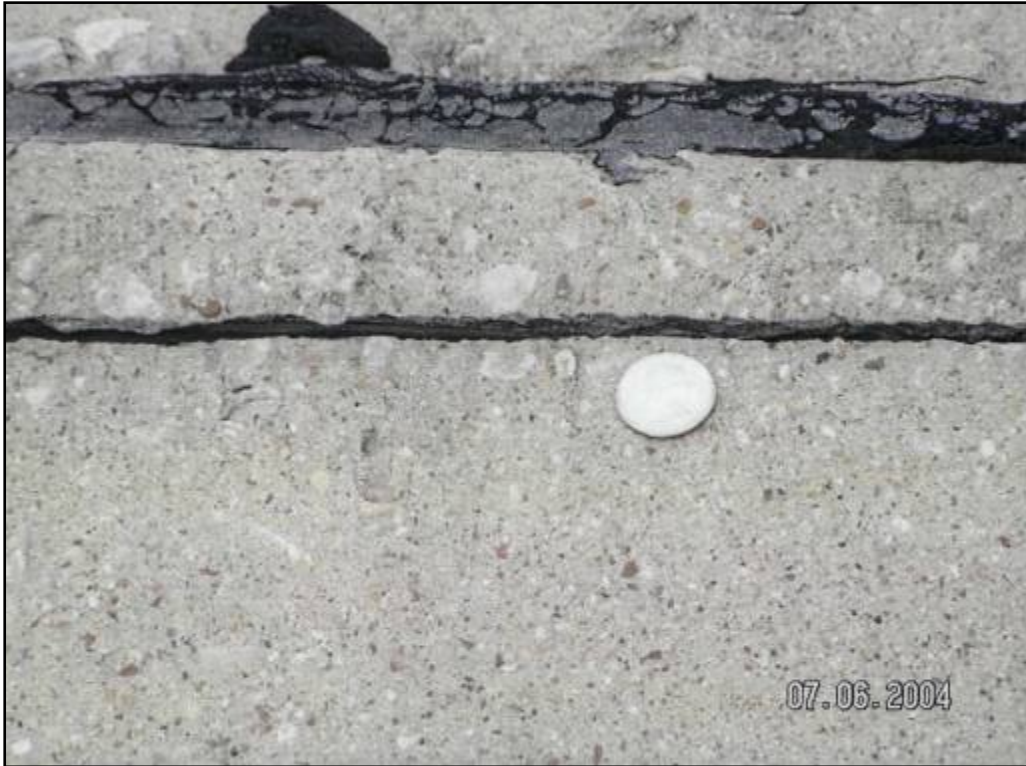
**Containment Cell
Concrete crack adjacent to Crest Seam**

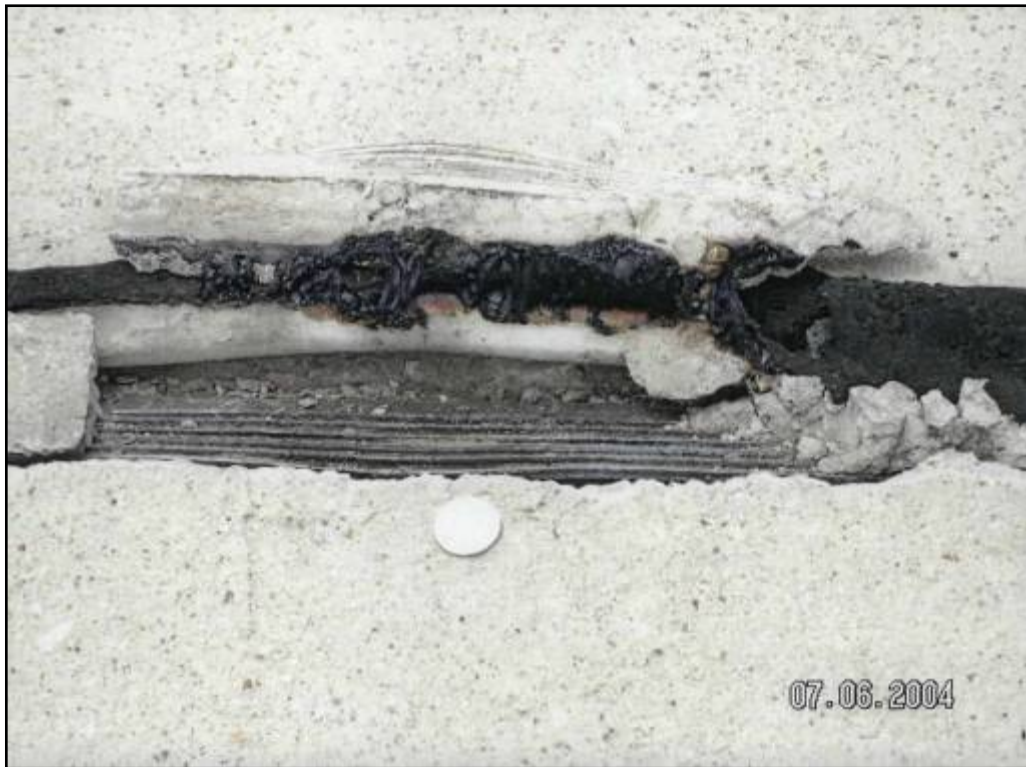
A previous concrete repair of the crest joint was showing some separation.

**Containment Cell
Cracked concrete at Crest Seam
Foam Expansion joint visible**

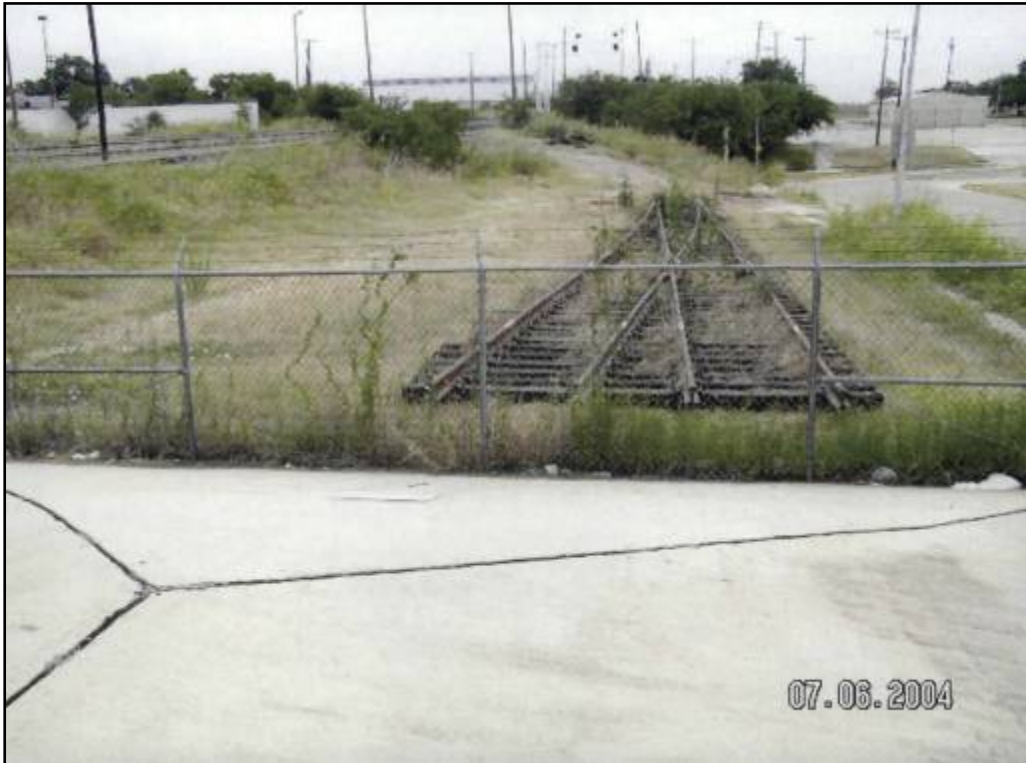
**Area south of Containment Cell
View to the South**

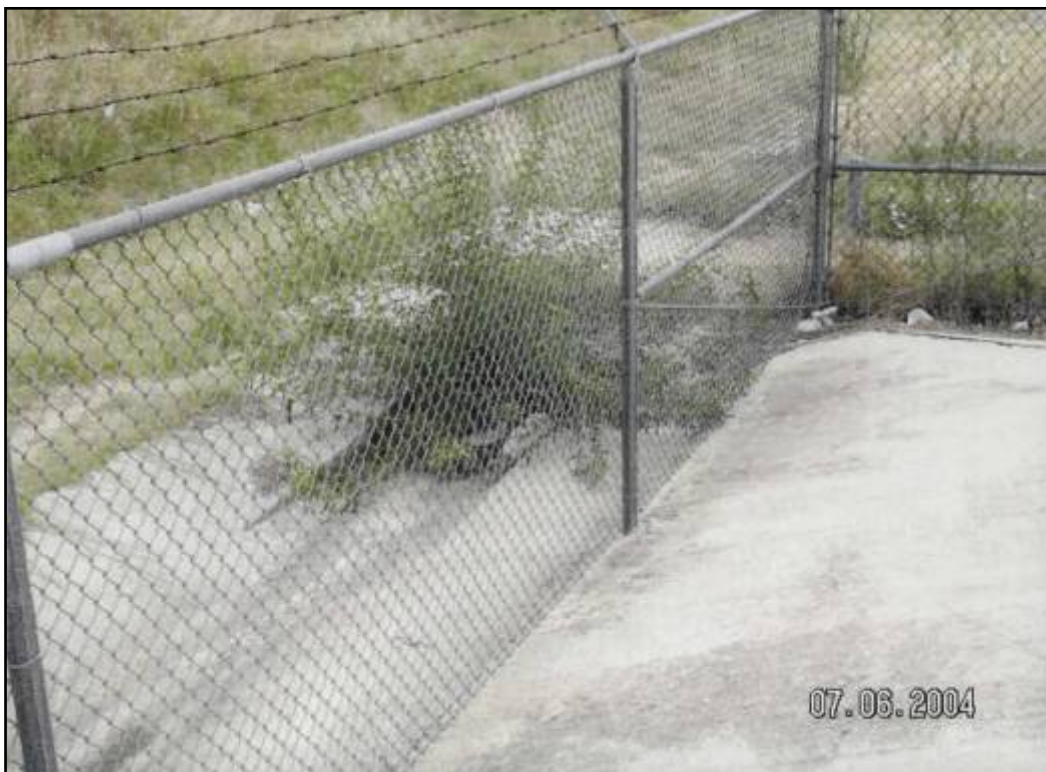
Vegetation was observed growing in several of the expansion joints in isolated areas of the cap, and along the bordering fence line. The concrete drainage channel which parallels the site on the east side of the south field cell cap had some weed growth in the joints and a small tree was located in the drop inlet at the terminus of the channel. No shrubs or trees were observed to be growing on the cap. The site fence was found in good repair, and the damaged section noted in the last five-year review was repaired and in good condition. There was no evidence of differential settlement or excessive cracks in other areas of the concrete cap. No leachate or seeps were noted. The cap was well posted with warning signs. The site was left locked and secured.

**Small tree growing in a drain box
Southeast corner of the Containment Cell**

It is necessary to maintain the integrity and effectiveness of the cap system to achieve long-term effectiveness of the remedy. Semi-annual site inspections by TCEQ should continue. In addition, TCEQ should continue to perform site maintenance activities including making repairs to the cap and site fencing as necessary to correct any defects. Repairs necessary at the current time include mending/resealing the cracked concrete at the top seam of the concrete cap, removal of weeds from the expansion joints and fence, and re-sealing the cap and drainage channel expansion joints. Finally, the small tree should be removed from the drop inlet of the drainage channel.
