U.S. Department
of Transportation

Federal Railroad
Administration

Human Factors Root Cause Analysis of Accidents/Incidents Involving Remote Control Locomotive Operations

Office of Research
and Development
Washington, DC 20590

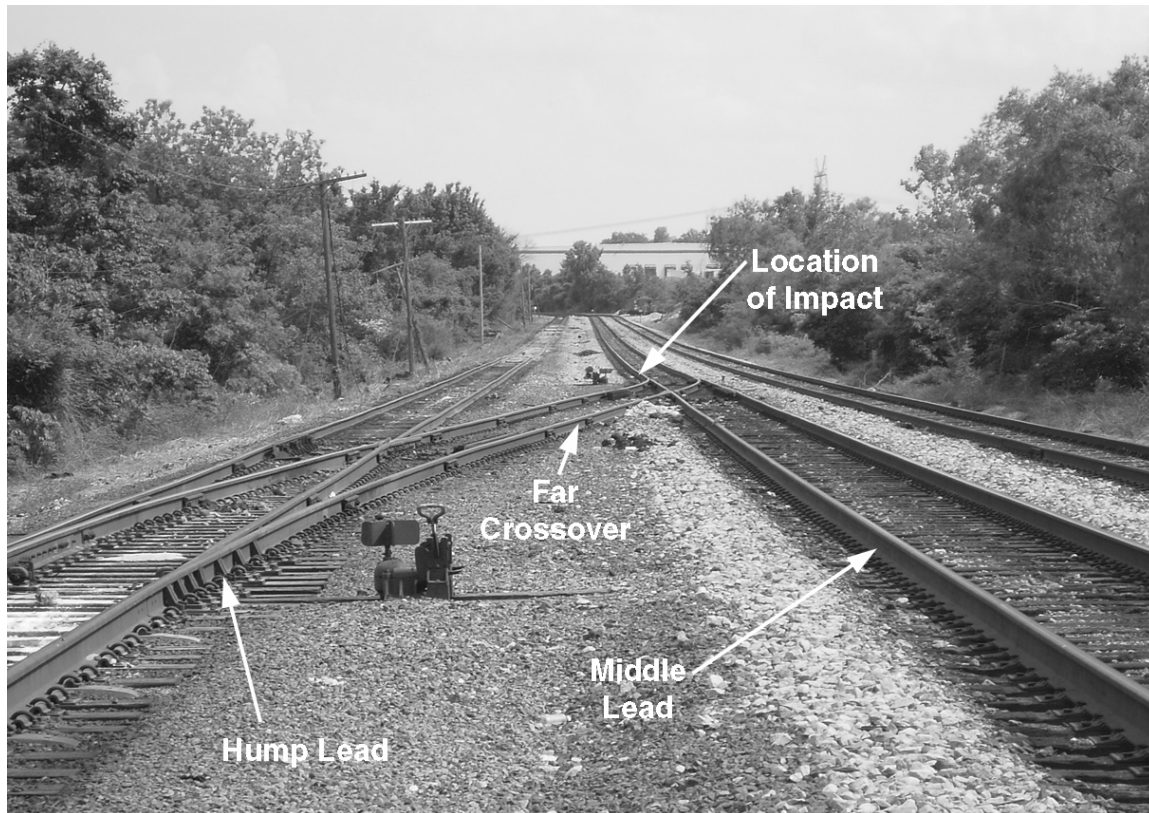
111's speed was 2.61 mph upon impact, when the RCL event recorder shows a low pipe pressure event, likely due to a break in the air hose at the front of 111's locomotive as it impacted with a car from 222. The low pipe pressure event caused the RCL system to initiate an emergency brake application and brought 111 to a stop. According to the event recorder, 222 was traveling between 1.8-2.0 mph at the time of impact.

Figure 15. RCL1 southward view of collision location

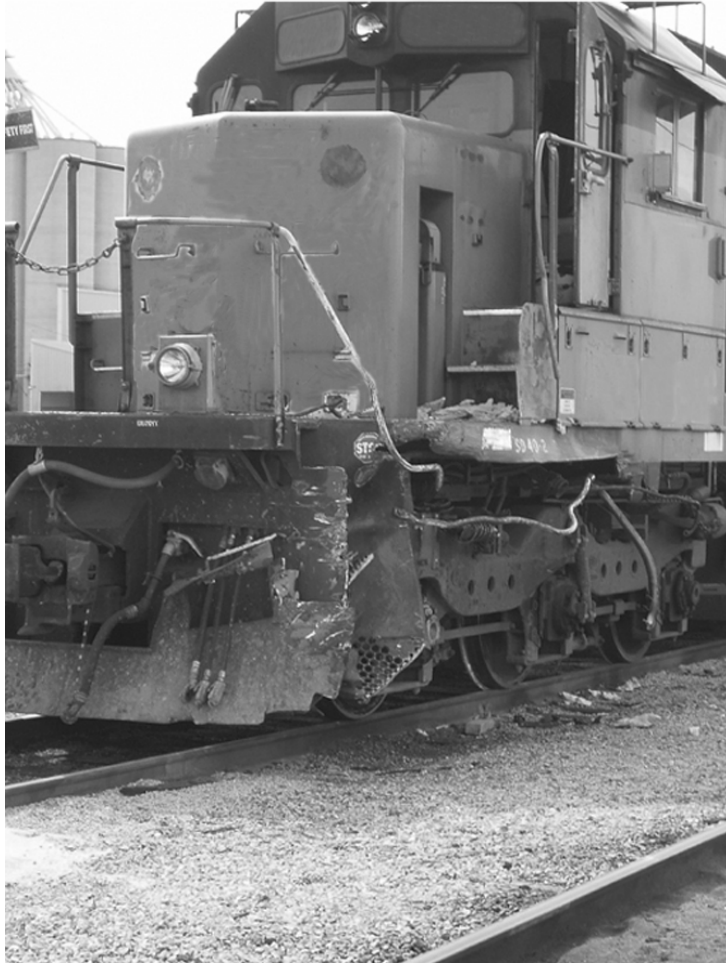
Figure 16. RCL1 damaged 111 RCL

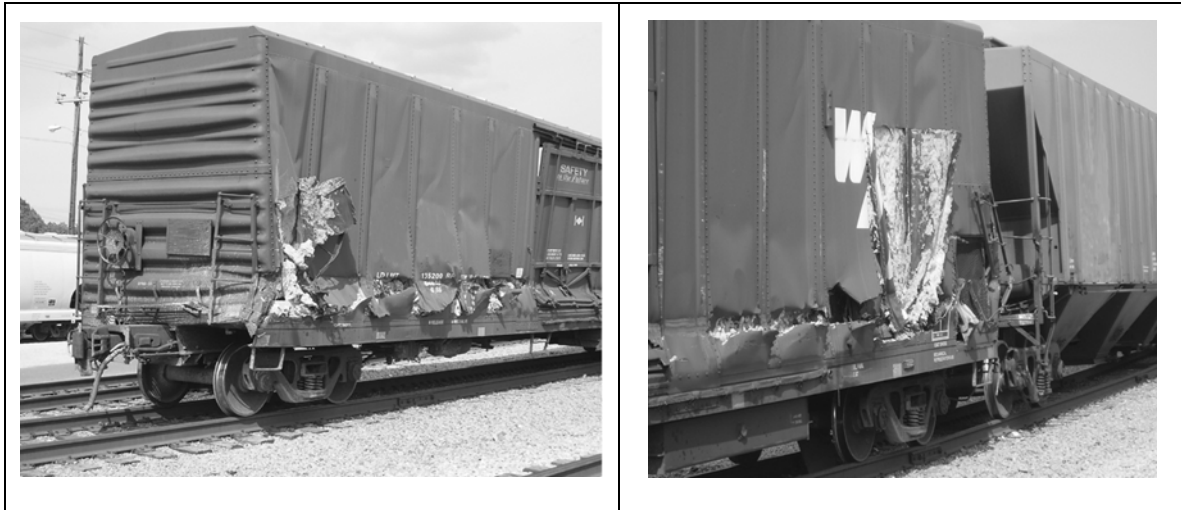
Figure 17. RCL1 damage to box car

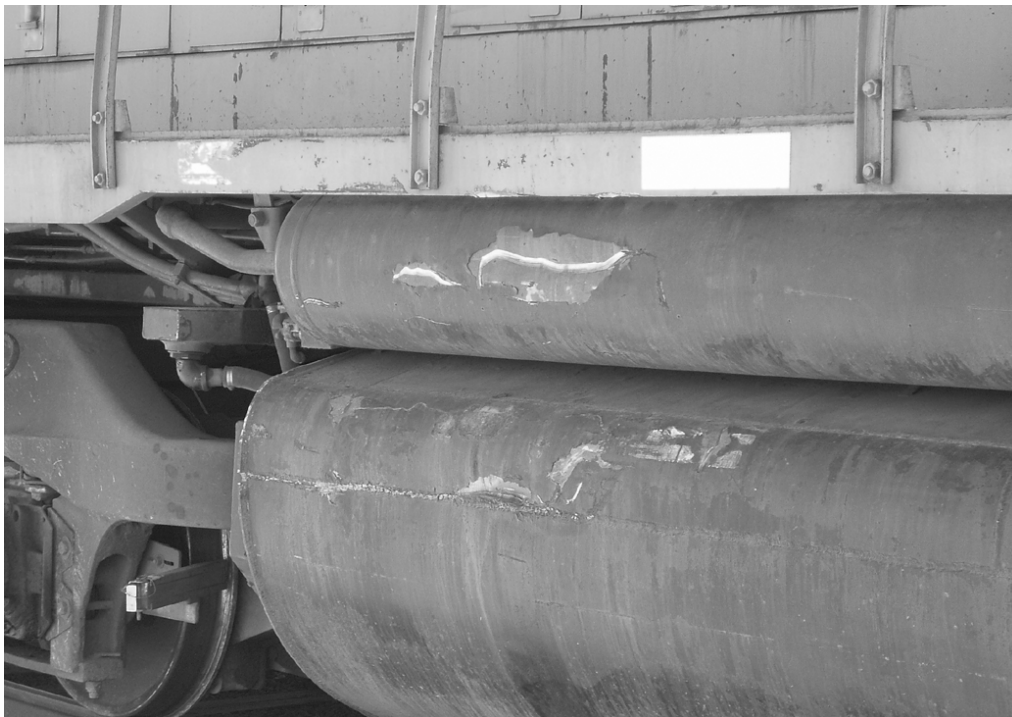
The accident resulted in damage to the RCL (see Figure 20) and the derailment of four tanker cars on the departing train (see Figure 21), as well as damage to the R1 track (see Figure 22 and Figure 23), nearby switch, and signal.

Figure 20. RCL2 damaged locomotive fuel tank

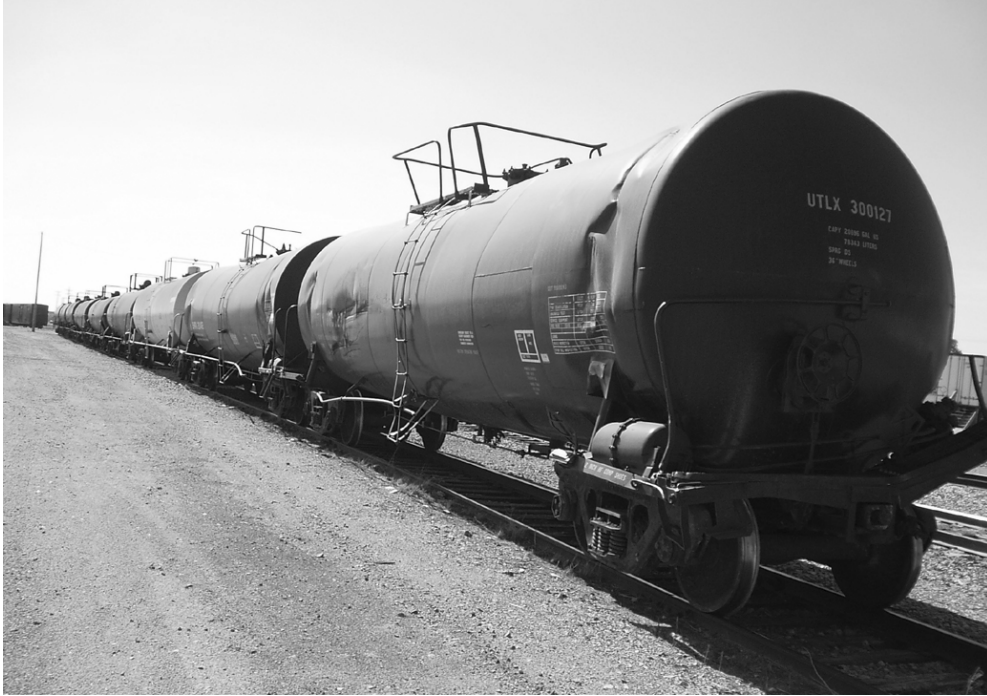
Figure 21. RCL2 damaged tank cars

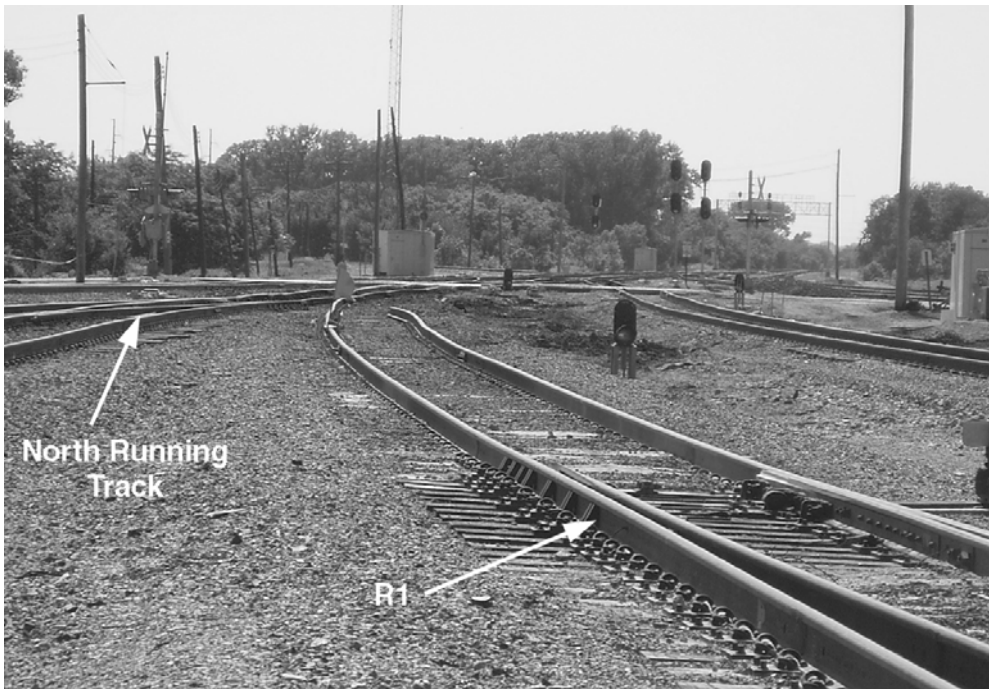
**Figure 22. RCL2 location of collision and damaged track
(out of service indicated by flag on left rail)**

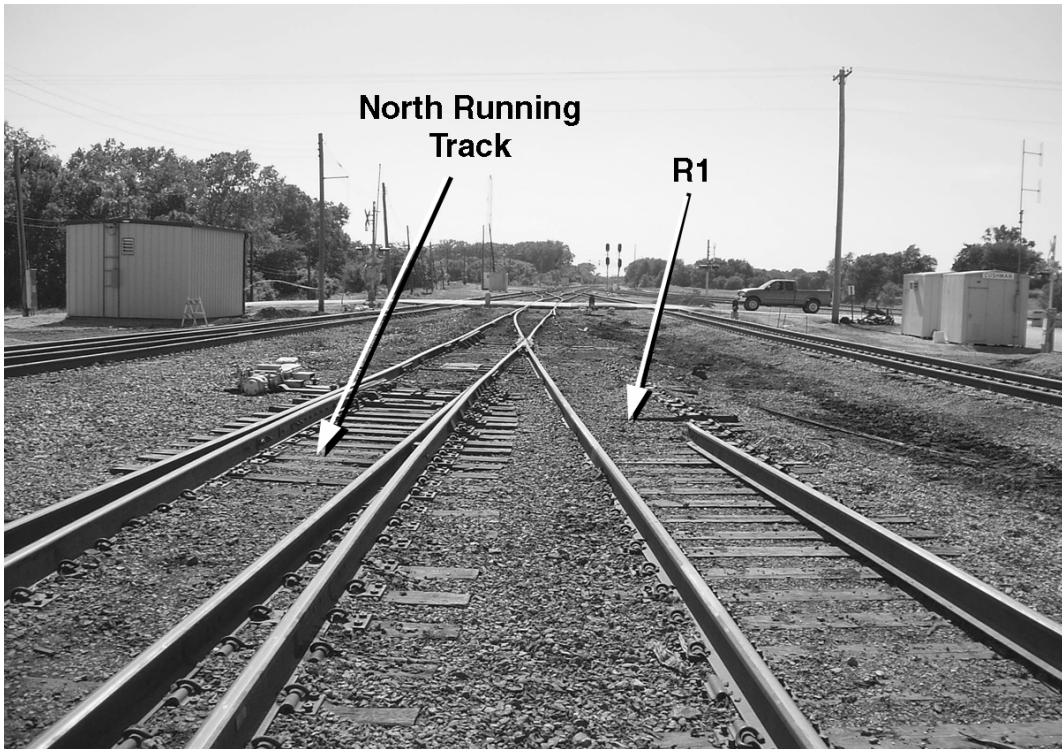
Figure 23. RCL2 closeup of damaged track (out of service)

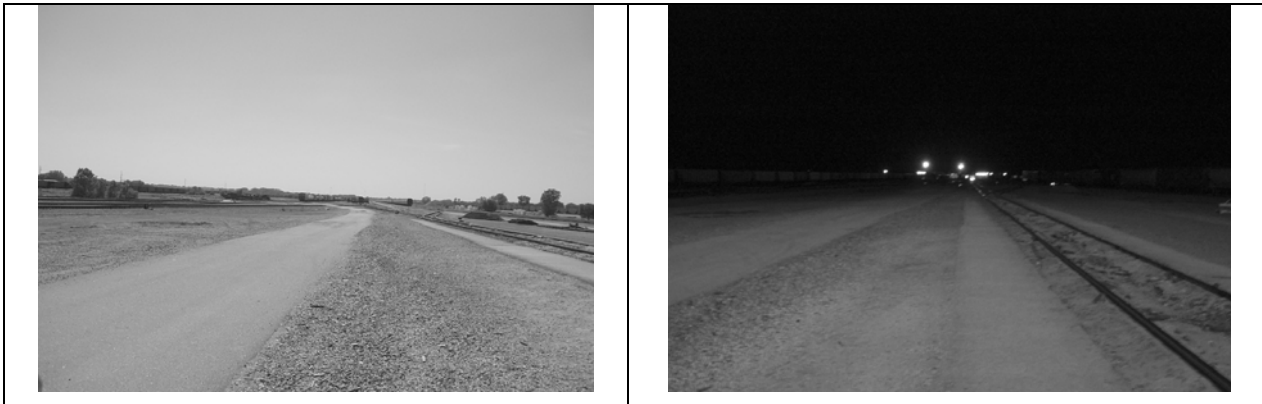
- Inadequate lighting. Although a set of lights is mounted on a pole to illuminate the west side of the west end of the yard and lights on the east end of the yard, no lights are on the east side of the west end of the yard, near the hump office, to help crewmembers shove cars to the hump. The lack of adequate lighting in this part of the yard at night made it more difficult to see the RCO's cut moving in either direction in the track (see Figure 26 for a view from the hump and Figure 27 for a view from inside the hump office looking westward toward the receiving tracks). Rail cars that are dark, such as black tank cars, are especially difficult to see at this end of the yard. *Preconditions for operator acts/environmental factors/physical environment.* **Probable contributing factor.**

Figure 26. RCL2 view from hump pin puller position looking westward in daytime (left) and at night (right)

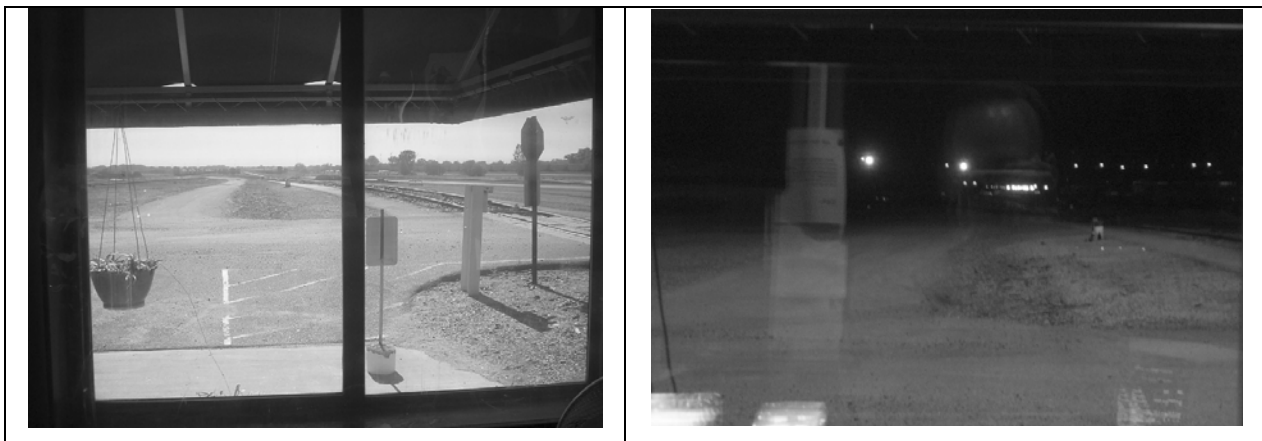
Figure 27. RCL2 view from hump office looking westward in daytime (left) and at night (right)

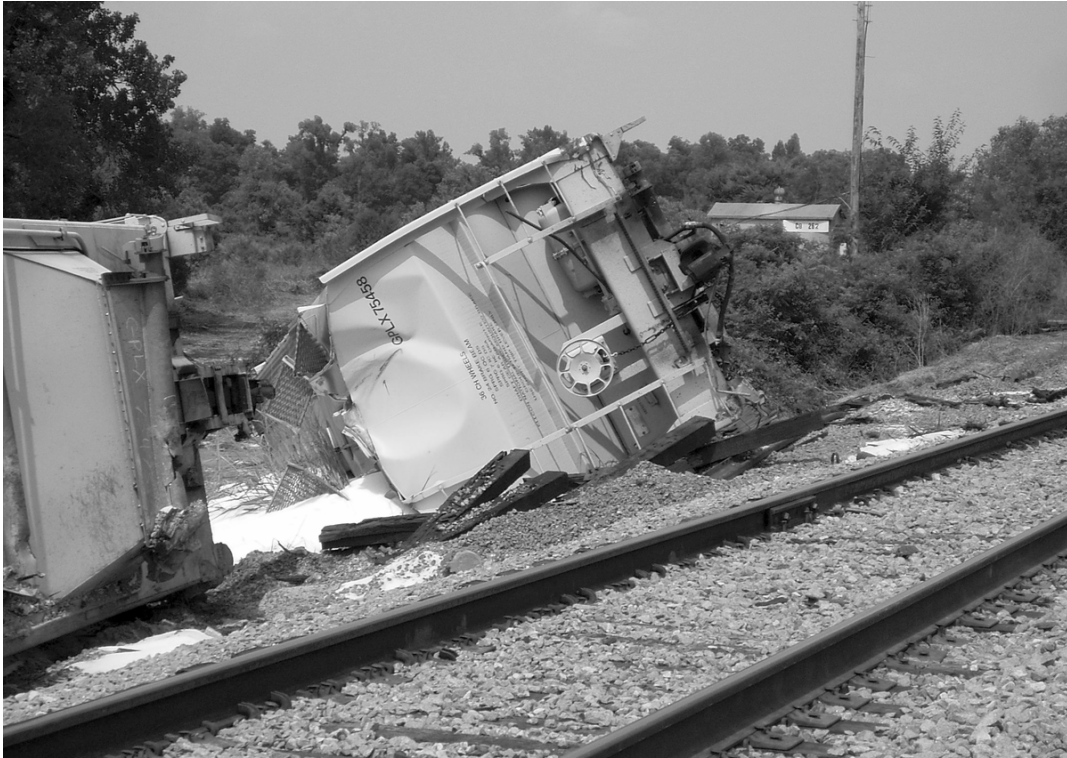
The lead RCL sideswiped the 9th and 10th cars behind the locomotives of the westward train and derailed the next 8 cars (see Figure 34 and Figure 35). The lead RCL derailed and toppled over on its side (see Figure 36), while the trailing RCL and first car derailed but remained upright. No injuries occurred. Damages were estimated to range from \$500,000 to \$1,000,000.

Figure 34. RCL3 derailed hopper car of inbound road train

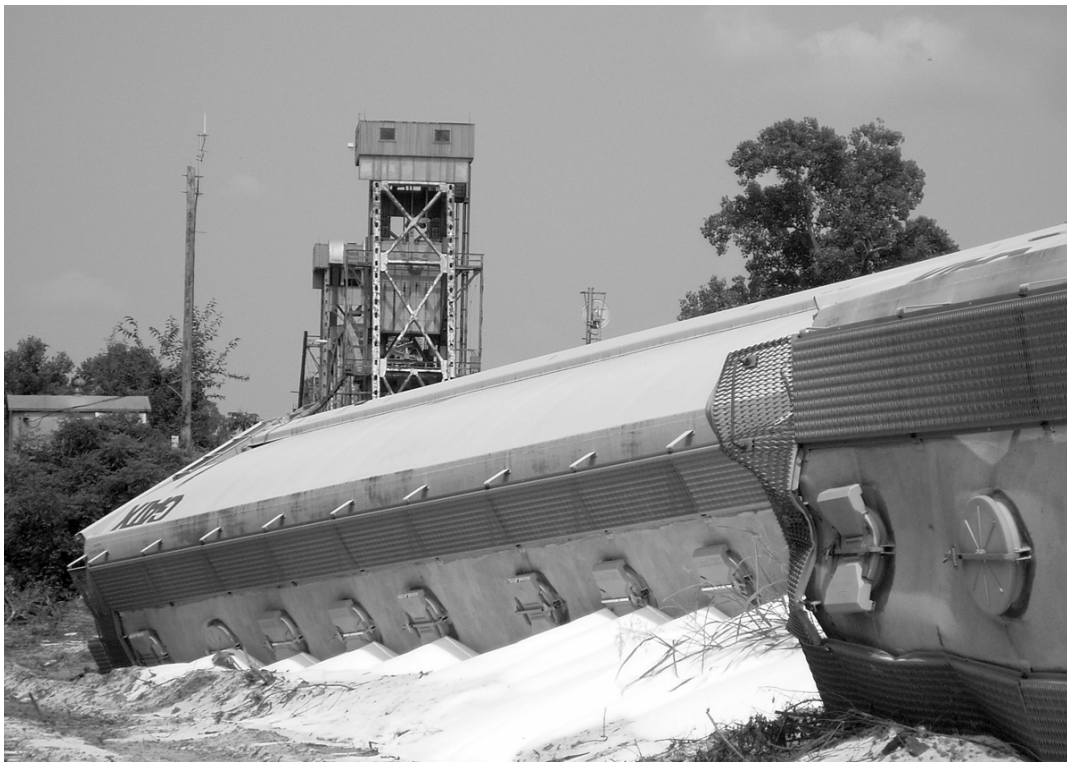
Figure 35. RCL3 spilled plastic pellets from derailed hopper car

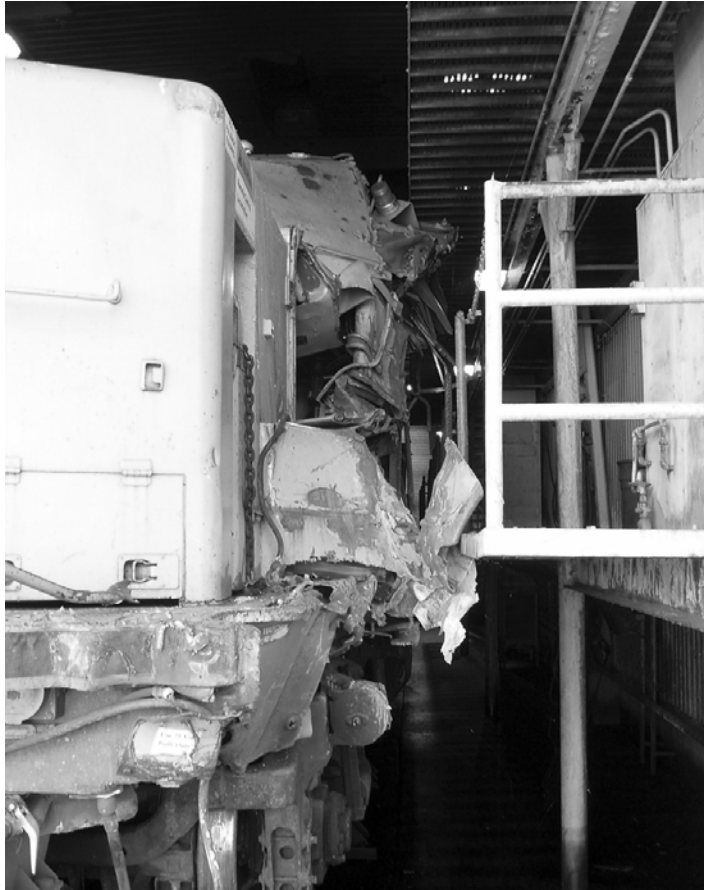
Figure 36. RCL3 view of damaged sheared left side of lead RCL

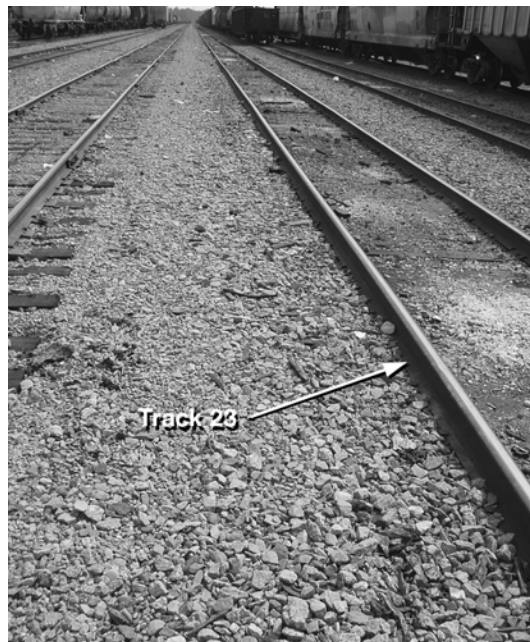
The foreman instructed his helper to make a safety stop before coupling to the standing cut of cars in track 23. His intent was to receive the pitch from his helper and control the move from the vantage point at the coupling from the ground. After the cut had stopped, the foreman began to dismount the side ladder when his RCD struck a ladder rung. The RCD fastened on the RCO's vest at the lower and middle sets of clasps¹⁸, lifted up, knocked his eyeglasses off, obstructed his view of the ladder and ground, and caused the foreman to lose his balance as he was lowering himself. The foreman's foot missed the sill step, and he fell to the ground and landed on a combination of large and small ballast (see Figure 39).

Figure 39. RCL4 approximate location of fall

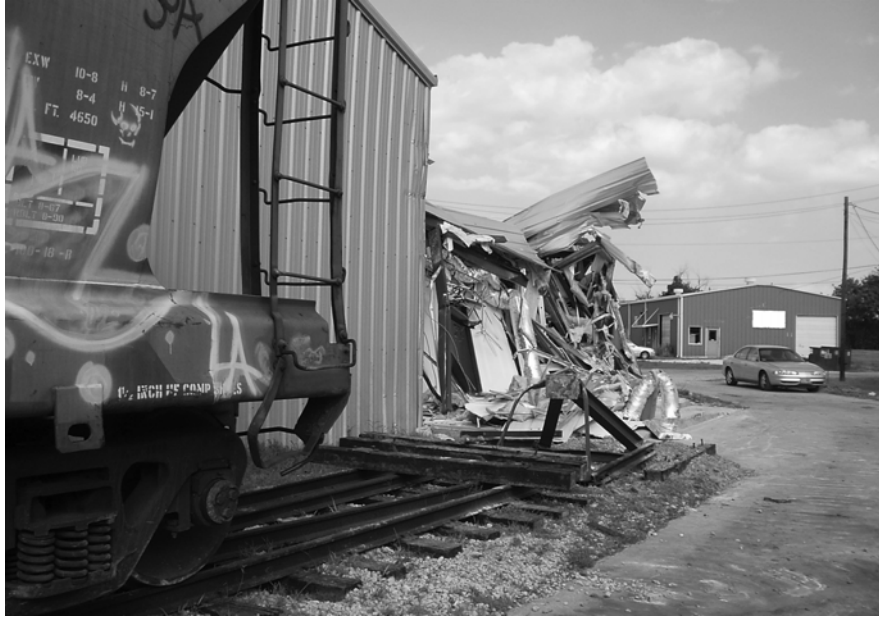
Figure 52. RCL5 damaged bumper post and industry building conference room

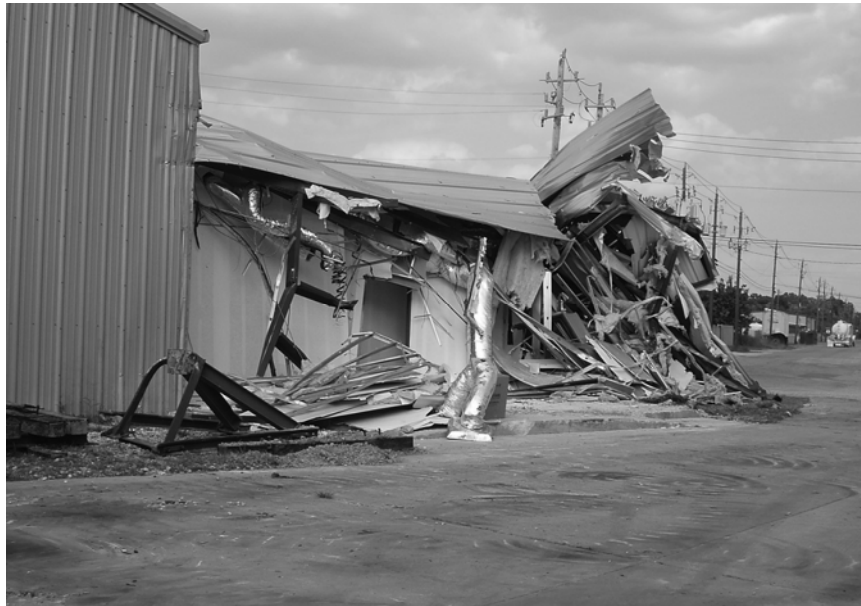
Figure 53. RCL5 damaged industry building conference room

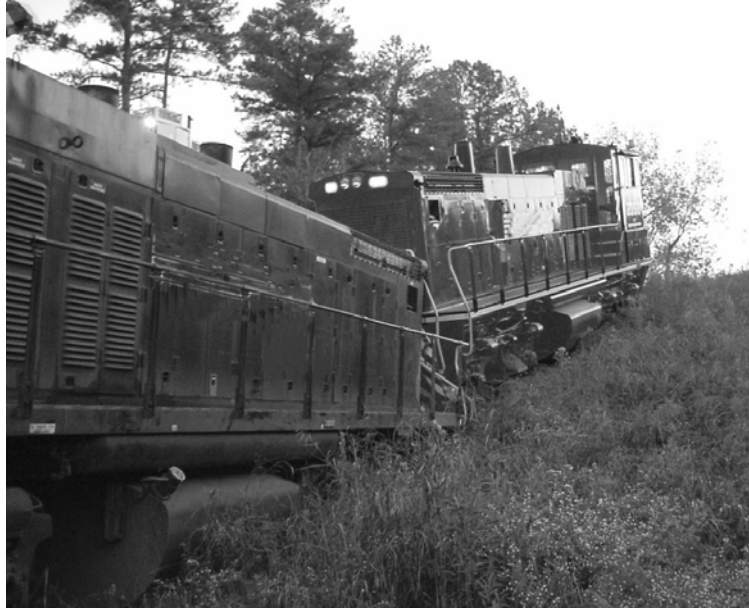
Figure 65. RCL6 view of locomotives derailed up embankment at end of track
(modified and reprinted with permission of the railroad)

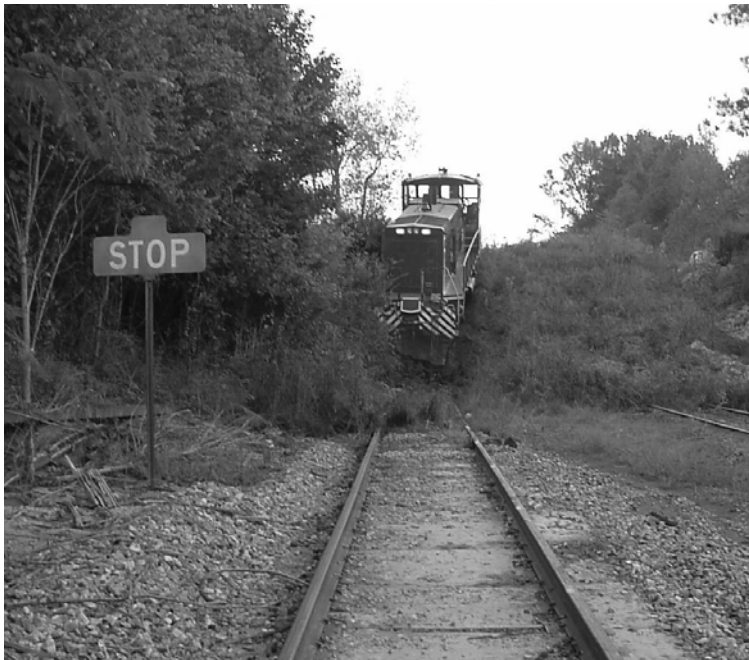
Figure 66. RCL6 view of lead (RCL) locomotive derailed up embankment
(modified and reprinted with permission of the railroad)

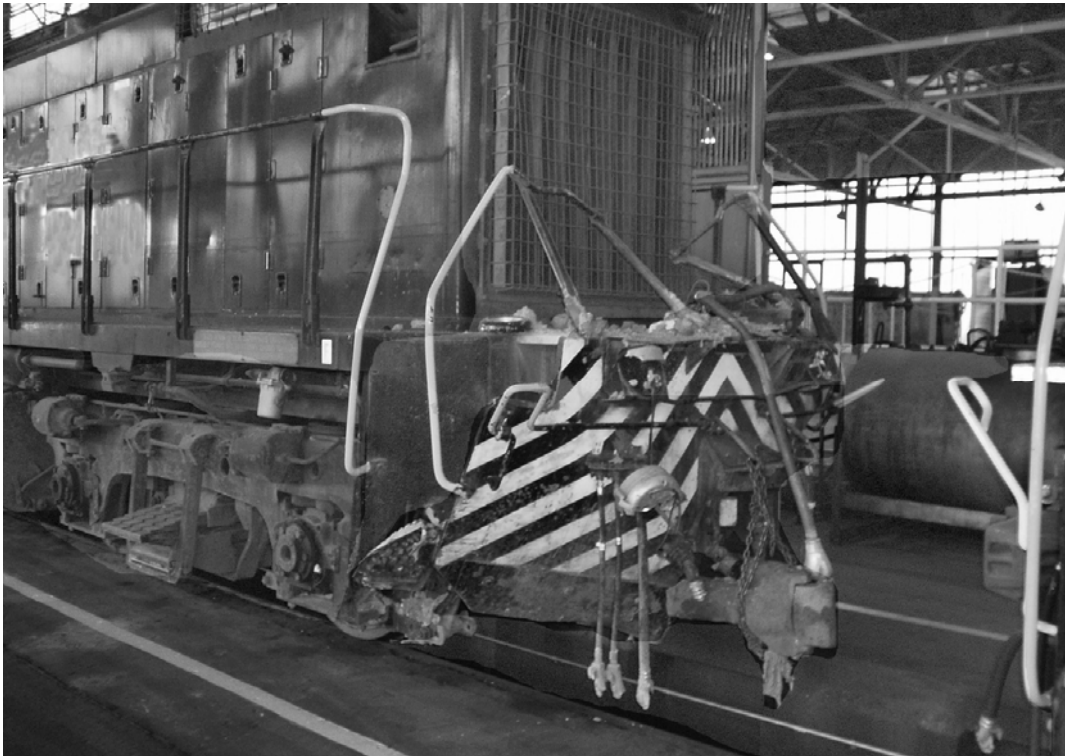
The accident resulted in minor damage to both locomotives, with an estimated cost of around \$23,000 (see Figure 20 and Figure 68).

Figure 67. RCL6 damage to trailing locomotive

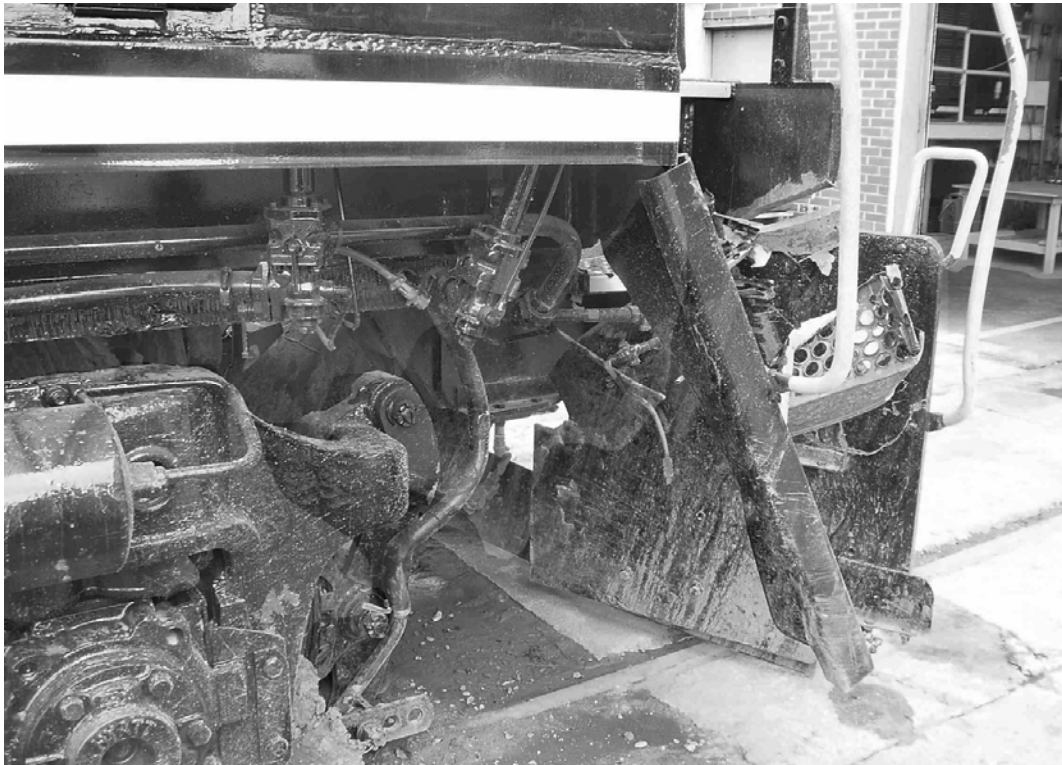
Figure 68. RCL6 damage to leading RCL

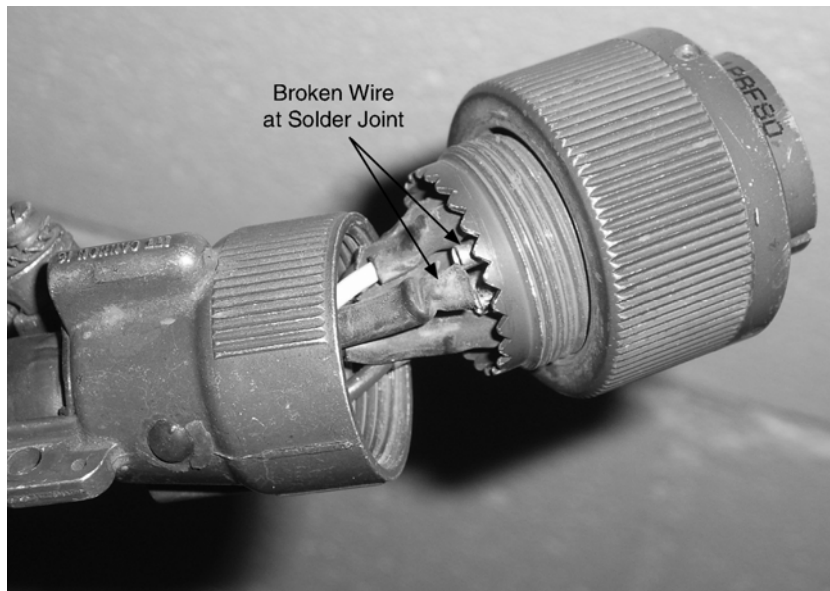
Figure 69. RCL6 view of disconnected wire at connector solder joint
