U.S. Department  
of Transportation

Federal Railroad  
Administration

# Repair of Budd Pioneer Coach Car Crush Zones

## Rail Passenger Equipment Impact Tests

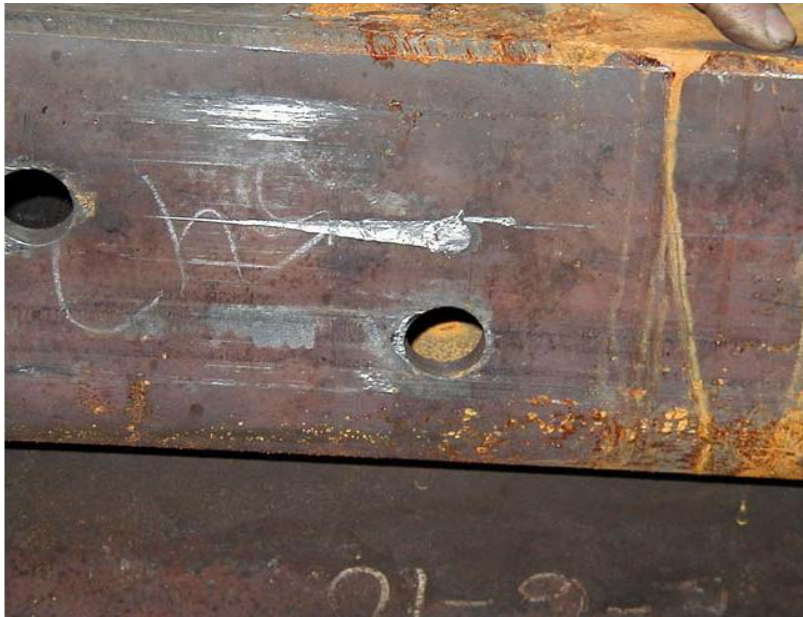
Deformation of the sliding sill occurred only at the bolt holes that connect the sliding sill to the fixed sill; the holes for connecting the buff lug to the sliding sill were not perceptibly deformed. The holes that did deform were elongated in the longitudinal direction by less than 0.010 in (0.25 mm) in every case. (The holes in the fixed sill showed greater deformation; see below.) Figure 5 shows an example of the holes after the test. The sliding surface was generally in very good condition, but burrs were in proximity to the deformed holes, requiring limited grinding.

**Figure 5. Bolt Hole in the Sliding Sill of One of the Crush Zones After the Test**

The holes in the sliding sill did not need modification or repair except for some grinding and polishing to provide smooth sliding surfaces.

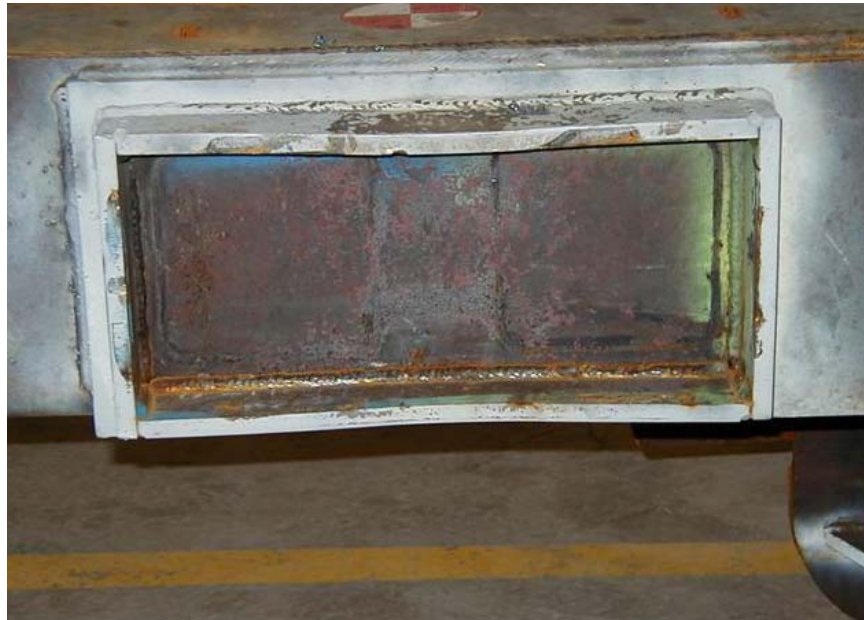
The rear (inboard) face of the end beam deformed as a result of the high load from the primary energy absorbers. Figure 8 shows a photograph of this area for one of the cars. The deformation is not very clear from the photograph, but after the frame members were removed, use of a straight edge indicated that the face had deformed inward by approximately 0.125 in (3 mm) at its center. The inside of the end beam, which includes reinforcing gussets, was not opened for inspection.

**Figure 8. Back Surface of the End Beam After the CEM Test in the Area at Which the Primary Energy Absorber Contacts**

The primary repair on the end frame was the stiffening of the end beam's rear face at the locations at which the primary energy absorbers contact. The collar on the back of the end beam into which the primary energy absorbers protrude was first removed on each side. The end beam surface was then built up with weld metal and ground as flat as possible. A 0.75 in (19 mm), A572-50 plate (or A36 in some cases), whose area was larger than the area originally bounded by the collar, was then welded onto the rear of the end beam; the rear thickness of the A710 (minimum yield strength, 75 ksi [517 MPa]) end beam is 0.375 in (9.5 mm). The decreased length of the primary energy absorber accounted for this added plate (see below). Figure 18 shows a photograph of this region, together with the new retention device and the primary energy absorber.

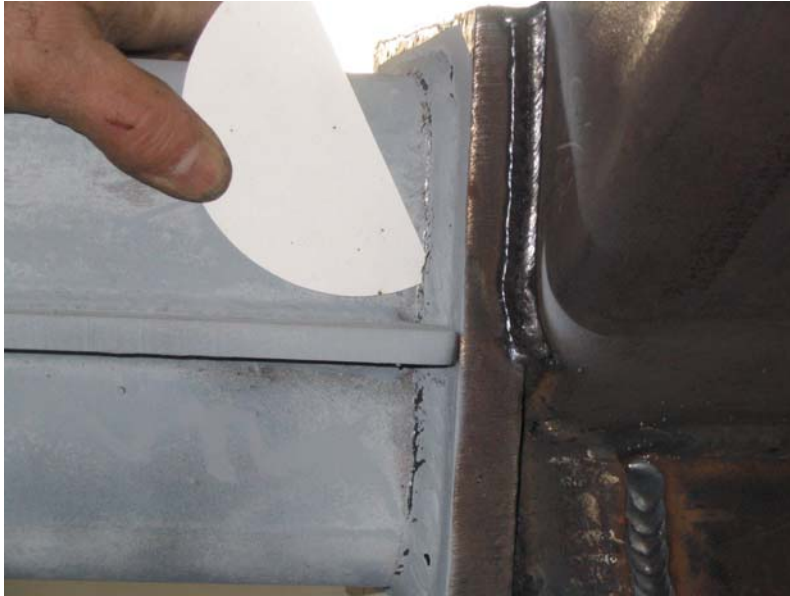
Figure 9 shows evidence of cracking between the sliding tube of the roof absorber and the back of the AT beam for car end 248A. A fillet weld connects the sliding tube to the AT beam.

**Figure 9. Crack at the Connection Between the Sliding Roof Absorber Tube and the Back of the AT Beam for End 248A After the One-Car CEM Test**

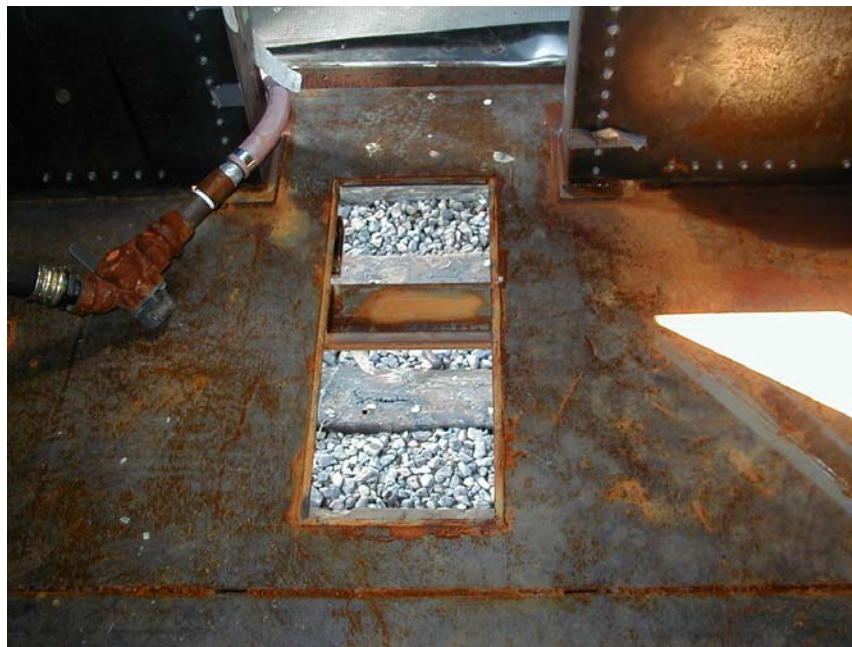
**Figure 15. Access Hole Cut in the Floor Plate in the Vicinity of the Sliding Sill/Fixed Sill Connection**

The repair included preparation of the cars for new components and modifications. The sliding components were first removed from the car as a single unit and placed in a special location for examination and repair; Figure 6 shows one such end. Several components were then cut from the car, including the primary energy absorbers, the bell-mouth face plate, and the coupler carrier. The surfaces to which these components had been welded were then ground flat. Floor plate sections were cut for access in the vicinity of the inboard ends of the primary energy absorbers and in the area in which the sliding sill connects to the fixed sill. Figure 15 shows the access hole.

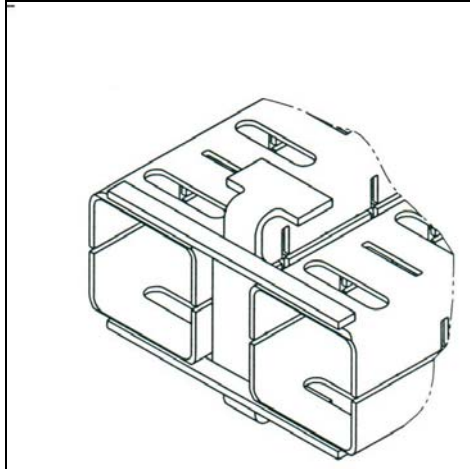
**Figure 22. Image of Part of the Sliding Sill Retention Device**

Figure 22 shows an image of the device's part attached to the primary energy absorber. The device consists of a hook and slot. The hook is a bent part that is welded to the inside surfaces of the primary energy absorber and to two straps that are in turn welded to the top and bottom of the absorber. The slots are part of the new frame on the end beam's rear surface that is used to restrict the primary energy absorber from lateral or vertical motion during crush. The top and bottom pieces of this frame each include a slot.

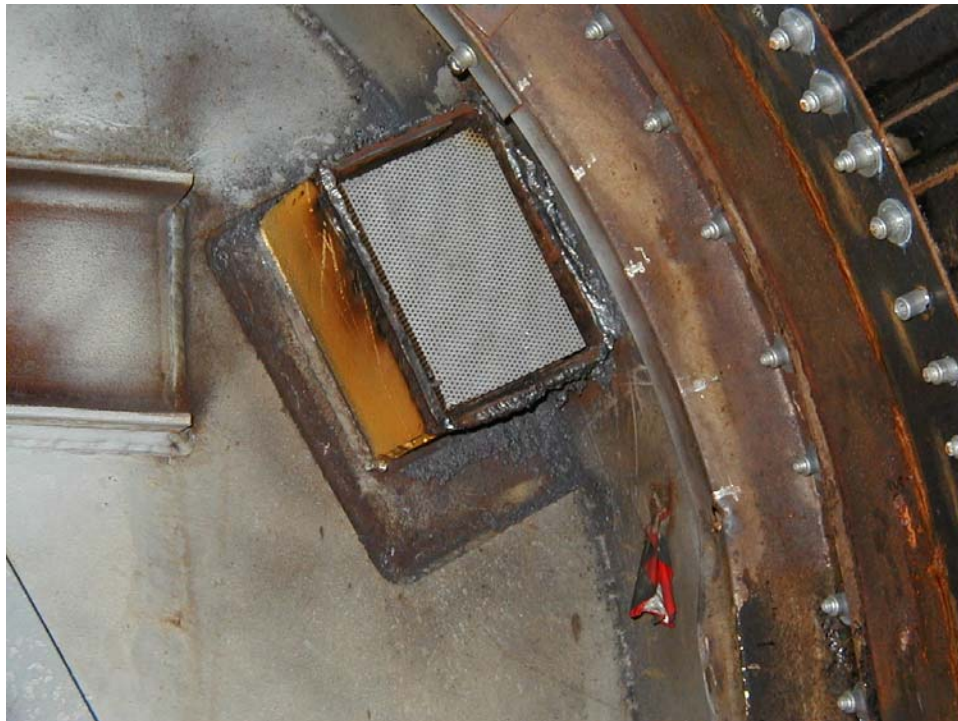
The rear plate of the roof absorber fixed tube required removal in order to extract the aluminum honeycomb cartridges. Figure 26 shows that the absorber tube deformed after the end plate was removed. In some instances, a section of the carline was also removed to allow extraction of the honeycomb cartridges. About one-half of the uncrushed honeycomb absorber cartridges were reused. The research team ordered the remaining required absorbers with the same specifications used for the original crush zone ends. Additional weld metal strengthened the regions at which a bulge had occurred in the fixed tube; the bulge remained untouched.

**Figure 26. Inboard End of the Fixed Roof Absorber Tube After Removal of the End Plate to Extract Absorber Elements**
