[Docket No. FAA-2006-24074; Directorate Identifier 2005-NM-213-AD]

#### Airworthiness Directives; Bombardier Model CL-600-2C10 (Regional Jet Series 700, 701, & 702) Airplanes, Model CL-600-2D15 (Regional Jet Series 705) Airplanes, and Model CL-600-2D24 (Regional Jet Series 900) Airplanes

**ACTION:** Notice of proposed rulemaking (NPRM).

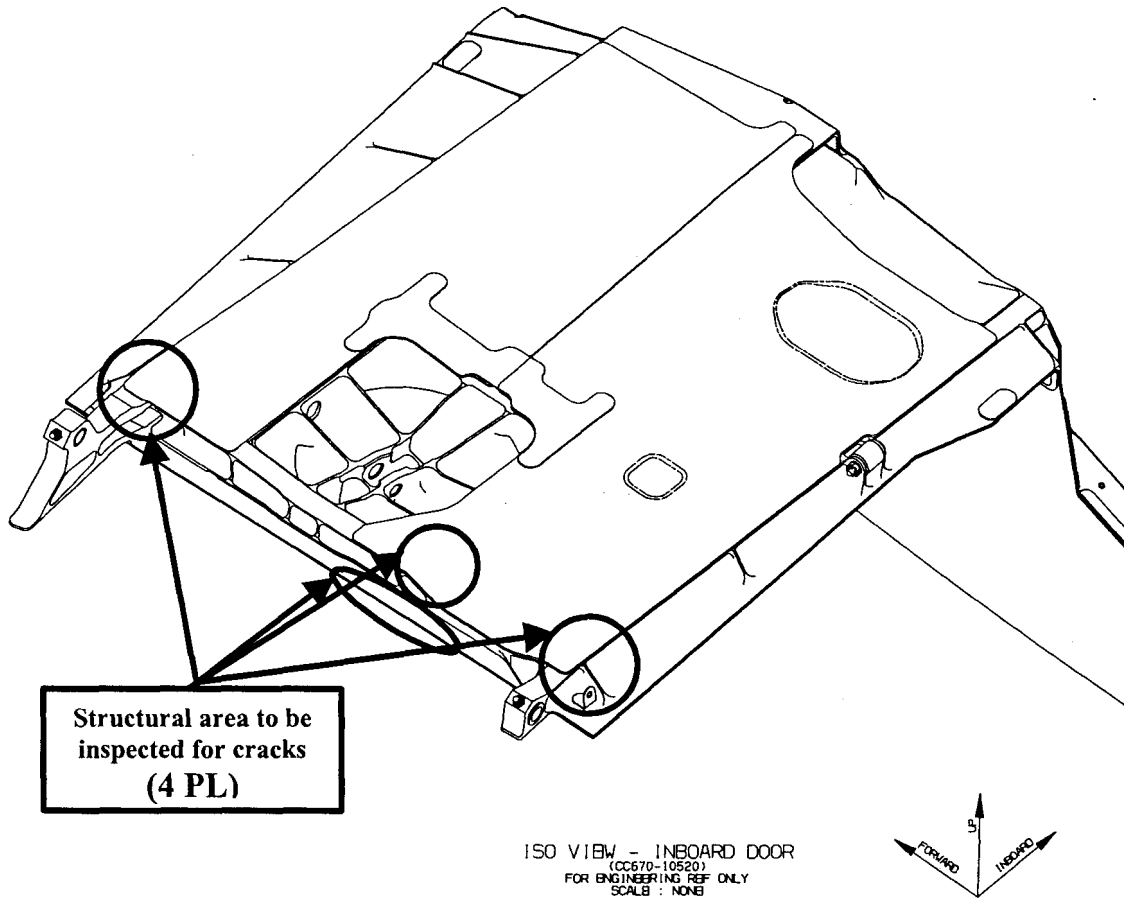
**Figure 1**  
**LH side shown**  
**RH side opposite**

(g) For Model CL-600-2C10 (Regional Jet series 700 & 701) series airplanes, S/Ns 10003 through 10999 inclusive; and Model CL-600-2D24 (Regional Jet series 900) series airplanes, S/Ns 15002 through 15990 inclusive: At the applicable time specified in paragraph (f) of this AD, perform detailed inspections of the lower panel, part number (P/N) CC670-10520, of the left- and right-hand MLG doors for the conditions and in the areas specified in paragraphs (g)(1), (g)(2), (g)(3), and (g)(4) of this AD; and Figures 1, 2, and 3 of this AD.

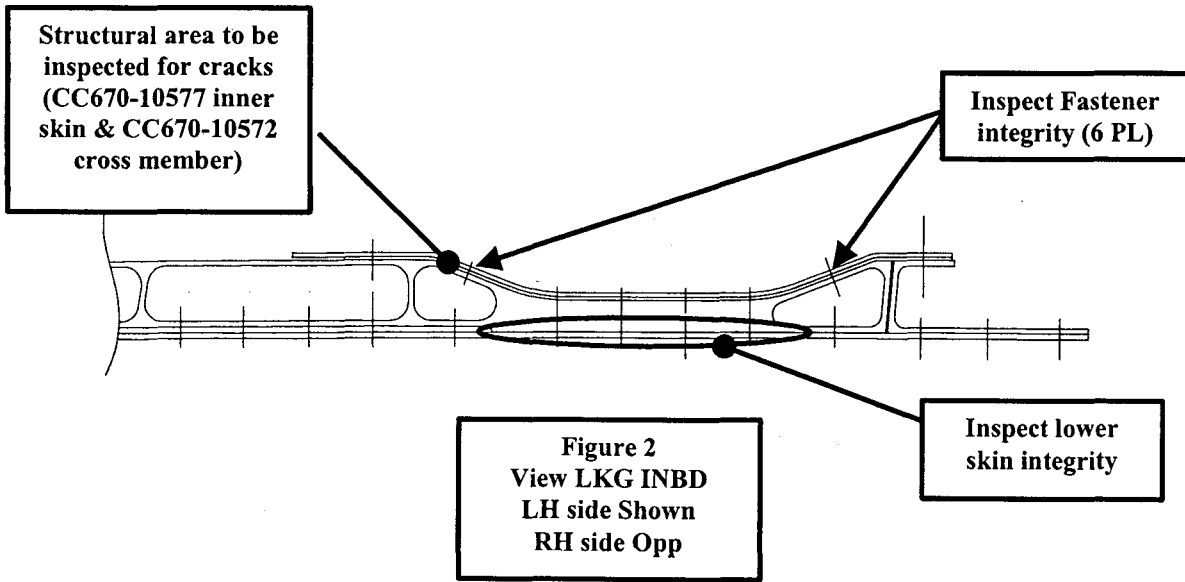
(1) Inspect the cross member, P/N CC670-10572, of the MLG door lower panel for cracking or deformation, in accordance with Figure 2 of this AD.

cross member (P/N CC670-10572) for cracking or deformation, or pulled or missing fasteners, in accordance with Figure 2 of this AD.

fasteners, in accordance with Figure 2 of this AD.

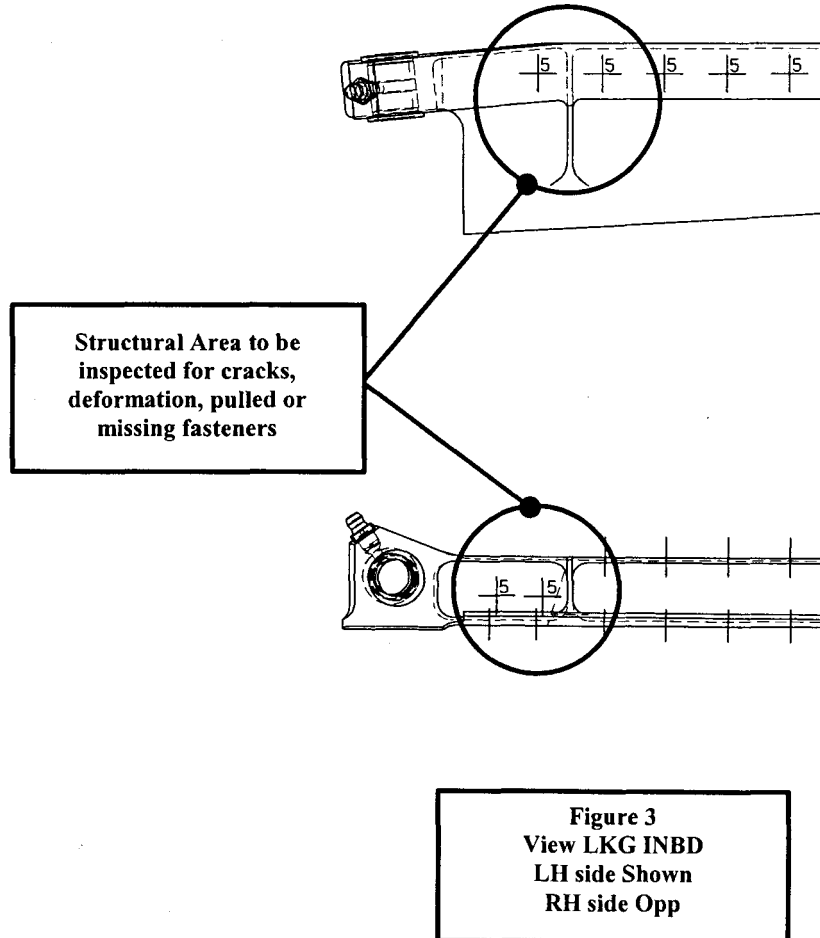
(4) Inspect the forward member, P/N CC670-10570, and aft member, P/N CC670-10571, of the MLG door lower panel, for cracking or deformation, or pulled or missing fasteners, in accordance with Figure 3 of this AD. Figures 1 through 3 of this AD follow.
