[Docket No. FAA-2006-23871; Directorate  
Identifier 2006-NE-01-AD]

#### Airworthiness Directives; General Electric Company (GE) CF6-80C2 Turbofan Engines

**ACTION:** Notice of proposed rulemaking  
(NPRM).

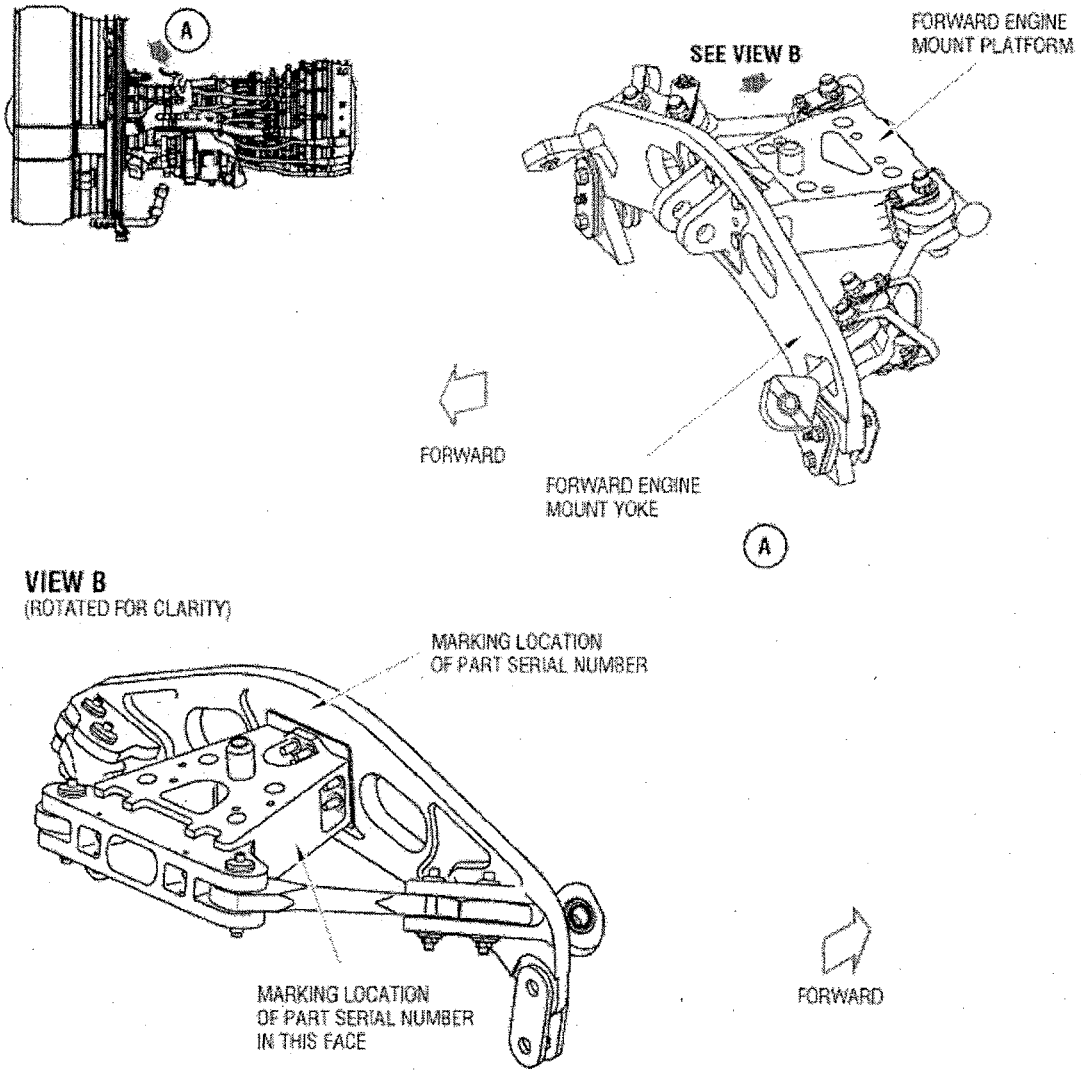
Location of Forward Engine Mount Platform and Forward Engine Mount Yoke  
Figure 1

(d) This AD results from the discovery of cracks in a forward engine mount platform and a forward engine mount yoke found during fluorescent penetrant inspection (FPI). We are issuing this AD to prevent cracks in the forward engine mount platform and forward engine mount yoke that could result in possible separation of the engine from the airplane.

(f) Table 1 of this AD lists the P/Ns and serial numbers (SNs) of the weld-repaired forward engine mount platforms that have a weld repair in a non-redundant area of the mount and must be replaced.

(p) Location of the forward engine mount platform and forward engine mount yoke and SN are illustrated in the following Figure 1.

(n) Replace the affected forward engine mount platform and or the affected forward engine mount yoke with a non-weld-repaired cast titanium forward engine mount platform and or the forward engine mount yoke or a forged titanium forward engine mount platform or a forged titanium forward engine mount yoke.
