[Docket No. FAA–2007–29089; Directorate Identifier 2007–NM–215–AD; Amendment 39–15197; AD 2007–18–52]

### Airworthiness Directives; Boeing Model 737–600, –700, –700C, –800, –900, and –900ER Series Airplanes

**2007-18-52 Boeing:** Amendment 39-15197. Docket No. FAA-2007-29089; Directorate Identifier 2007-NM-215-AD.

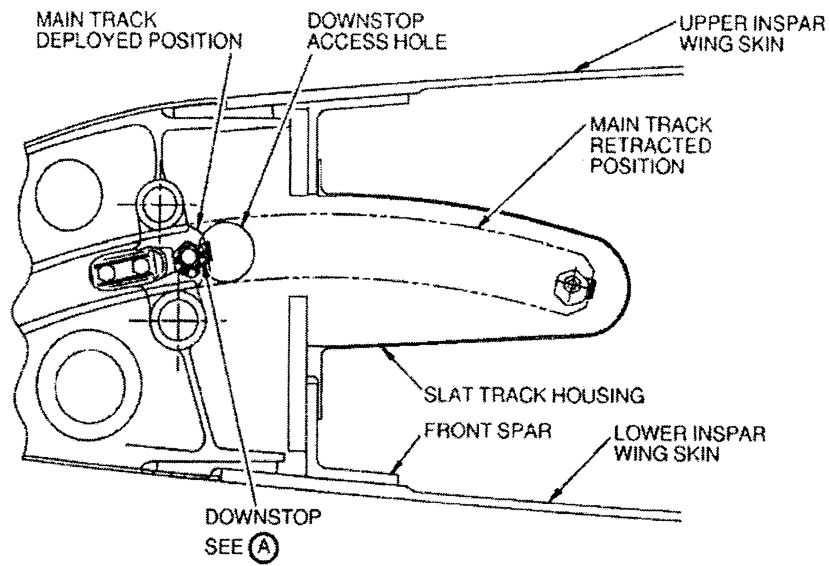
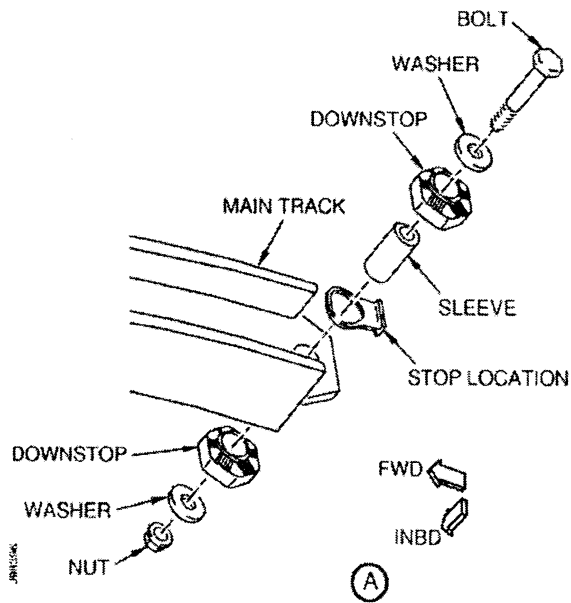
**Figure 1**

(d) This AD results from additional reports of parts coming off the main slat track downstop assemblies. We are issuing this AD to detect and correct loose or missing parts from the main slat track downstop assemblies, which could result in a fuel leak and consequent fire.

**Slat Track Downstop Assembly**

(f) Within 10 days after the effective date of this AD: Do a detailed inspection or a borescope inspection of each main slat track downstop assembly to verify proper installation of the slat track hardware (i.e., the bolt, washers, downstops, stop location, and nut shown in Figure 1 of Boeing Service Letter 737-SL-57-084-B, dated July 10, 2007, and in this AD). Proper installation of the sleeve need not be confirmed, and the stop location part may be installed on either the inboard or the outboard side of the slat track. If any part is missing or is installed improperly, before further flight, install a new or serviceable part using a method approved in accordance with the procedures specified in paragraph (h) of this AD; and do a detailed inspection of the inside of the slat can for foreign object debris (FOD) and

damage. Before further flight, remove any FOD found and repair any damage found using a method approved in accordance with the procedures specified in paragraph (h) of this AD. Using Boeing Multi Operator Message Number 1-523812011-1, issued August 25, 2007; or 1-527463441-1, issued August 28, 2007; is one approved method for verifying proper installation; installing a new or serviceable part; and inspecting for damage and FOD, and removing FOD and repairing damage. Repeat the actions required by paragraph (f) of this AD thereafter at intervals not to exceed 3,000 flight cycles.

(g) Within 24 days after receipt of AD 2007-18-51: Apply a torque between 50 to 80 inch-pounds to the nut. The bolt head must be held with the torque applied to the nut.
