[Docket No. 2003–SW–10–AD; Amendment 39–13344; AD 2003–21–09]

Airworthiness Directives; Eurocopter France Model AS355E, F, F1, F2, and N Helicopters

2003-21-09 Eurocopter France:

Amendment 39-13344. Docket No. 2003-SW-10-AD. Supersedes AD 2002-21-51, Amendment 39-12982, Docket No. 2002-SW-48-AD.

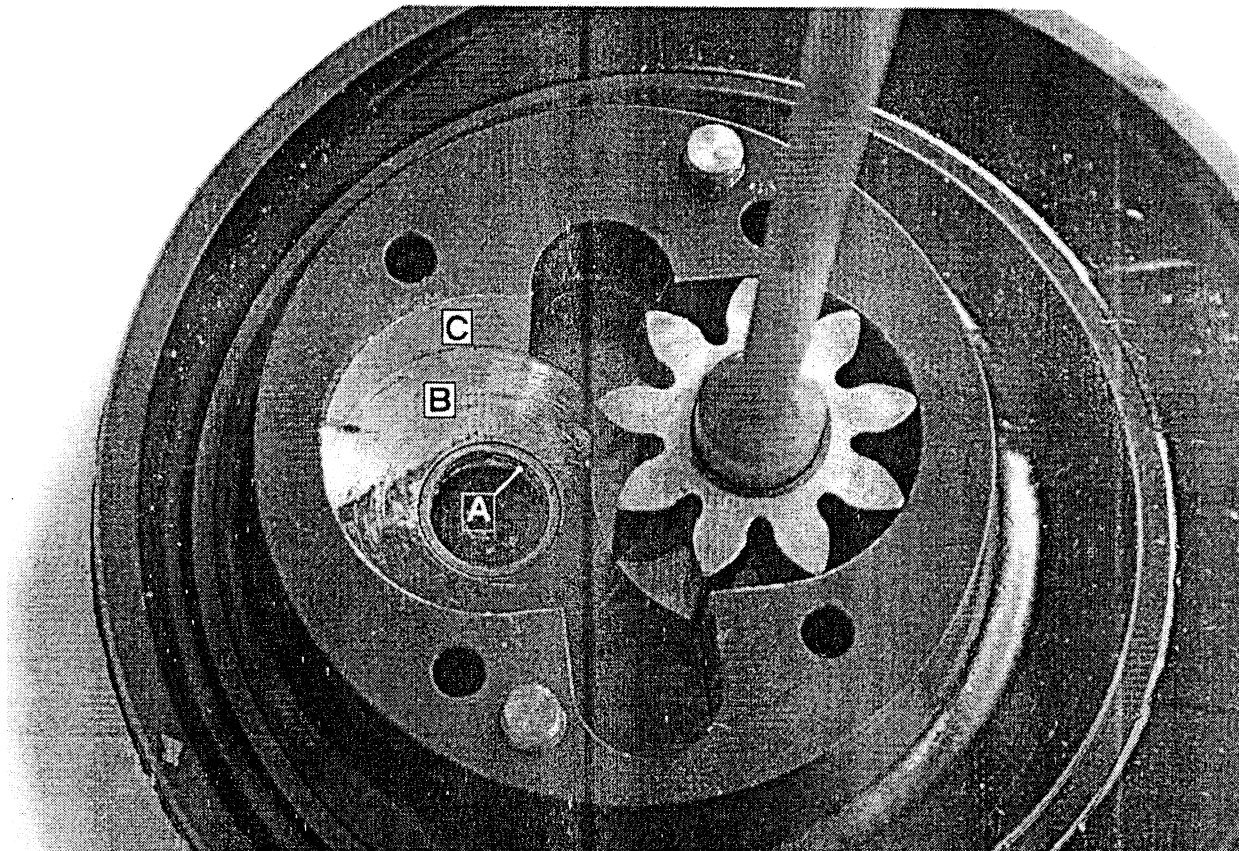
Figure 1

(d) While inspecting the pump, if you find any of the following, replace the MGB and the pump with an airworthy MGB and pump before further flight:

- (1) Crank pin play,
- (2) Out of round bronze bushing (A of Figure 1),

- (3) Offset of the driven gear pinion,
- (4) Metal chips, or
- (5) Wear (C of Figure 1).

Note 2: If wear is present in the B area only as depicted in Figure 1, replacing the MGB and the pump is not required.
