Landslides Triggered By Hurricane Mitch In Tegucigalpa, Honduras

By Edwin L. Harp, Mario Castañeda, and Matthew D. Held

Open-File Report 02-33

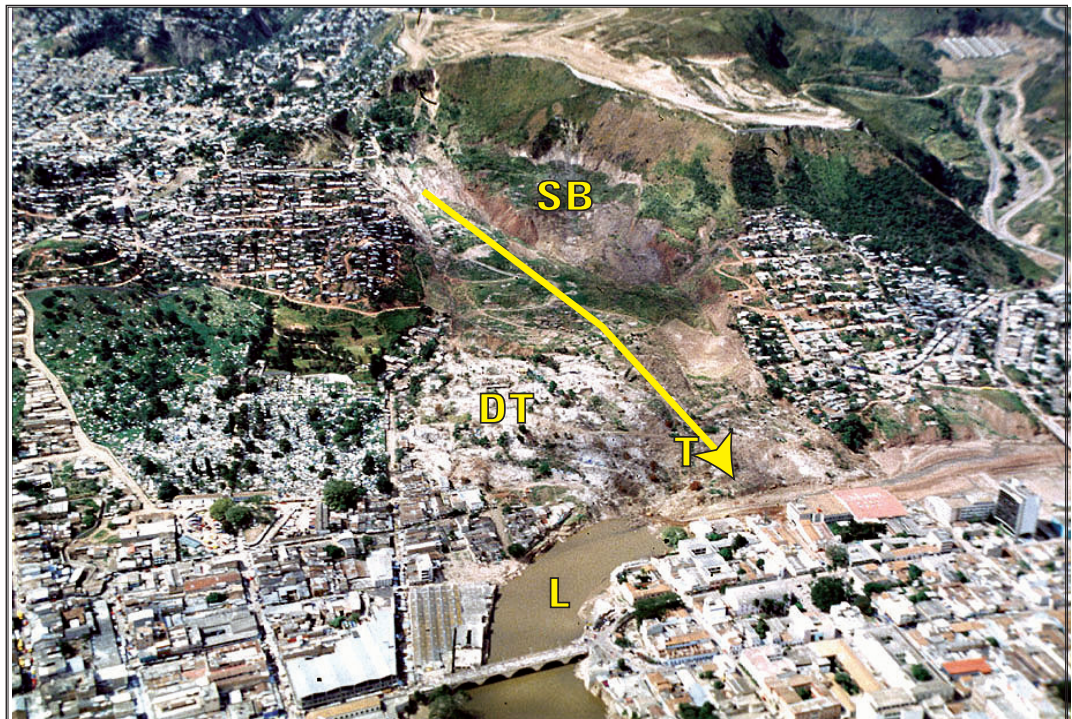
The El Berrinche landslide in Tegucigalpa was the largest single landslide (#1, Plate 1) triggered by Hurricane Mitch in Honduras. It destroyed a portion of the central part of the city known as Colonia Soto and dammed the Río Choluteca, creating a sewage-filled lagoon upstream from the landslide dam (figure 2). This complex slump/earth flow had a volume of approximately 6 million cubic meters. Because of initial slow movement of the landslide during the hurricane-associated rainfall, city residents living on the landslide mass were evacuated prior to its rapid movement that culminated in the damming of the river. The river was dammed at approximately 12:30 a. m. on October 31, about one hour after the peak flood flow of the Río Choluteca.

The El Berrinche landslide consists of three basic parts. With reference to figure 2, the part of the landslide marked "DT" is a highly deformed toe that buckled and folded extensively but did not travel across the Río Choluteca. A view of this area soon after the landslide occurred is shown in figure 3.

Just upslope from the deformed toe is an earth-flow tongue that extends the entire length of the landslide from upper left to lower right. This earth-flow tongue is that part of the slide mass that actually flowed across and dammed the Río Choluteca creating the lagoon. A downslope view of this part of the landslide mass is shown in figure 4.

Figure 2. Aerial view of the El Berrinche landslide, a complex slump/earth flow that dammed the Río Choluteca in Tegucigalpa. The arrow indicates the direction of movement of the earth-flow tongue. "T" denotes the toe of the landslide that dammed the river, and "L" indicates the lagoon dammed by the toe of the landslide. "DT" indicates the highly deformed toe of the landslide where the center of Colonia Soto was, and "SB" denotes the upper slump block.

Just to the left and upslope from the earth flow in figure 4 (denoted by a vertical arrow) is the third main portion of the landslide, a slump block shown as "SB" in figure 2. This slump block has a scarp approximately 30 m high at its upslope margin. This scarp appears to be a contact between deeply weathered deposits of clay and silt derived from rhyolitic volcanics that contain interspersed conglomerate and hard, competent, rhyolitic ignimbrite exposed above the scarp.

The damming of the Río Choluteca by the landslide and the creation of the lagoon upstream from the landslide dam also created a significant health hazard to the people who lived in the downtown area near the river. In early December 1998, dredging by construction crews from Mexico proved to be insufficient to cut a deep enough channel to drain the lagoon. With the drainage of the lagoon a high priority of the city of Tegucigalpa and the government of Honduras, the U.S. Army Corps of Engineers and the U.S. Geological Survey were asked, on an emergency basis and with no time to complete a systematic study, to evaluate the stability of the landslide mass near the toe should a deeper channel be excavated through the landslide dam. With the proposed channel design from local engineers, geologists from the U.S. Army

Corps of Engineers and the U.S. Geological Survey considered the proposed shape and dimensions of the landslide toe once the channel had been excavated and concluded that the toe would be stable except for small localized slumping of the toe as the river eroded material from the toe during the drainage of the lagoon. This decision, based mainly on experience and judgement and without the aid of borings, samples, or any preliminary stability analysis, proved to be correct, and the landslide toe has remained relatively stable since the lagoon was drained.

Since the initial draining of the lagoon, a slope stability analysis has been performed by the U.S. Army Corps of Engineers, and most of the landslide mass has been regraded and contoured to enhance the stability and drainage of the slide mass. Both rainy seasons since Hurricane Mitch have produced lower than normal cumulative rainfall, and the El Berrinche landslide has remained stable except for localized slumping within the lowest part of the landslide toe where steeper slopes have been produced by channel excavation. A more rigorous test of the landslide's stability will occur when a future rainfall season exceeds normal rainfall totals.

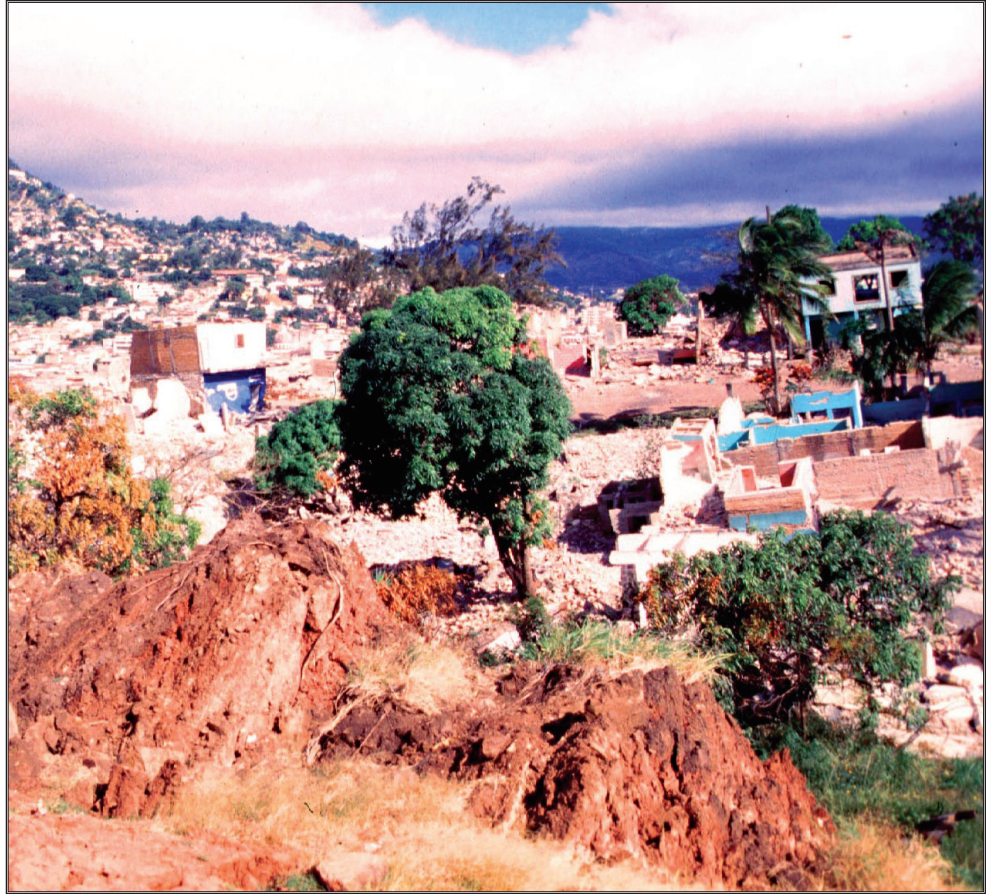
Figure 3. View of the highly deformed toe area of the El Berrinche landslide that destroyed Colonia Soto. The view here is of the remains of Colonia Soto as seen in December 1998. The remains of houses and streets can be seen rotated at high angles from horizontal.

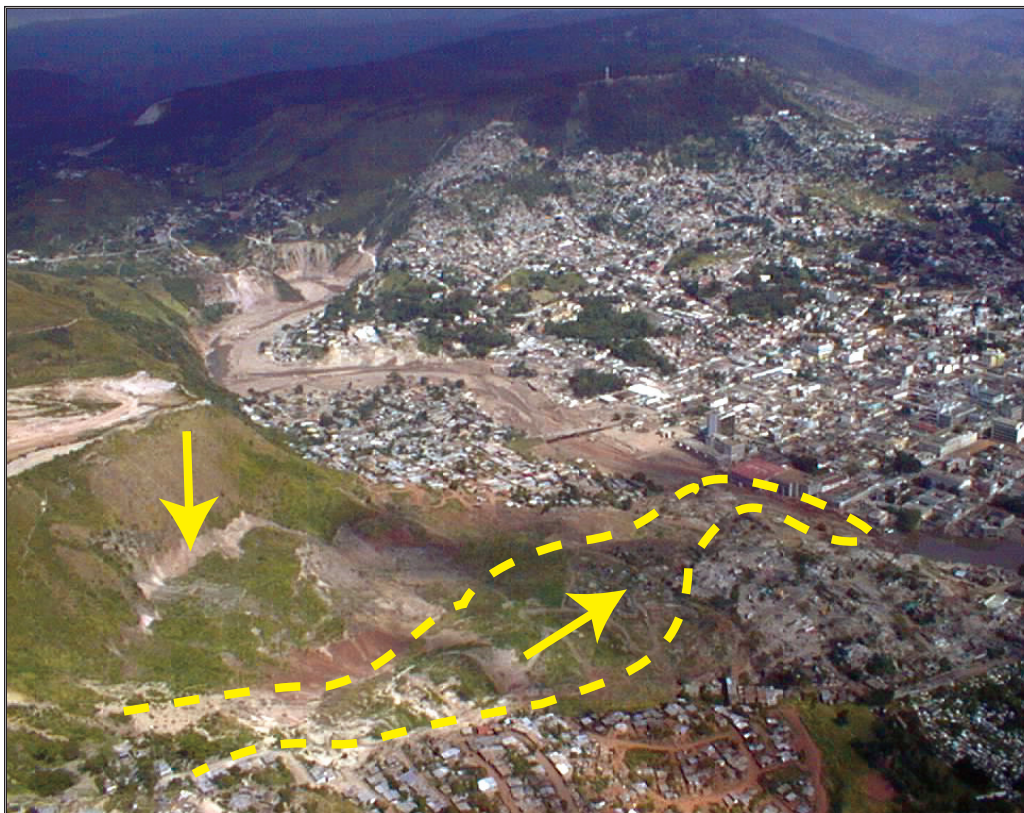
Figure 4. View of the El Berrinche landslide looking obliquely downslope. The earth flow that dammed the Río Choluteca is outlined by the yellow dashed line, and the direction of flow denoted by the yellow arrow. Vertical yellow arrow points to scarp of large slump block at head of landslide.

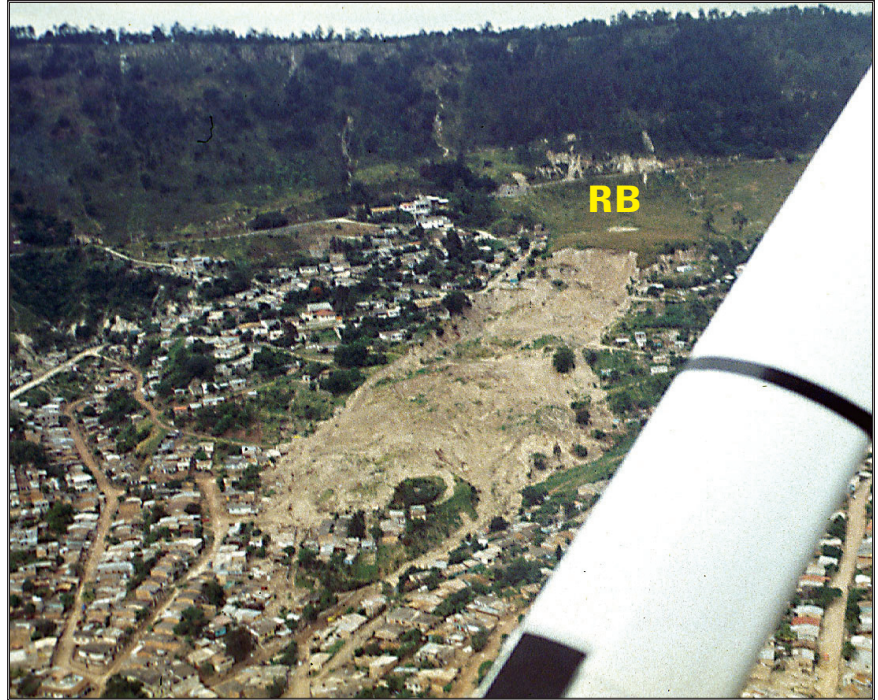
Another deep-seated landslide, a slump/debris flow having a volume of 400,000 m³, destroyed numerous houses in the Colonia El Reparto section of Tegucigalpa (#2, Plate 1; figure 5). This landslide occurred during the mid-morning of October 31 over a time span of several hours. The final movement of the slump resulted in the formation of a debris flow, which mobilized from the oversteepened toe of the landslide and demolished the houses. Because of the

The El Reparto landslide is a reactivated portion of a larger landslide complex. Its headscarp is at the margin of a large downward-rotated block (shown as "RB" in figure 5) of an older landslide complex whose headscarp is the surrounding steep slope forming the skyline in figure 5.

Figure 5. Aerial view of the El Reparto slump/debris flow. "RB" denotes a rotational block of an older landslide complex whose headscarp is the steep slope forming the skyline.

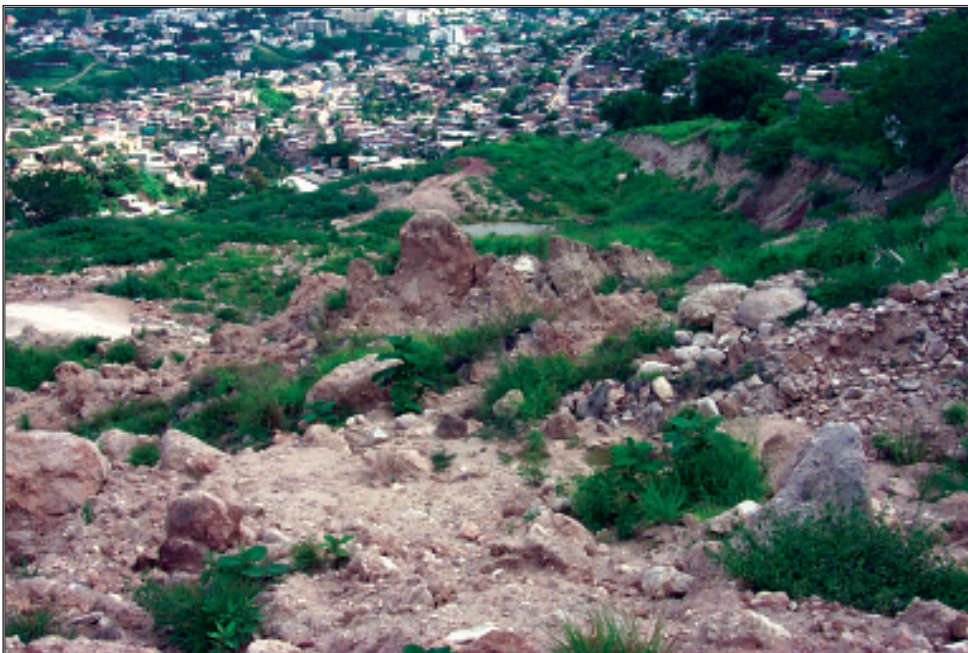
Figure 6. Headscarp area of El Reparto landslide showing small pond in right center of photo.

As shown in figure 6, the area below the headscarp of the landslide has a small pond fed by water and sewage lines that were severed by the landslide movement. Recommendations were made to the city to divert flow from these water sources to decrease the water level within the slide mass. These recommendations were subsequently undertaken in November 2000.

A series of survey points were established on the landslide mass in July 2000; These survey points were resurveyed periodically so that any renewed movement could be detected. This monitoring was undertaken because of all the residences that are still occupied adjacent to and downslope of the landslide.

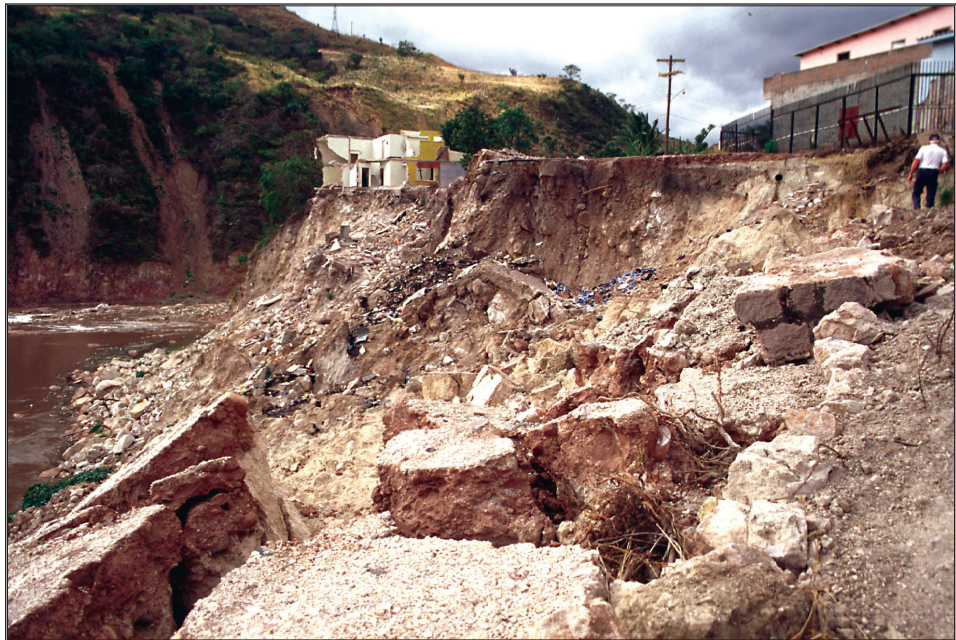
Several other deep-seated landslides caused damage to people and property in the city of Tegucigalpa. Two debris slides triggered by the undercutting of river banks destroyed houses at Barrio Mira Mesi adjacent to the Río Choluteca and at Nueva Esperanza adjacent to the Río Guacerique. The slide at Barrio Mira Mesi (#3, Plate 1) began as a relatively small debris slide of about 5,000

m³ in older terrace deposits adjacent to the Río Choluteca (figure 7). Several houses were destroyed or damaged by the sliding and subsidence caused by the erosive undercutting of the terrace by the river. The headscarp of this landslide continued to be unstable even during dry seasons of 1999 and 2000 and continued to retrogress upslope and involve additional houses (figure 8).

Figure 7. Debris slide at Barrio Mira Mesi adjacent to the Río Choluteca.

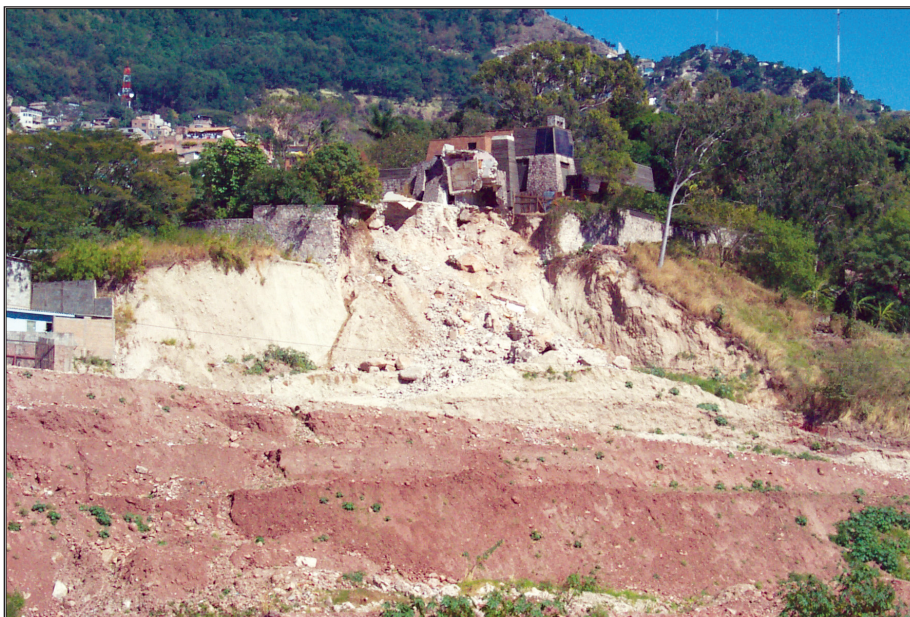
Figure 8. Debris slide at Barrio Mira Mesi that has progressed headward even during dry seasons following Hurricane Mitch despite the placement of a soil berm (shown in the foreground) to protect the slope.

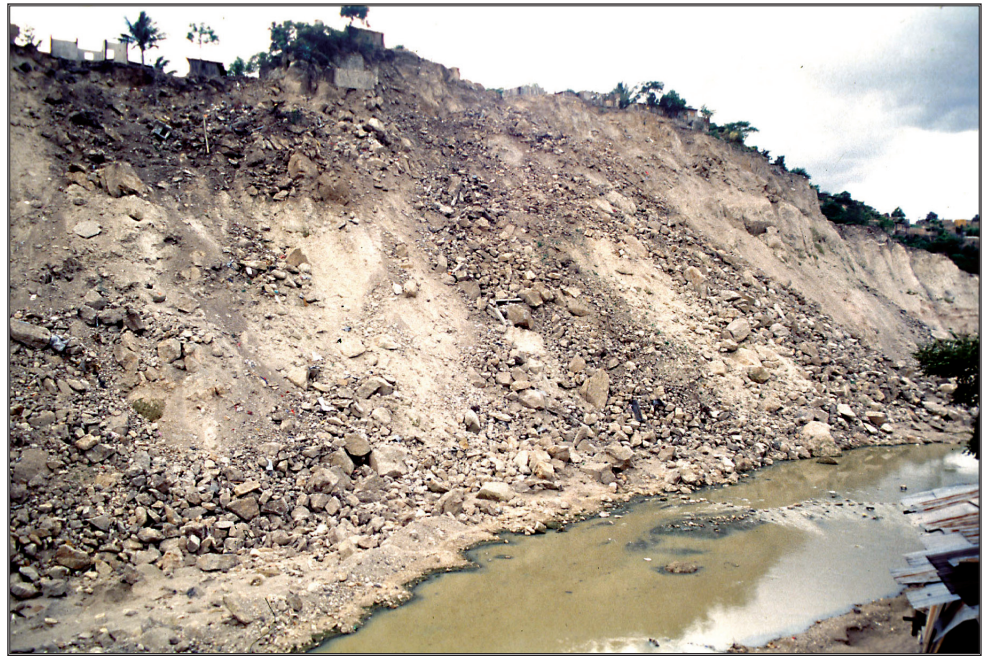
The debris slide at Nueva Esperanza (#4, Plate 1; figure 9), triggered by the erosive undercutting of the slope by the Río Guacerique during its peak flow during Hurricane Mitch, destroyed more than 20 homes perched on the steep

slopes above the river. As at Mira Mesi, the loose alluvial deposits continued to slide, especially during the rainy seasons following the hurricane; the ongoing sliding destroyed several additional homes.

Figure 9. Debris slide along the Río Guacerique.

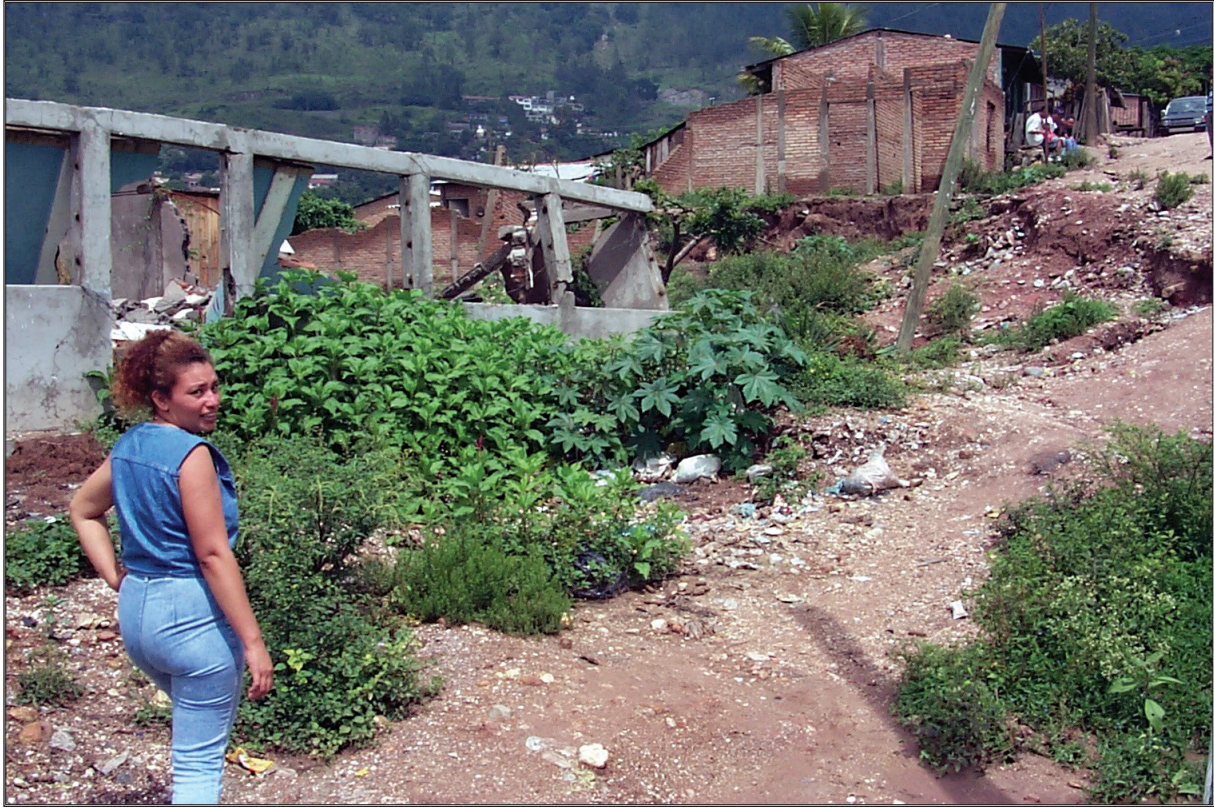
In Barrio Santa Rosa, 0.5 km southeast of the El Reparto landslide, a slow-moving slump was reactivated in September 1999. An incipient slump that had begun to form during Hurricane Mitch, with about 80 cm of displacement along a partially formed headscarp underwent renewed movement during a period of intense afternoon rainfall. The

reactivated slump involved a volume of about 1,800 m³ and affected 37 homes. This occurred at a time when we were doing field work in Honduras, so we responded to a request from the city to advise them on how many people should be evacuated from the area. The reactivated movement on the headscarp of the slump began on the afternoon of September 23 and totaled about 80 cm that evening, with another 30 cm of displacement occurring by the next morning (figure 10). We assessed the situation on the afternoon of the 23rd and recommended evacuation for those homes that were within the limits of the slump. After the end of the intense period of rainfall that afternoon and night, the movement of the slump also terminated. Little, if any, renewed movement has occurred since this episode.

Figure 10. Reactivated slump in Barrio Santa Rosa triggered by intense rainfall in September 1999.

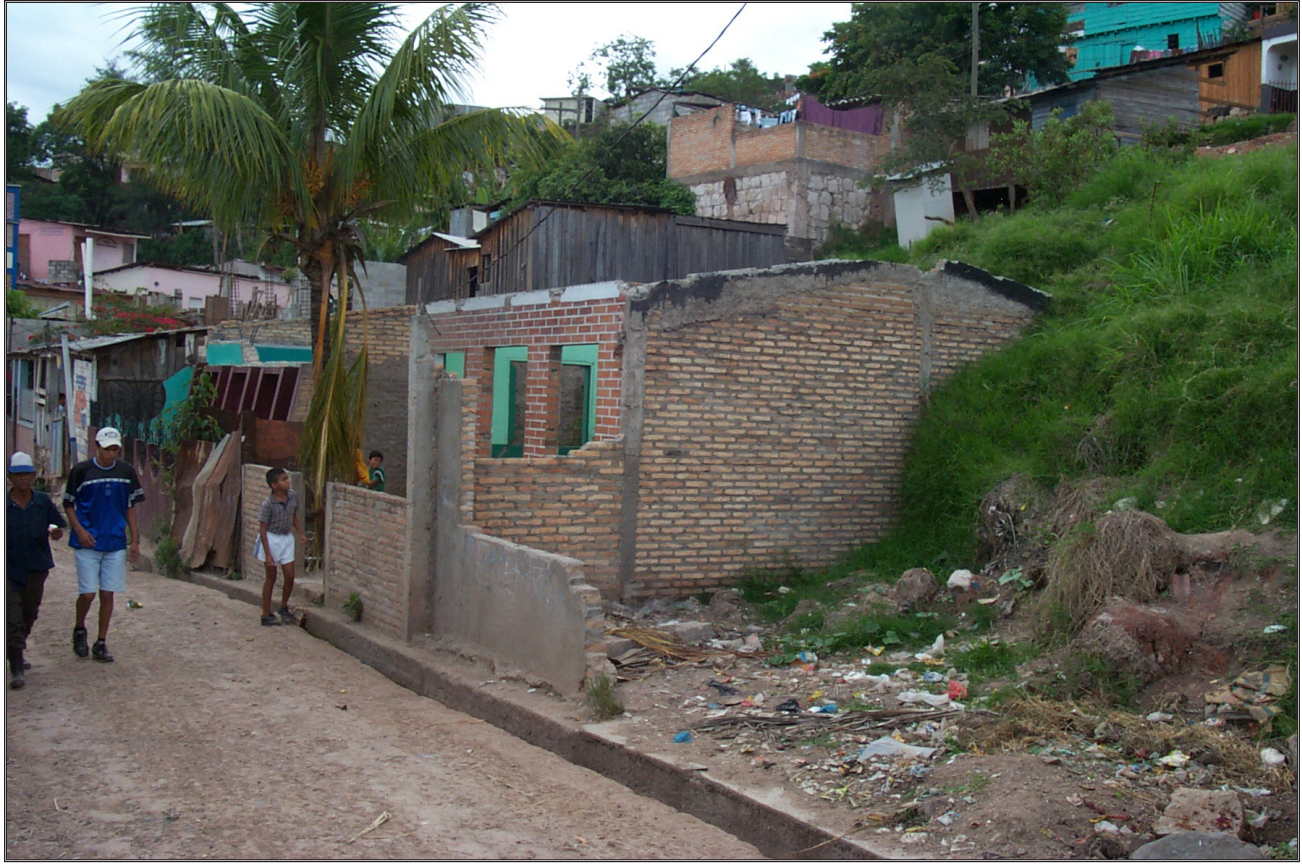
Another moderate-sized slump of about 2,500 m³ occurred about 200 m south of the El Berrinche landslide in a small neighborhood called Campo Cielo. This landslide began its movement on or about September 23, 1999, on the southeast-facing nose of the ridge just south of the El Berrinche landslide. The initial movement occurred as a scarp about 15 m long having about 20 cm of displacement. Once this scarp had formed, little additional displacement occurred at this site, and subsequent slope movement shifted downslope as another headscarp area formed with multiple cracks from which water percolated. The slope below this was saturated to the surface, making foot travel across the landslide almost impossible without sinking into the saturated soil. The toe of this slump was situated behind a row of houses next to a street in the neighborhood. As the slump continued to move at a rate of several centimeters per day over a period of

several weeks at the end of the rainy season, the toe grew and eventually made contact with the back walls of the row of houses fronting the street (figure 11). As movement continued, the toe of the slump began squeezing between these houses and breaking through the back walls of the houses. Residents of the houses evacuated the dwellings just prior to the toe of the slump reaching the rear walls.

This area had been the site of recurring spring activity in the rainy seasons of most years. Prior landslide movement of this hillside occurred during Hurricane Gilbert in 1986, when four houses were destroyed and during Hurricane Mitch, when 17 houses were destroyed. During the dry season of 2000, the city dug trenches through the landslide that are greater than the depth of the slide surface, which is 2-3 m deep. These trenches have succeeded in draining the slide mass and halting movement of the slope.

Figure 11. Toe of slump in neighborhood of Campo Cielo in Tegucigalpa. At the right of the photo, the toe of the slide mass is seen impinging against the row of houses.
