# **AQUETONG ROAD/ WINDY BUSH ROAD**

## **Road Safety Audit**

October 2007

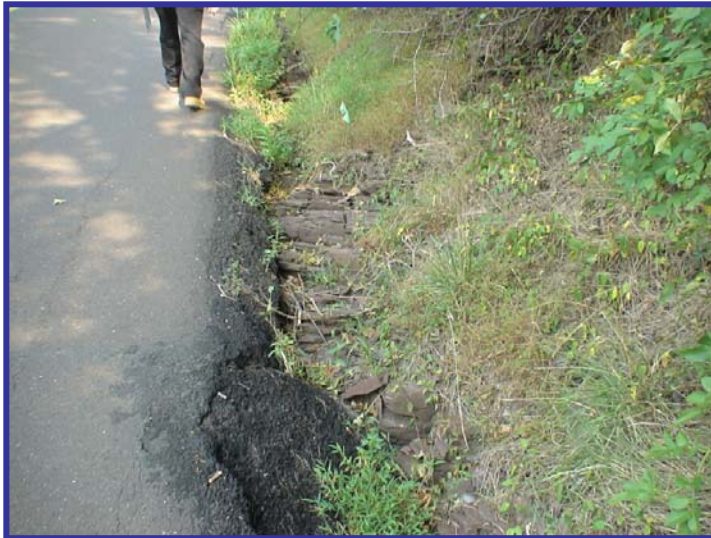
Edge of roadway deterioration on Aquetong Road between Cover Bridge Road and Rockwood Path

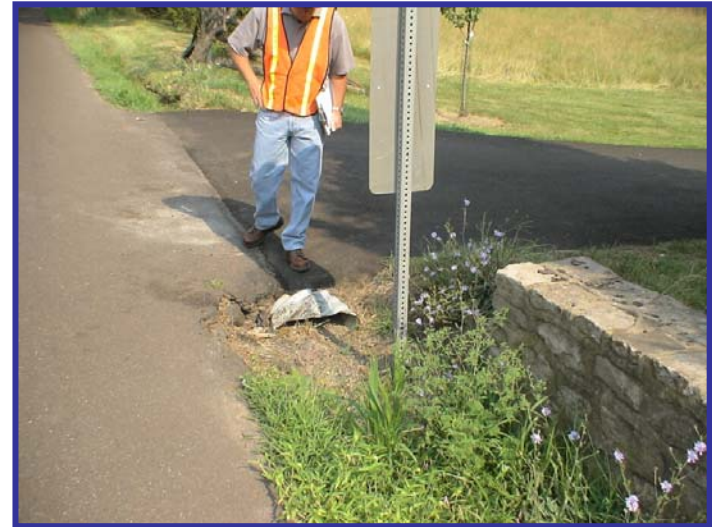
Drain at private property driveway on Aquetong Road west of Cover Bridge Road

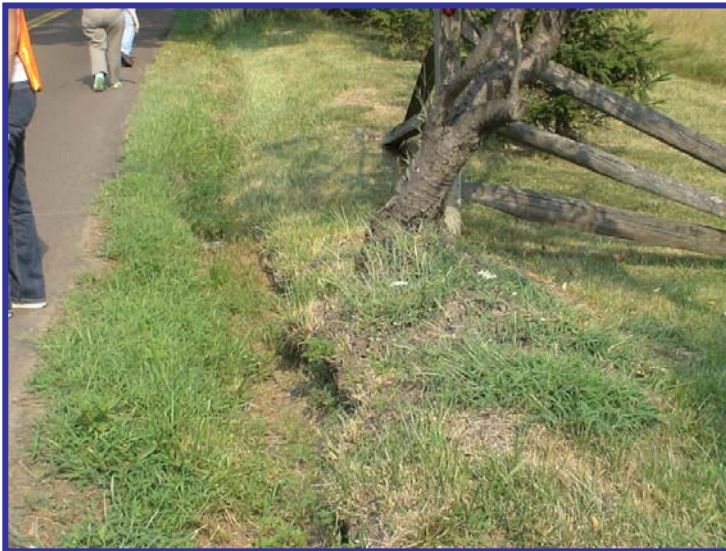
Poor drainage on Aquetong Road west of Cover Bridge Road

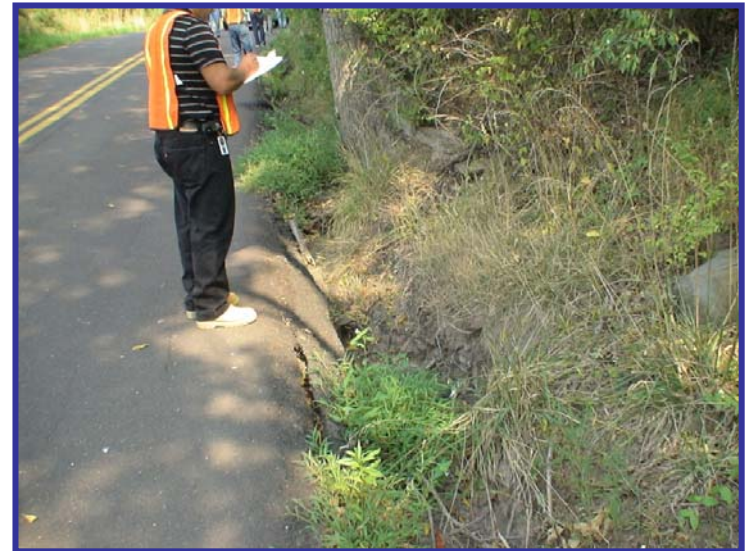
Edge of pavement drop off on Aquetong Road west of Cover Bridge Road

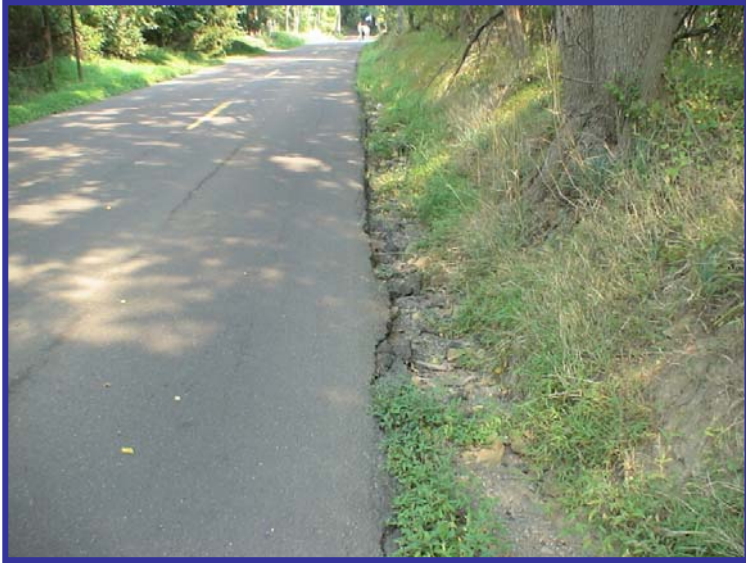
Edge of pavement drop off on Aquetong Road west of Cover Bridge Road

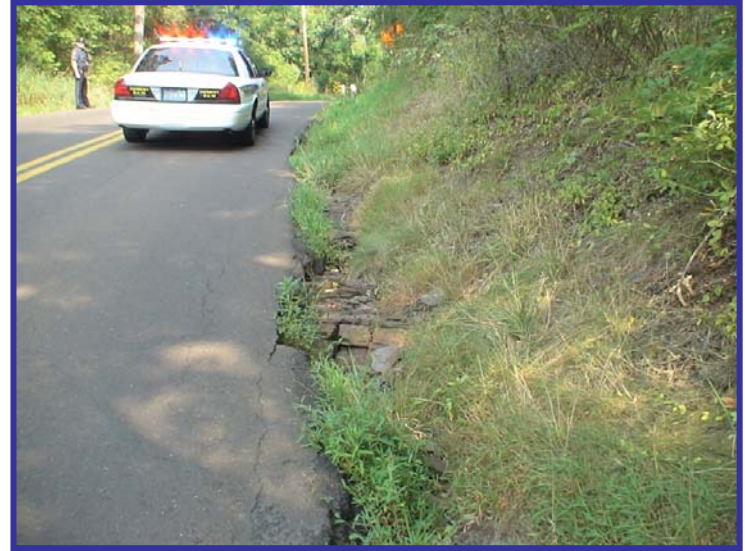
Edge of pavement drop off and deterioration on Aquetong Road west of Cover Bridge Road

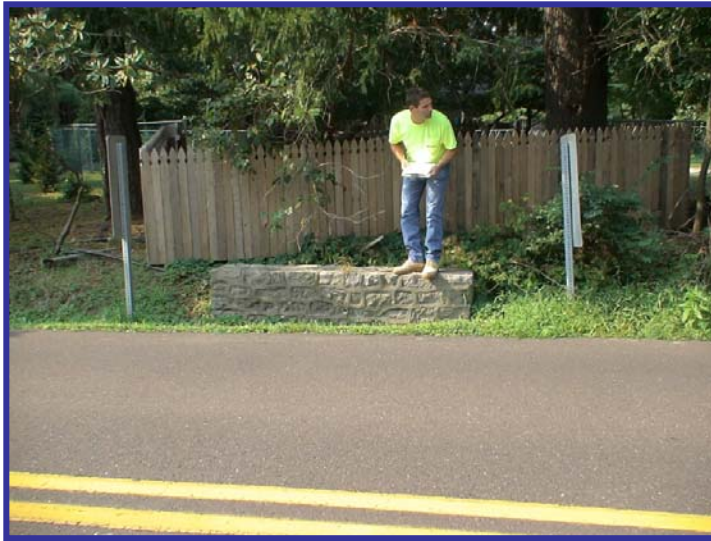
Stone headwall on Aquetong Road

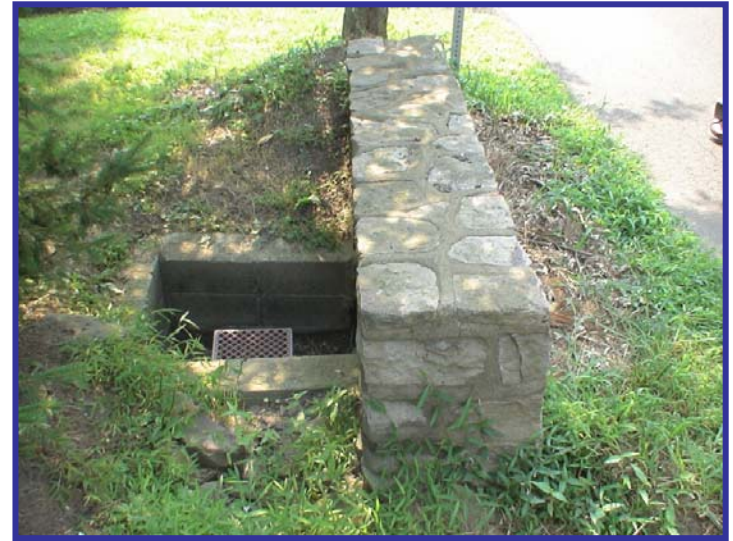
Stone headwall and inlet on Aquetong Road

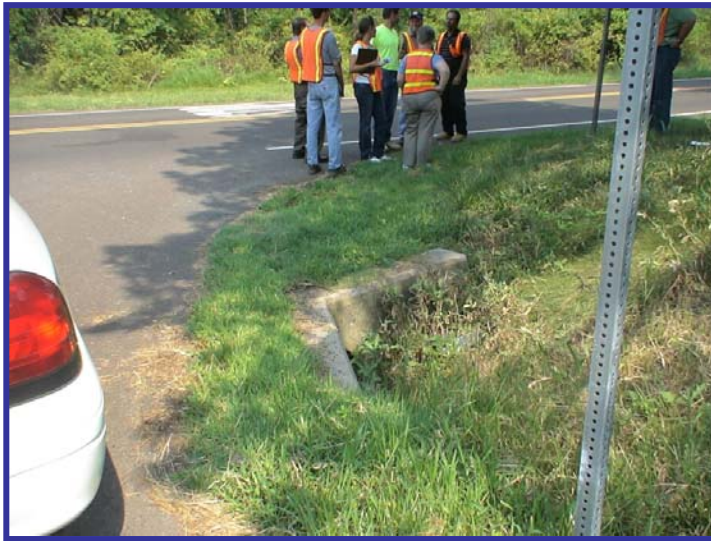
Inlet at the intersection of Aquetong Road and Windy Bush Road

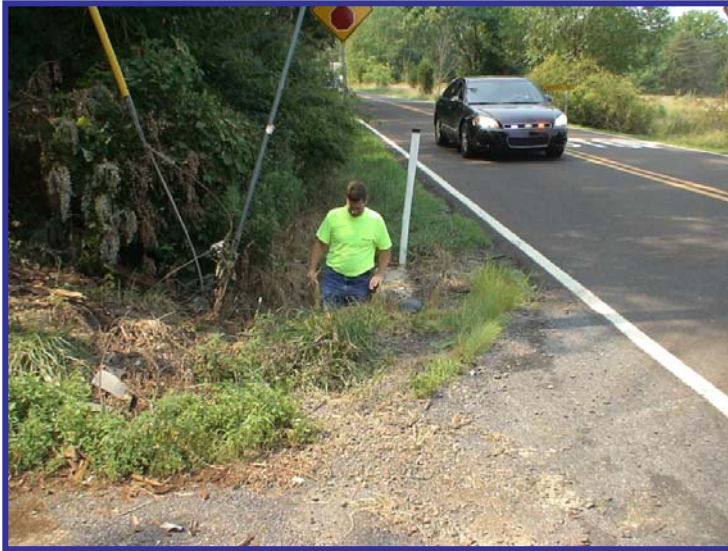
Inlet at the intersection of Old Windy Bush Road and Windy Bush Road

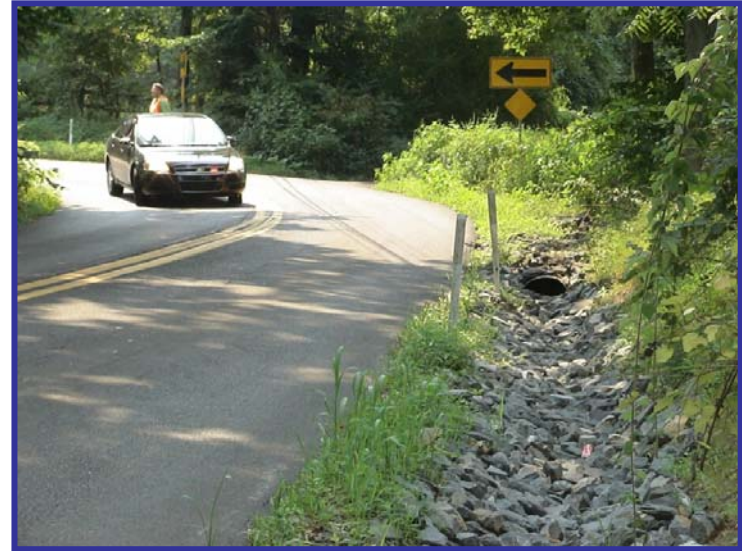
Treated drain on Aquetong Road on curve east of Sugan Road

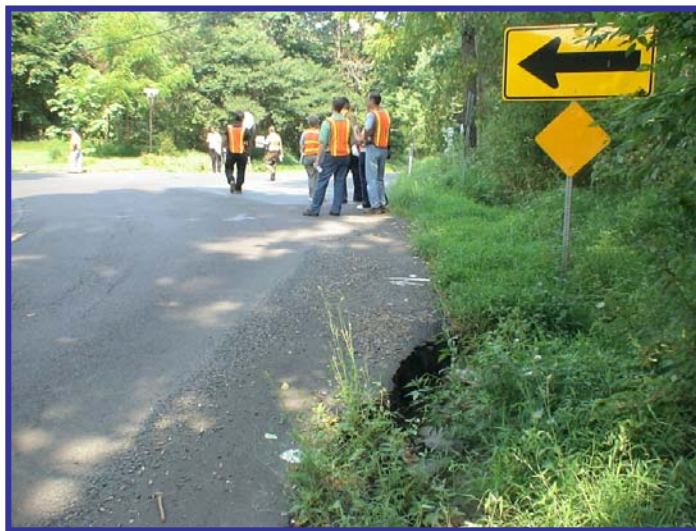
Edge of pavement drop off and deterioration on Aquetong Road east of Sugan Road

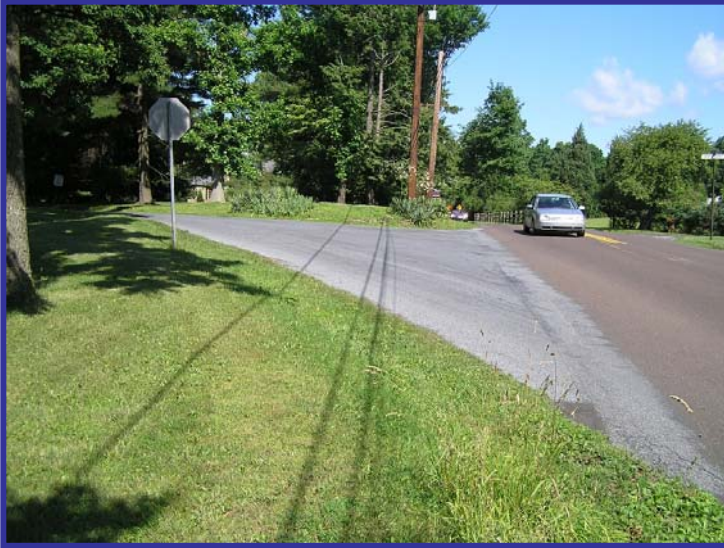
Intersection of Aquetong Road and Cover Bridge Road looking west

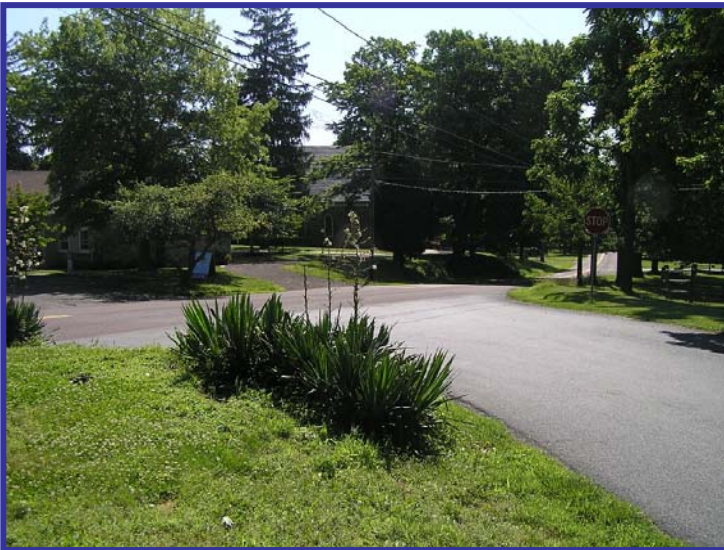
Intersection of Aquetong Road and Cover Bridge Road showing no pavement markings

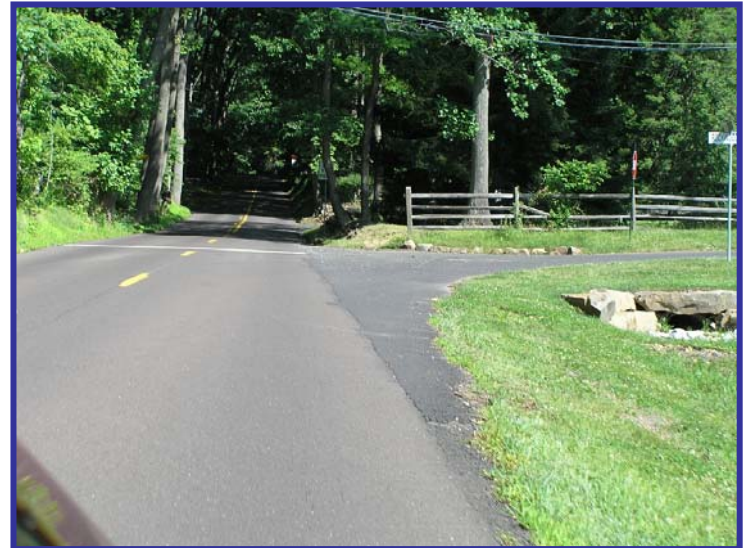
Tree canopy on Aquetong Road east of Rockwood Path

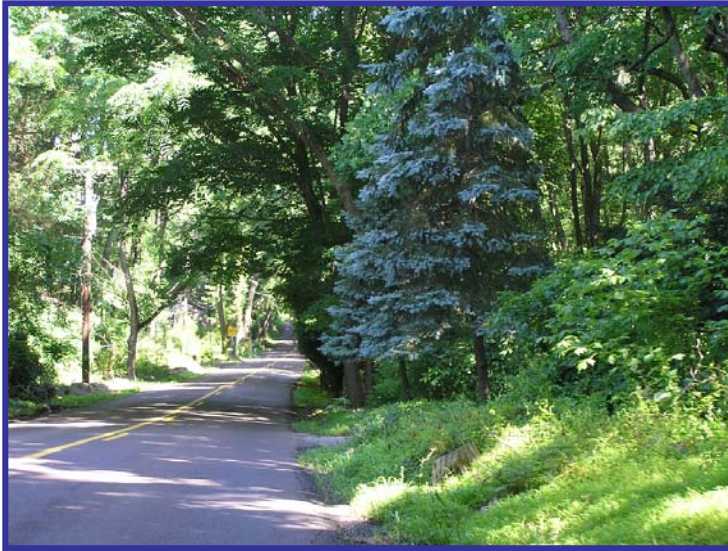
Trees on Aquetong Road in the clear zone

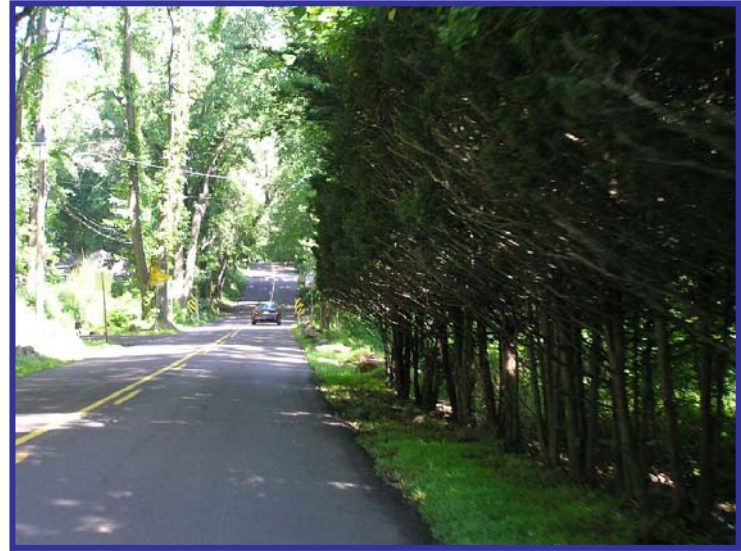
Trees on Aquetong Road in the clear zone

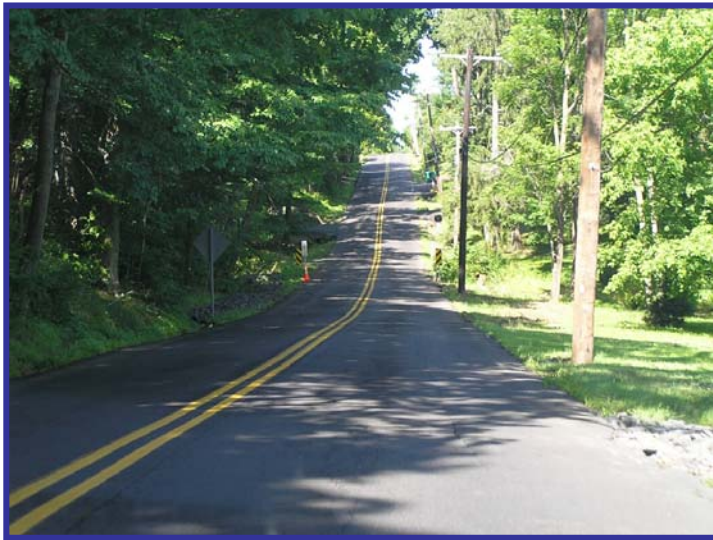
Utility poles in the clear zone on Aquetong Road east of Sugan Road

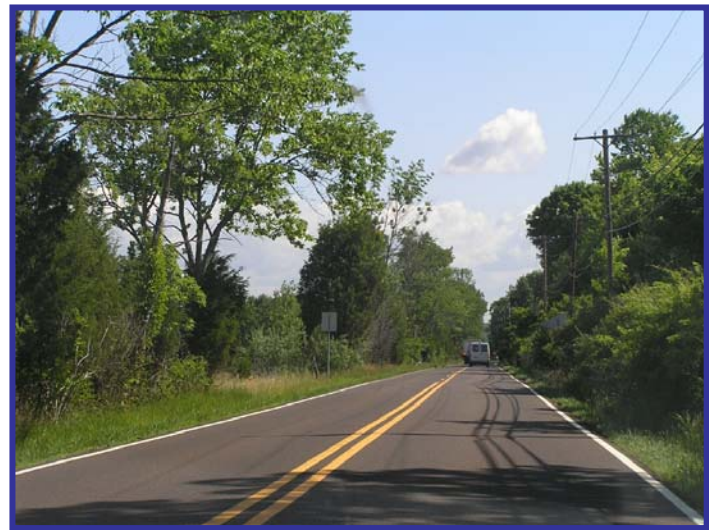
Narrow pavement of Windy Bush Road

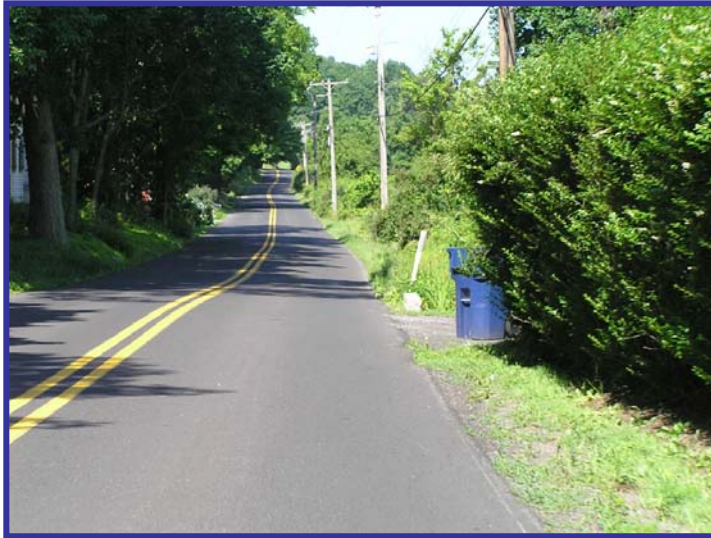
Narrow pavement of Aquetong Road west of Sugan Road

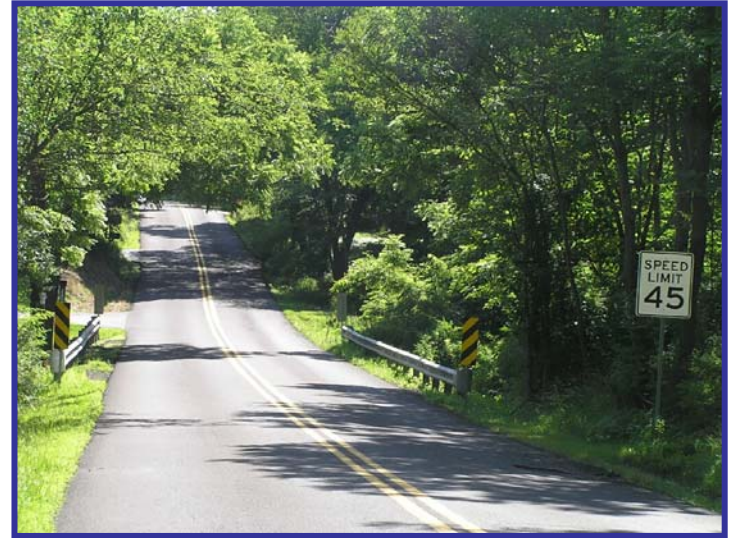
Narrow pavement of Aquetong Road west of Sugan Road, chevron signage at guide rail

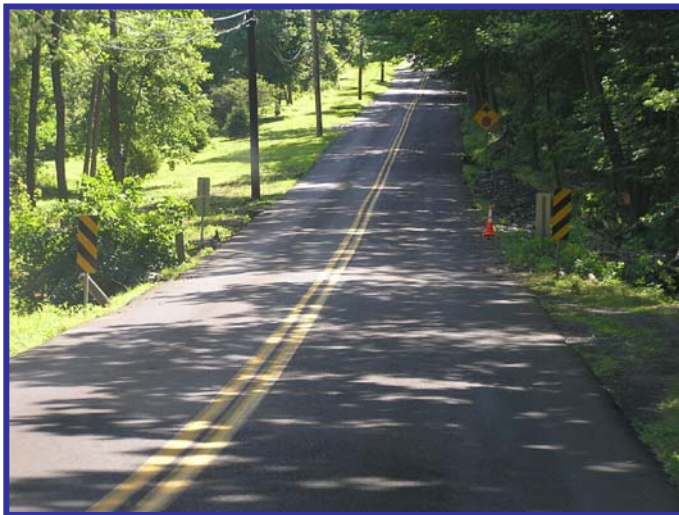
Narrow pavement of Aquetong Road, signs delineating inlet

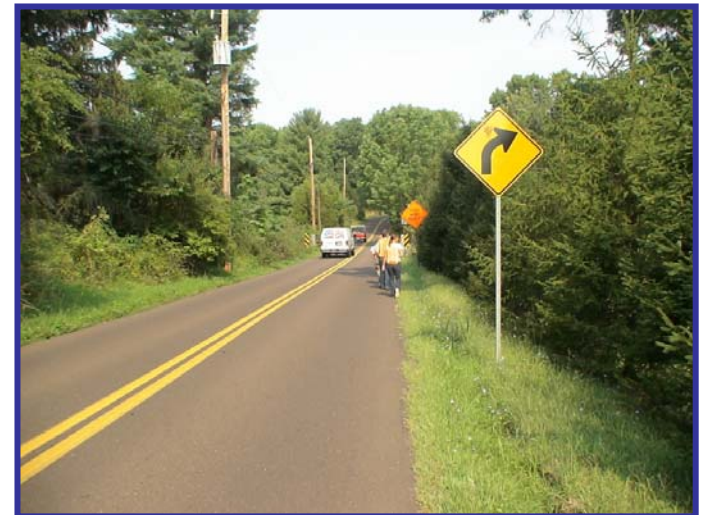
Narrow pavement of Aquetong Road with no pedestrian amenities

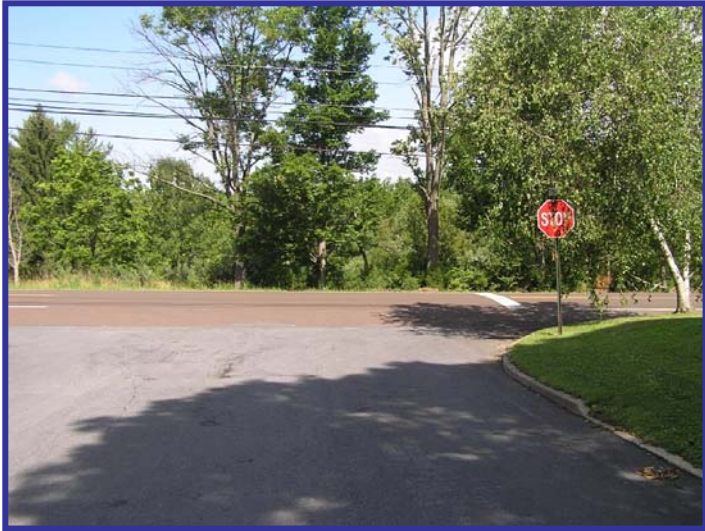
Cornwell Drive showing no pavement markings

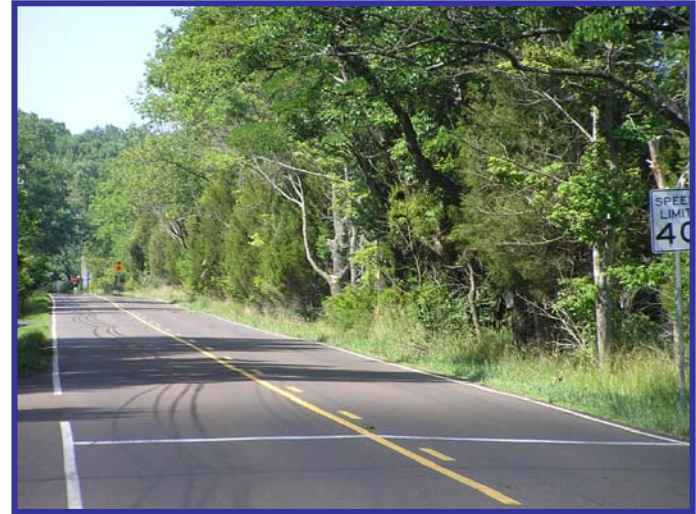
Windy Bush Road looking south at Cornwell Drive – passing zone, narrow shoulders

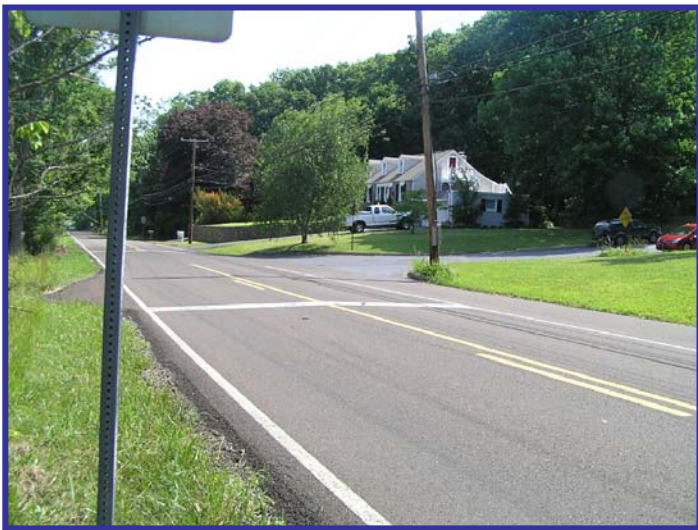
Windy Bush Road looking north at Cornwell Drive – passing zone, wider shoulders for decel lane

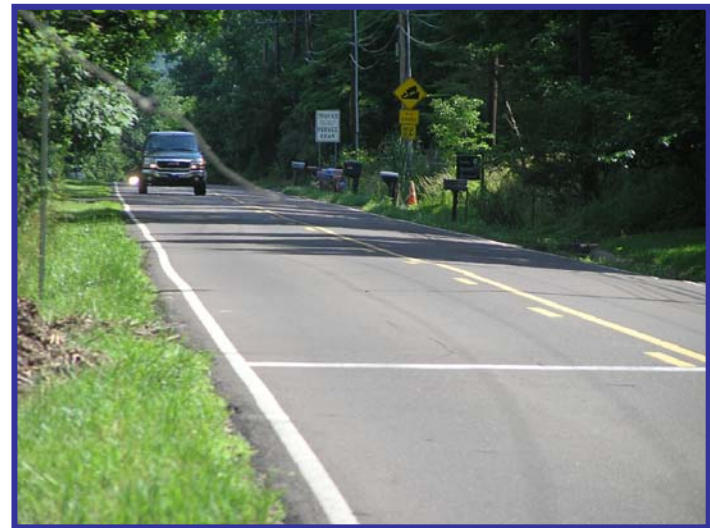
Windy Bush Road looking north at Cornwell Drive – passing zone, narrow shoulders

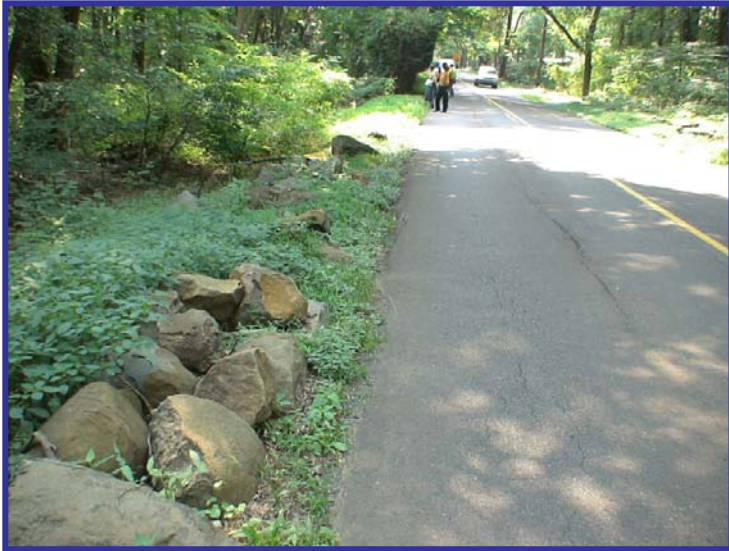
Rocks along Aquetong Road in the clear zone

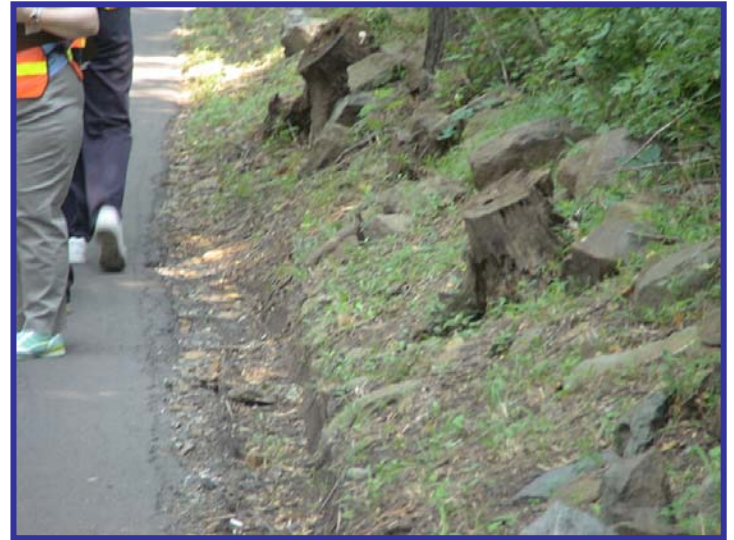
Rocks and tree stumps along Aquetong Road in the clear zone

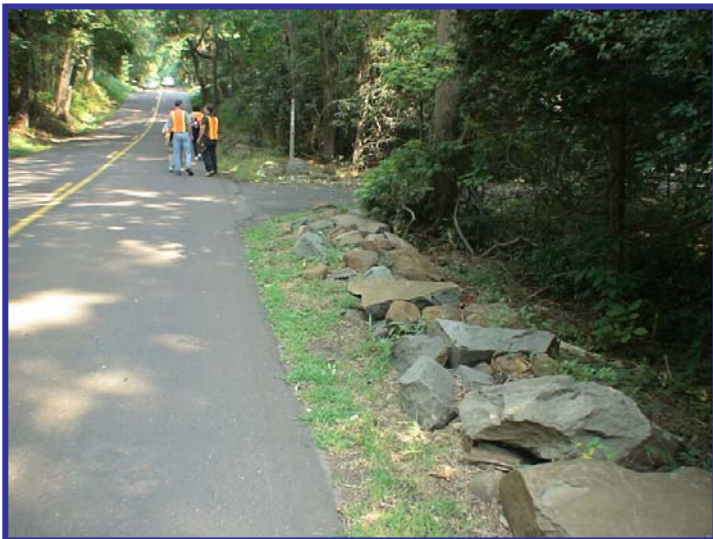
Rocks along Aquetong Road in the clear zone

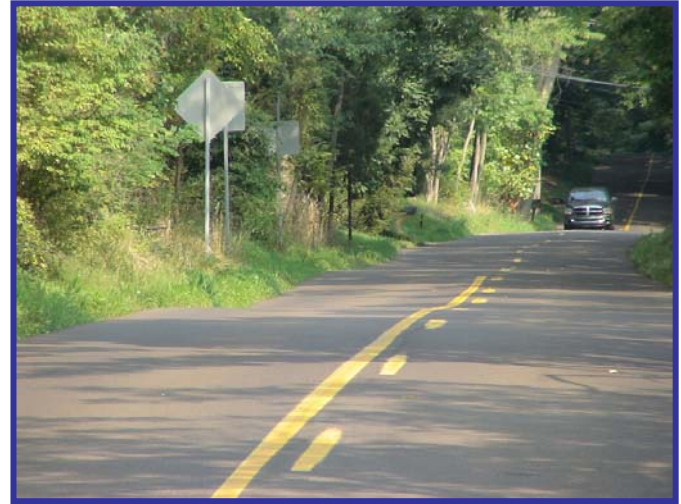
Passing Zone on Aquetong Road

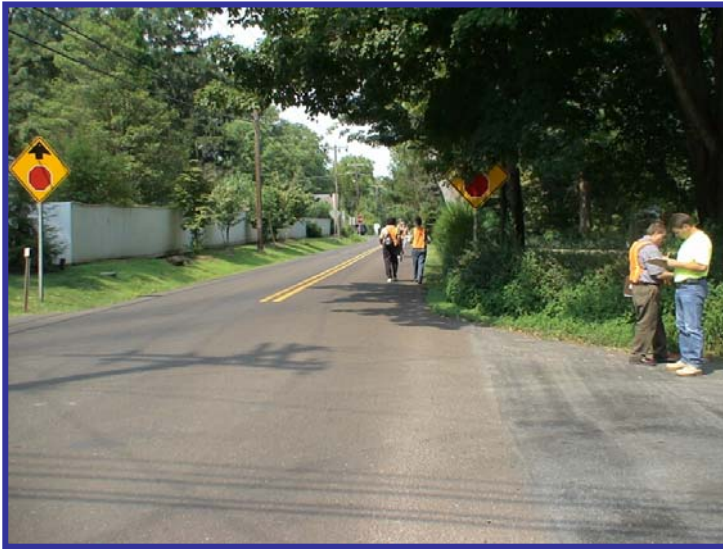
Sign partially hidden by tree branches along Aquetong Road

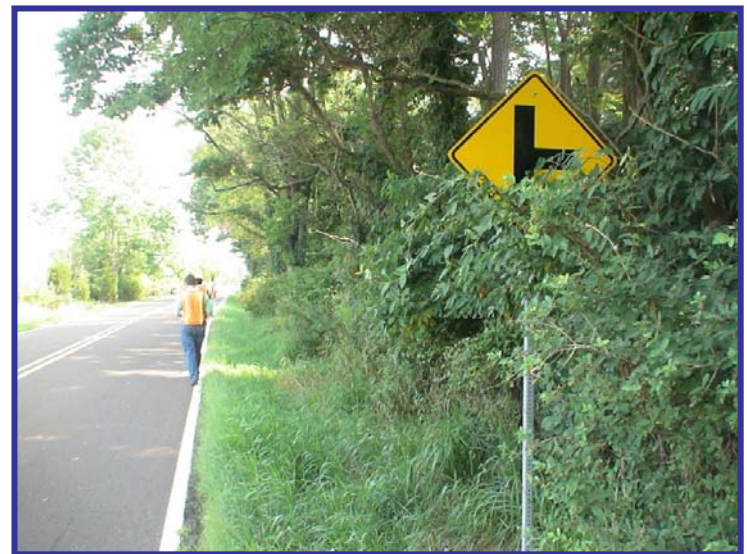
Sign partially hidden by tree branches along Windy Bush Road

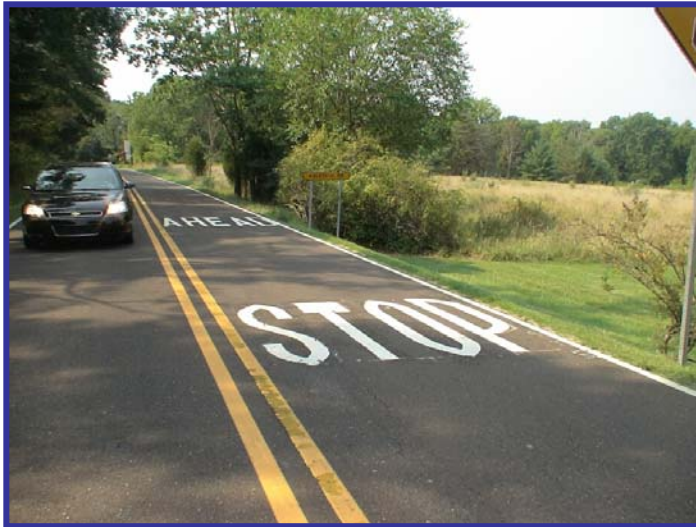
Pavement marking on Windy Bush Road north of the Aquetong Road intersection

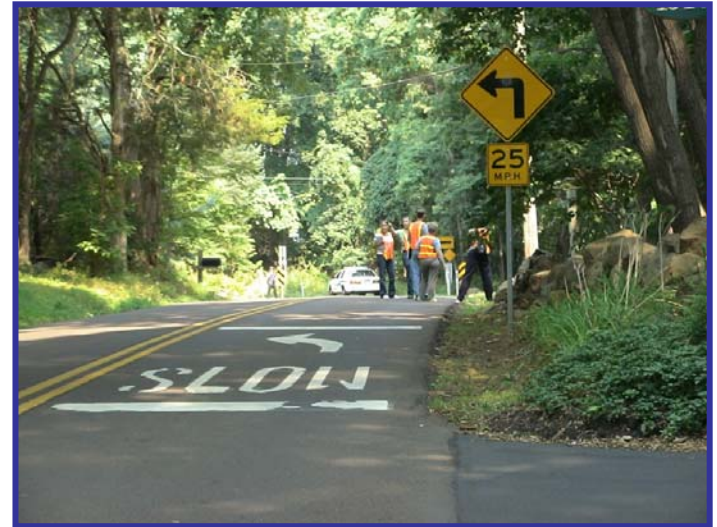
Deteriorating pavement marking on Aquetong Road

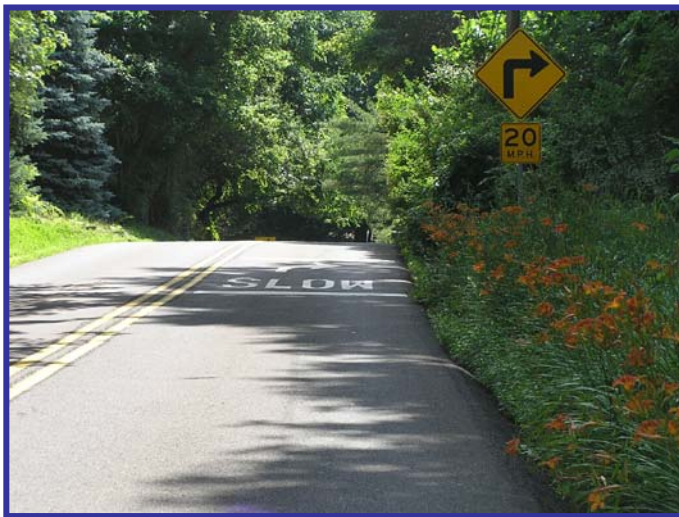
Pavement marking on Aquetong Road

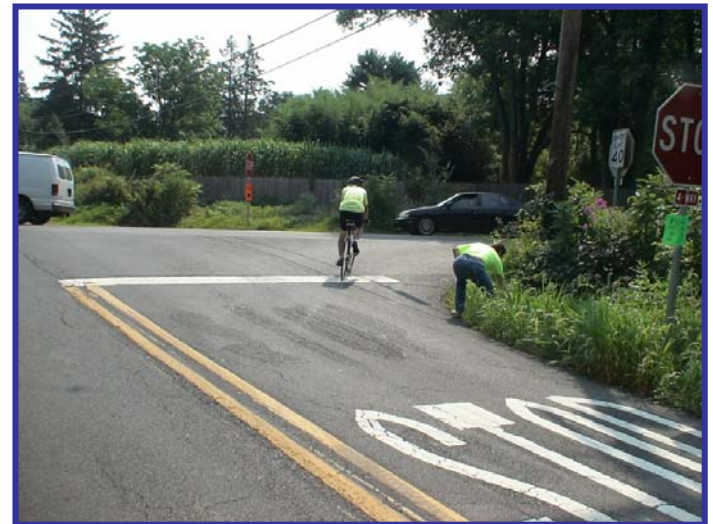
Pavement marking on Aquetong Road at the Windy Bush Road intersection

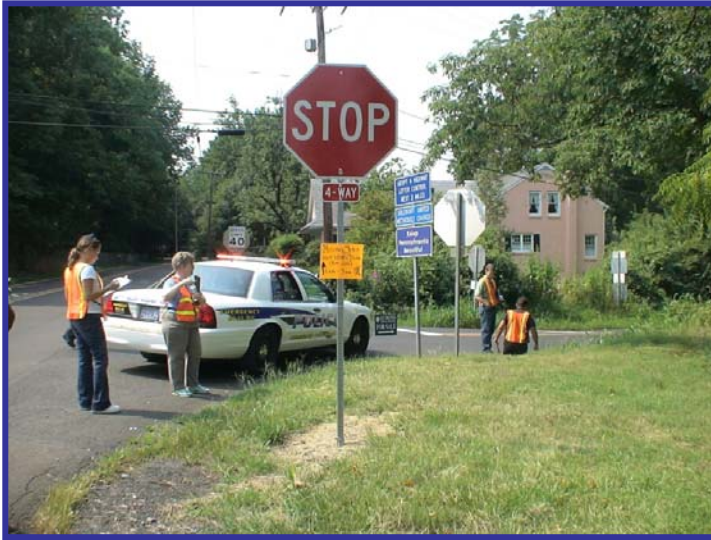
Signs at the Aquetong Road/Windy Bush Road intersection

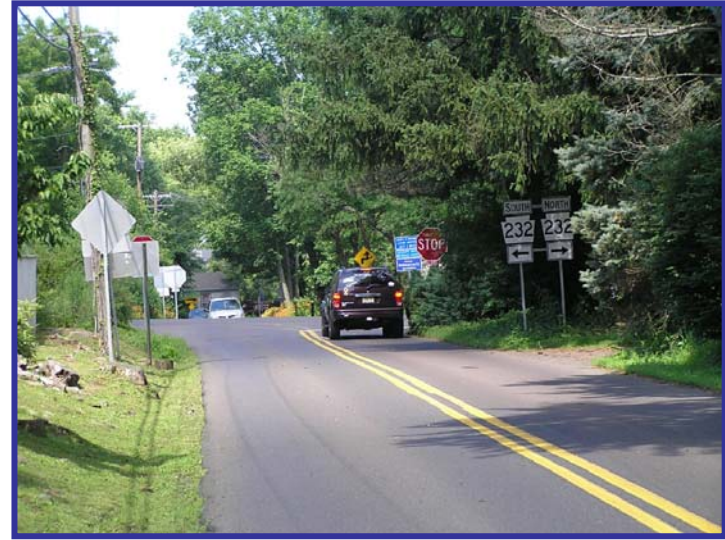
Signs at the Aquetong Road/Windy Bush Road intersection

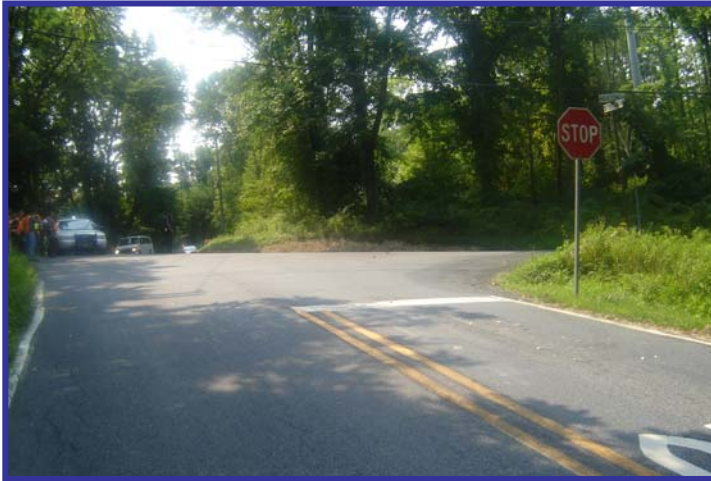
Aquetong Road/Sugan Road intersection looking south

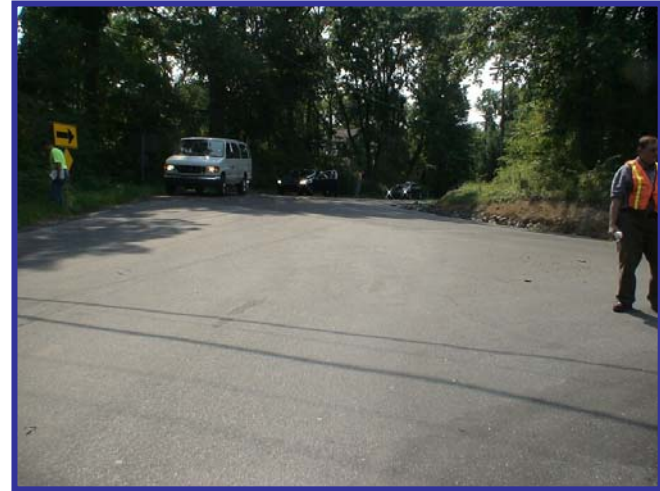
Aquetong Road/Sugan Road intersection Showing no pavement markings
