PACKER ENGINEERING INC,
1950 North Washington Street,
Naperville, IL 60566

**Metallurgical Evaluation of a DOT-3AA Cylinder,
Serial No. 441106, with Pin Hole Leak**

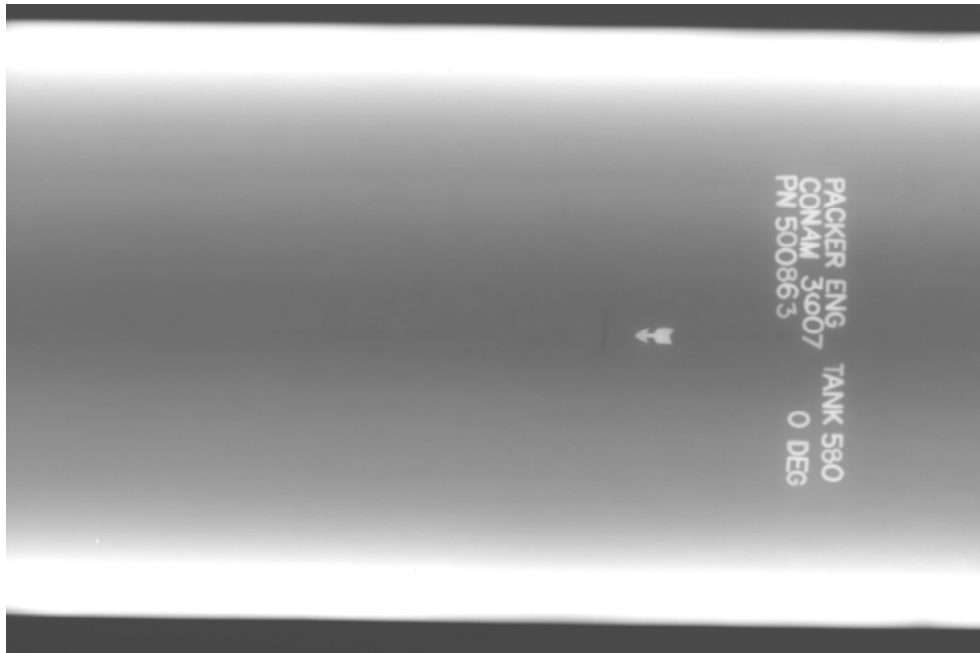
Figure 5: Radiograph of DOT cylinder with the X-ray source perpendicular to the flaw. The arrow is pointing to the defect.

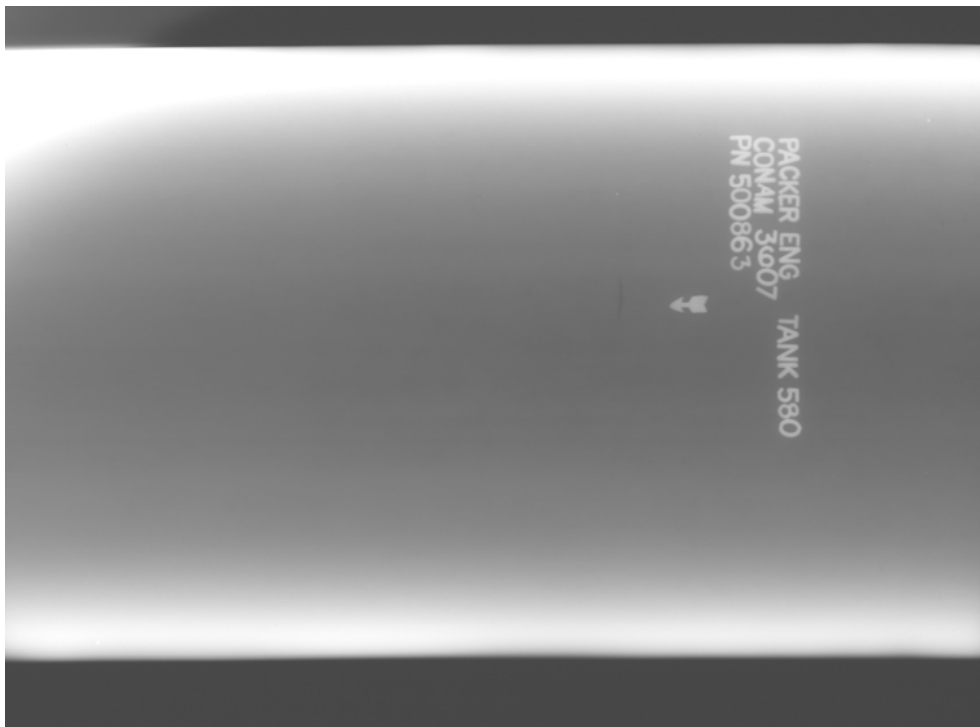
Figure 6: Radiograph of DOT cylinder with X-ray source at 45 ° to the flaw. The arrow is pointing to the defect.

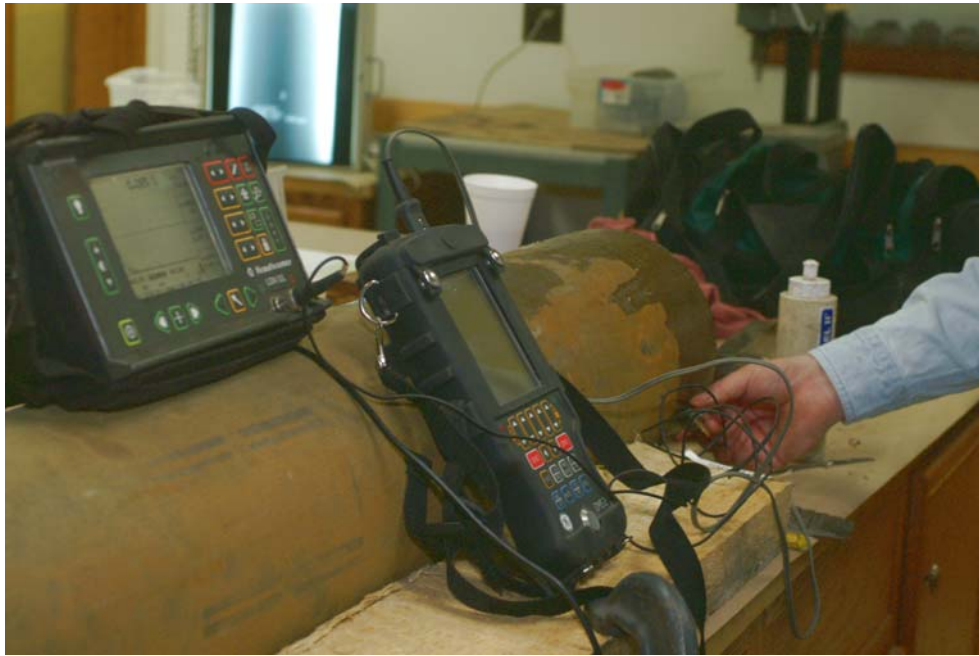
Figure 7: Ultrasonic testing of the DOT-3AA cylinder

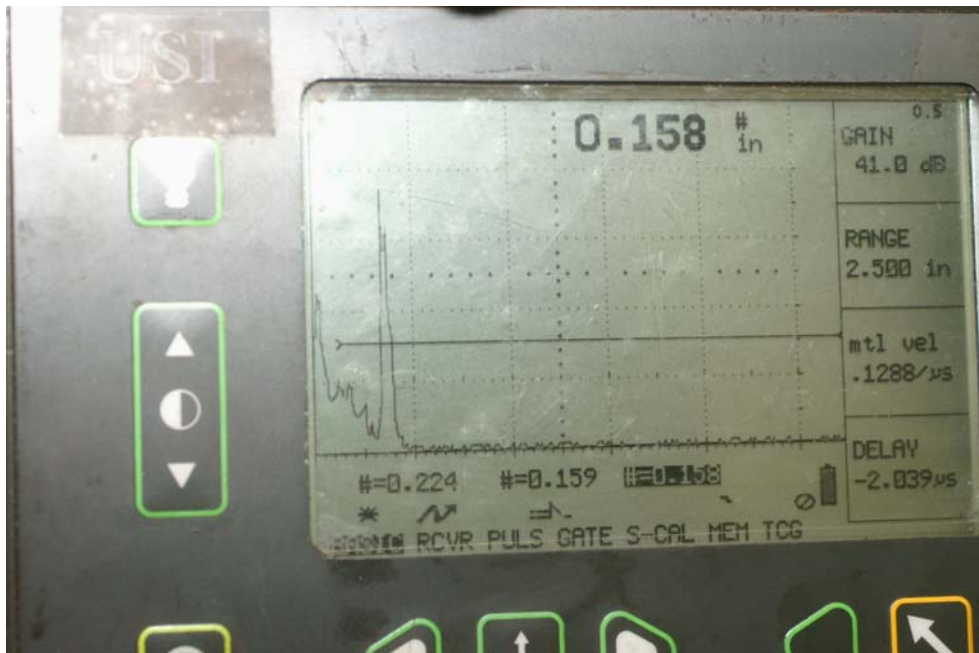
Figure 8: Ultrasonic testing - crack depth from 180 ° back measured using shear wave analysis

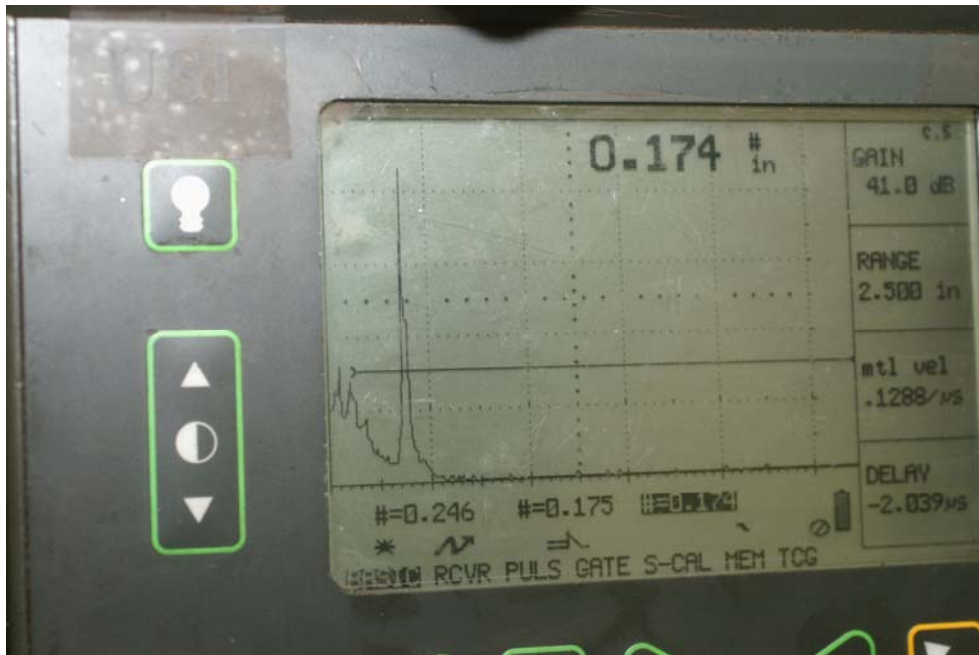
Figure 9: Ultrasonic Testing - maximum depth of crack measured using shear wave analysis

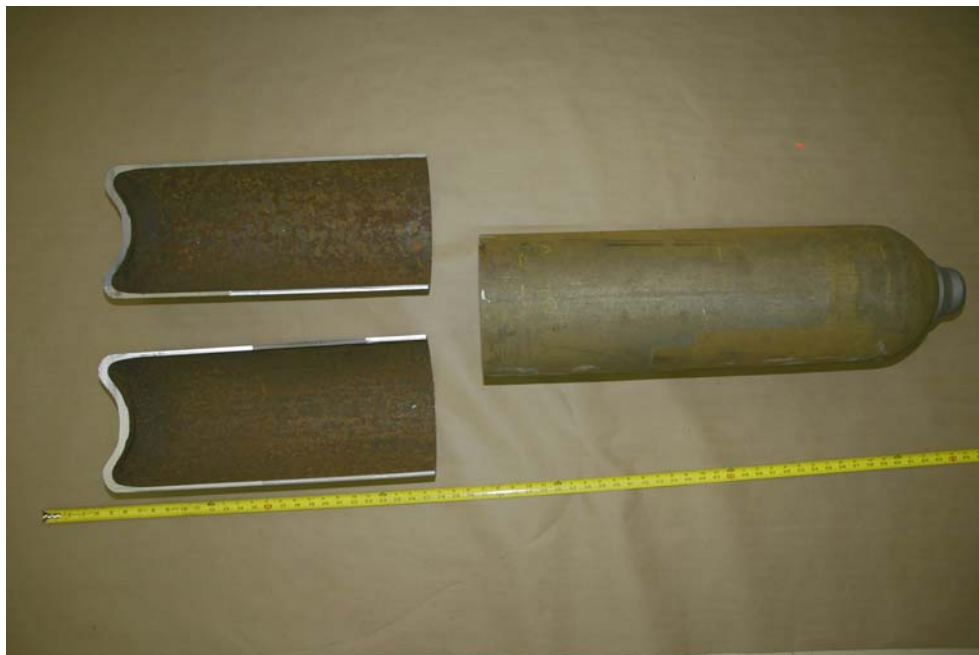
Figure 10: Showing location of sectioning of the DOT-3AA cylinder

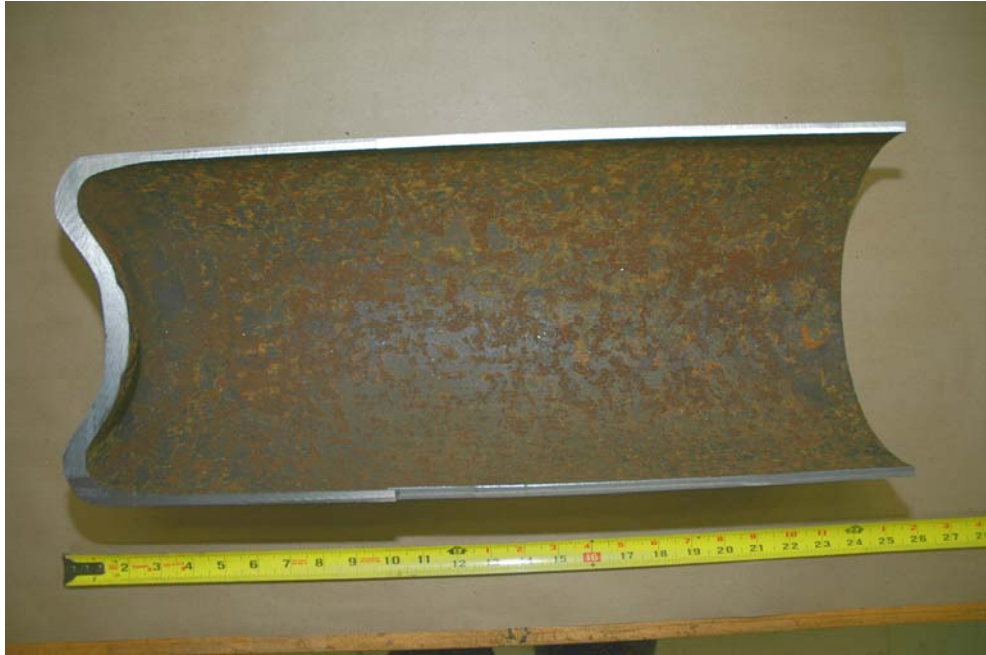
Figure 11: Shows corrosion on the inside wall of the cylinder

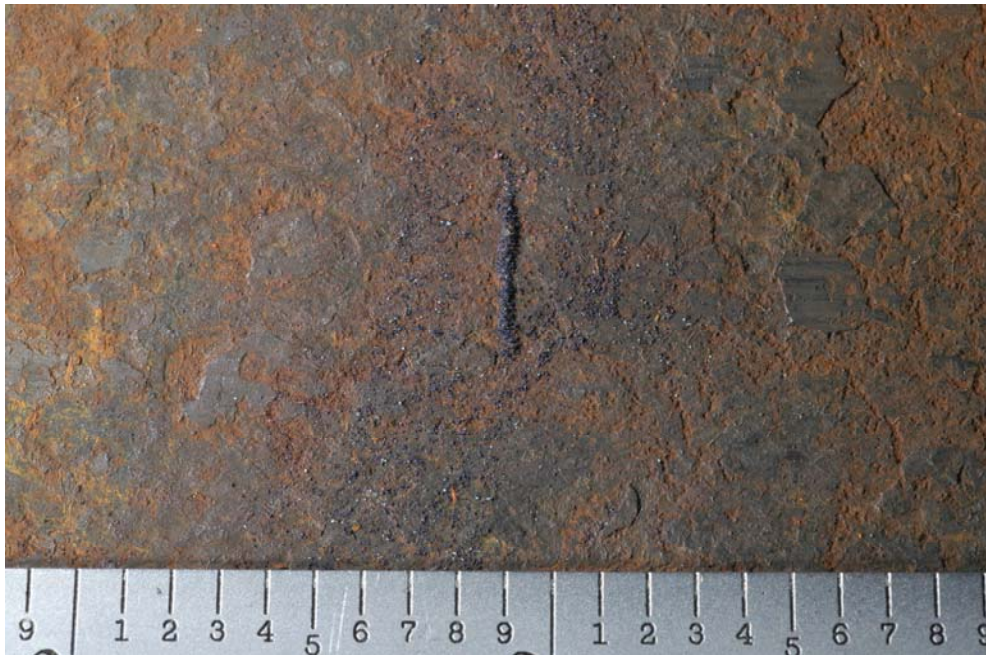
Figure 12: Shows the inside surface of the leak

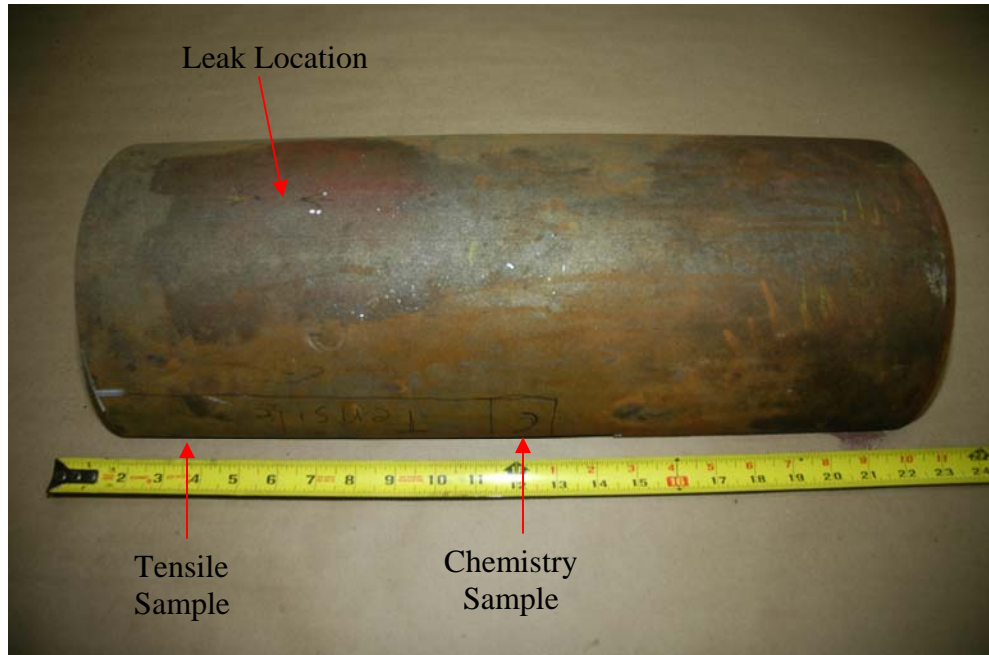
Figure 13: Shows location at with the samples for tensile testing and chemistry analysis were sectioned

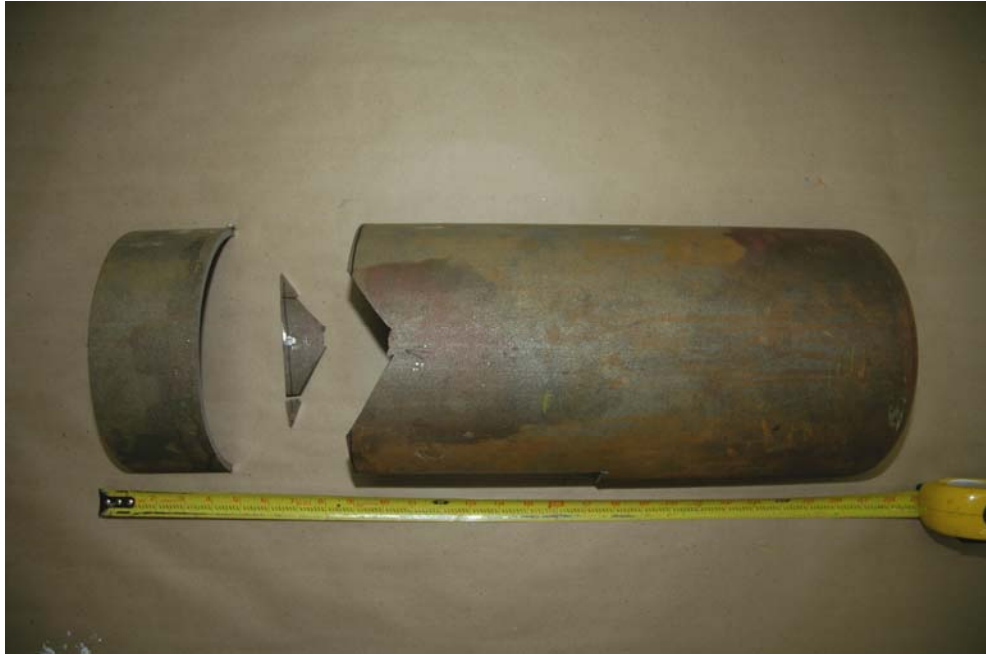
Figure 15: Sectioning of the cylinder to cut open the leak

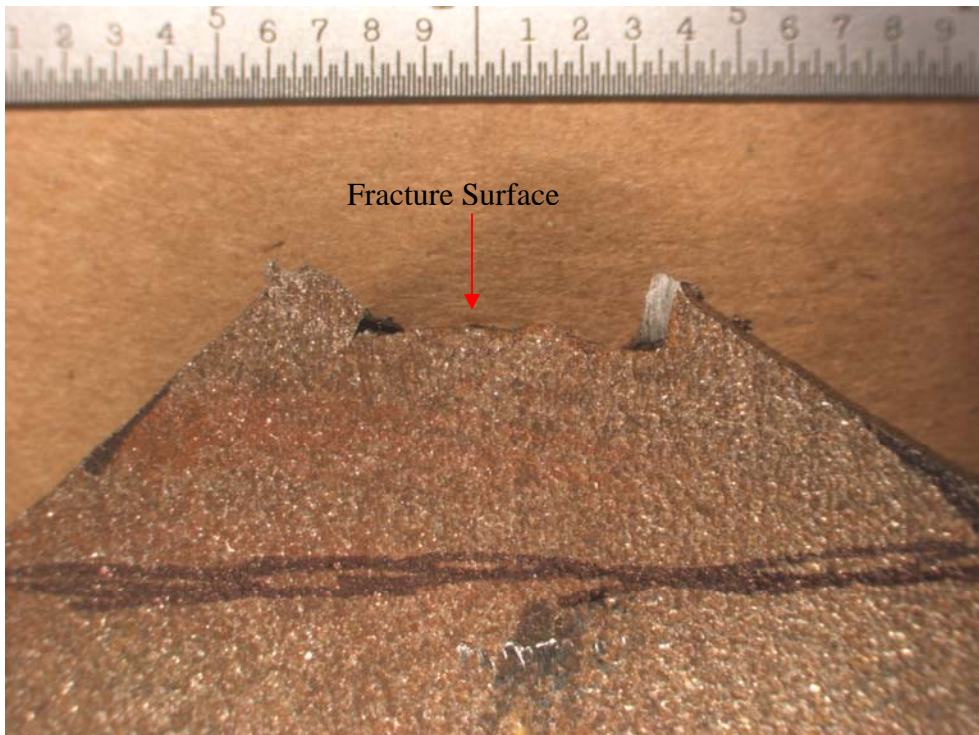
Figure 16: Stereoscope image of the outer surface of the cylinder section containing the fracture surface. Magnification 65X

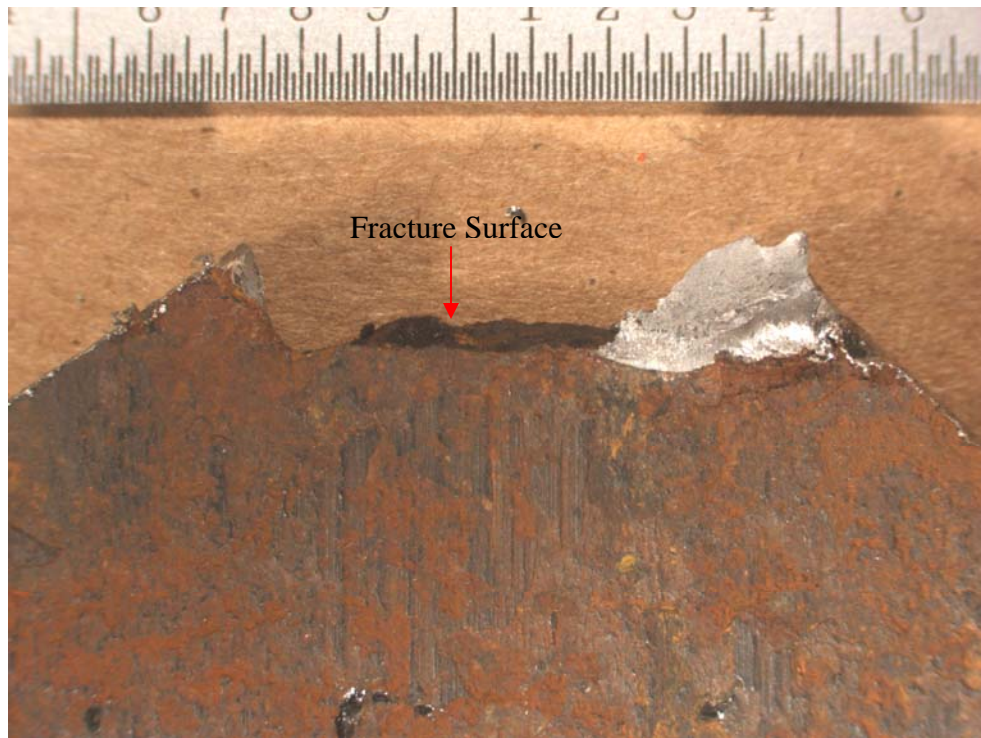
Figure 17: Stereoscope image of the inner surface of the cylinder section containing the fracture surface. Magnification 65X

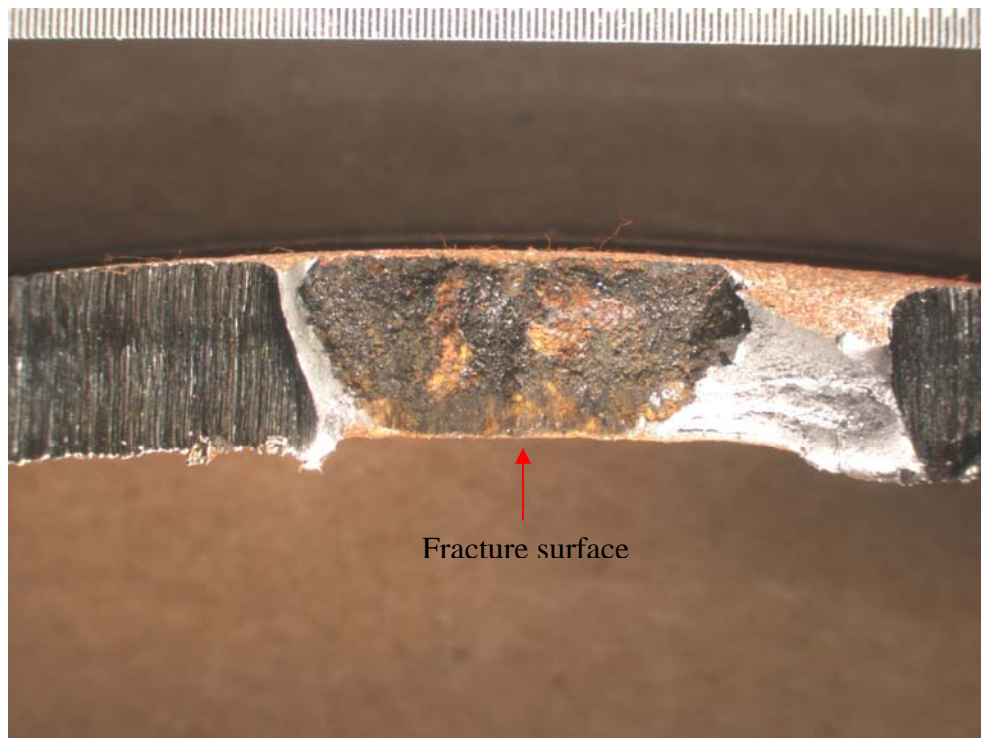
Figure 18: Stereoscope image of the cylinder section showing the fracture surface. Magnification 65X

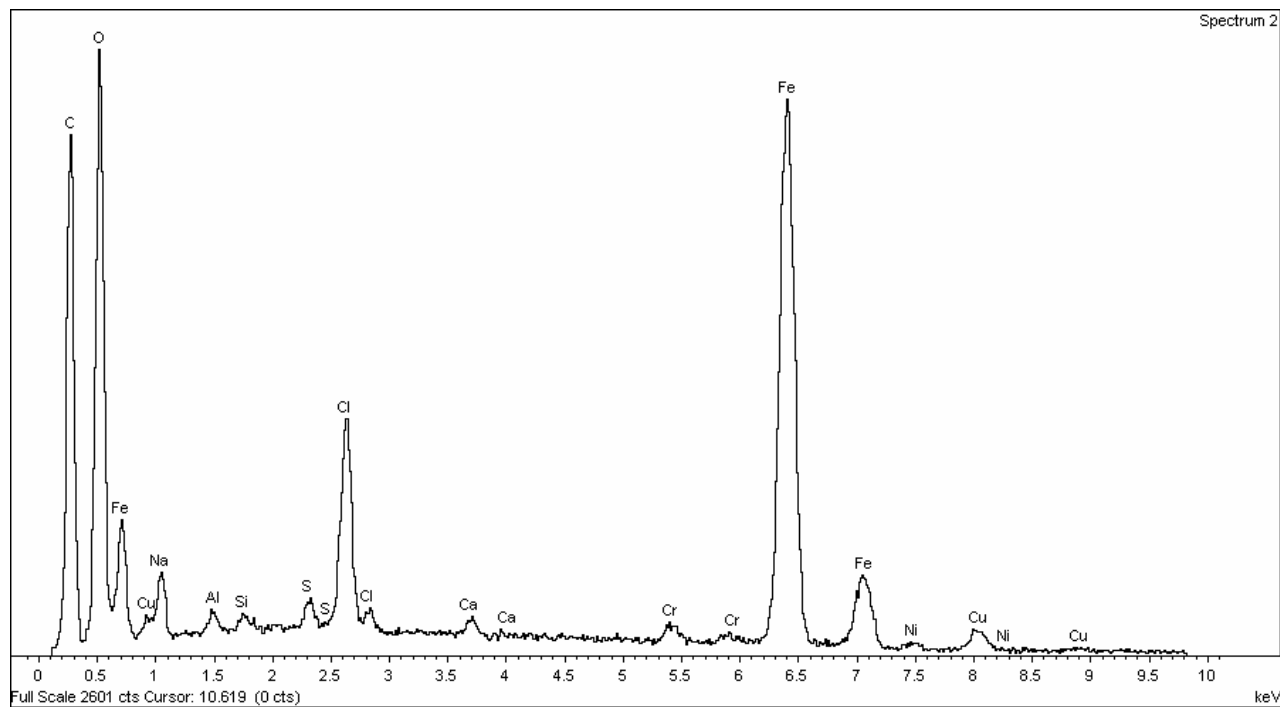
Figure 19: EDS of the non-cleaned fracture surface of the cylinder

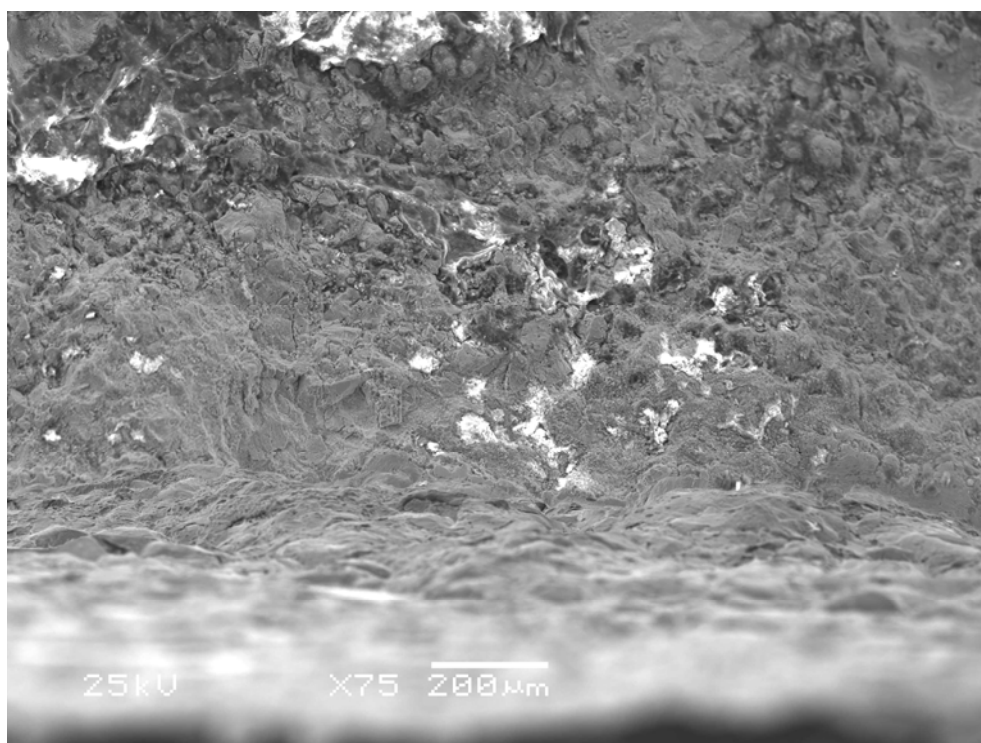
Figure 20: SEM image of the fracture surface close to the inner diameter of the cylinder wall. Magnification 75X.

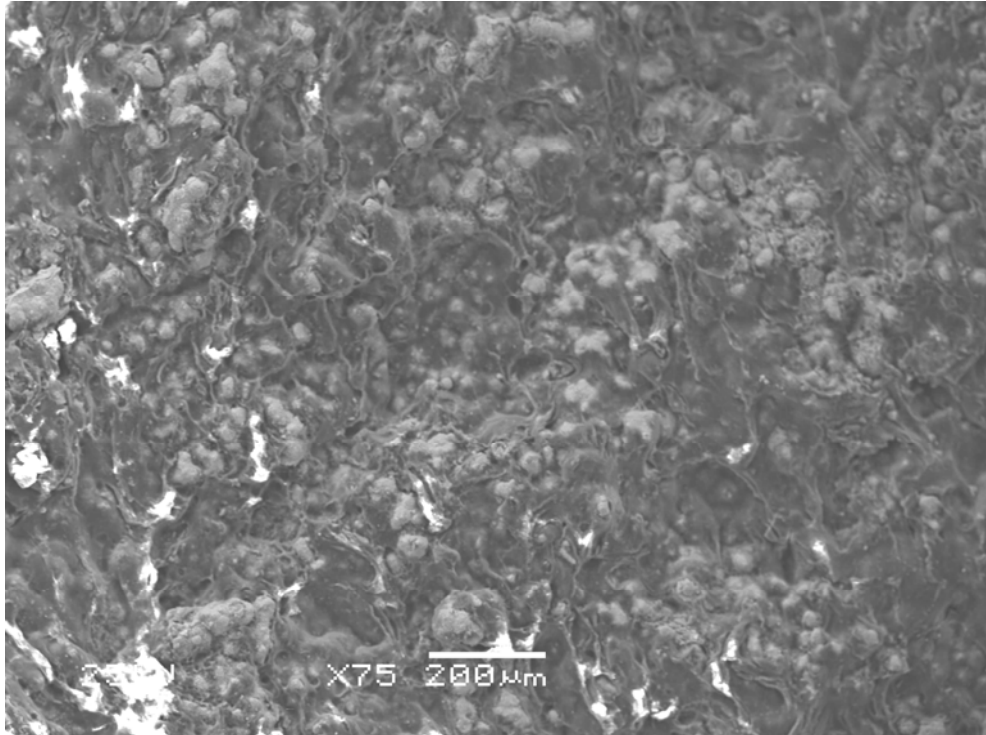
Figure 21: SEM image at the center of the fracture surface. Magnification 75X

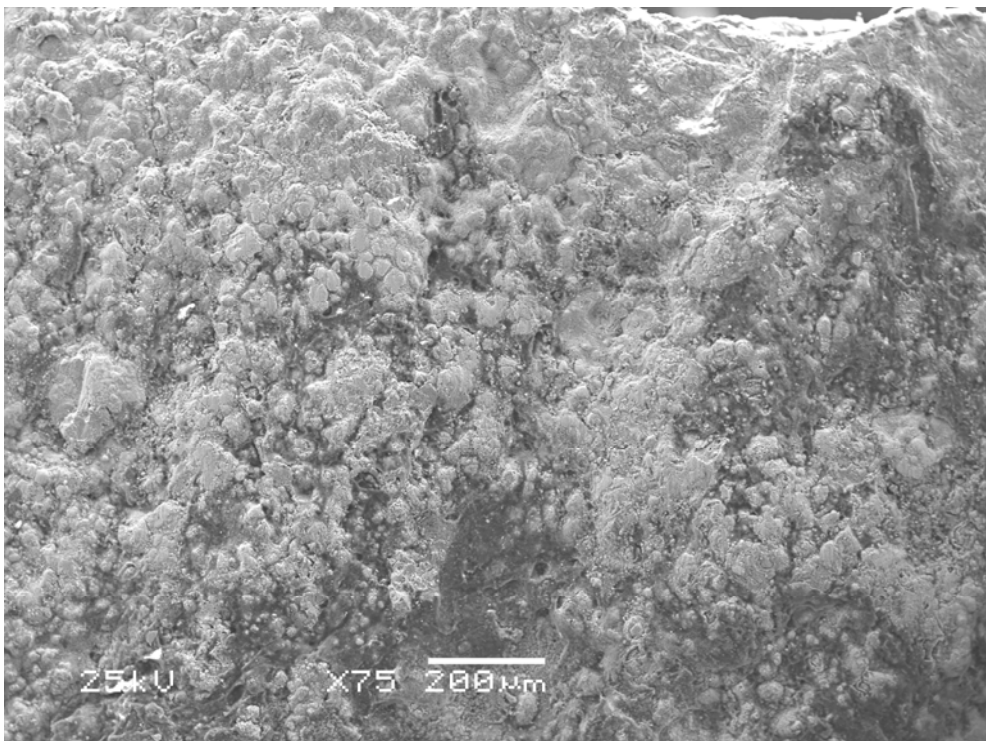
Figure 22: SEM image of the fracture surface close to the outer diameter of the cylinder wall. Magnification 75 X

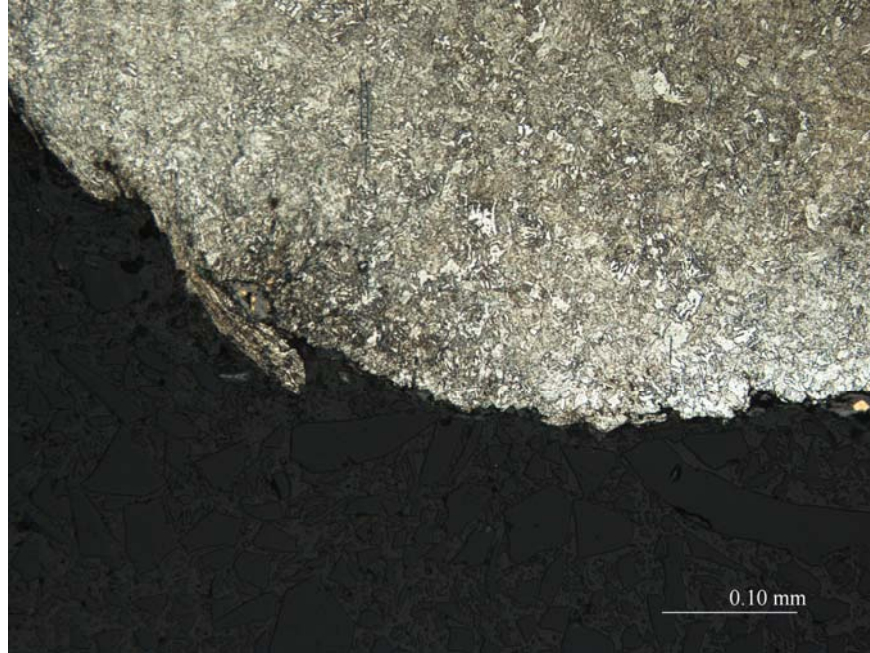
Figure 23: Microstructure across the fracture surface at the outer diameter of the cylinder. Magnification 200X. Etchant: 2% Nital

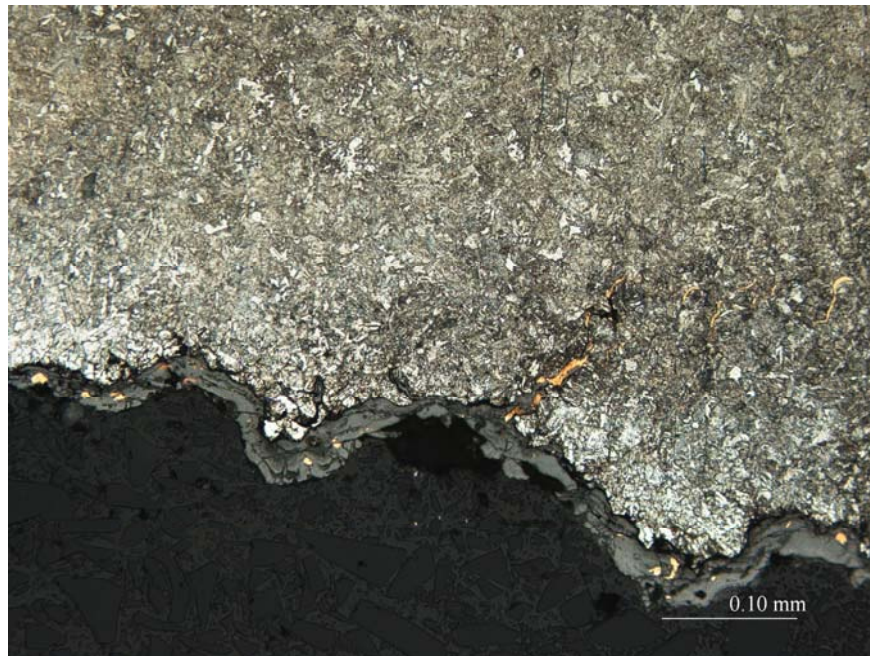
Figure 24: Microstructure across the fracture surface showing tempered martensite structure, presence of corrosion products (gray) and copper colored phase (orange) in continuation with Figure 23. Magnification 200X. Etchant: 2% Nital

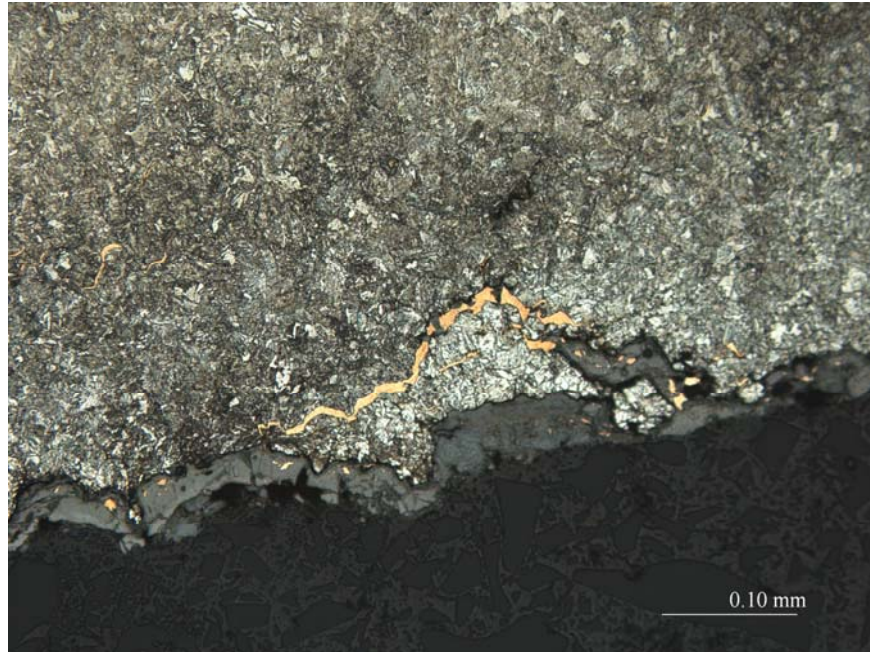
Figure 25: Microstructure across the fracture surface showing copper colored phase in the tempered martensite structure in continuation with Figure 24. Magnification 200X. Etchant: 2% Nital

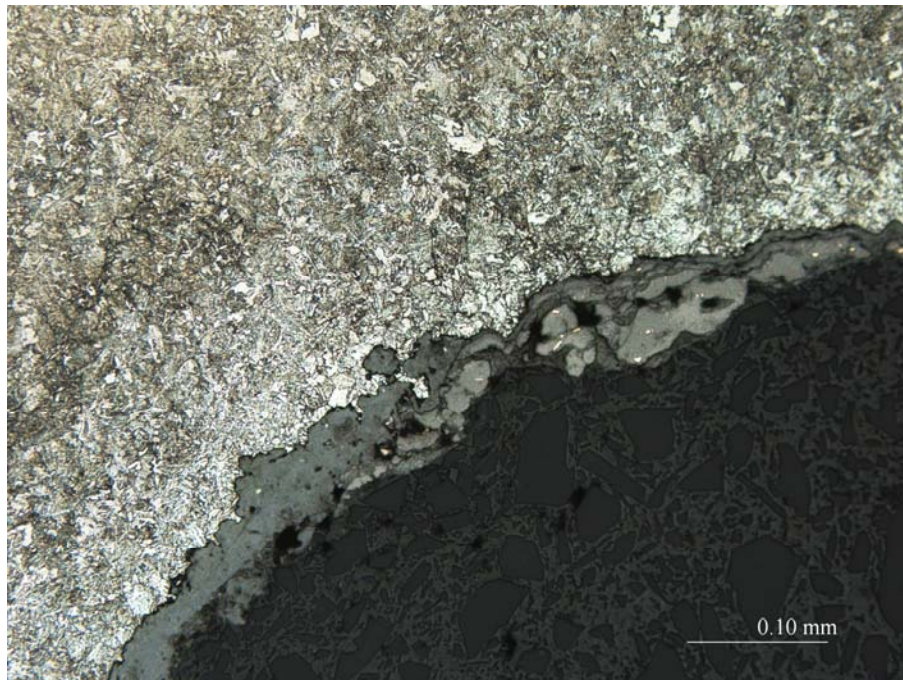
Figure 26: Microstructure across the fracture surface in continuation with Figure 25. Magnification 200X. Etchant: 2% Nital

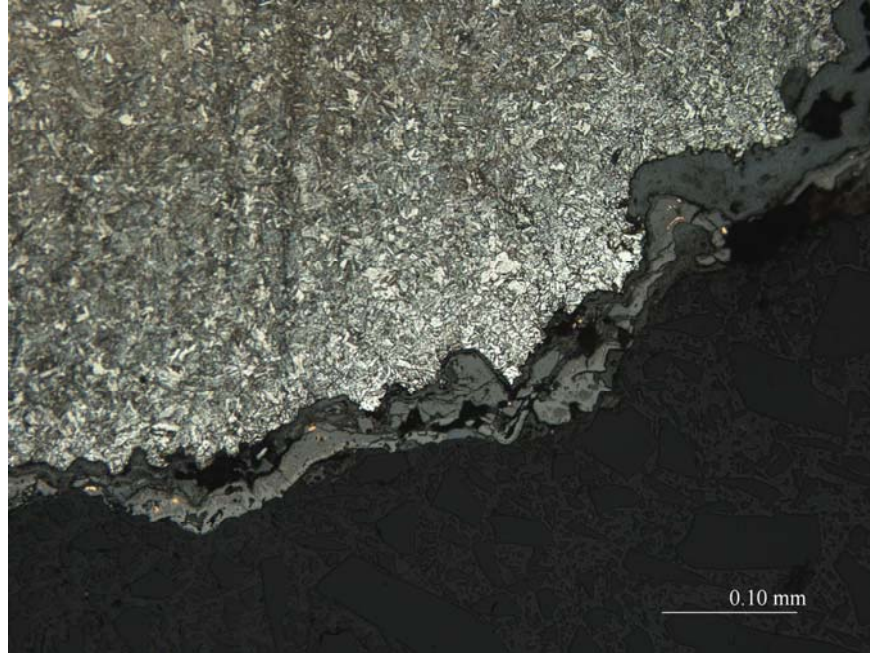
Figure 27: Microstructure across the fracture surface in continuation with Figure 26. Magnification 200X. Etchant: 2% Nital

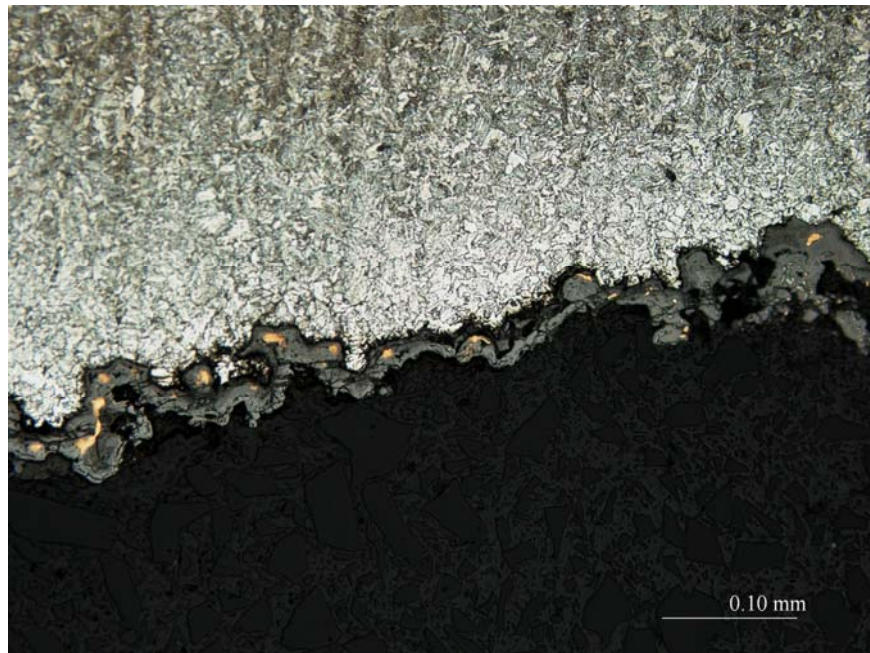
Figure 28: Microstructure across the fracture surface in continuation with Figure 26. Magnification 200X. Etchant: 2% Nital

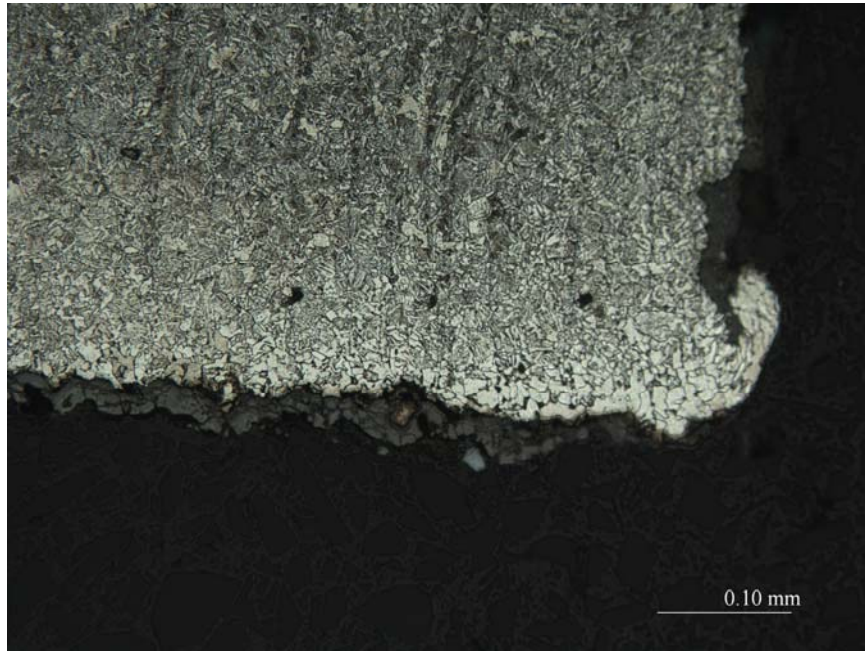
Figure 29: Microstructure across the fracture surface at the ID in continuation with Figure 28. Magnification 200X. Etchant: 2% Nital

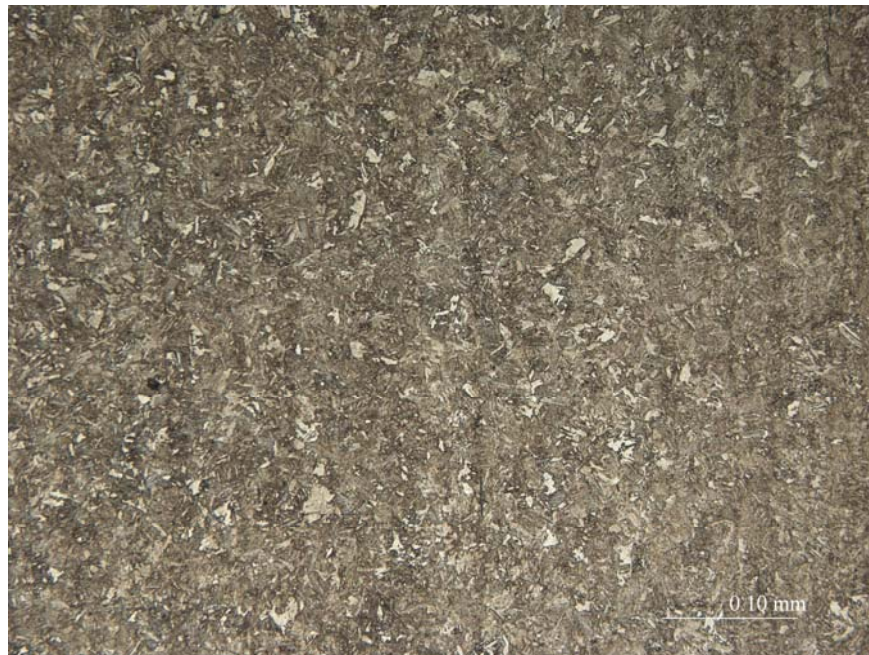
Figure 30: Tempered martensite structure observed in the sample containing fracture surface. Magnification 200X. Etchant: 2% Nital

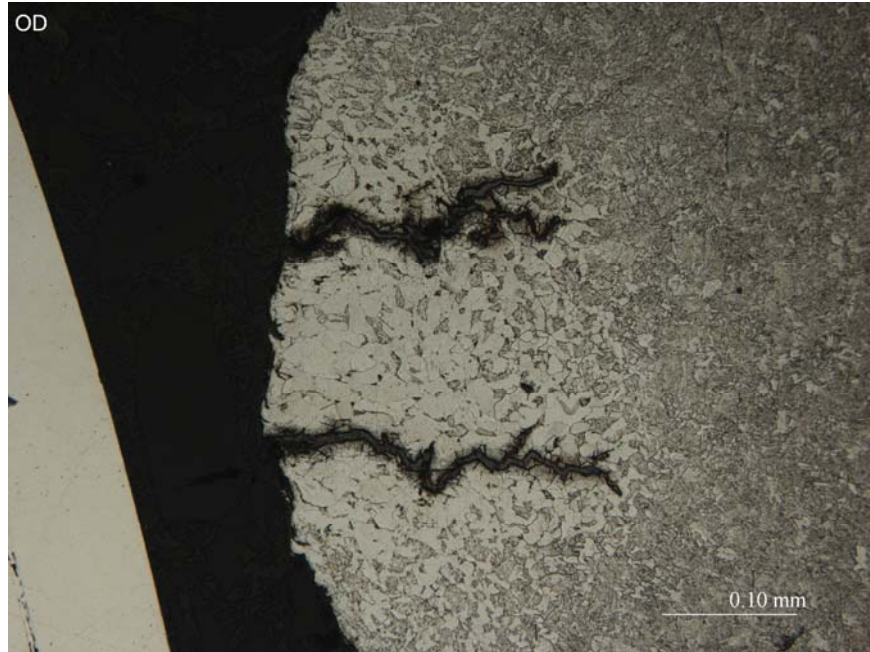
Figure 31: Shows decarburization at the OD of the cylinder in the sample containing fracture surface. Two crack like areas can be seen in the decarburized region. Magnification 200X. Etchant: 2% Nital

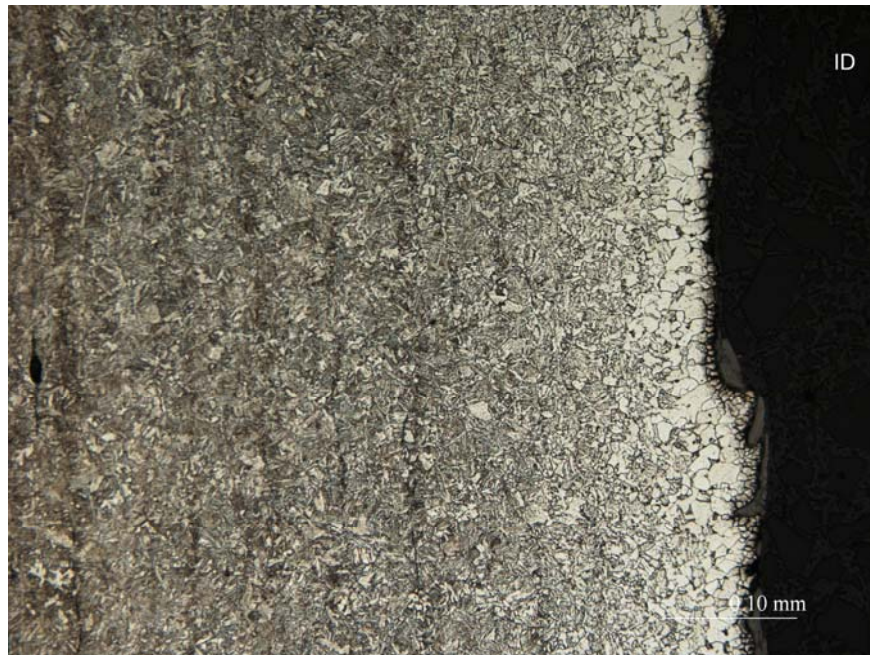
Figure 32: Shows decarburization at the ID of the cylinder in the sample containing fracture surface. Magnification 200X. Etchant: 2% Nital

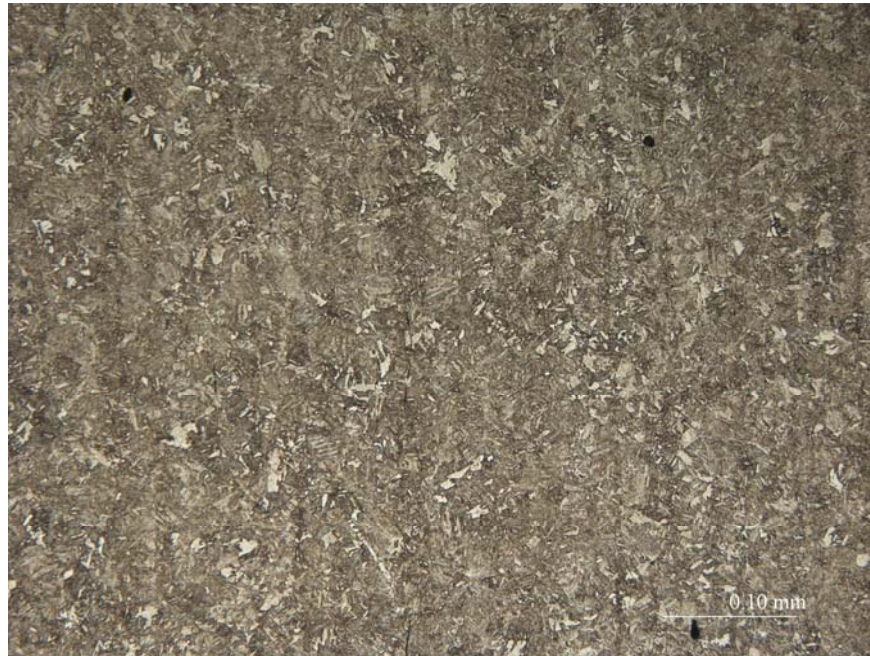
Figure 33: Tempered martensite structure observed in the sample taken away from the fracture surface. Magnification 200X. Etchant: 2% Nital

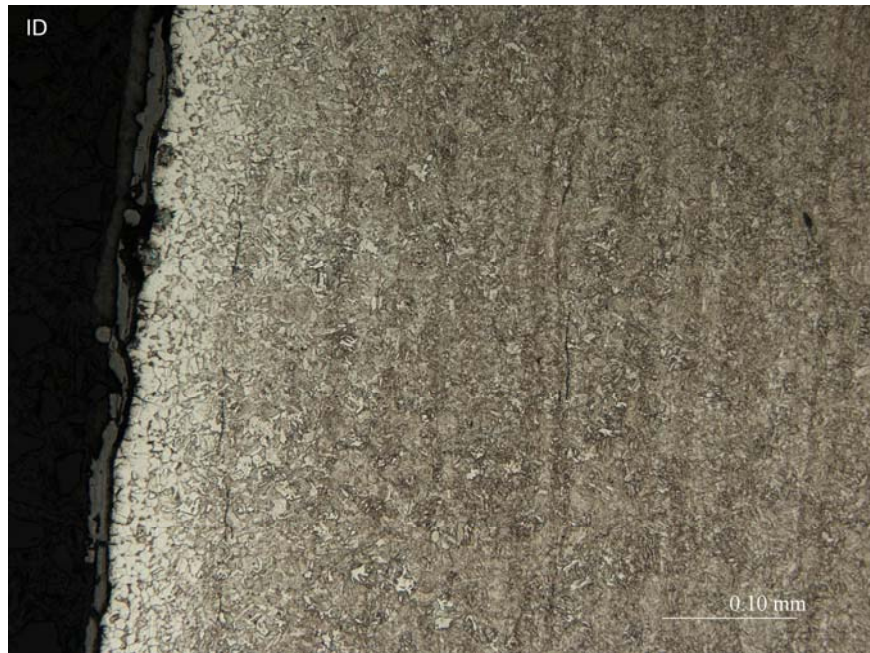
Figure 34: Shows decarburization at the ID of the sample taken away from the fracture surface. Magnification 200X. Etchant: 2% Nital

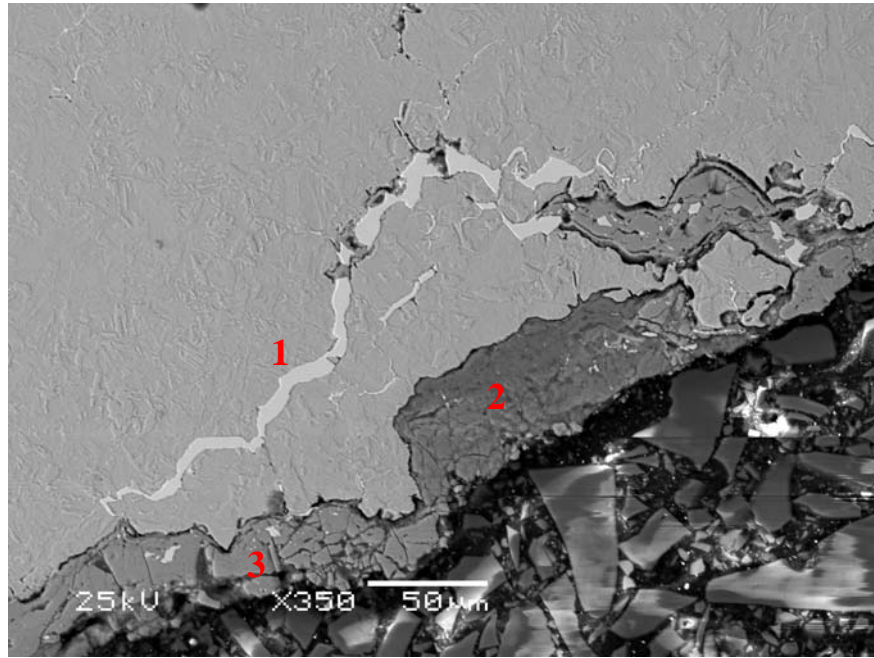
Figure 35: Shows the locations near the fracture surface at which EDS analysis was performed. Magnification 350X.

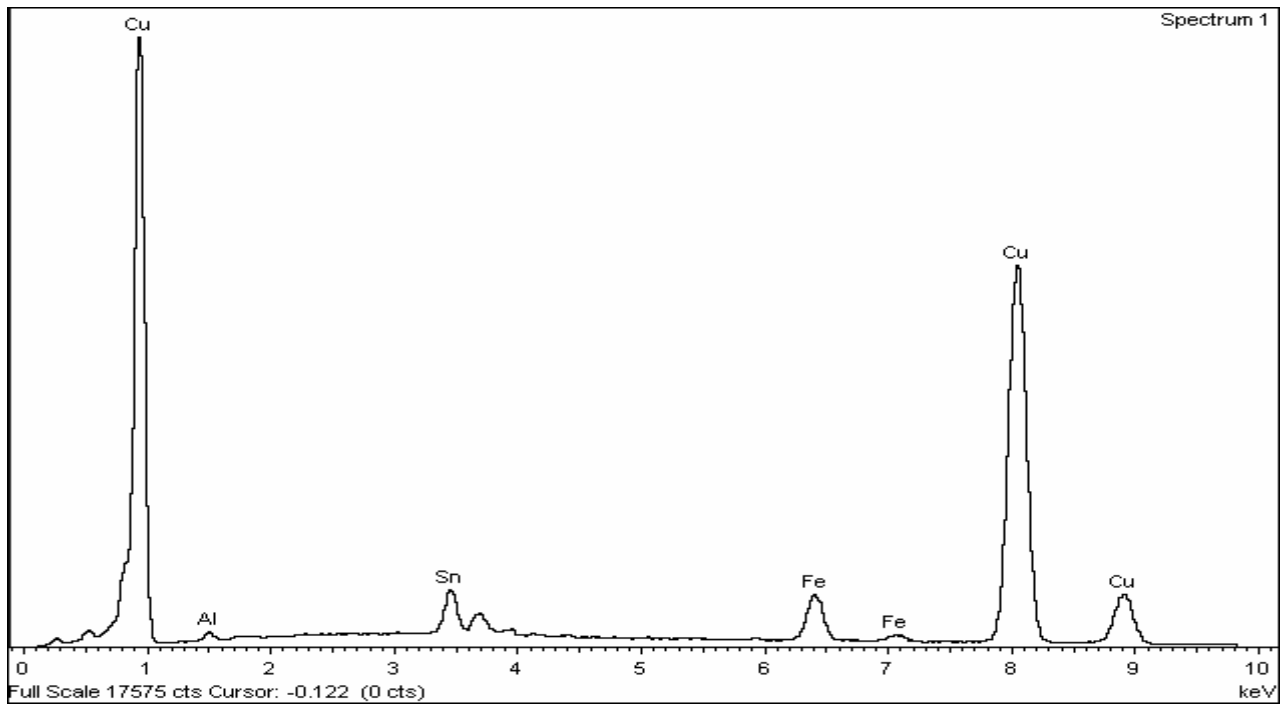
Figure 36: EDS analysis near the fracture surface at Location 1 identified in Figure 35

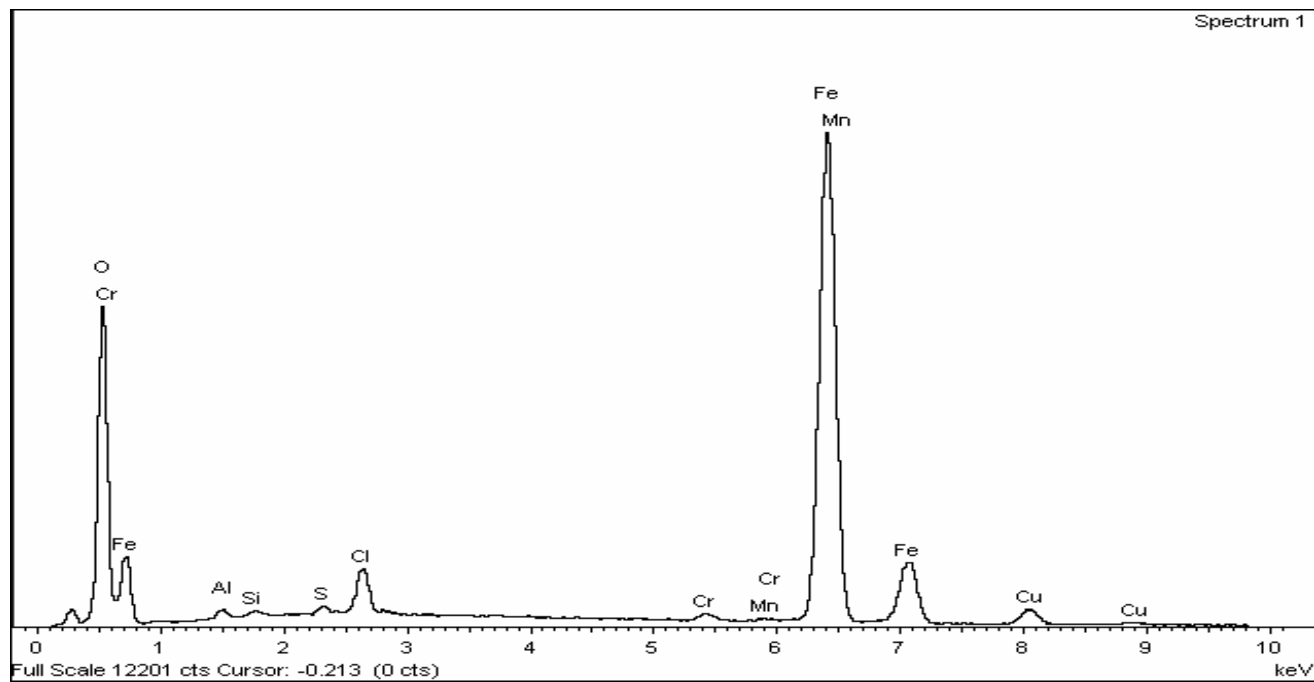
Figure 37: EDS analysis near the fracture surface at Location 2 identified in Figure 35

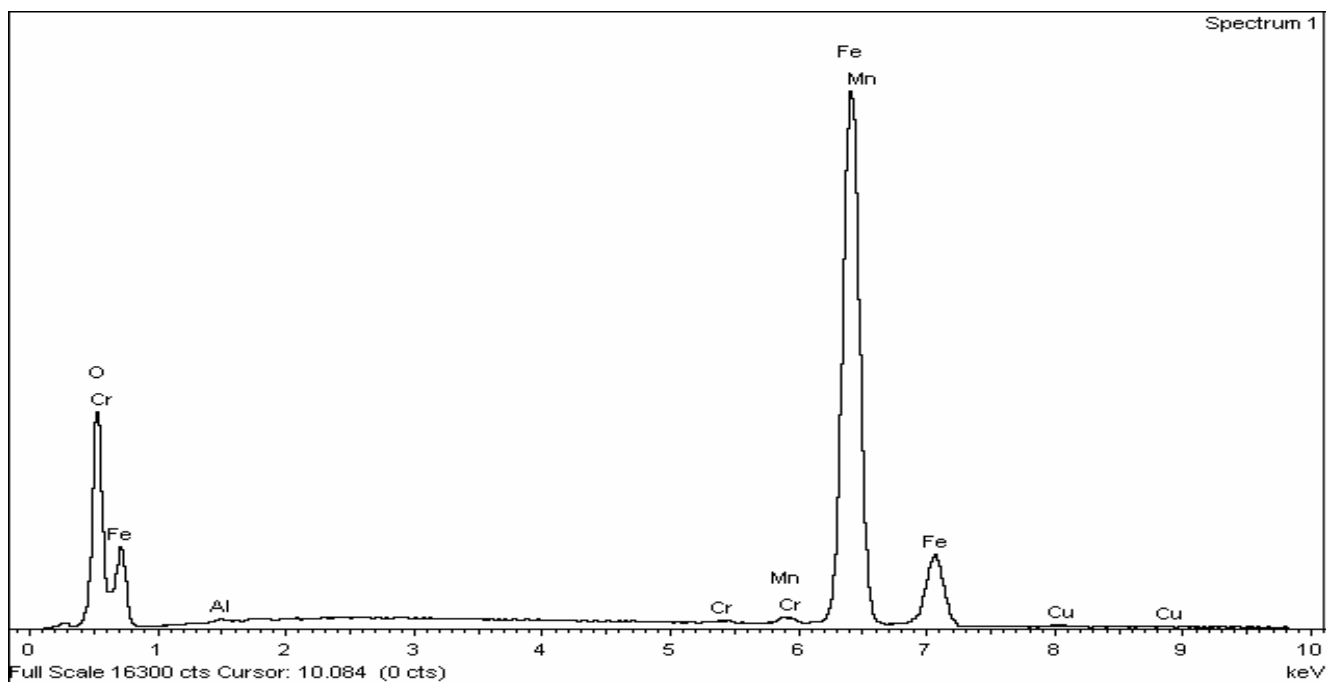
Figure 38: EDS analysis near the fracture surface at location 3 identified in Figure 35
