D-11
Vol. 1 of 3
February 1997

**MELROSE ESTATE
NATCHEZ NATIONAL HISTORICAL PARK**

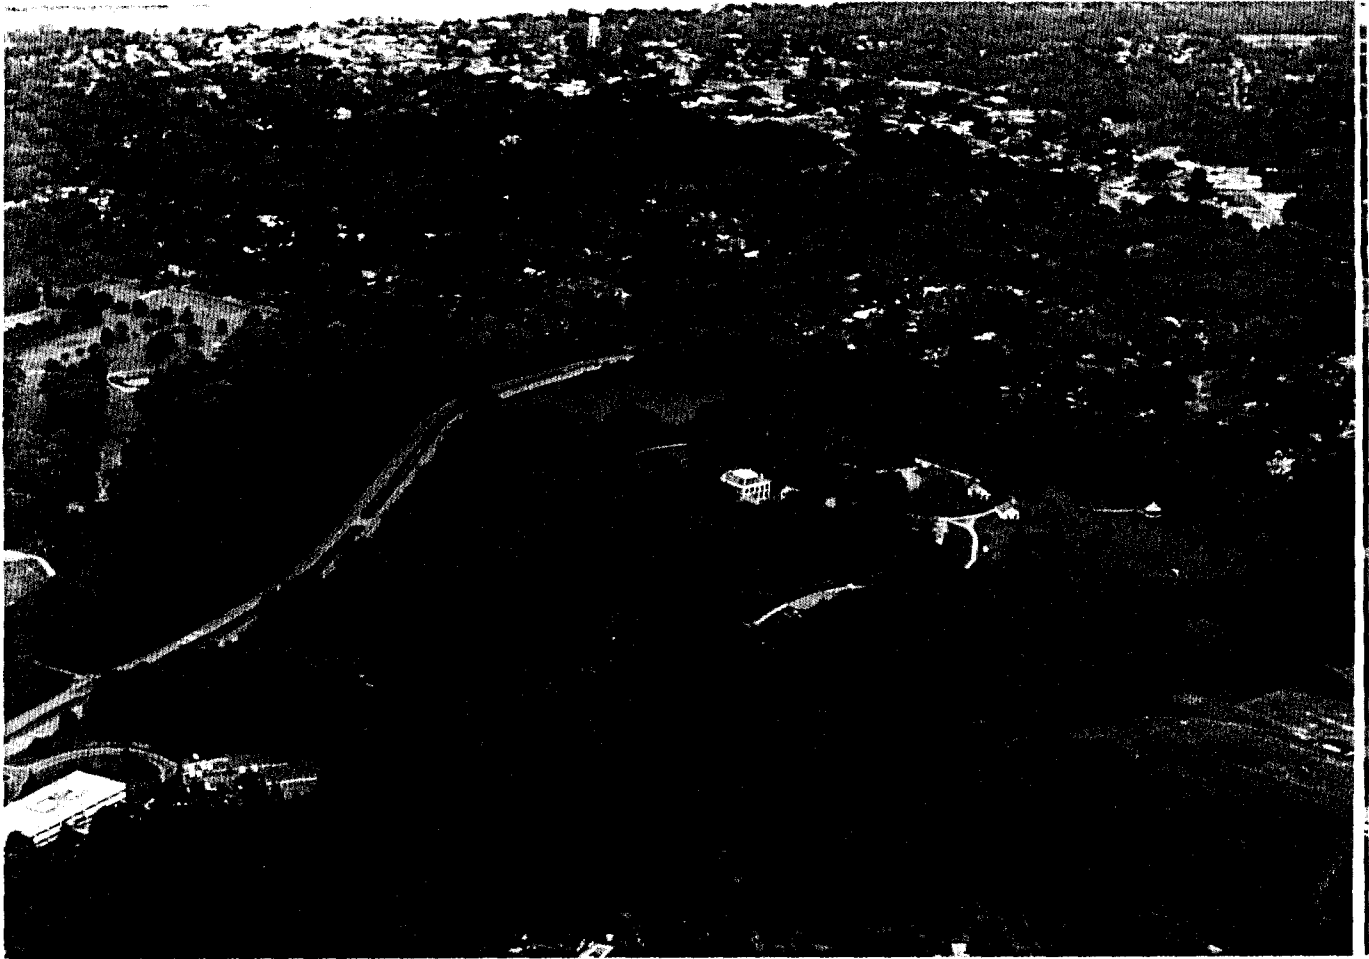
1-H Aerial view of Natchez and Melrose. (Historic Natchez Foundation - HNF)

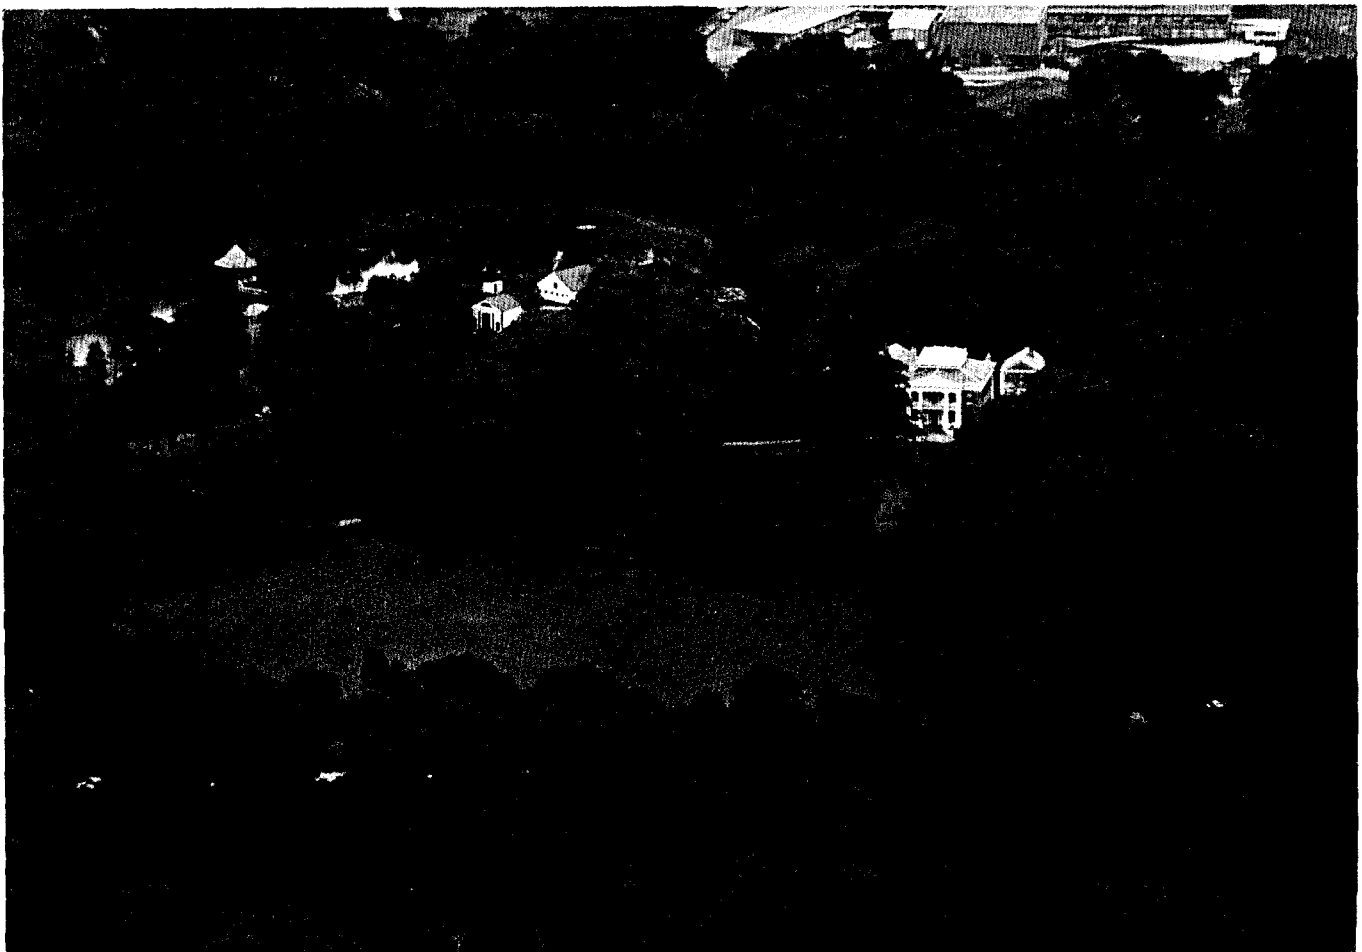
2-H Aerial view of Melrose. (HNF)

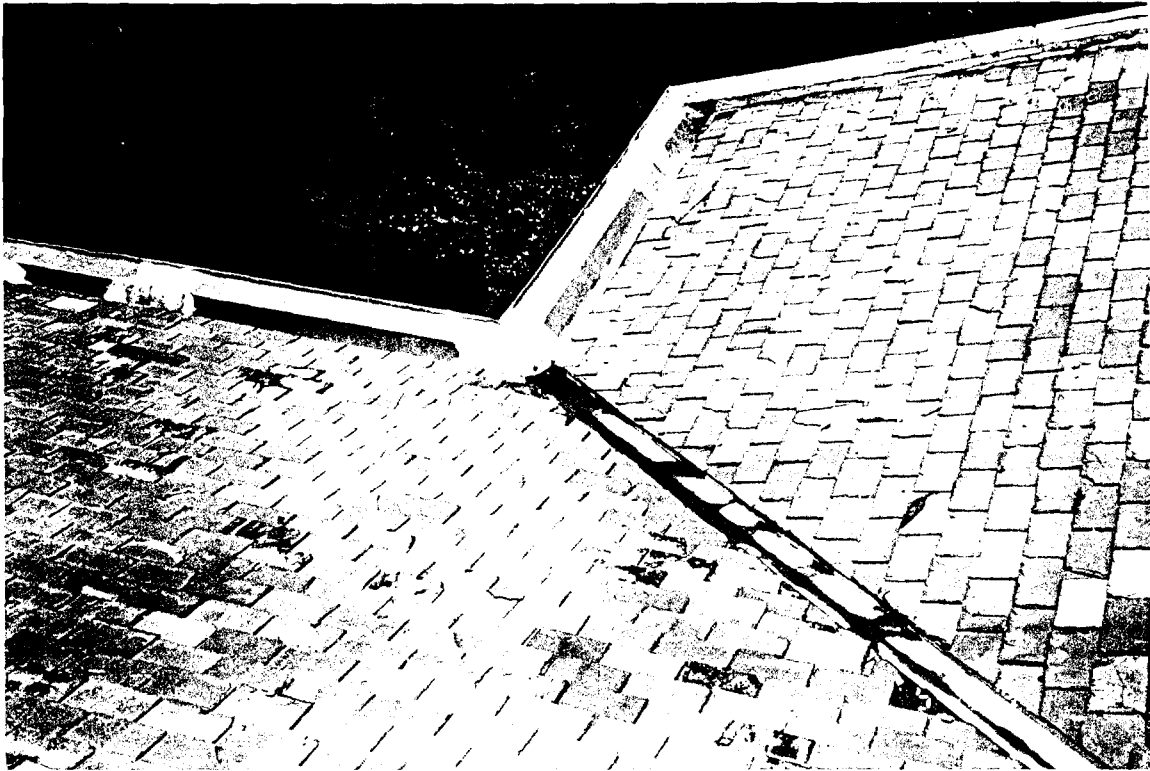
49-A Main House - Rusting valley flashing. (ABA)

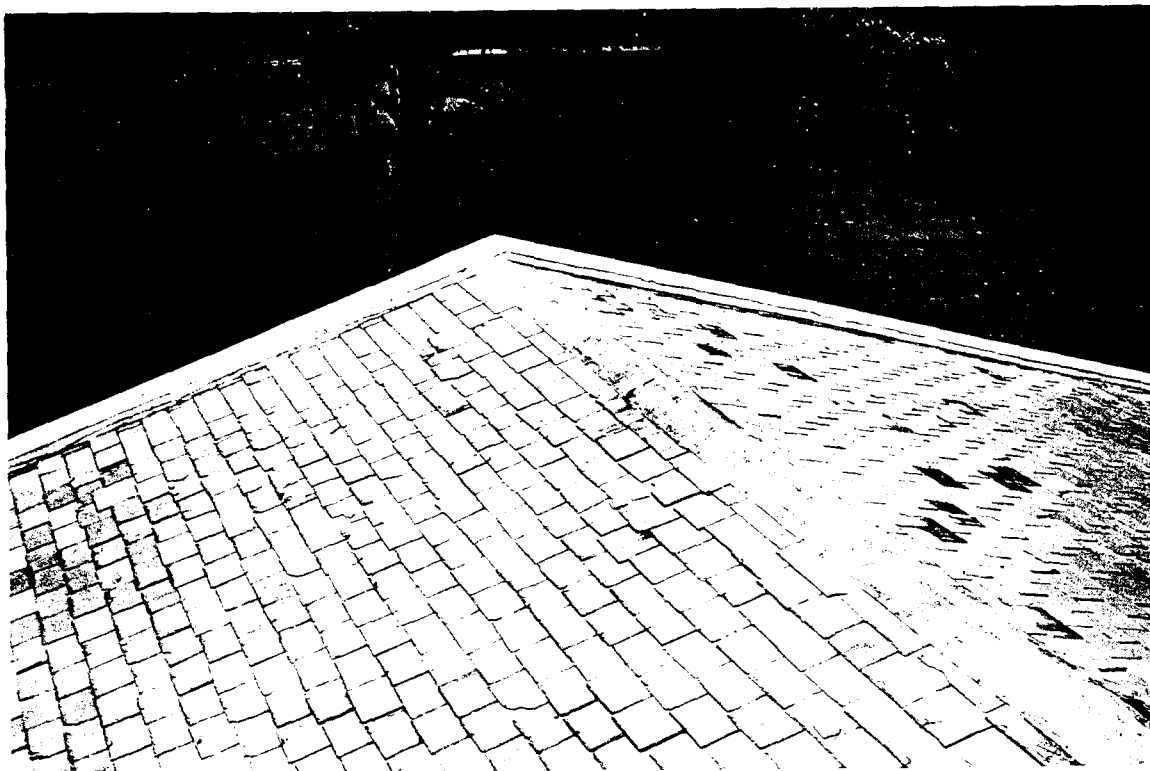
50-A Main House - Rusting ridge flashing. (ABA)

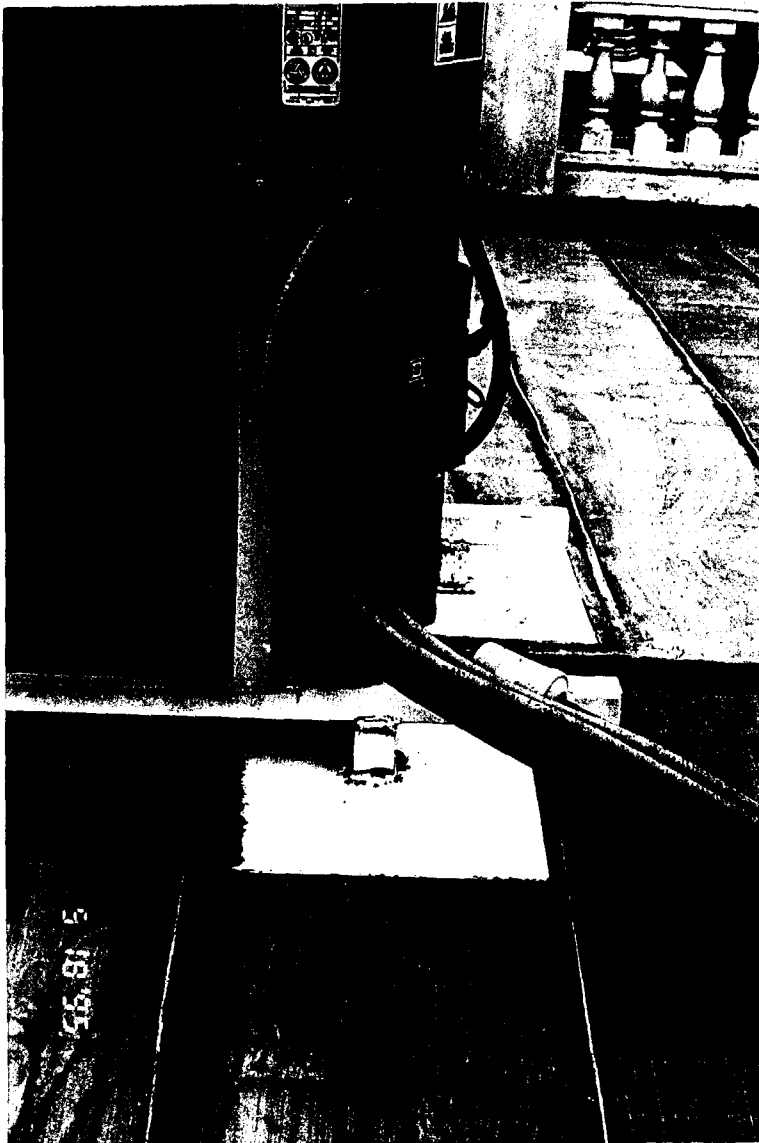
51-A Main House - Rusting steel pads. (ABA)

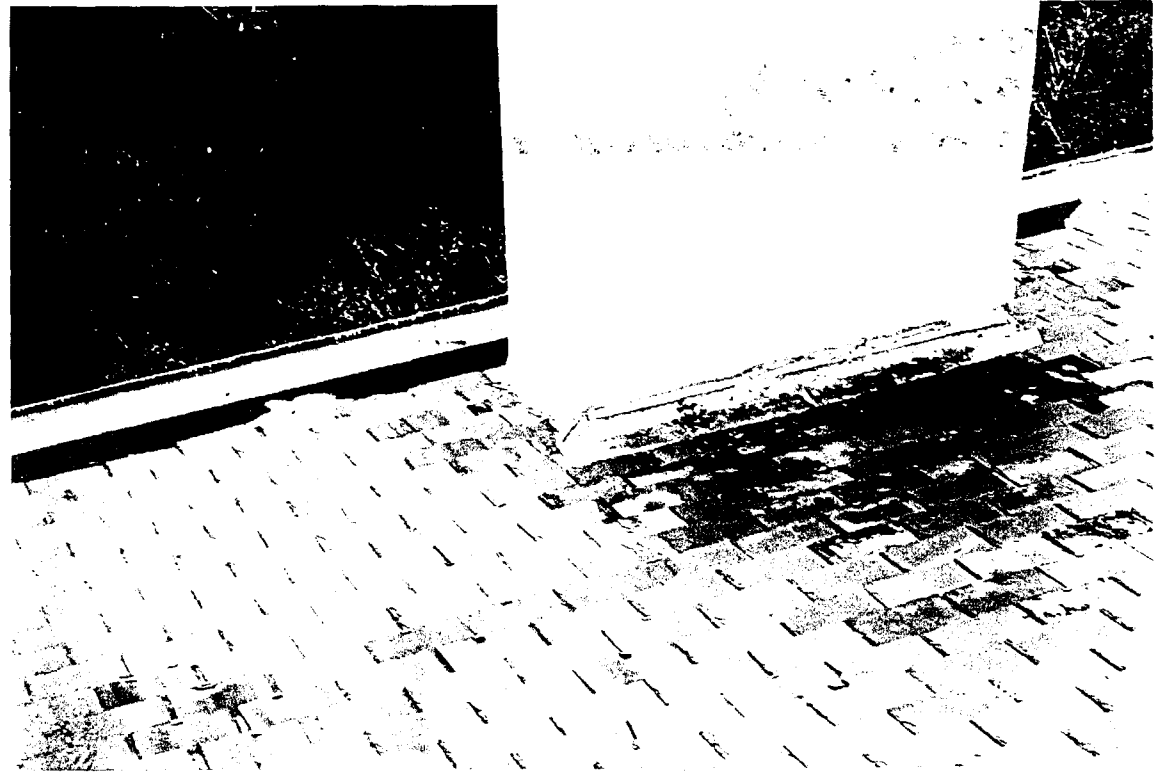
52-A Main House - Flashing at chimneys. (ABA)

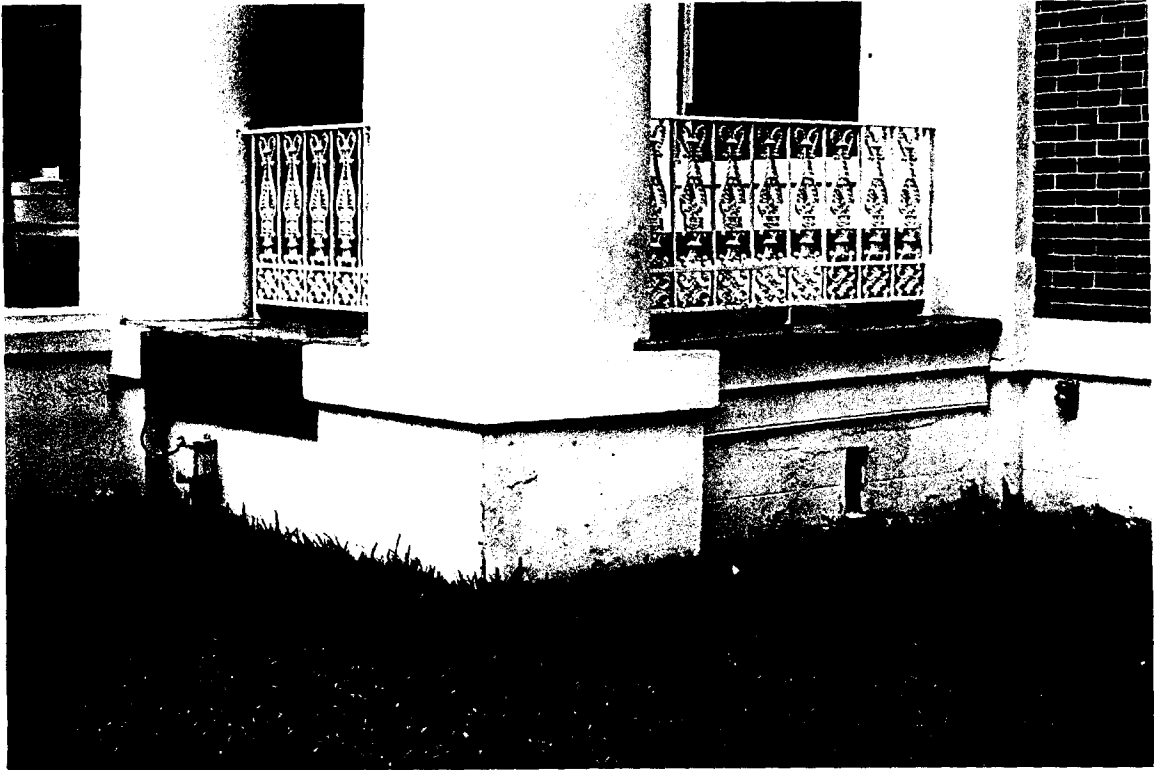
53-A Main House - Moisture problems with foundation stucco. (ABA)

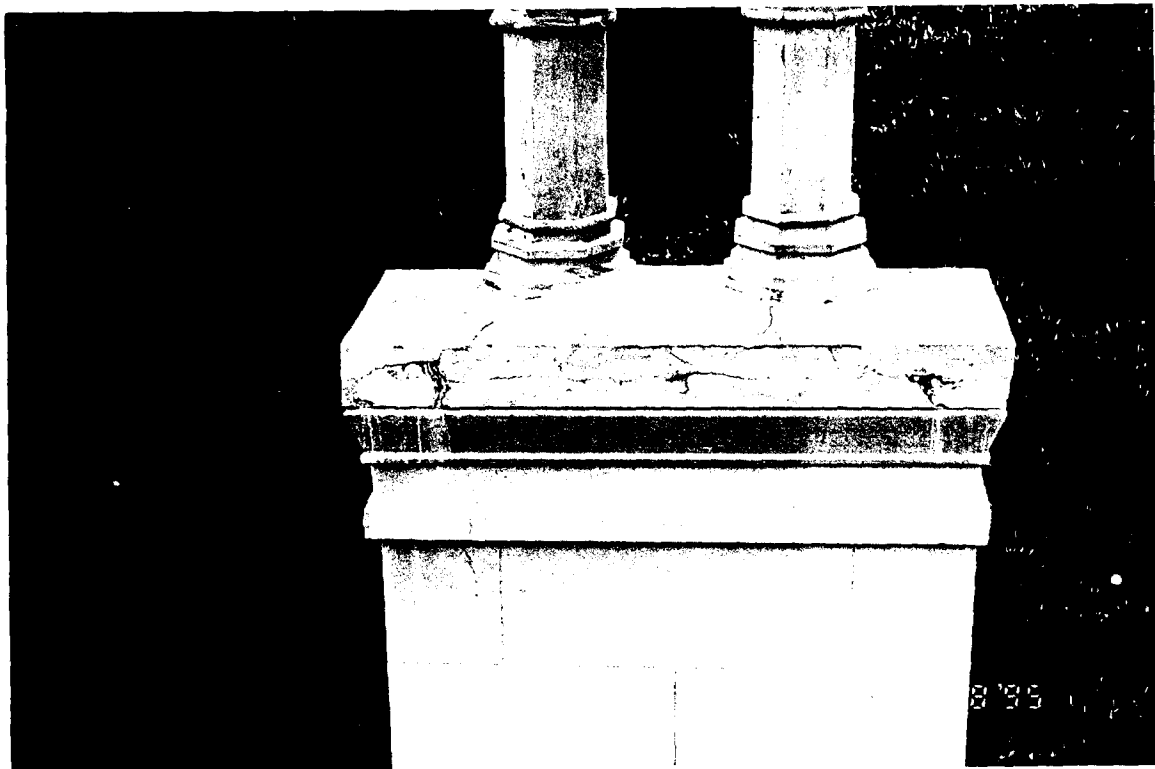
54-A Main House - Spalling at chimneys. (ABA)

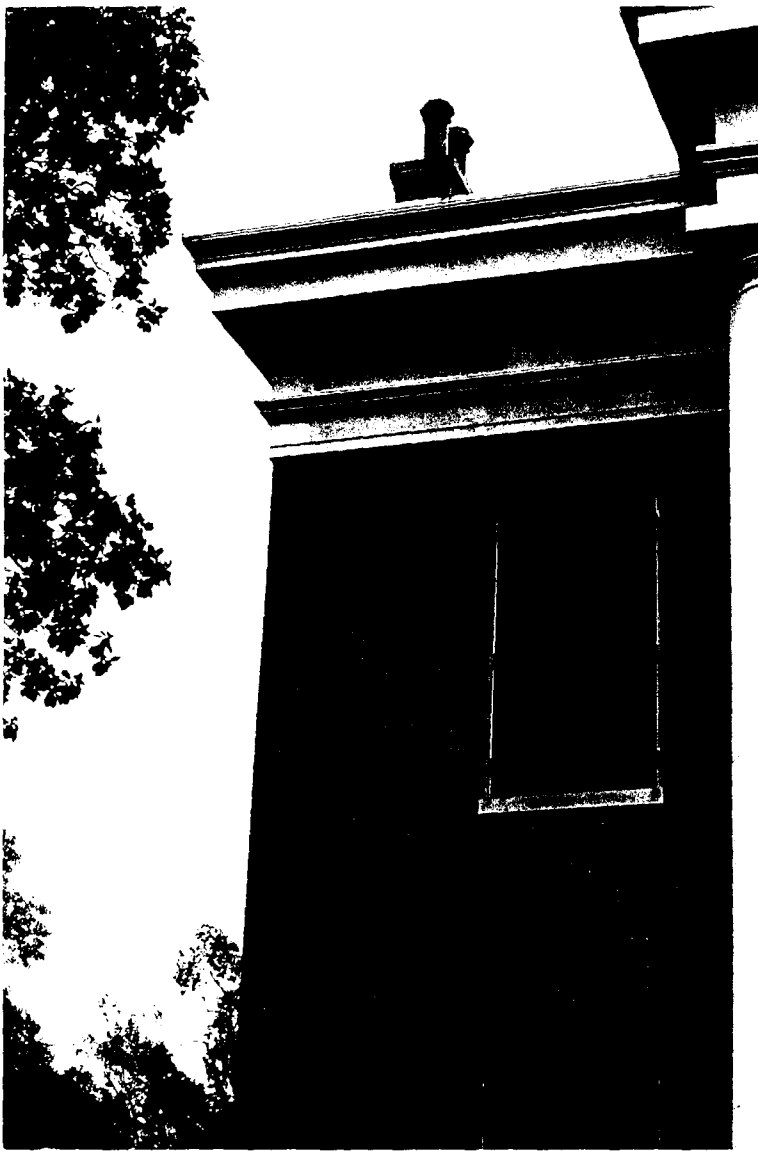
55-A Main House - Efflorescence on west facade. (ABA)

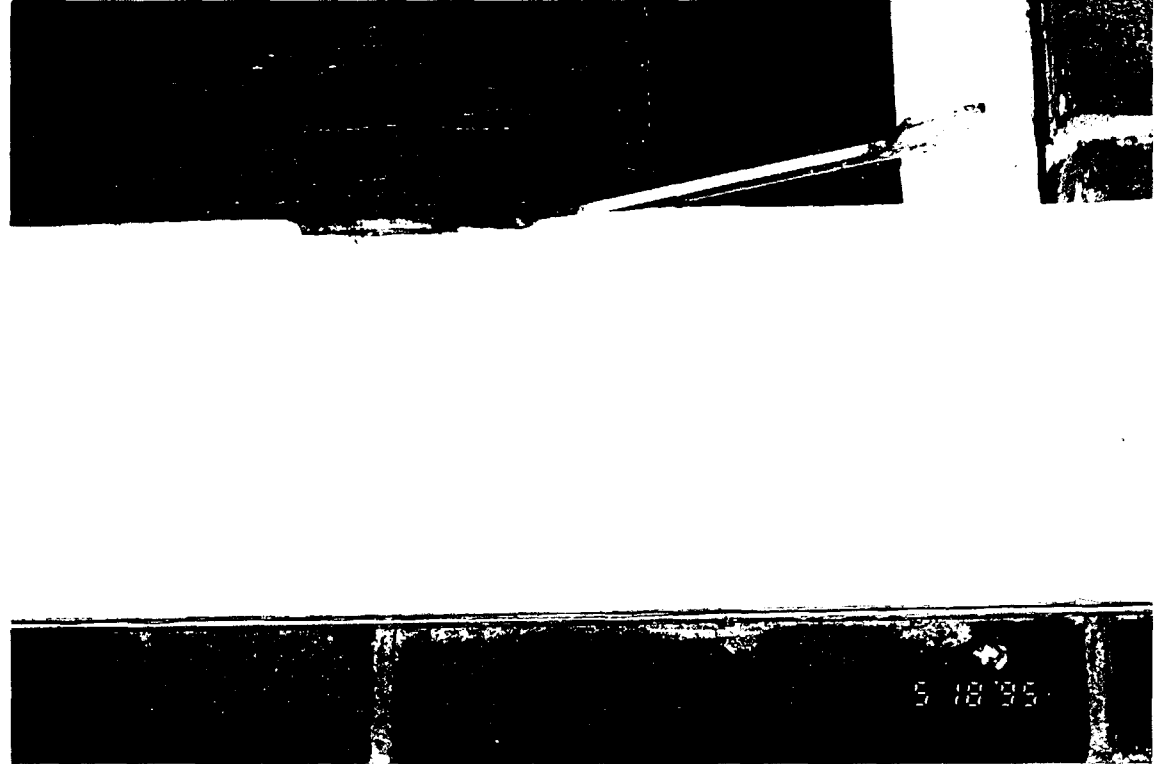
60-A Main House - Rusted shutter dogs. (ABA)

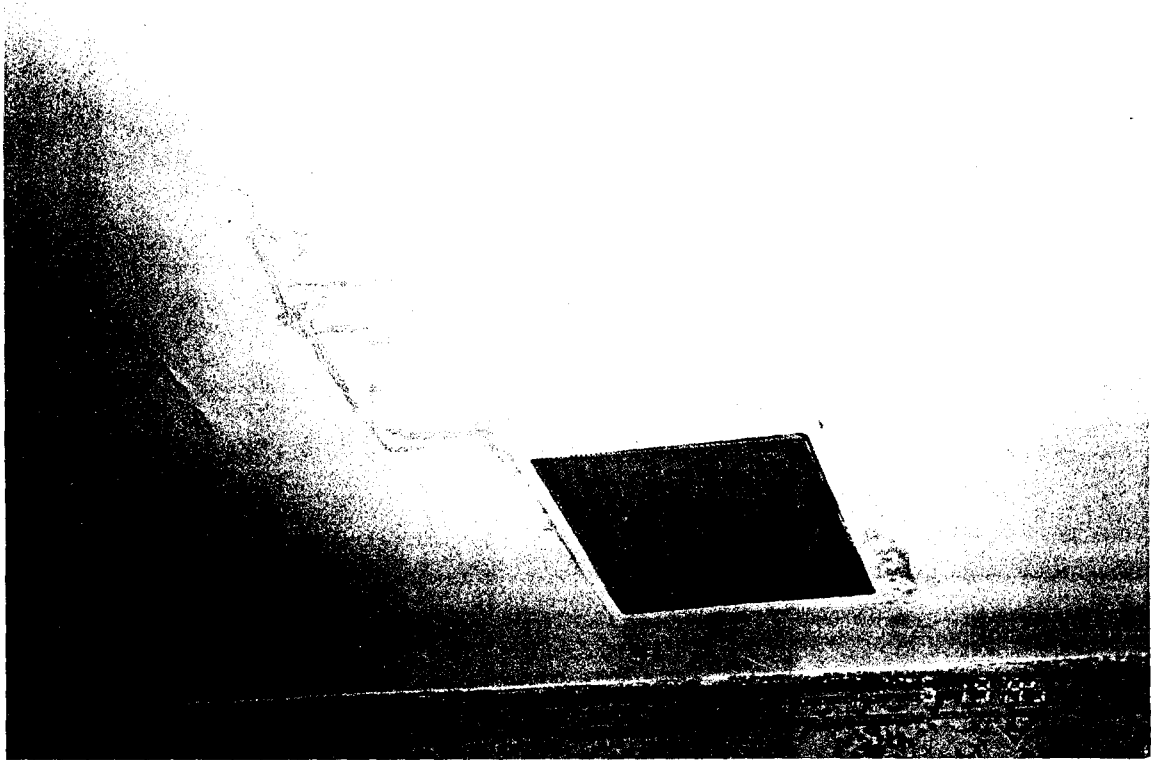
61-A Main House - North Front Bedroom ceiling plaster damage. (ABA)

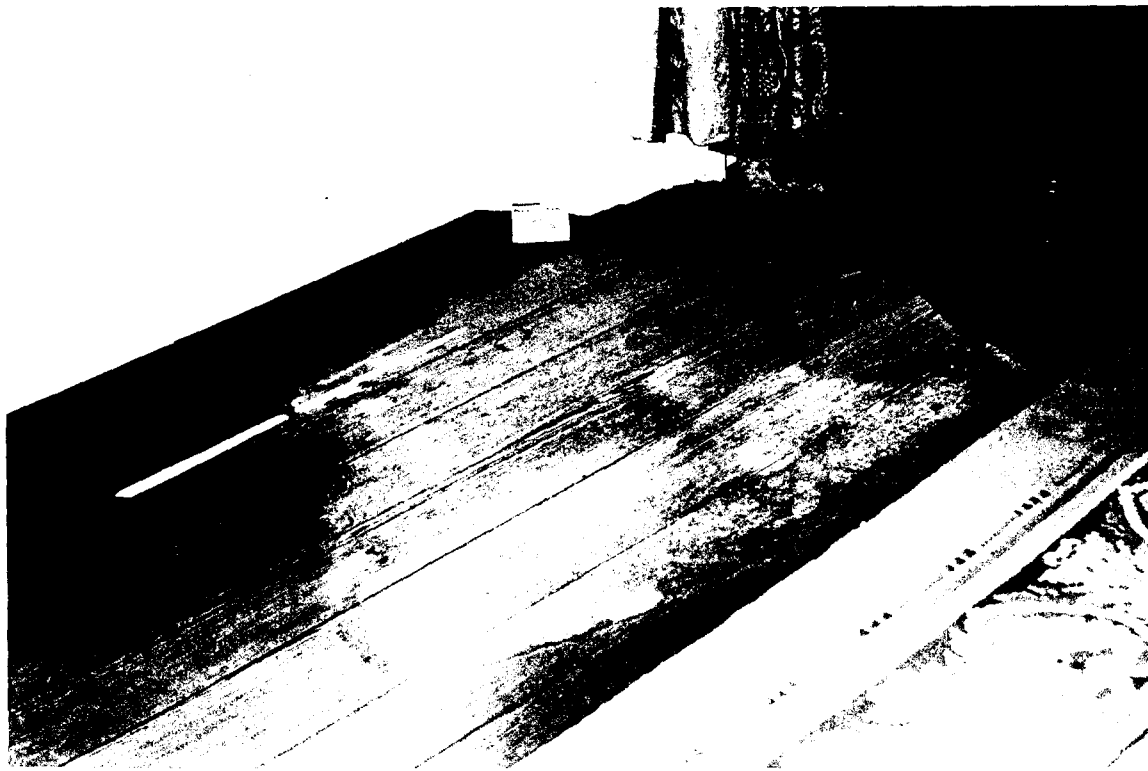
62-A Main House - Floor damage caused by humidifiers. (ABA)

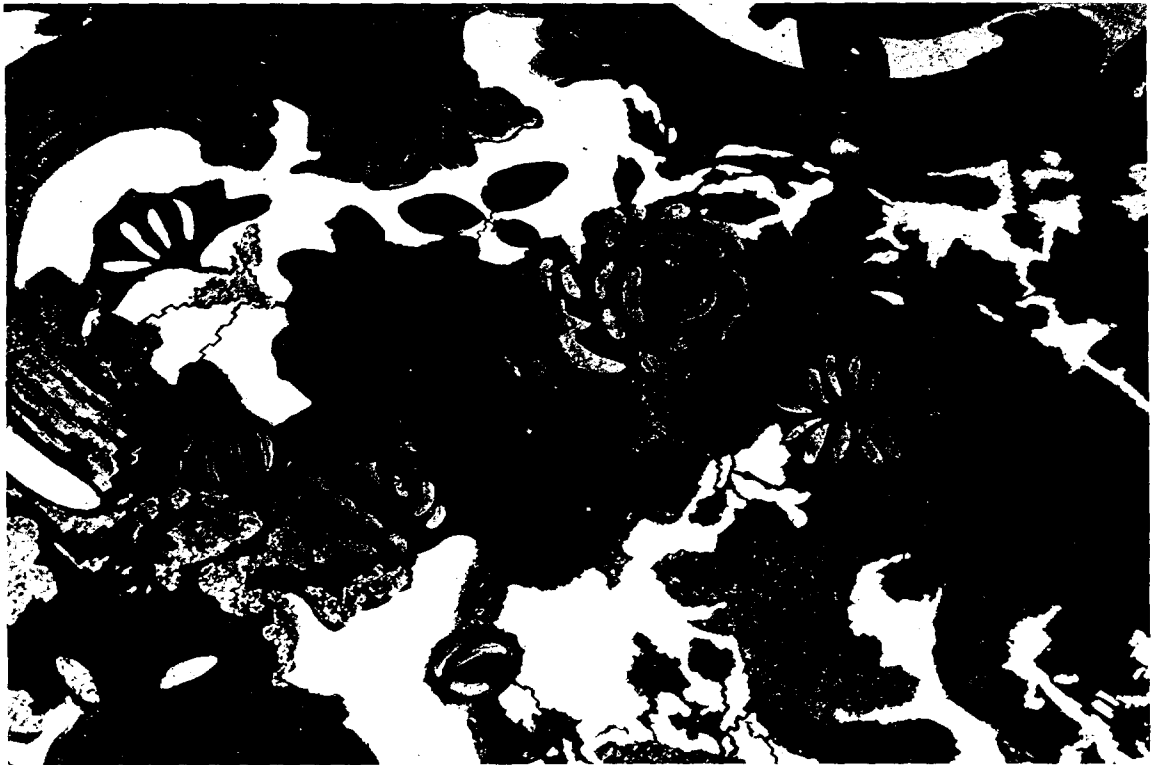
63-A Main House - Infill paint to decorative floorcloth. (ABA)

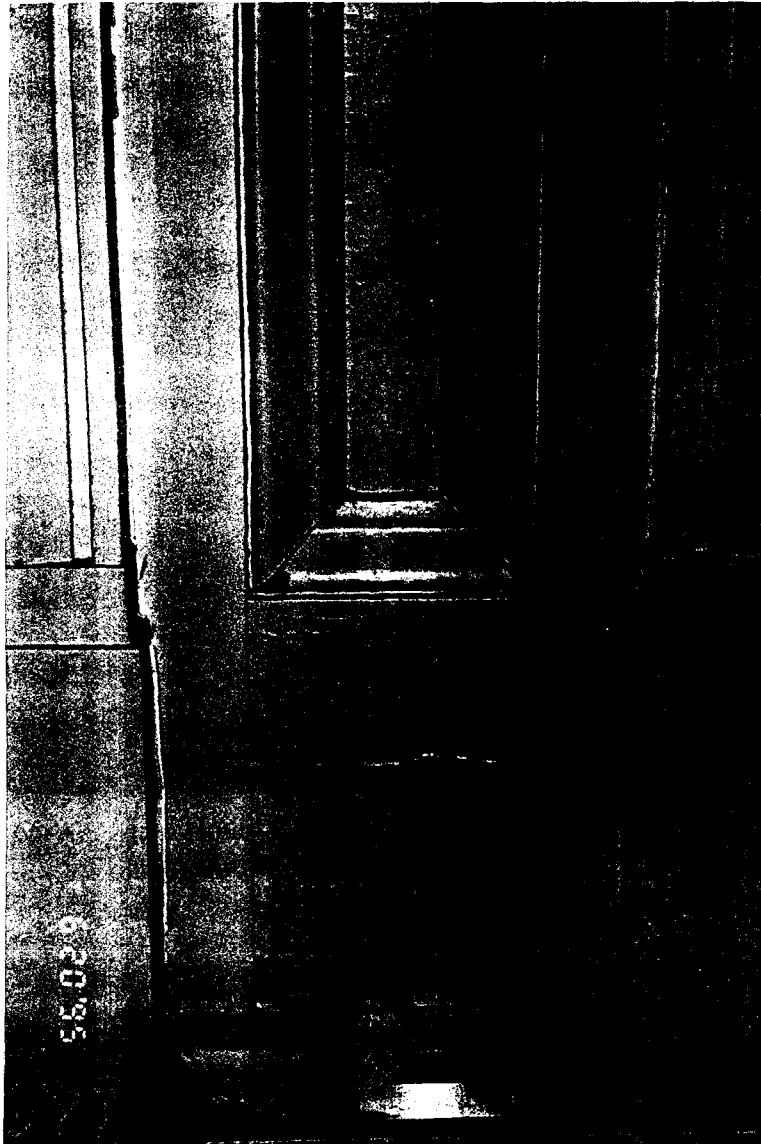
65-A Main House - Wood panels showing moisture damage to Front Hall. (ABA)

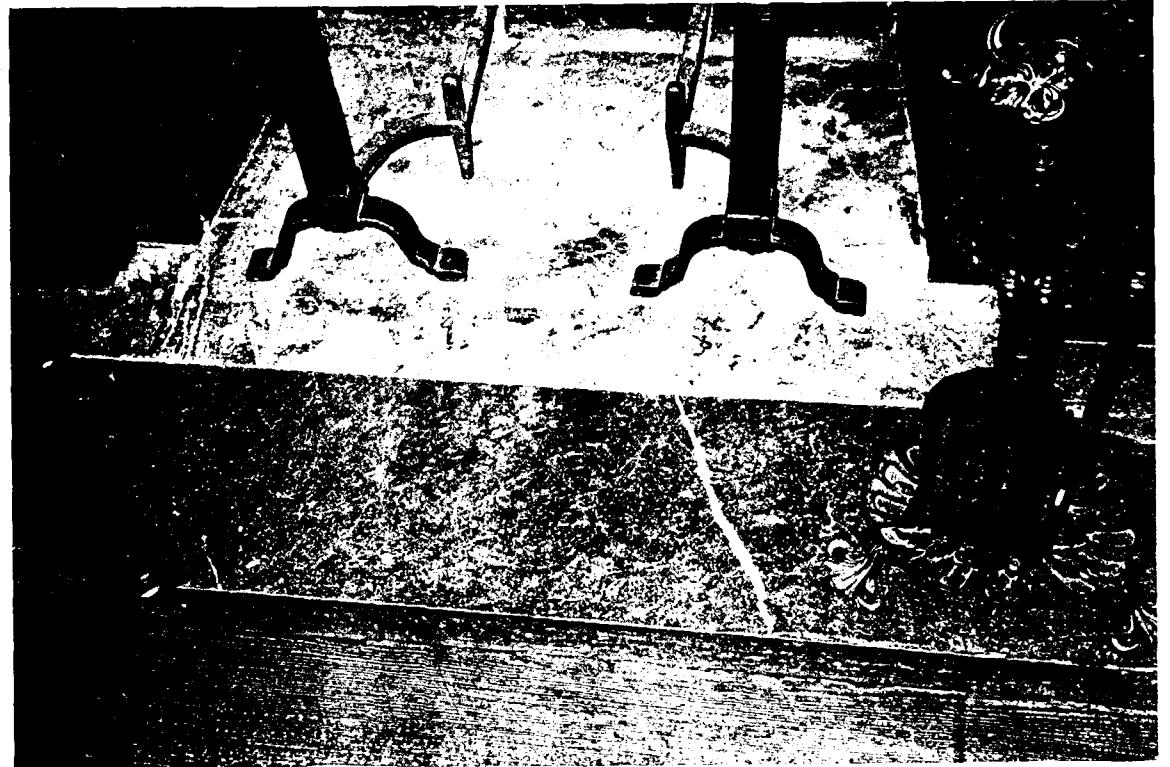
66-A Main House - Crack in fireplace hearth in Middle Bedroom. (ABA)

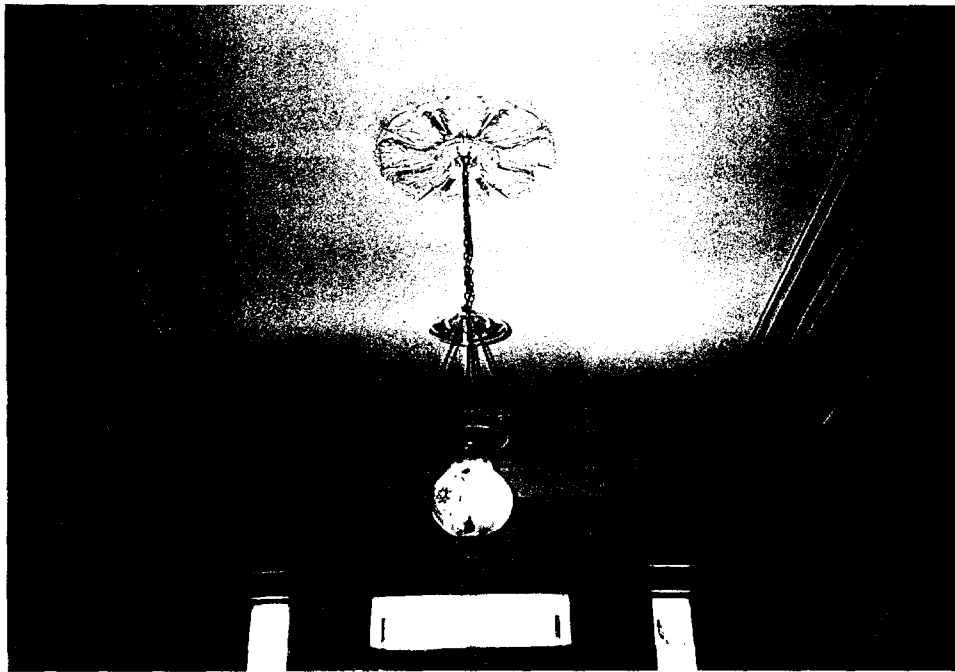
67-A Main House - Front Hall light fixture. (ABA)

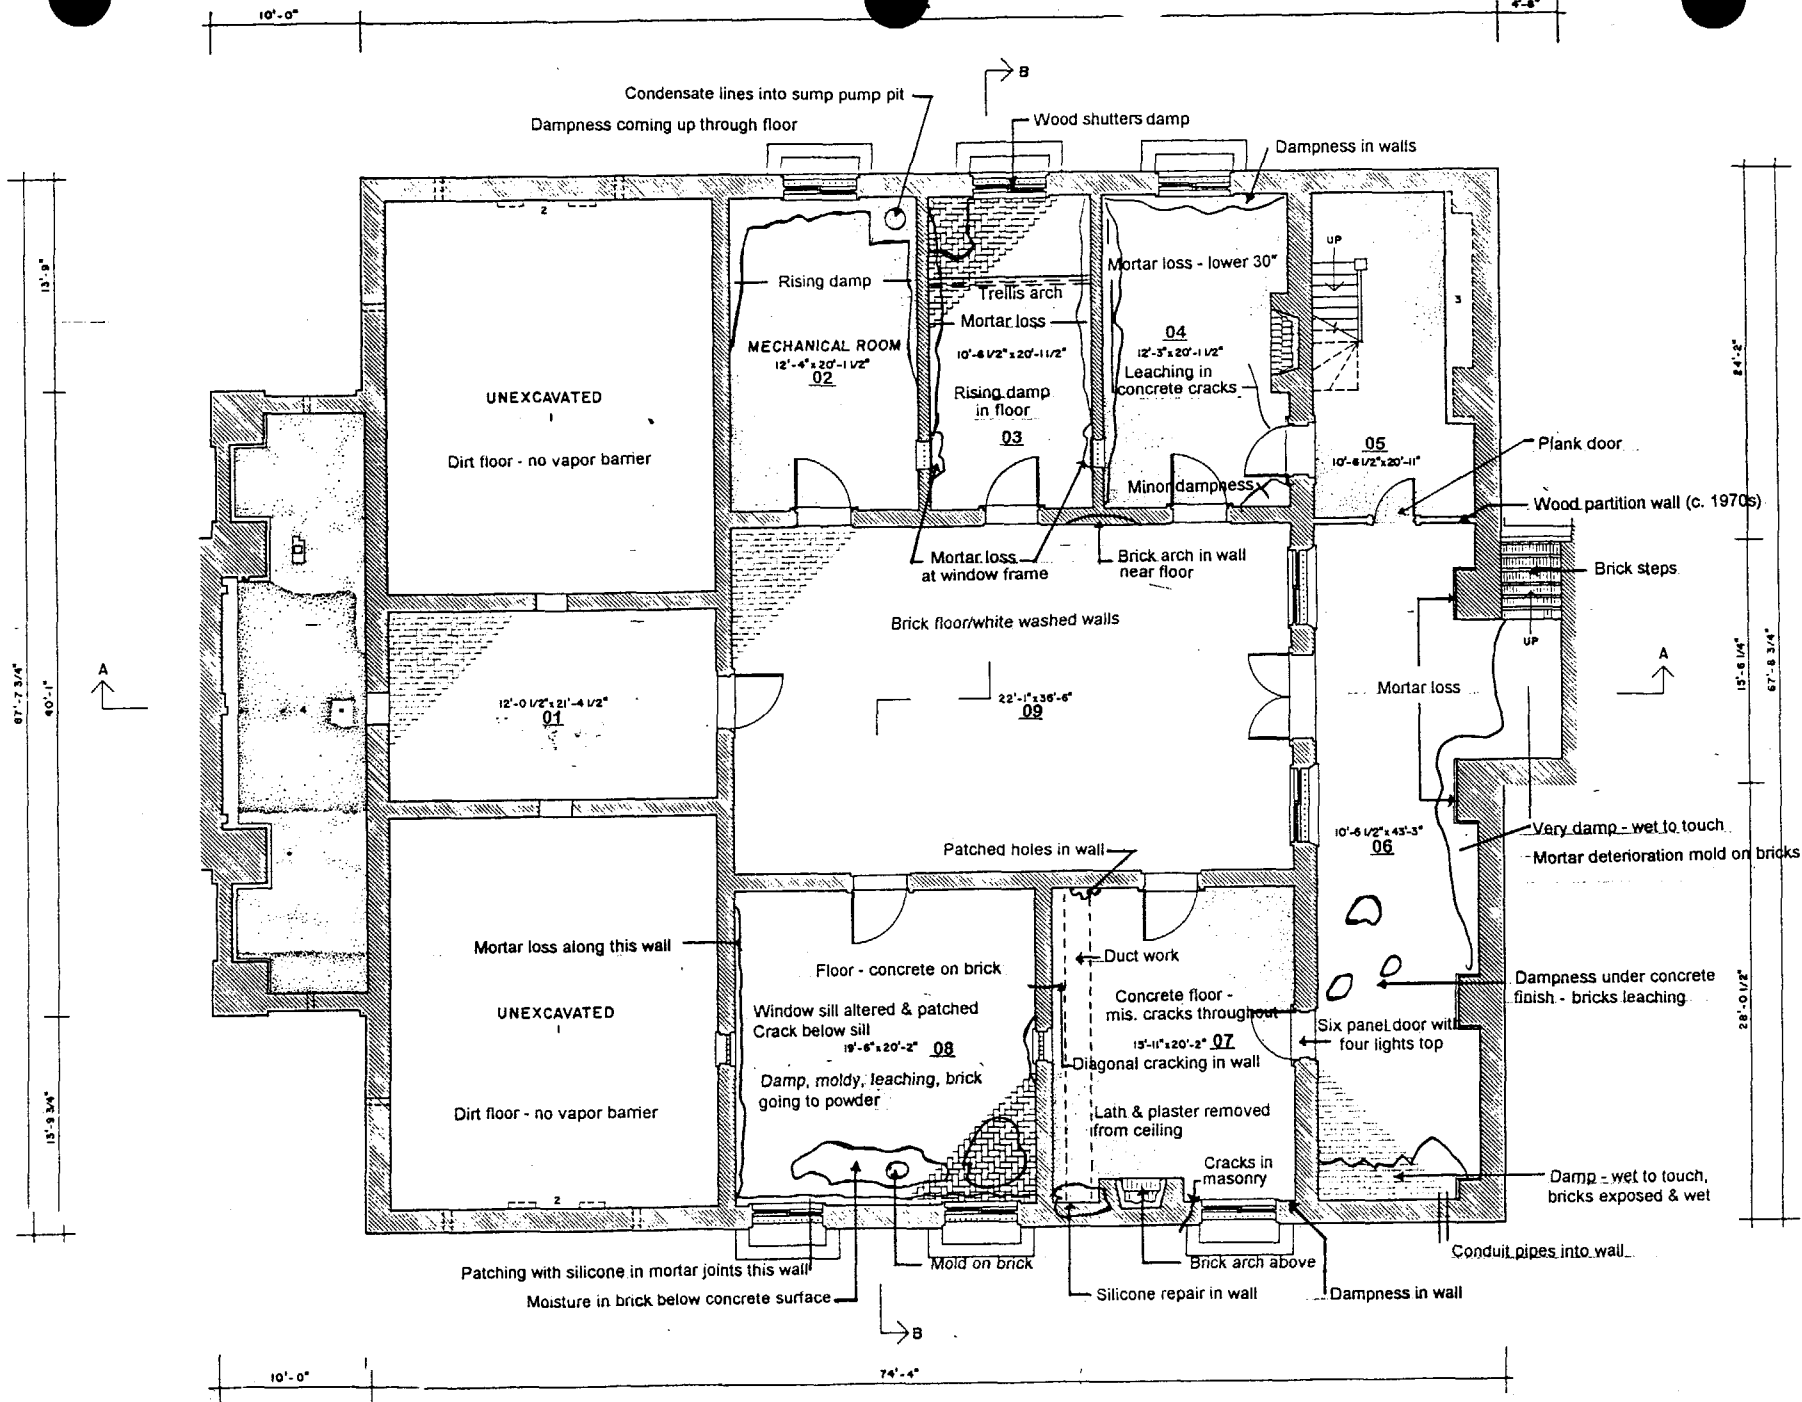
BASEMENT FLOOR PLAN
Existing Conditions

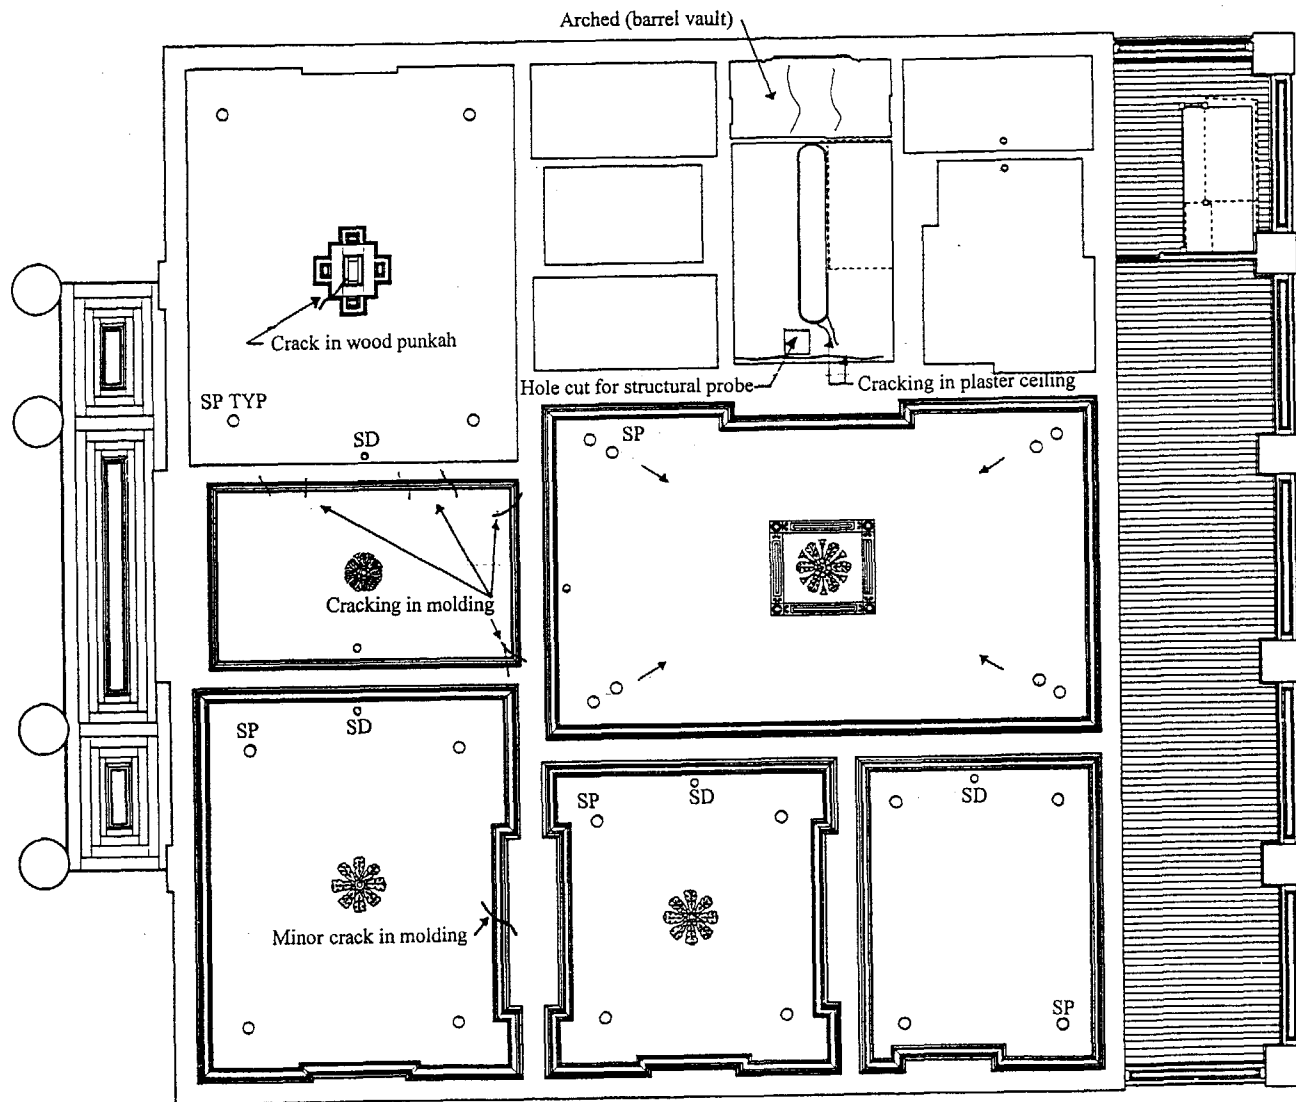
FIRST FLOOR REFLECTED CEILING PLAN
Existing Conditions

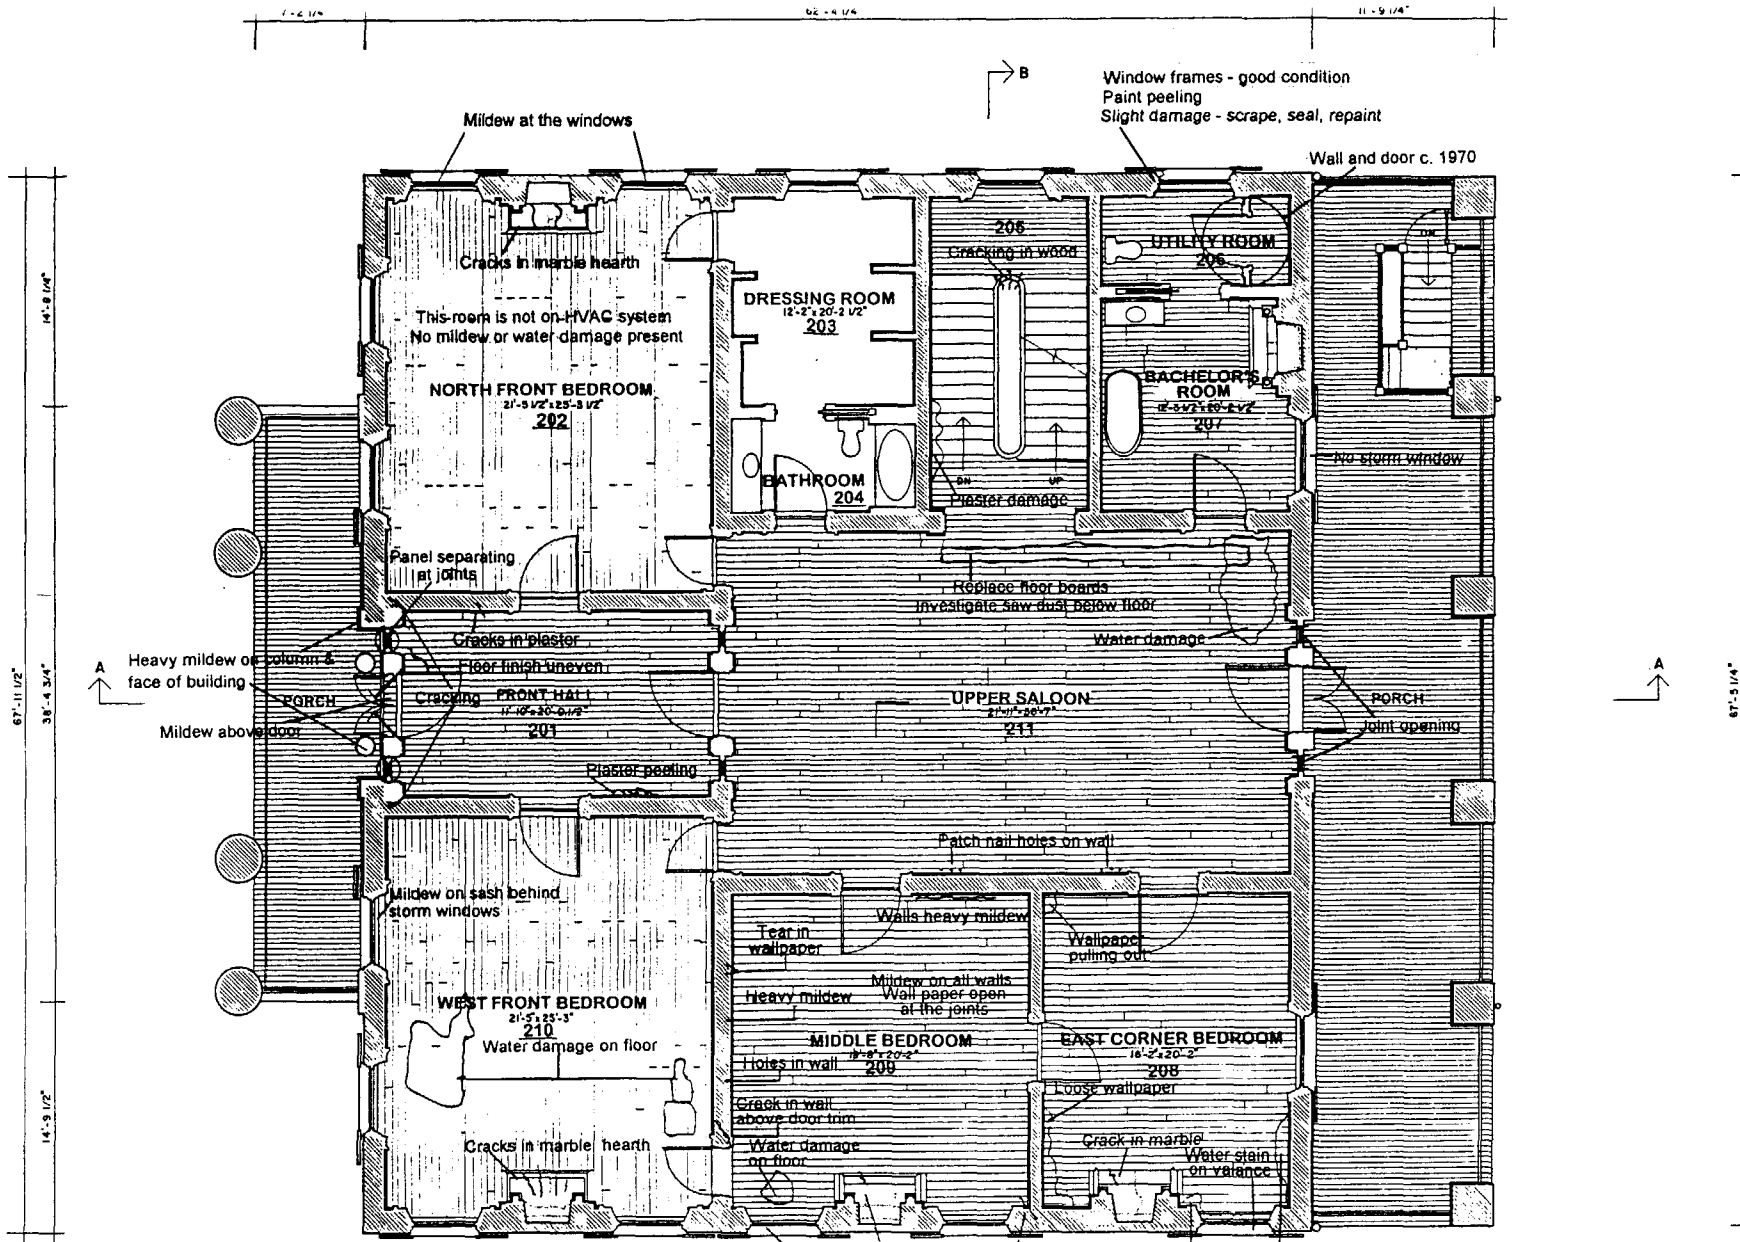
SECOND FLOOR PLAN
Existing Conditions

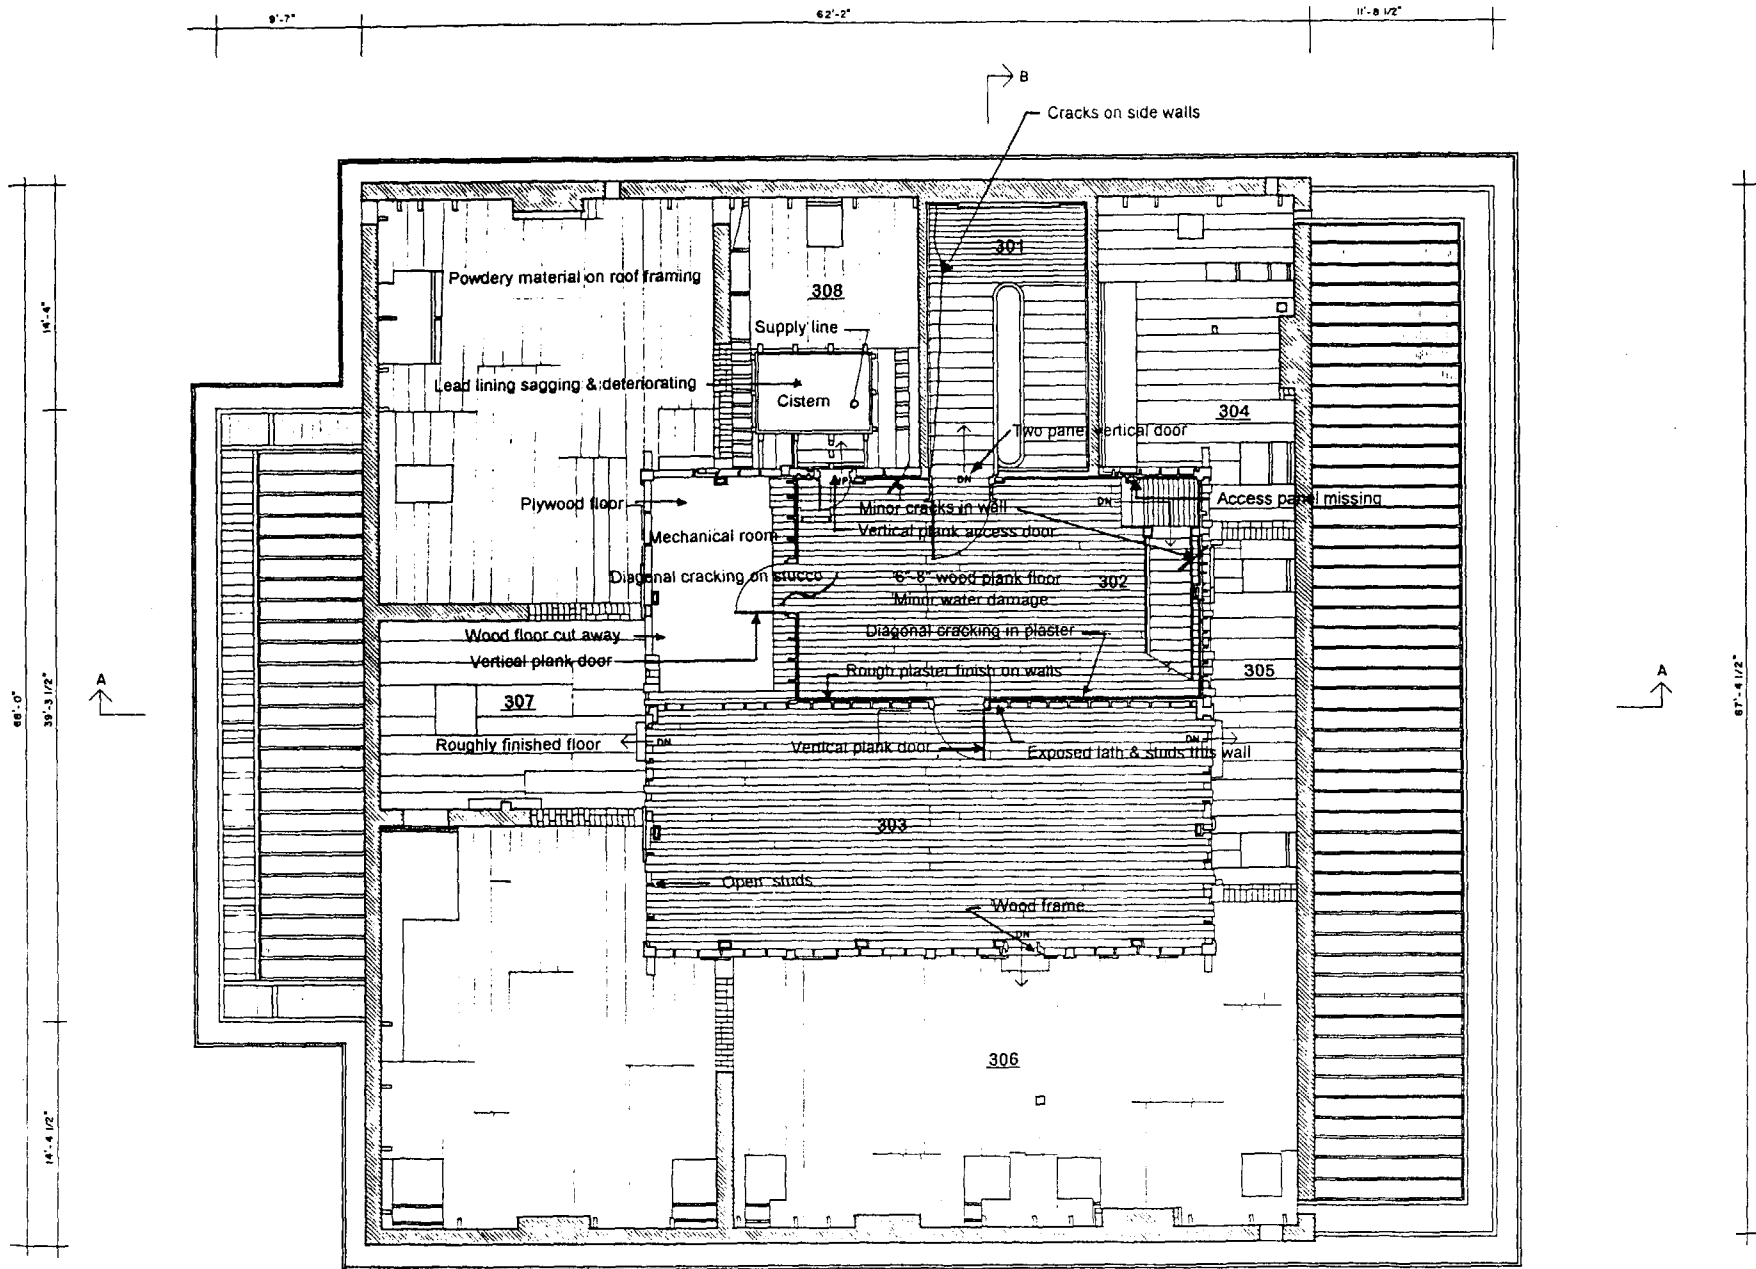
- All doors & frames - good condition
- Hardware missing on some clerestory pull boxes
- All windows in good condition
- Unpainted wood base - good condition
