D-11
Vol. 1 of 3
February 1997

**MELROSE ESTATE
NATCHEZ NATIONAL HISTORICAL PARK**

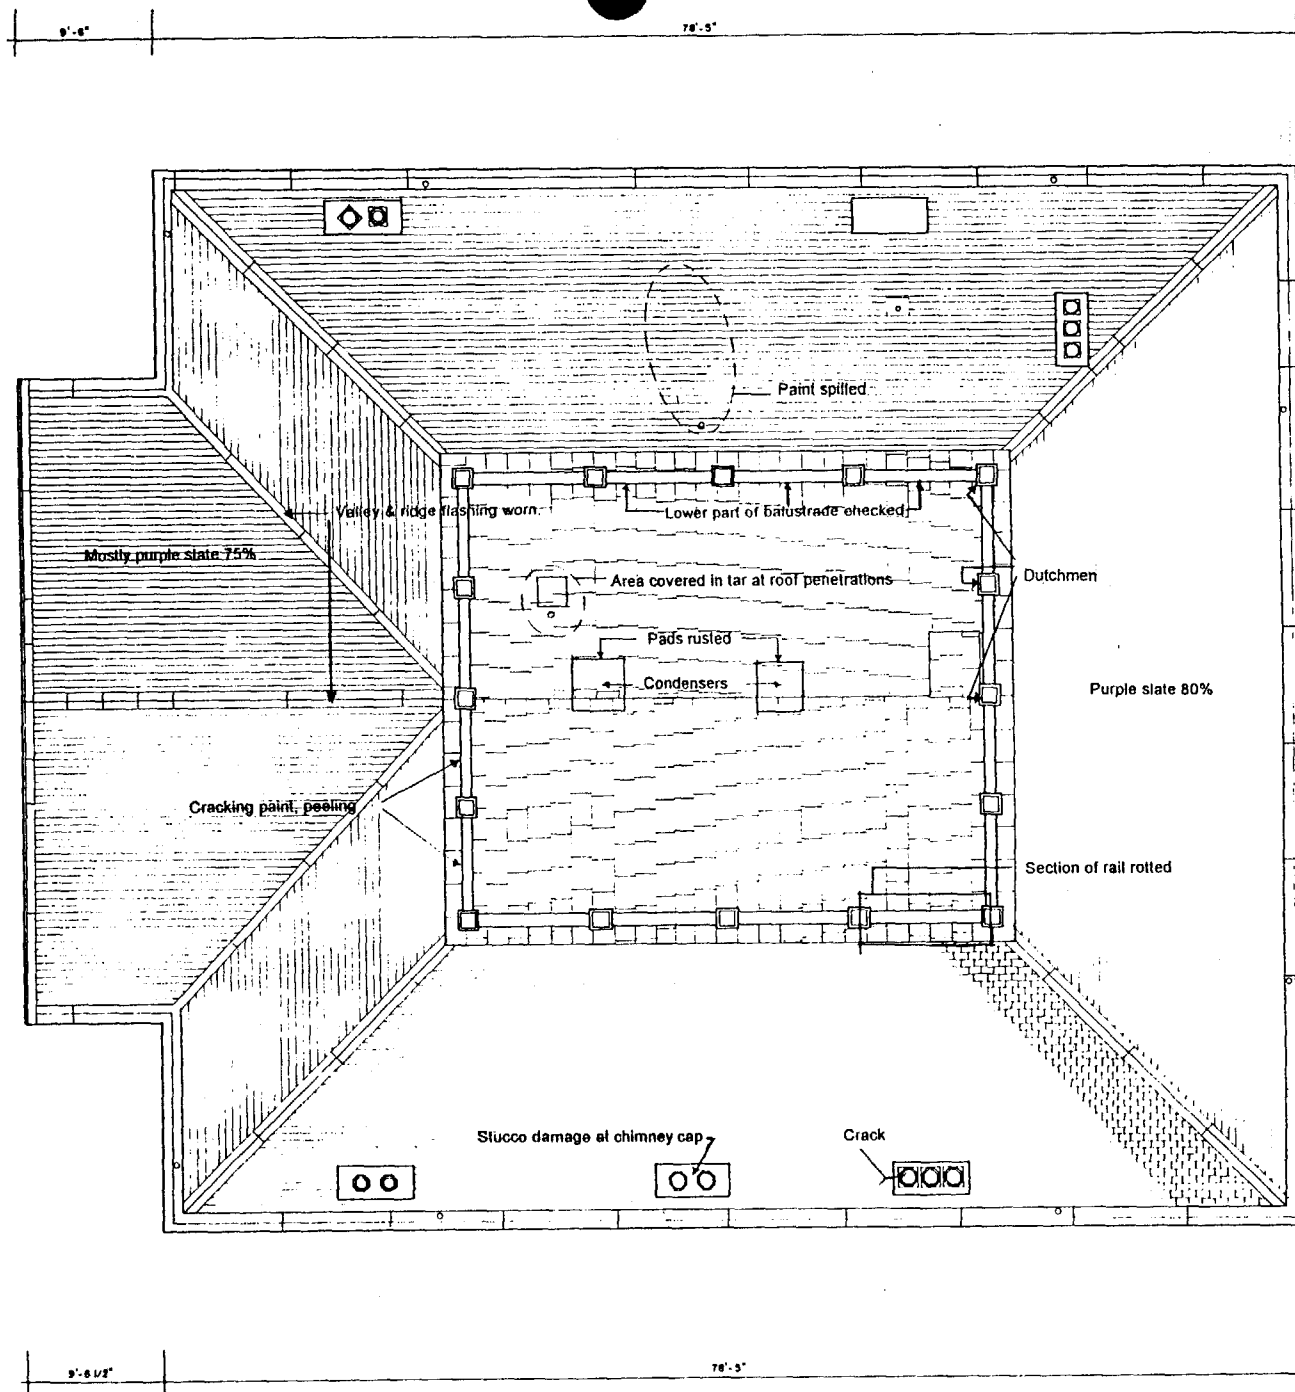
ROOF PLAN
Existing Conditions

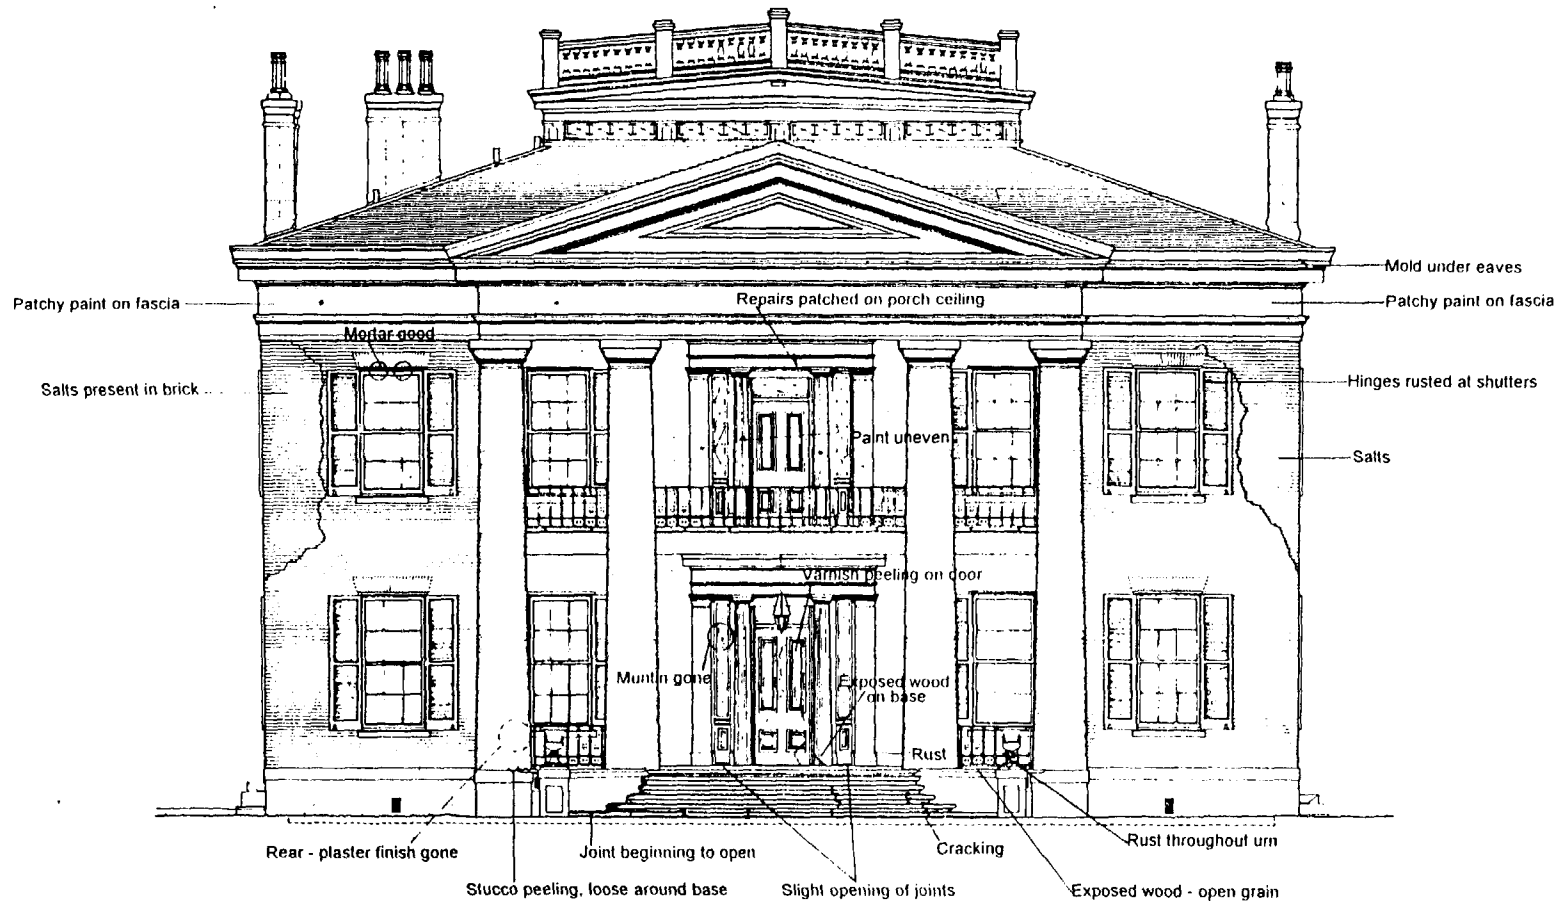
MATERIALS
SLATE SHINGLES
METAL ROOFING ON CUPOLA

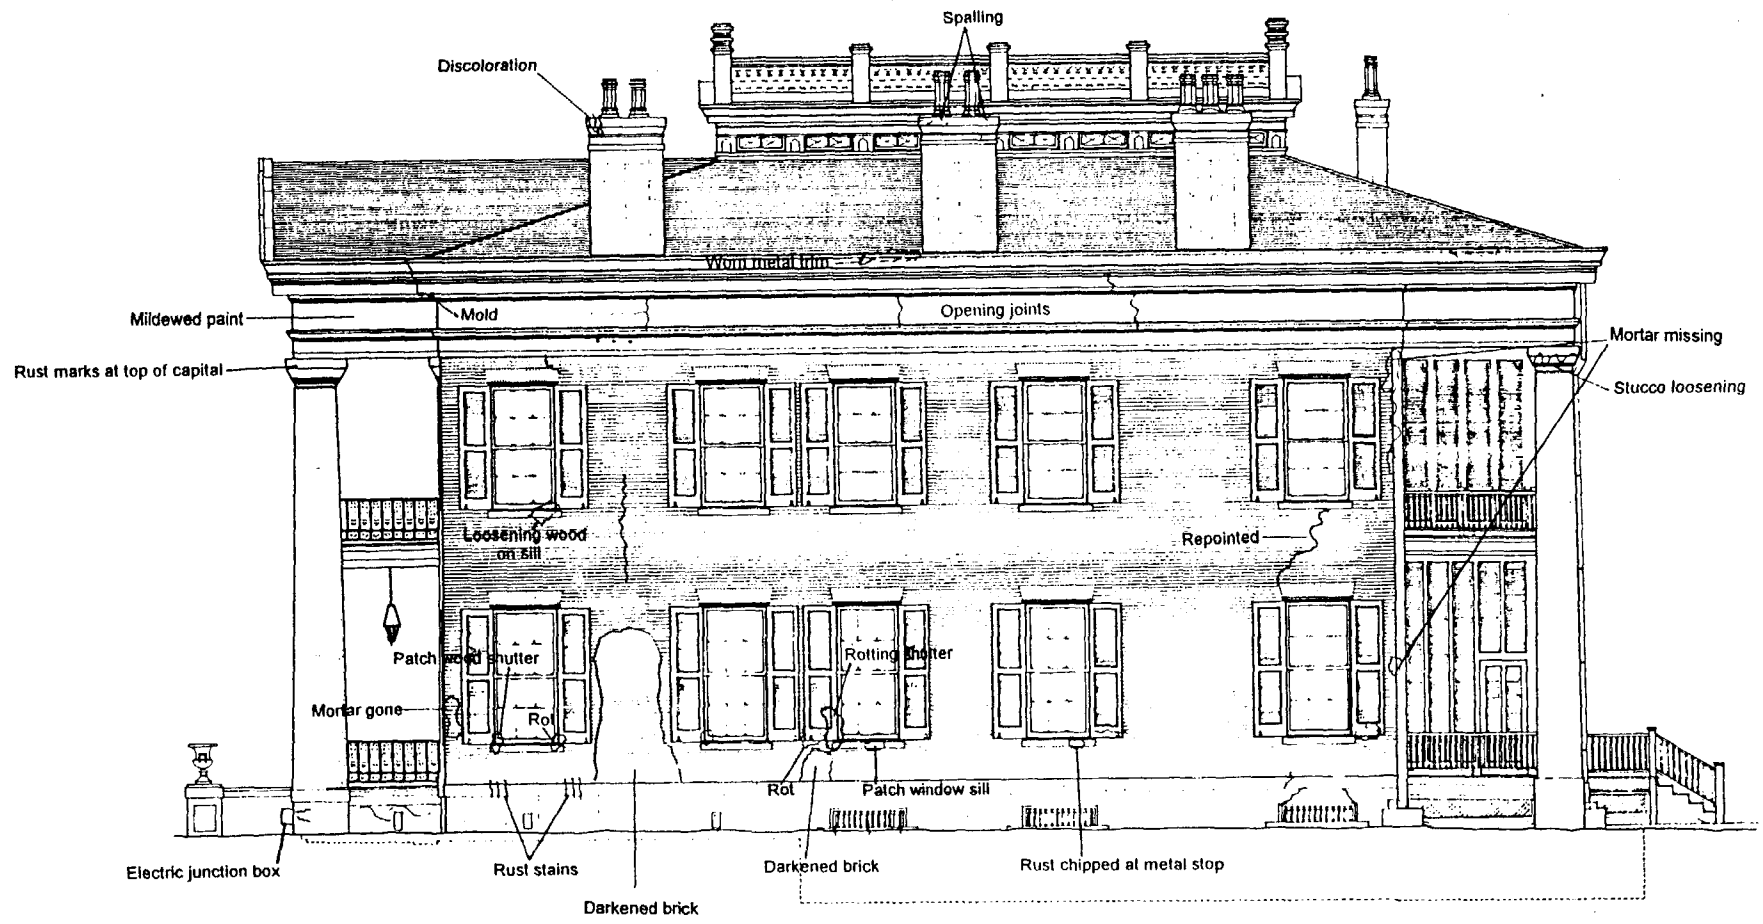
SOUTH ELEVATION
Existing Conditions

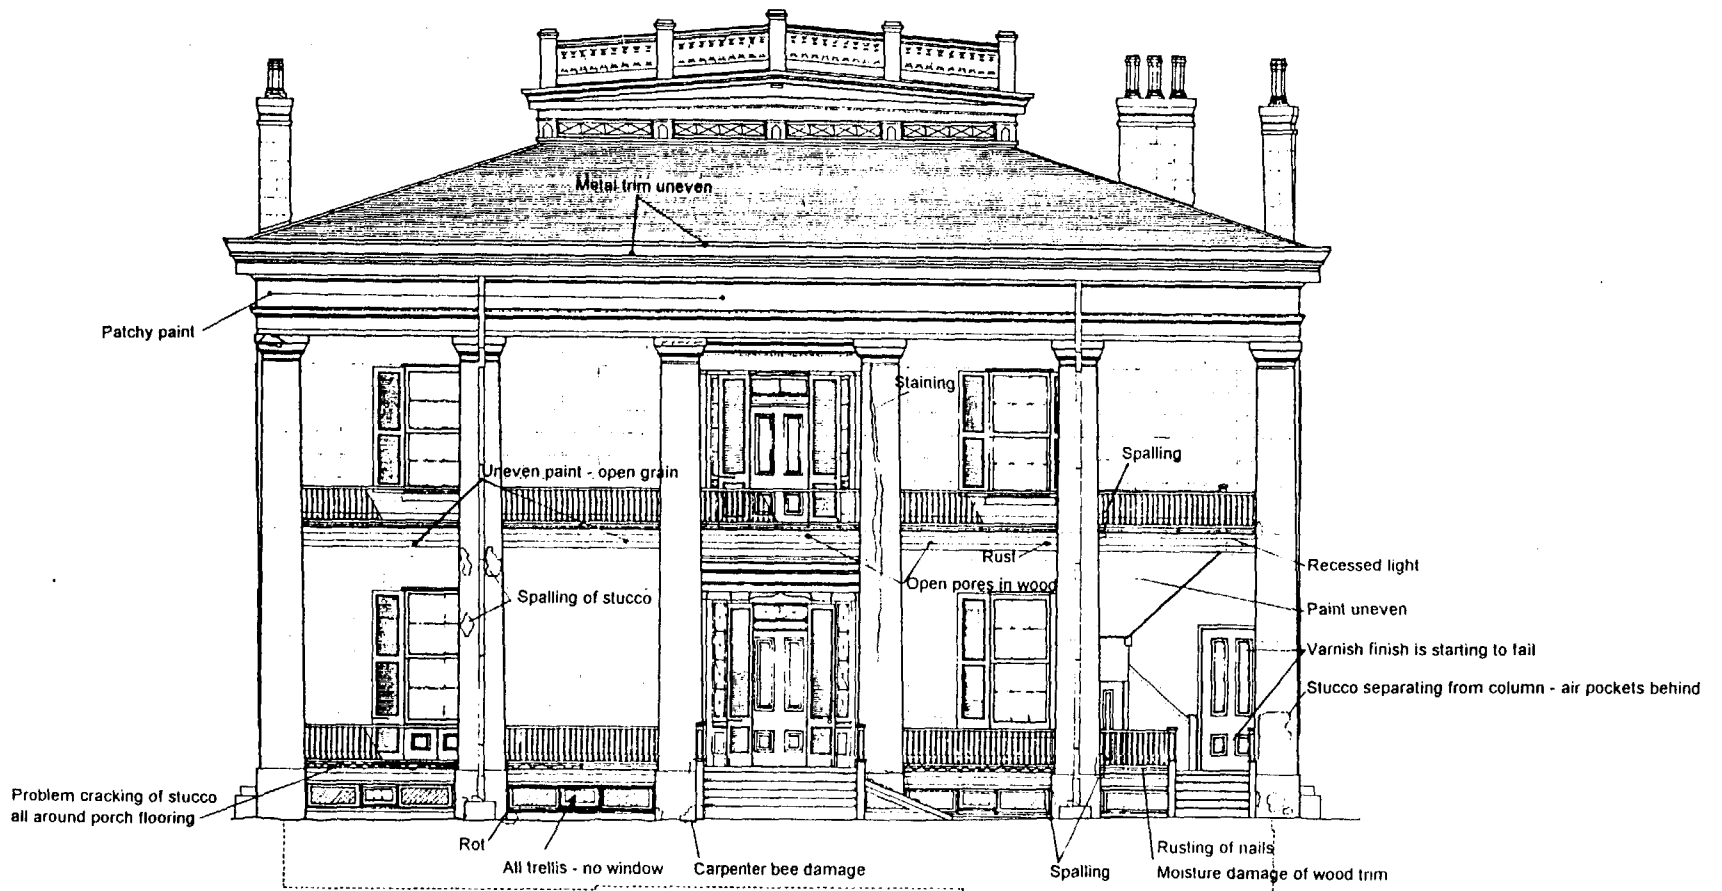
| ROOFING | SLATE SHINGLES |

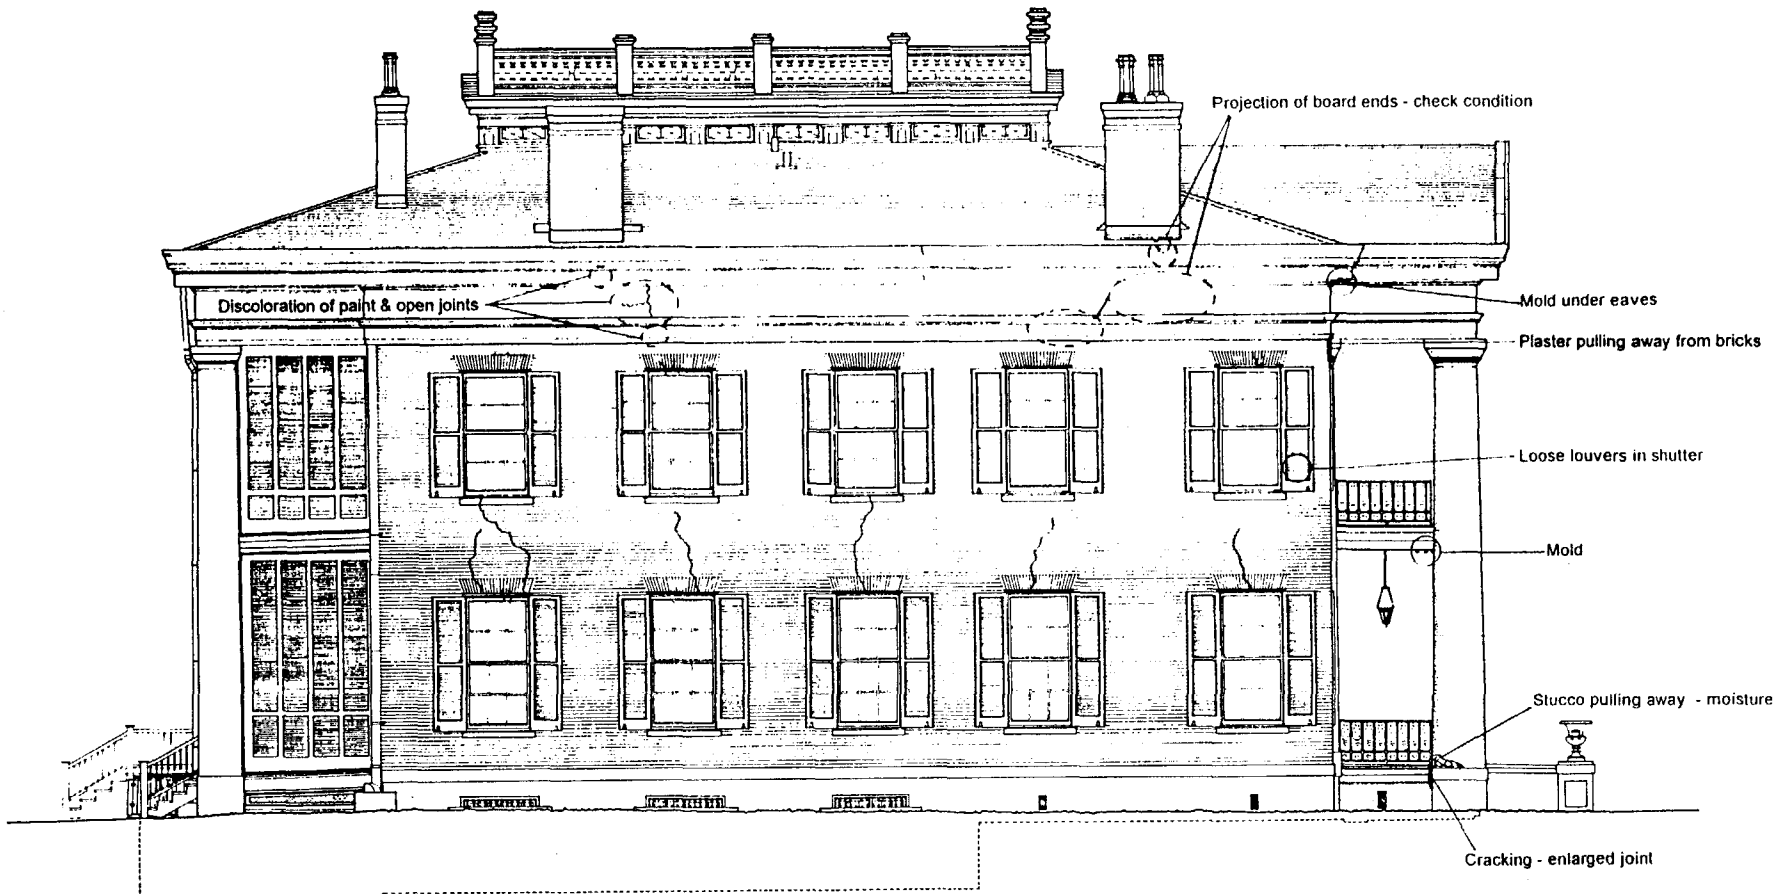
Only four windows visible

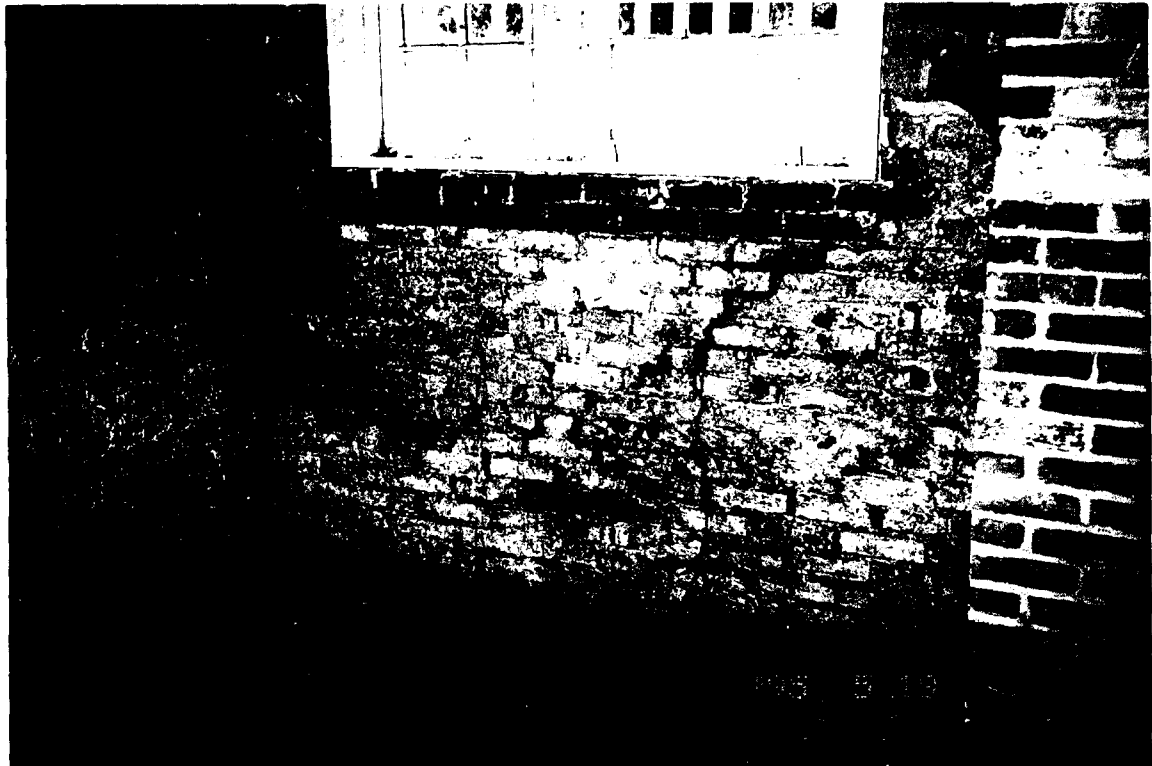
79-S Main House - Crack in southeast corner of basement.
(Robert Silman Associates - RSA)

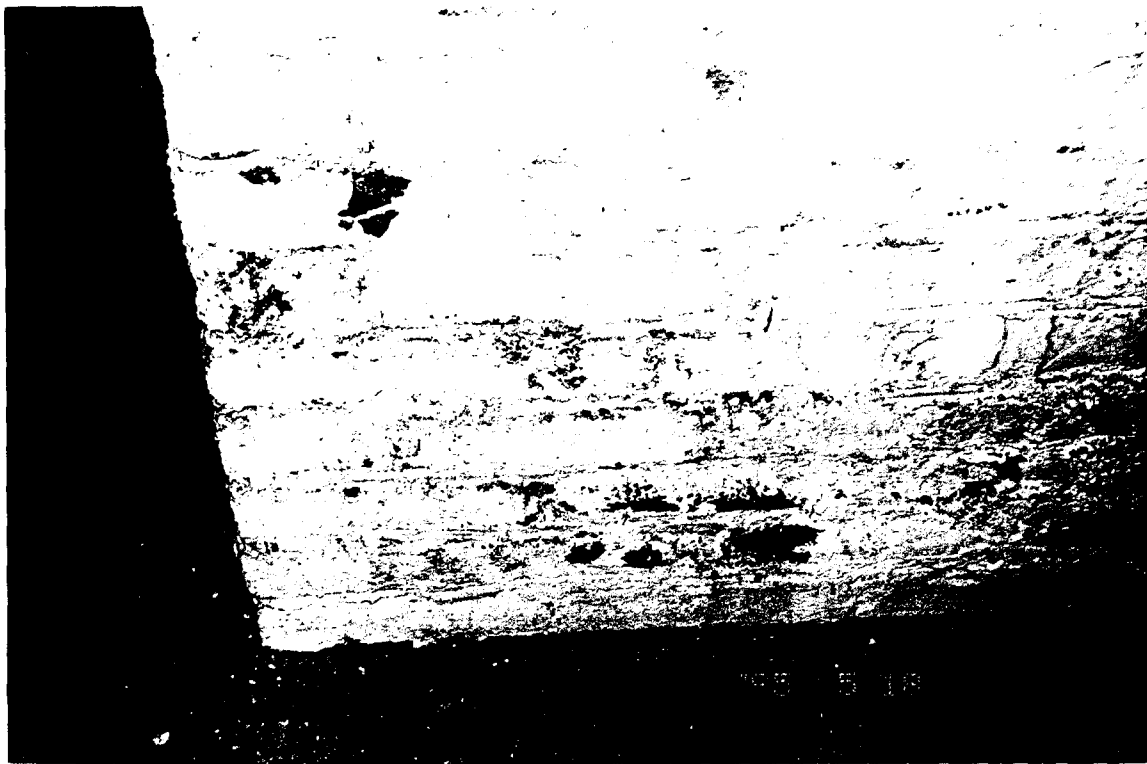
80-S Main House - Spalling brick in basement. (RSA)

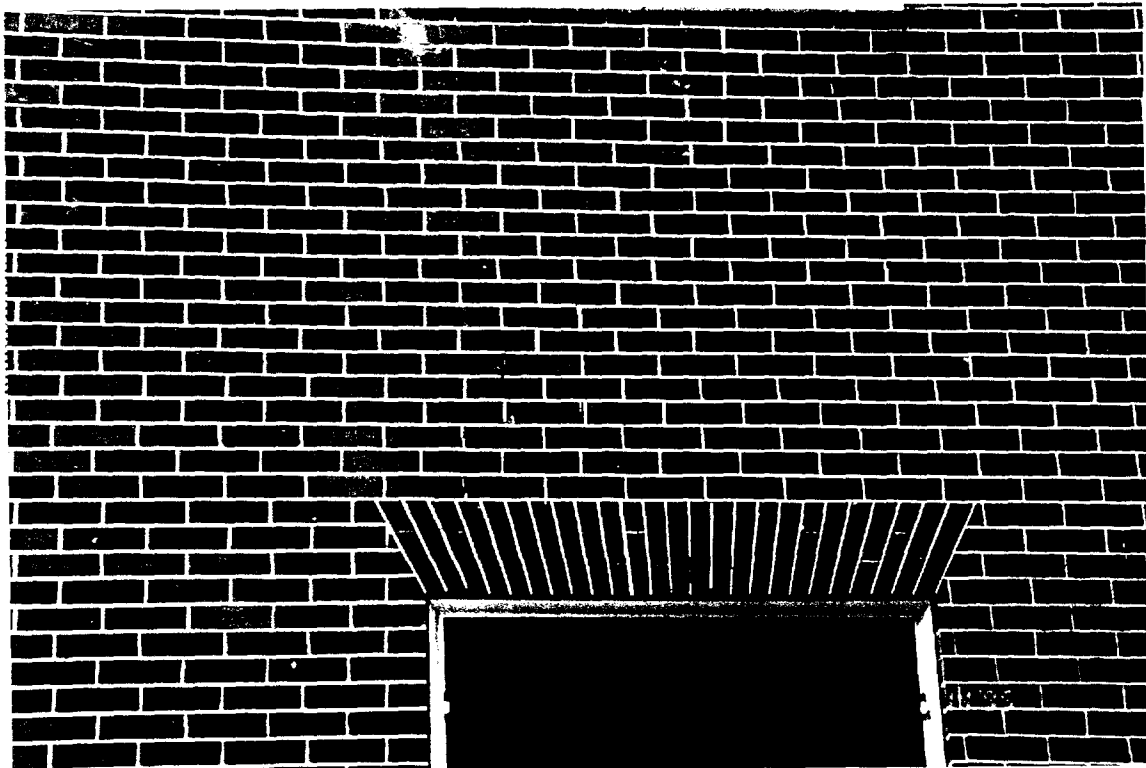
81-S Main House - Crack in exterior brick wall. (RSA)

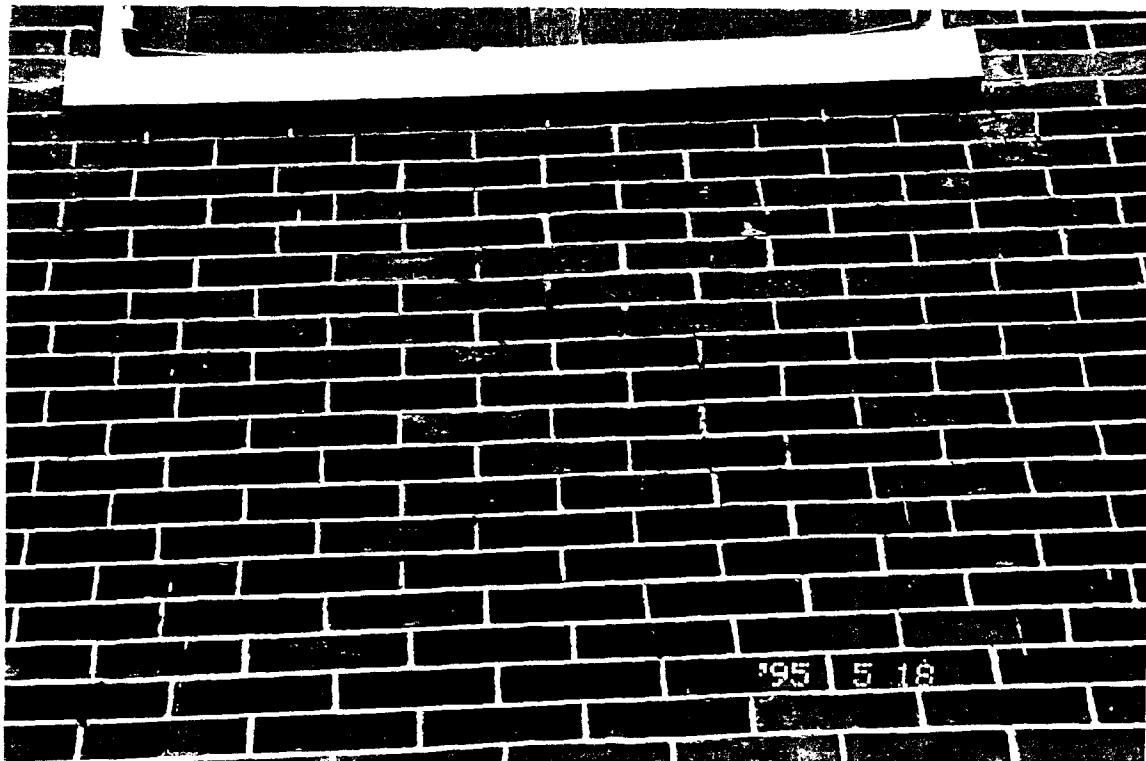
82-S Main House - Crack in exterior brick wall. (RSA)

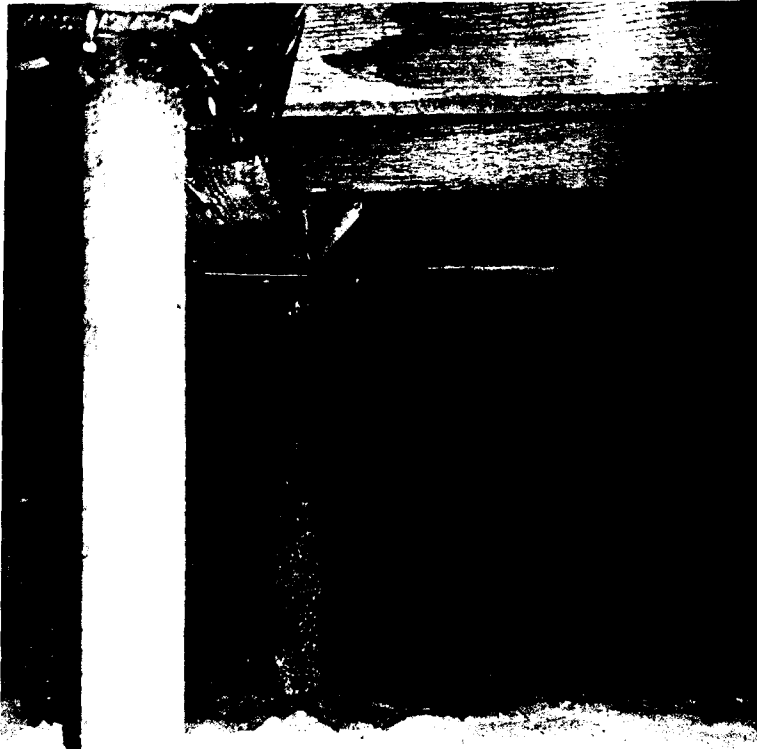
83-S Main House - Rusting columns and deteriorated brick wall under west porch. (RSA)

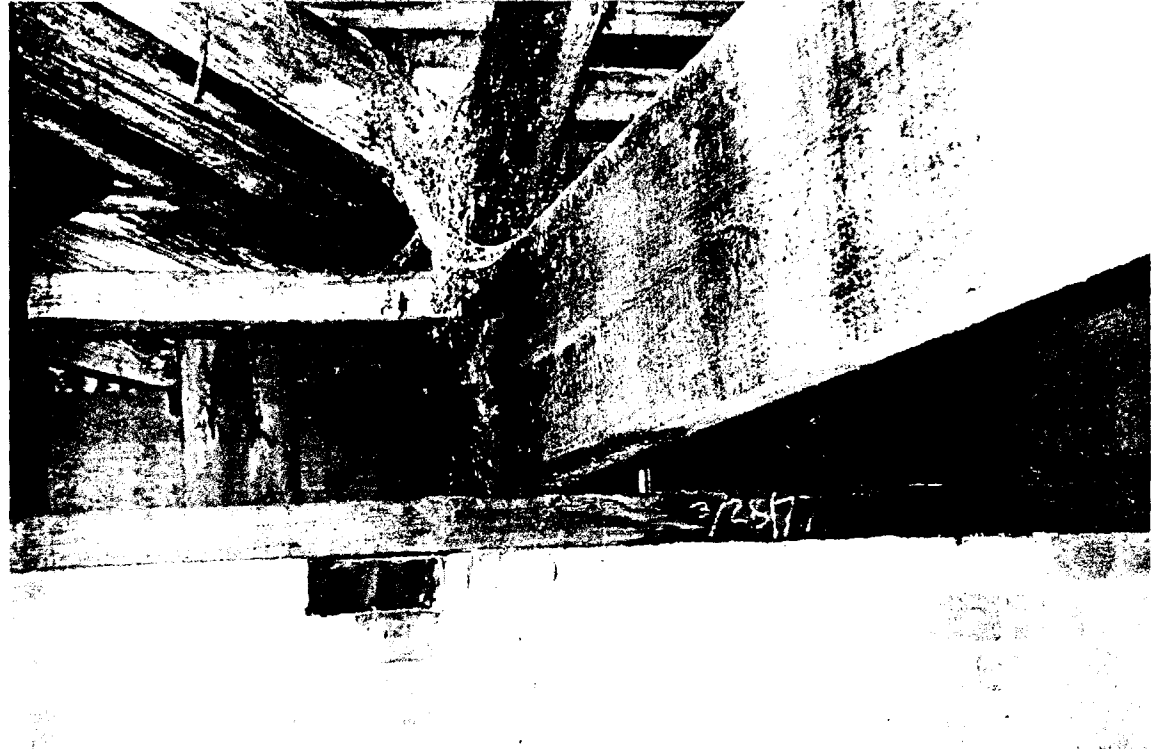
84-S Main House - Wood rot in roof framing. (RSA)

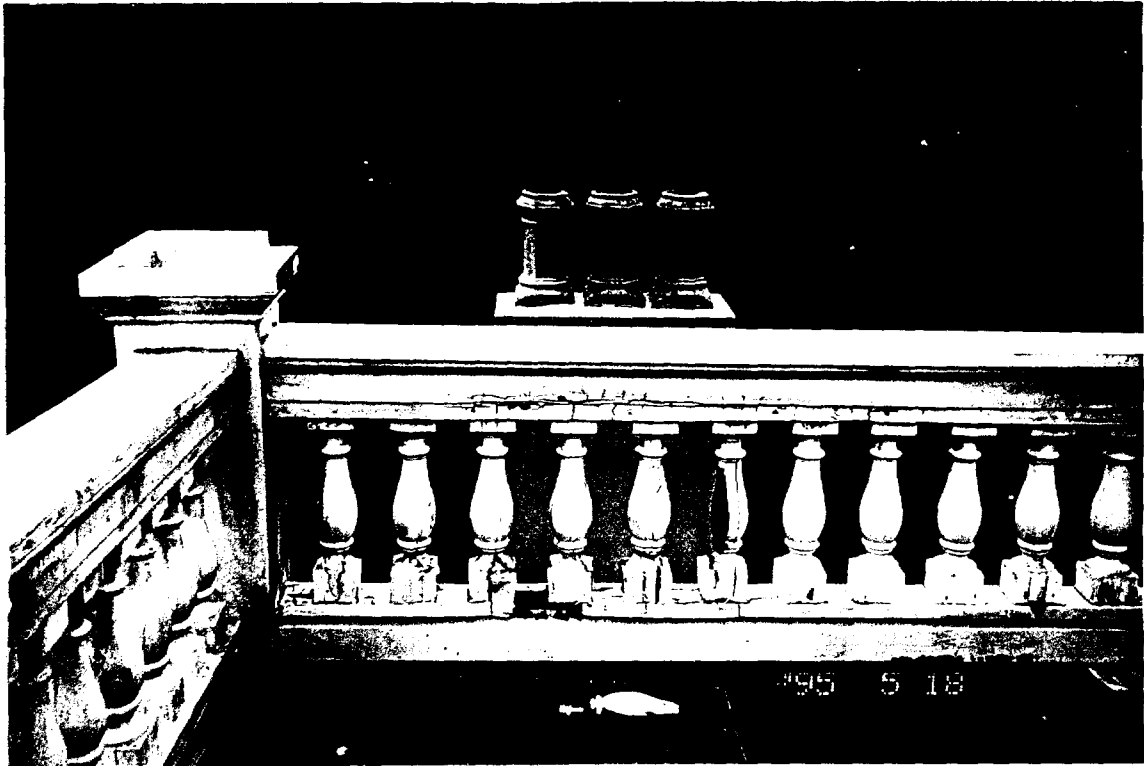
85-S Main House - Wood deterioration in roof balustrade. (RSA)

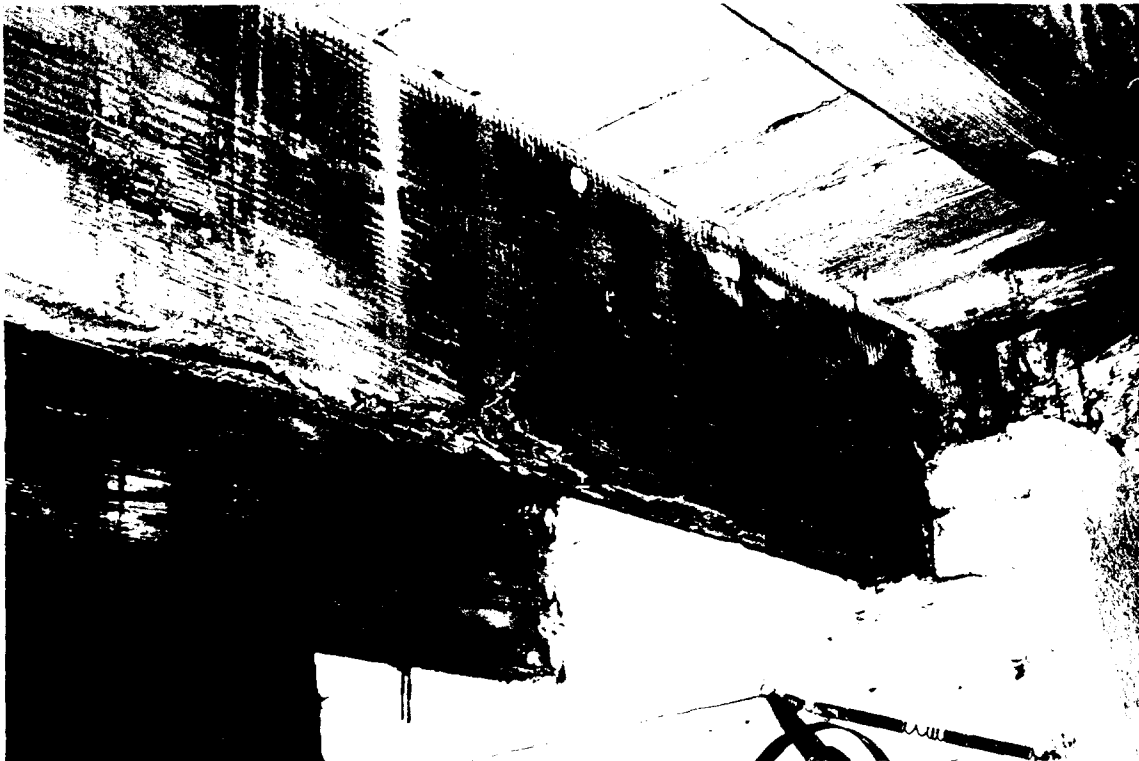
86-S Main House - Insect damage to wood under south porch. (RSA)

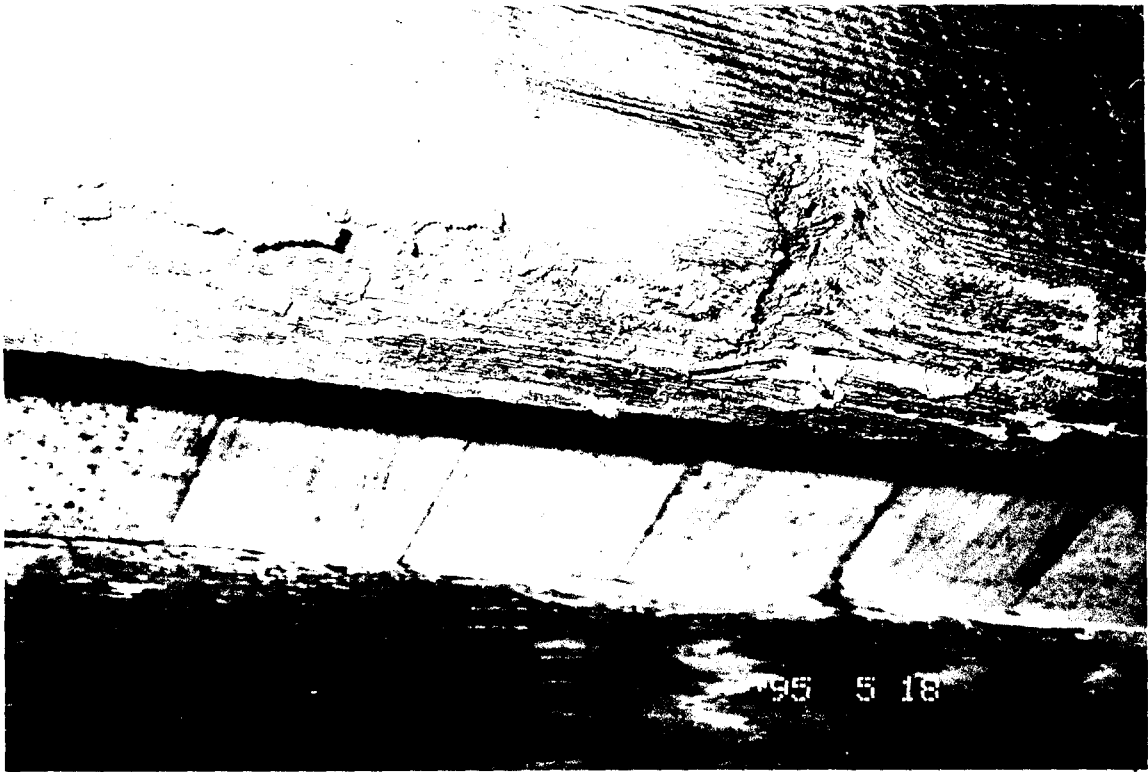
87-S Main House - Close-up of 86-S. (RSA)

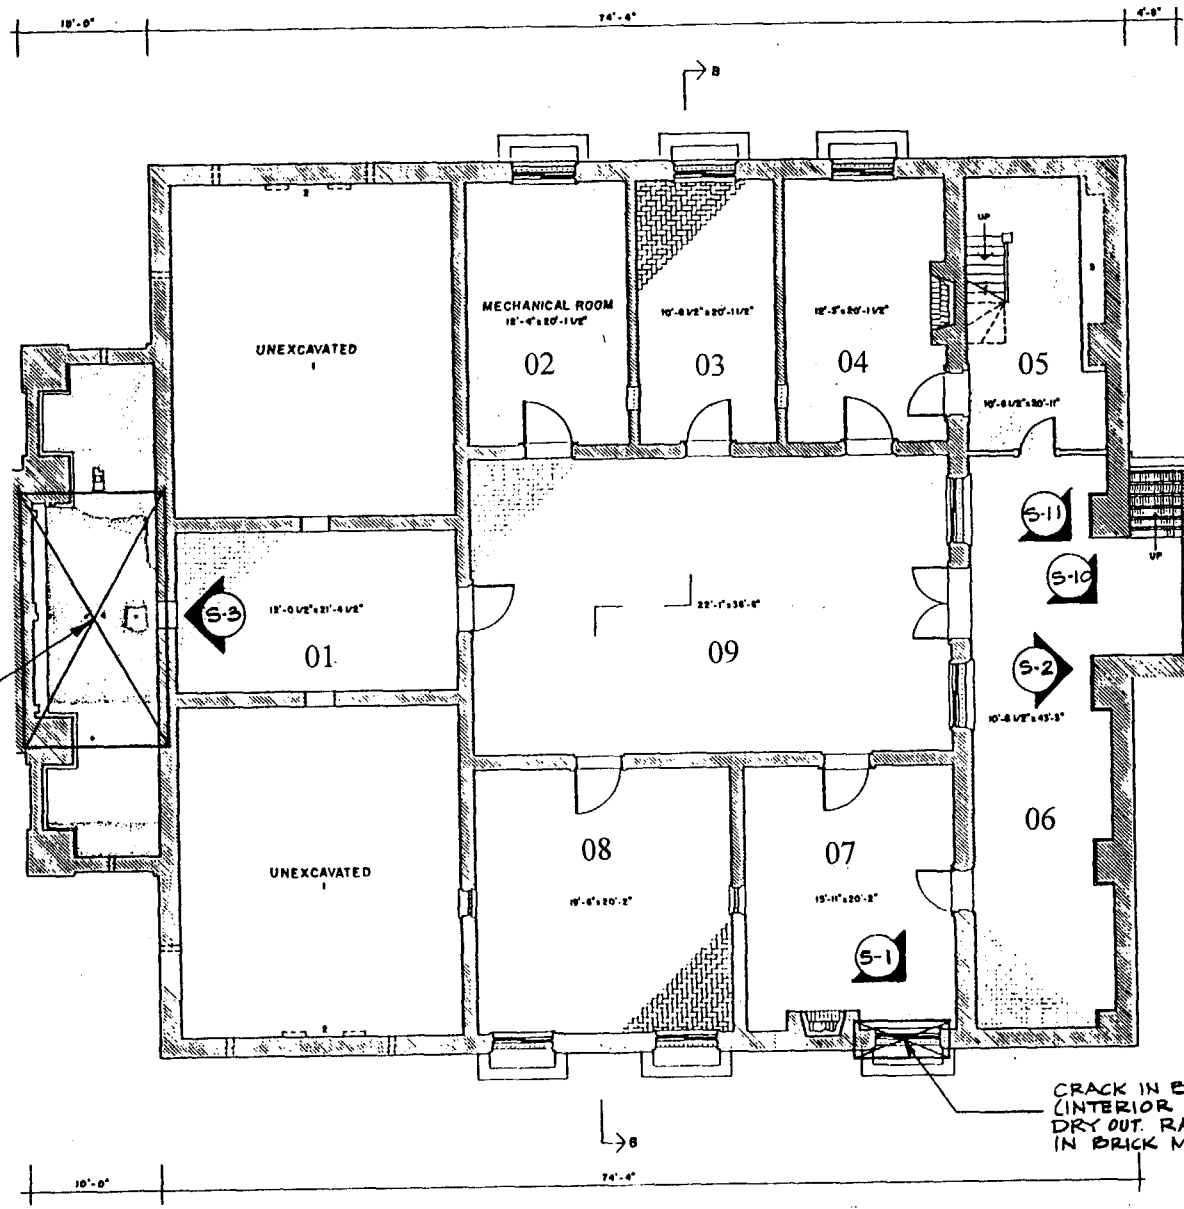
REMOVE THE RUST FROM THE STEEL PIPE COLUMNS UNDERNEATH THE NORTH PORCH. REPAINT THE COLUMNS WITH A RUST INHIBITIVE PAINT, REPAIR OR REPLACE THE BEARING SUPPORT UNDERNEATH THESE COLUMNS. RAKE AND REPOINT ALL ERODED BRICK MORTAR JOINTS.

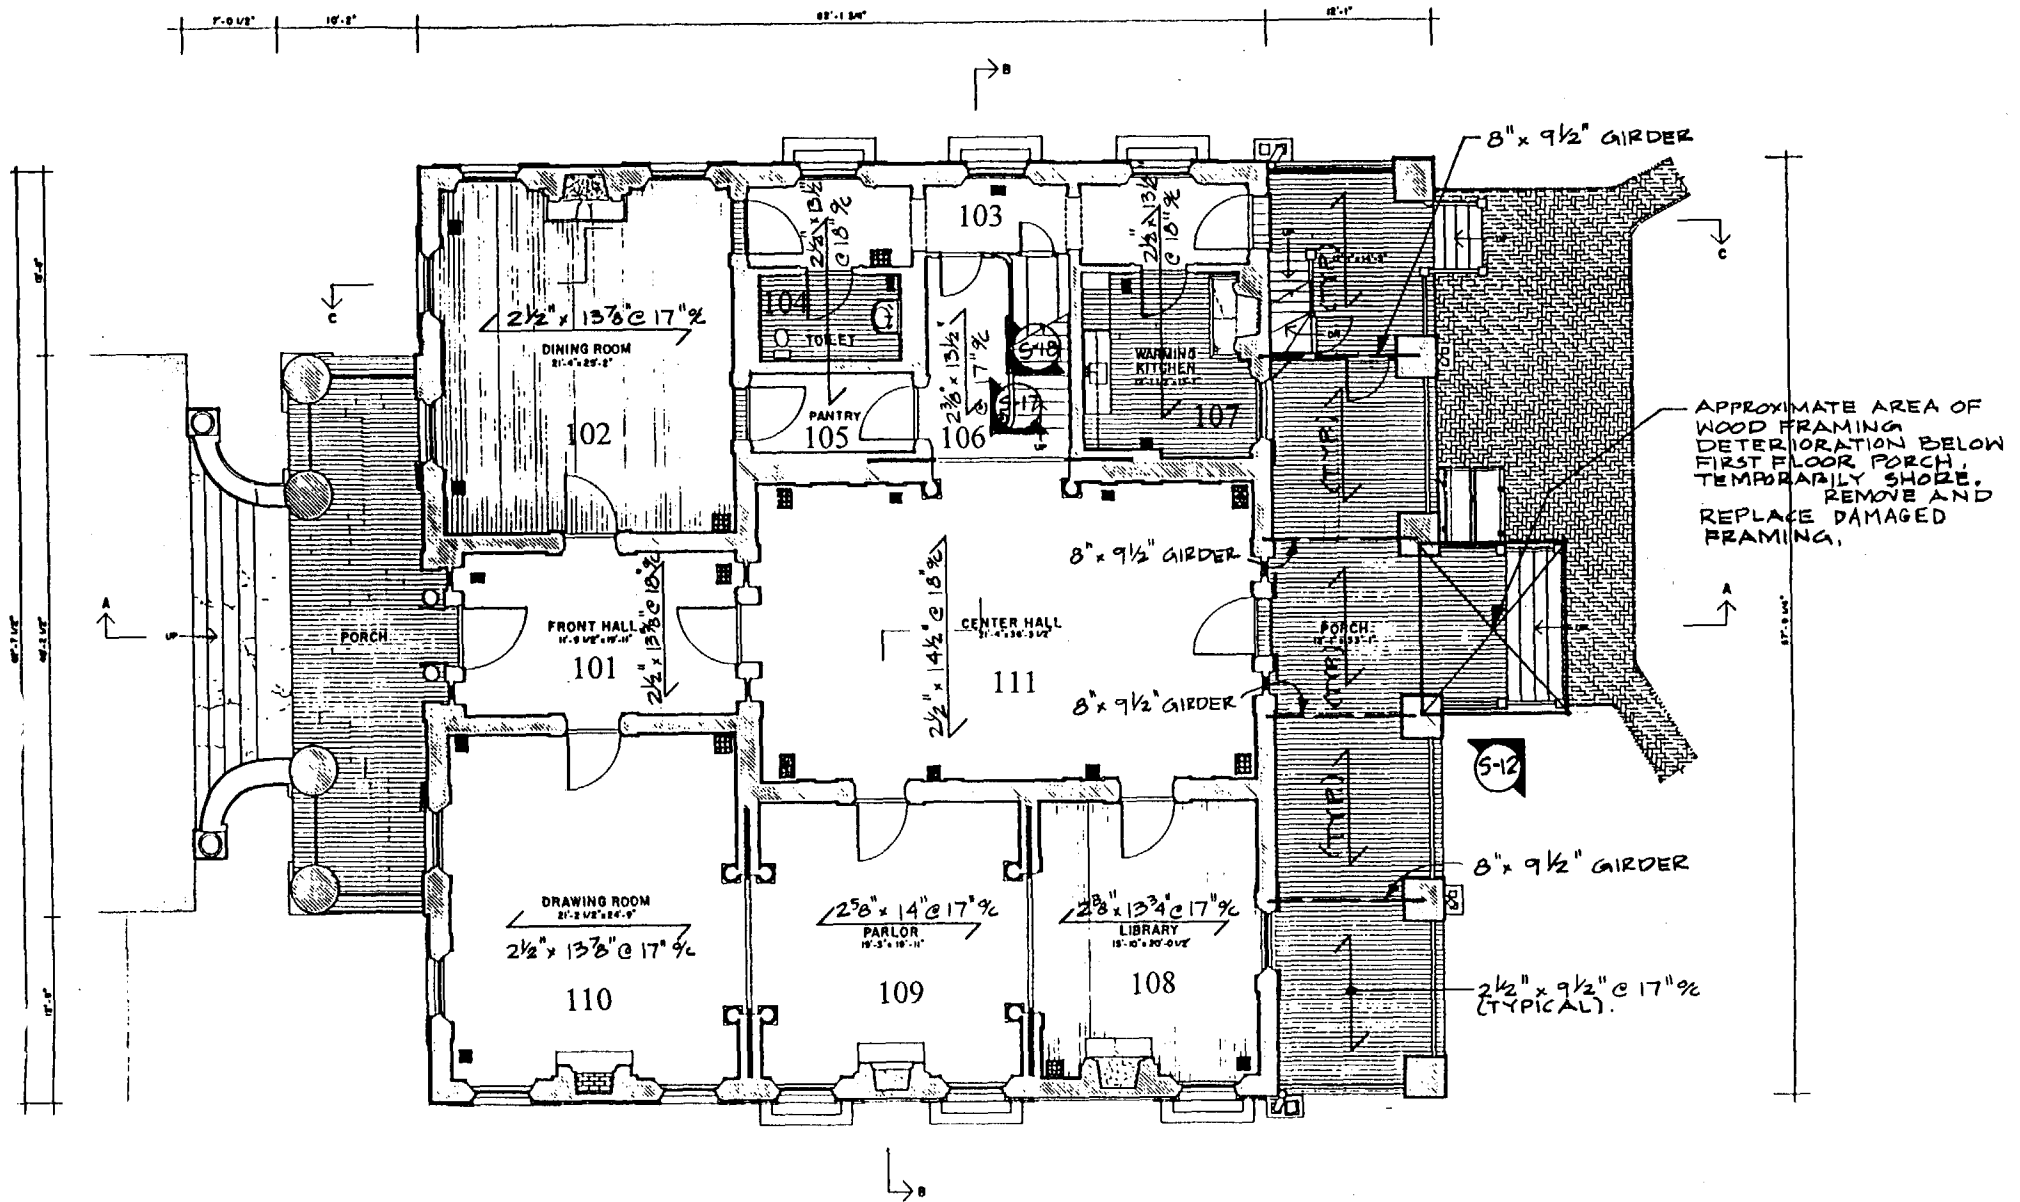
FIRST FLOOR PLAN
Existing Structural Conditions

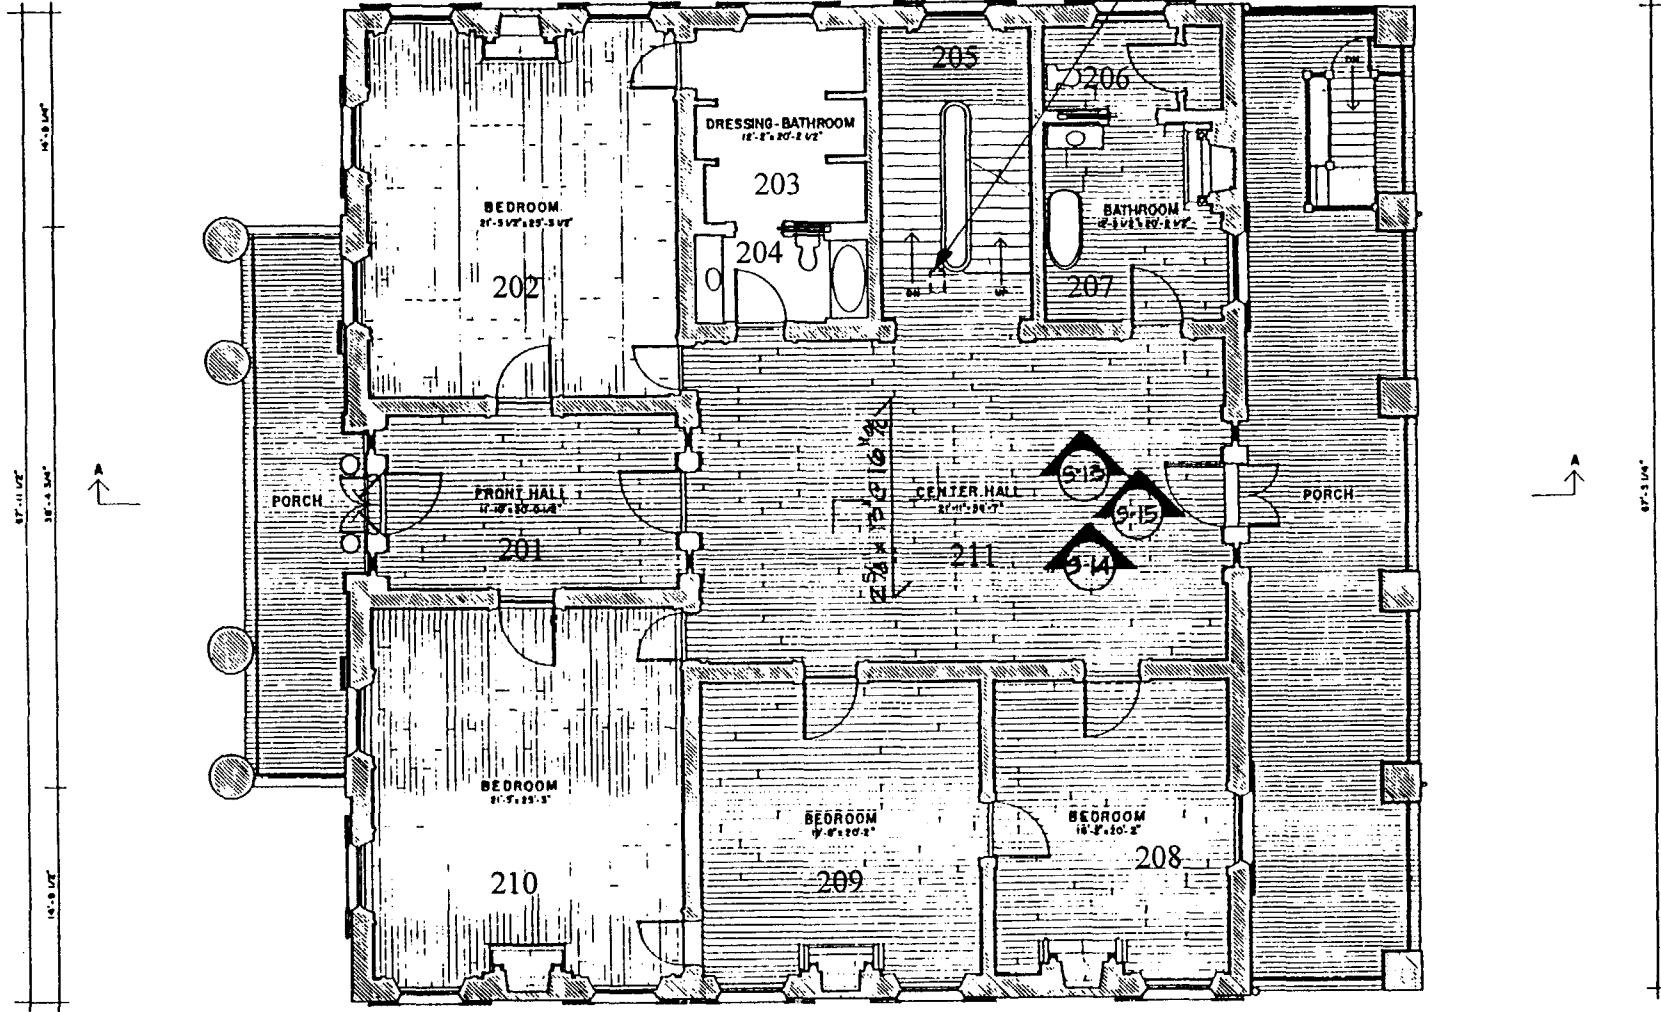
SECOND FLOOR PLAN
Existing Structural Conditions

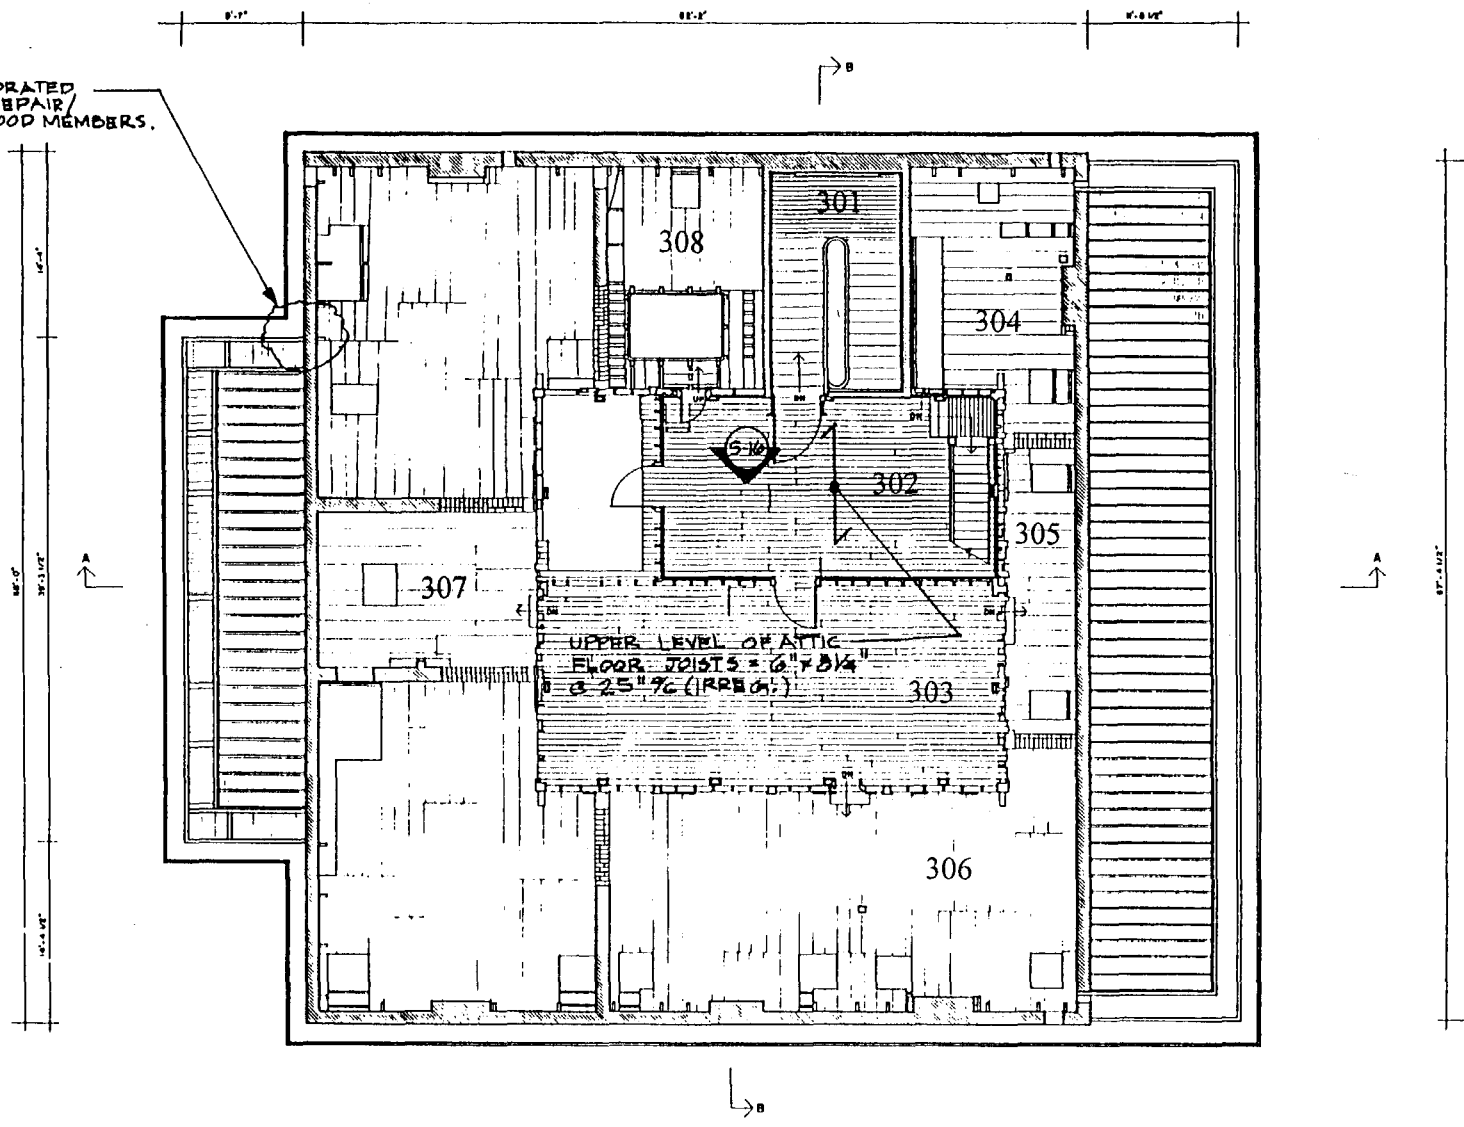
ATTIC FLOOR PLAN
Existing Structural Conditions
