D-11
Vol. 1 of 3
February 1997

**MELROSE ESTATE
NATCHEZ NATIONAL HISTORICAL PARK**

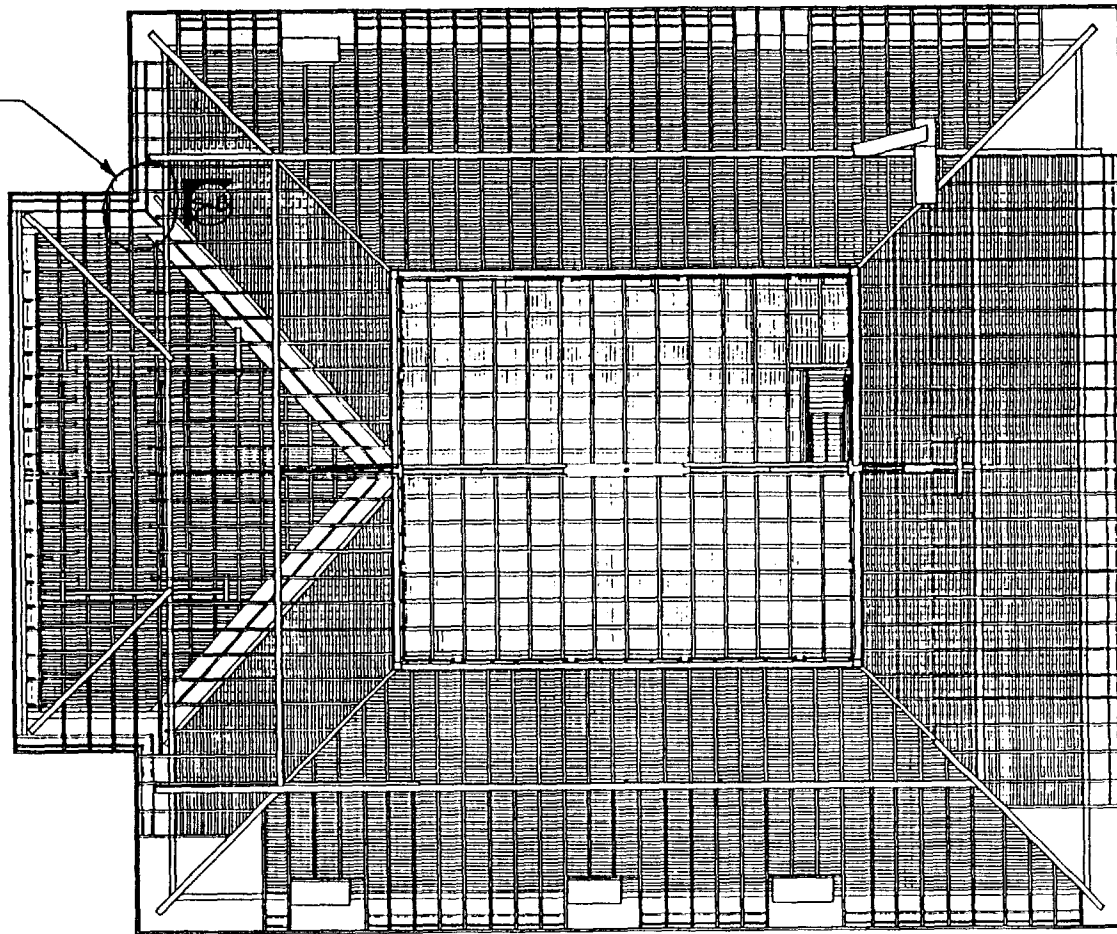
REFLECTED ATTIC CEILING PLAN
Existing Structural Conditions

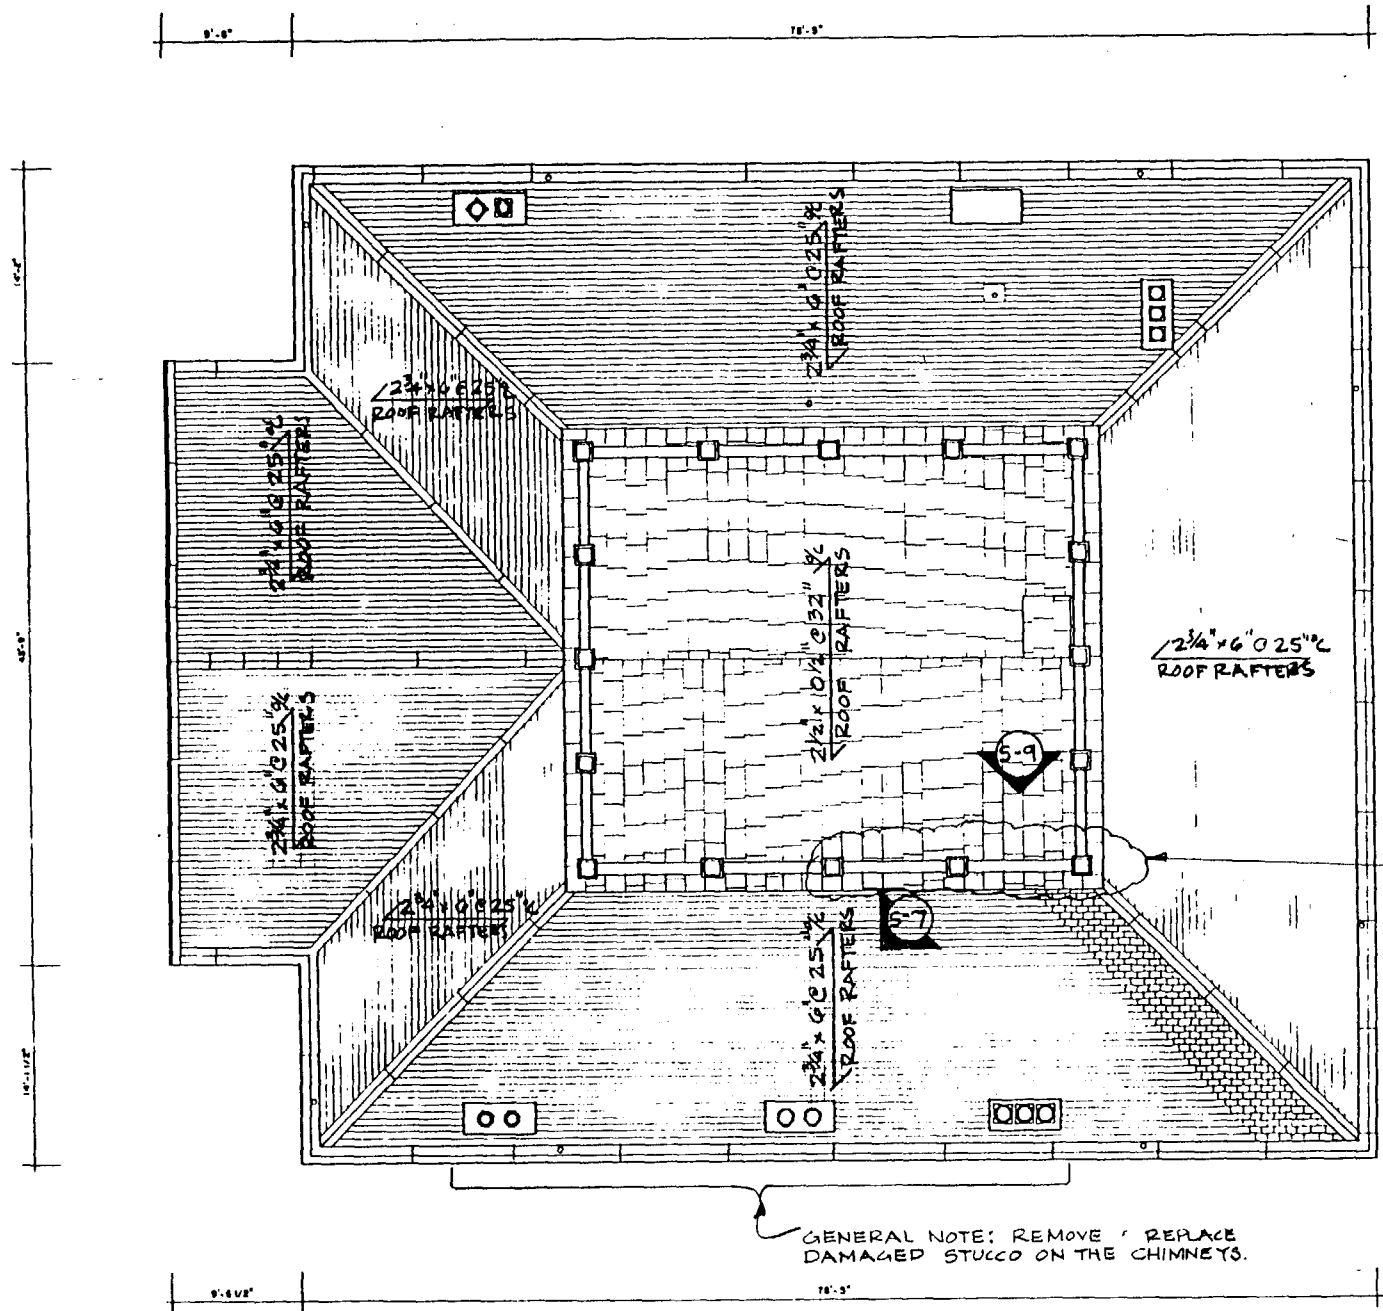
REMOVE AND REPLACE THE ROTTED WOOD BALUSTER AND SILLS THAT ARE ON THE PERIMETER OF THE FLAT ROOF.

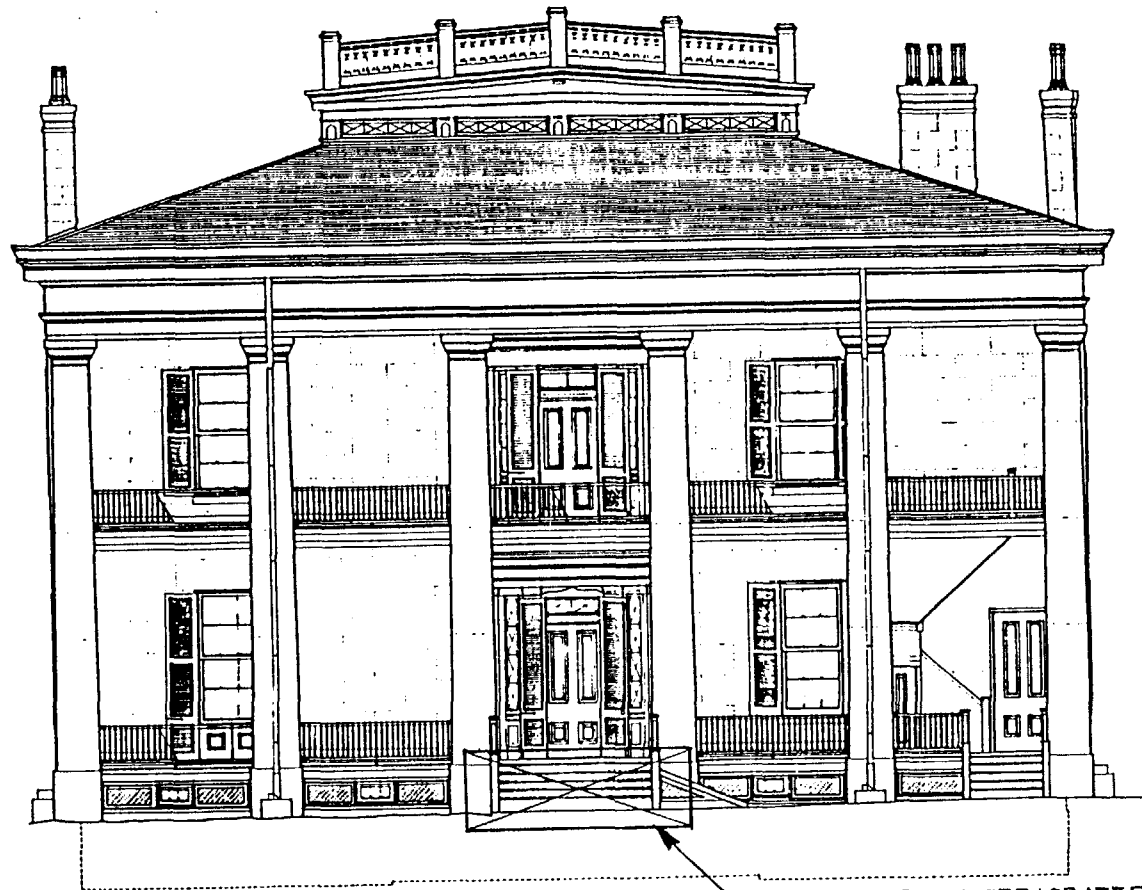
AREA OF DETERIORATED WOOD FRAMING.
 TEMPORARILY SHORE, REMOVE AND
 REPLACE DAMAGED FRAMING.

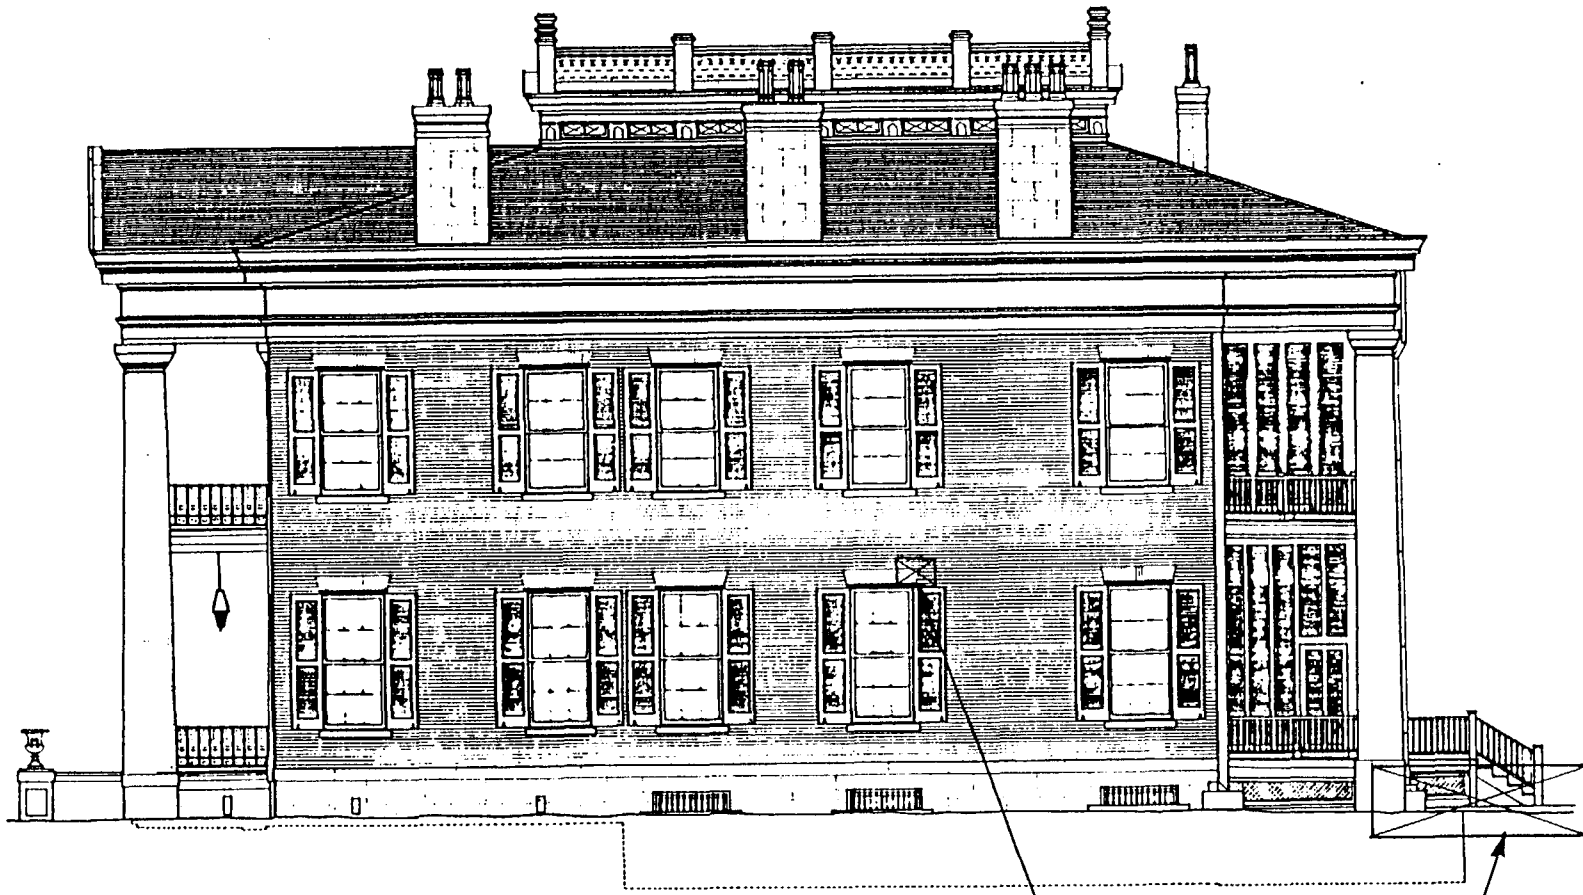
CRACKING IN BRICK NEAR OR IN JACK ARCH. REBUILD AND REPOINT THE BRICKWORK AS REQUIRED.

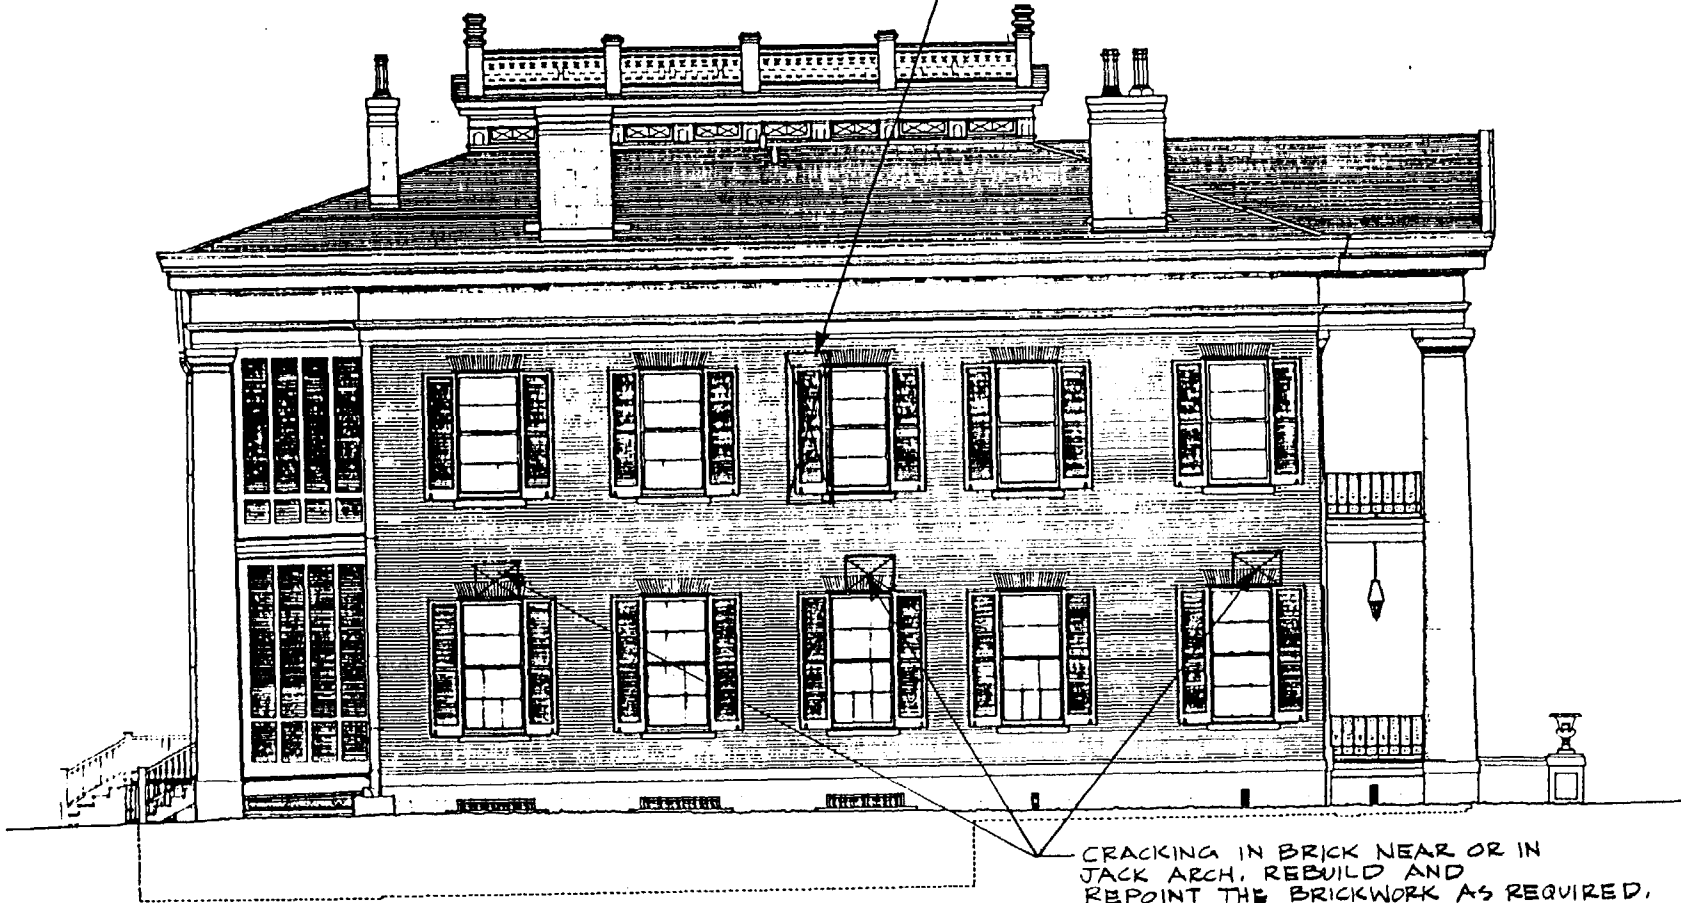
CRACKING IN BRICK NEAR OR IN
JACK ARCH. REBUILD AND
REPOINT THE BRICKWORK AS REQUIRED.

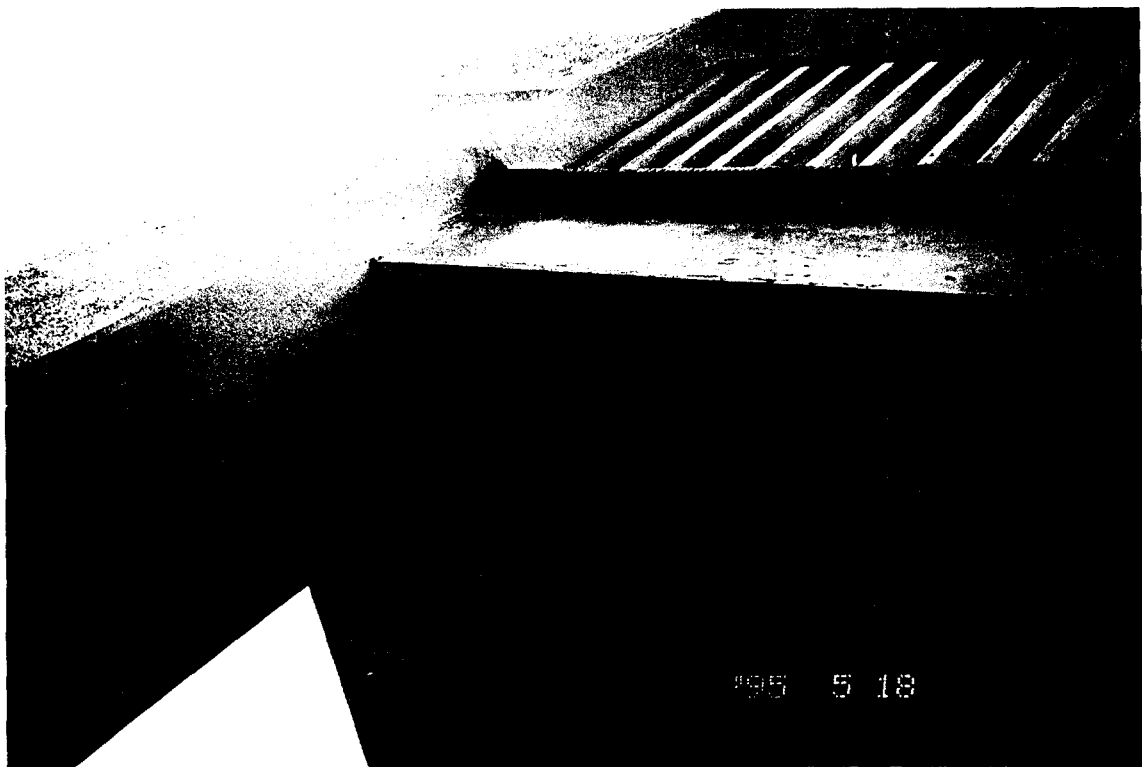
100-S Kitchen - View of deterioration of underside of second-floor porch. (RSA)

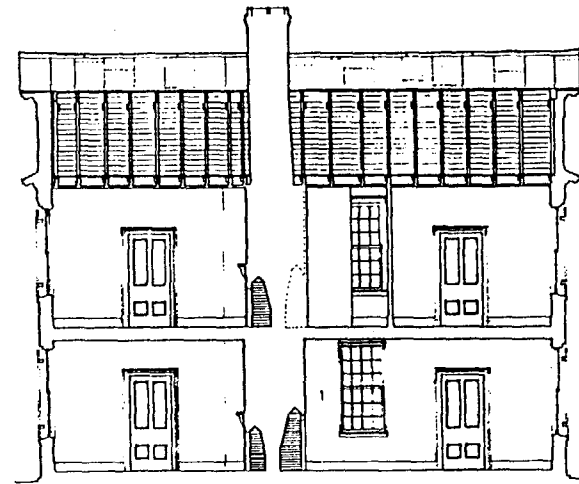
MATERIALS
 FOUNDATION PLASTER
 WALLS BRICK
 ROOFING METAL

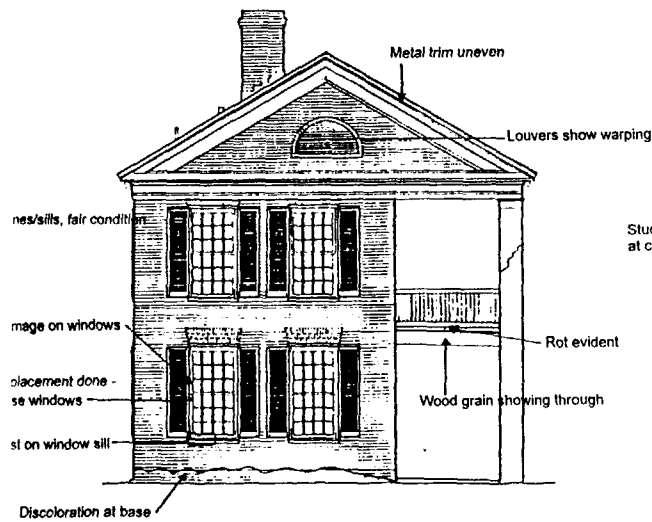
MATERIALS
 FLOORS BRICK AND WOODEN LATHS
 WALLS PLASTER
 CEILING PLASTER

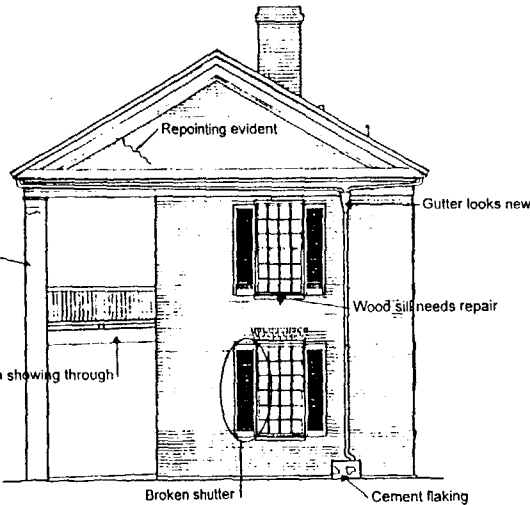
MATERIALS
 FOUNDATION BRICK
 WALLS STUCCO ON BRICK
 COLUMNS METAL
 ROOFING

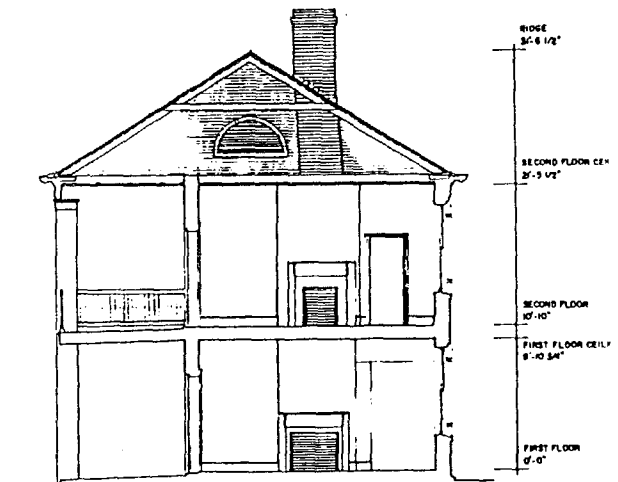
MATERIALS
 FOUNDATION BRICK
 WALLS STUCCO ON BRICK
 COLUMNS METAL
 ROOFING

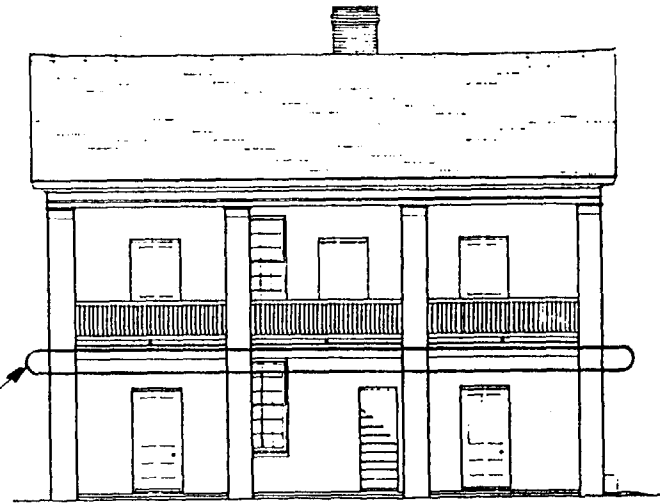
MATERIALS
 FLOORS: RANDOM WIDTH WOODEN BOARDS
 WALLS: PLASTER
 CEILING: PLASTER

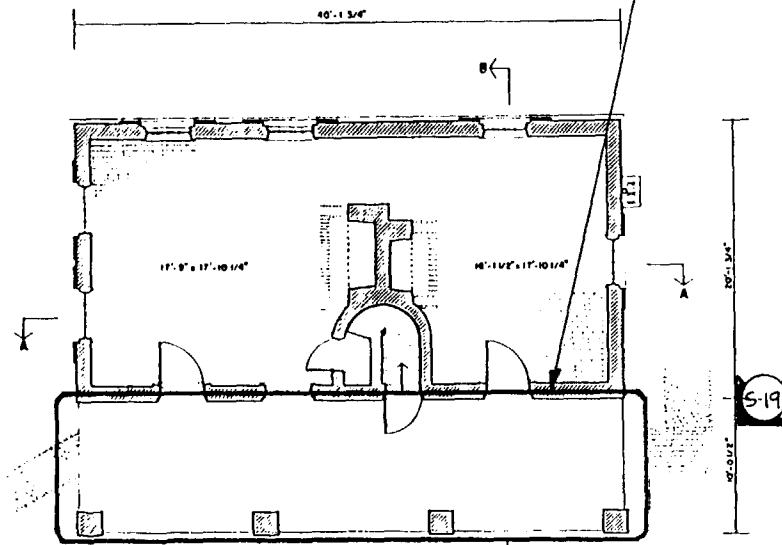
REMOVE AND REPLACE PLASTER
 CEILING OF THIS PORCH (FIRST
 FLOOR CEILING). REPAIR WOOD
 JOISTS & GIRDERS AFTER THE EXTENT
 OF DETERIORATION IS REVEALED,

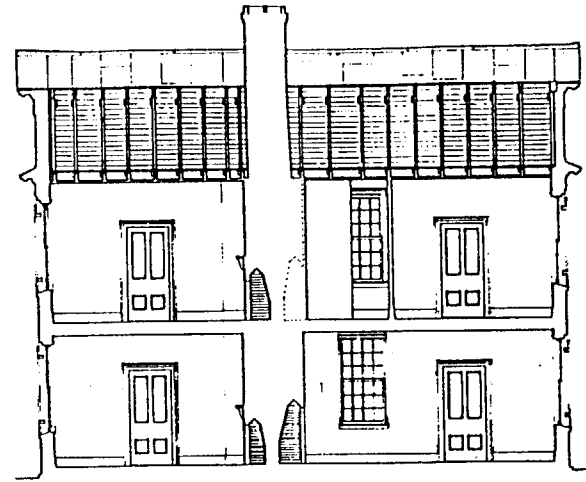
MATERIALS
 FOUNDATION BRICK
 WALLS METAL
 ROOFING

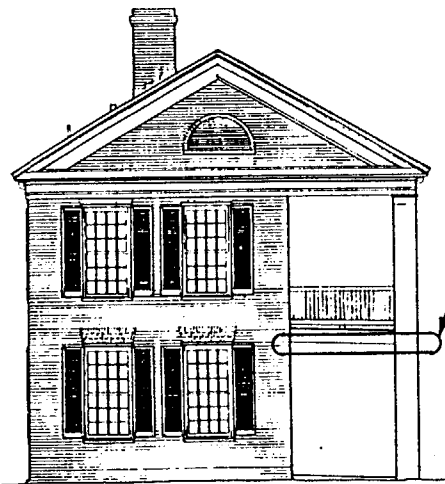
REMOVE AND REPLACE PLASTER CEILING OF THIS PORCH (FIRST FLOOR CEILING). REPAIR WOOD JOISTS & GIRDERS AFTER THE EXTENT OF DETERIORATION IS REVEALED.

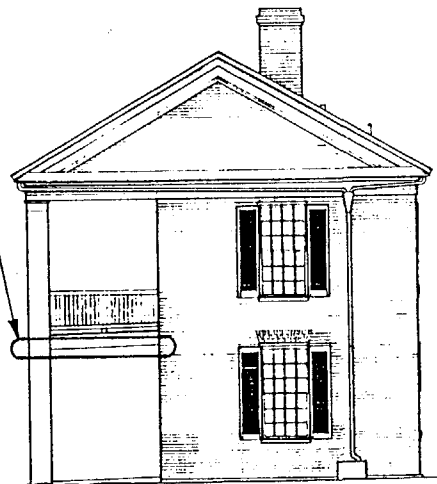
MATERIALS
 FOUNDATION BRICK
 WALLS STUCCO ON BRICK
 COLUMNS METAL
 ROOFING

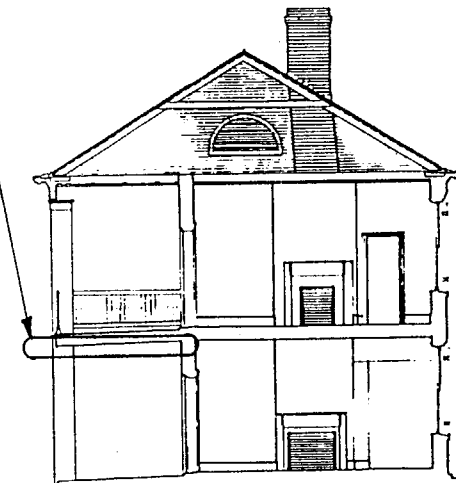
MATERIALS
 FOUNDATION BRICK
 WALLS STUCCO ON BRICK
 COLUMNS METAL
 ROOFING

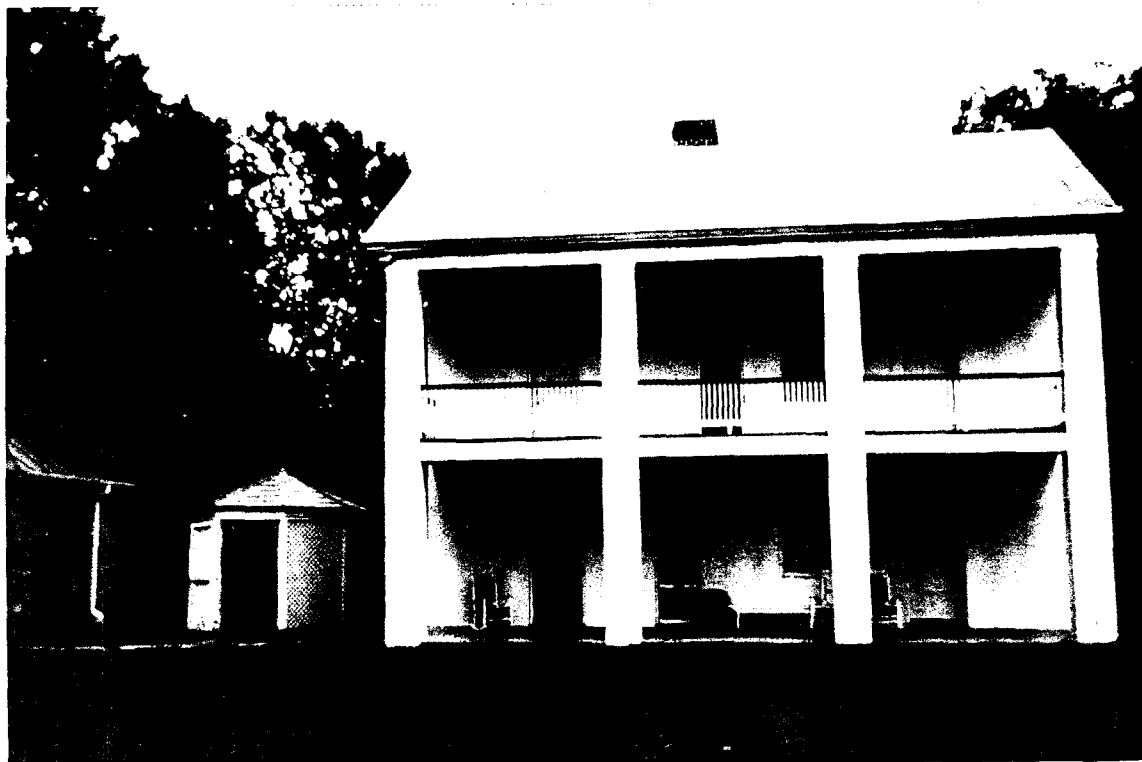
101-A Dairy - North Elevation (ABA)

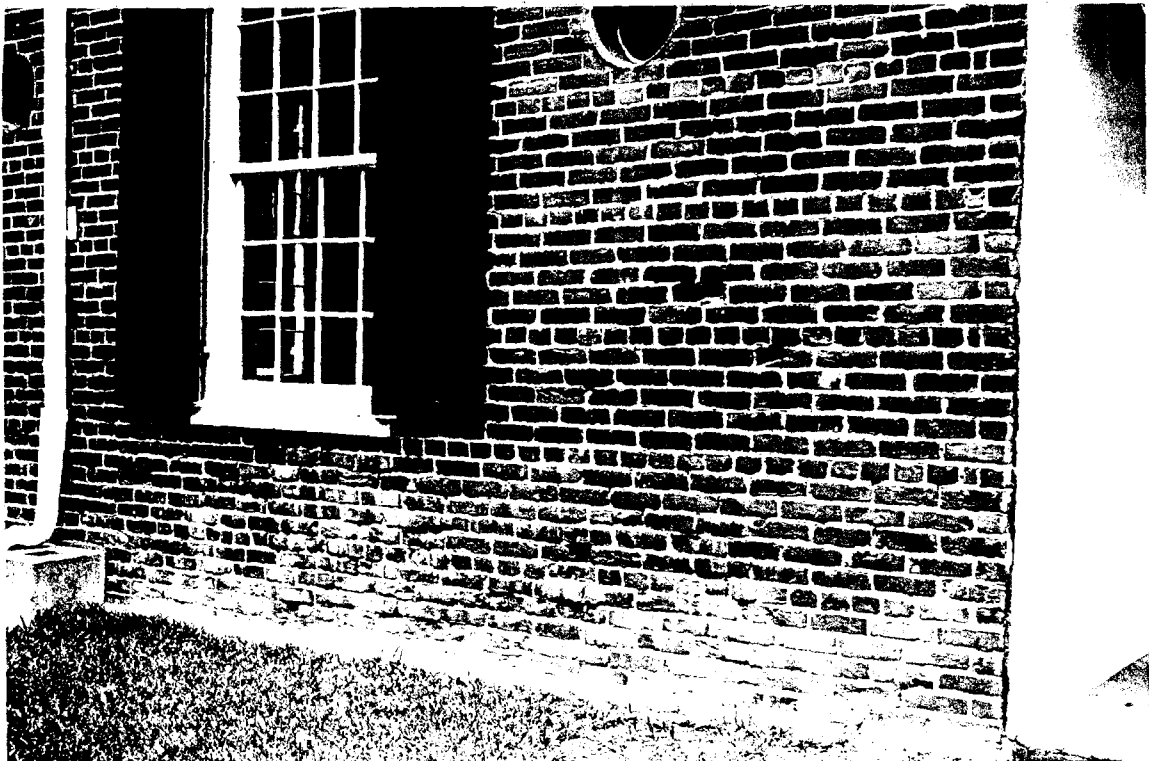
106-A Dairy - Spalling bricks due to removal of parging. (ABA)

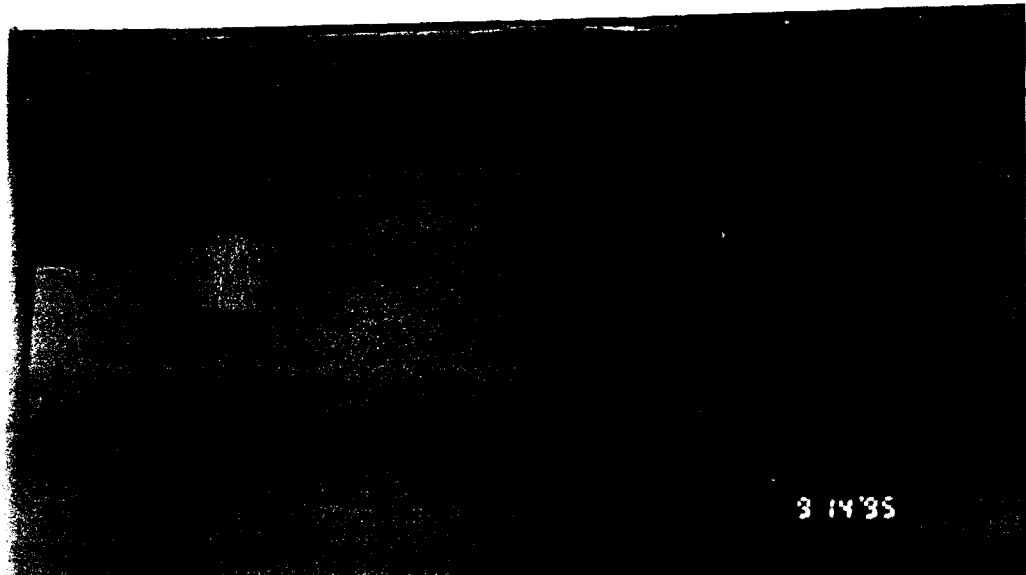
107-S Dairy - View of probe into underside of second-floor porch. (RSA)

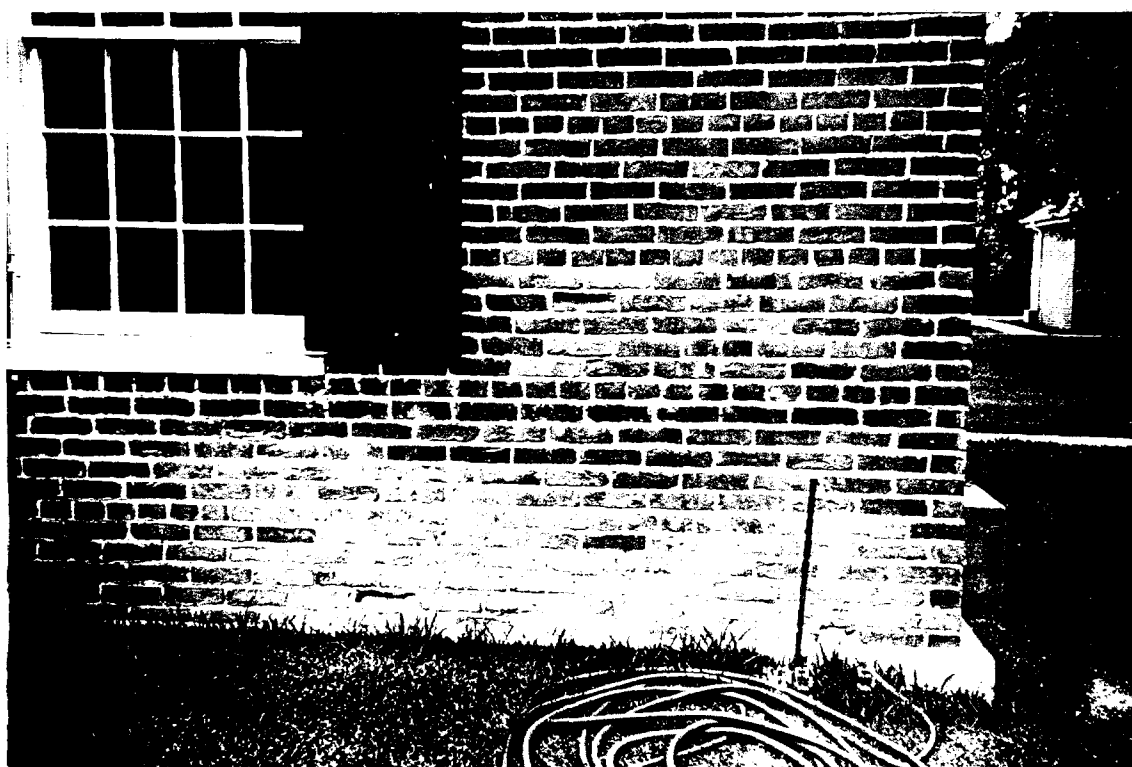
110-S Dairy - View of southwest corner showing rising damp and related damage. (RSA)

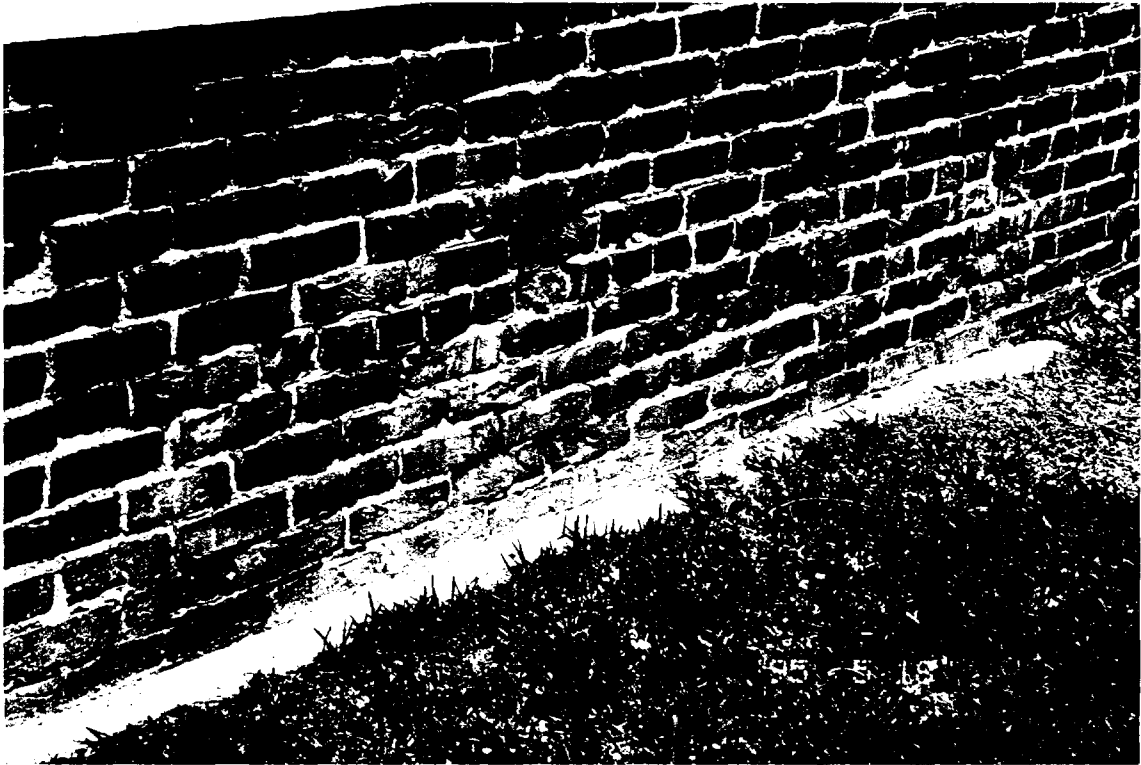
111-S Dairy - Close-up view of 109-S showing rising damp and related damage. (RSA)

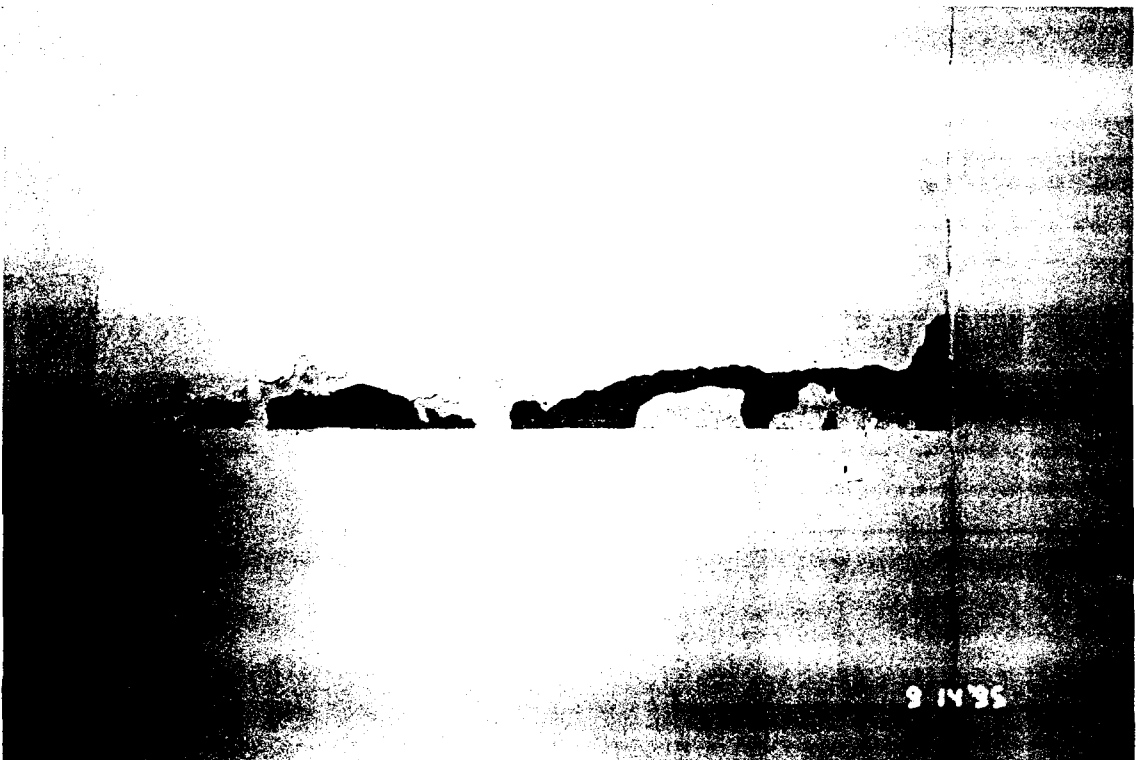
112-S Dairy - Damage to interior plaster. (RSA)

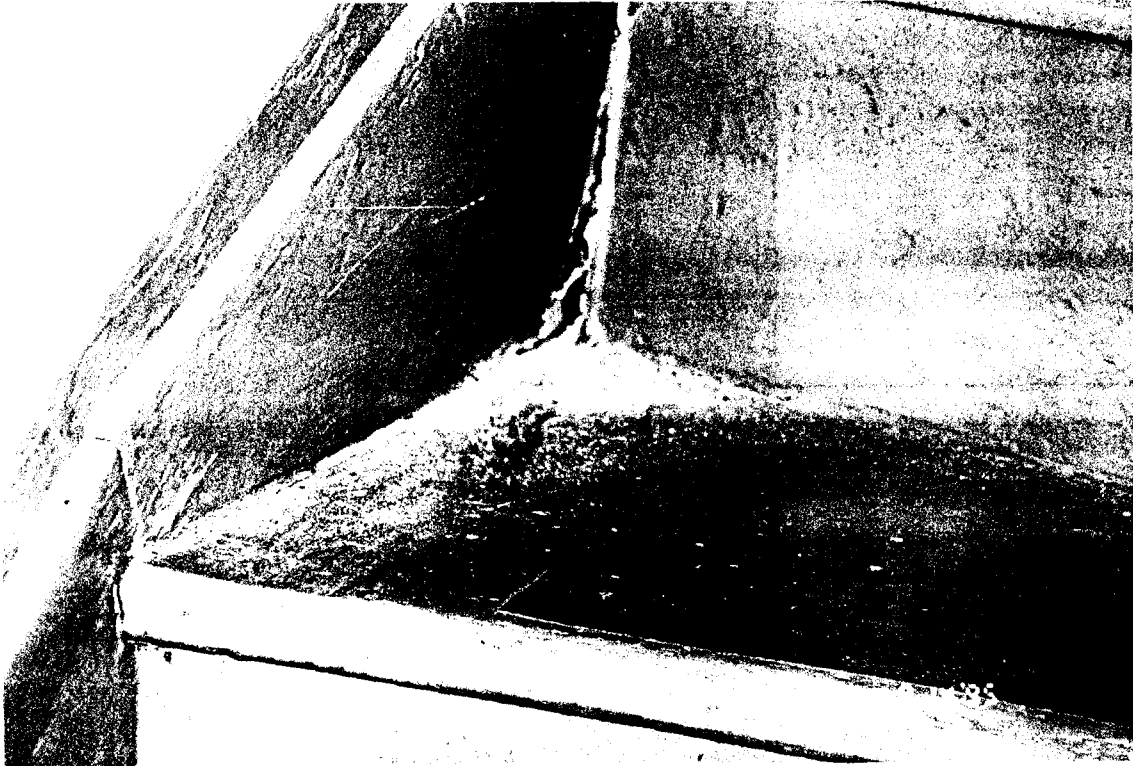
113-S Dairy - Damage to wood stairs. (RSA)

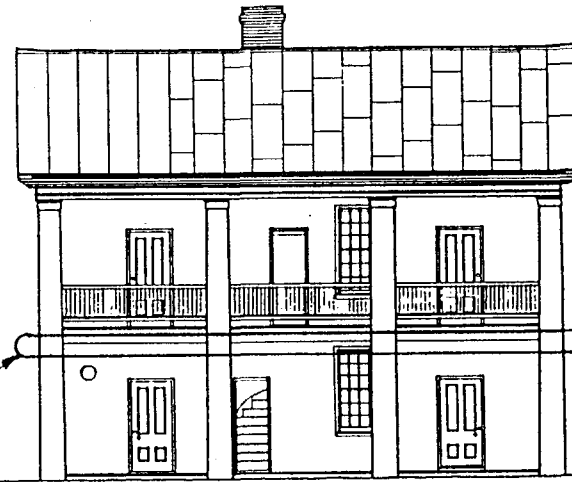
MATERIALS
FLOORS RANDOM WITH WOODEN BOARDS
WALLS PLASTER
CEILING PLASTER

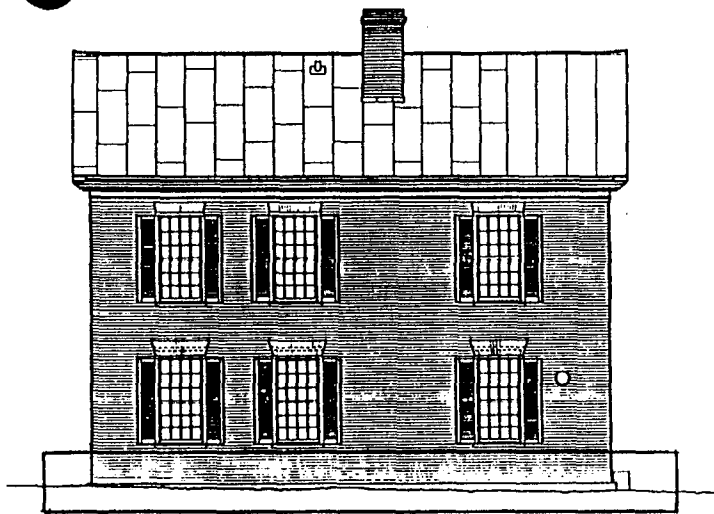
| FIRST FLOOR | 8'-0" |

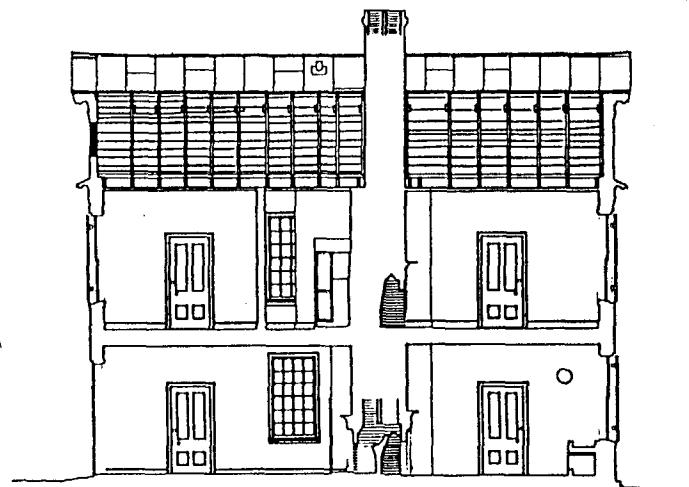
MATERIALS
 FOUNDATION BRICK
 WALLS BRICK
 ROOFING METAL

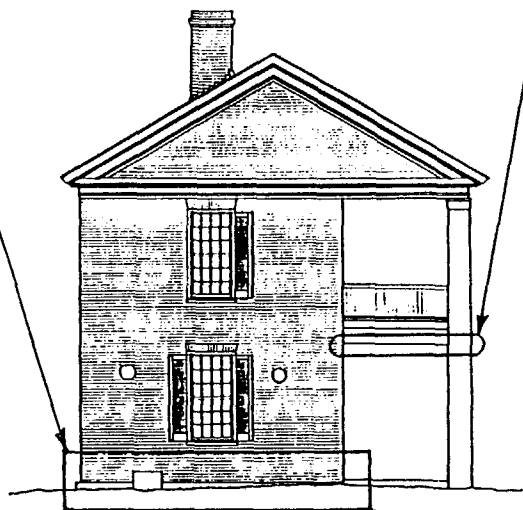
REMOVE AND REPLACE PLASTER CEILING OF THIS PORCH (FIRST FLOOR CEILING). REPAIR WOOD JOISTS & GIRDERS AFTER THE EXTENT OF DETERIORATION IS REVEALED.

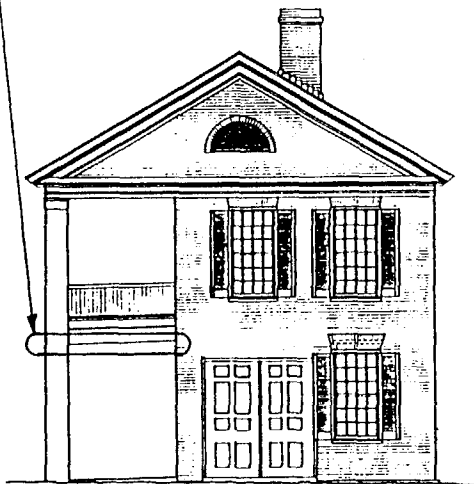
MATERIALS
 FOUNDATION BRICK
 WALLS BRICK
 COLUMNS STUCCO ON BRICK
 ROOFING METAL

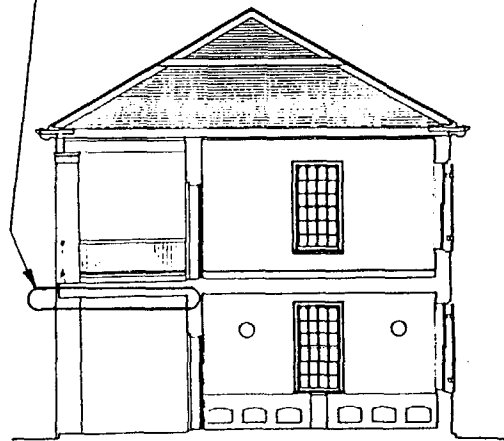
MATERIALS
 FOUNDATION BRICK
 WALLS BRICK
 COLUMNS STUCCO ON BRICK
 ROOFING METAL

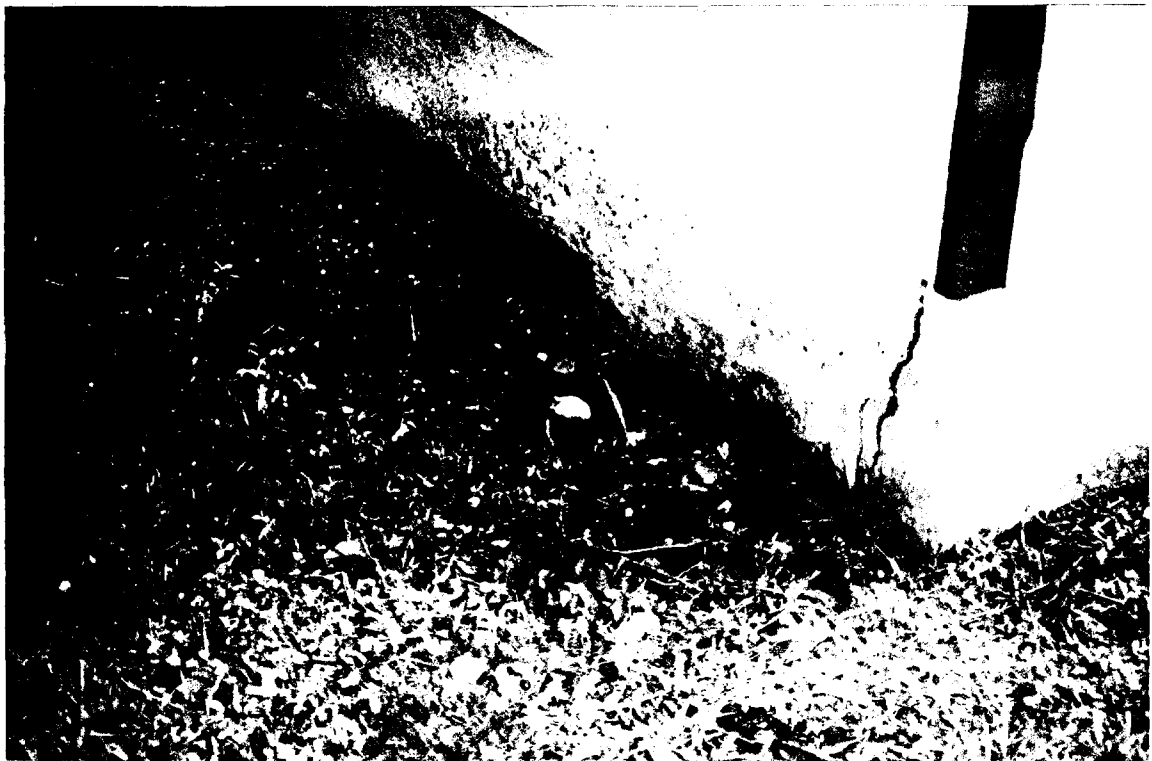
119-A Carriage House - Cracked concrete foundation wall
at northeast corner of shed. (ABA)

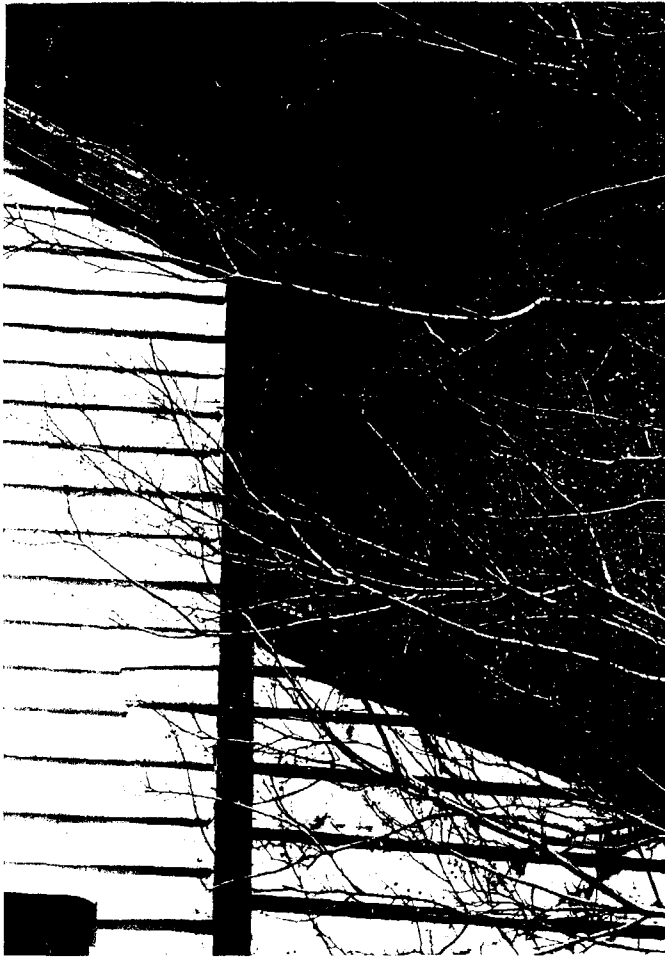
120-A Carriage House - Deteriorated wood rake trim on south side. (ABA)

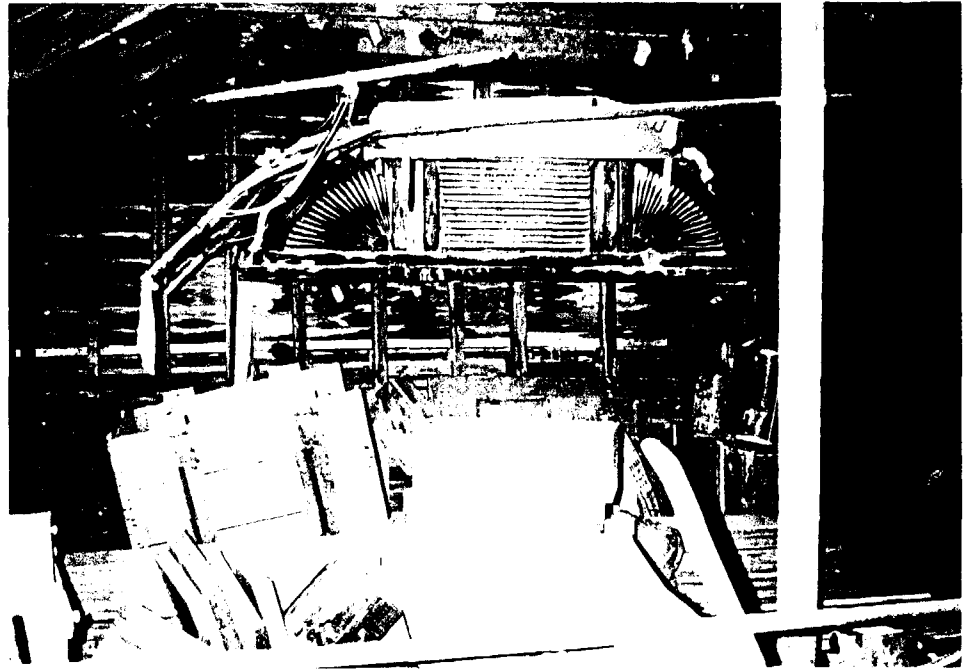
121-A Carriage House - Wood vents, interior view. (ABA)

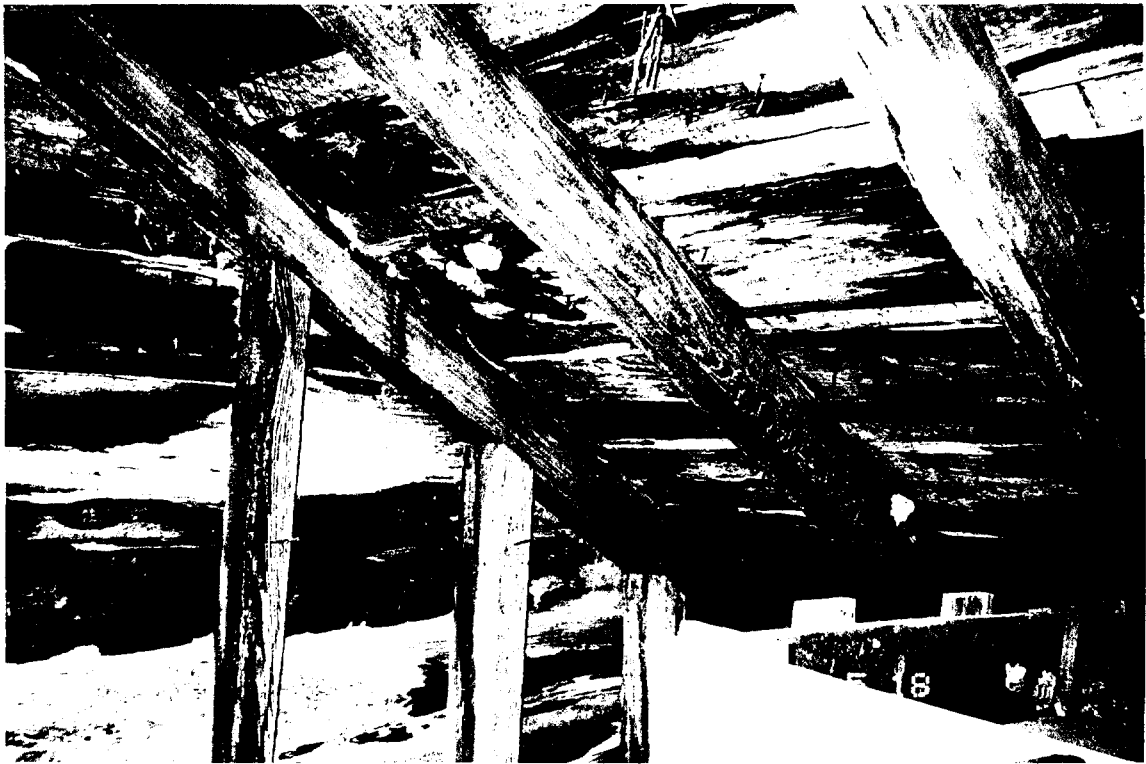
123-S Carriage House - Water infiltration to wood roof framing. (RSA)

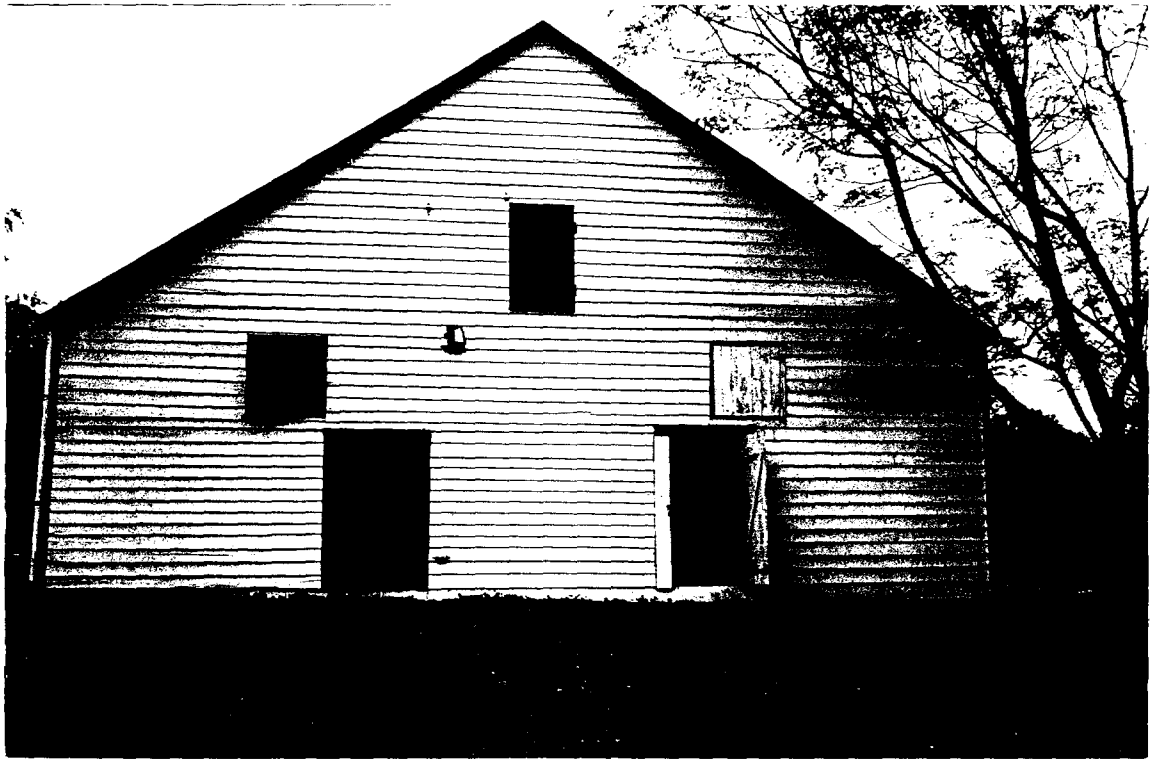
127-A Stable - South Elevation (RRA)
