D-11
Vol. 1 of 3
February 1997

**MELROSE ESTATE
NATCHEZ NATIONAL HISTORICAL PARK**

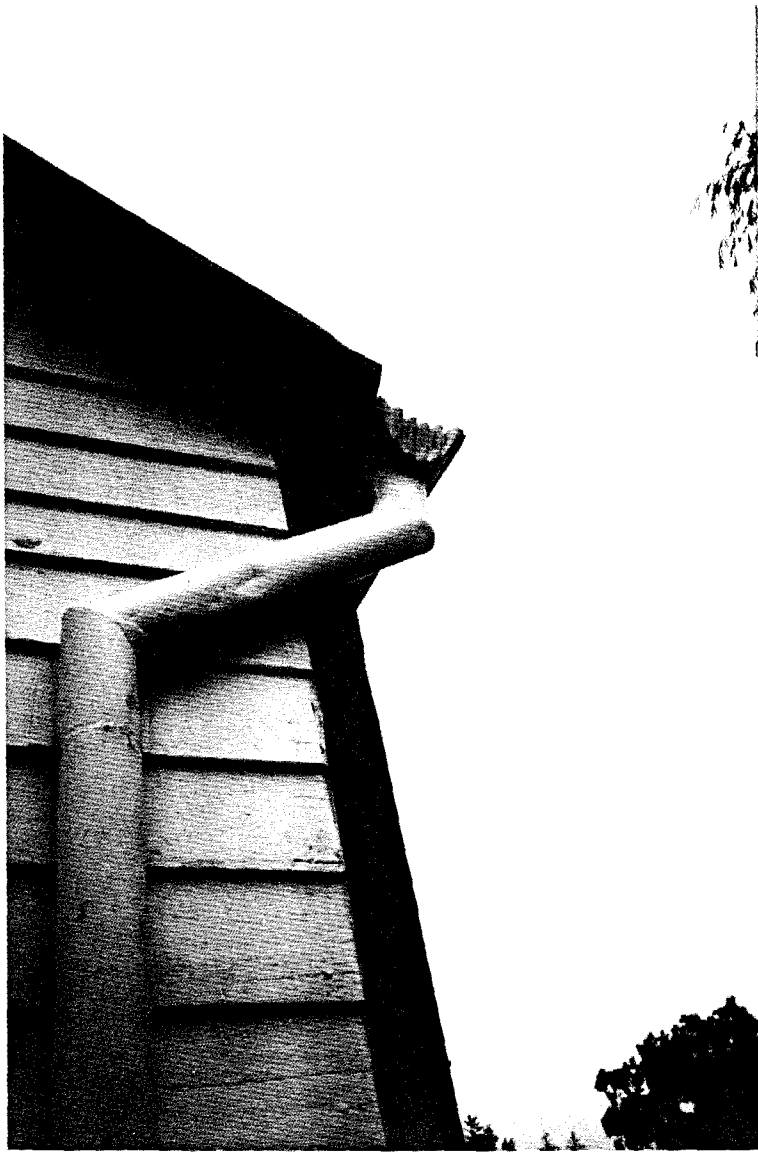
128-A Stable - Metal roofing turned down and nailed into eaves and rakes. (ABA)

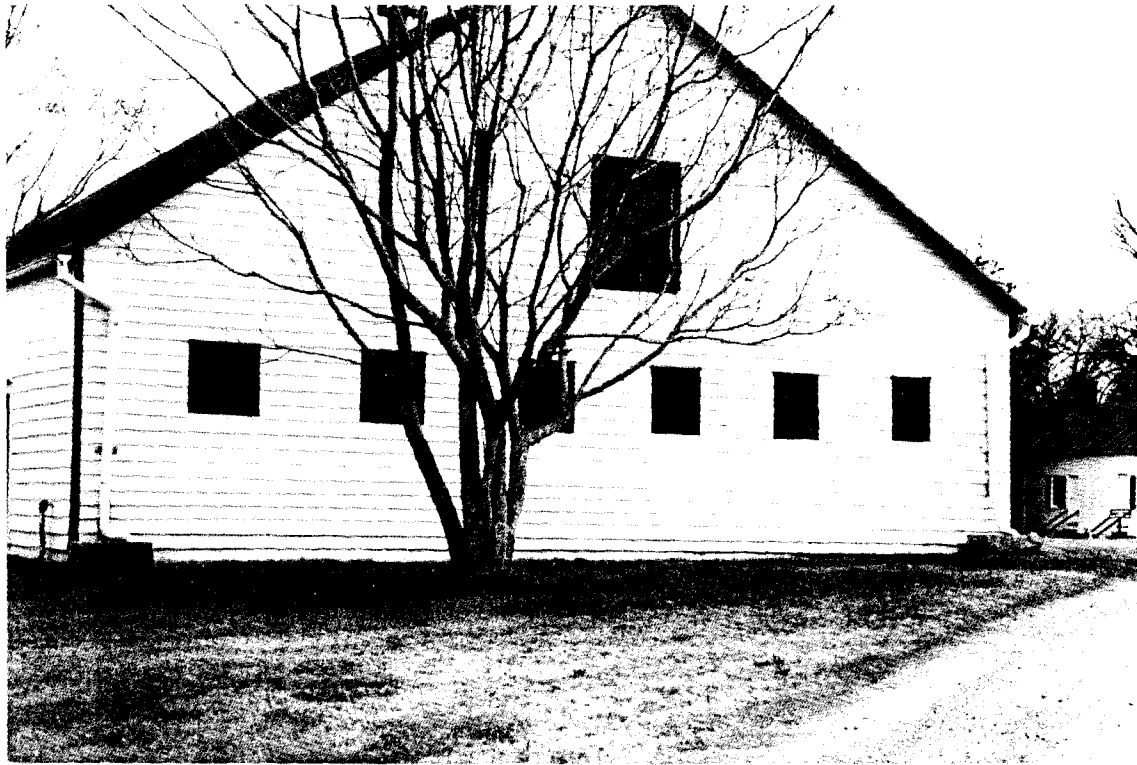
130-A Stable - Loose downspout hangers. (ABA)

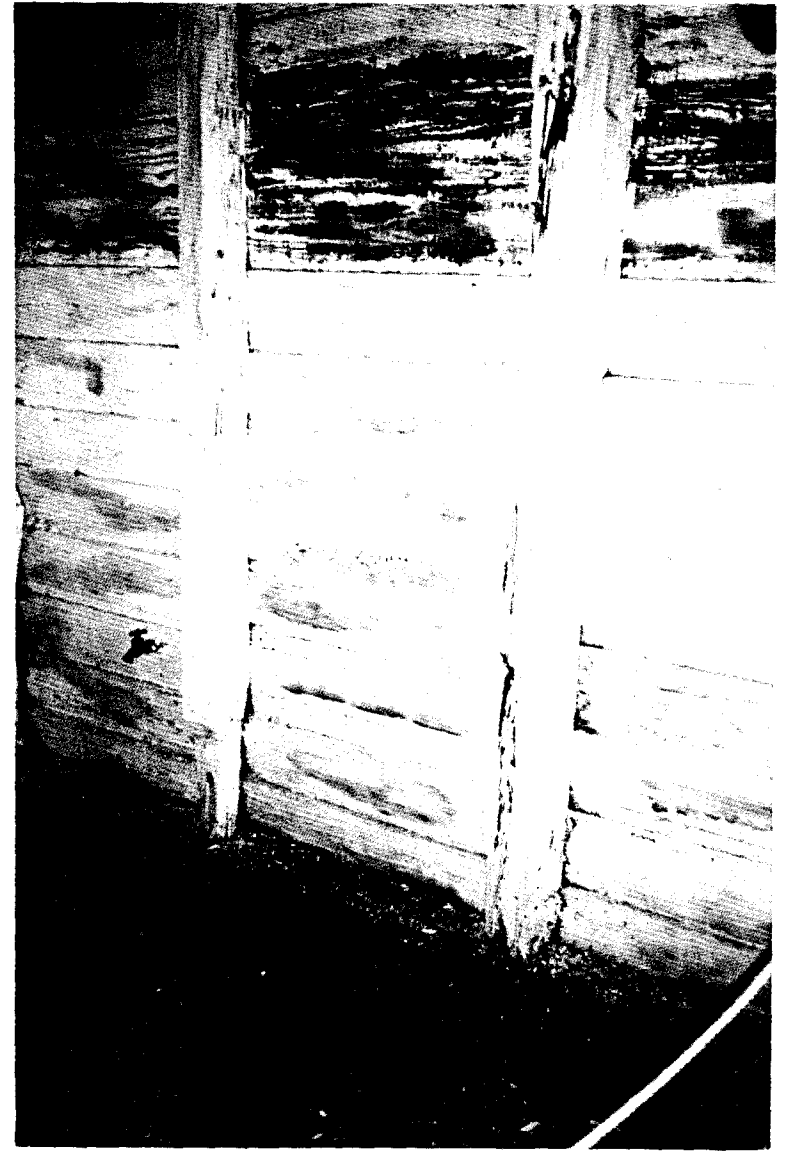
131-A Stable - Rotted and insect damaged columns, interior view. (ABA)

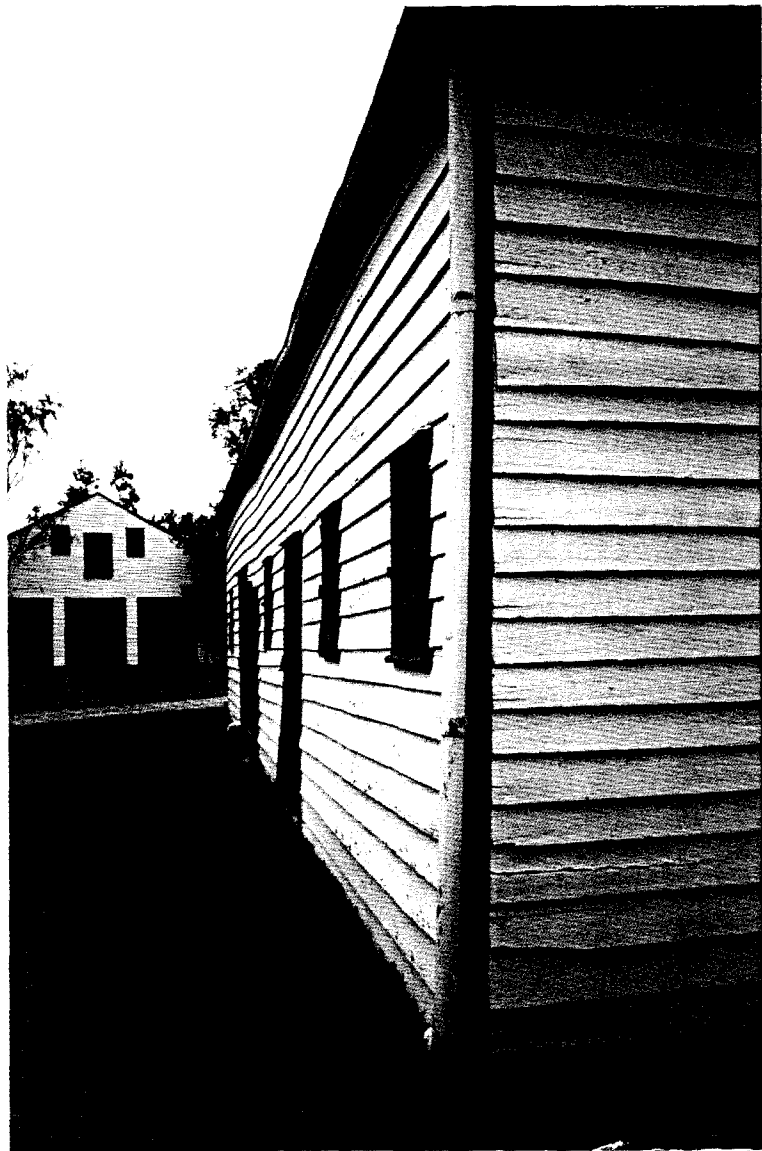
132-A Stable - West wall is not plumb. (ABA)

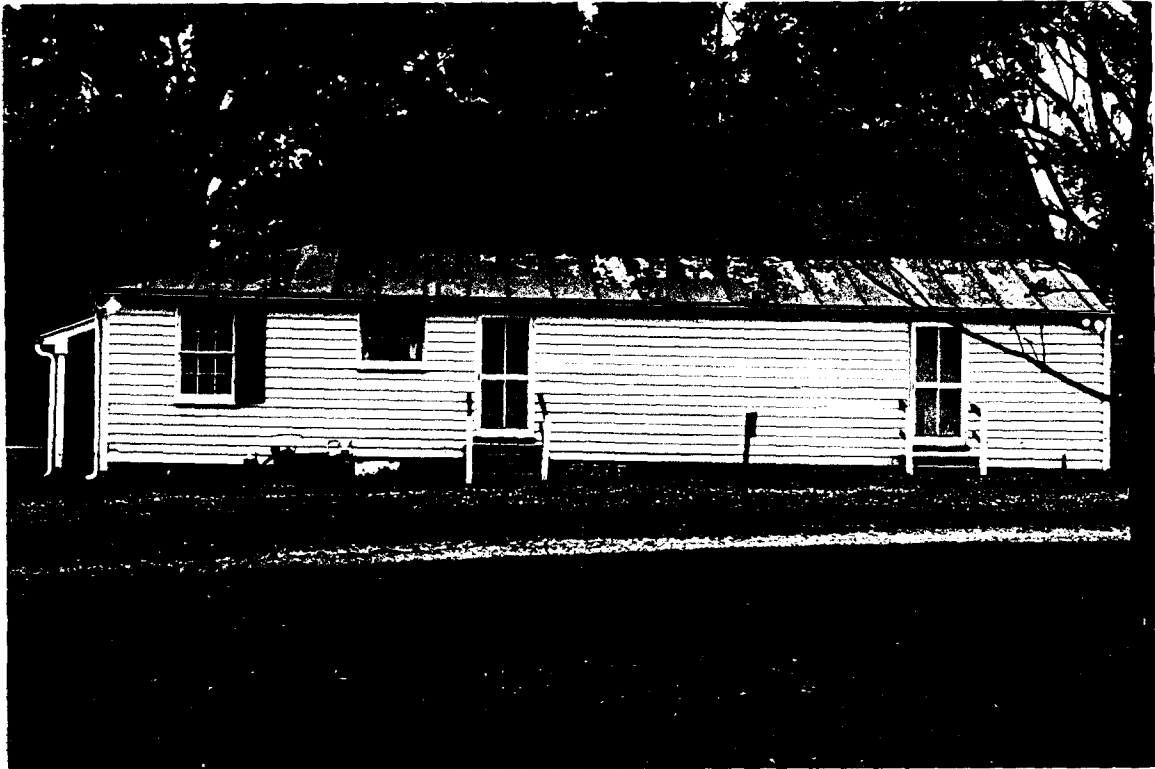
134-A North Slave Cabin - East Elevation (RRA)

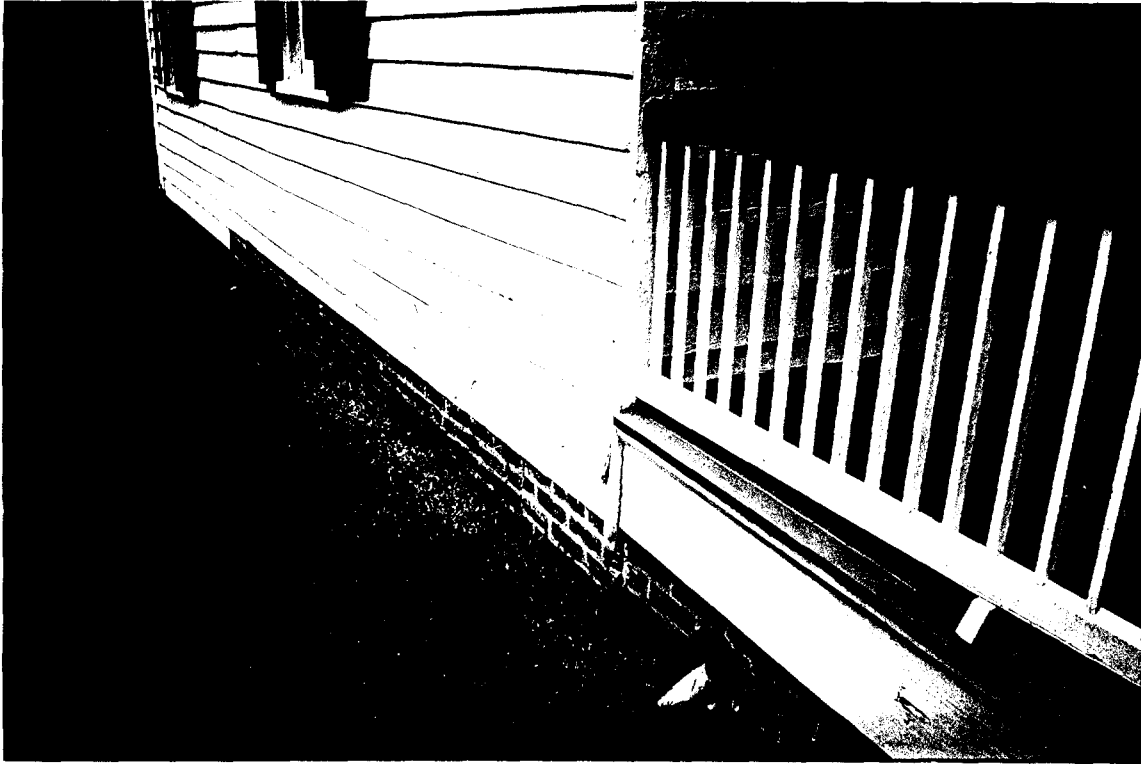
142-A North Slave Cabin - Loose siding at floor line on north wall. (ABA)

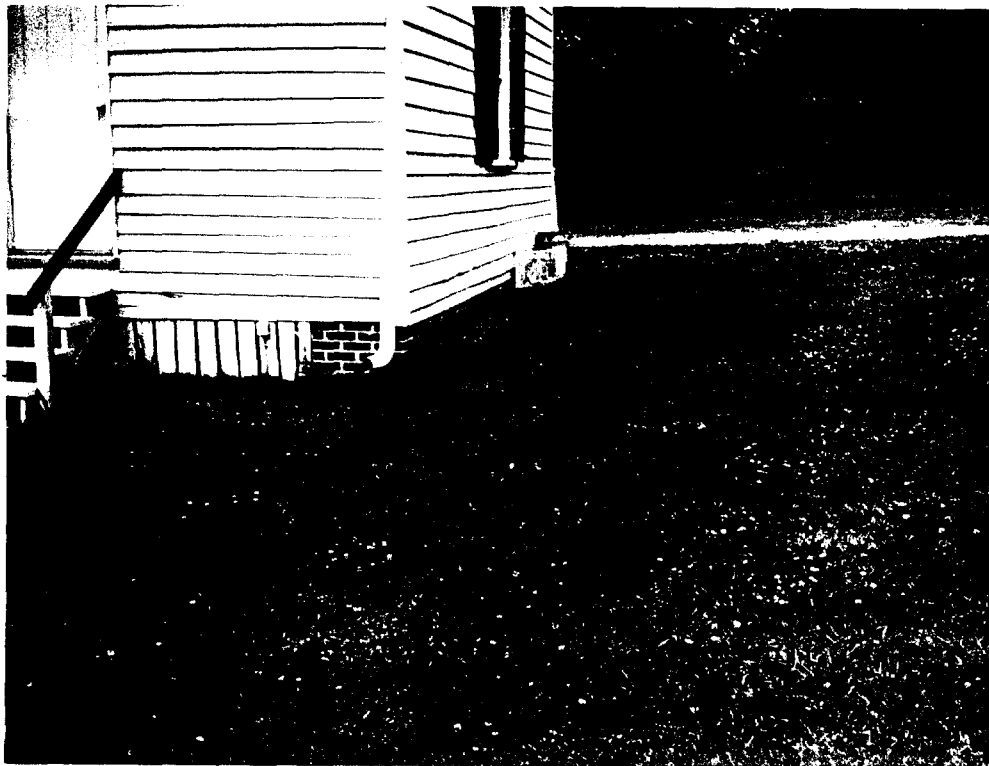
143-A North Slave Cabin - Algae growing on brick on north wall. (ABA)

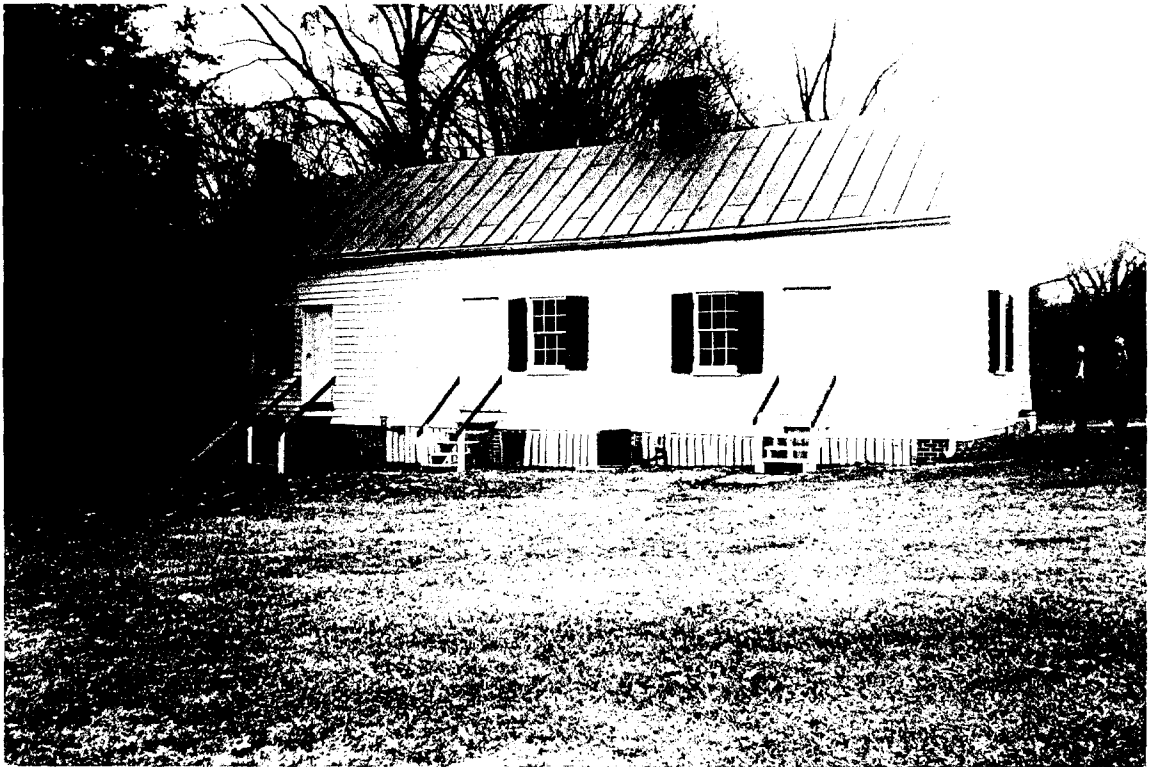
144-A South Slave Cabin - East Elevation (RRA)

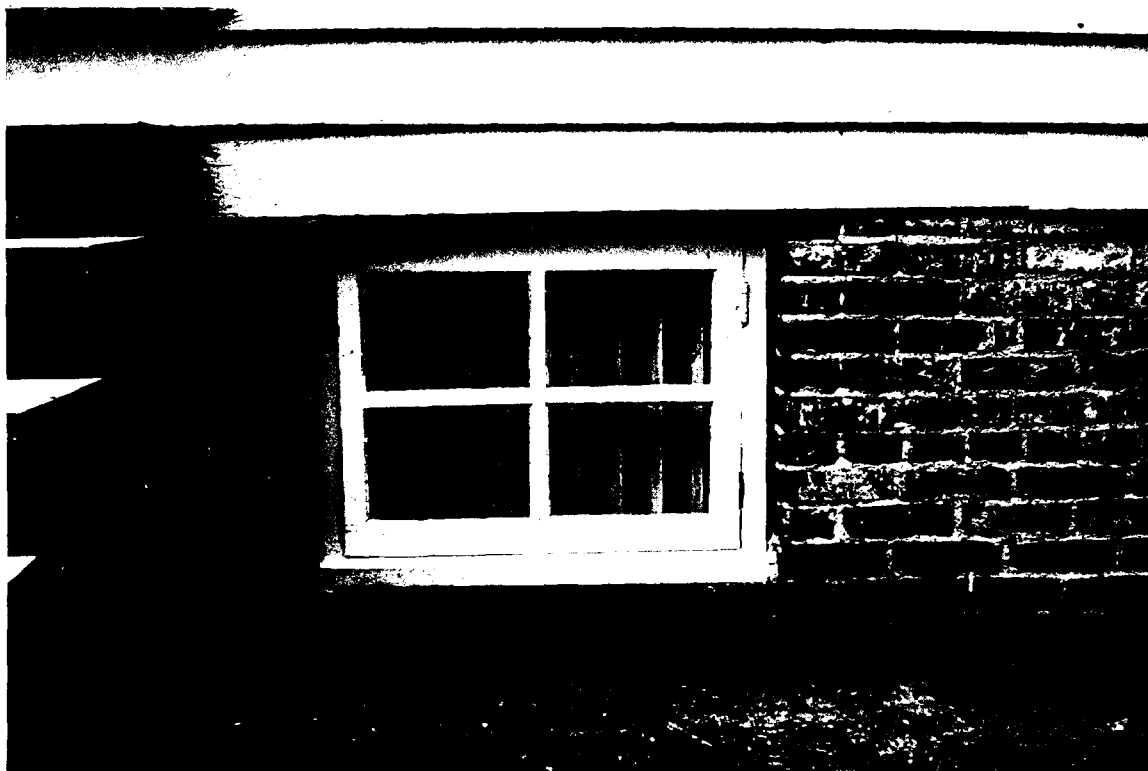
148-A South Slave Cabin - Spalling and efflorescence on cellar brick walls. (ABA)

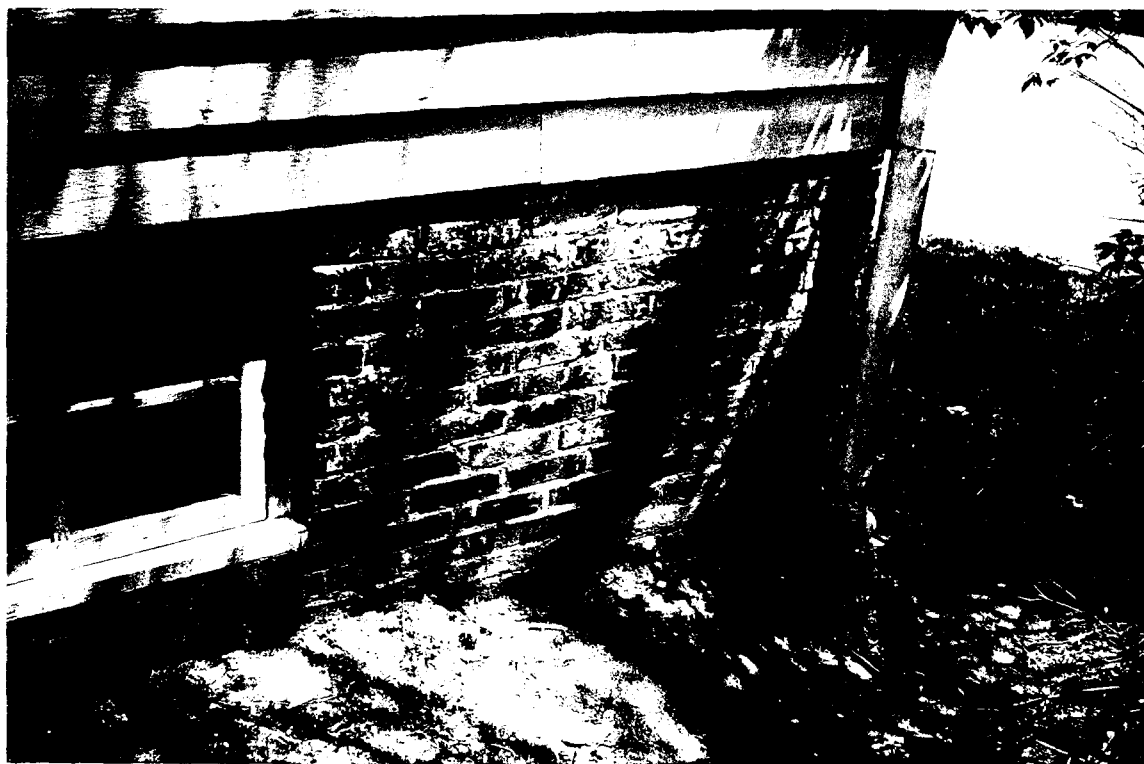
149-A South Slave Cabin - Bowing south brick wall of cellar. (ABA)

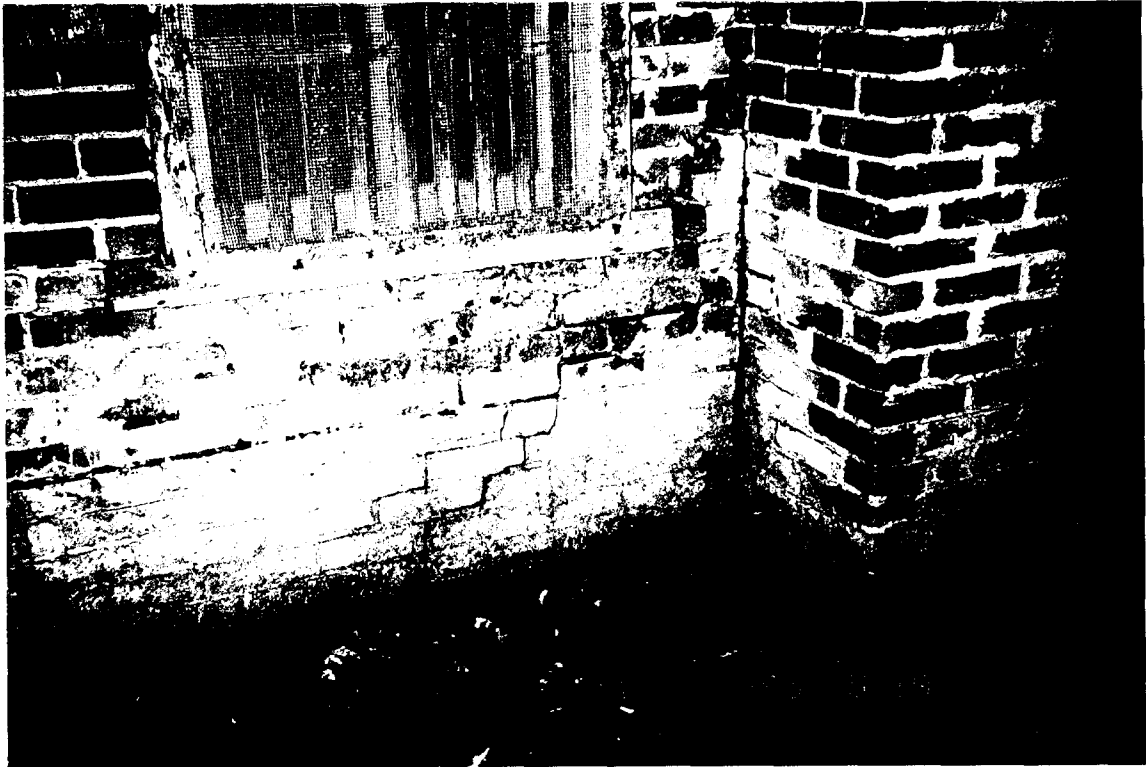
151-S South Slave Cabin - Deteriorated brick on inside of basement walls. (RSA)

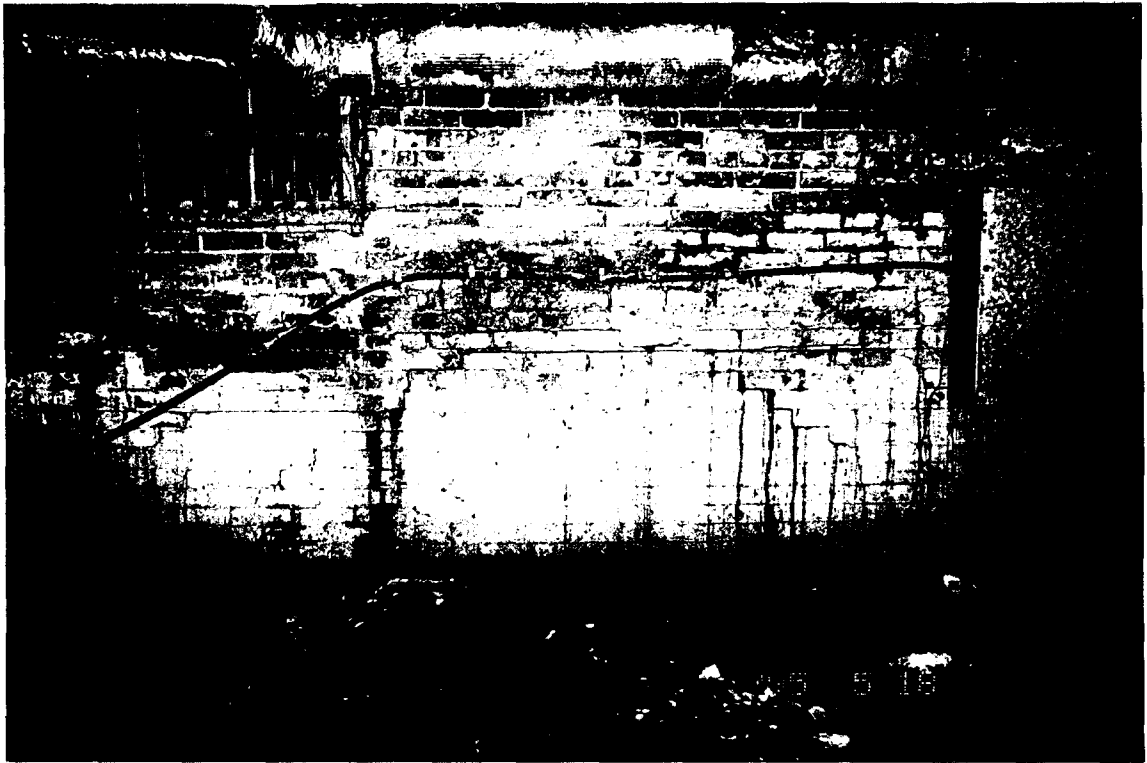
152-S South Slave Cabin - Deteriorated brick on inside of basement walls. (RSA)

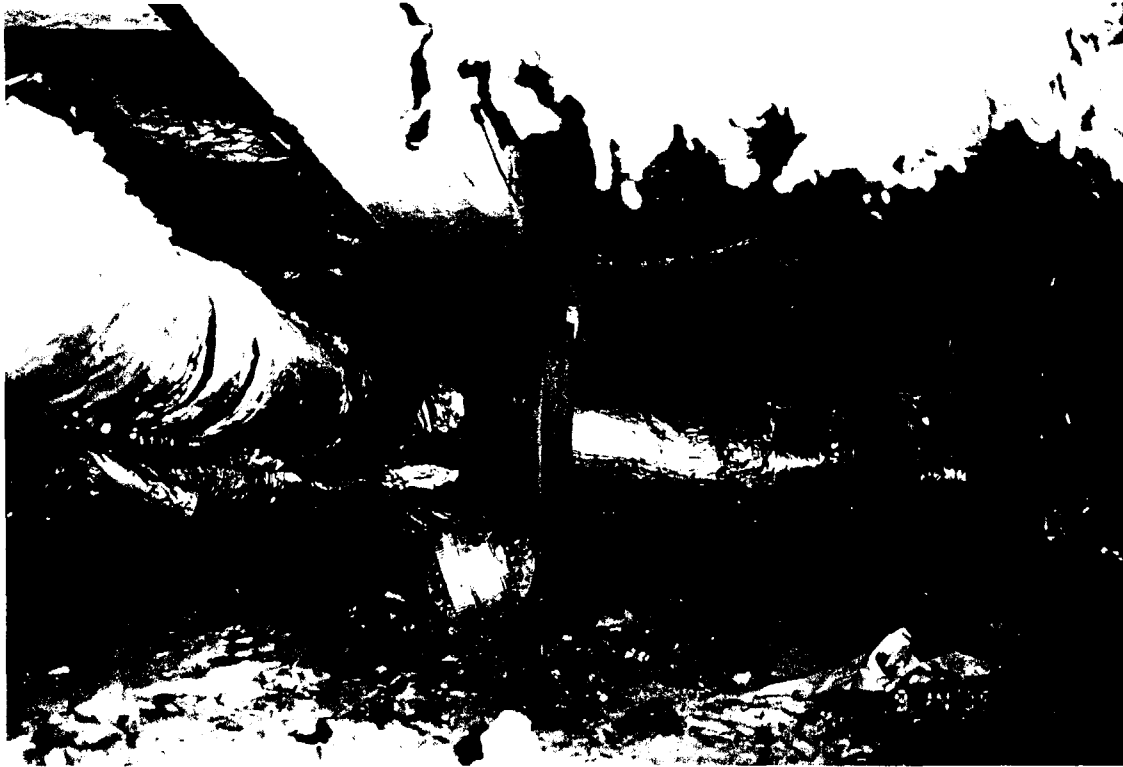
153-S South Slave Cabin - View of wood post in crawlspace which is loose and requires better connection to the underside of the wood girder. (RSA)

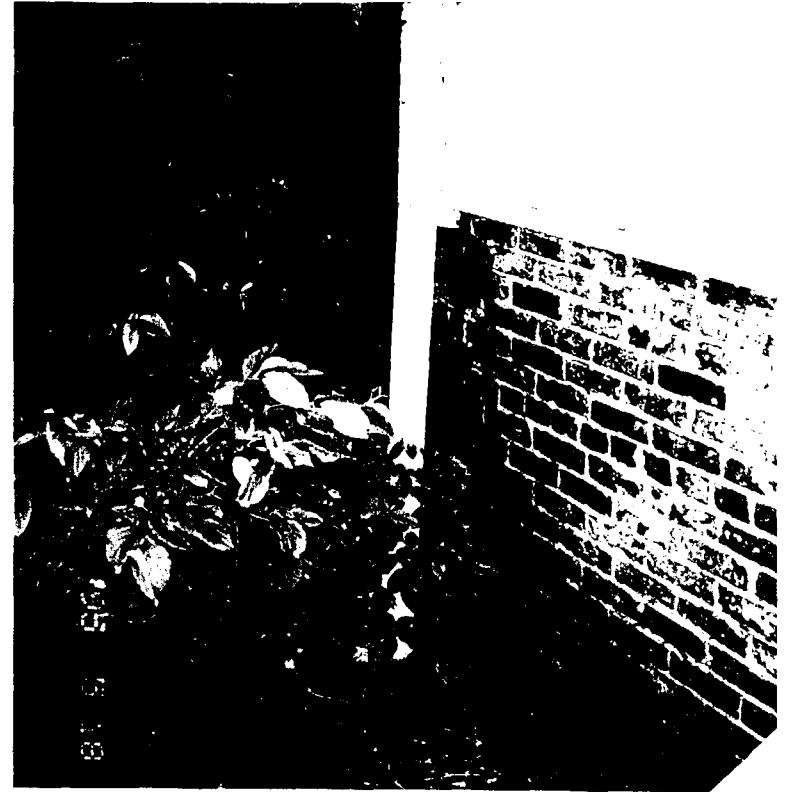
154-S South Slave Cabin - Rising damp damage, including algae growth, on brick. (RSA)

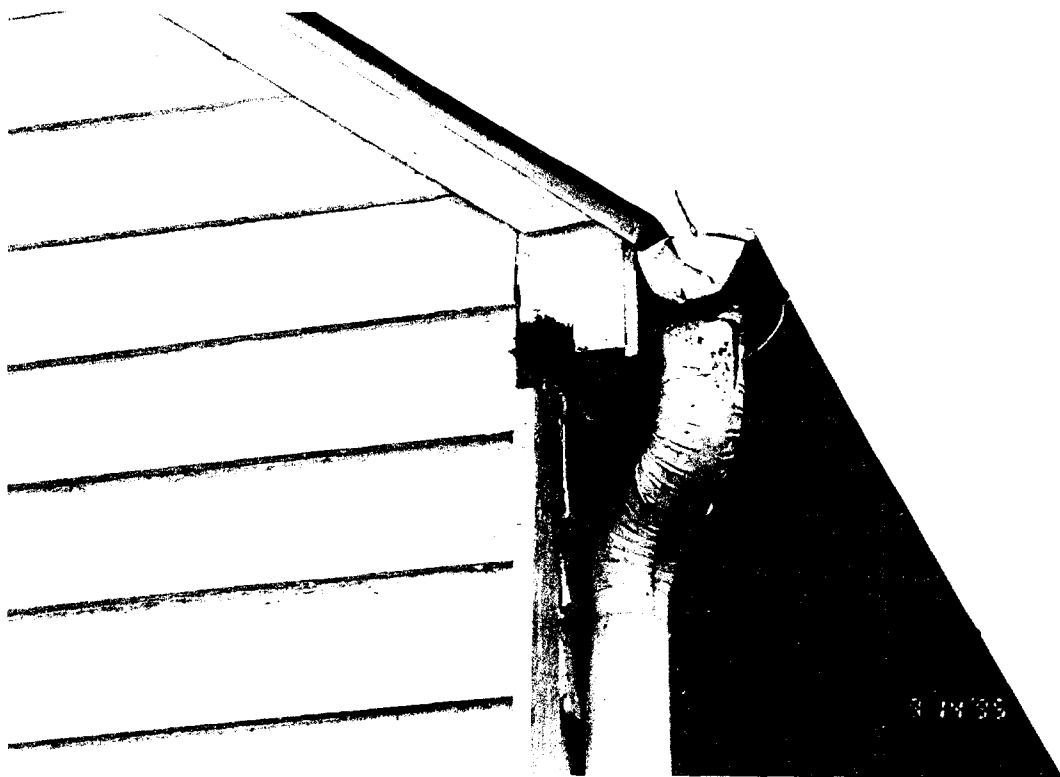
155-S South Slave Cabin - Damage to wood cornice. (RSA)

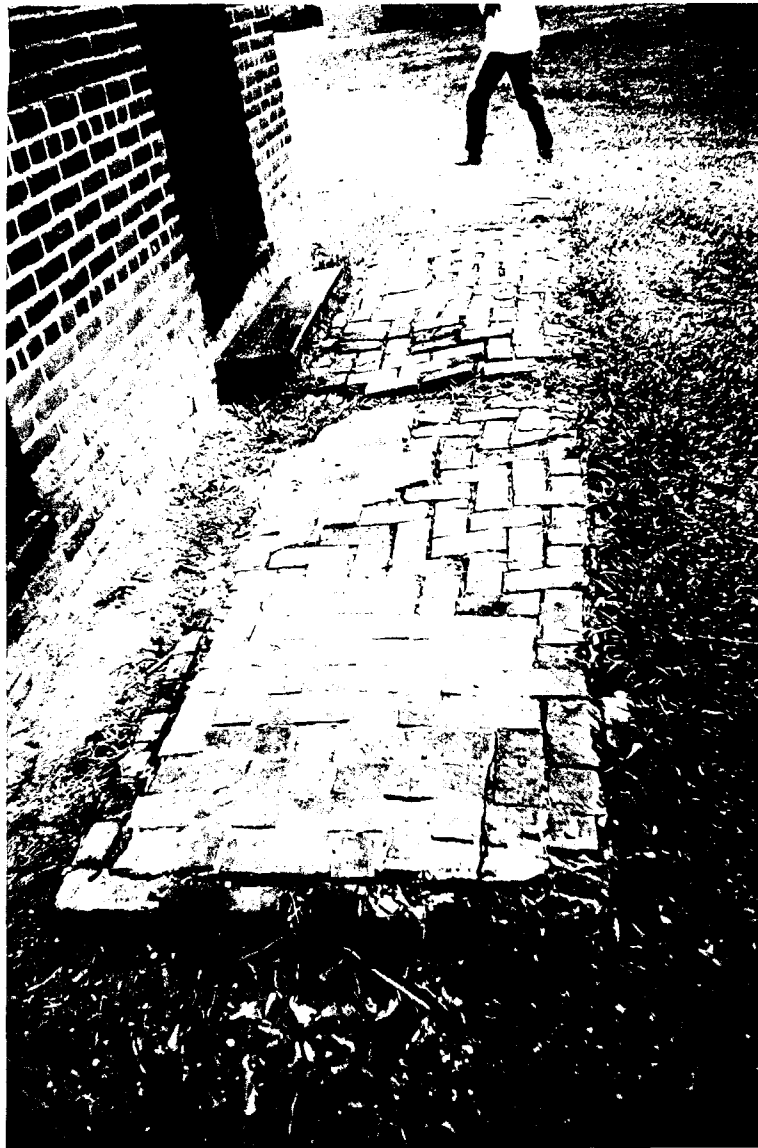
158-A Privy - Brick walks. (ABA)

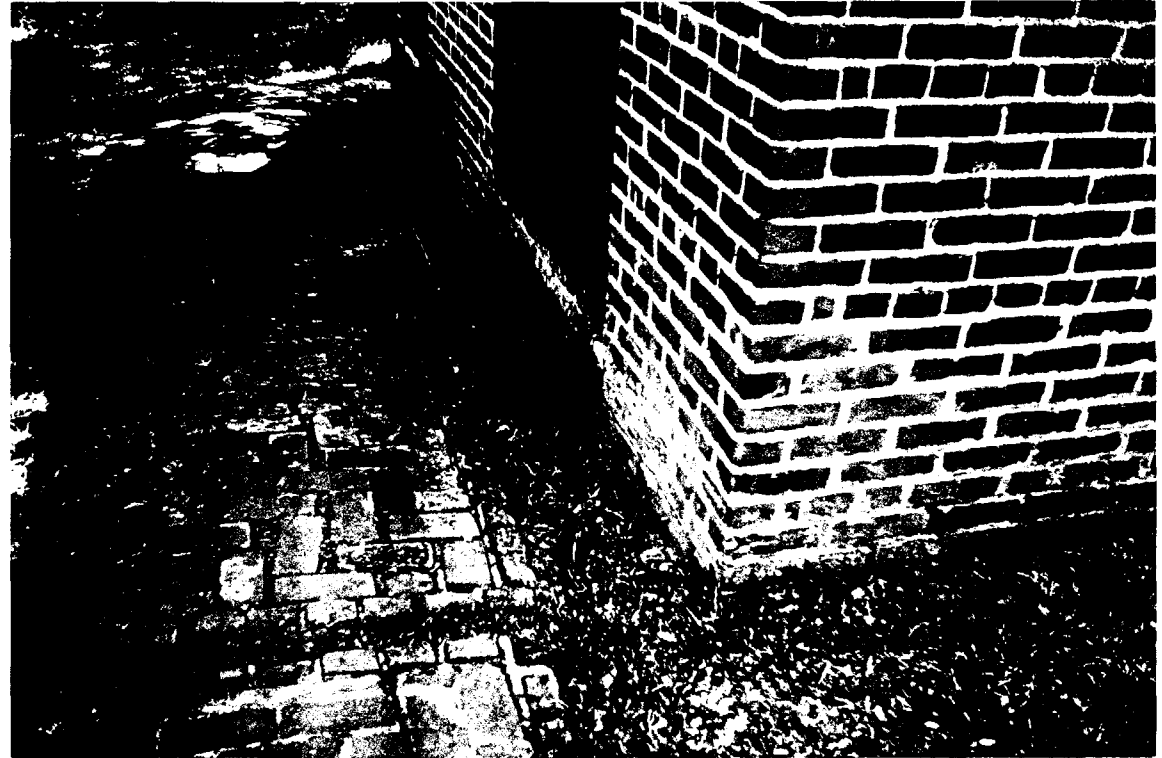
159-A Privy - Deteriorated brick at corner. (ABA)

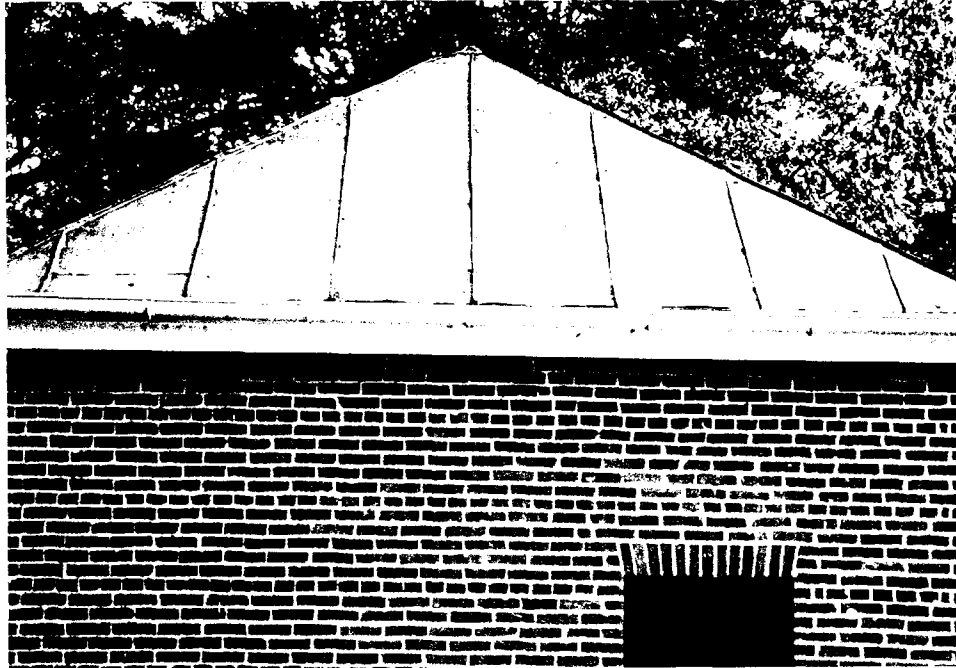
160-A Privy - Bottom edge of roofing, no overhang or flashing. (ABA)

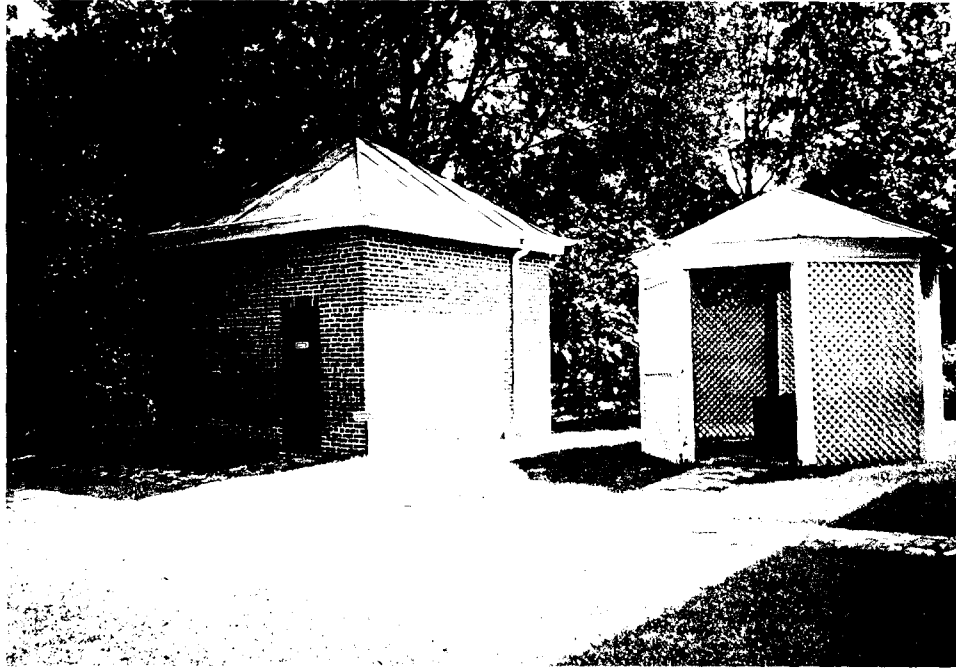
162-A Privy - West wall, deteriorated fascia and downspouts. (ABA)

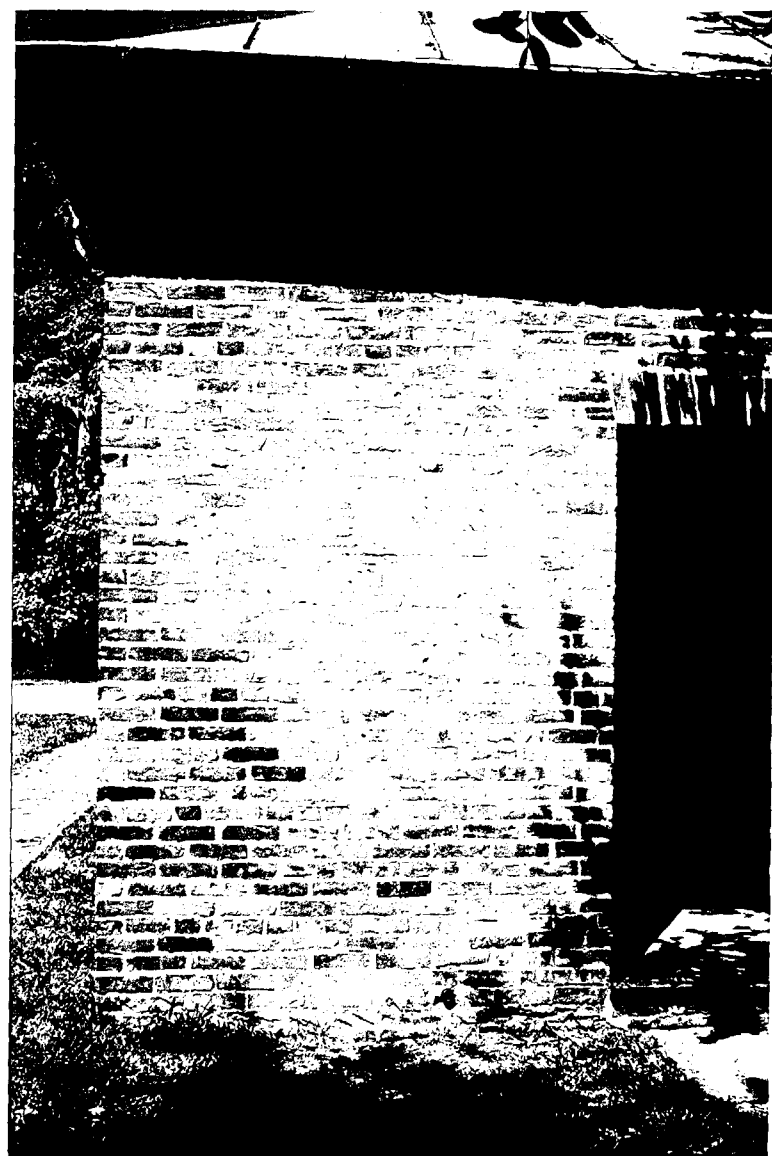
166-A Smokehouse - Deteriorated bricks below floor line. (ABA)

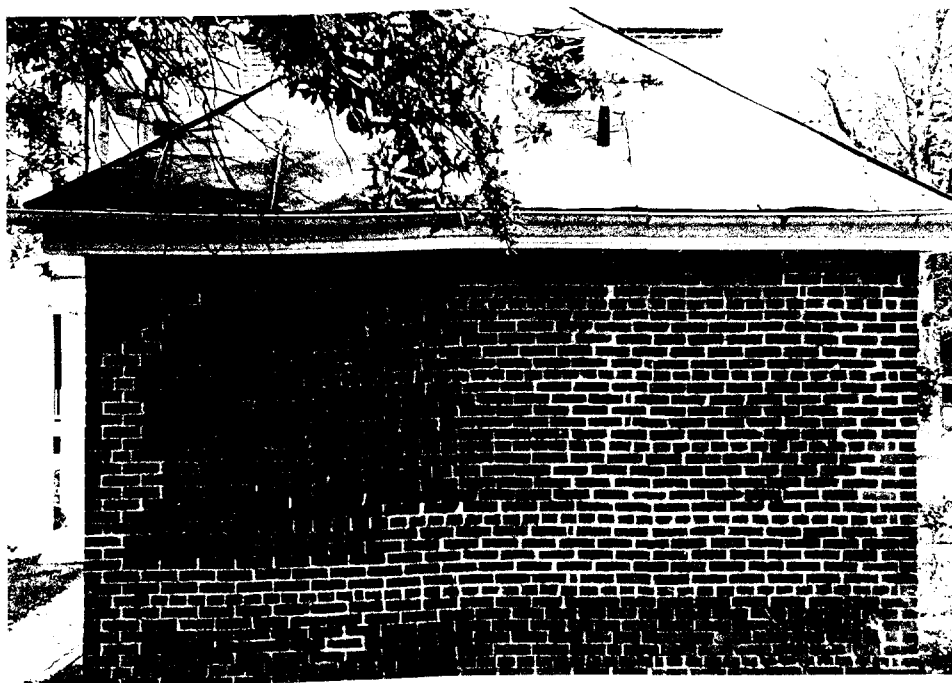
167-A Smokehouse - South wall, missing and cracked bricks. (ABA)

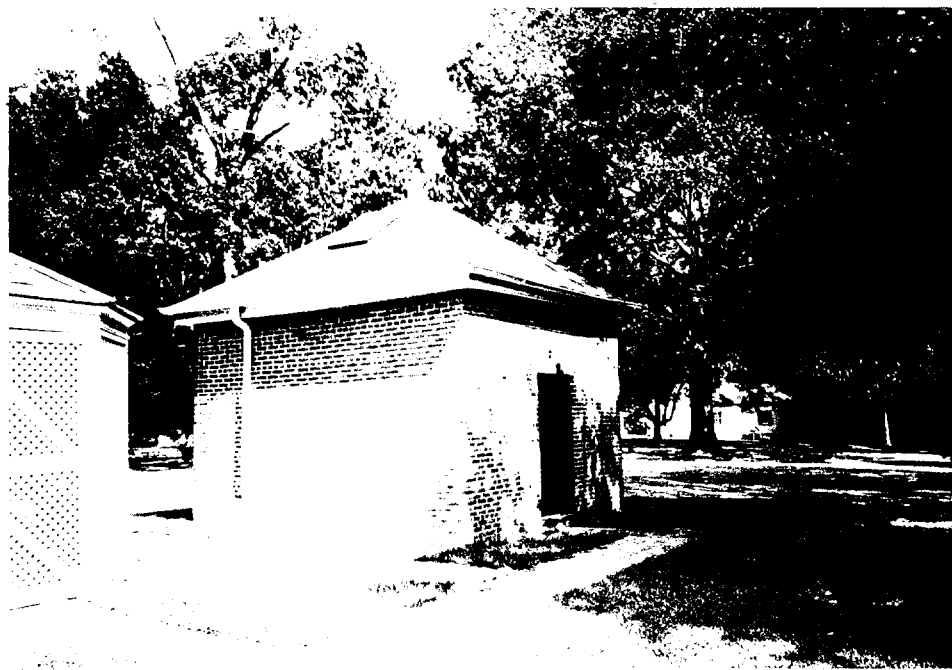
168-A Smokehouse - North wall, rotted fascia. (ABA)

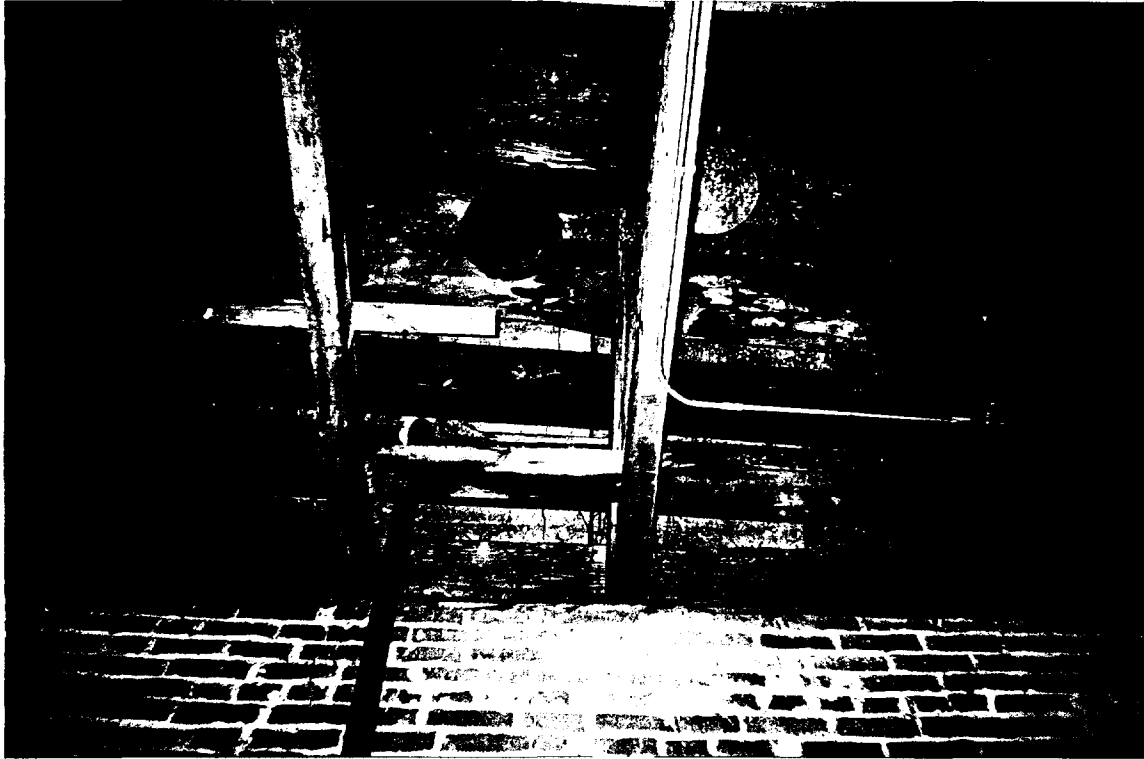
169-A Smokehouse - Water stained roof deck. (ABA)

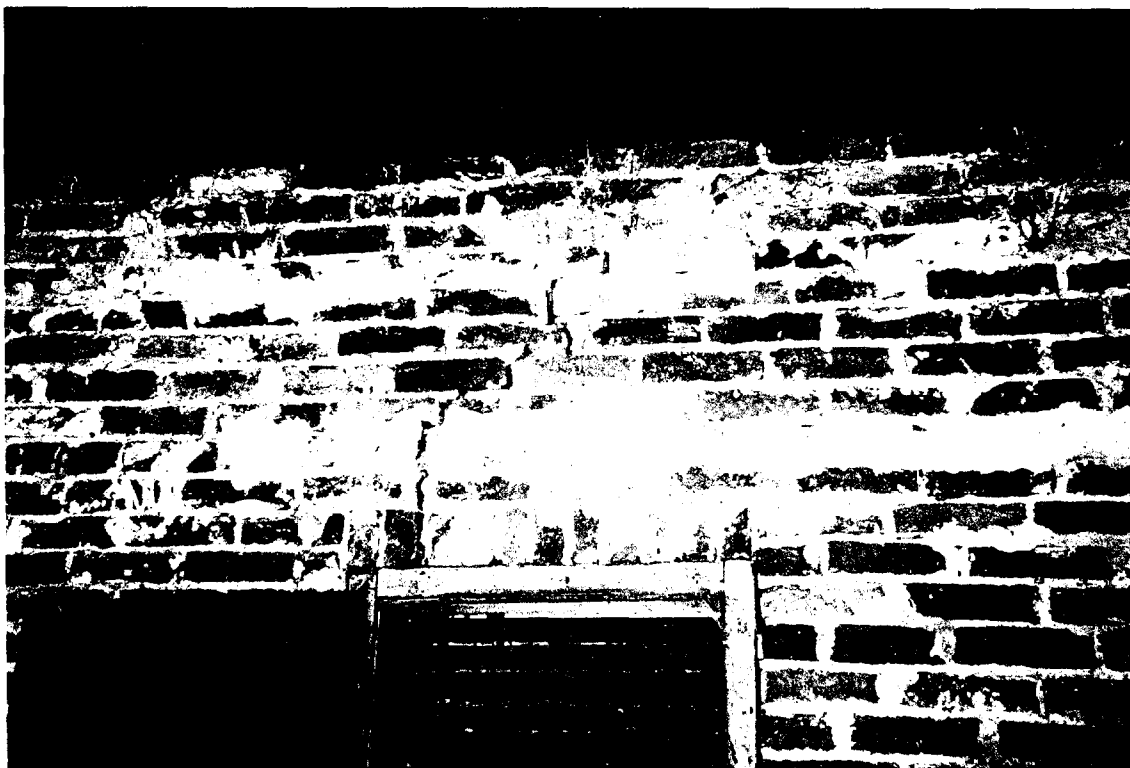
170-S Smokehouse - Crack in interior face of exterior brick wall. (RSA)

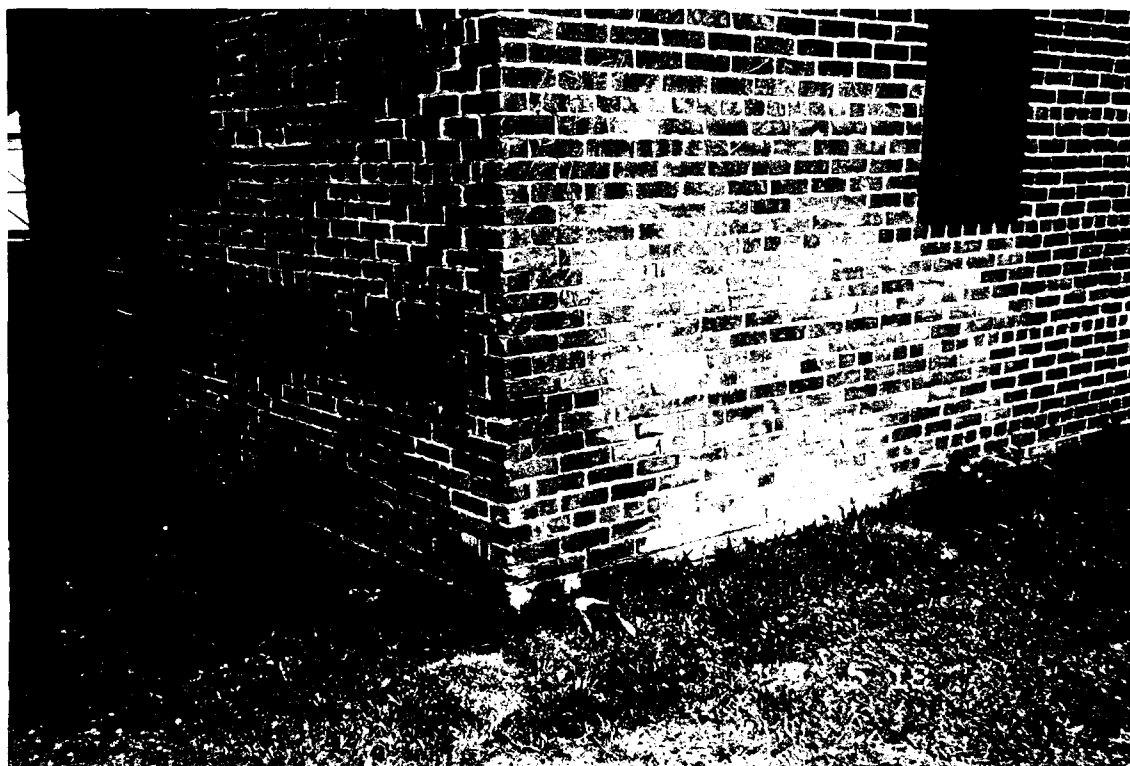
171-S Smokehouse - Rising damp and related damage to masonry. (RSA)

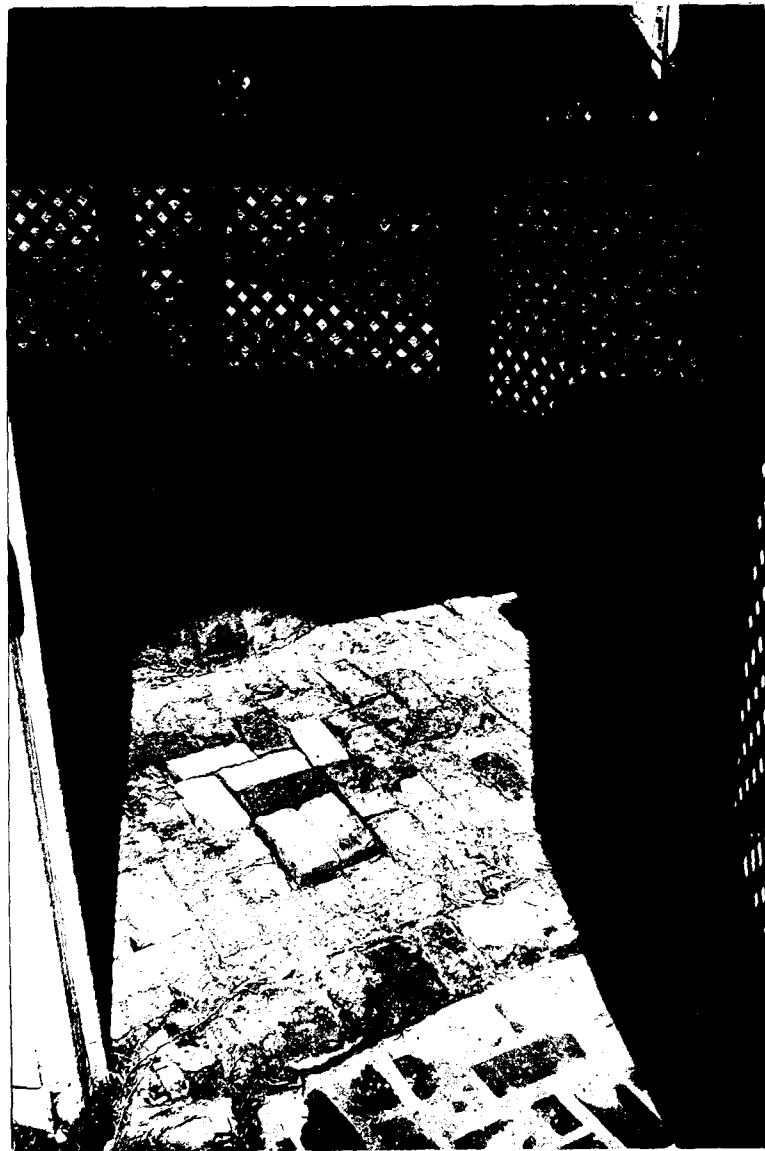
173-A Cistern - Loose and cracked bricks in floor of North Cistern. (ABA)

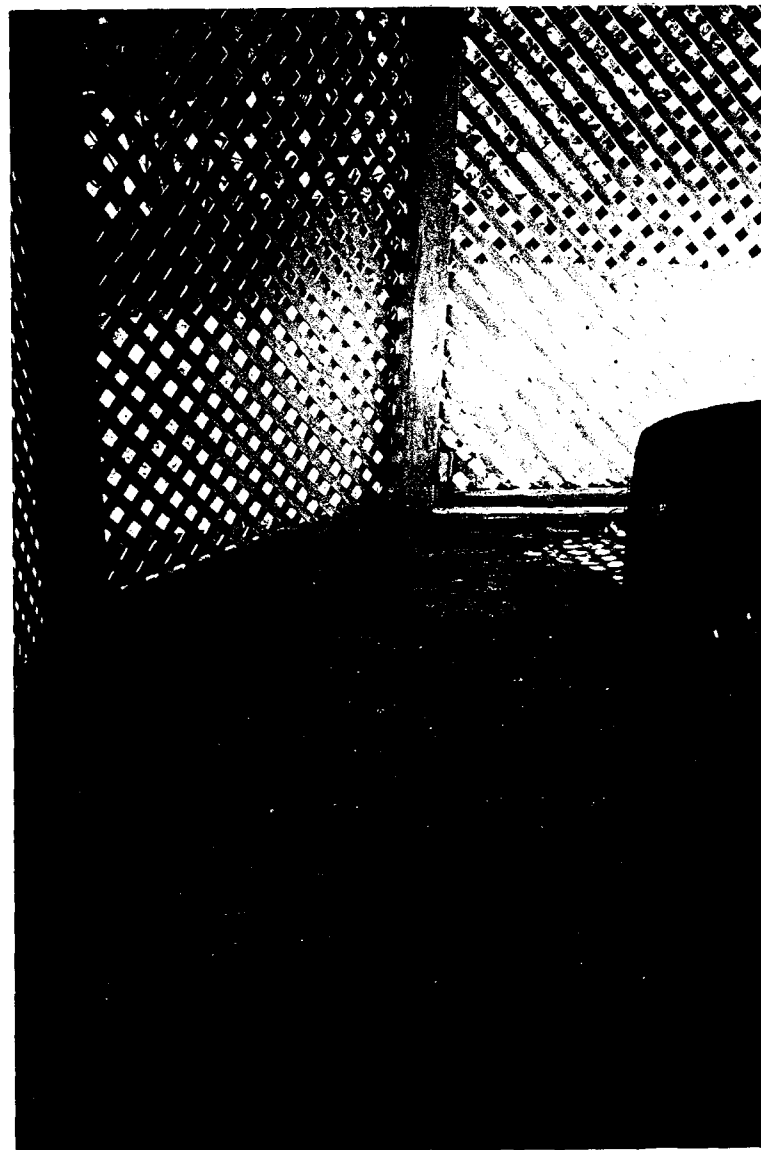
174-A Cistern - Wood framing set on brick floor in North Cistern. (ABA)
