D-11
Vol. 1 of 3
February 1997

**MELROSE ESTATE
NATCHEZ NATIONAL HISTORICAL PARK**

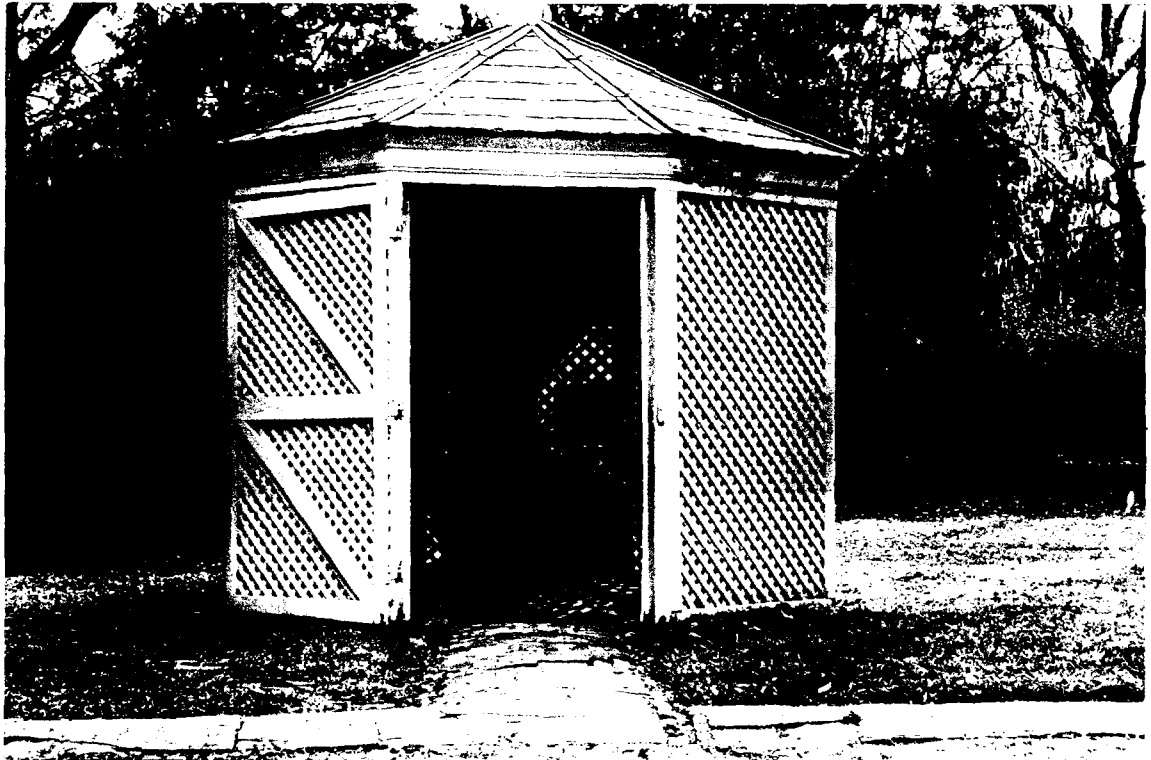
176-A Cistern - Deteriorated brick walks at South Cistern. (ABA)

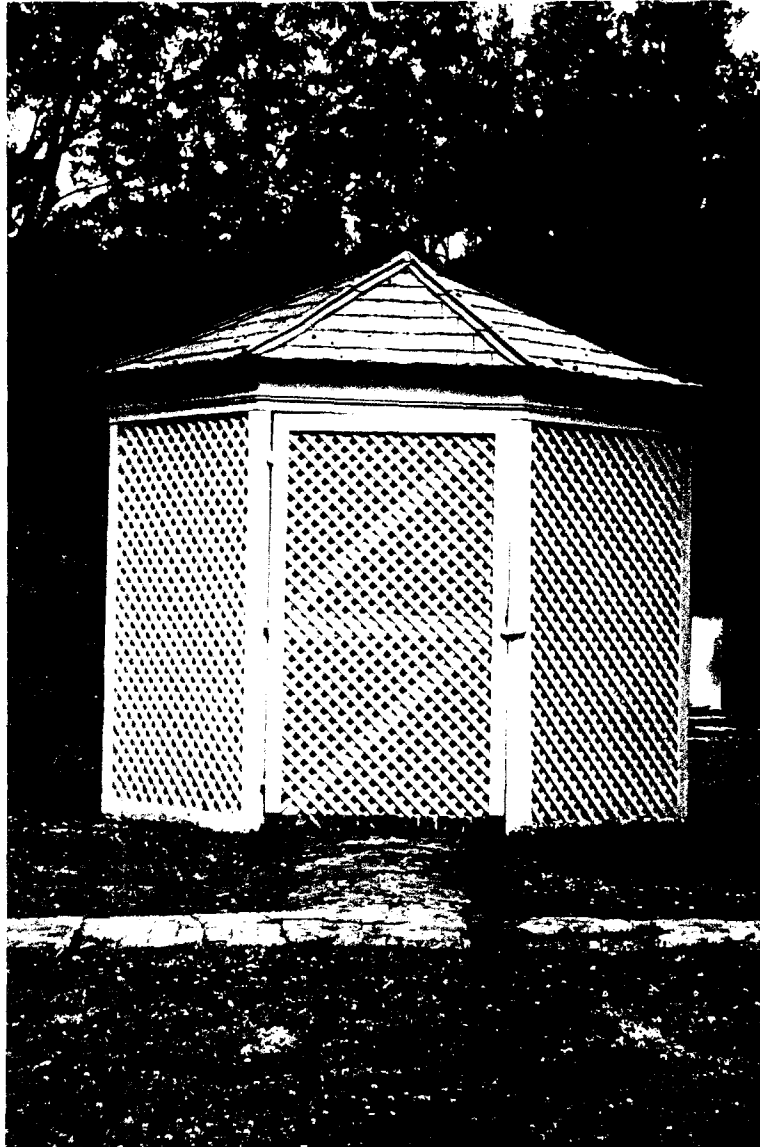
177-A Cistern - Missing bottom door frame at South Cistern. (ABA)

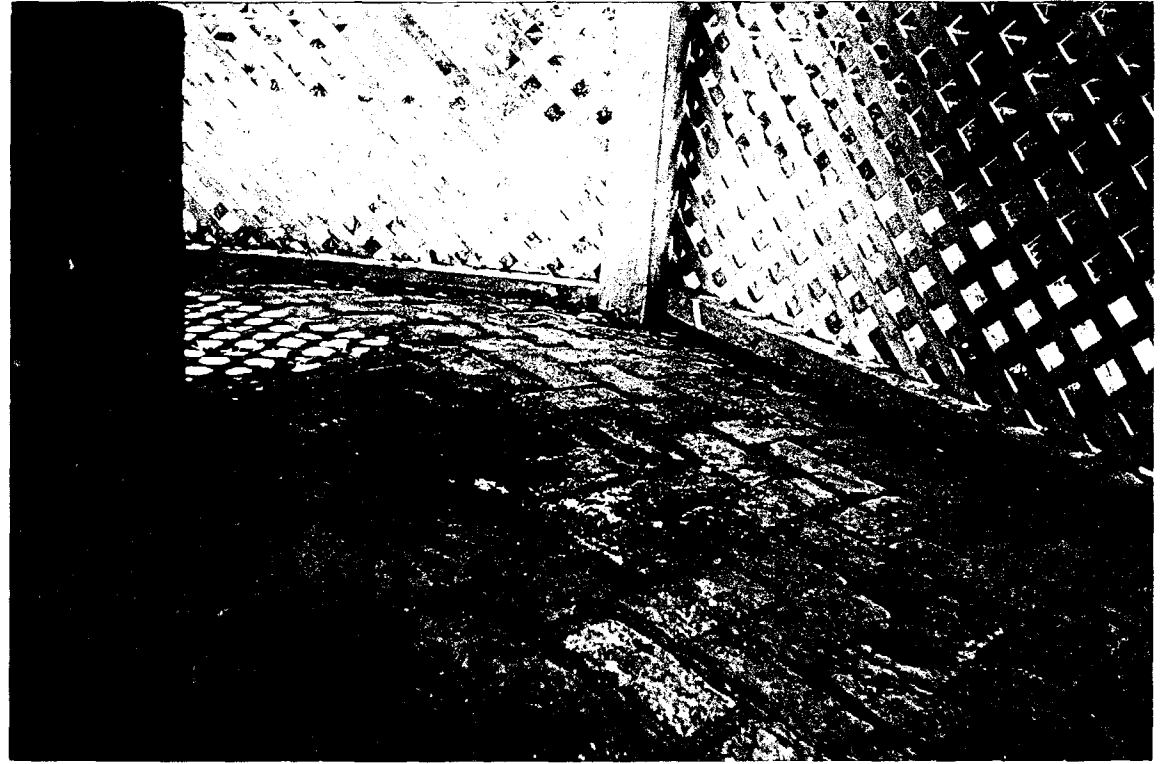
178-A Cistern - Crumbling brick floor at South Cistern. (ABA)

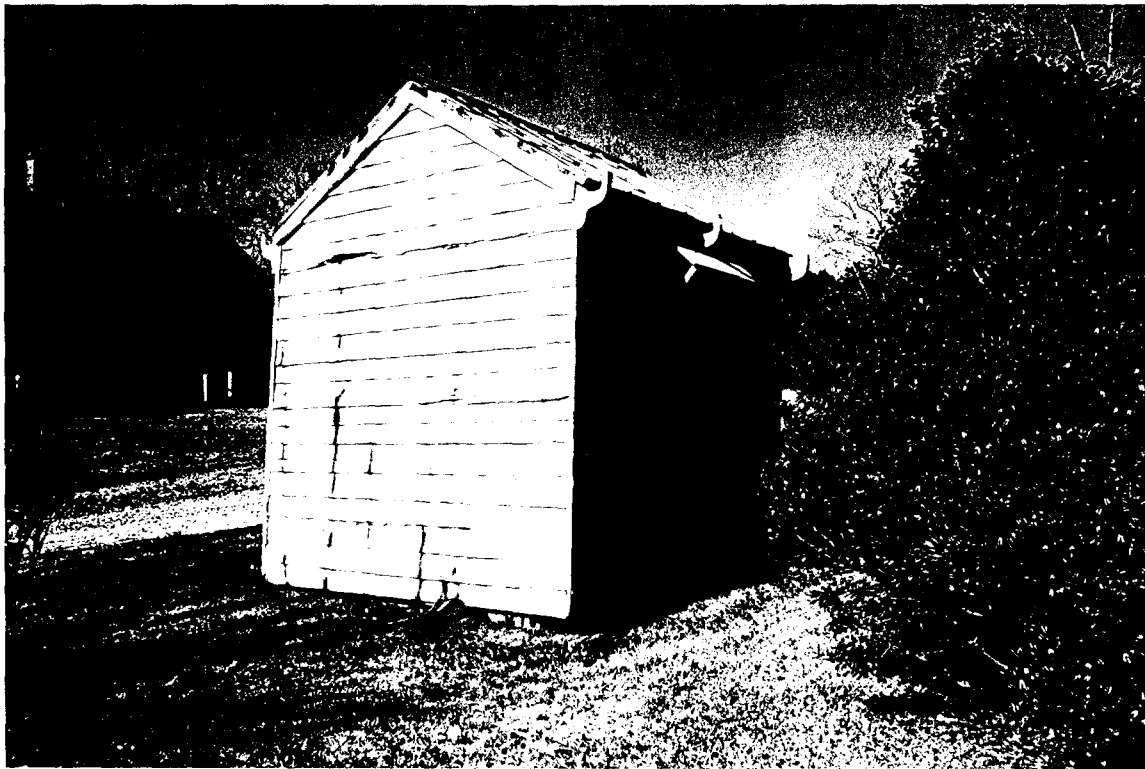
179-A Slave Privy - South and West Elevations. (ABA)
