Cape Hatteras National Seashore
Bodie Island Coast Guard Station

Historic Structure Report

2005

2005
Historic Structure Report
Bodie Island Coast Guard Station
Cape Hatteras National Seashore
Manteo, NC
LCS#: 07238

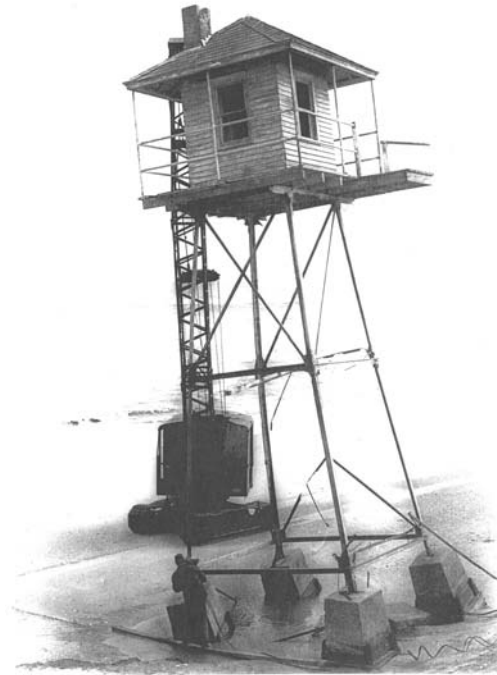
Unfortunately, delays occurred. The situation became critical by February 6, 1978 when high seas had undercut the foundations and the tower was tilting at about 85 degrees. The attempt made to rescue the tower before it collapsed failed. Although the tower was carefully documented by HABS, this element of the 1925 station was ultimately lost.⁹⁸ In February 1979, the original nomination which still included the lookout tower was approved, and the property was officially included in the National Register.

Figure B-15 Lookout tower, February 6, 1978, NPS archives, Outer Banks Group

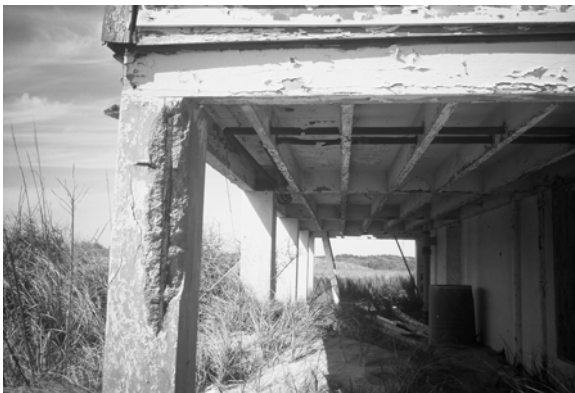
Figure C-4 Porch foundation and floor framing

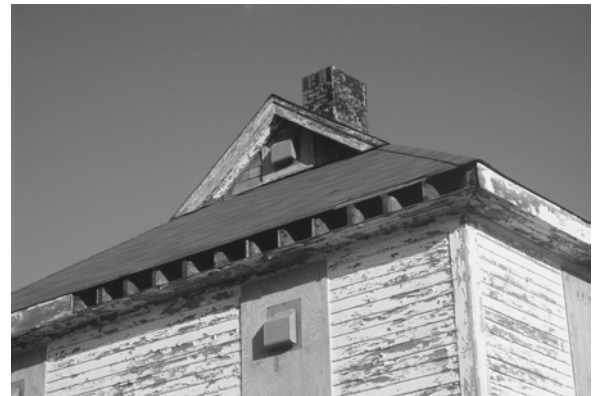
The station has asphalt shingle roofing on all roof surfaces; it is in relatively good condition. No gutters or downspouts are in place, though early photographs show them installed on the porch roof and roof of the main block. Some fascia boards of the main block are currently missing, including an approximately 16 feet long section on the north elevation, and two sections totaling approximately 20 feet on the east elevation.

Figure C-5 Missing fascia board on the north elevation

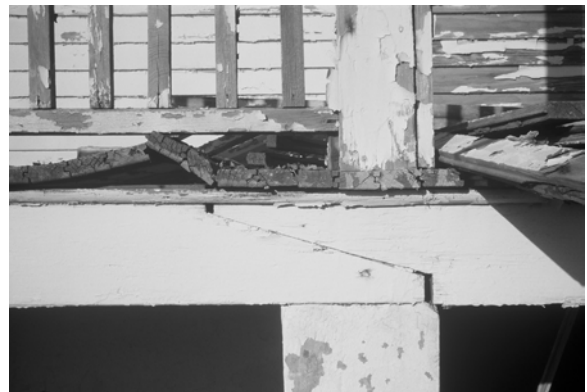
Porches: The first-floor wraparound porch on the south and west elevations is an original feature. The shallow pitch of the hip roof and concrete foundation piers of the porch remain unchanged. The south portion of the porch was enclosed at some time between 1956 and 1962. In 1962, stairs were built in their current location off the northernmost bay of the west section of the porch. Both the stairs and the exposed portion of the porch are in poor condition. Severely peeling paint has allowed access by water, causing the wood to swell and buckle, and rot has formed in numerous areas. The flooring in the south bay of the west section has collapsed.

Figure C-8 Buckling porch flooring and collapsed porch railings

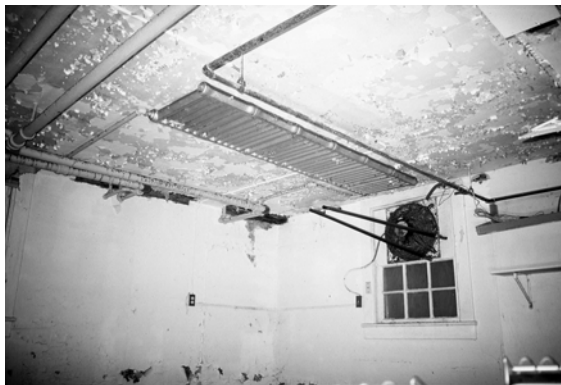
Figure C-12 Exhaust fan replaces top sash

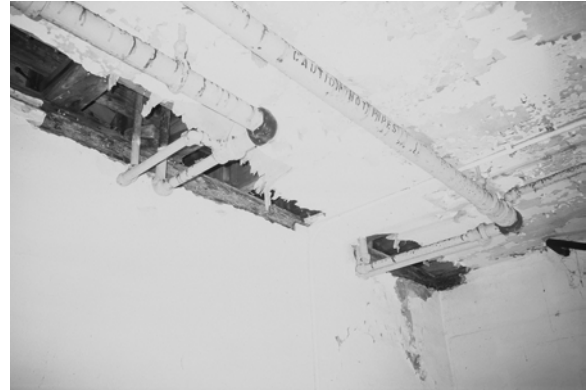
Figure C-13 Termite damage to ceiling joists and sill plate

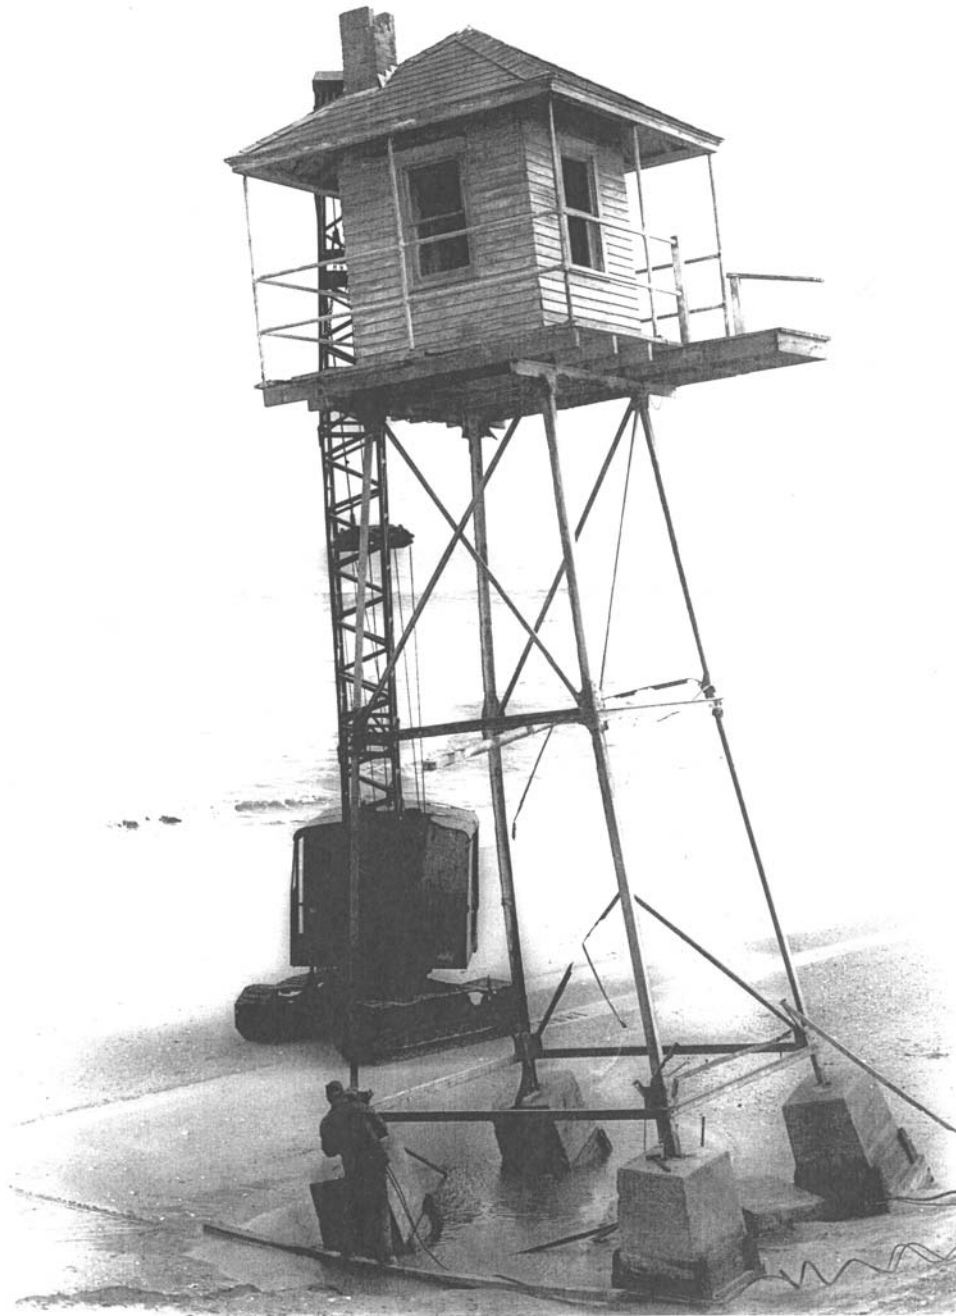
H.26 Crane in a failed attempt to save the 1925 Lookout Tower, Feb. 6, 1978.
