CAPE LOOKOUT NATIONAL SEASHORE
Coca-Cola House

HISTORIC STRUCTURE REPORT

Historical Architecture, Cultural Resources Division
Southeast Regional
Office
National Park Service

2004

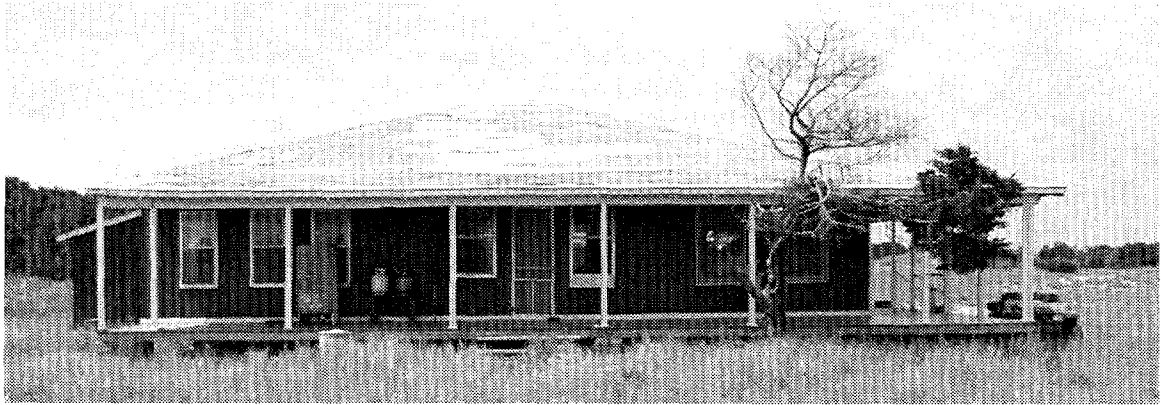
Figure 19 View of northeast side of house. (NPS-SERO-CR, 2002)

A number of the rafters, especially on the south side of the house, have been repaired by sistering new material to the old. The repairs, which are fully visible from the interior, resulted in the removal of small sections of the interior partition walls on the southwest side of the building, but this does not appear to have destabilized the structure. Perimeter sills have also been extensively replaced.

- Rework repaired connections between rafters and wall framing to improve appearance from the interior.
- Reconstruct missing wall framing and paneling at southwest ends of walls on either side of southwest wing of hall.
- Repair termite damage as necessary.

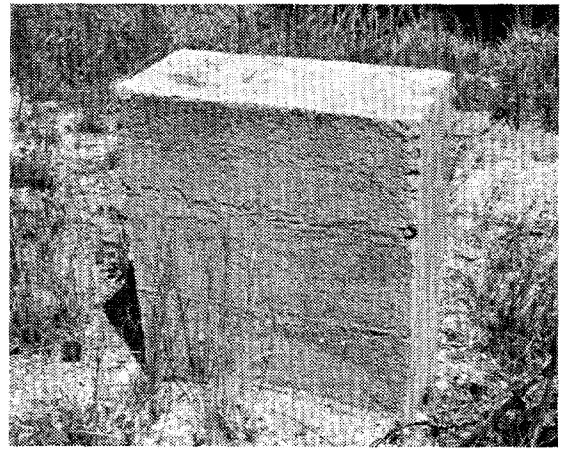
Figure 20 View of typical concrete pier. (NPS-SERO-CR, 2002)

Except for some of the buildings at the old Coast Guard and Lighthouse stations, which were built on brick piers, most of the residences at Cape Lookout were built on wood pilings. The wood frame of the Coca-Cola House, however, was built on poured concrete piers, spaced about six feet apart, and probably set on some sort of spread footing. Piers are about 8" by 15" in plan and 15" high. All of the piers remain in relatively good condition, except where the original porch was removed along the south sides of the house, allowing some of the piers to be overturned or destabilized.

- Eliminate wood- to- ground contact at all locations, repairing damaged beams as necessary.
- Install metal termite shields at all piers.

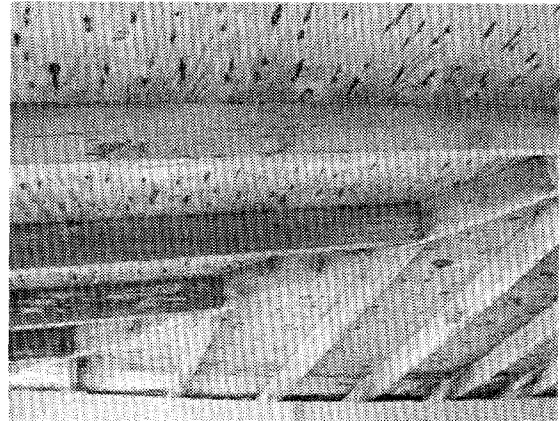
Figure 22 View of original porch roof framing at north corner of house. (NPS-SERO-CR, 2003)

According to tradition, the house was painted red through much of its existence. Traces of this red paint are still visible in the framing of the porch roof around the north corner of the building, and red is also visible on window casing along with white window sash in one of the 1976 photographs. Except for white window sash and an unpainted porch floor, it is
