# Magnolia Plantation Gin Barn Historic Structure Report

CANE RIVER CREOLE NATIONAL HISTORICAL PARK  
MAGNOLIA PLANTATION

~ GIN BARN ~  
HISTORIC STRUCTURE REPORT

2004  
Historic Structure Report  
Gin Barn  
Cane River Creole National Historical Park  
Magnolia Plantation  
LCS#: 91561

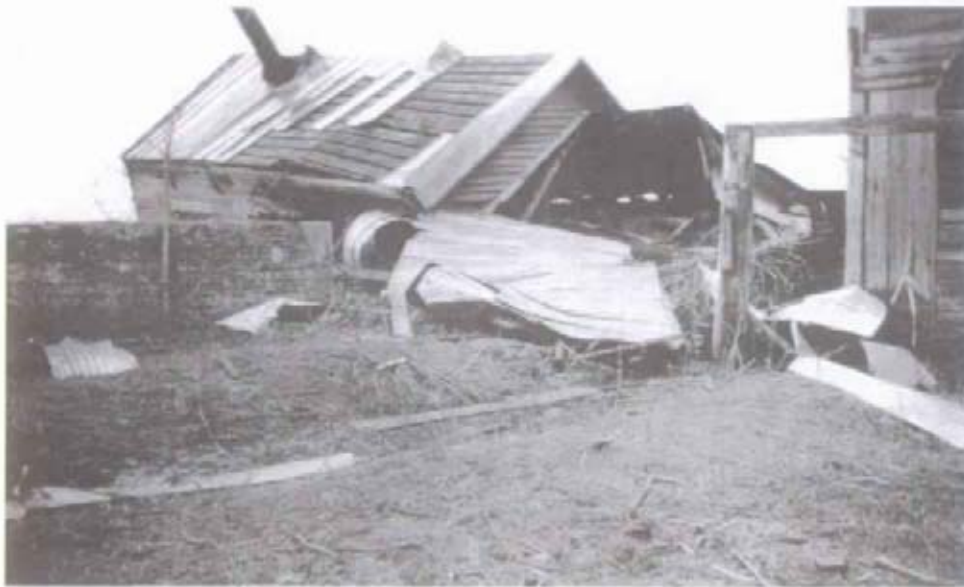
**Figure 6** View of destroyed engine house at Gin Barn after 1939 tornado. The barn is partially visible at right. (Hertzog Family Collection, Magnolia Plantation)

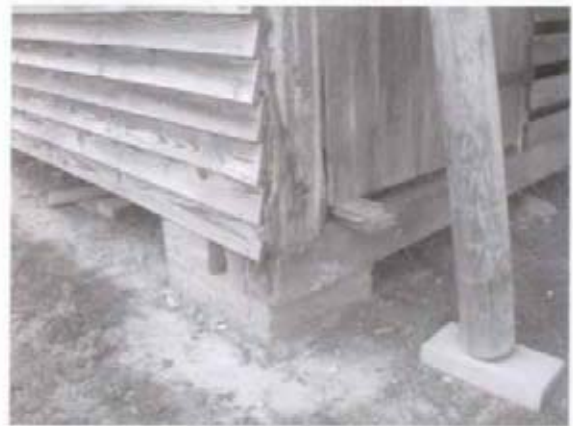
**Figure 18** View of northeast corner of barn, showing brick pier rebuilt in 1996. (NPS-SERO-CRS, 2001)

- Preserve existing historic brick and stone piers (on interior) and brick foundation to steam-powered press.
- Add additional piers if necessary to provide adequate support for anticipated loads (see below).
- Repoint historic masonry as necessary.

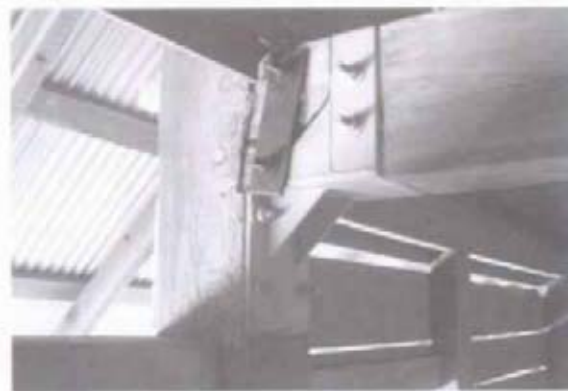
**Figure 20** View of typical beam/post connection, reinforced with metal brackets in 1996. (NPS-SERO-CRS, 2001)

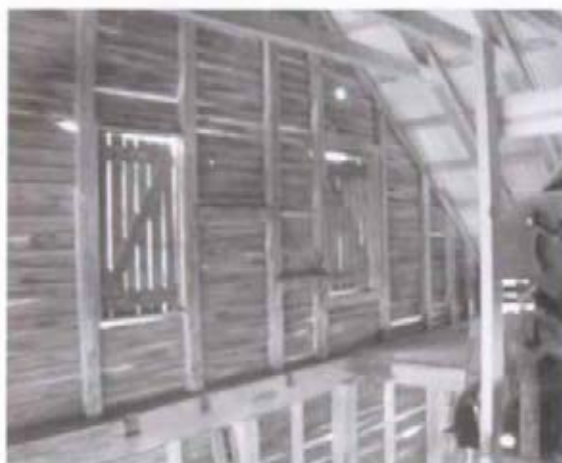
**Figure 26** View to southeast showing part of east end of barn; note empty mortises for framing around missing stairway. (NPS-SERO-CRS, 2001)

- Replace all missing framing and flooring at second level; replace missing flooring in lint room and on south side of east end of first floor as indicated on plan.
- At the second floor, preserve all existing flooring, adding flooring on top of the historic material if necessary to provide a safe route for visitors.
- Rebuild part of east wall of lint room; repair remainder of walls in lint and seed rooms.
- Rebuild wall on second floor above west wall of lint room or install railing at that location.
- Install railing around perimeter of former seed room floor.
- Reconstruct historic stairs at northeast corner of building; remove stairs at southeast corner of building.

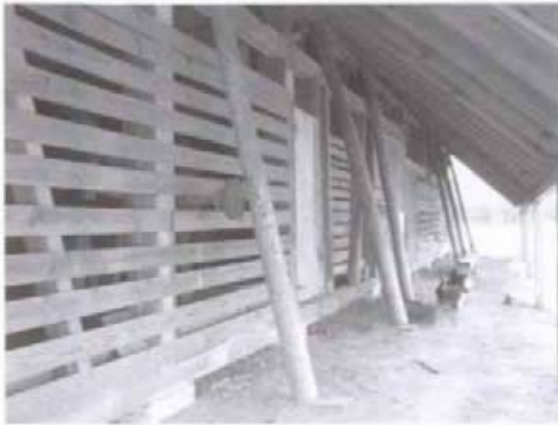
**Figure 32** View of north side of building, showing typical open siding. Note that siding near center is attached to the interior face of the studs. (NPS-SERO-CRS, 2001)

- Repair siding as necessary, maintaining lapped siding on ends and on dormers, spaced slat siding on the sides,

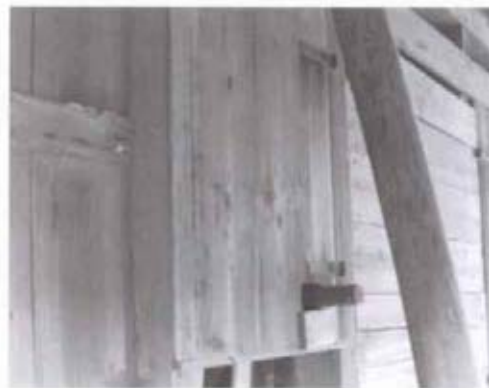
**Figure 36** View of window H, which originally had sash but was closed when existing gin machinery was installed c. 1900. (NPS-SERO-CRS, 2001)

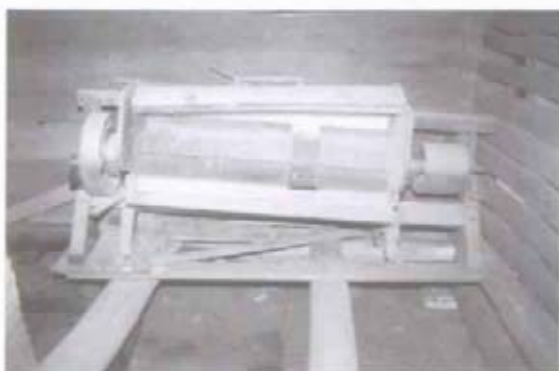
**Figure 39** View of disassembled Eagle gin stand in northwest corner of first floor. (NPS-SERO-CRS, 2001)

In addition to this equipment, which was used until 1939, an older Eagle gin stand is lying in the northwest corner of the gin room end of the barn and parts of its associated equipment may have been incorporated into the present system gin. Representatives of the Continental Gin Company have noted that any equipment

- Engage conservators and specialist in early twentieth century gins to guide conservation, re-assembly, and display of existing gin machinery, including the old Eagle gin.
- As part of overall exhibit design for the building, determine how much recreation of missing ductwork, drive shaft belts, and other missing components is necessary for good interpretation of the ginning and pressing operation.

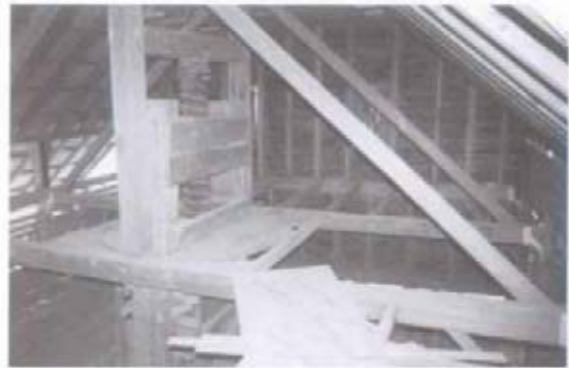
**Figure 45** View of top frame of wood-screw cotton press, which would have originally been surrounded by flooring. (NPS-SERO-CRS, 2001)

- Determine character and condition of press footing through archaeological investigation.
- Brace press with modern materials if necessary to insure structural stability.
- Avoid any disassembly or replacement of historic materials.
- Do not operate historic press; construct working scale model to demonstrate its operation to visitors.

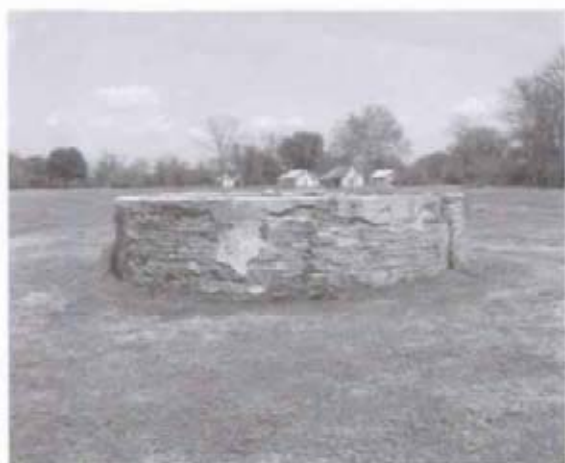
**Figure 47** View to northeast of cistern at Gin Barn. (NPS-SERO-CRS, 2001)

- Conduct complete archeological investigation around and within footprint of present building.
- Repair and repoint cistern; preserve engine base.
- Define appropriate routing of visitors around building.
- Keep perimeter of building free of vegetation.
