# HISTORIC STRUCTURE REPORT The Wright Cycle Company Building

(HS - 01)

Dayton Aviation Heritage National Historical Park  
Dayton, Ohio

March 31, 1999  
Final Submission

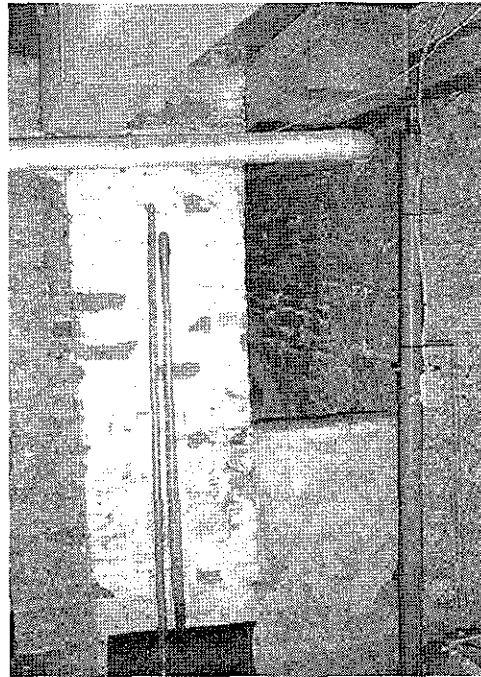
Figure 2: The chimney was constructed at the time of the addition. The brick infill at the left of the chimney indicates that it was not part of the original wall.

Two chimney chases are currently located at the basement level: one at the western half of the north wall, the other near the center of the east wall. The east chimney is not original, as indicated by the brick infill used on the north side and the former stairwell behind it (Figure 2). This chimney was probably added as part of the addition construction. One interior wood stair at the east end of the south wall leads up to the first floor. There is one small window over the stair, high in the south wall. An original window in the east wall, south end, was bricked up, probably when the addition was built.

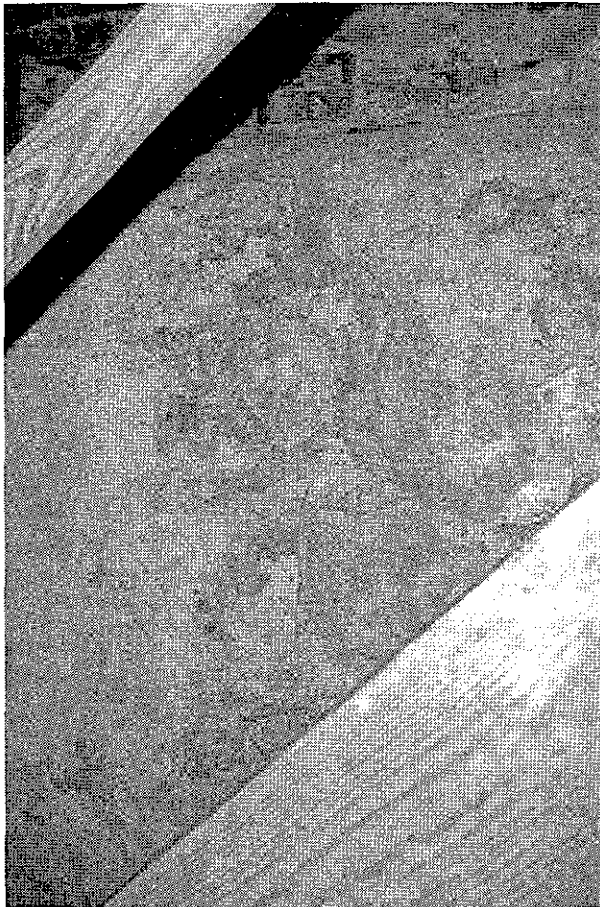
No apparent cracking or similar stresses were observed in the stone foundation walls of The Wright Cycle Company building (HS-01) with the exception of the south wall. The south wall has a layer of parging covering the stone foundation wall. The parging is severely cracked and pieces have fallen off in several locations. The poor condition of the parging can be directly related to the condition of the stone foundation wall. Any moisture penetration into or between the wall and the parging will damage the wall and the parging. When moisture is trapped in or between the wall and the parging, it will try to escape. Through its attempted escape, the moisture or vapor will deteriorate the stone wall resulting in a loss of strength of the wall. The water will also cause the parging to crack. These cracks expose more surface area for water penetration to occur, thus allowing more deterioration to occur.

The moisture penetration into the south foundation wall of The Wright Cycle Company building (HS-01) may be due to a combination of reasons. During the inspections, NPS personnel stated that the relationship between the gutters of The Wright Cycle Company building (HS-01) and the residence to the south of The Wright Cycle Company building (HS-01) is problematic. The gutters on the residence are ineffectual and leak heavily into the space between the buildings. Water can easily be collected in the ground between these two buildings due to the small distance -- only two feet -- between them. This small space prohibits wind and sun to either move or evaporate the water. Therefore, the water gravitates downward through the soil, creating a larger soil pressure on the foundation walls of both buildings. The "wet" soil pressure can be two to four times the normal "dry" soil pressure depending on the in-situ soil makeup. As the water progresses, some of it may be moving through the south foundation wall of The Wright Cycle Company building (HS-01). As it migrates through the walls, the water may chemically react with and dissolve the cementitious materials and aggregates in both the mortar and the parge. This chemical reaction causes the mortar and the parge to lose strength, begin deteriorating, form cracks, and show other signs of distress.

Figure 1 View of the cracked and missing parging of the south foundation wall at the stair, 1996 (Fitzpatrick Structural Engineering).

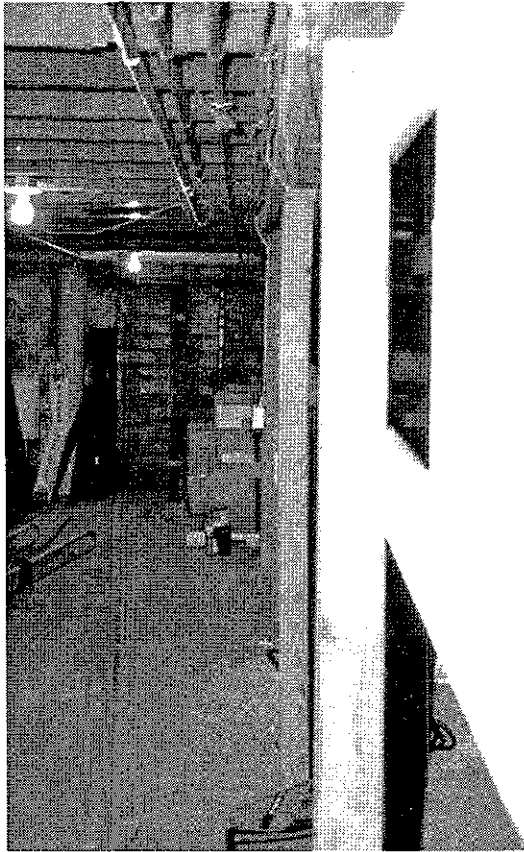
Figure 2 View of columns E (in the foreground) and D (in the background), 1996 (Fitzpatrick Structural Engineering).

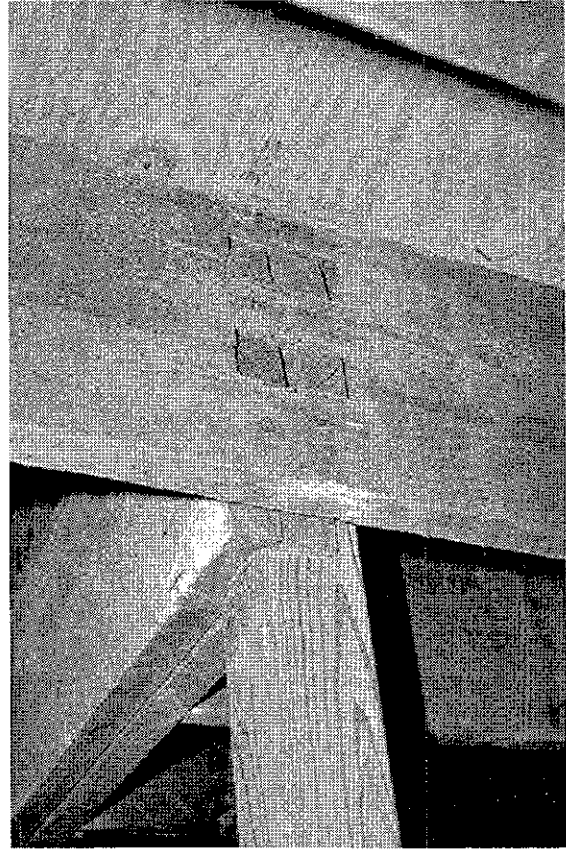
Figure 3 View of the eastern connection between the stair header, joist and wood post, 1996 (Fitzpatrick Structural Engineering).

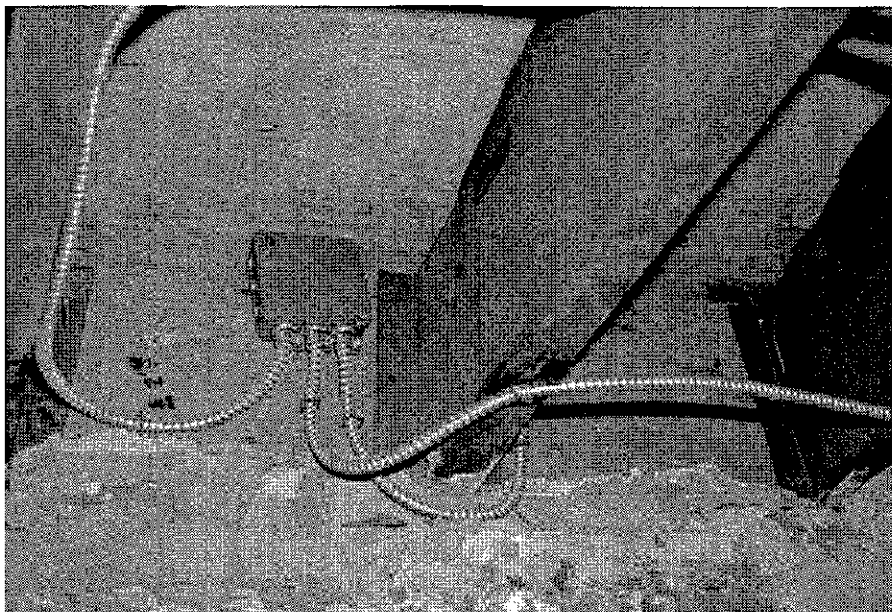
Figure 4 View of the joists rolled on the south bearings and new metal joist hangers, 1996 (Fitzpatrick Structural Engineering).

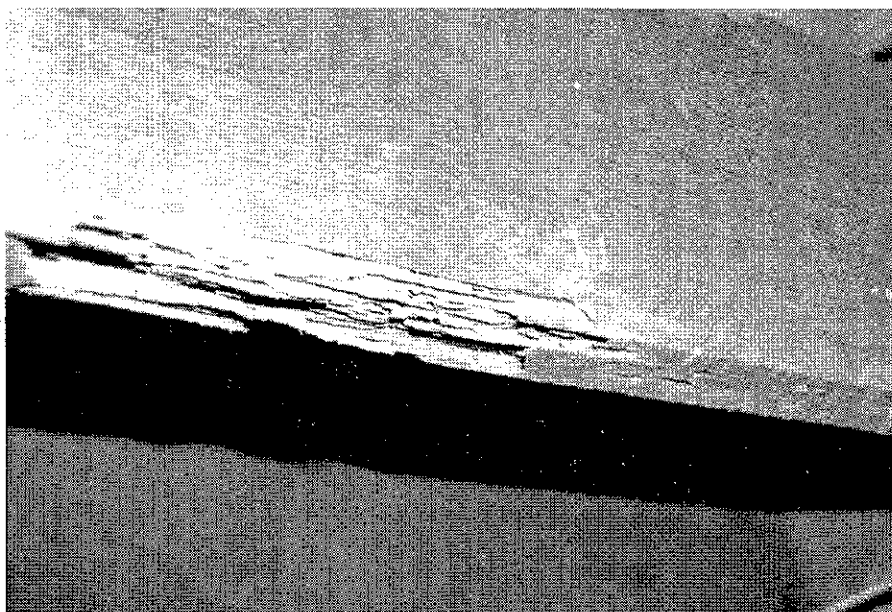
This insect damage appears to have ceased and the new members have reinforced this western end of the first floor. The four western-most members have been replaced with newer 2x12s (nominal). The fifth western-most

Figure 5 View of the insect damaged joist, 1996 (Fitzpatrick Structural Engineering).

joist is an original joist that has not been reinforced. The sixth and seventh western-most joists have been sistered on their south halves with newer 2x12s (nominal).

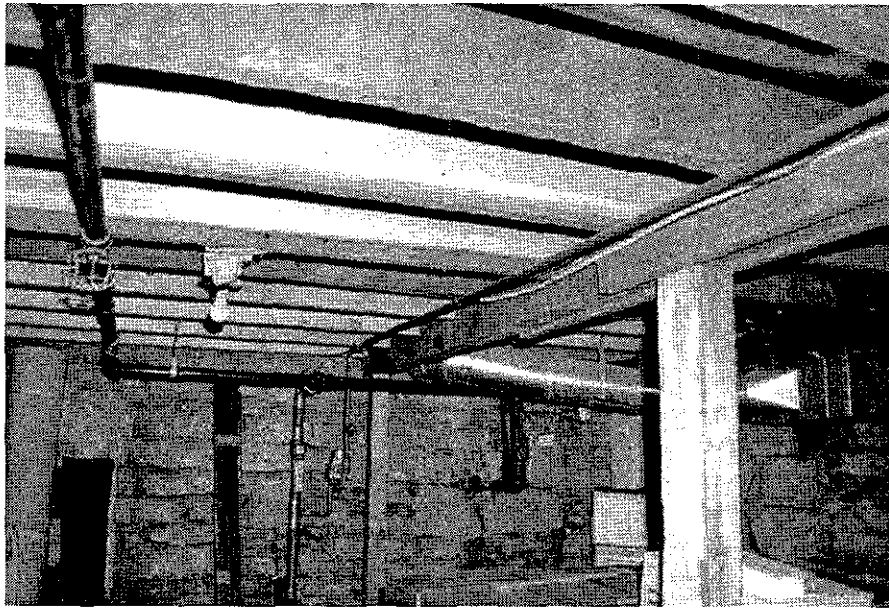
Figure 6 View of the western end of the first floor framing, 1996 (Fitzpatrick Structural Engineering).
