HISTORIC STRUCTURE REPORT

FORT McHENRY

HISTORICAL AND ARCHITECTURAL DATA

FORT McHENRY NATIONAL MONUMENT AND HISTORIC SHRINE

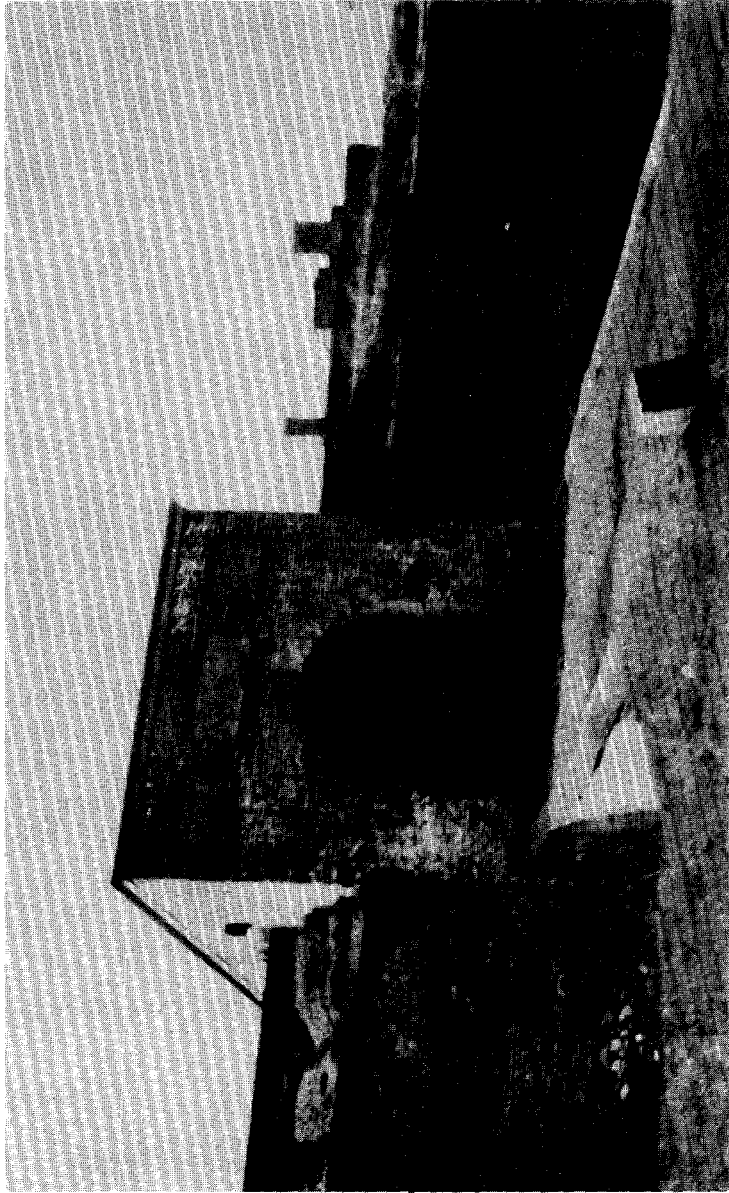
Illustration No. 11.

Sally Port, HS 6, 1927, on eve of restoration by the Army. Note advanced deterioration of the scarp to the left of the entrance. The ditch here is deeper than it is today. The entrance to one of the bombproofs may be seen directly in the entranceway.

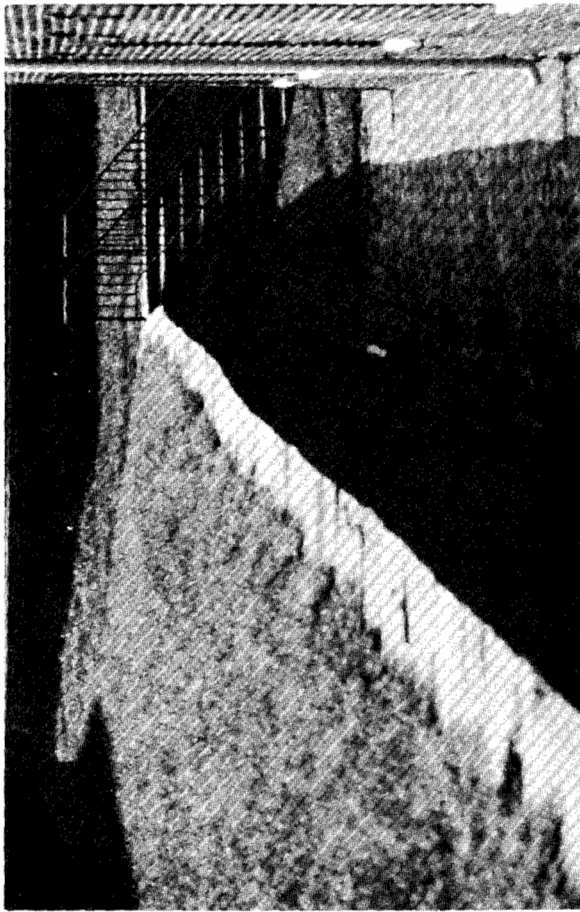
Illustration No. 15.

Terreplein behind barracks, HS 5, 1973. Note complete absence of 4-foot-wide infantry banquette. The flight of steps is a modern reconstruction of historic ones from the parade to the terreplein.

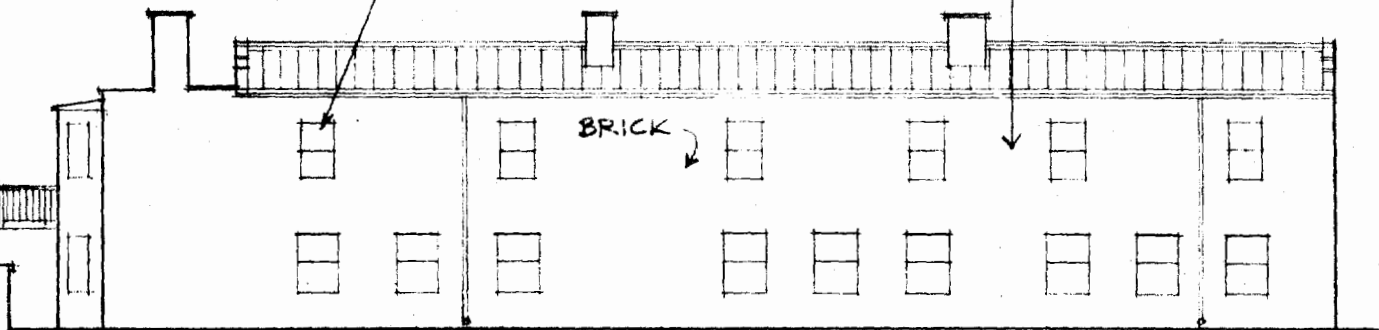
15% OF MORTAR
NEEDS REPOINTING.

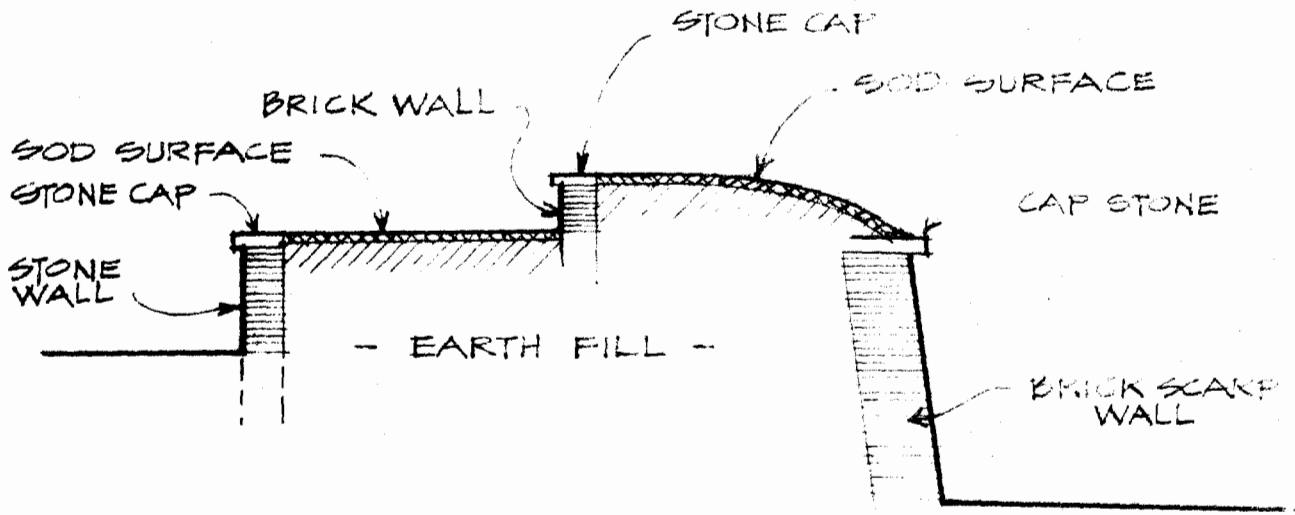
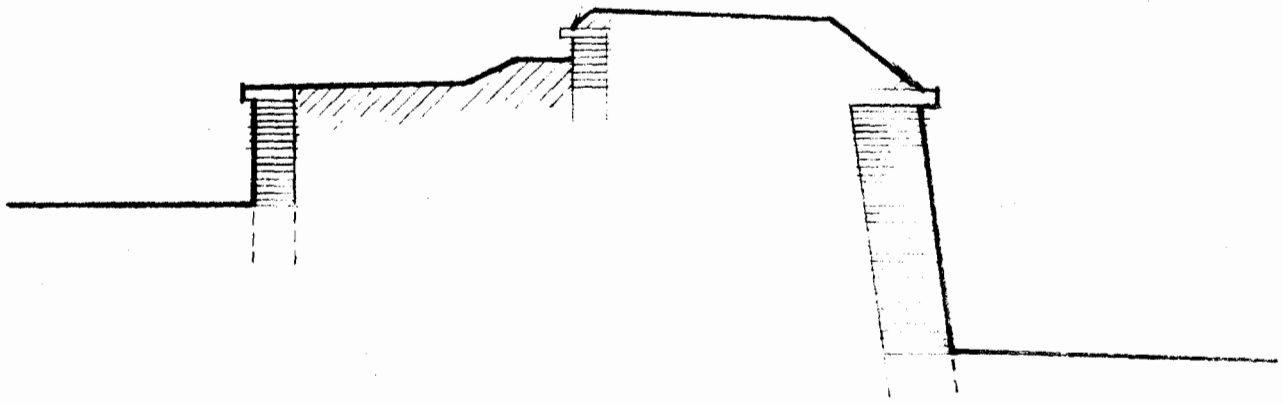
Drawing No. 19.

Bottom: Existing section through
rampart.

Top: New recommended section through
rampart.
