historic structures report
architectural data section
volume two
may 1981

HISTORIC STRUCTURES REPORT
ARCHITECTURAL DATA SECTION
FLOYD BENNETT FIELD
GATEWAY NATIONAL RECREATION AREA
VOLUME II

By
Susan Simpson

UNITED STATES DEPARTMENT OF THE INTERIOR
NATIONAL PARK SERVICE
DENVER SERVICE CENTER
MID-ATLANTIC/NORTH ATLANTIC TEAM
BRANCH OF HISTORIC PRESERVATION
DENVER, COLORADO

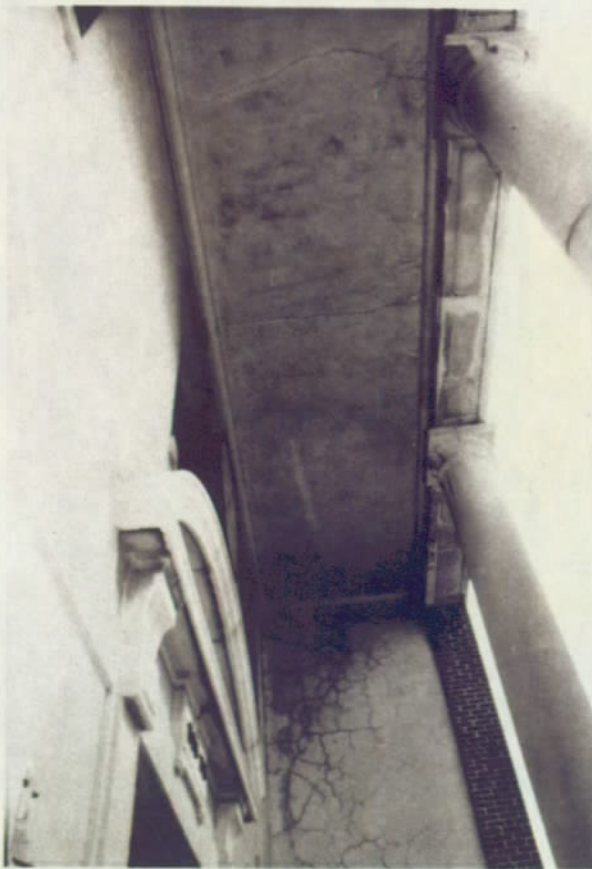
Entry Portico

Cement coating is stained and cracked.

The cement topping over walls at the west entry be repaired.

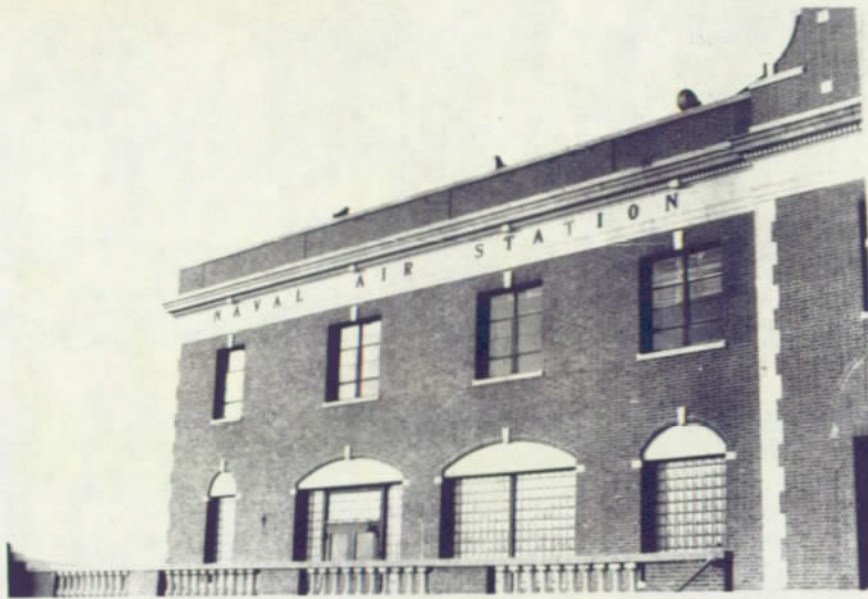
East Elevation at South End - Note later copper letters ("Naval Air Station") and glass block windows (Compare with Sheet 1 of Contract 2000 following). October 1978.

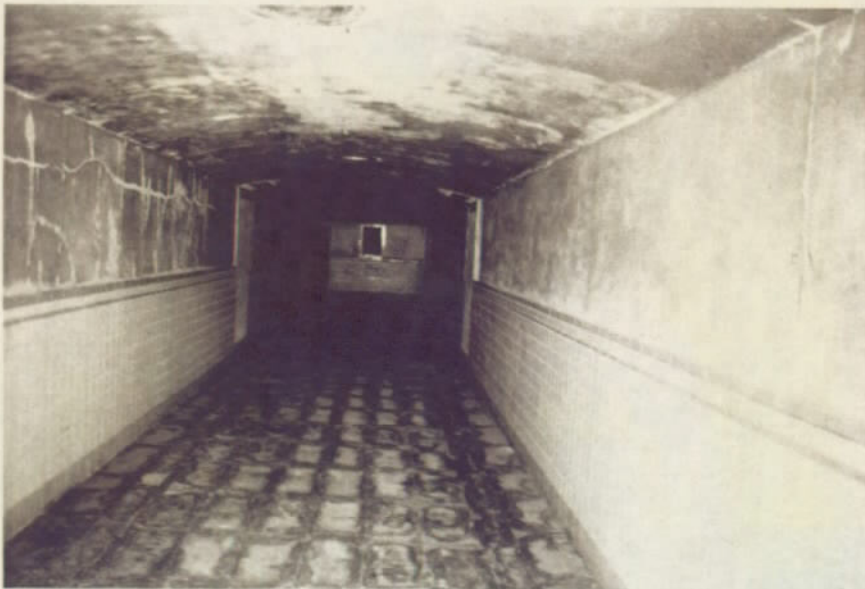
WPA Tunnel - Old wall openings have been sealed with concrete, and no documentation as to what was behind them was found. April 1979.

The current contract calls for sealing the tunnel opening. If future use and interpretation warrants, the tunnel could be cleaned and used in its "as-is" condition.

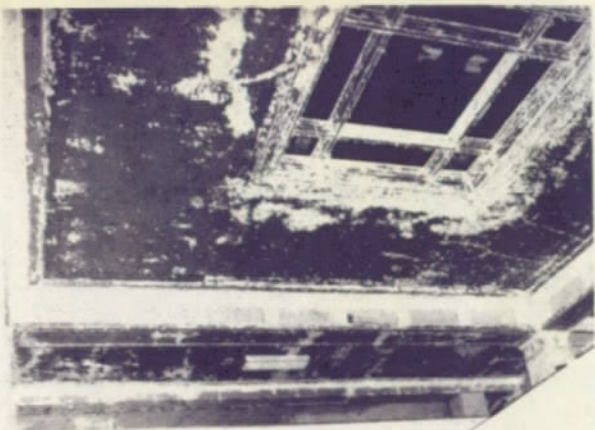
Lobby/Waiting Room Area
looking north. Wood-frame
partition at right has cut
the space in two.

Partitions can be added to provide for varying uses, but it is recommended that no historic partitions or fixtures be removed, and that no changes be made that are irreversible.

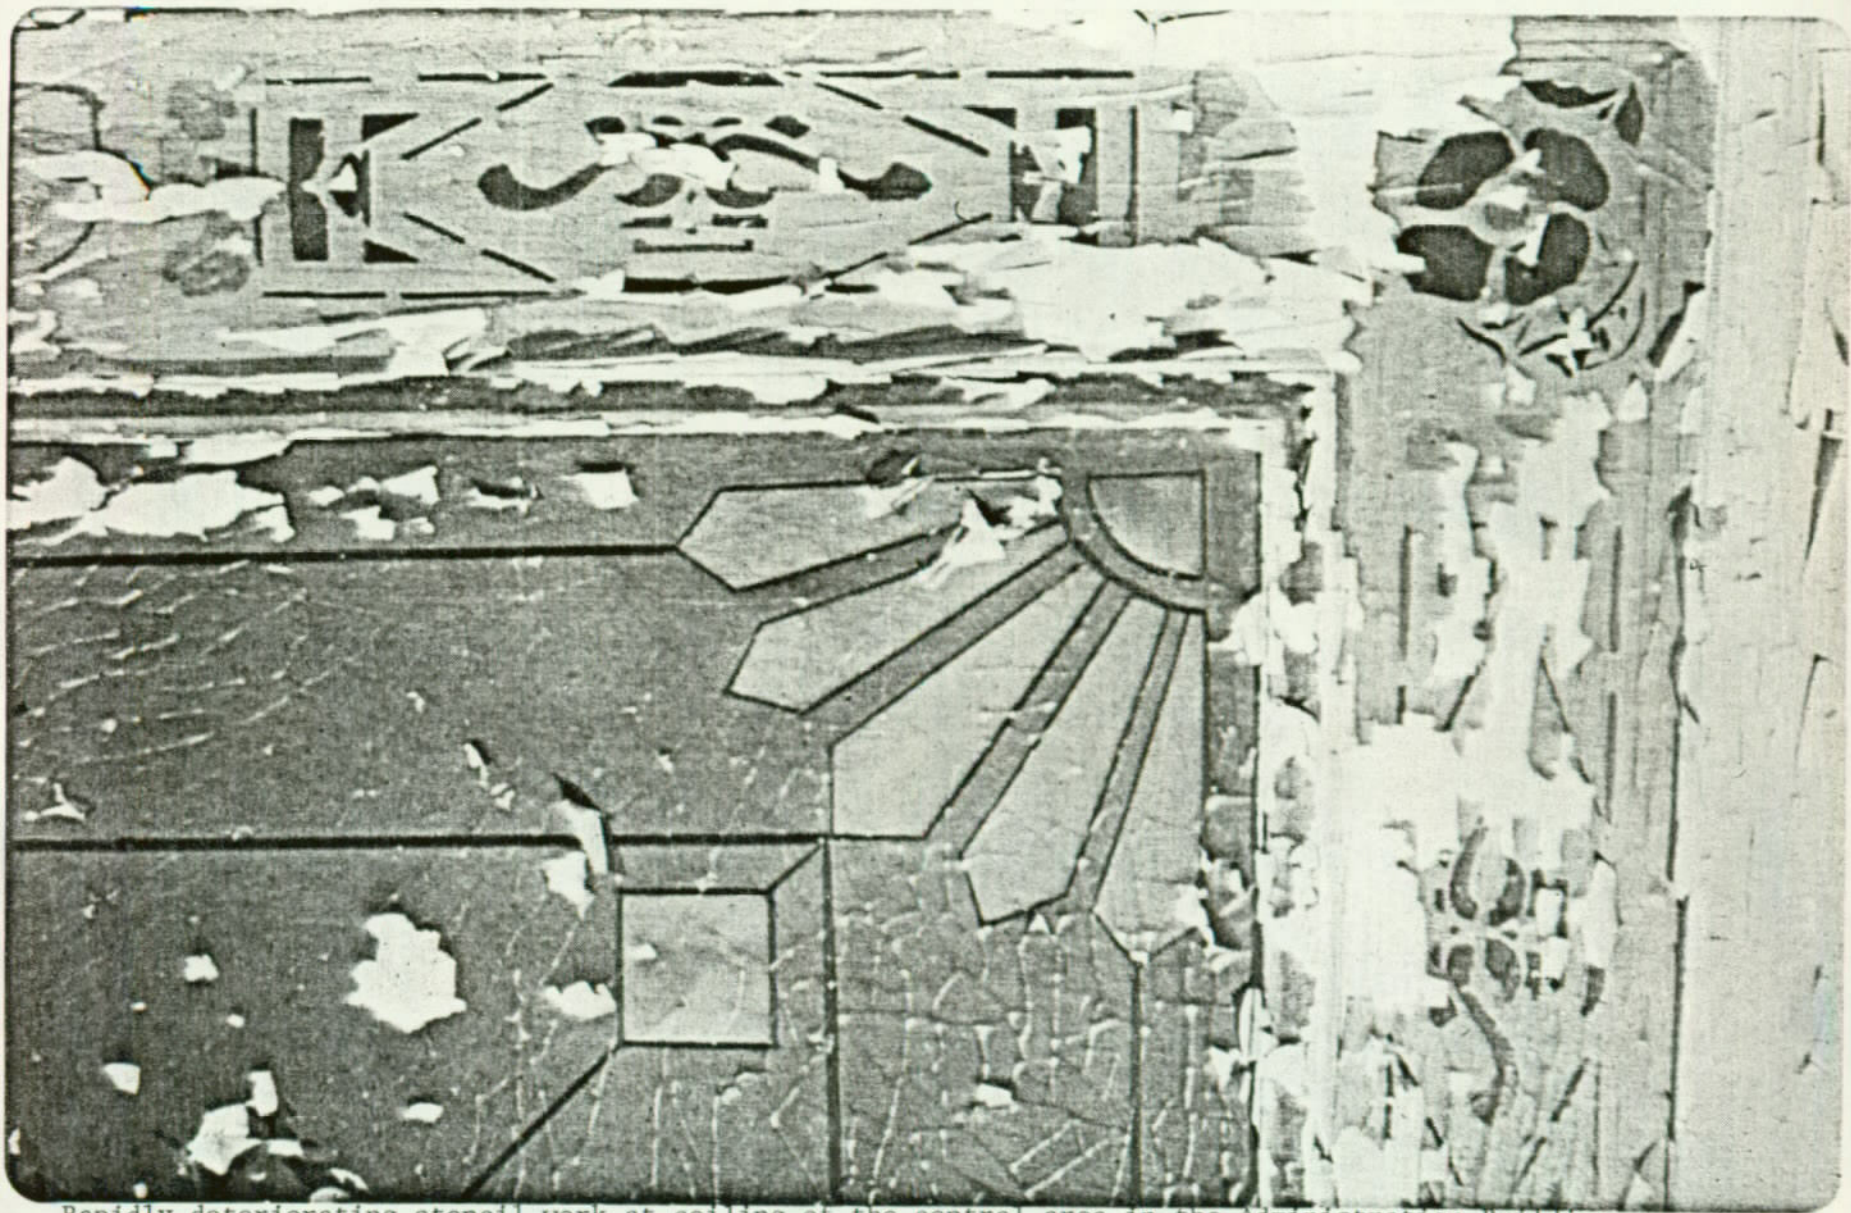
Ceiling stenciling at the lobby/waiting room area is rapidly deteriorating. It is already difficult to discern much of the pattern.

Rapidly deteriorating stencil work at ceiling of the central area in the Administration Building
(Photo courtesy of Brooks Vaughn - Gateway NAR - Ext. Affairs)

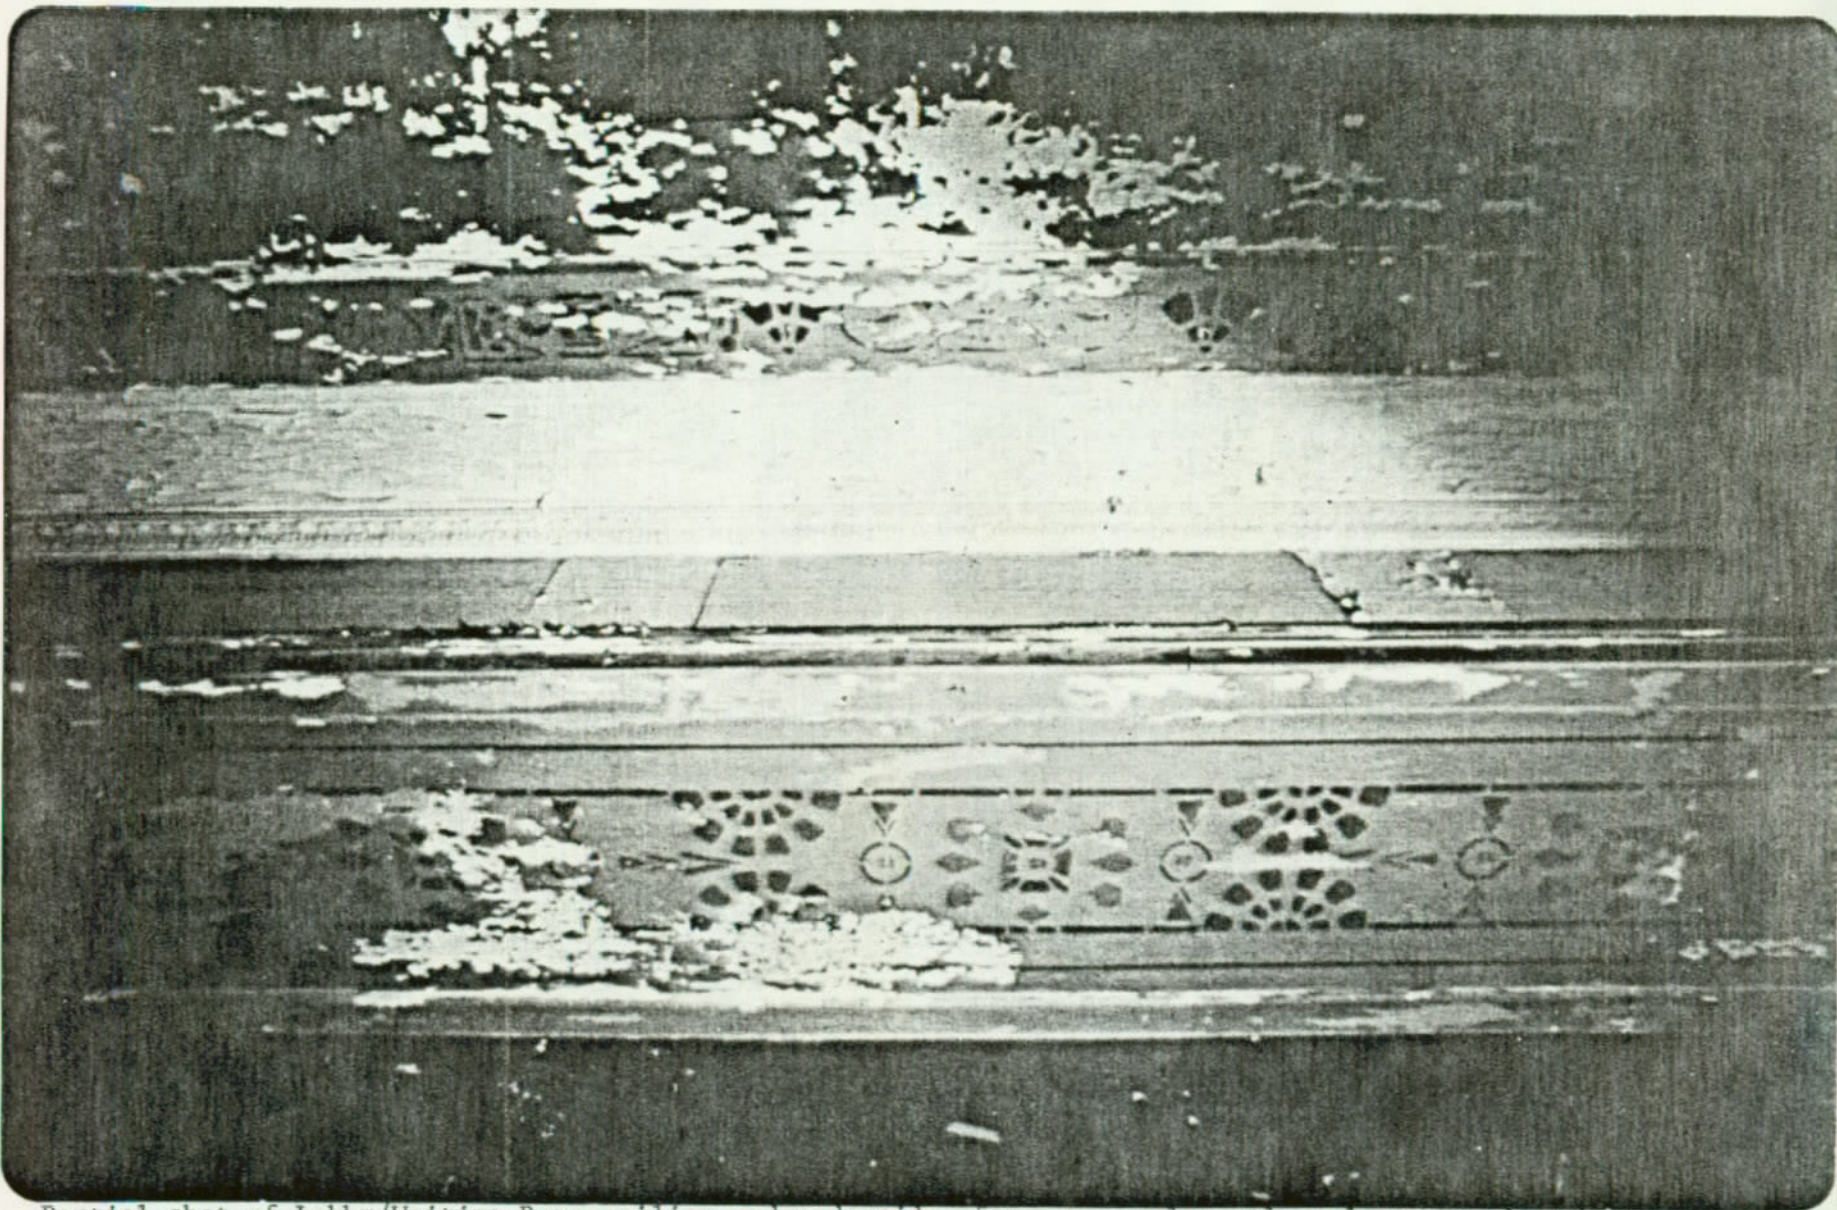
Partial shot of Lobby/Waiting Room ceiling and underside of upper mural panel - plaster work and stenciling rapidly deteriorating. Administration Building. (Photo courtesy of Brooks Vaughn - Gateway NAR - Ext. Affairs)

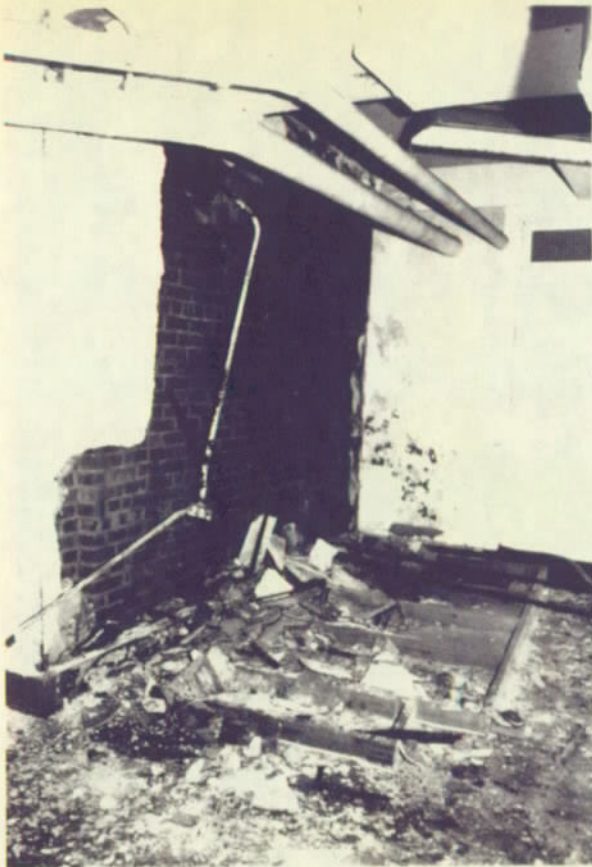
Parts of the ceiling and walls are deteriorating. Most of the deterioration is caused by water which has rusted the channels and lath. This damage is severe at the east, along the area beneath the first floor terrace.

Plaster damage in basement
in room beneath first-floor
level terrace.
April 1979.

Plaster damage at walls and ceiling should be repaired. Any exposed steel members should be cleaned and painted before recovering.

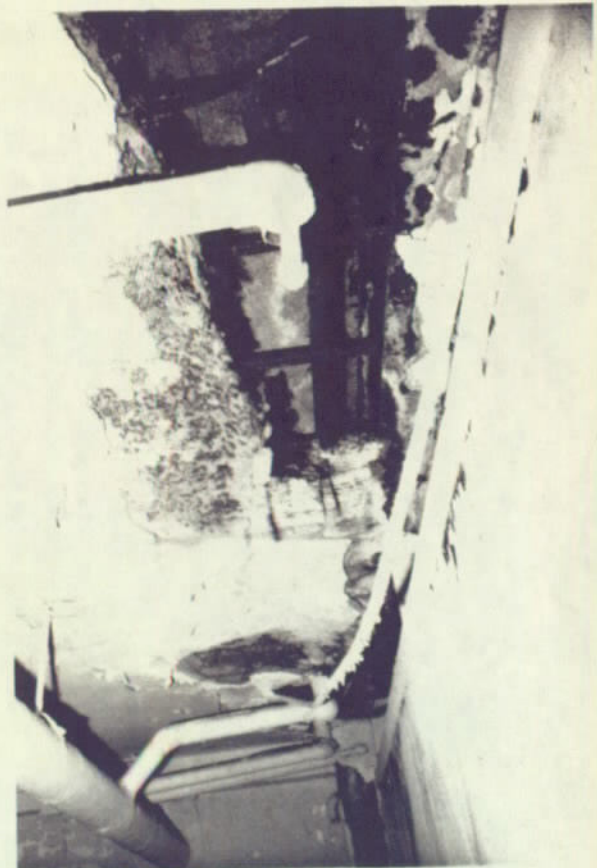
Ceiling damage in basement
reveals construction detailing.
April 1979.

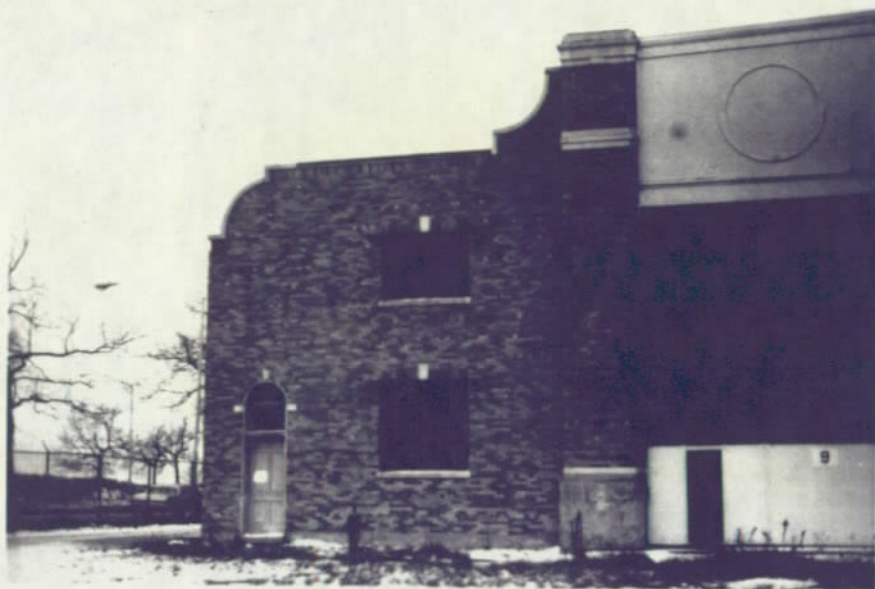
West Hangar Leanto - South elevation
note loose and missing bricks at
the parapet
January 1979

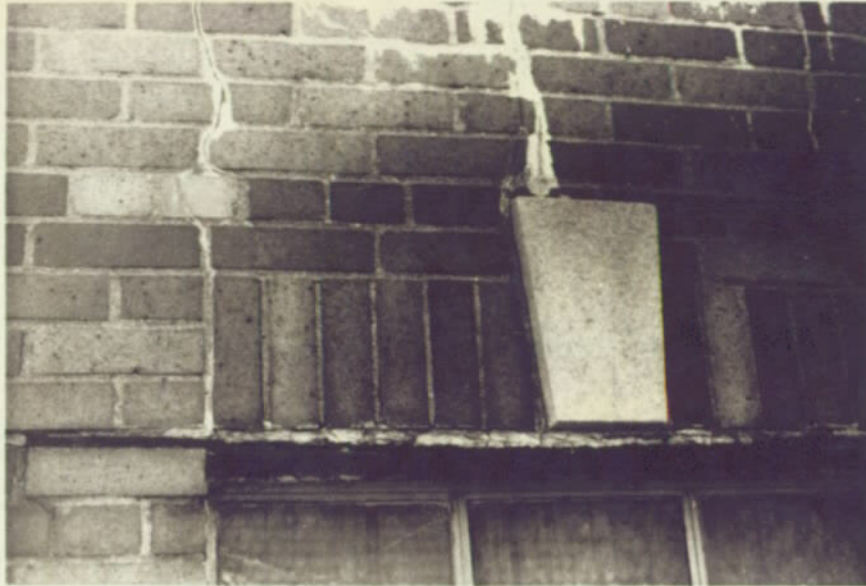
Typical window head condition
note rusting, expanding lintel
January 1979

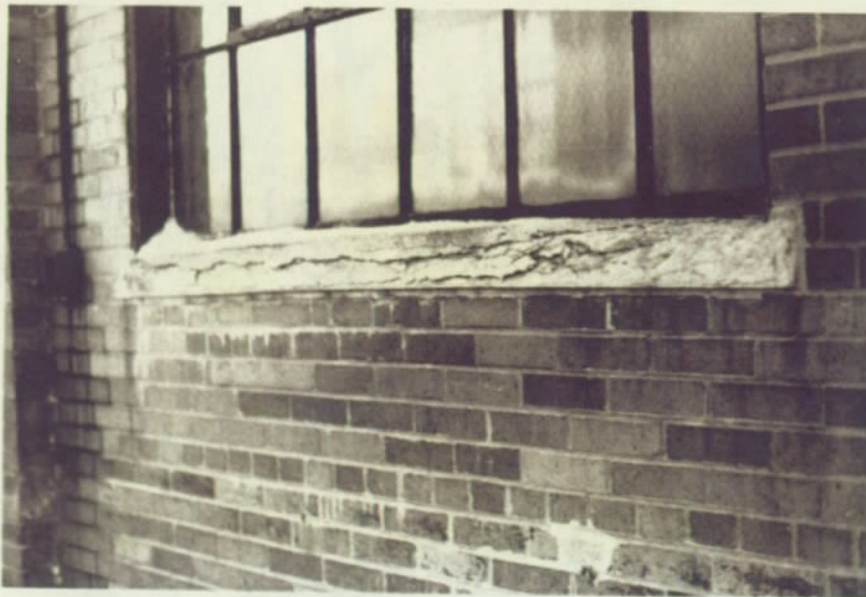
Sill condition - cast stone extremely deteriorated
January 1979

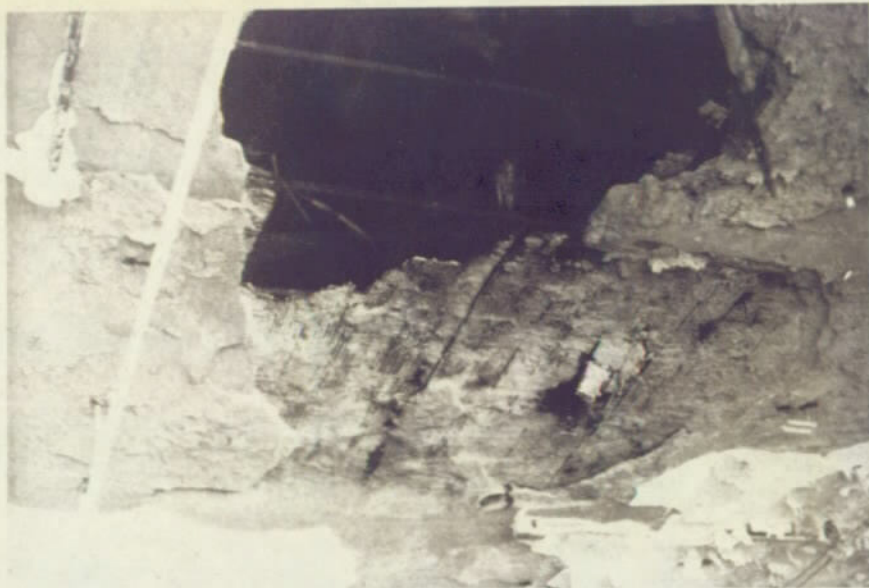
Extreme deterioration of ceiling fabric
found in West Hangar Lean-To
January 1979

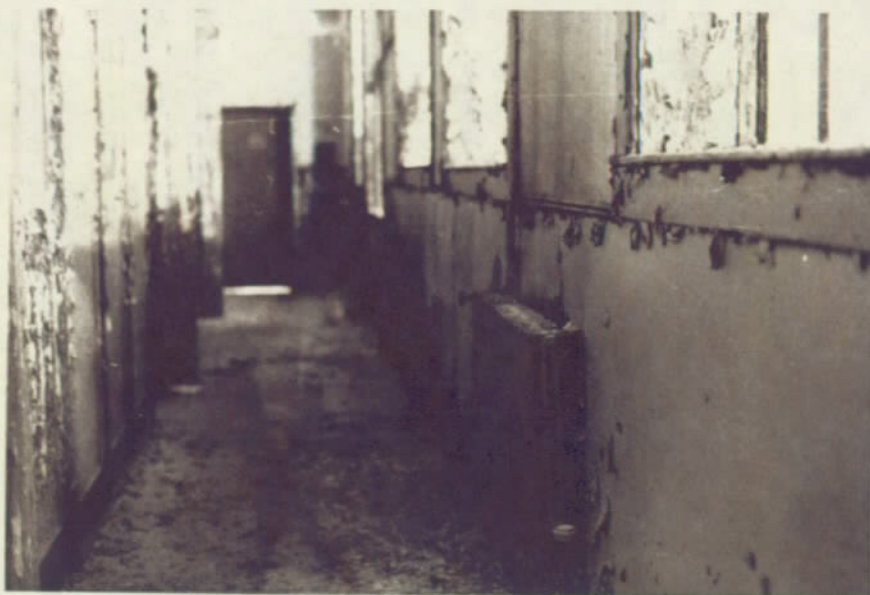
Typical condition at second story of
East Hangar Lean-To
January 1979

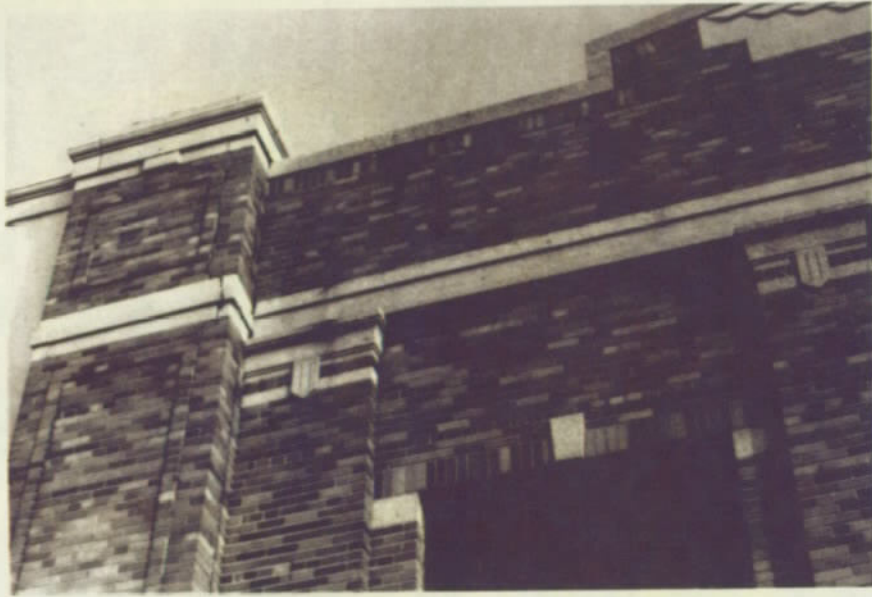
North WPA infill - note typical pilaster damage.
April 1979

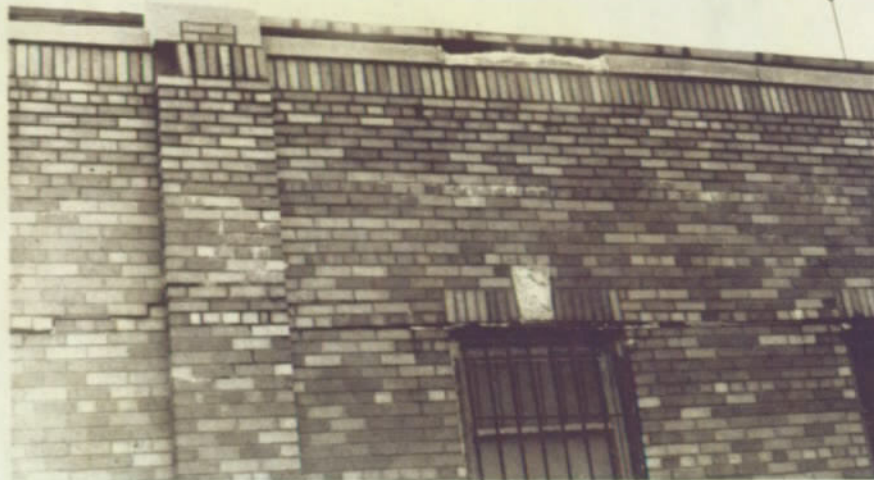
Upper wall at west elevation - note separation along
lintel lines and extremely deteriorated mortar.
April 1979

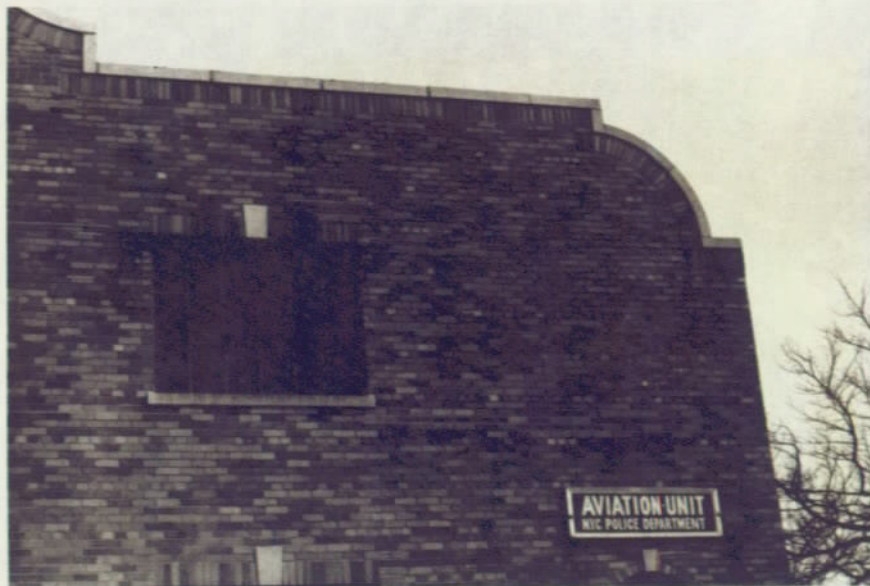
Northwest corner parapet - typical parapet condition.
April 1979

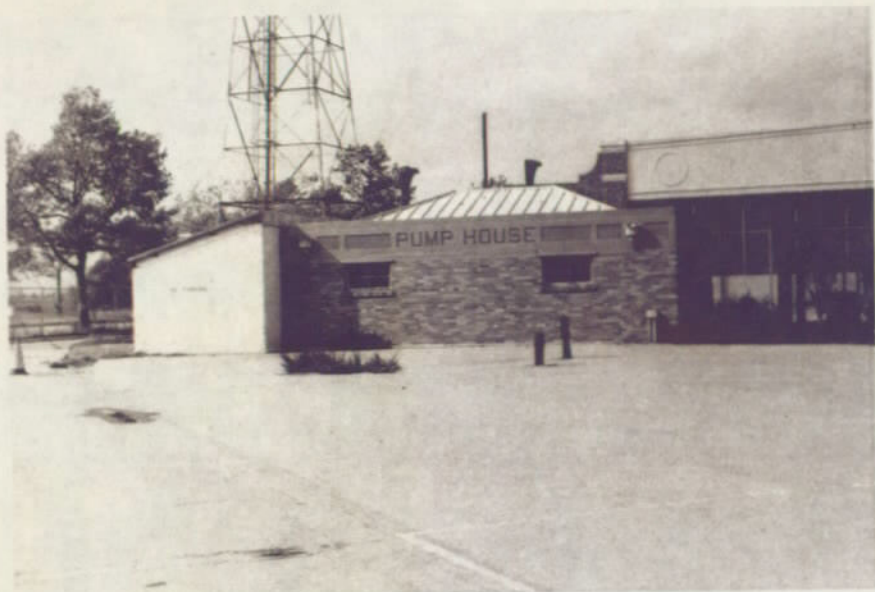
South Elevation - Downspouts missing. Note Beacon Tower 145 at left rear and Hangar Complex 5 at right. October 1978

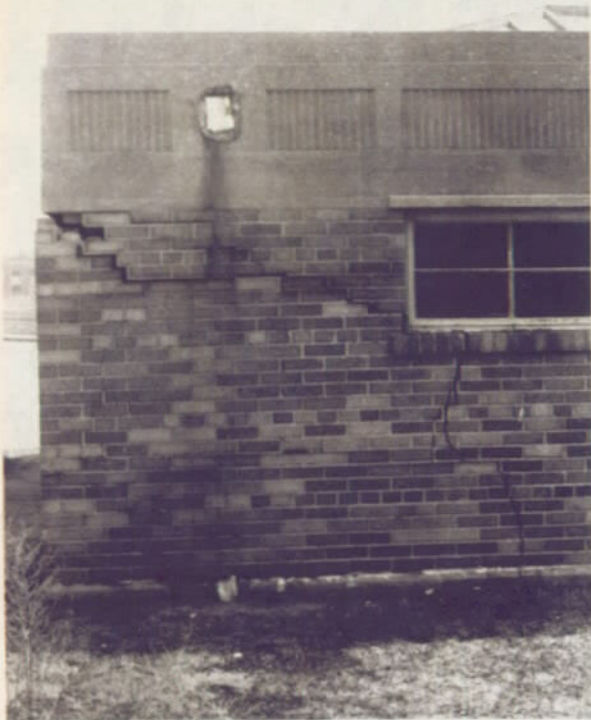
East Side of North Elevation

Foundation has sunken at this corner (probably due to excess water saturating the earth at this point). October 1978

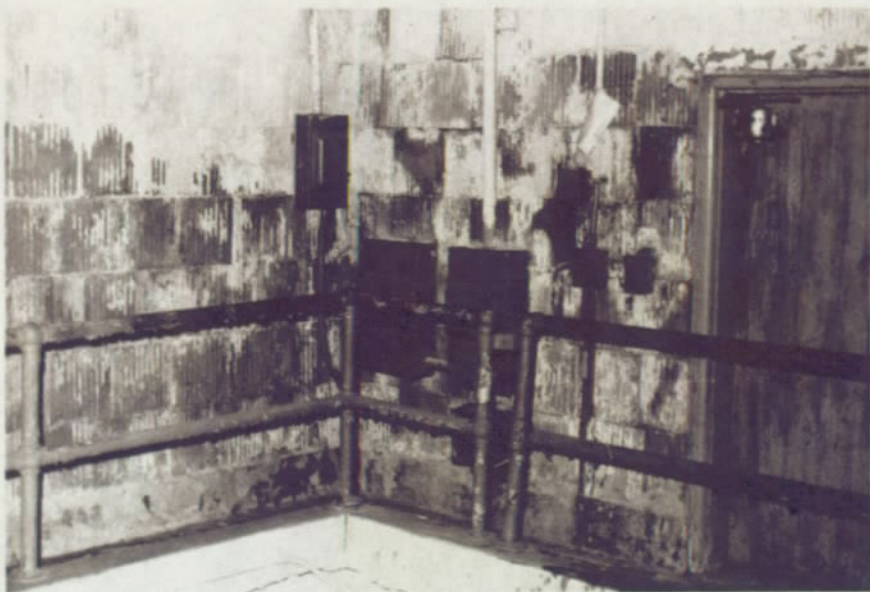
Northeast corner - typical wall and railing condition. June 1979

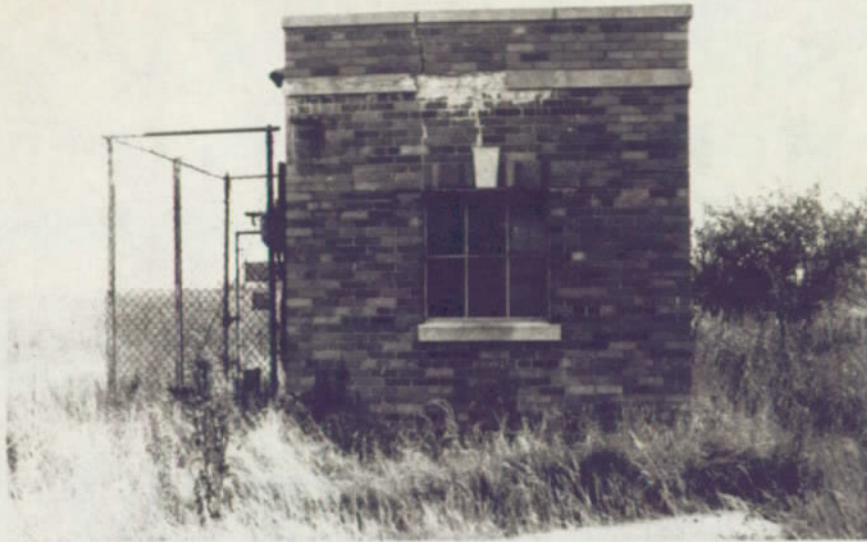
North elevation - structure is cracked both vertically and horizontally. October 1978

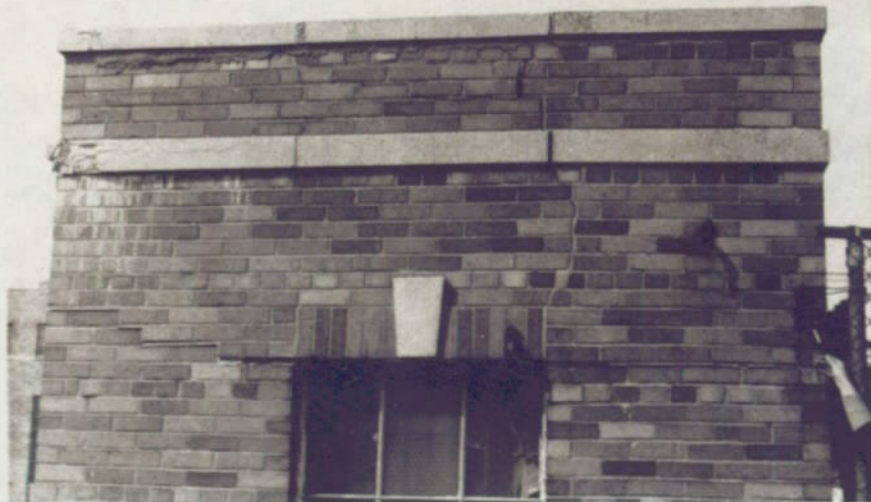
South elevation - vertical separation continues parallel to that at north. Horizontal separation continuous along lintel heights. October 1978

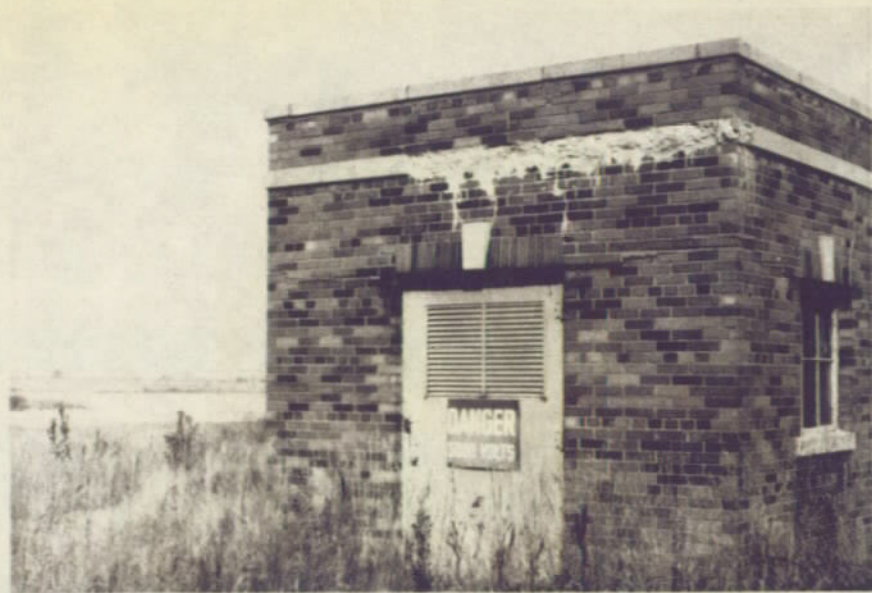
West elevation - note cast iron trim deterioration and bulge at lintel. October 1978

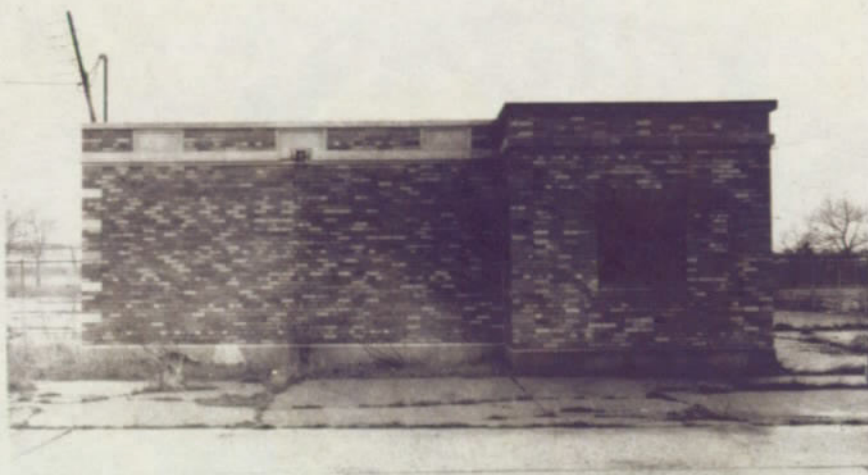
East Elevation - As seen from the airfield. Note opening beneath the center cast stone parapet panel for missing scupper and horizontal separation at window head line.
January 1979

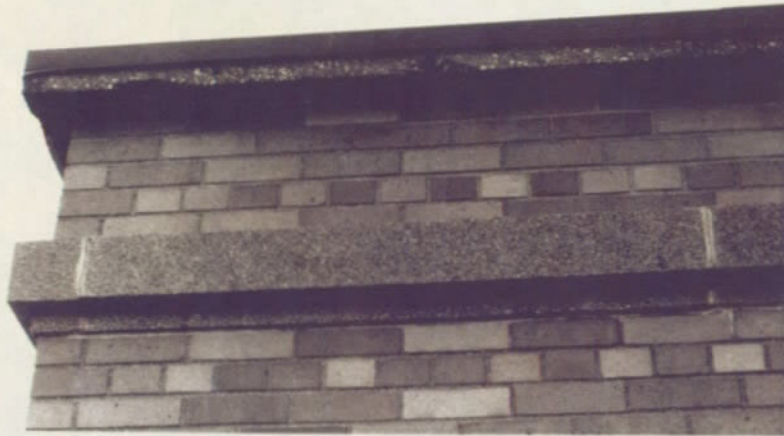
Roof of later wing - Note spalled concrete and exposed steel reinforcement.

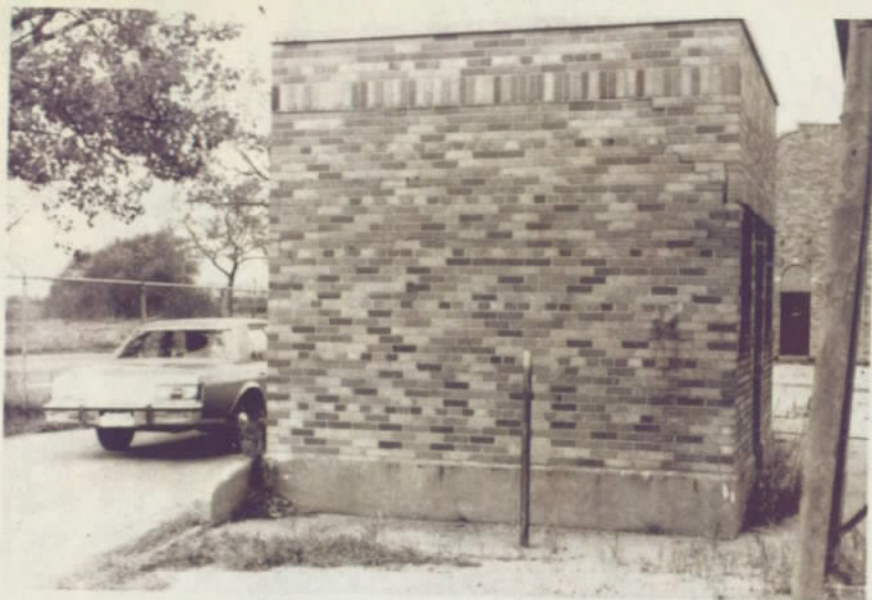
South Elevation - Note crack from lintel expansion at east extending around corner to south side. October 1978

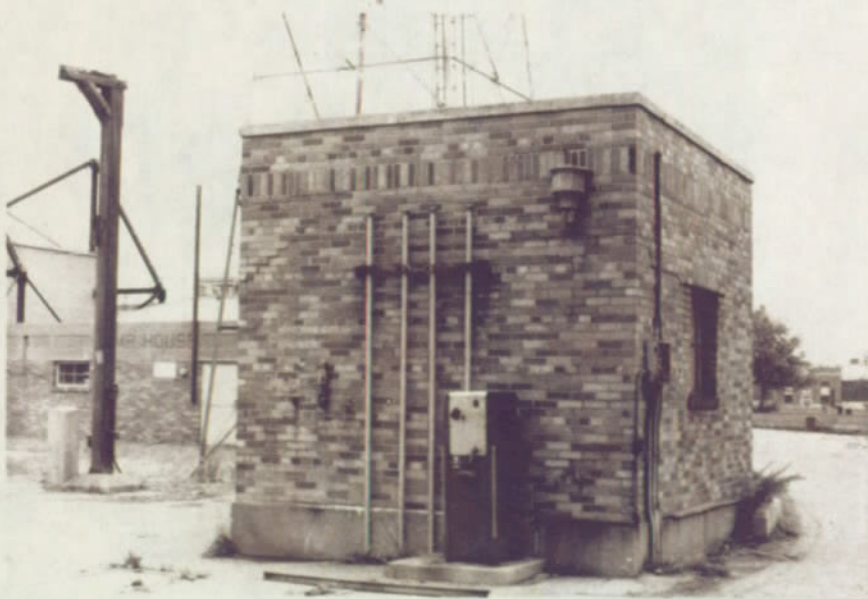
North Elevation - Missing downspout - crack at west lintel level - crack at east lintel extends around corner and up at north elevation. Note loading post at left, lower part of beacon tower behind. October 1978
